DAILY INSPECTION REPORT - No. 20230809

Haight Farm, Site No. 837006

TRC Engineers, Inc. (TRC) performed a post-storm inspection on Wednesday, August 9, 2023, of the Haight Farm site (Site) located at 4879 Upper Holley Road, in the Town of Clarendon, Orleans County, New York. The purpose of the Site inspection was to observe the landfill cap, perimeter fence and monitoring wells after recent storm events.

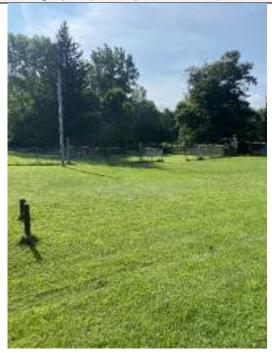
Photo 1: Access gate of capped area found to be open upon TRC arriving, facing southwest.

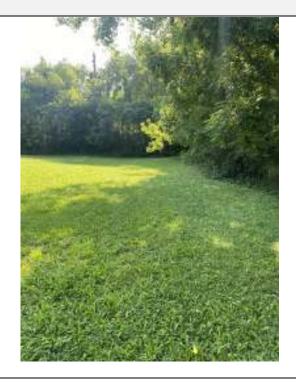
Photo 2: Vegetation overgrowth on fence in southeast corner of Site, facing southeast.

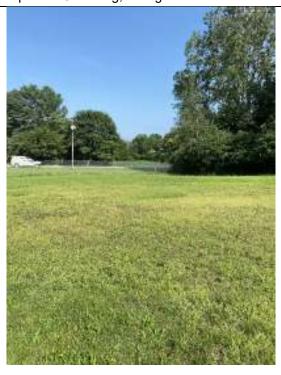
Photo 3: Landfill cap, facing northwest.

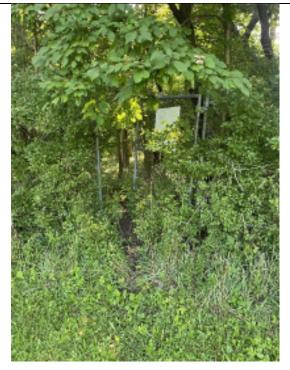
Photo 4: East access gate found to be open, facing east.

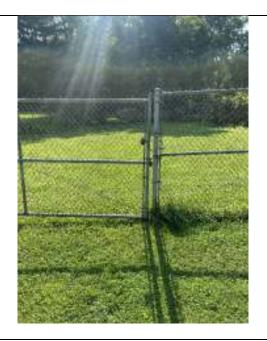
Photo 5: Front access gate locked by TRC when leaving, facing east.

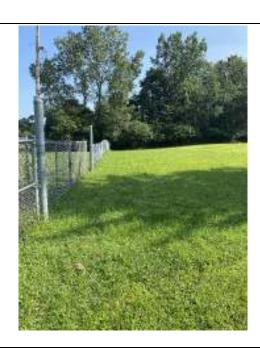
Photo 6: East fence-line, facing north

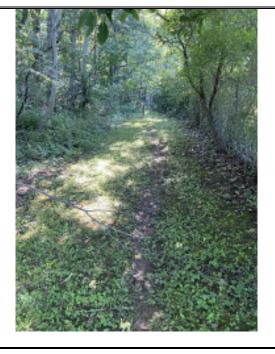
Photo 8: Path to MW-6S and MW-6D, facing east.
