October 1, 2007

**RE: NYSDEC Standby Contract  
Site Management # D004440-25  
North Franklin Street Site, Site No. 8-49-002  
Site Inspection Letter Report - August 2007**

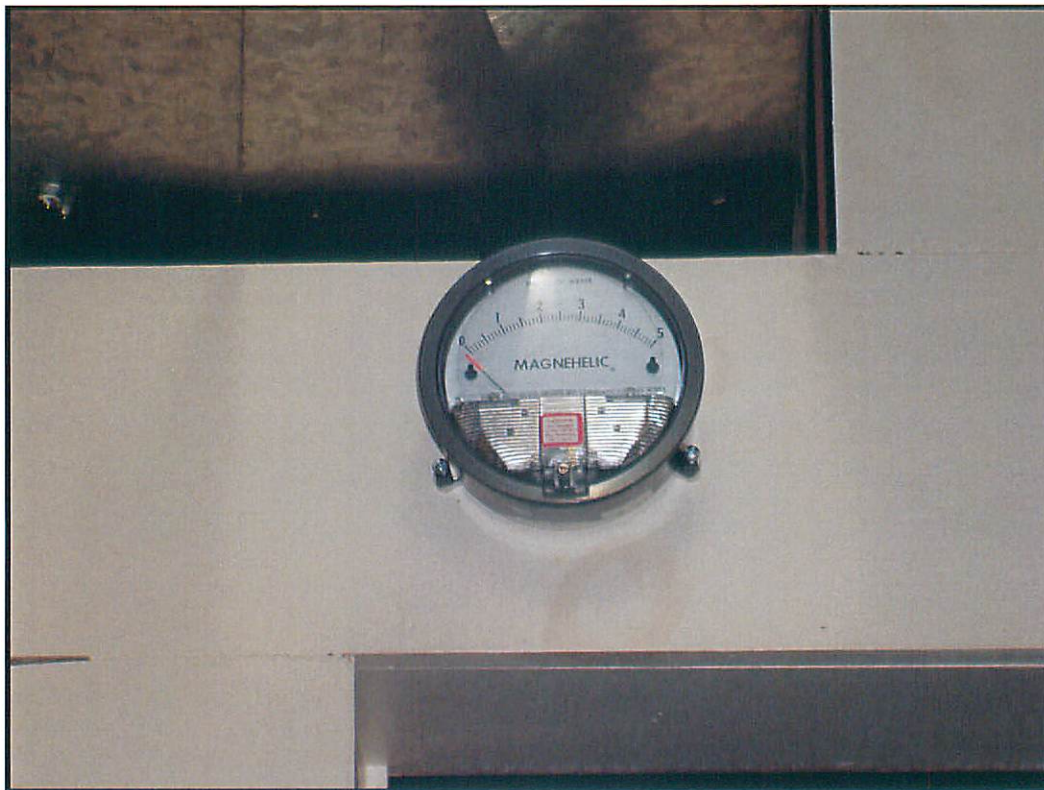
Although the magnehelic gauge reading from Suction Point #1 was 0.0 inches of water, the remaining two suction points indicated a vacuum, which indicates that the system fan is working. Vacuum testing performed after the installation of the SSD system indicated that Suction Point #1 had an influence beneath the northern half the build floor even though it had a lower vacuum reading on the magnehelic gauge when compared to Suction Points #2 and #3.

Photo 1: VFW suction point #1 magnahelic.

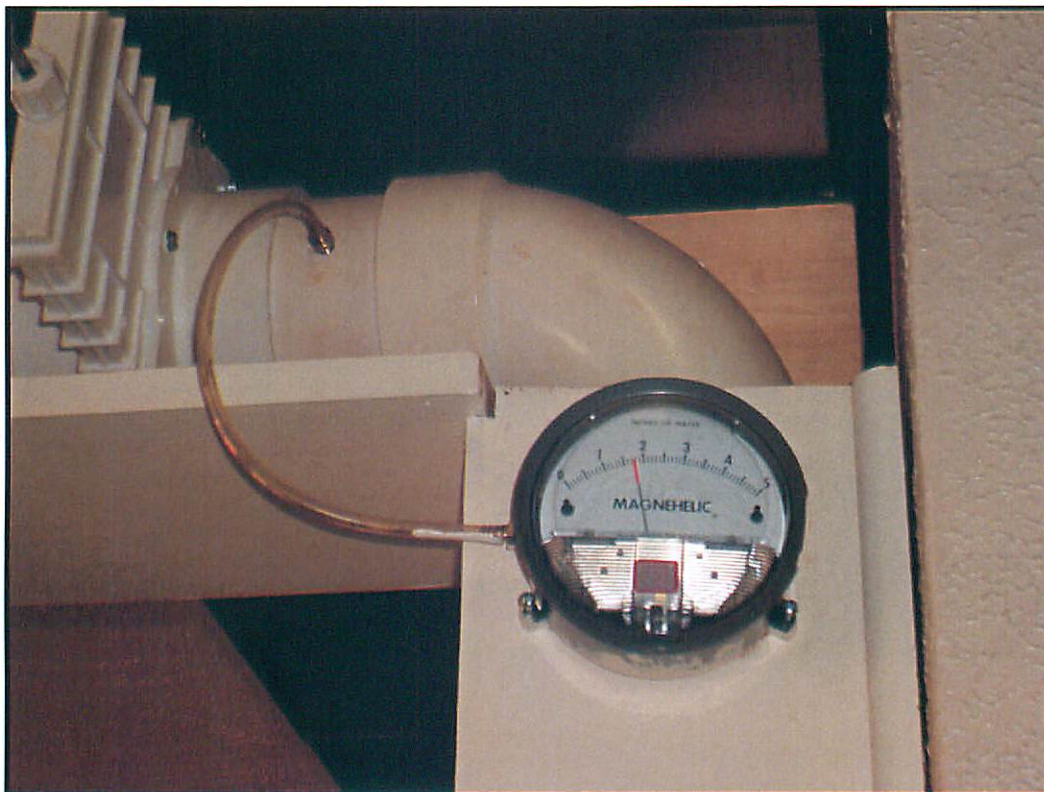
Photo 2: VFW suction point #2 magnahelic.

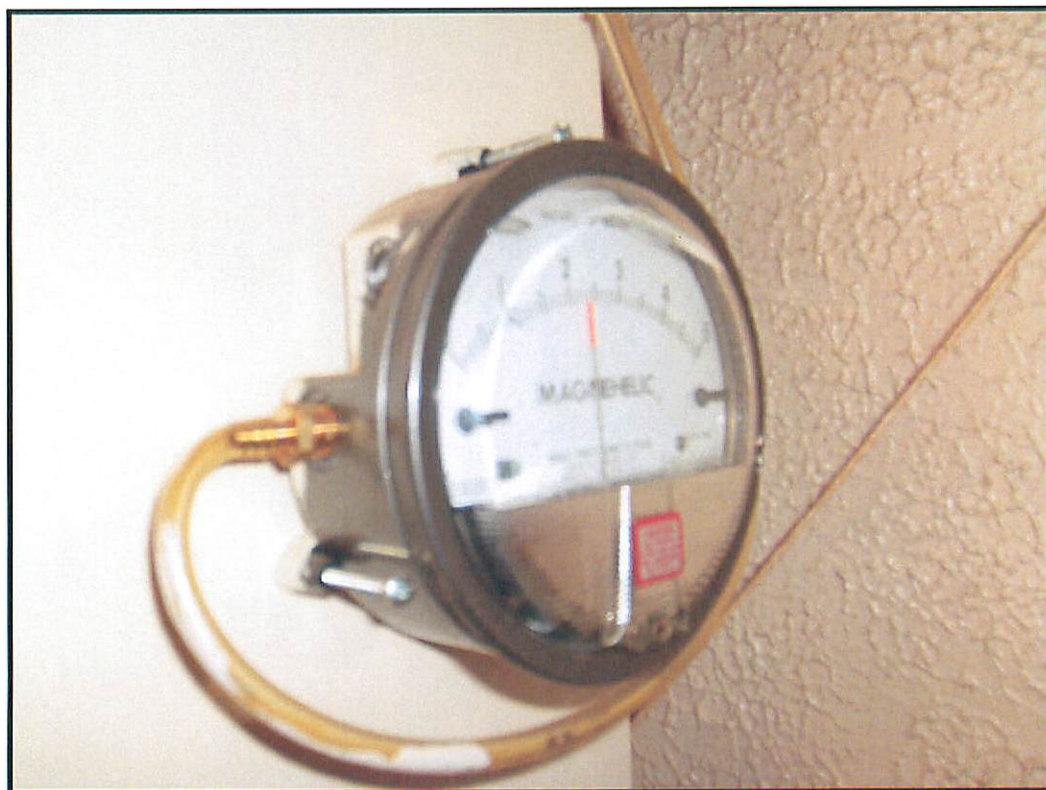
Photo 3: VFW suction point #3 magnahelic.

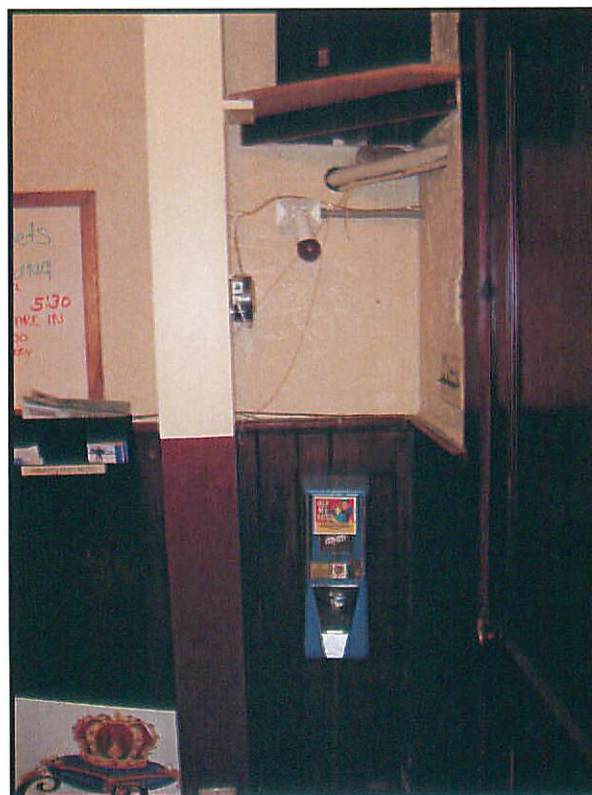
Photo 4: VFW suction point #3, magnahelic, and indicator light.

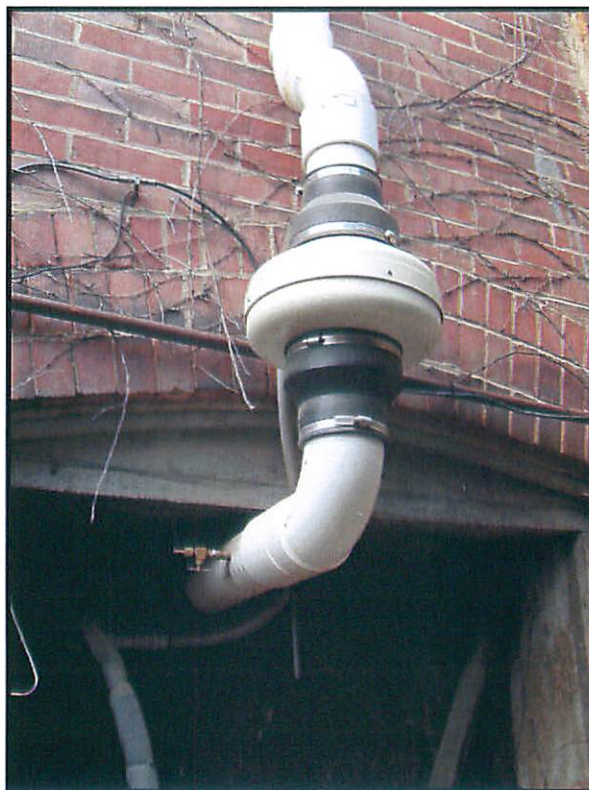
Photo 5: VFW SSD system fan.

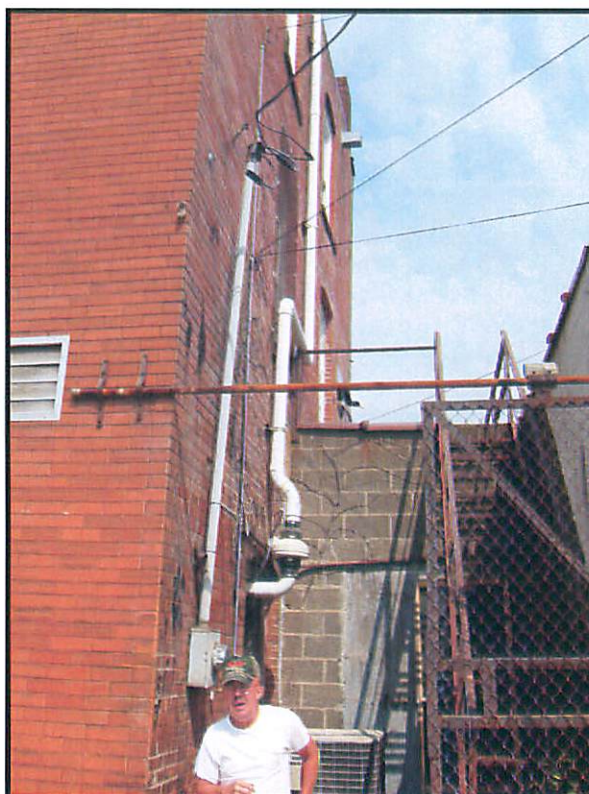
Photo 6: VFW SSD system fan and vent stack.

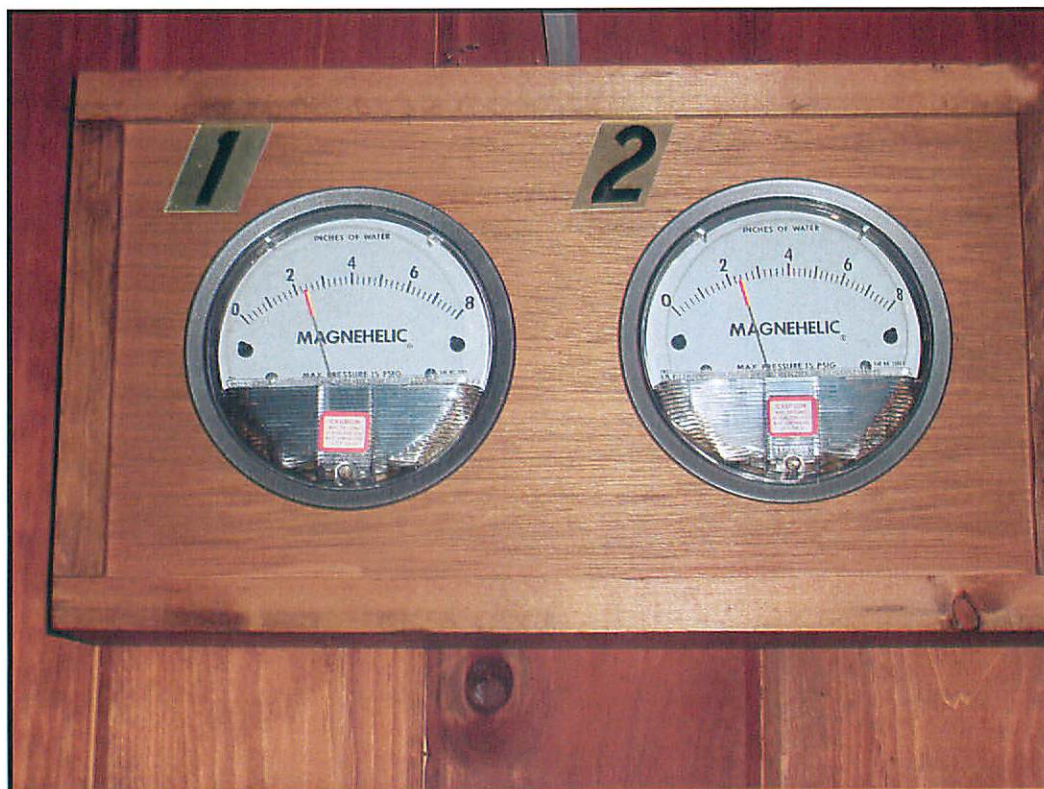
Photo 7: Seneca Market suction point #1 and #2 magnahelics.

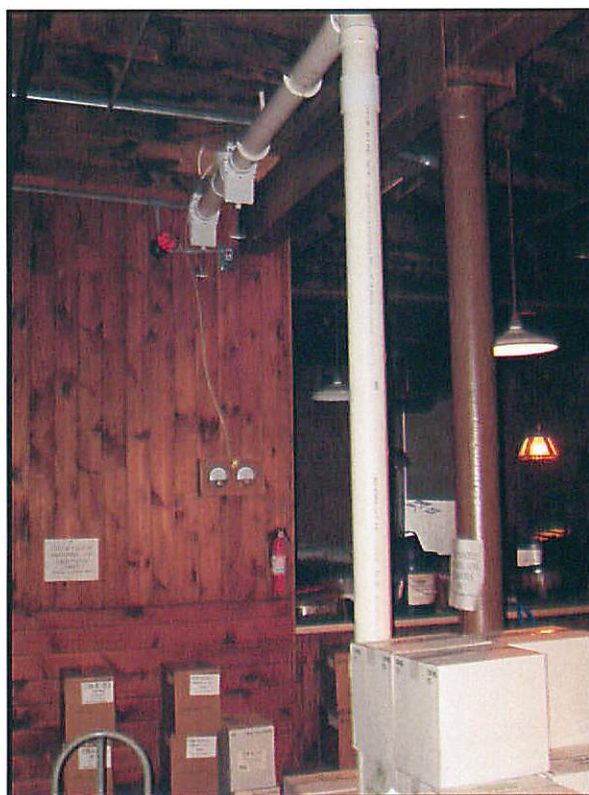
Photo 8: Seneca Market suction point #1, magnahelics, and indicator light.

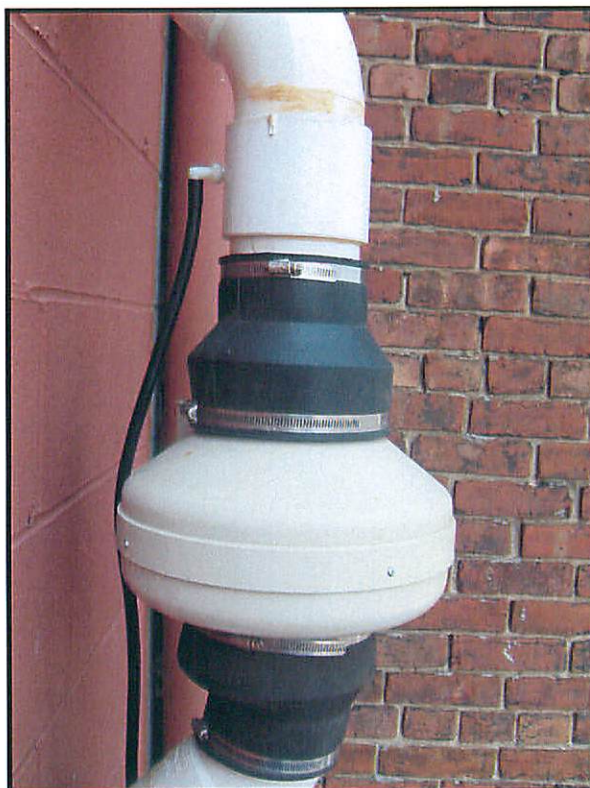
Photo 9: Seneca Market SSD system fan.

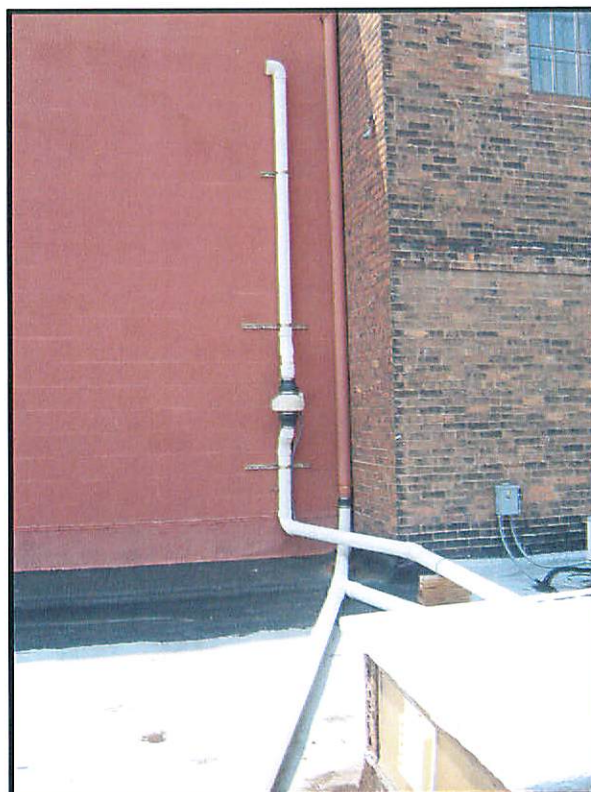
An inspection of the SSD fan indicated that it was operating properly, the sampling port was closed and the moisture by-pass tube was still attached above the fan. The vent stack appeared to be in good condition. Inspection details are provided in Attachment 1. A photographic log is provided in Attachment 2.

Photo 10: Seneca Market SSD system fan  
and vent stack.
