## DAILY CONSTRUCTION REPORT

PROJECT: North Franklin Street Site-Site Management  
CONTRACTOR URS-Buffalo  
URS JOB No. 11174721  
URS PROJECT MANAGER: Chuck Dusel

## VFW PHOTO LOG

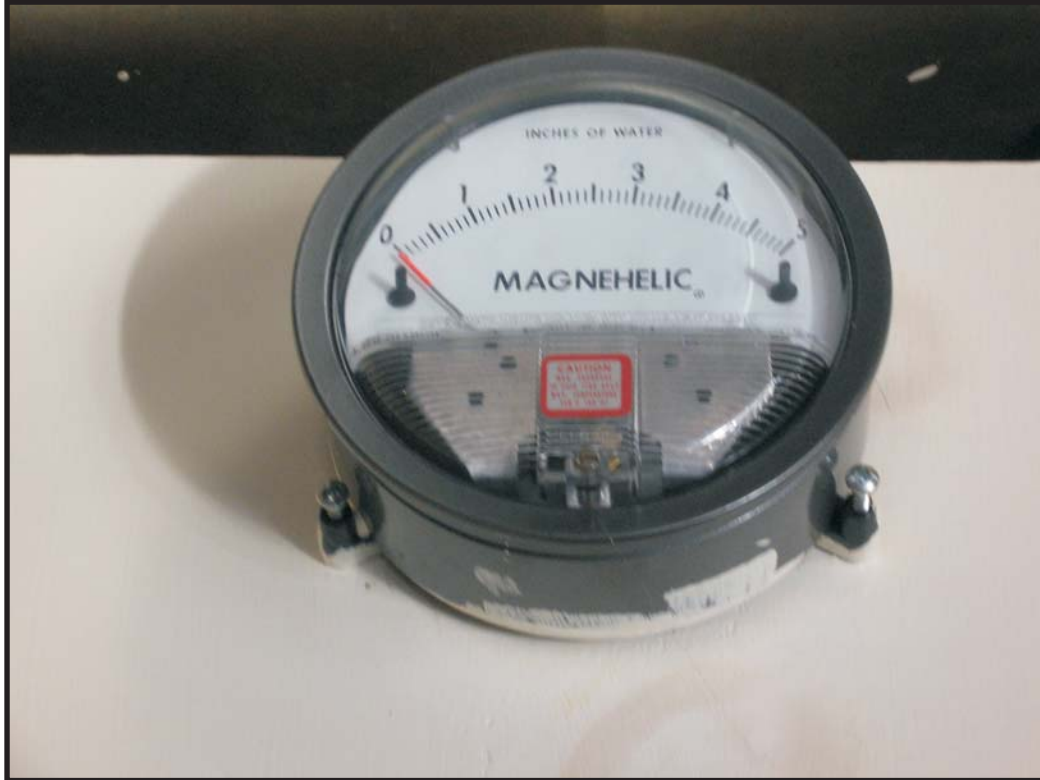
| EQUIPMENT AT THE SITE: |
|---|
| 1430. S. McCabe arrives at VFW Post in Watkins Glenn to replace magnehelic gauge at Suction Port #1. Reads 0 inches of water. |

Photo 1: VFW suction point #1 magnehelic.

| EQUIPMENT AT THE SITE: |
|---|
| 1455. Hook up new tubing and re-attach existing magnehelic gauge. Suction Port # 1 reads 2.3 inches of water. Check remaining gauges. Suction Port # 2 reads ~ 1.8 inches of water. Suction Port # 3 reads 2.3 inches of water. Adjust control valve at Suction Port # 4 now reads ~ 2.3 inches of water |

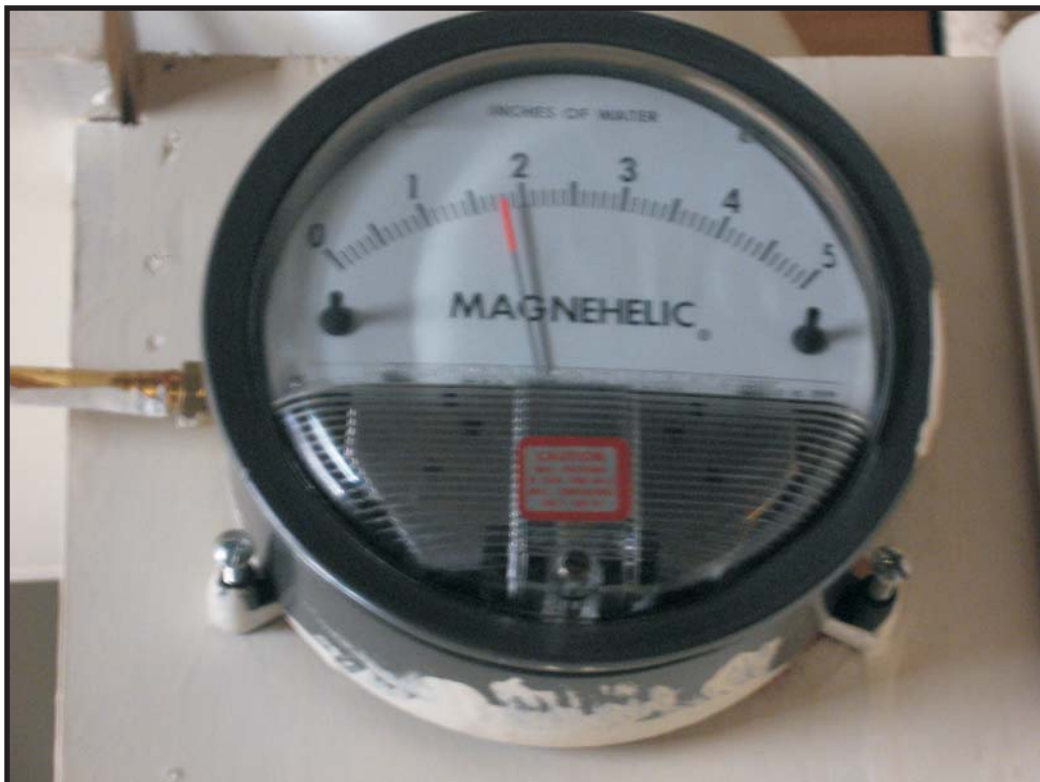
Photo 2: VFW suction point #2 magnehelic.

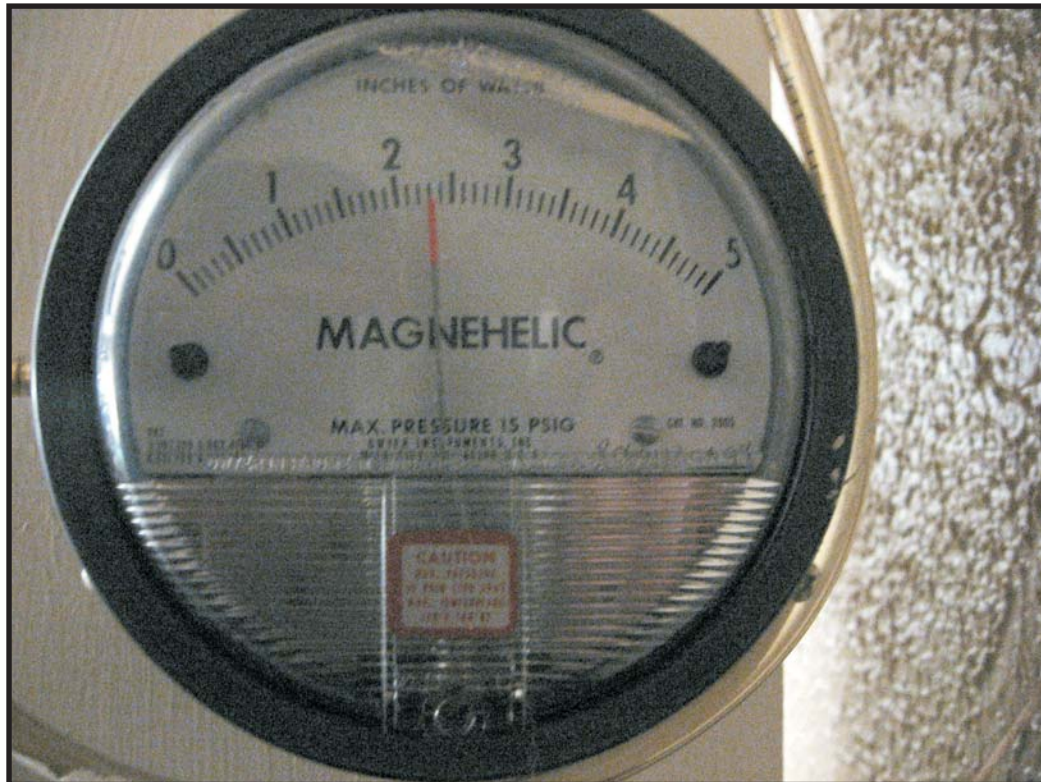
Photo 3: VFW suction point #3 magnehelic.

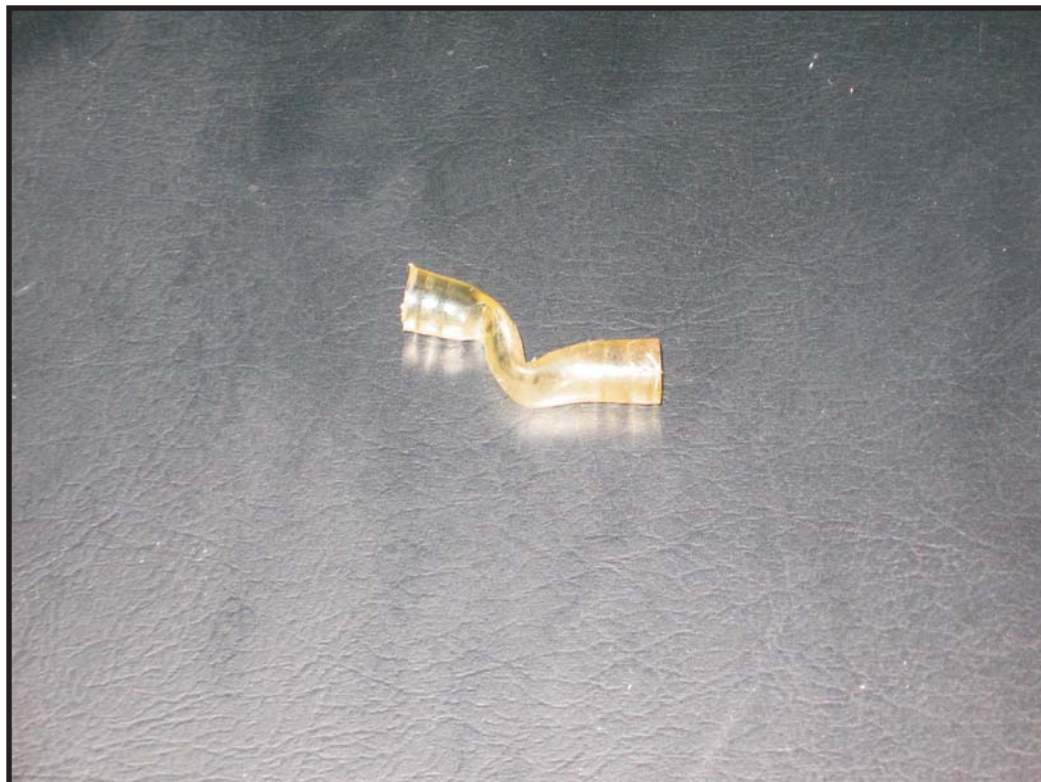
| EQUIPMENT AT THE SITE: |
|---|
| 1435. Upon removal of magnehelic gauge, it is noted that tubing connected to gauge is crimped. Uncrimped tubing and checked vacuum reading with existing magnehelic gauge. Vacuum reading of >2 inches of water. |

Photo 4: Crimped connection hose from suction point #1 magnehelic.

| EQUIPMENT AT THE SITE: |
|---|
| 1440. Called C. Dusel -URS to report findings. Will replace tubing and reconnect existing guage. Will not drill any additional vacuum test holes. |
| 1448. Call D. Chuisano - NYSDEC. Informed Dave of conditions. He agrees with replacing tubing. There is no need for additional vacuum test holes. Make note on information card that is near Indicator Light that all suction ports should have reading. |

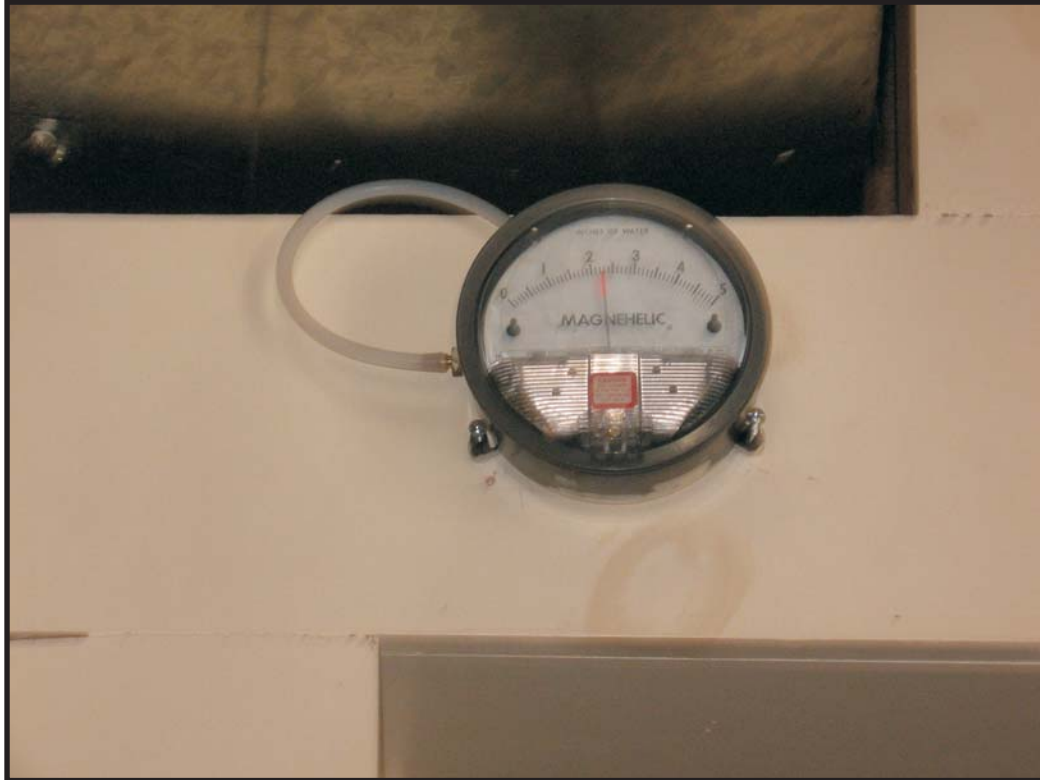
Photo 5: New connection hose for suction point #1 magnehelic.

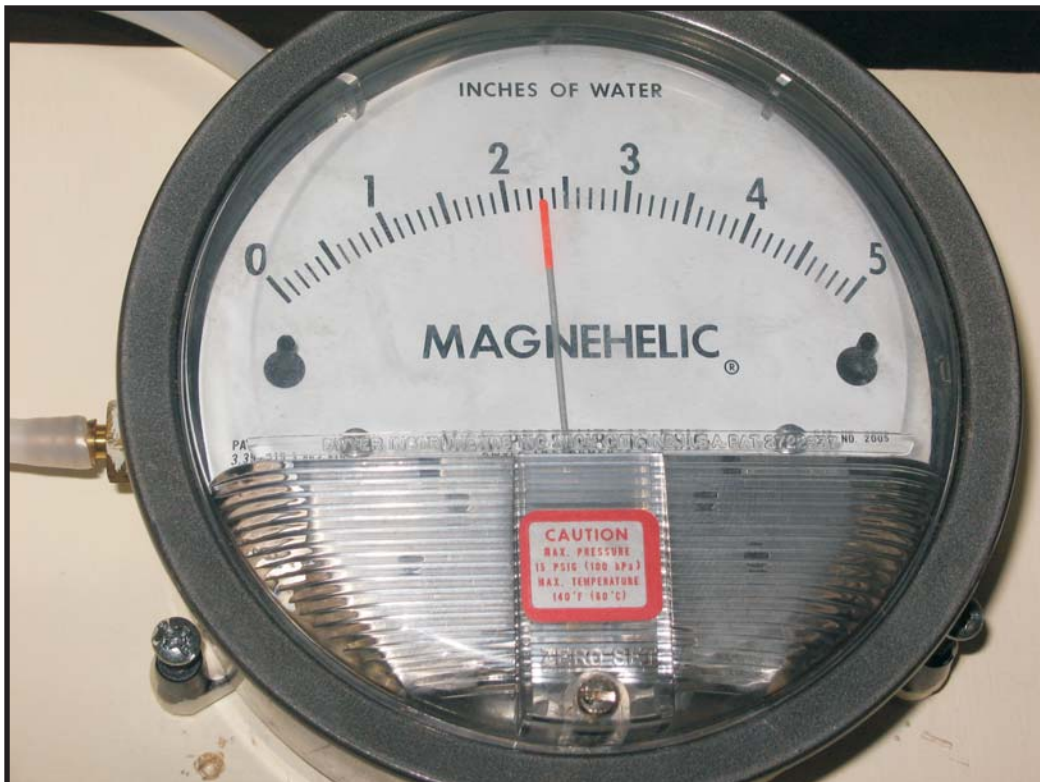
Photo 6: VFW suction point #1 magnehelic reading after installation of new connection hose.

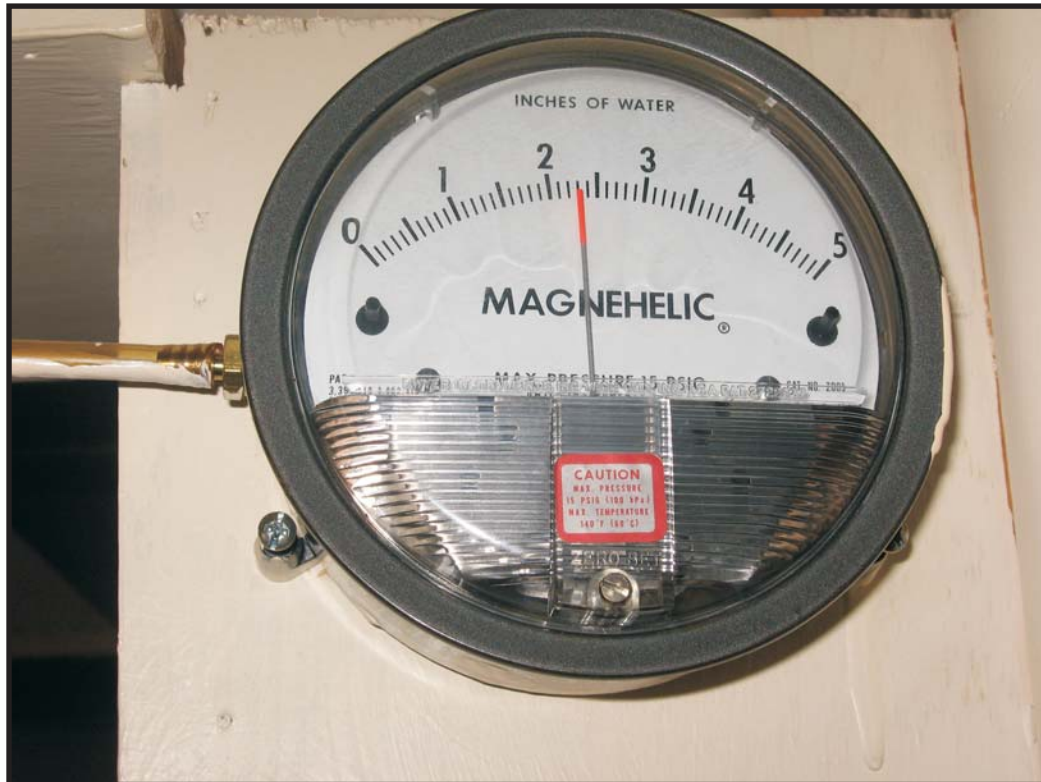
Photo 7: VFW suction point #2 magnehelic reading after gate valve adjustment.
