System Inspection Field Forms

VFW Post 2674

System Inspection Field Form
Soil Vapor Mitigation Systems, Endicott, NY

North Franklin Street – VFW Post 2674 Sub-Slab Depressurization System Inspection

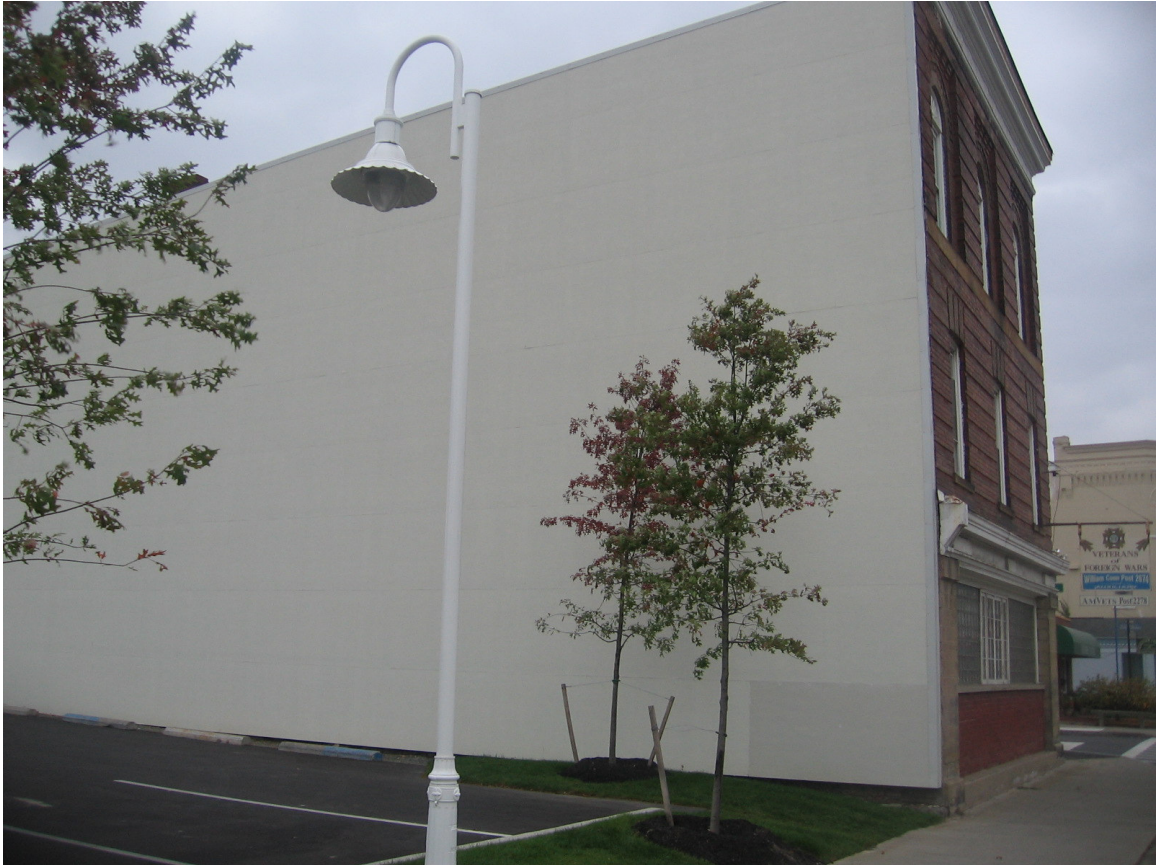
No	Yes	If yes, explain...
Building Footprint	<u>No</u>	_____	_____
Basement/Slab Occupancy	<u>No</u>	_____	<u>No basement</u>
Heating/Ventilating Systems	<u>No</u>	_____	_____
Basement Finish	_____	_____	<u>No basement</u>
Crawlspace	_____	_____	<u>No crawlspace</u>
Drains, Sumps, <u>Floor Cracks</u>	<u>No</u>	_____	<u>No drains or Sumps</u>
Wall Penetrations, Cracks	<u>No</u>	_____	<u>No new wall penetrations or cracks</u>
Appliances (in basement)	_____	_____	<u>No basement - therefore no appliances</u>
Ownership	<u>No</u>	_____	_____
Siding	_____	<u>yes</u>	<u>North exterior wall covered with</u>

If any of these items have changed, a redesign may be required. $\sim \frac{3}{8}$ " thick siding - see photo
Contact the maintenance supervisor for field review.

- 1. New siding on north side of VFW building.**

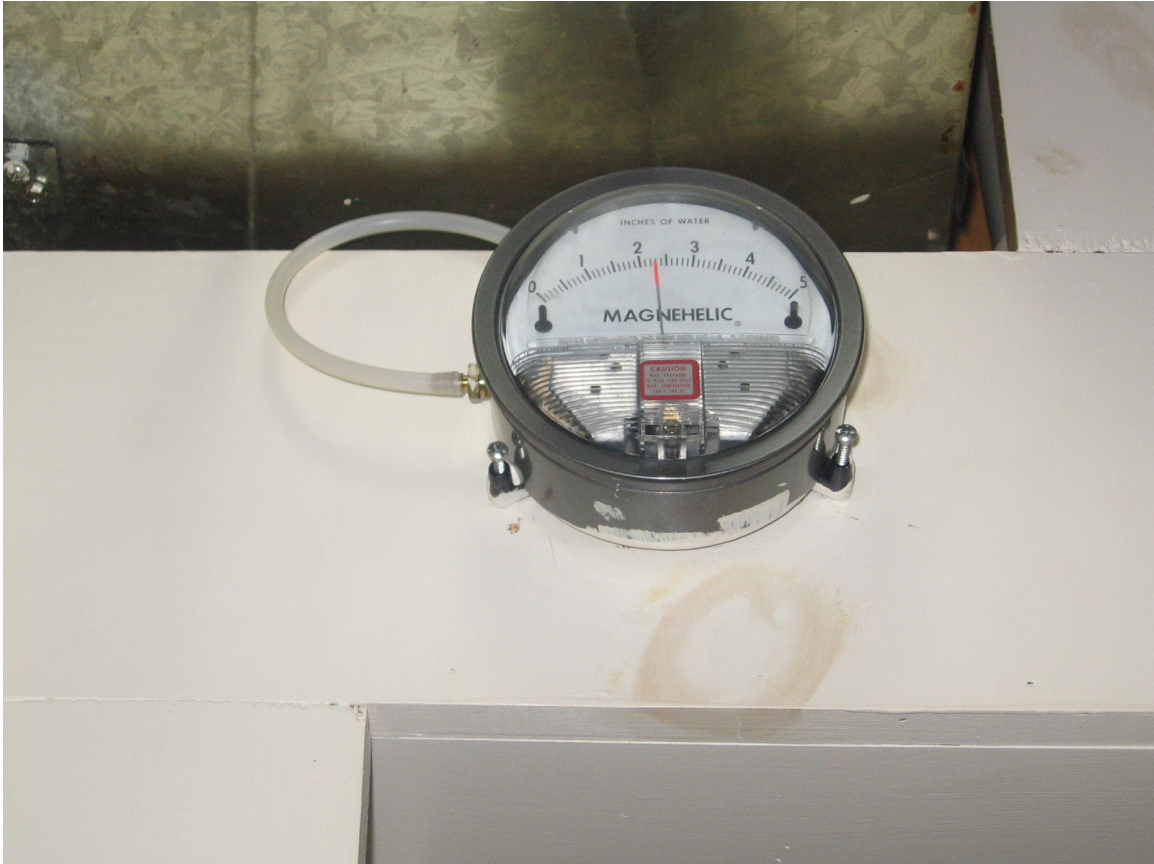
As Found		Manometer Reading (in. H ₂ O)	
Fan Model	SSD#	Prior	Current
	<u>1</u>		<u>2.3</u>
	<u>2</u>		<u>2.3</u>
	<u>3</u>		<u>2.3</u>

X
All 3 gauges read 2.3

2. Photograph of suction point #1 magnehelic gauge.

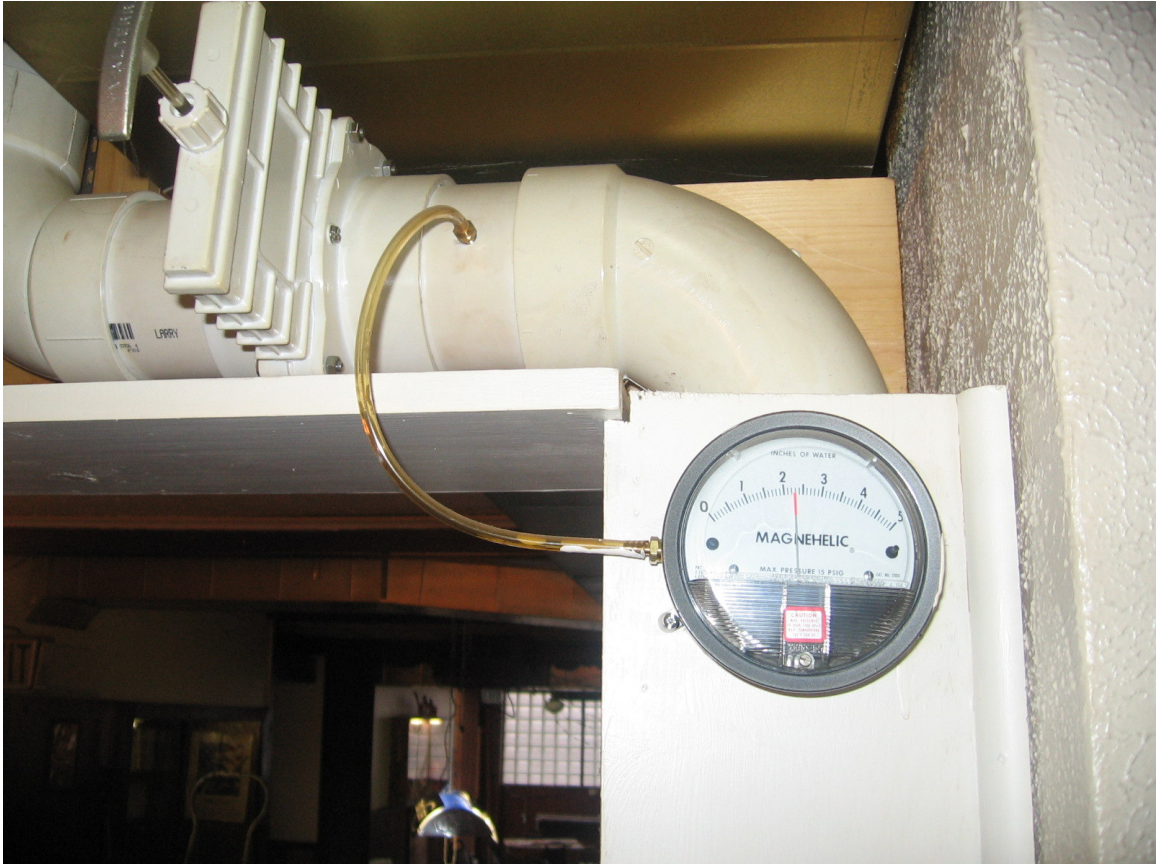
3. Photograph of suction point #2 magnehelic gauge.

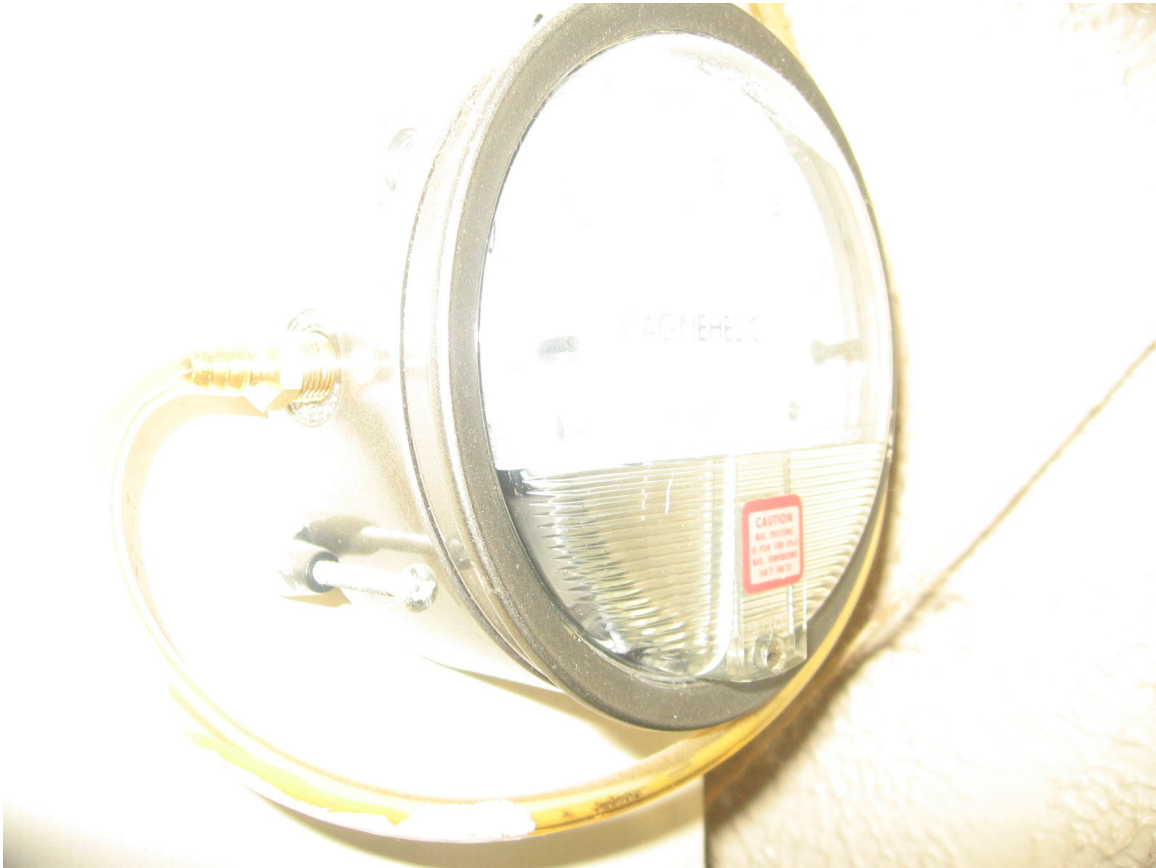
4. Photograph of suction point #3 magnehelic gauge.

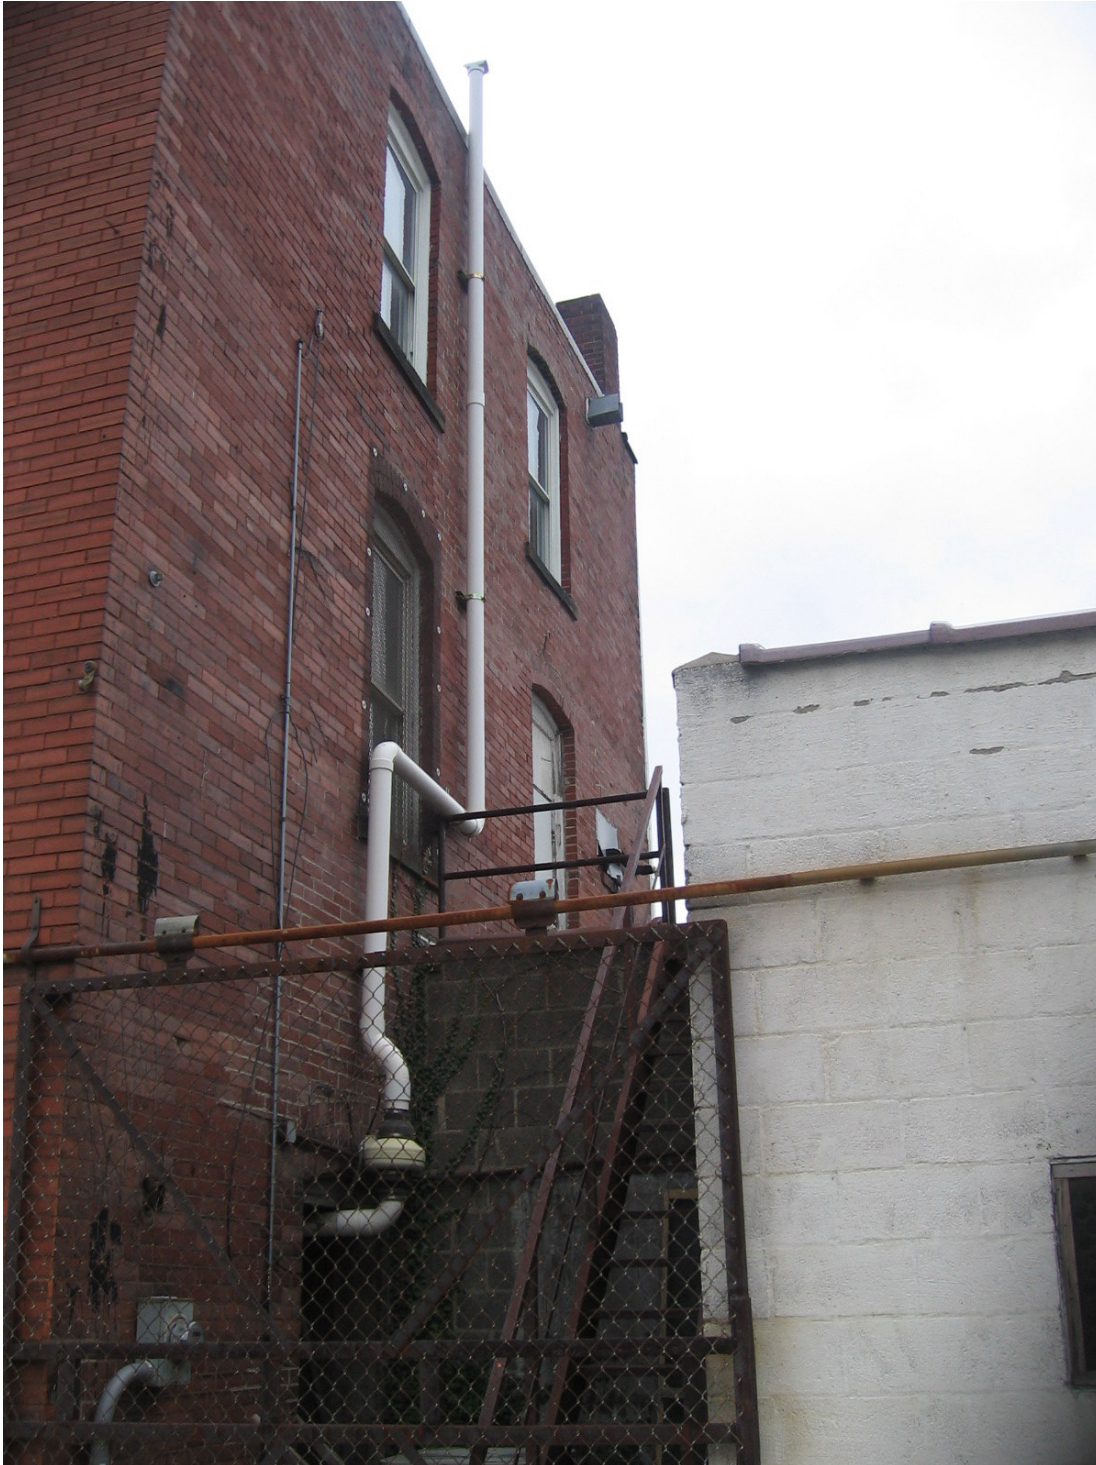
*- All supports + pipes good -
 - No red lights on -
 - could hear fan running.*

5. Photograph of suction fan and vent pipe. All fasteners re holding vent pipe securely to the wall..

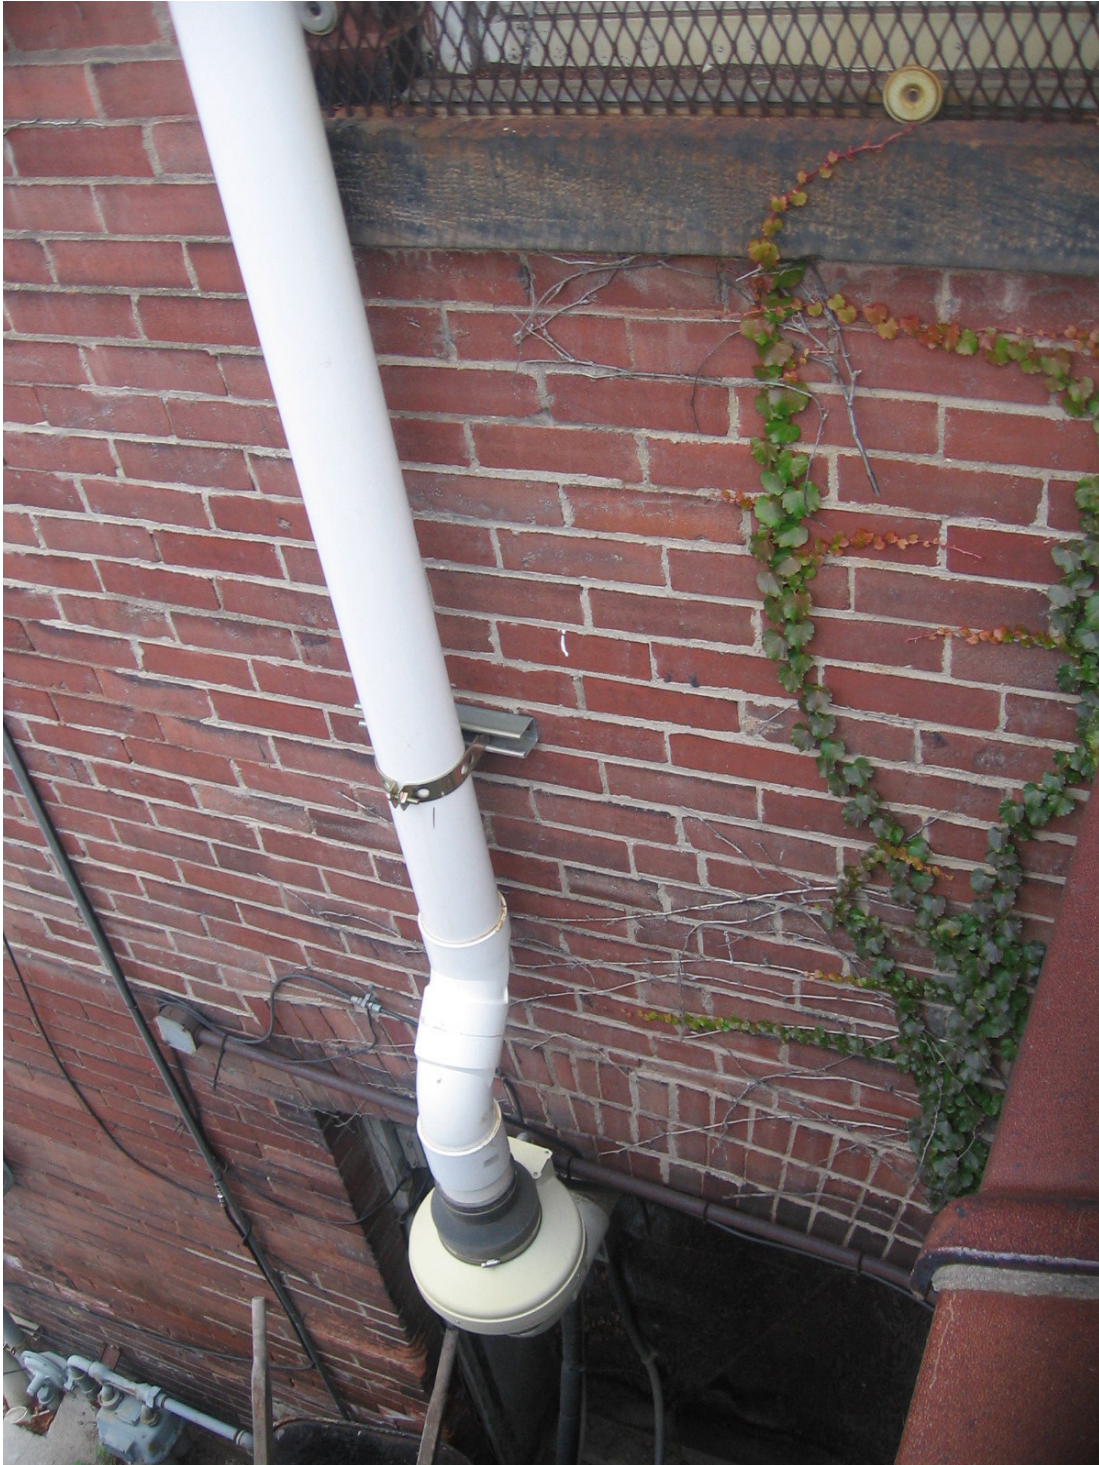
6. Close up of suction fan, vent pipe and fasteners.

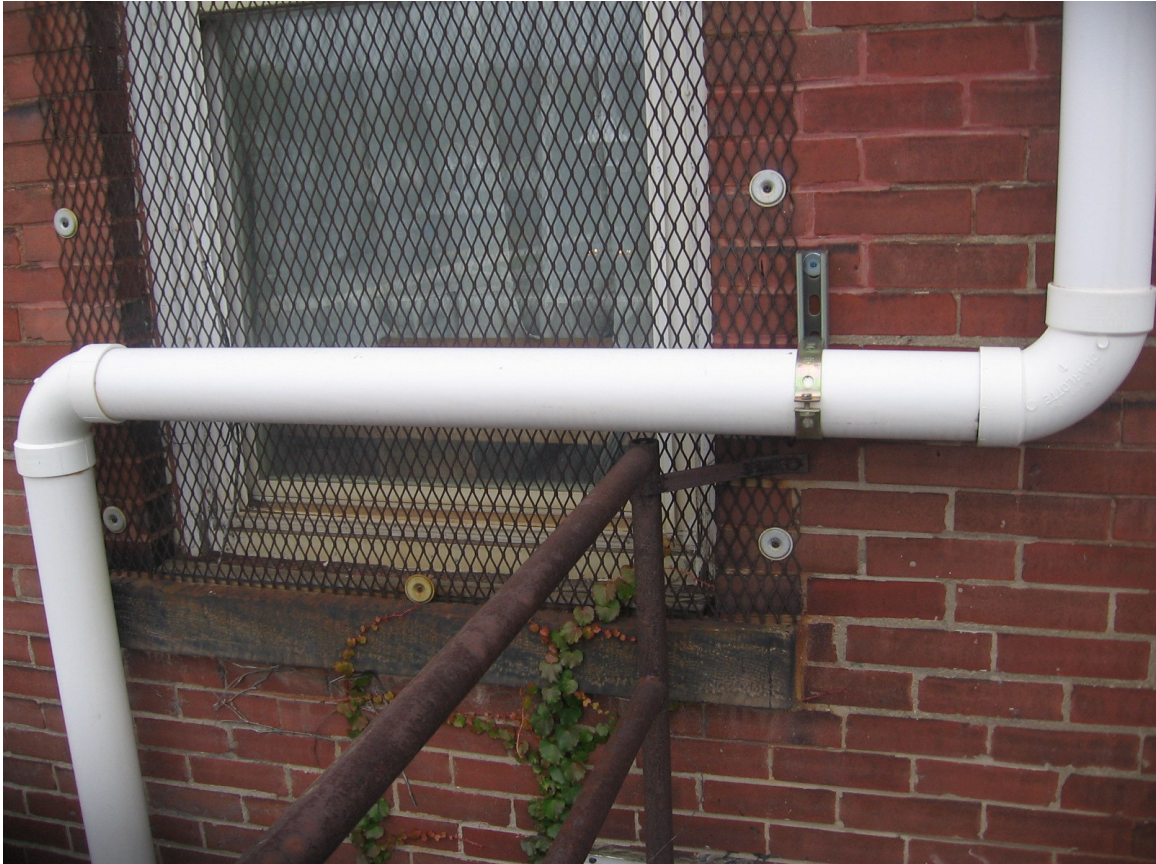
7. Close up of vent pipe and fasteners.

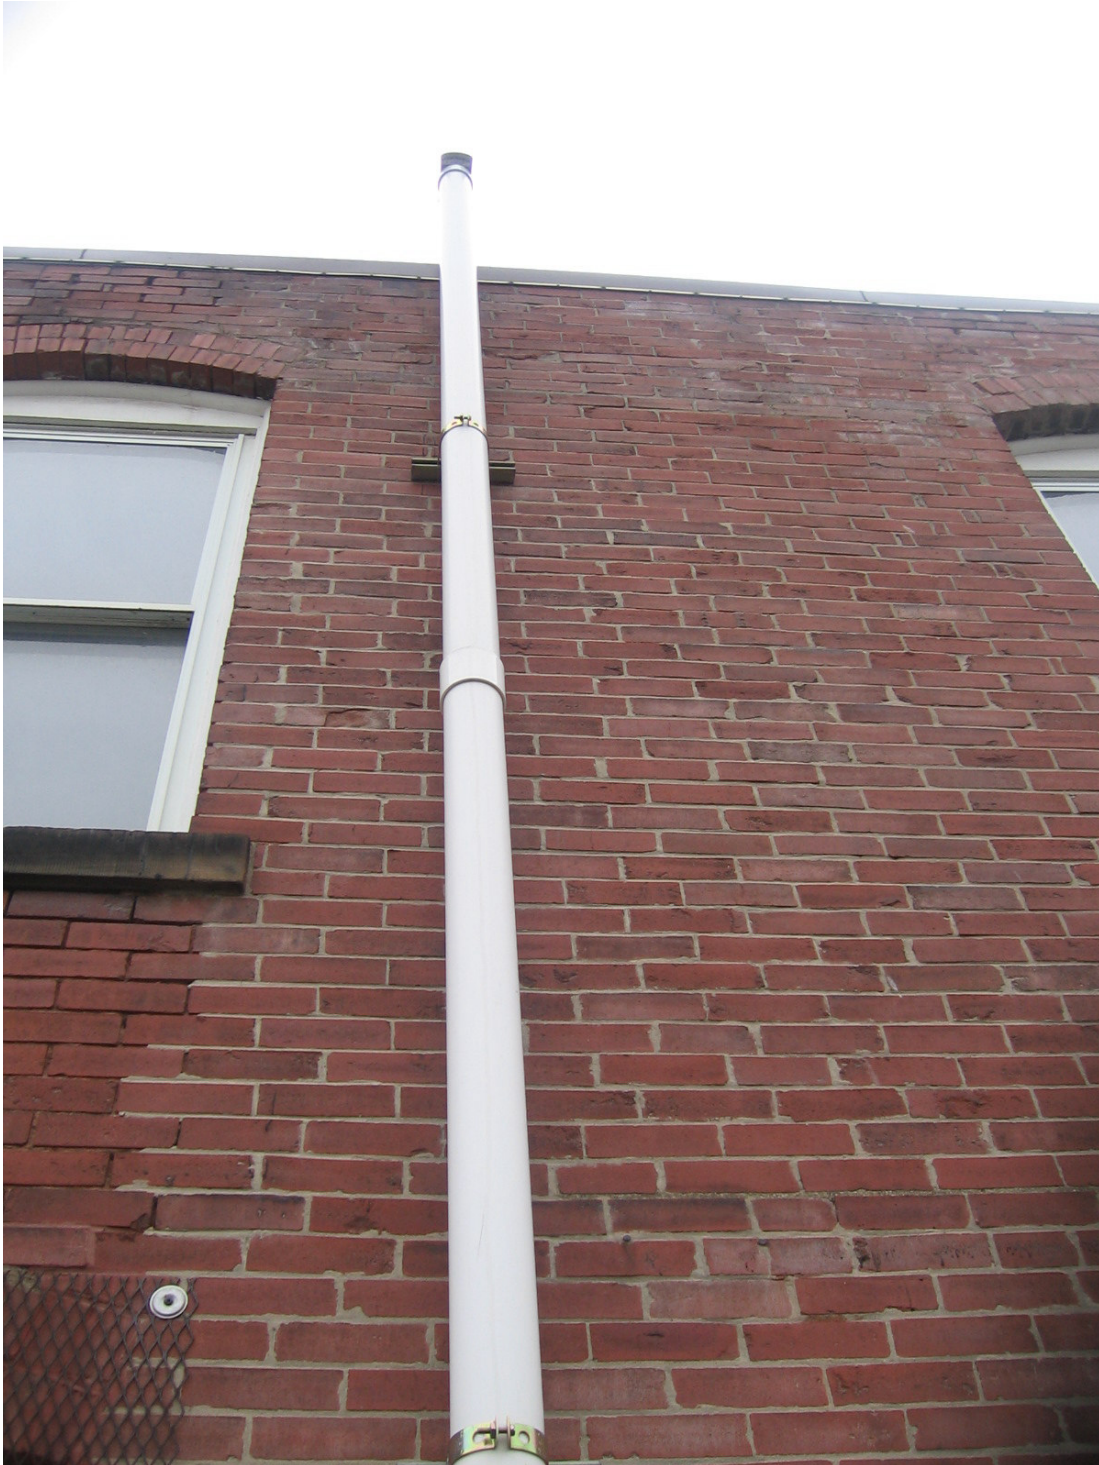
8. Close up of top of vent pipe, and fasteners.
