## System Inspection Field Forms

Sene ca Market  
inspection conducted  
3:50 pm  
10/14/08  
By . C. Dusek Tr.  
URS Corp.

FLOOR PLAN  
1 NORTH FRANKLIN STEET  
WATKINS GLEN, NY

# Seneca Market Building Sub-Slab Depressurization System Inspection

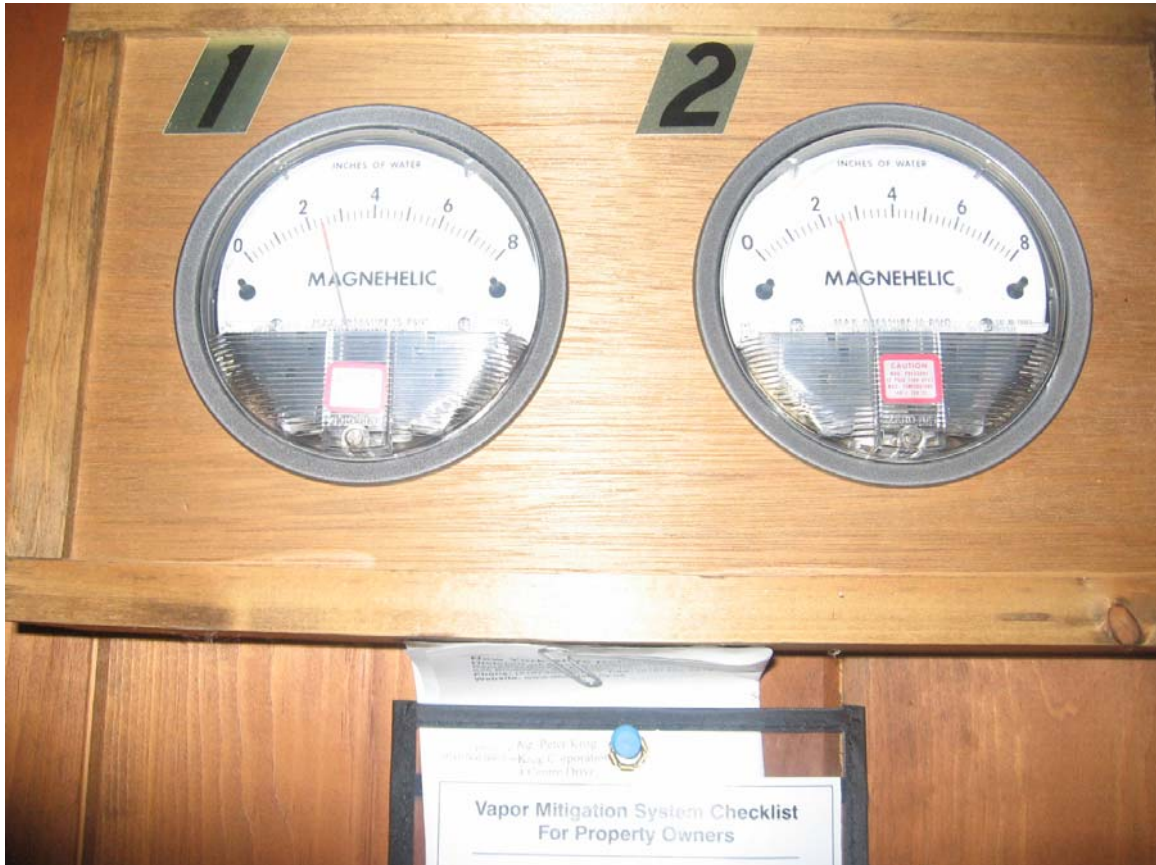
X  
*Both gauges read 2.2*

1. Close up of magnehelic gauges.

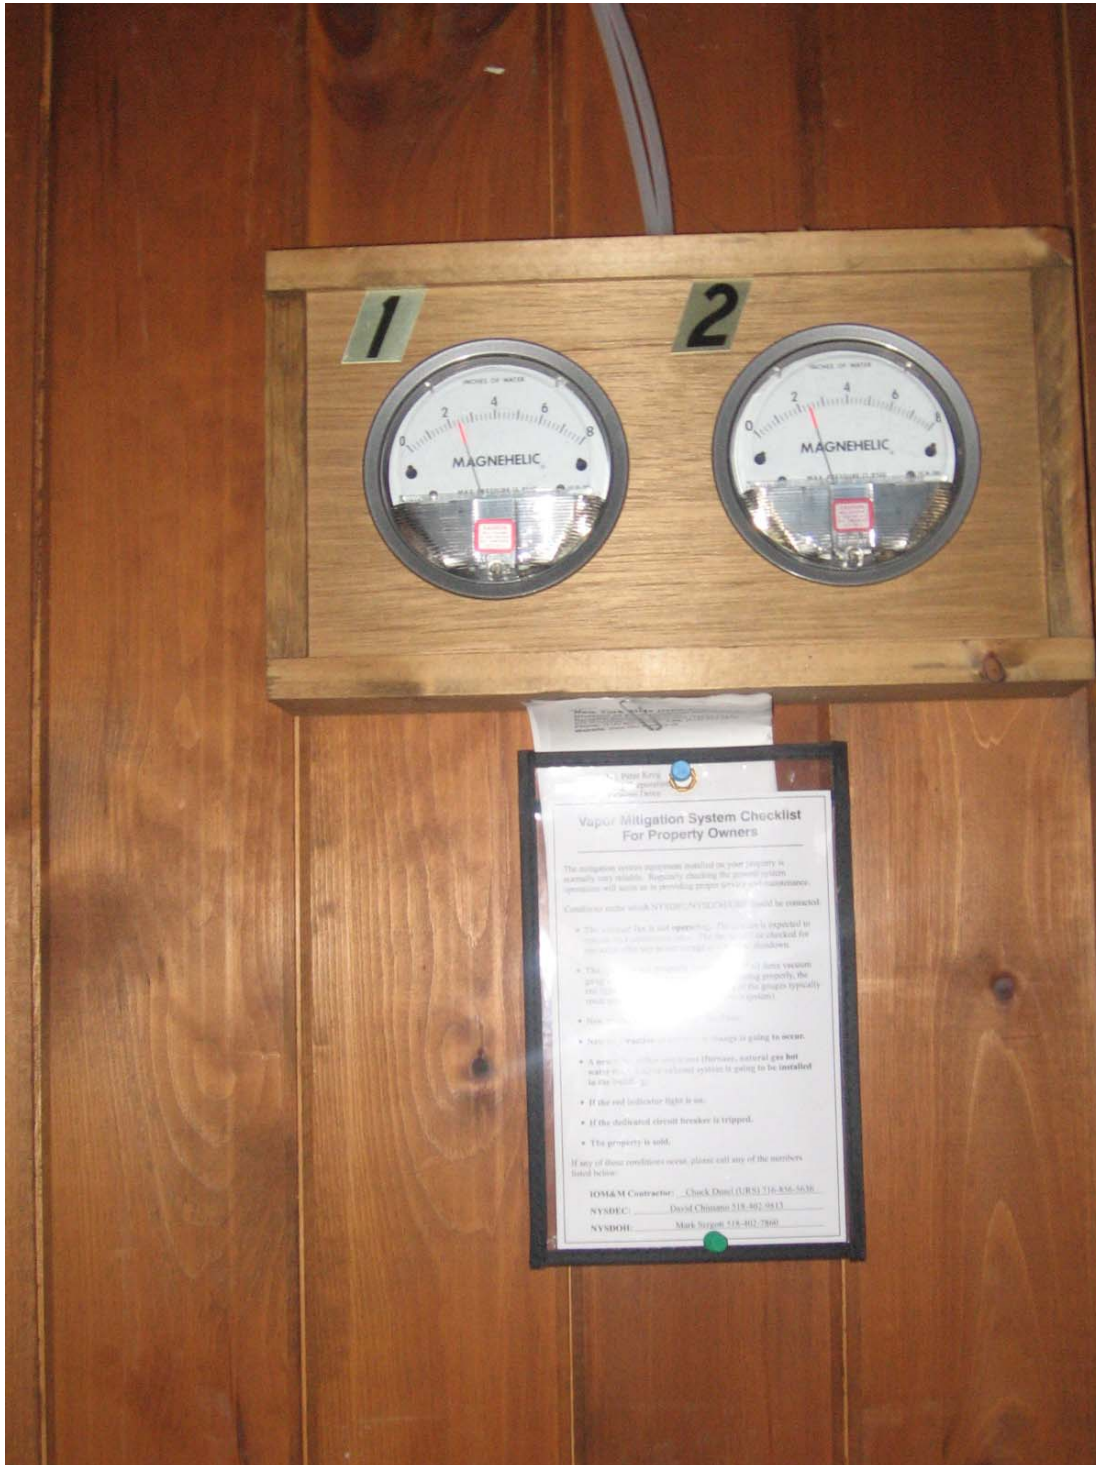
2. Photograph of magnehelic gauges and mitigation system labels

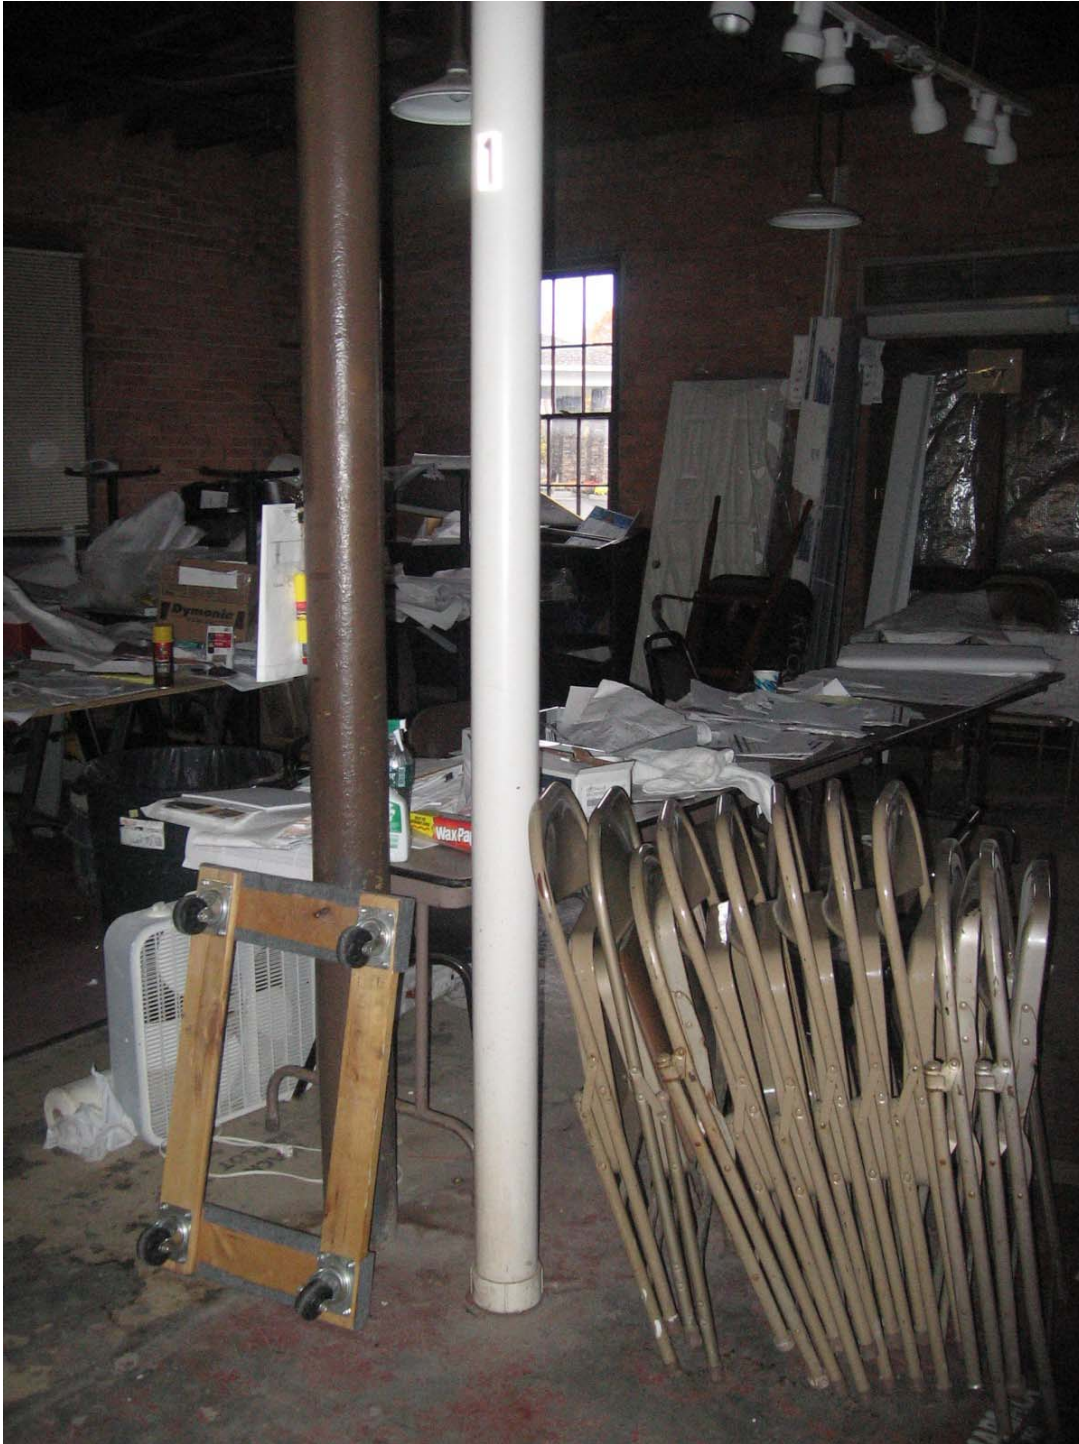
**3. Photograph of suction point # 1. There are no visible signs of cracks in slab, The floor penetration seal is competent.**

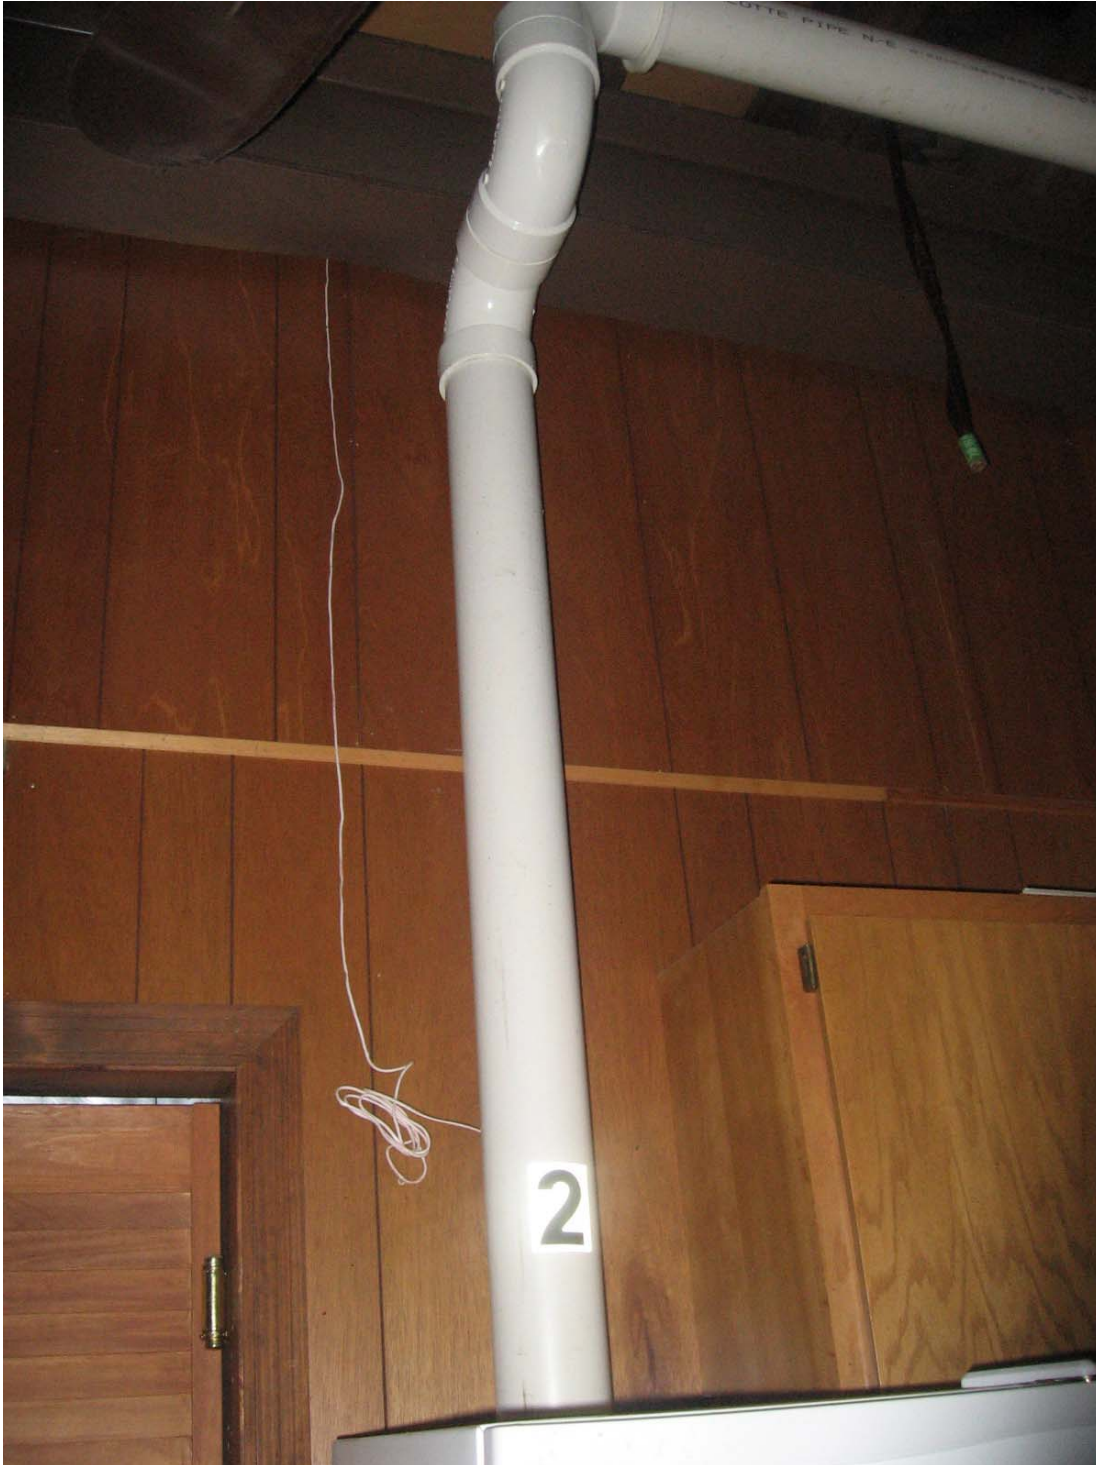
**4. Photograph of suction point #2. All PVC welds are in good shape.**

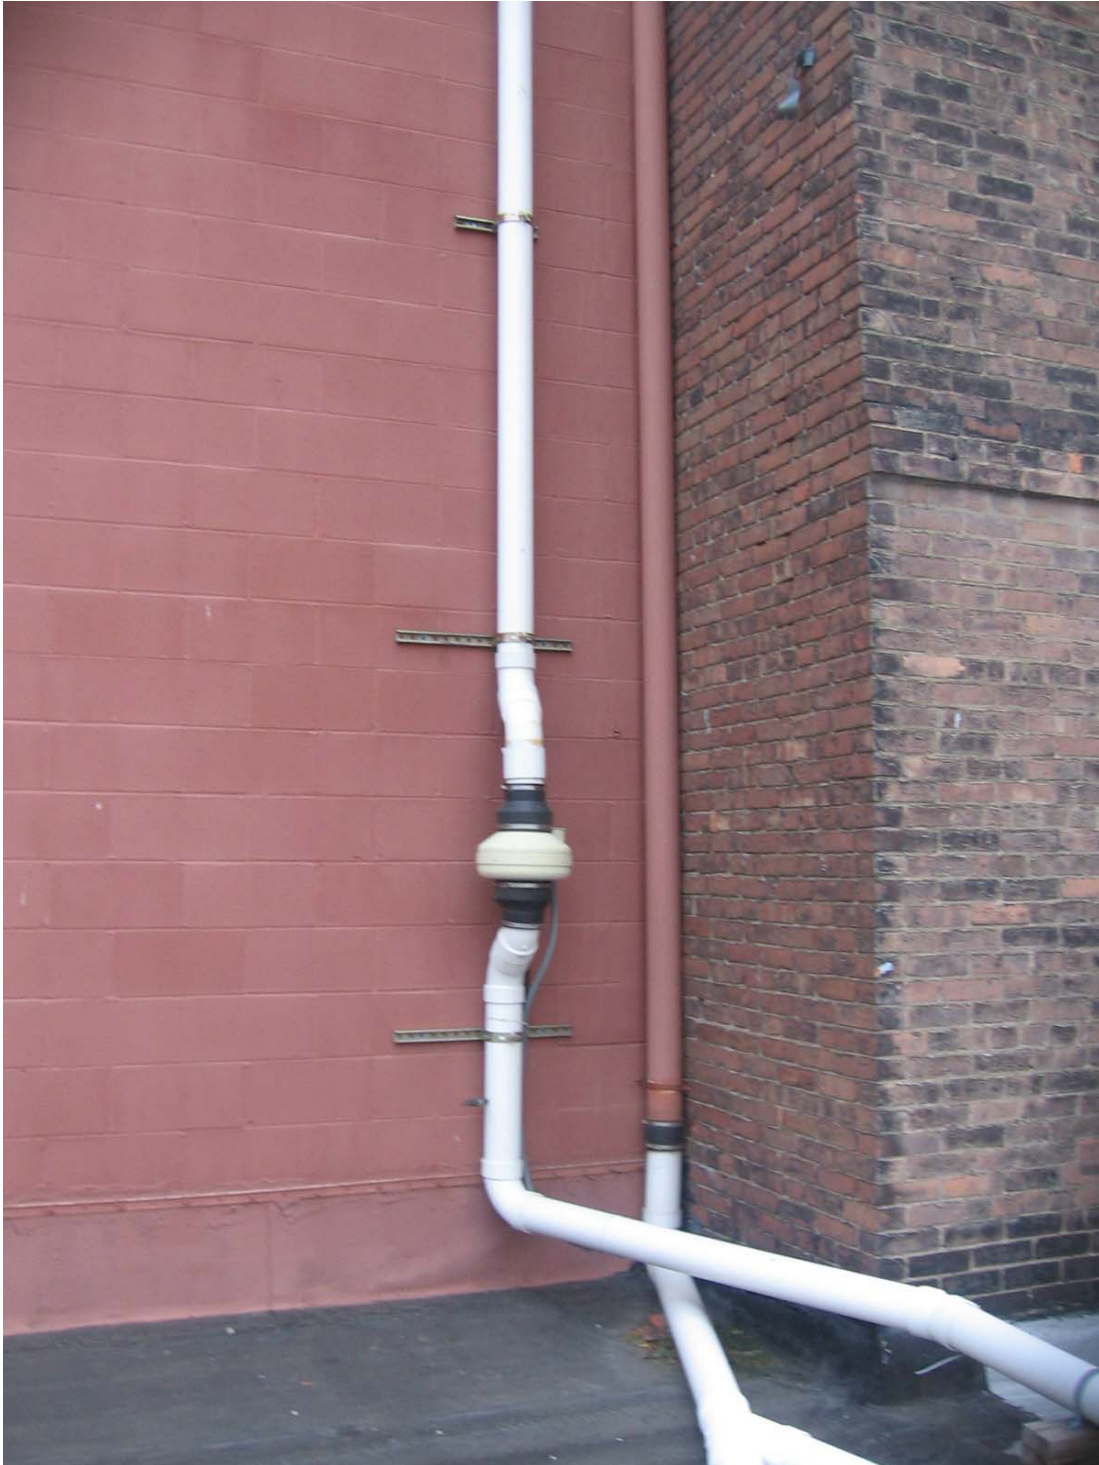
**5. Photograph of suction fan and vent pipe. All fasteners are holding vent pipe securely to the wall.**
