## Outfall Evaluation Report, Former Hampshire Chemical Corp Facility, Waterloo, New York

PREPARED FOR: Jerome Cibrik/Dow Remediation Leader

PREPARED BY: CH2M HILL Project Team

DATE: February 22, 2011

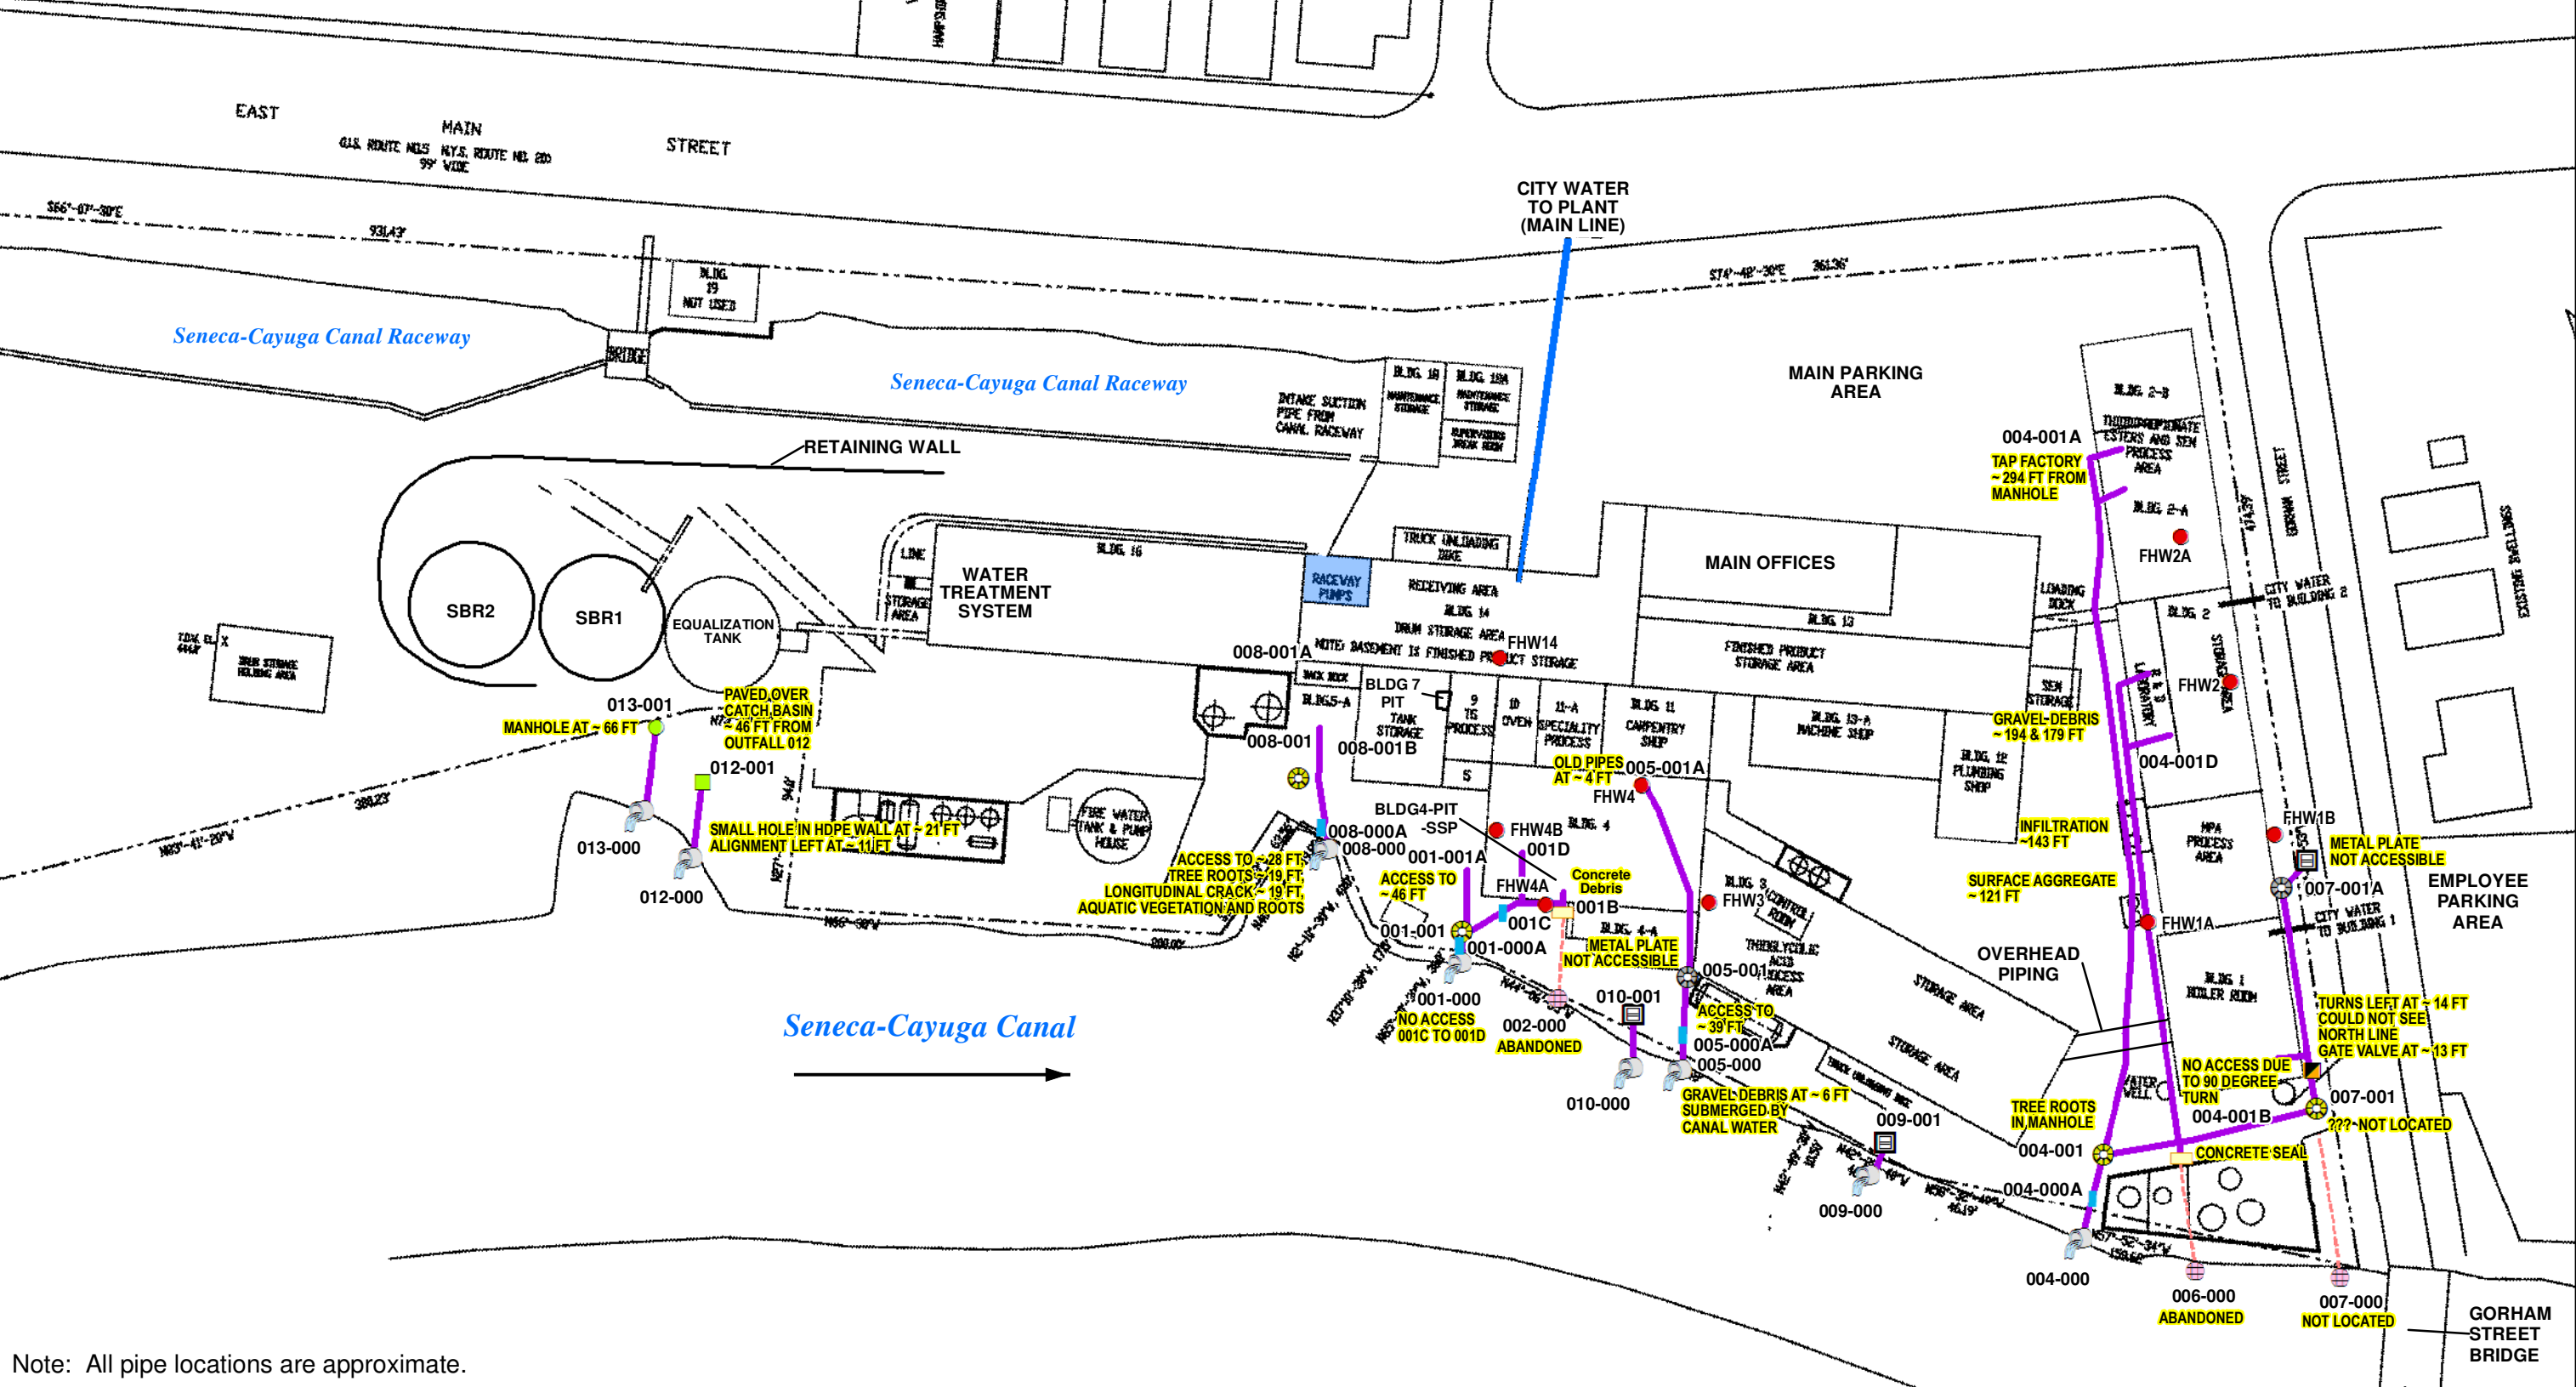
Figure 6  
Summary of Observations at  
CCTV Surveyed Piping  
Outfall Evaluation Technical Memorandum  
Former Hampshire Chemical Corp Facility  
Waterloo, New York

The following observations were made regarding the condition of the active outfall piping interior and are also summarized in Table 1.

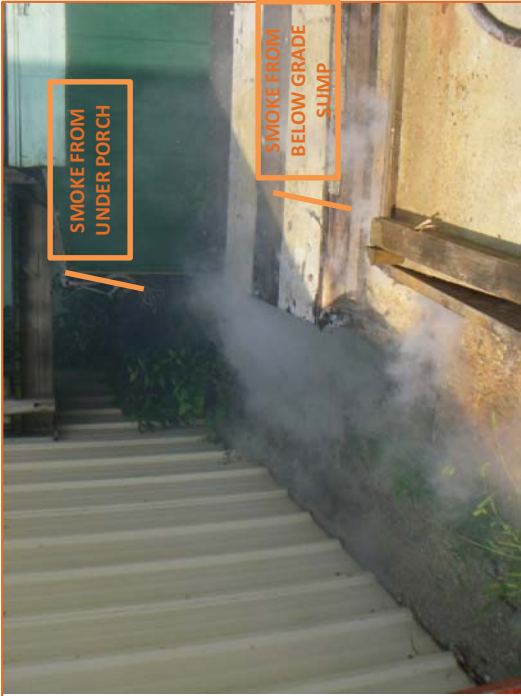
South of Building 9 and west of Building 4, smoke also was observed from an unexpected area that was covered with ply board (Attachment 3, Photograph 2). Site personnel informed CH2M HILL that a below grade sump and tank was present in that area which received water from Building 9 floor drains. Site personnel had removed the tank, the underground piping was disconnected, and the sump has been out of service for 6 to 7 years. Since then, water from the Building 9 floor drains has been pumped directly from Building 9 to the onsite treatment plant. Site personnel explained that the underground piping may have been cut in the area under the porch, and may have served to transport smoke from the Outfall 001 drain to this sump; however, there is no underground pipe connection from this sump to Outfall 001.

Photo 2. Outfall 001: Smoke observed north of 001-001A , under porch from Buildings 4 and 9 noncontact cooling water discharge lines

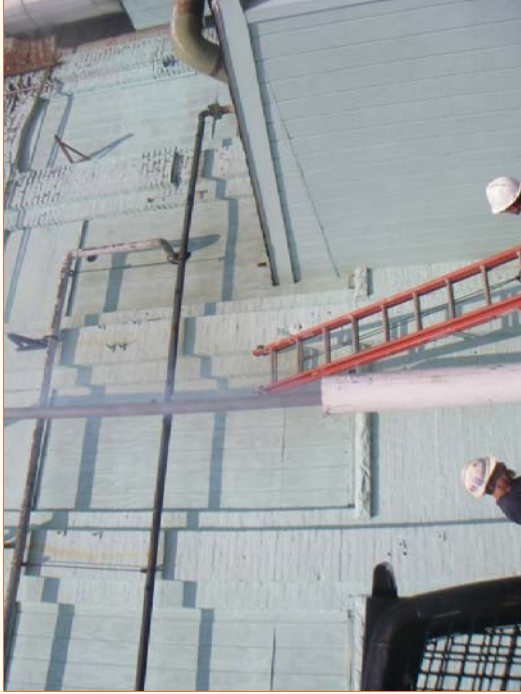
Photo 4. Outfall 001: Smoke observed at new vertical pipe between 001-001 and 001-001C

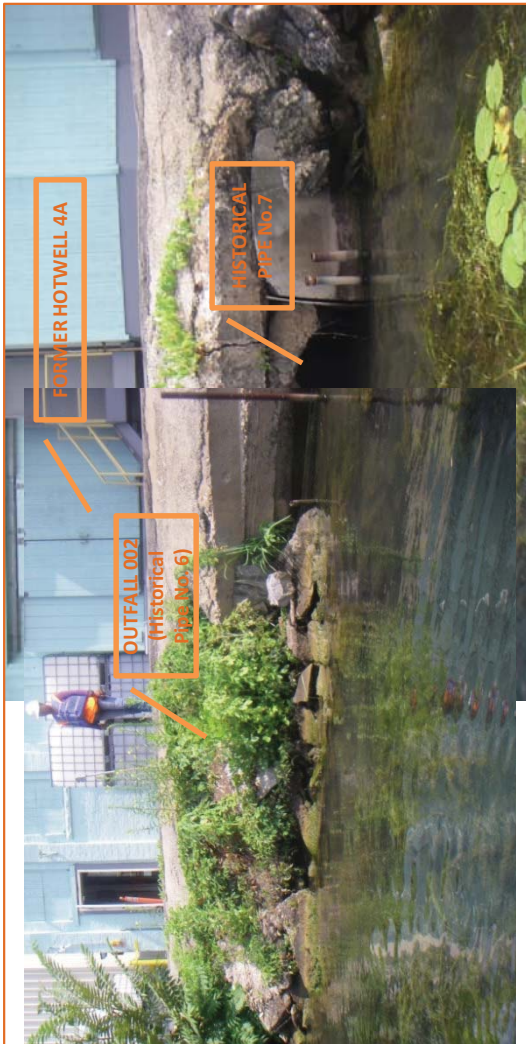
Photo 20. Outfall 002: Discharge point 002-000 may be covered under concrete rip rap, and possible historical pipe No. 7 located east of Outfall 002. See Figure 6.

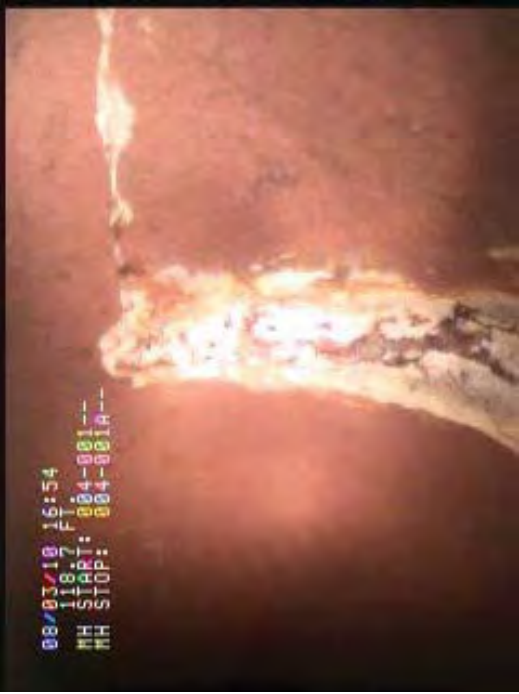
The piping interior from node 004-001 to 004-001A was found with infiltration stains at 32 feet, 116 feet, and 119 feet; infiltration dripper at 109 feet and 143 feet; a longitudinal crack at 119 feet; attached deposits at 121 feet; gravel deposits at 181 to 194 feet; and an active tap factory active at 294 feet. All footages were measured upstream from 004-001.

Photo 54. Outfall 004 (004-001A to 004-001): Longitudinal crack, 12 o'clock at 118 ft upstream of 004-001

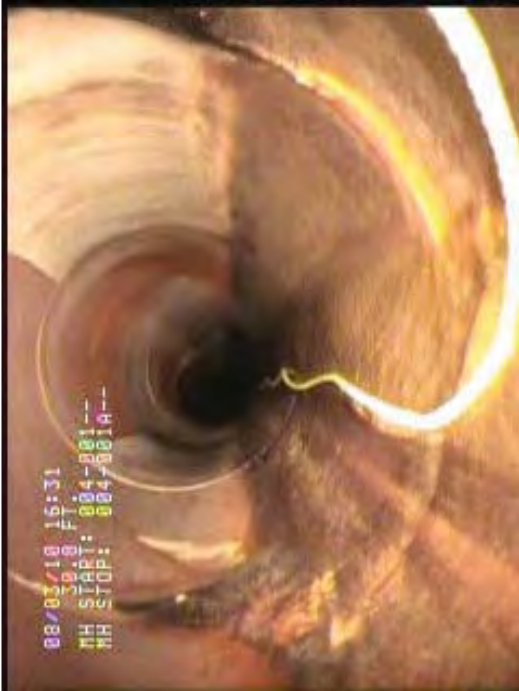
Photo 55. Outfall 004 (004-001A to 004-001): Infiltration stains at 30ft upstream of 004-001

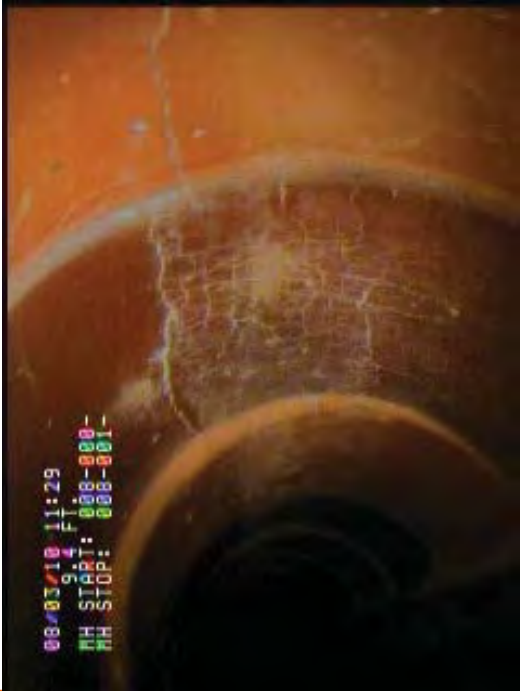
The outfall piping at 008-000 was partially submerged by canal water. Roots and aquatic weeds were present in the joints, a crack was observed at 9 feet upstream of 008-000, and a break-in tap was present at 28 feet upstream of 008-000 (Attachment 3, Photographs 75 to 80). Approximately 28 feet of piping were surveyed from 008-000 to 008-001A.

Photo 77. Outfall 008 (008-001 to 008-000): Longitudinal crack, 12 o'clock at 9 ft upstream of 008-000

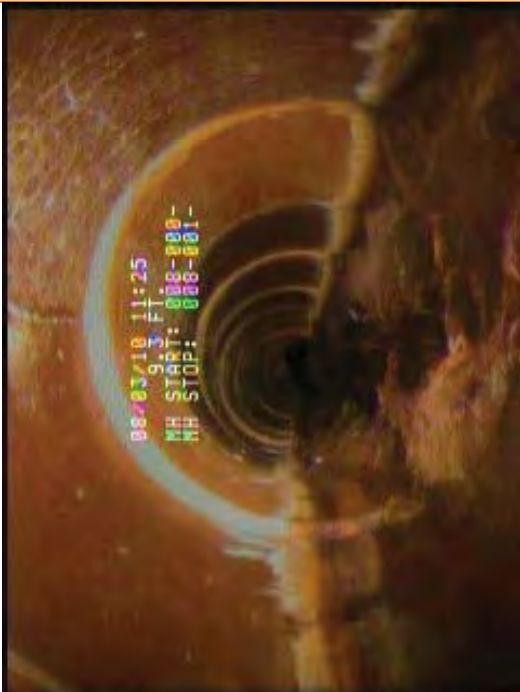
Photo 78. Outfall 008 (008-001 to 008-000): Roots and plants at 9 ft upstream of 008-000

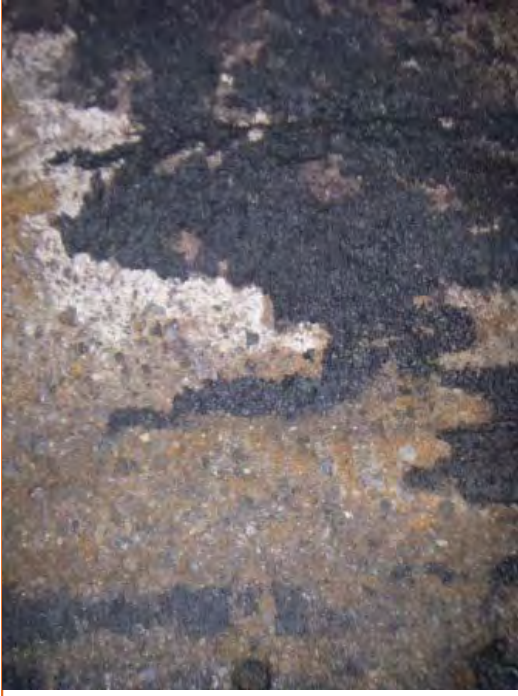
Photo 100. Outfall 004: 004-001 Manhole defects; wall deterioration

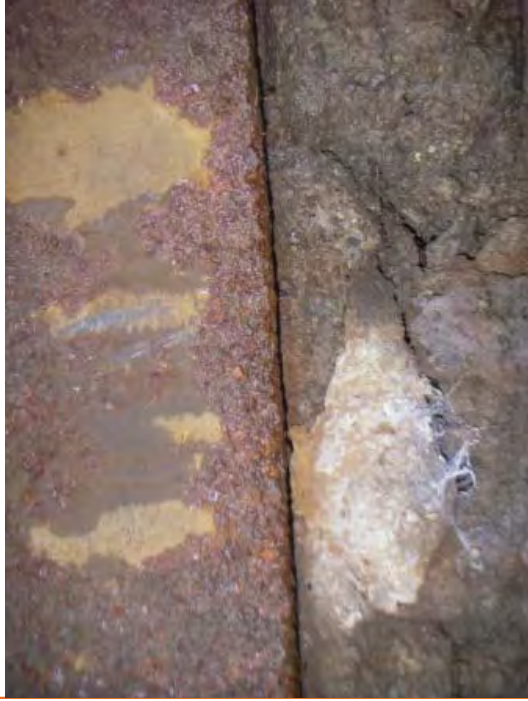
Photo 101. Outfall 004: 004-001 Manhole defects; frame/chimney seal deterioration
