Subject: Gorham Street/AOC C Interim Operations and Maintenance Plan/Periodic Review Report
2014; Former Hampshire Chemical Corp. Site, Waterloo, New York—Site No. 850001A

Interim Operations and Maintenance Plan/Periodic Review Report 2014, Gorham Street Area, Former Hampshire Chemical Corp. Facility, Waterloo, New York

PREPARED BY: CH2M HILL

DATE: January 2015

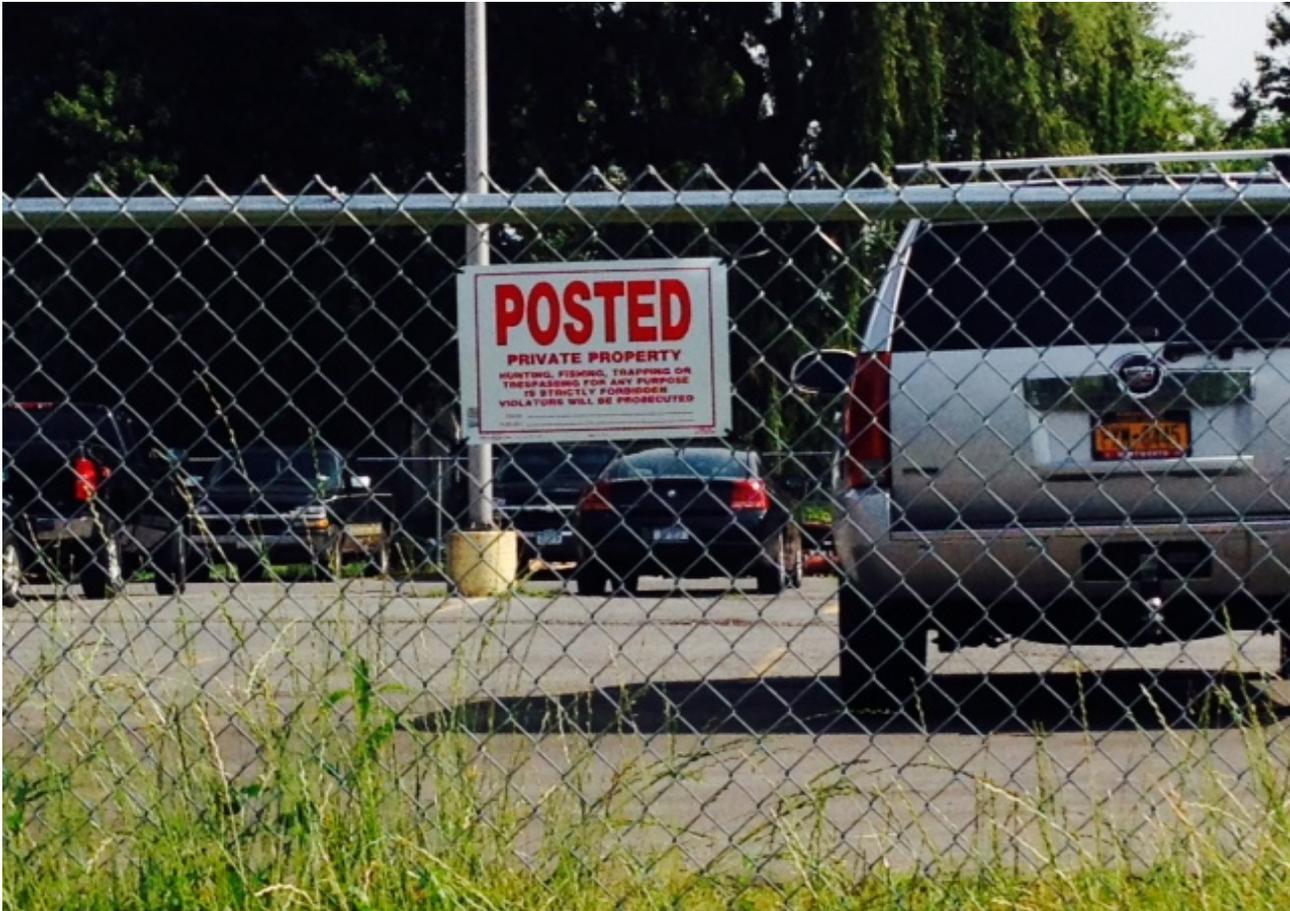
Photo 1 - Typical Posted No Trespassing Sign on Canal Side

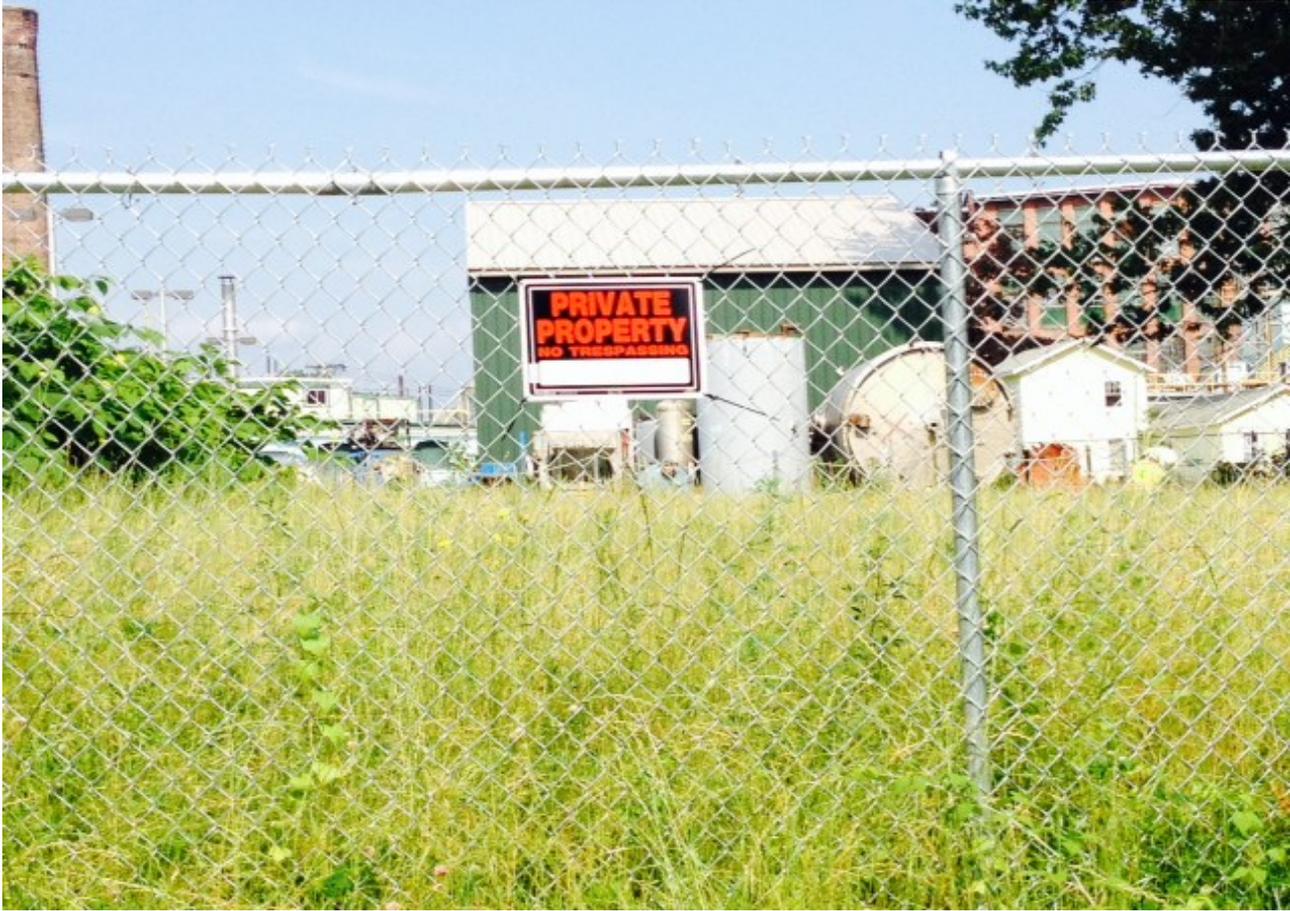
Photo 2 - Typical Posted No Trespassing Sign on East and North Side of Cap Area

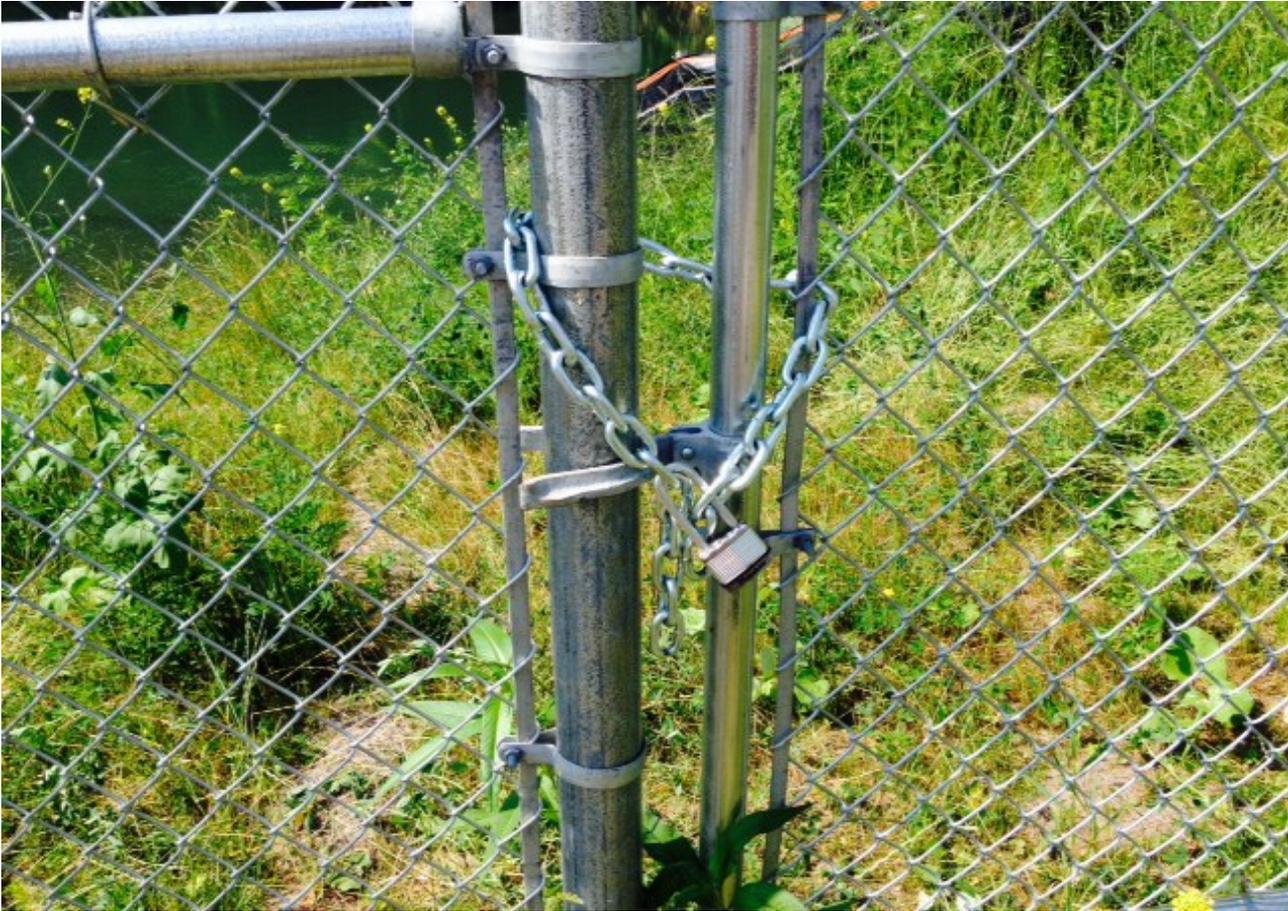
Photo 3 - Typical Locked Man Gate

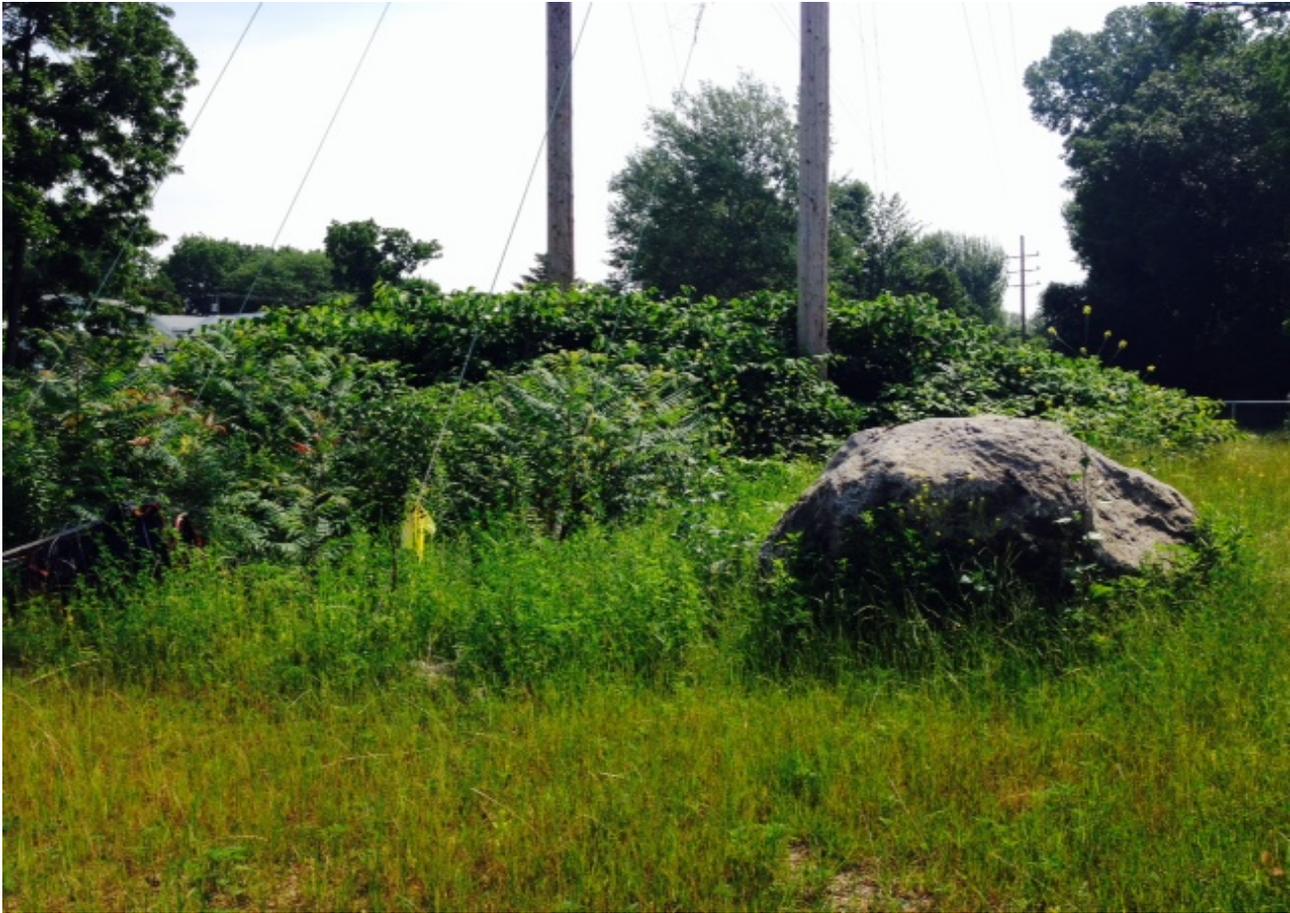
Photo 4 - Vegetation Around Power Poles and Guy Wire

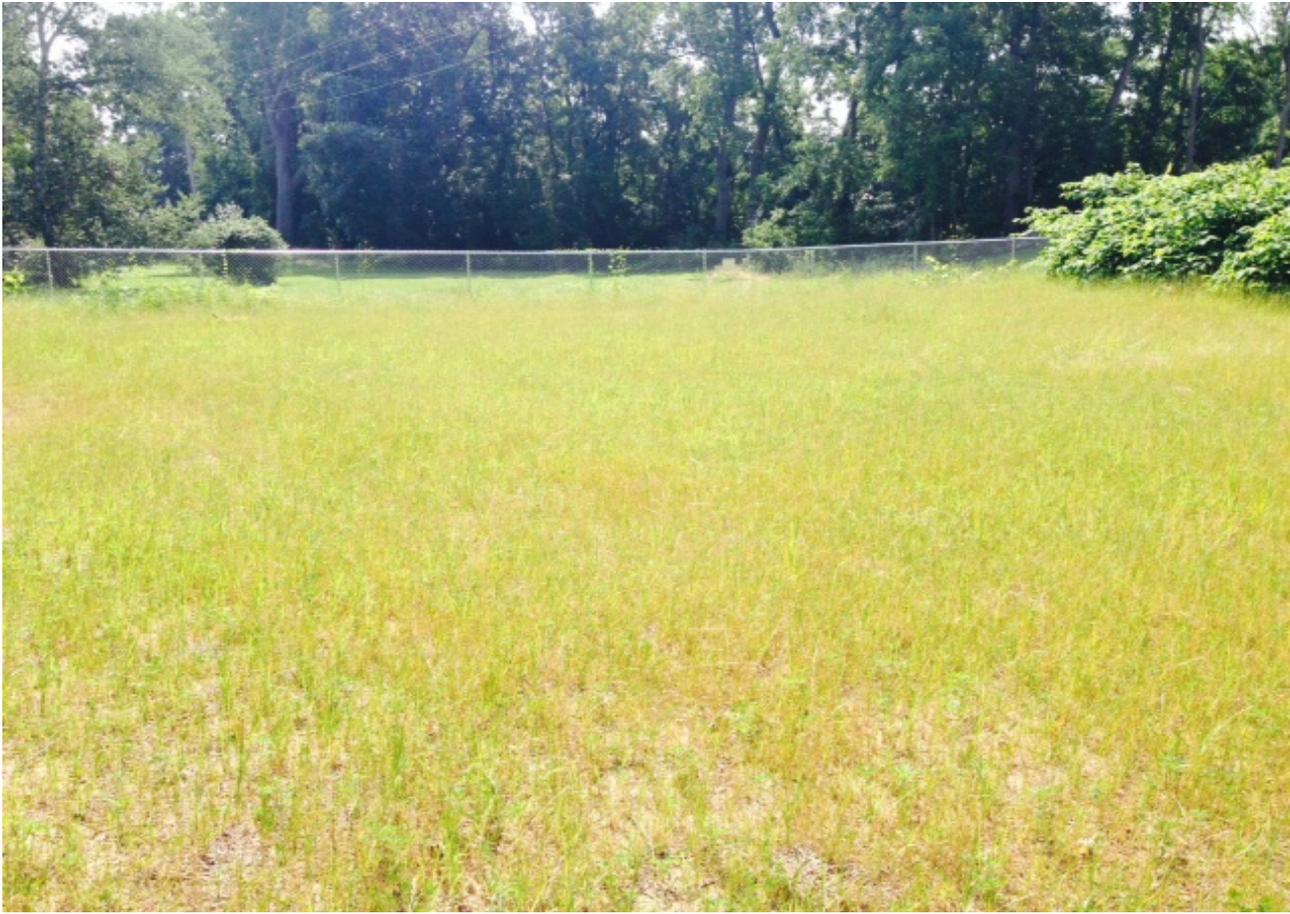
Photo 5 - Vegetation in Cap Area - Looking East

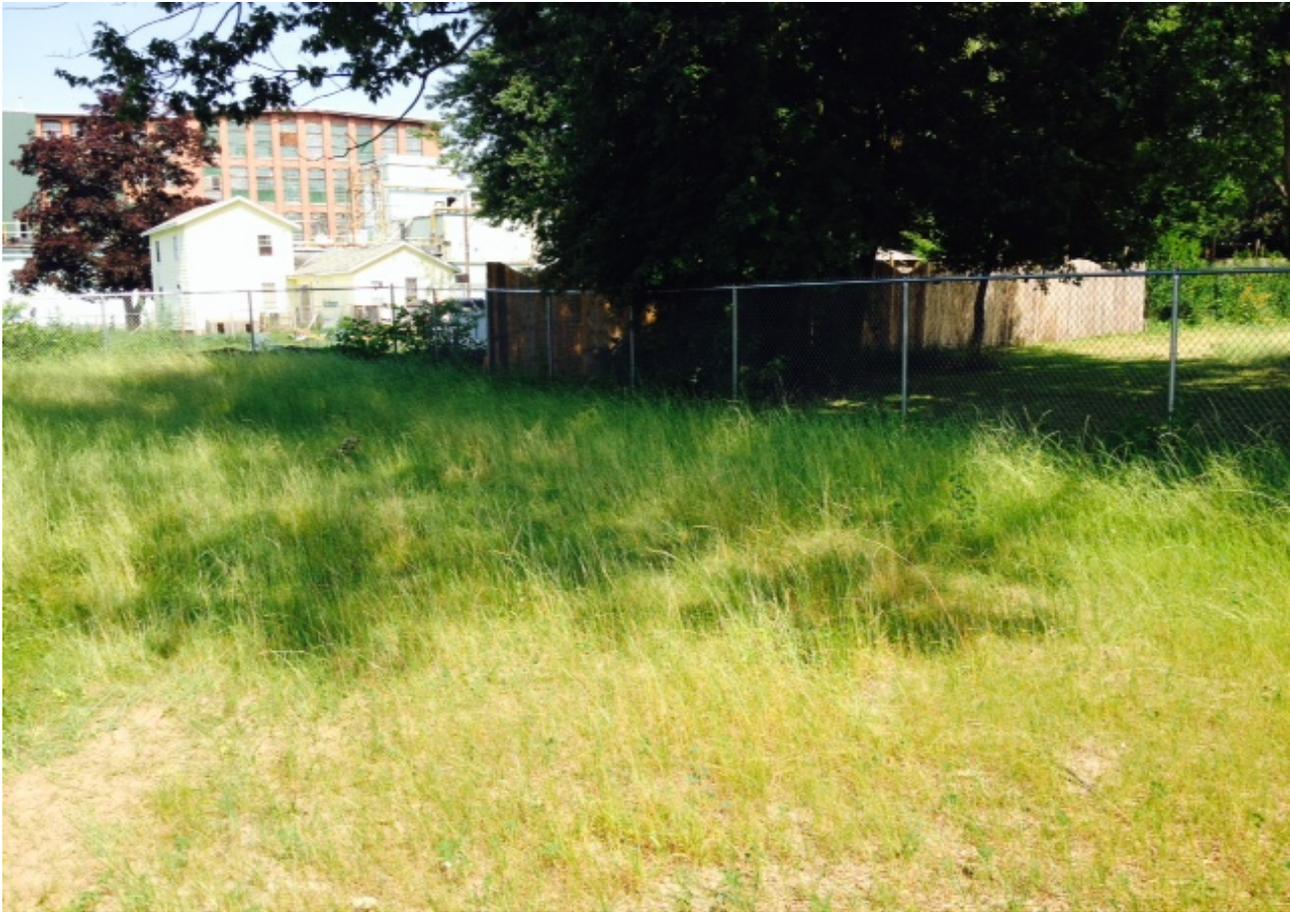
Photo 6 - Vegetation in Cap Area - Looking Northwest

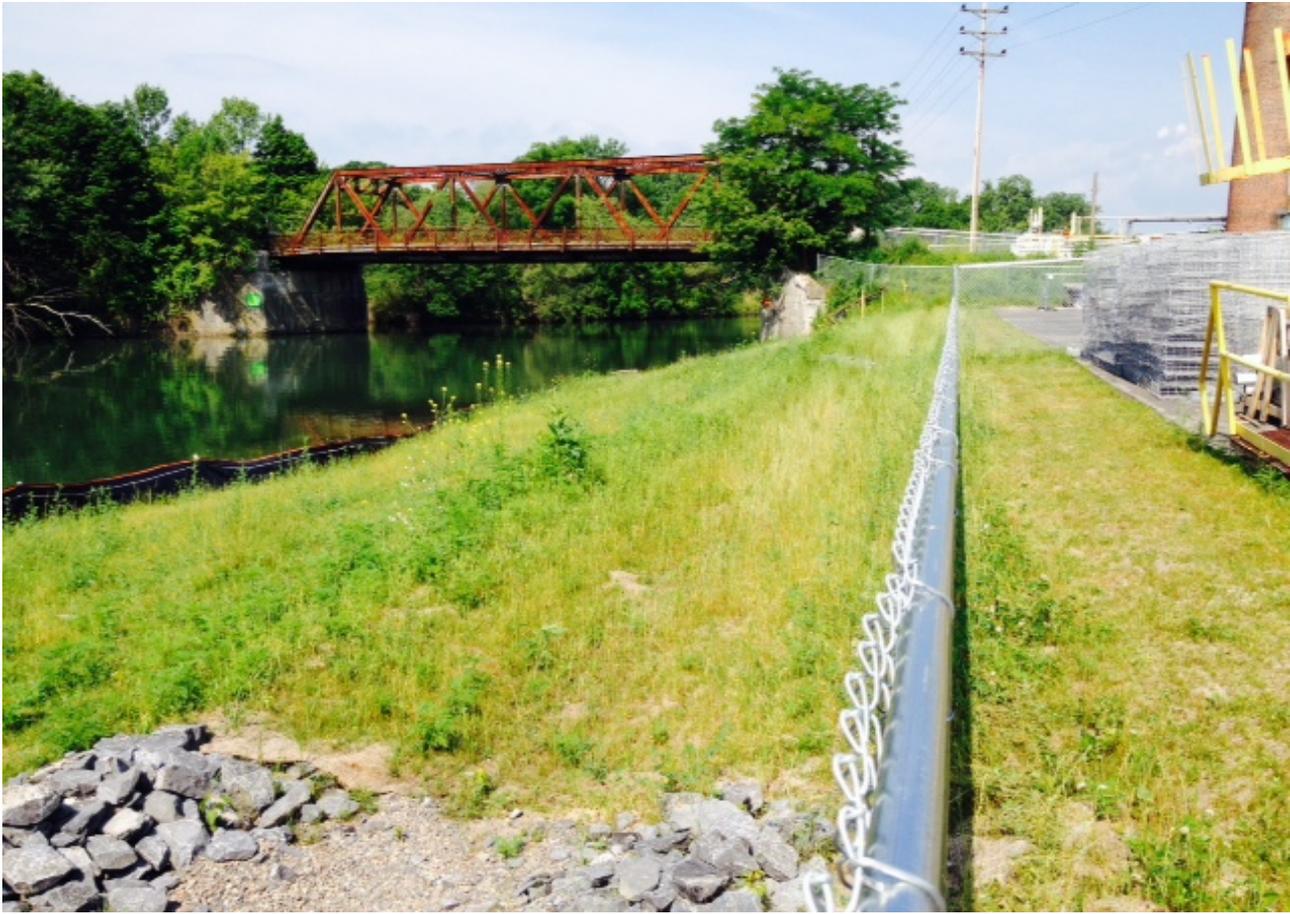
Photo 7 - Vegetation Along Canal Bank

1. Op Tech to mow site by 7-11-14
2. Op Tech to place additional top soil, seed and mulch
3. Op Tech to install Authorized Personnel Only signs on man gates
4. Op Tech to remove vegetation from fence during first mowing
5. Apply herbicide to weed in existing Evans Chemetics parking lot

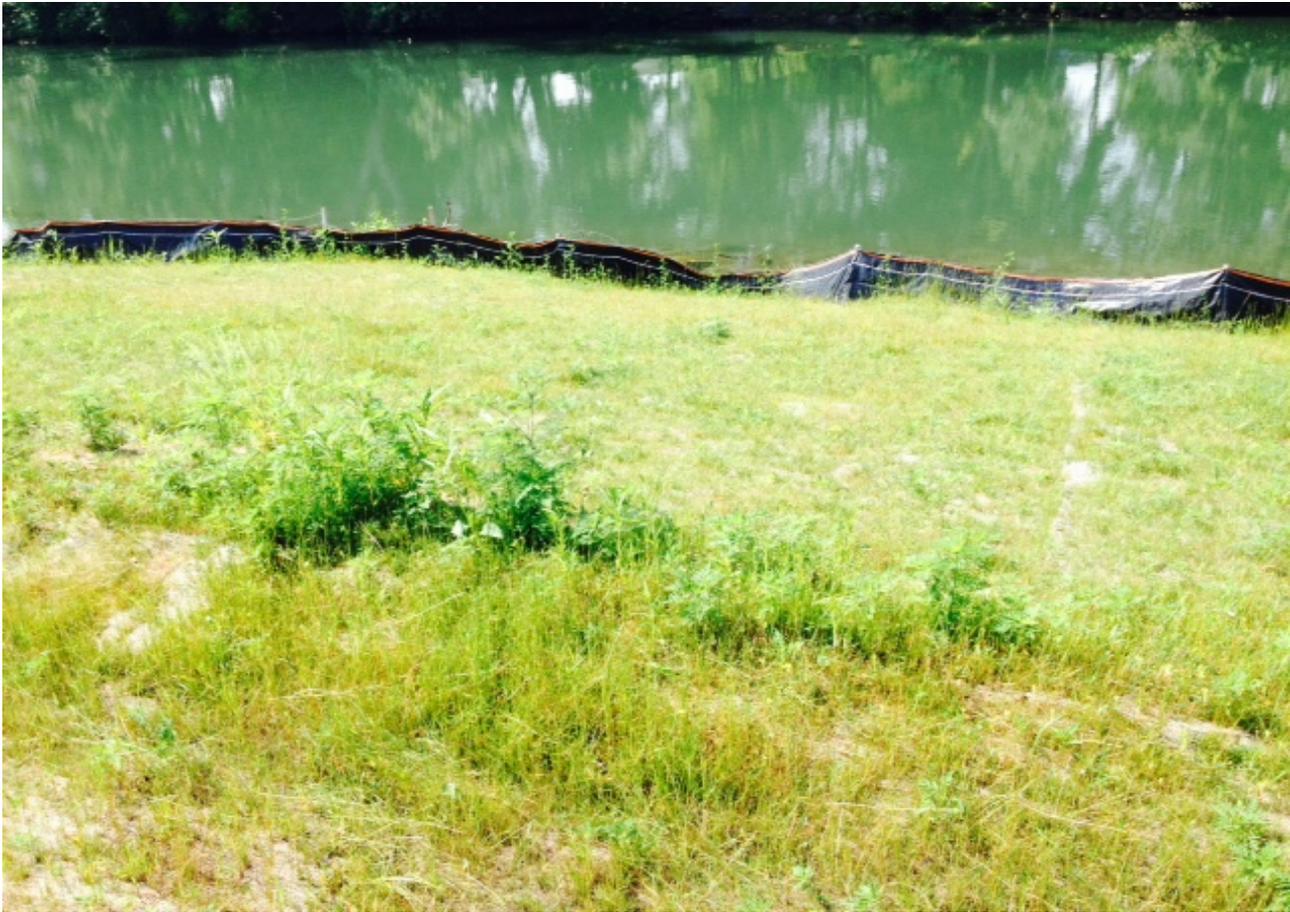
Photo 8 - Vegetation Along Canal Bank

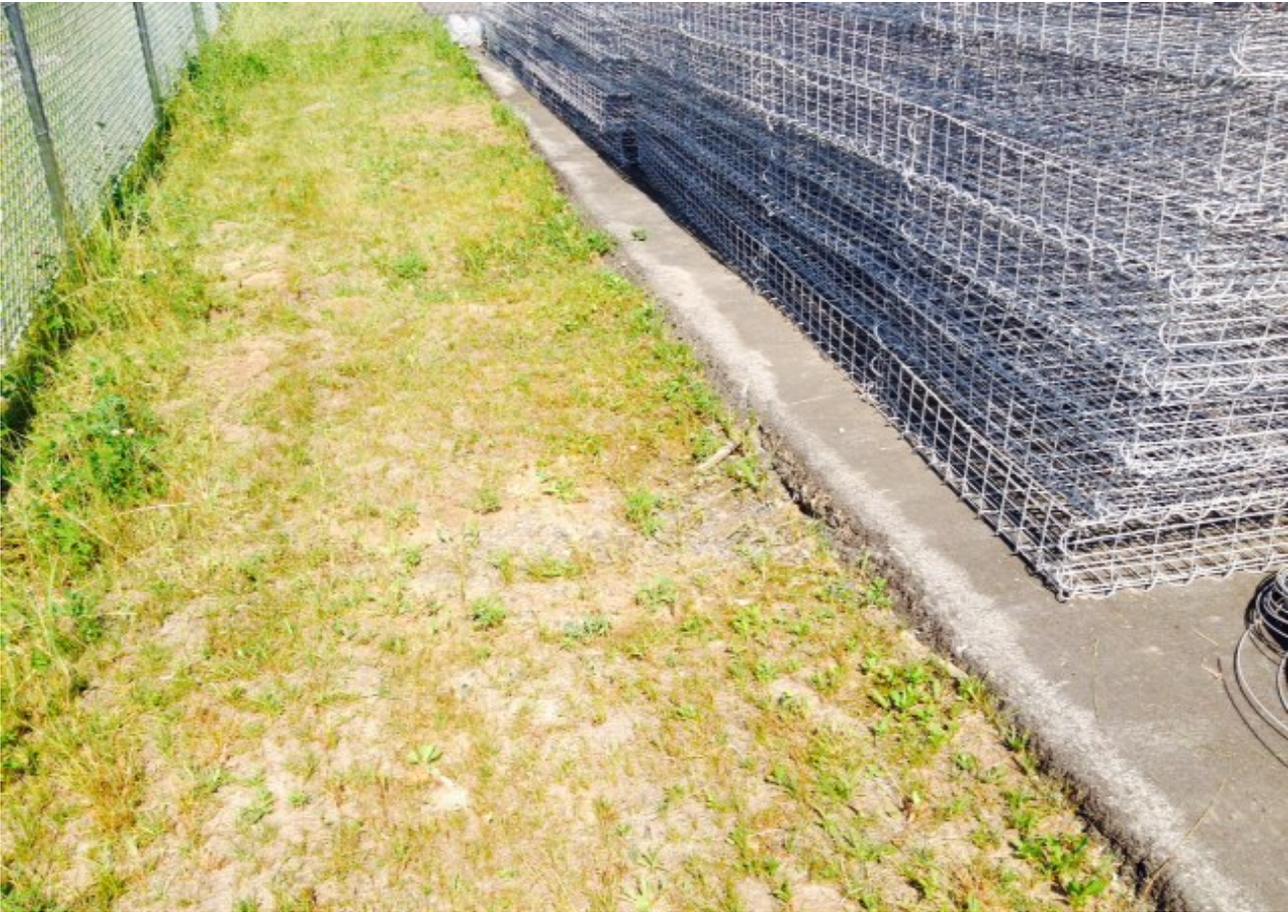
Photo 9 - Vegetation Near Asphalt Cap and Minor Erosion

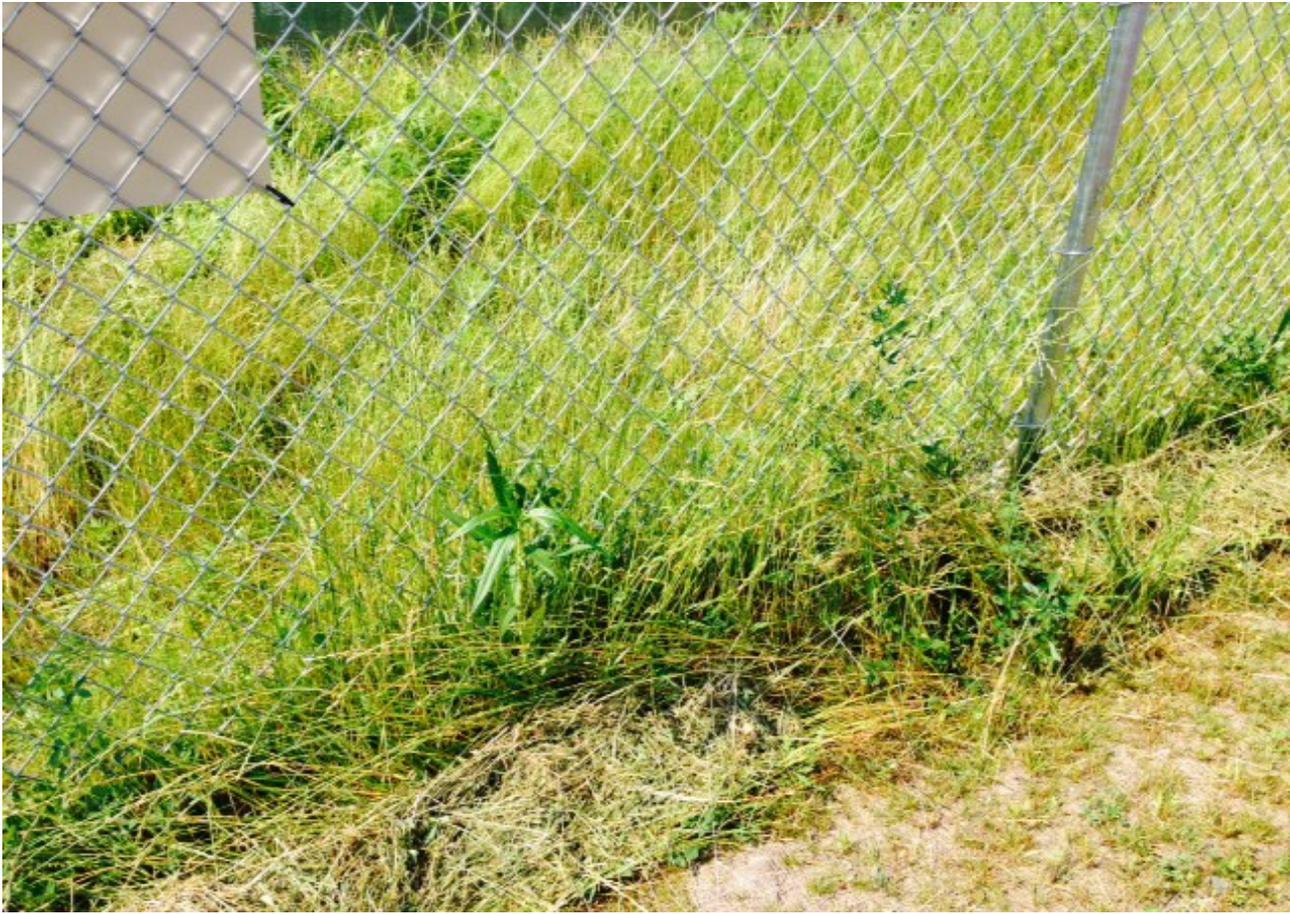
Photo 10 - Vegetation in Fence

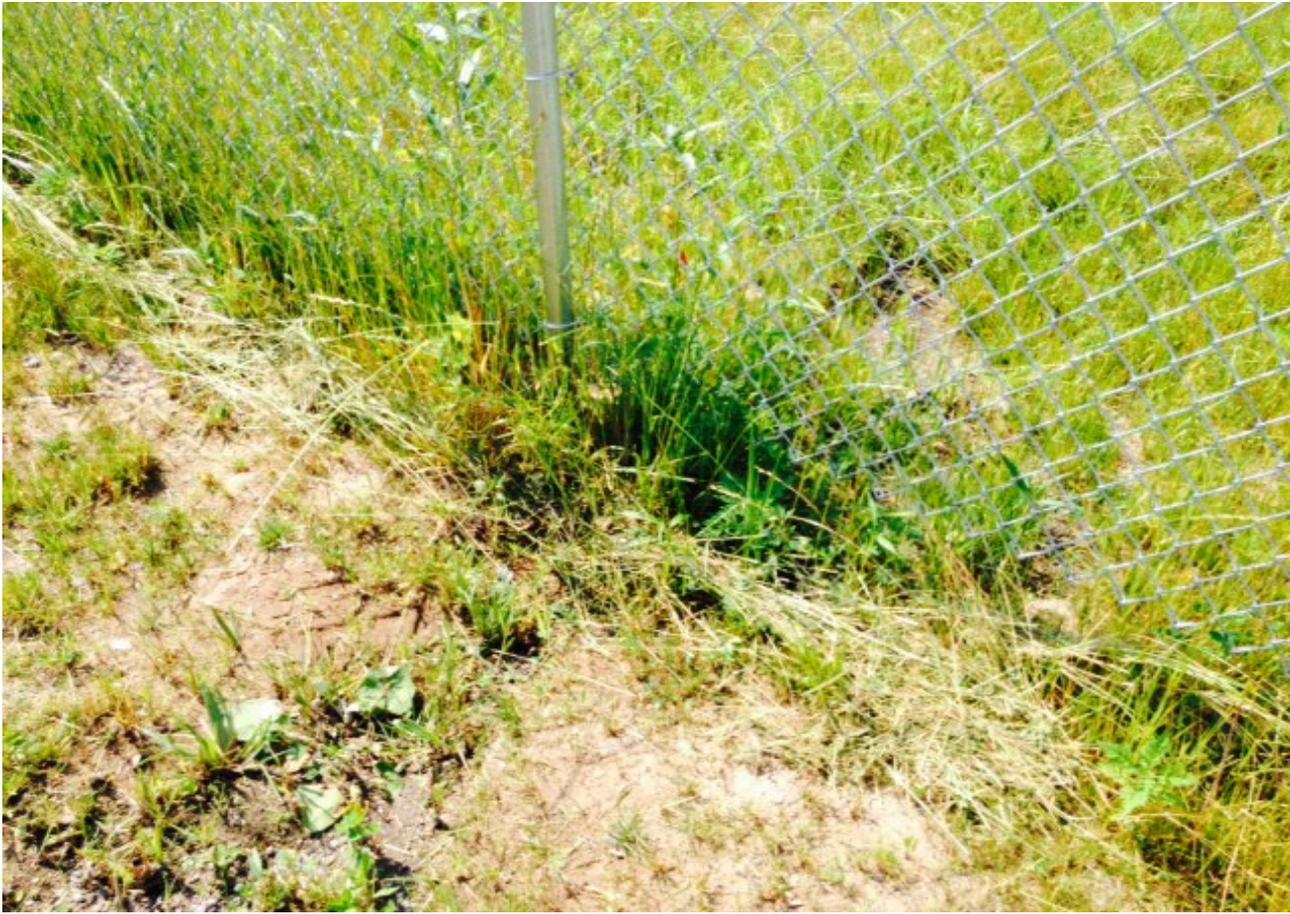
Photo 11 - Vegetation in Fence

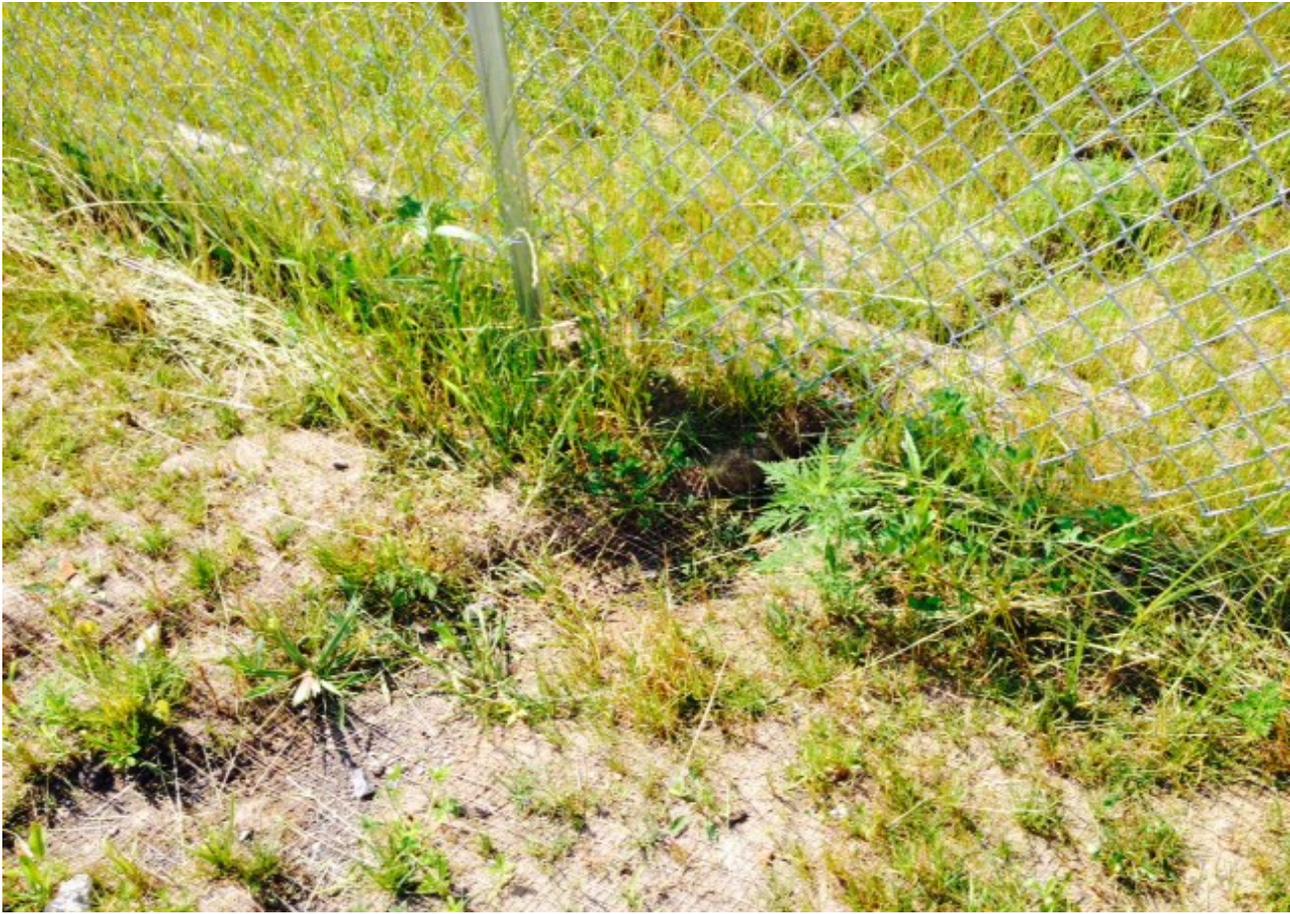
Photo 12 - Minor Erosion Near Edge of Asphalt Cap

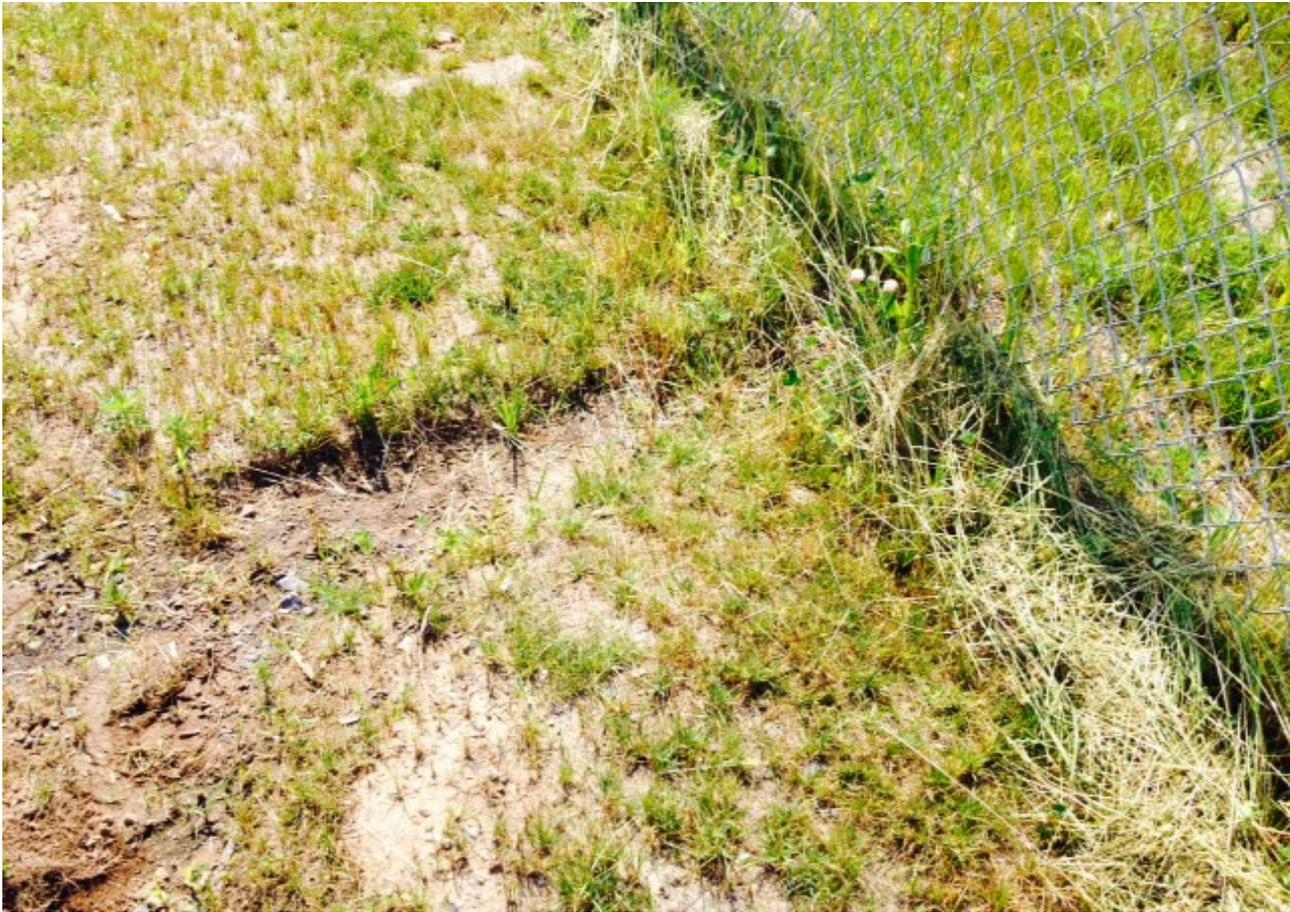
Photo 13 - Minor Erosion Near Edge of Asphalt Cap

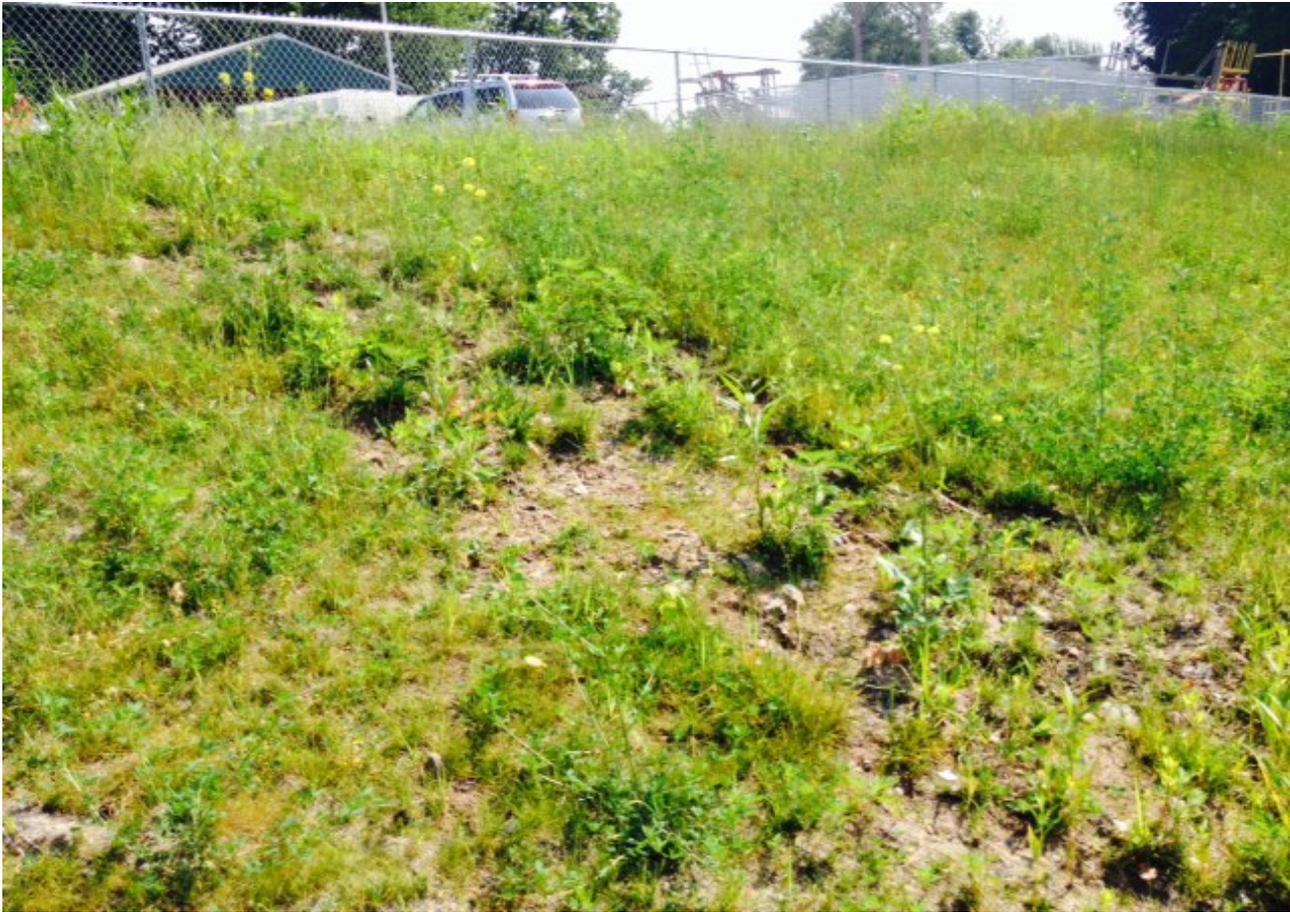
Photo 14 - Minor Erosion on South Side of Fence, North of Canal Bank
