# Interim Operations and Maintenance Plan/Periodic Review Report 2015, Gorham Street Area, Former Hampshire Chemical Corp. Facility, Waterloo, New York—Site No. 850001A

PREPARED FOR: Hampshire Chemical Corp.

PREPARED BY: CH2M HILL

DATE: December 7, 2015

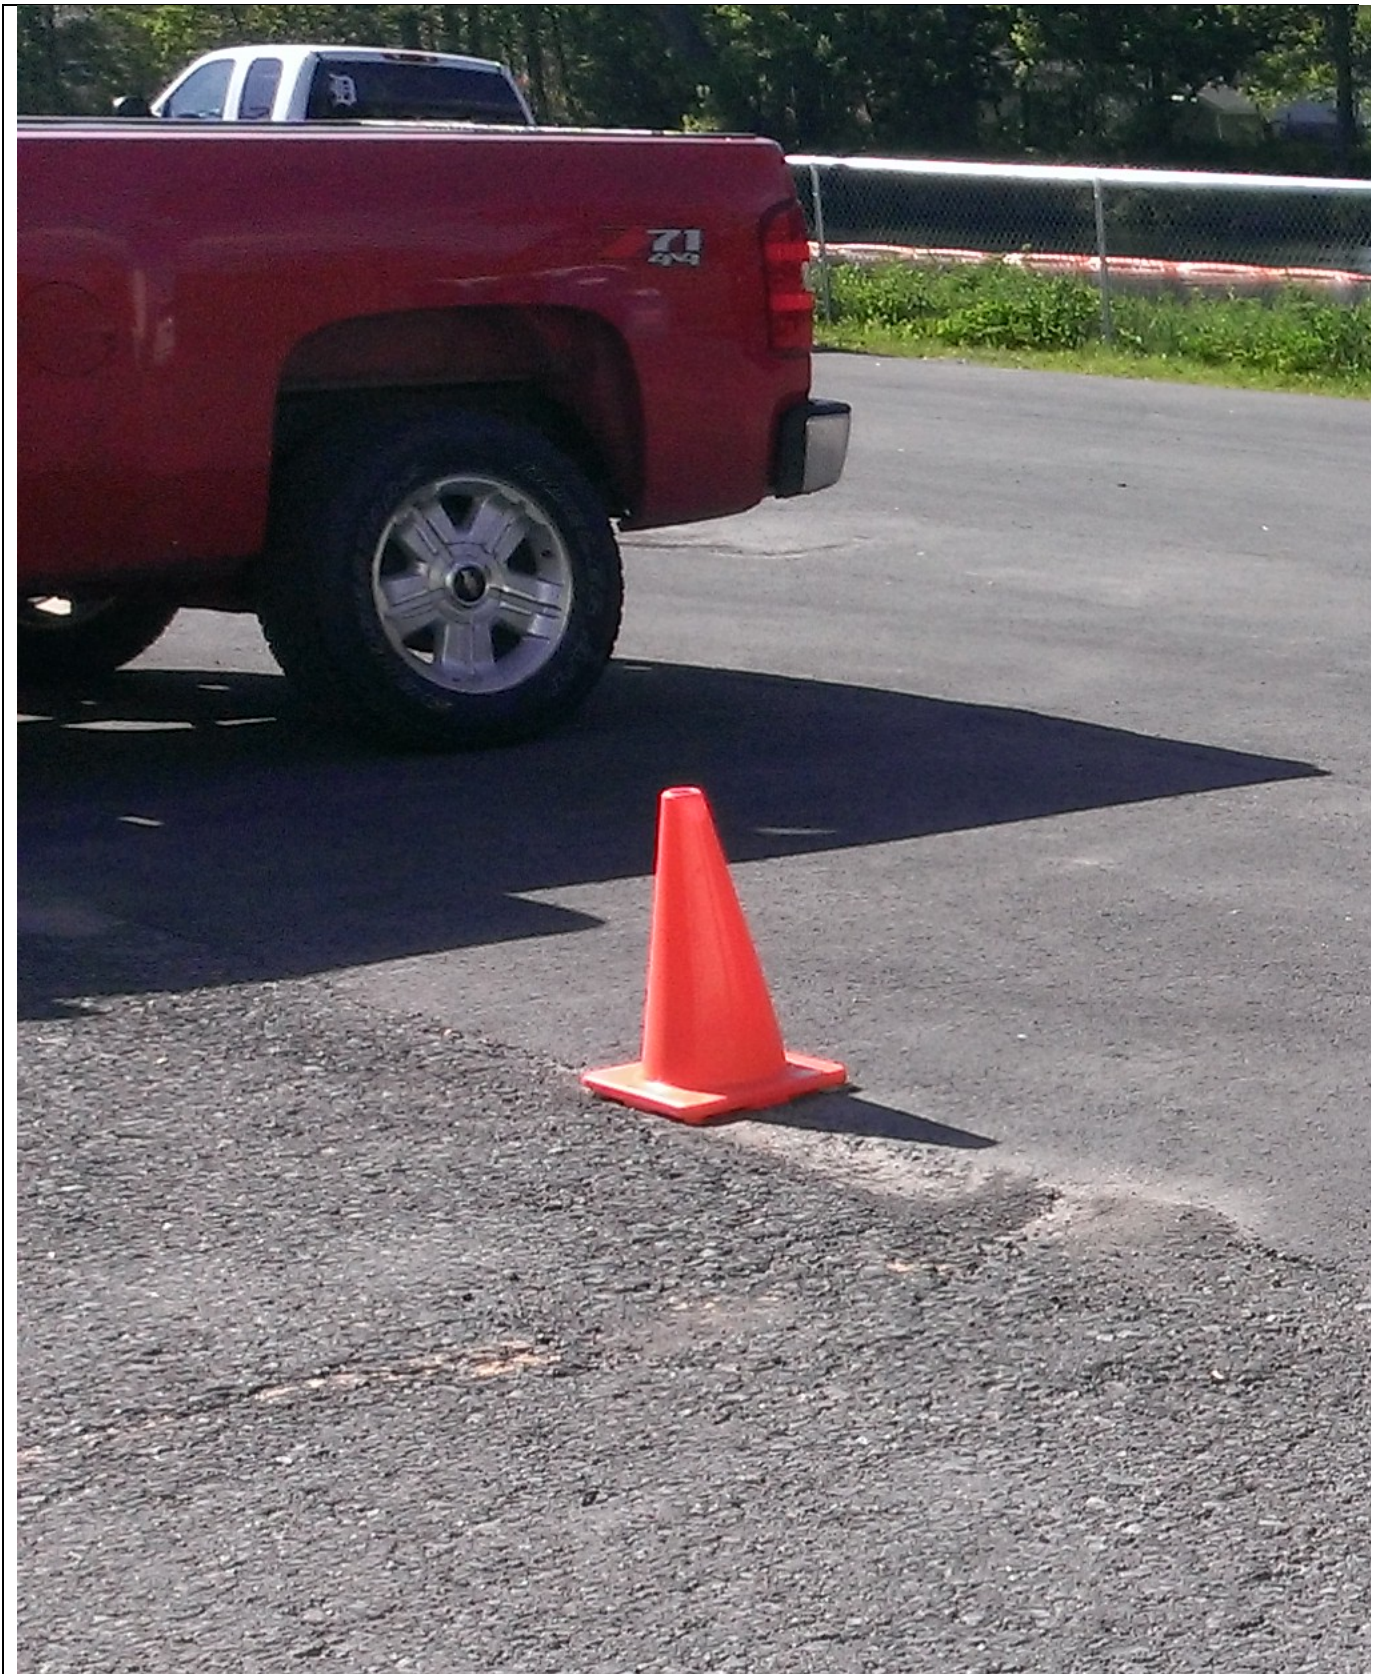
Soil Cover		Yes	No	Comments & Deficiencies Noted (Required if Shaded Area Selected)	CA Completion (Date/Initials)
Are there Signs of Stressed or Dead Vegetation?			X		
Is mowing of vegetation being performed at a suitable frequency?			X	Weeds along canal bank	Mowing performed on June 3, 2015 by Evans Chemetics personnel.
Are there Signs of Erosion, Furrows, Ruts, Penetrations, Cracking or Animal Burrows?			X		
Are there any Areas of Ponding Water?		X		At transition fence line	Existing grading in this area results in ponding water which evaporates within a couple days.
Any evidence of vandalism to the Cover?			X		
Is there evidence of slope movement along the canal?			X		
Are there Signs of traffic on the soil cover area other than from mowing equipment?			X		
Asphalt Cap		Yes	No	Comments & Deficiencies Noted (Required if Shaded Area Selected)	CA Completion (Date/Initials)
Are there Signs of Erosion, Furrows, Ruts, Penetrations, Cracking or Animal Burrows?		X		Cracks at transition lines	No action required at transition line cracks at this time

Asphalt Cap Transition Intersection

Asphalt maintenance subcontractor to seal cracks

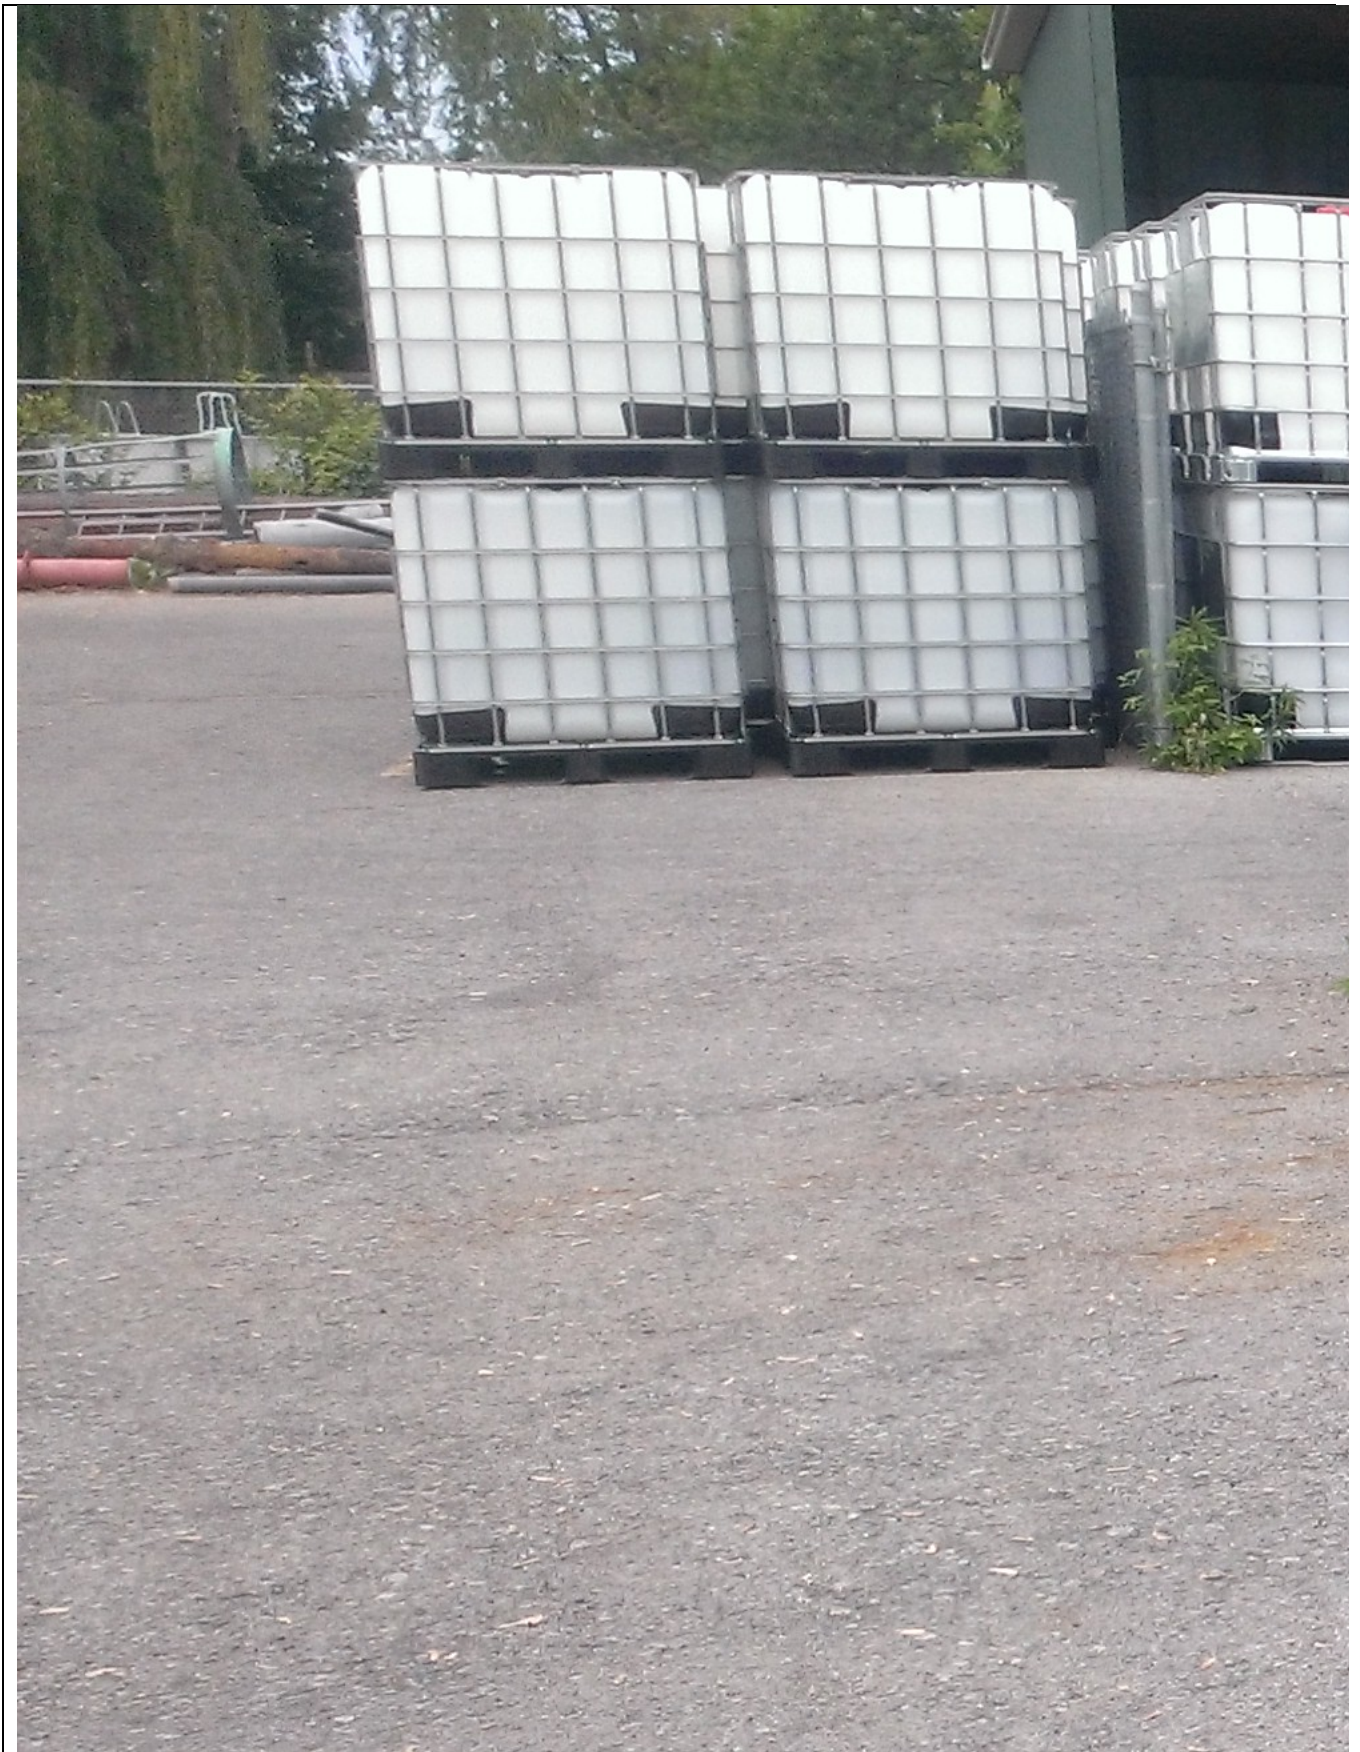
Asphalt Cap Condition

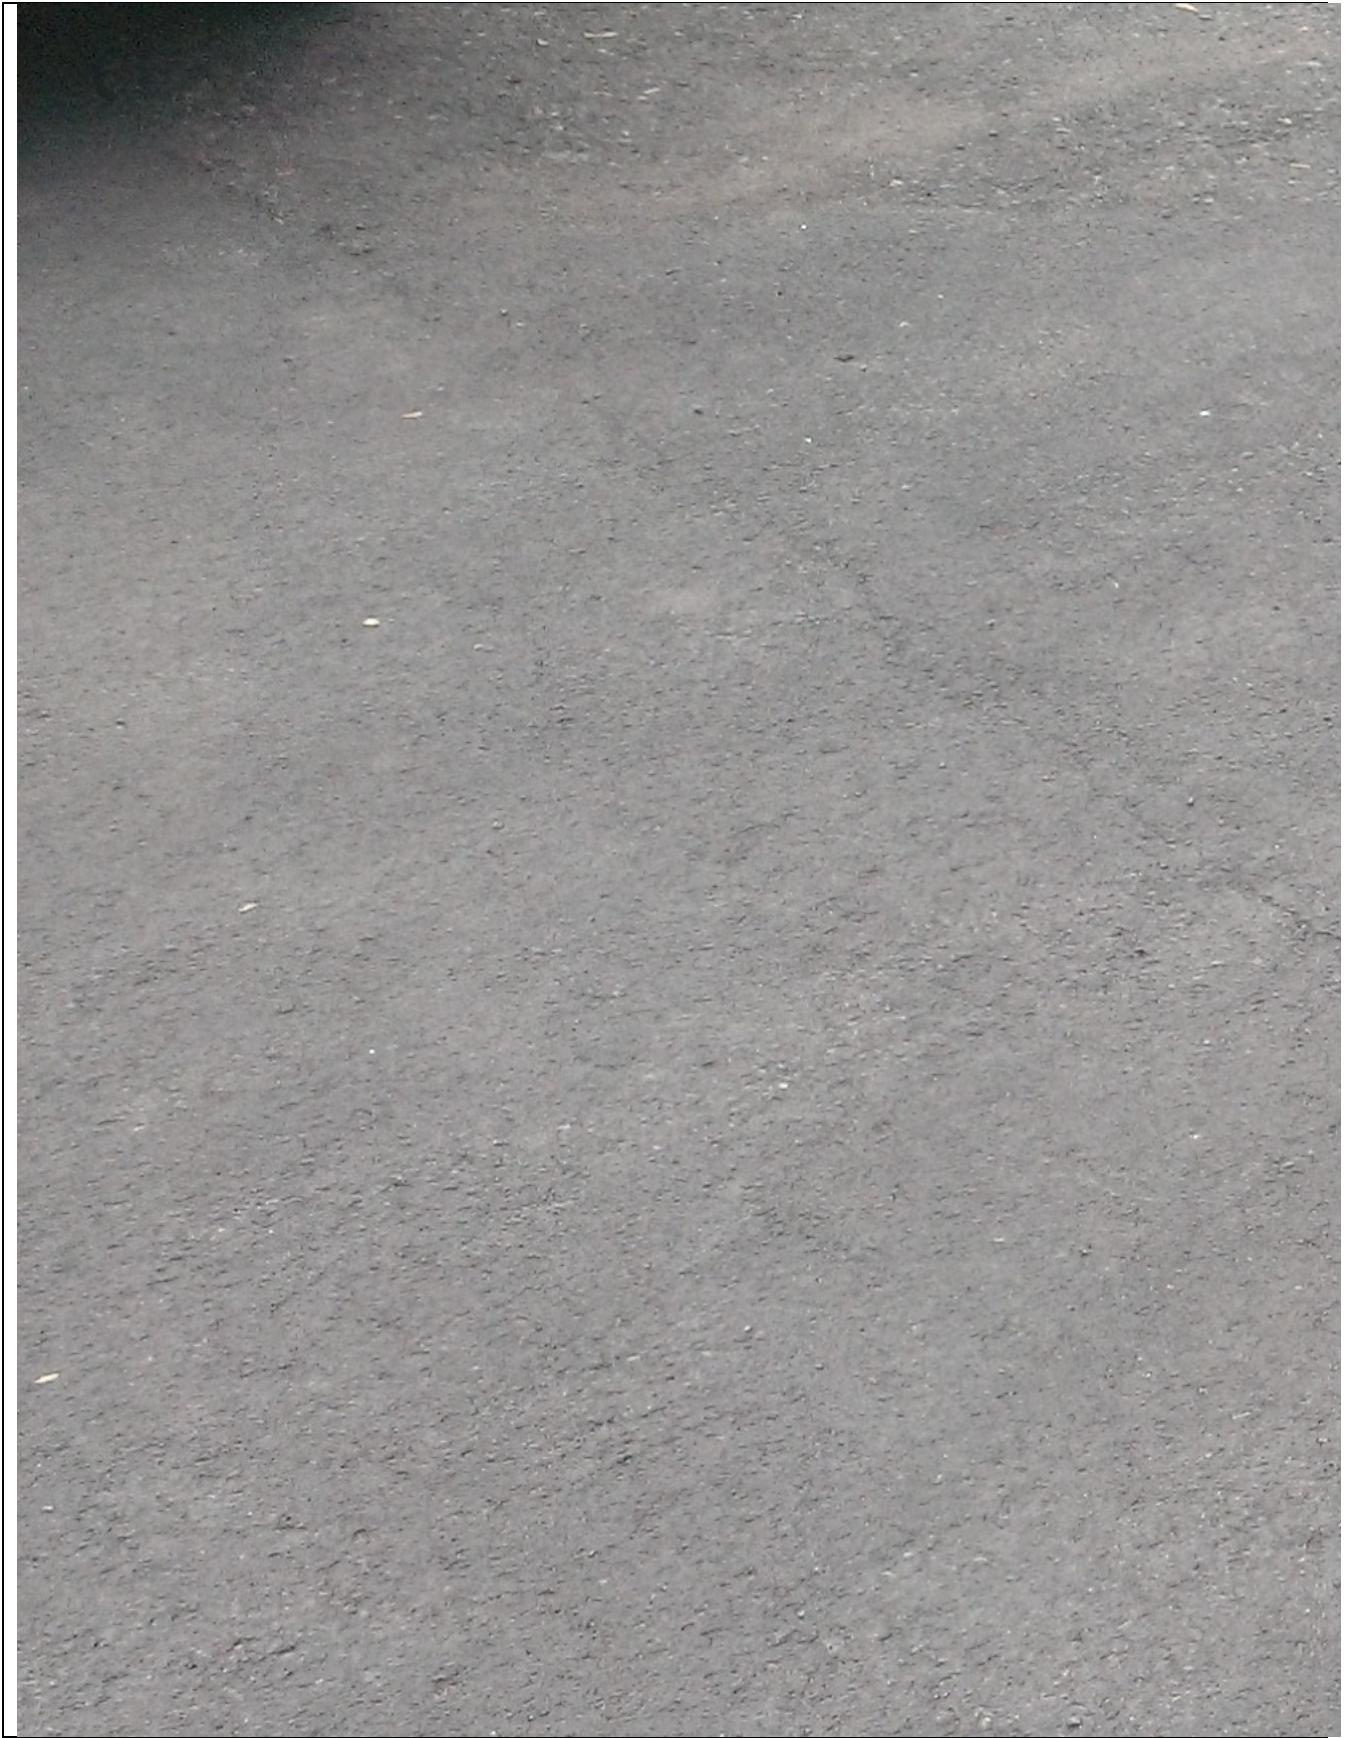
Asphalt Cap Condition

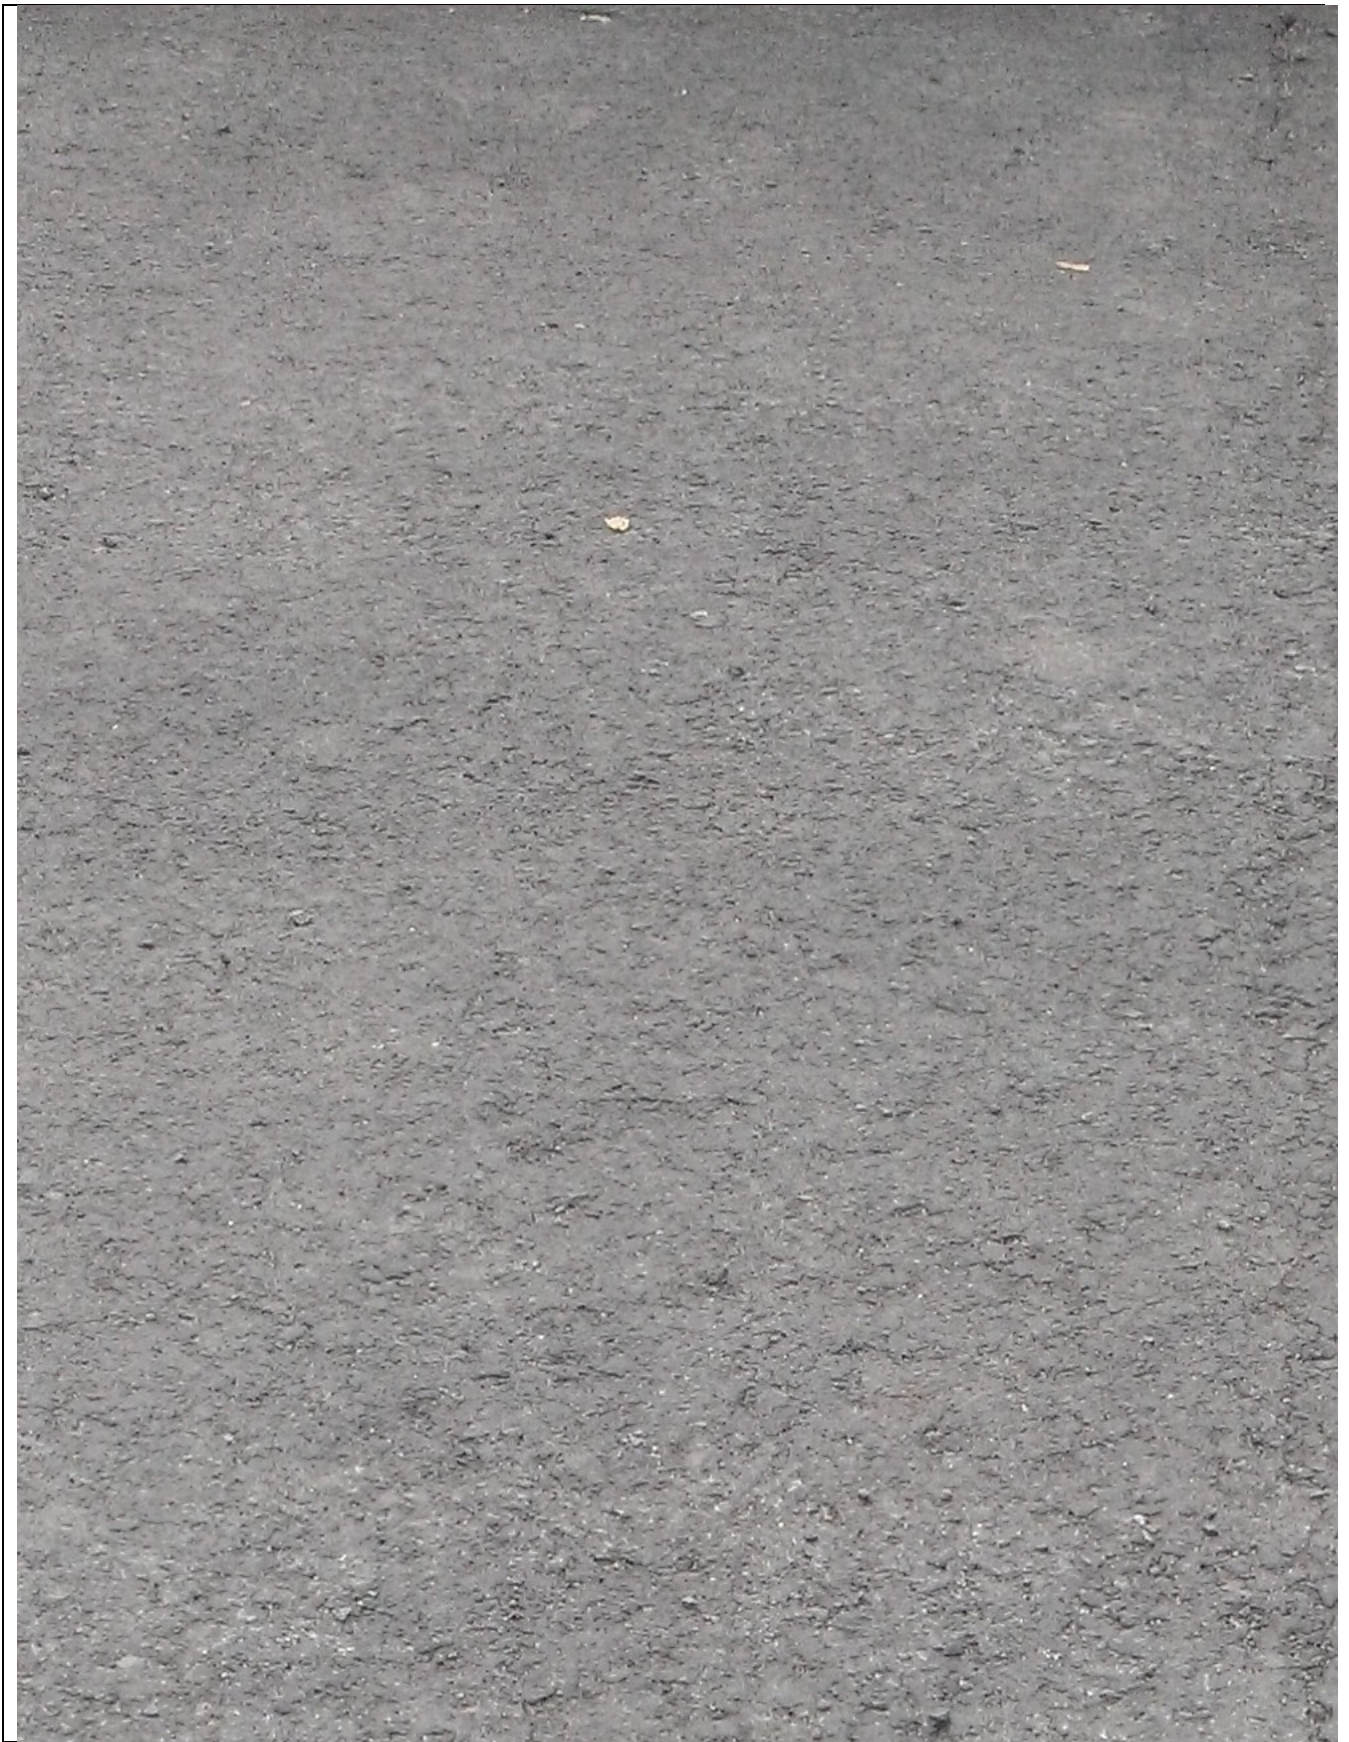
Asphalt Cap Condition

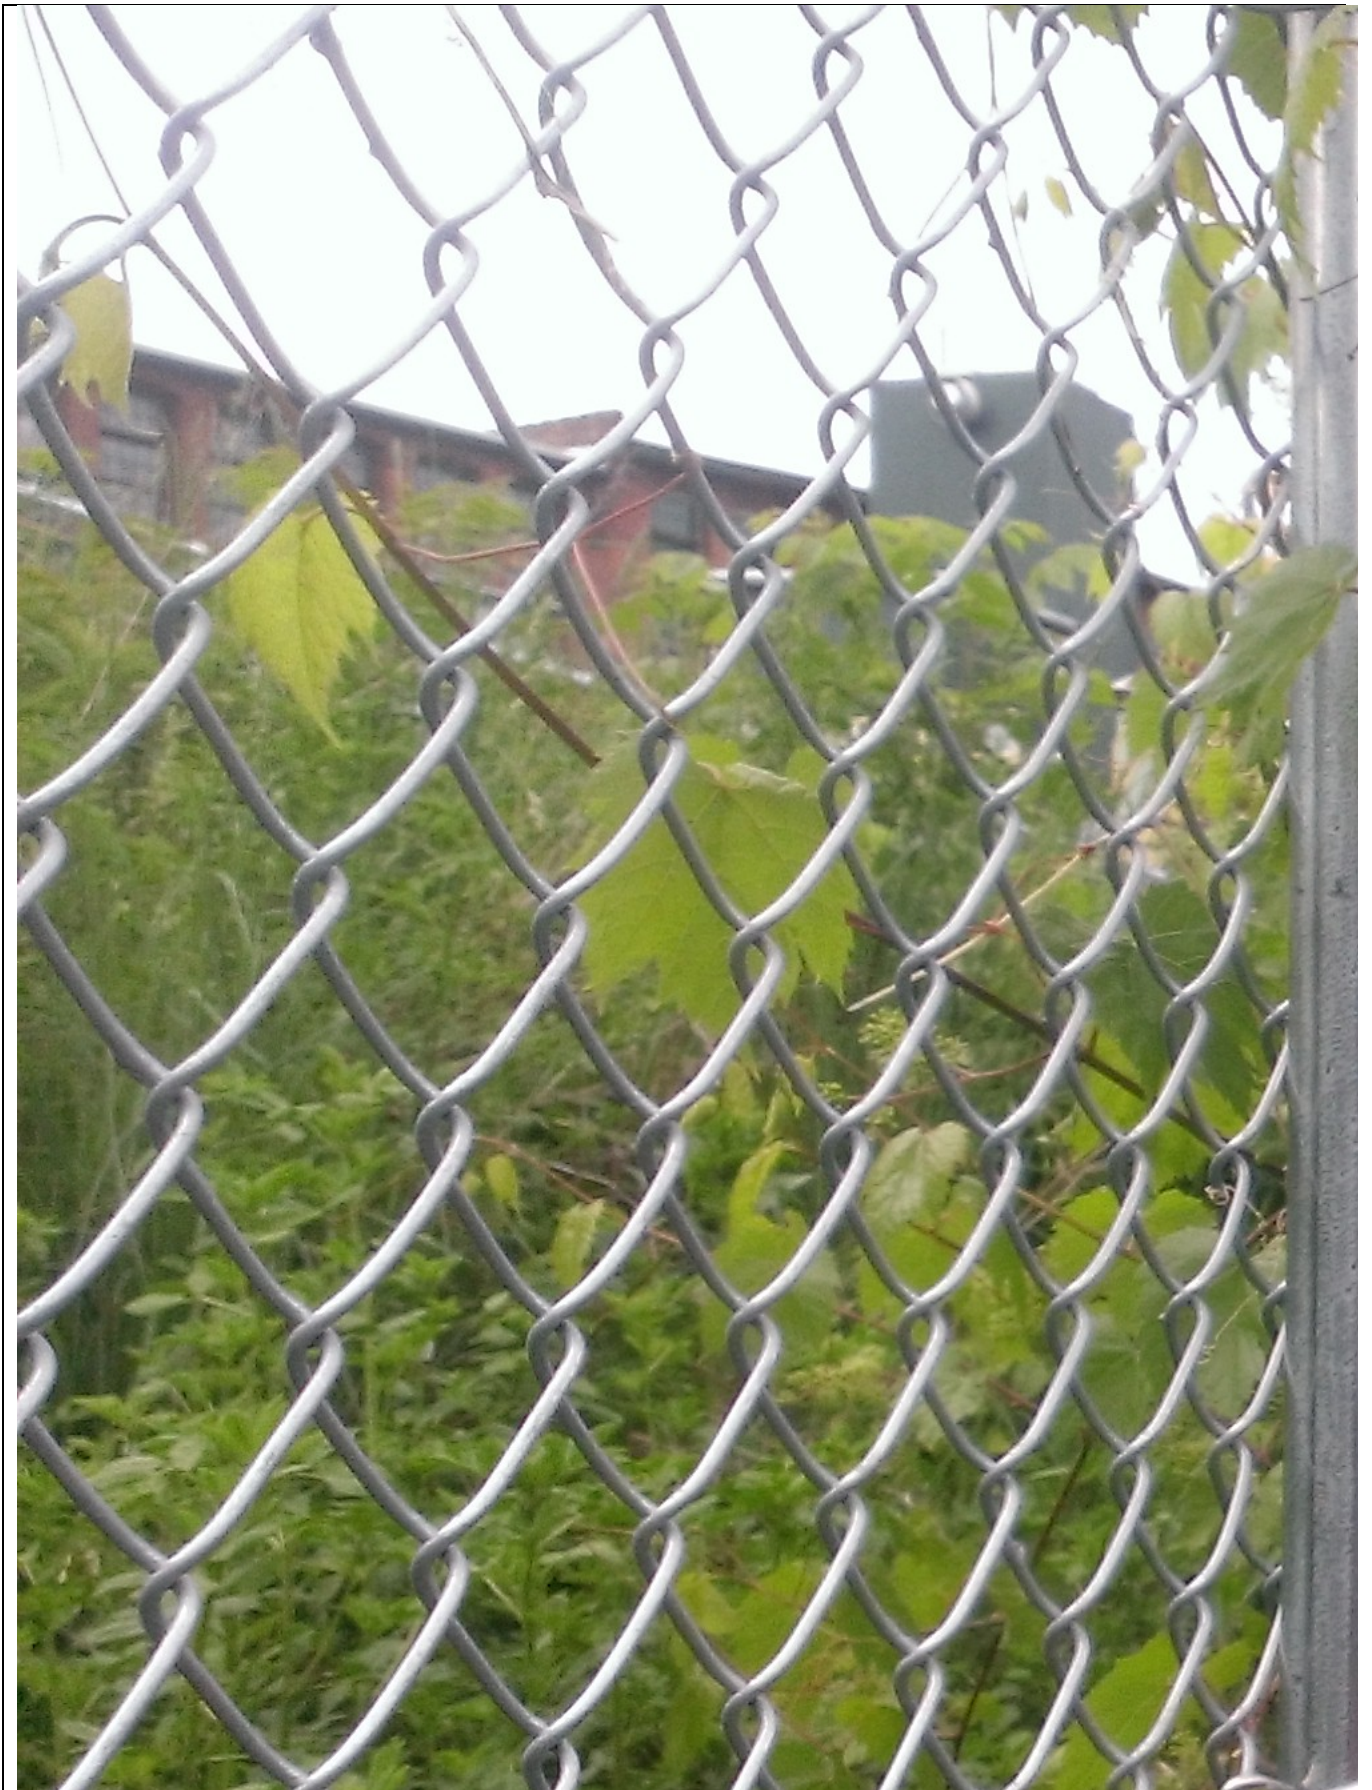
Are there any vegetation growth through the asphalt?		X		Yes - At transition to poles	Vegetation removal performed on June 3, 2015 by Evans Chemetics personnel.
Are there any Areas of Ponding Water?		X		Low areas in parking lot	Existing grading in this area results in ponding water which evaporates within a couple days.
Any evidence of vandalism to the Cap?			X		
Drainage Swales		Yes	No	Comments & Deficiencies Noted (Required if Shaded Area Selected)	CA Completion (Date/Initials)
Are the drainage swales still allowing for adequate flow towards the canal?		X			
Are there any signs of erosion, furrows, etc?			X		
Perimeter Security (Fences & Gates)		Yes	No	Comments & Deficiencies Noted (Required if Shaded Area Selected)	CA Completion (Date/Initials)
Are Security Signs in Place?		X			
Are all Gates Locked?		X			
Is Fence in Good Condition?		X			
Are there Signs of Vandalism?			X		
Is Vegetation growing on Fence or Gates?		X		Vegetation on fences	Vegetation removal performed on June 3, 2015 by Evans Chemetics personnel.

Vegetation on Fence

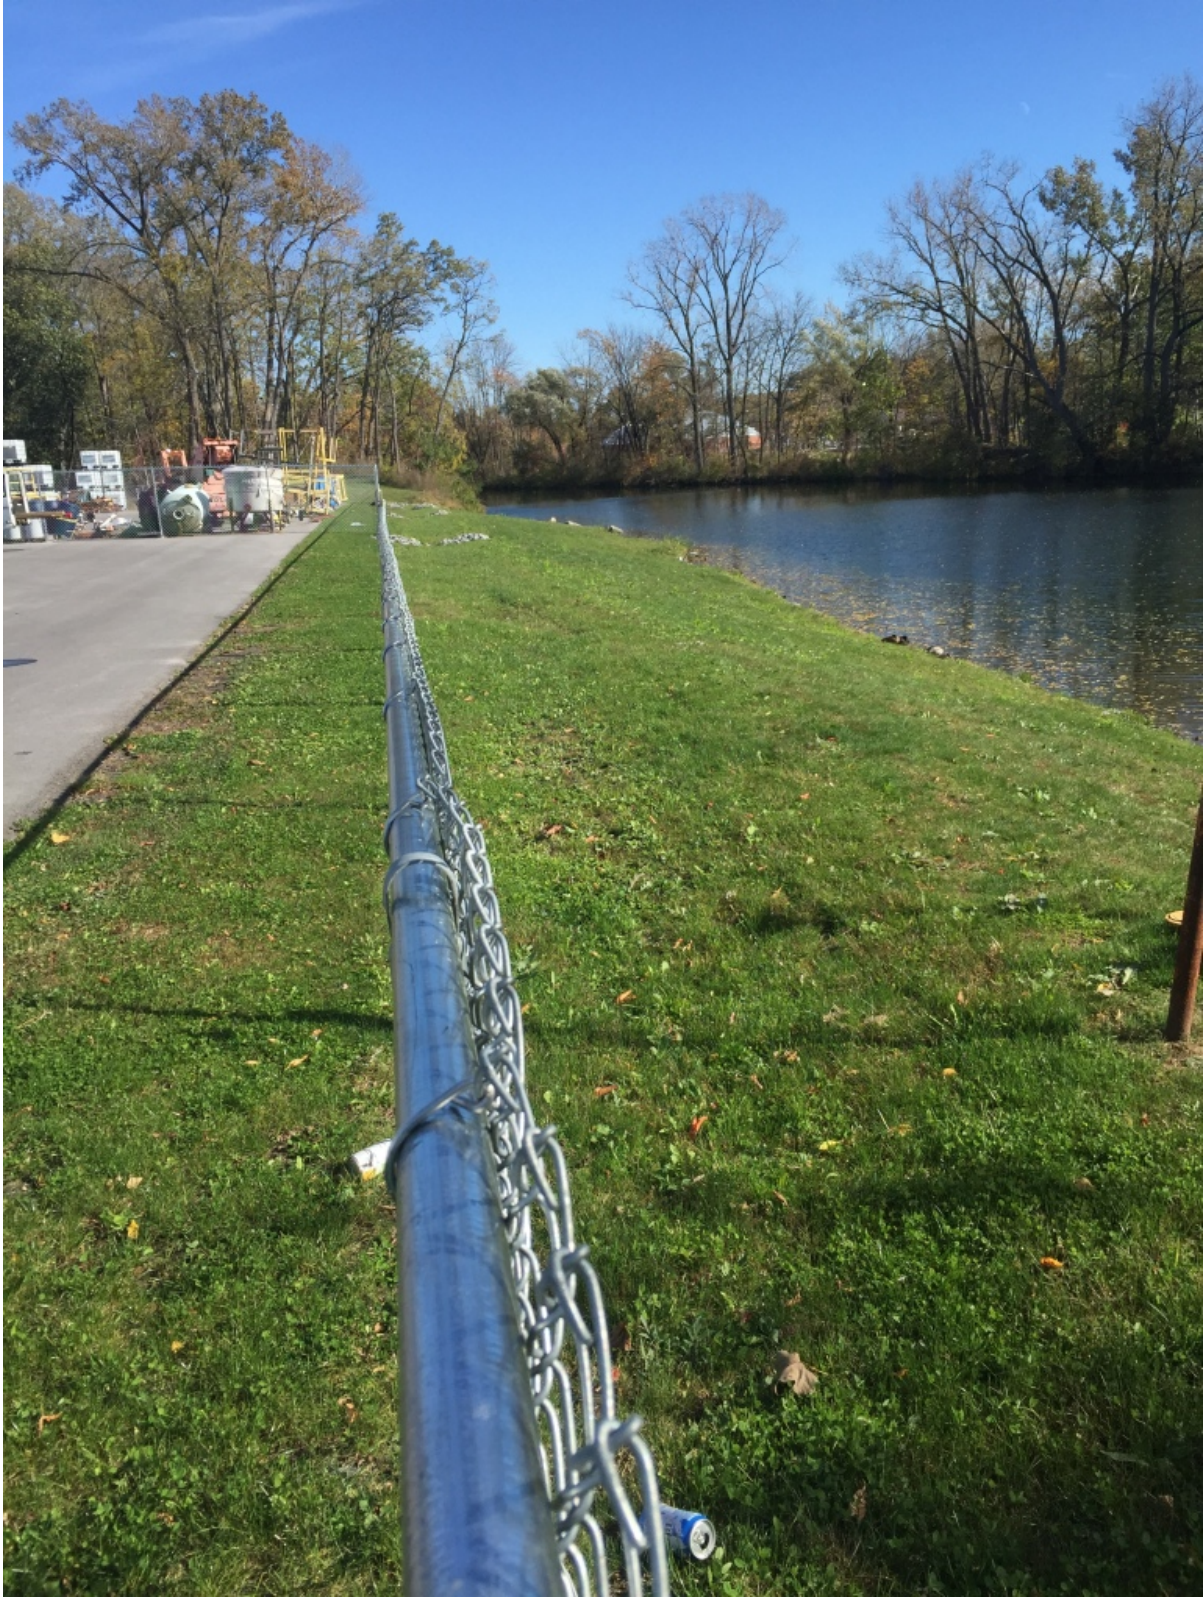
Canal Bank Cover

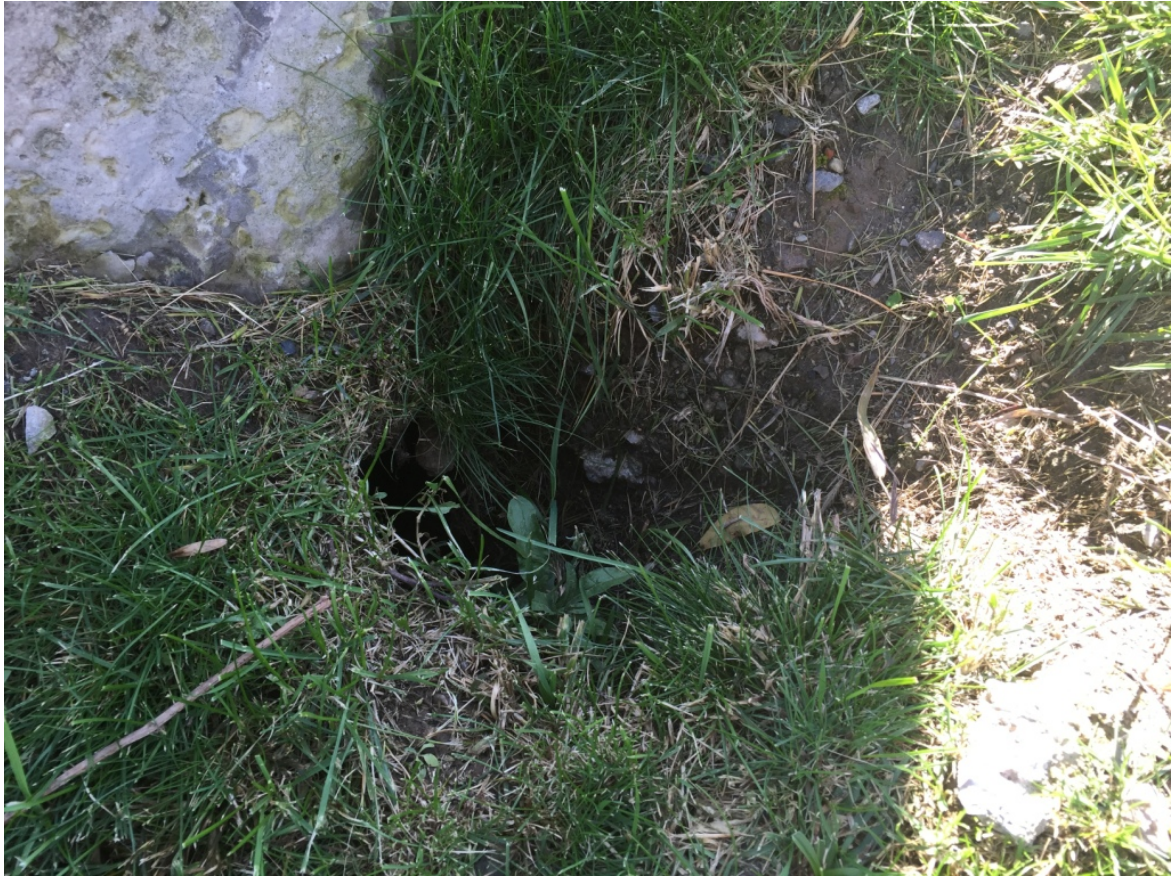
Animal Burrow on NW Corner of Large Rock

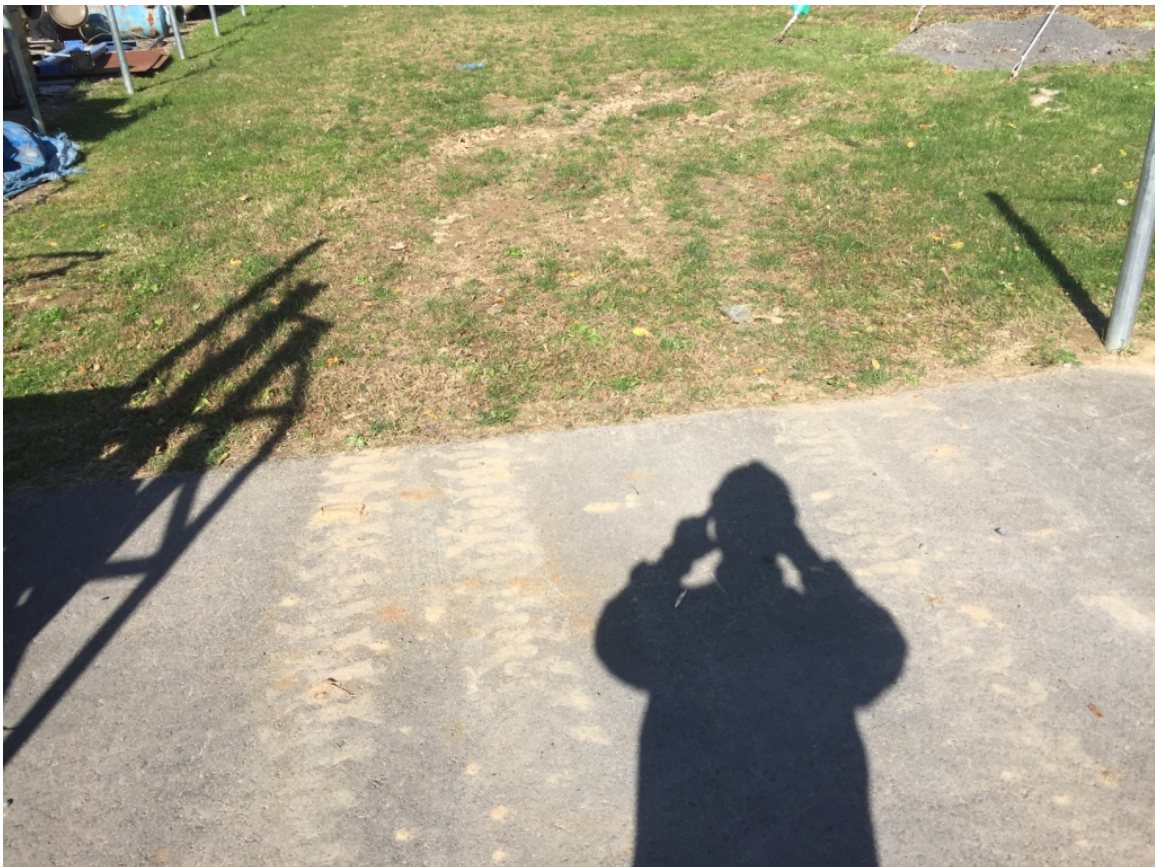
Tracking onto Cover Area – Appears to be from Tree Clearing around Power Poles

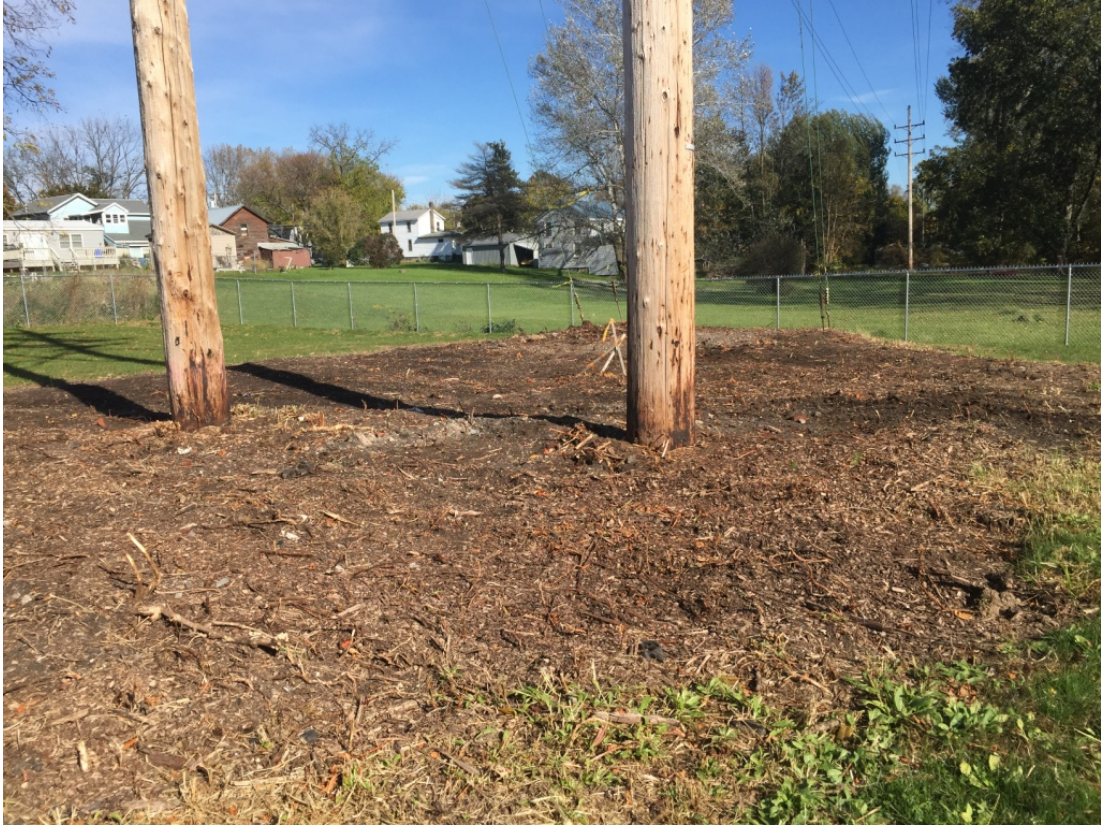
Tree Clearing around Power Poles

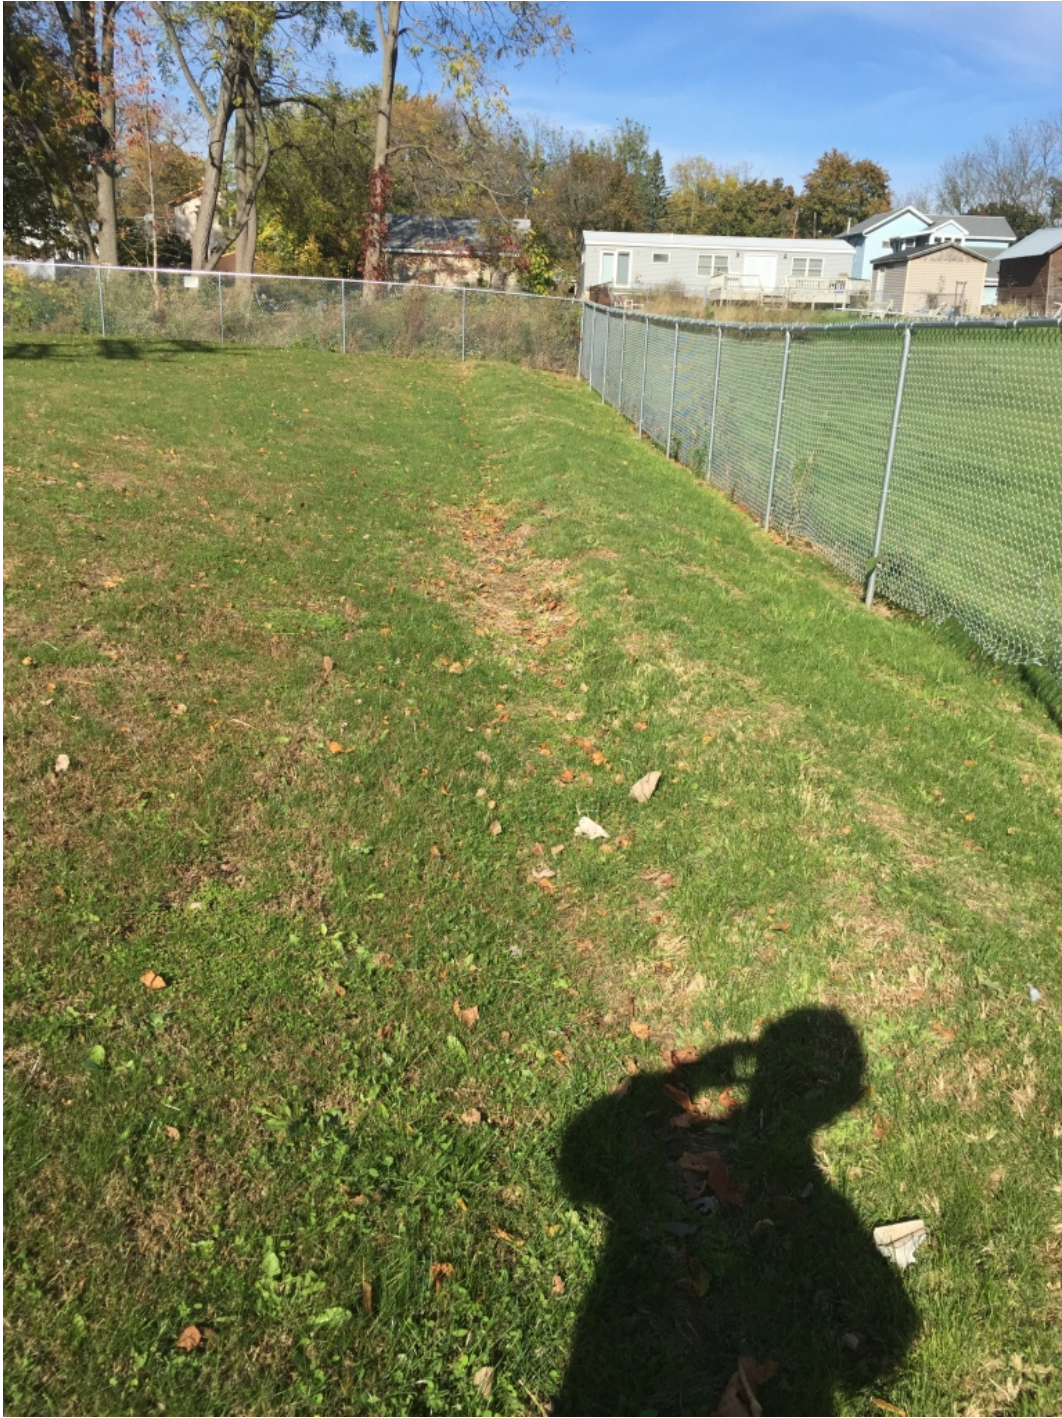
Drainage Swale Located on East Side of Cover Area

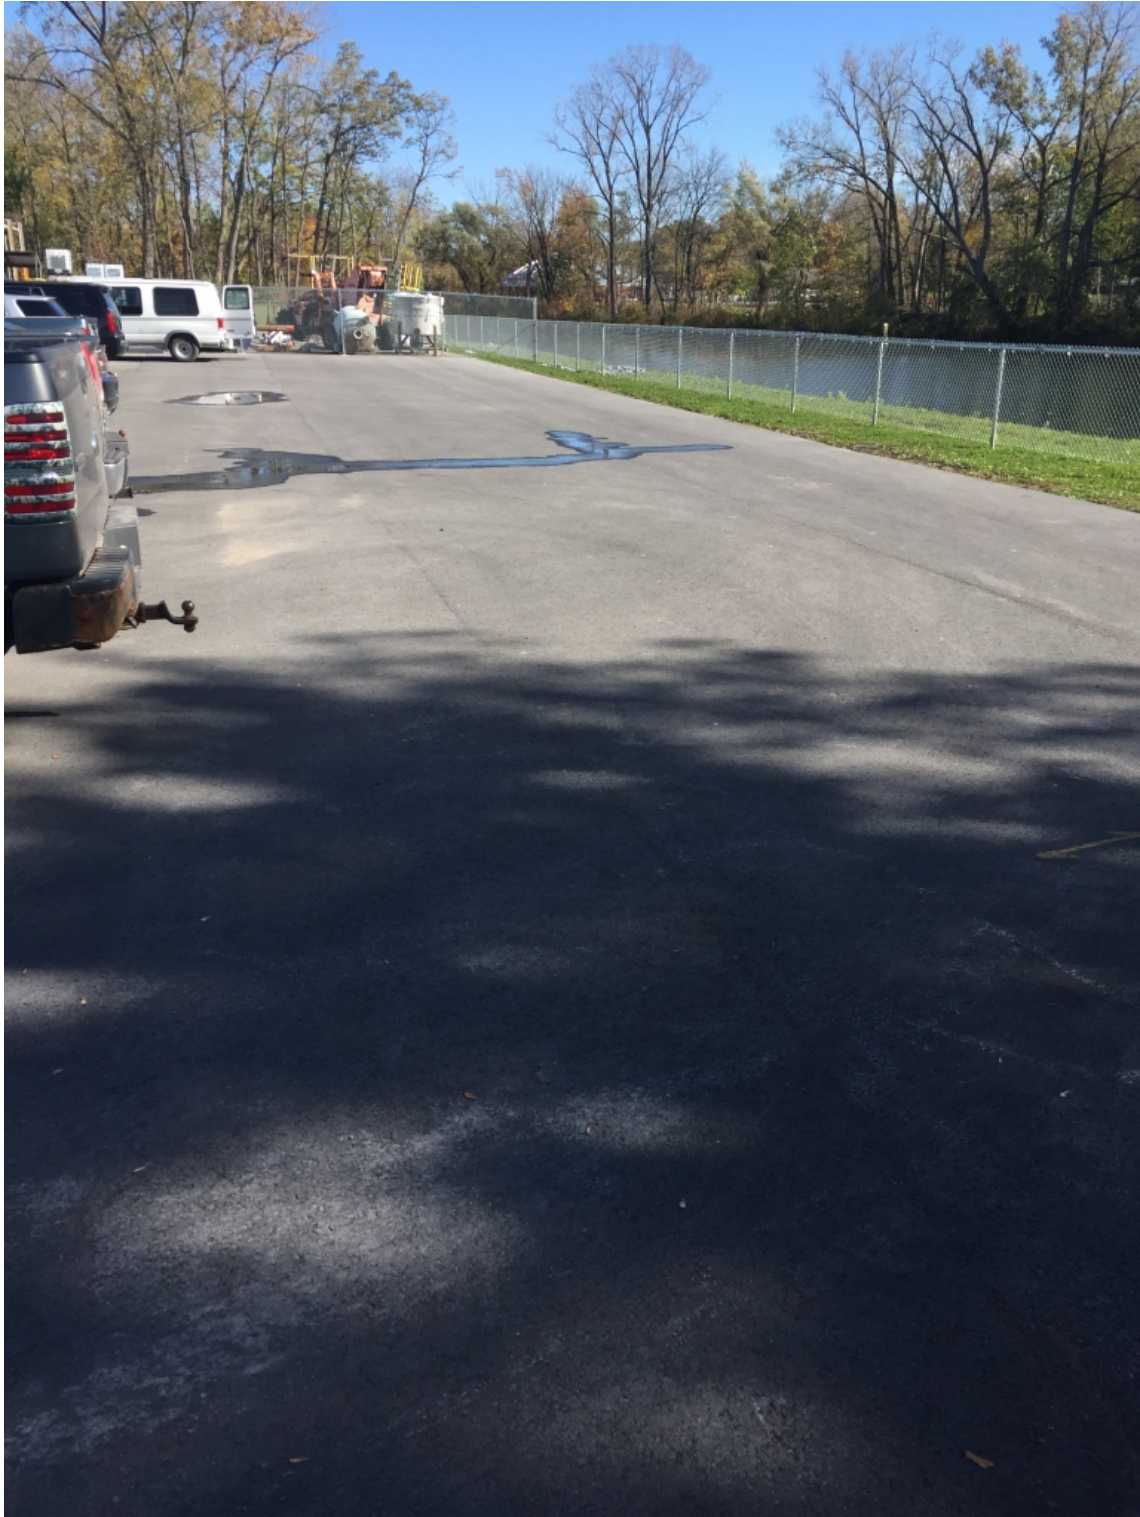
Asphalt Cover Area
