Interim Operations and Maintenance Plan/Periodic Review Report 2016, Gorham Street Area and Gabion Wall, Former Hampshire Chemical Corp. Facility, Waterloo, New York—Site No. 850001A

PREPARED FOR: Hampshire Chemical Corp.

PREPARED BY: CH2M HILL

DATE: November 15, 2016

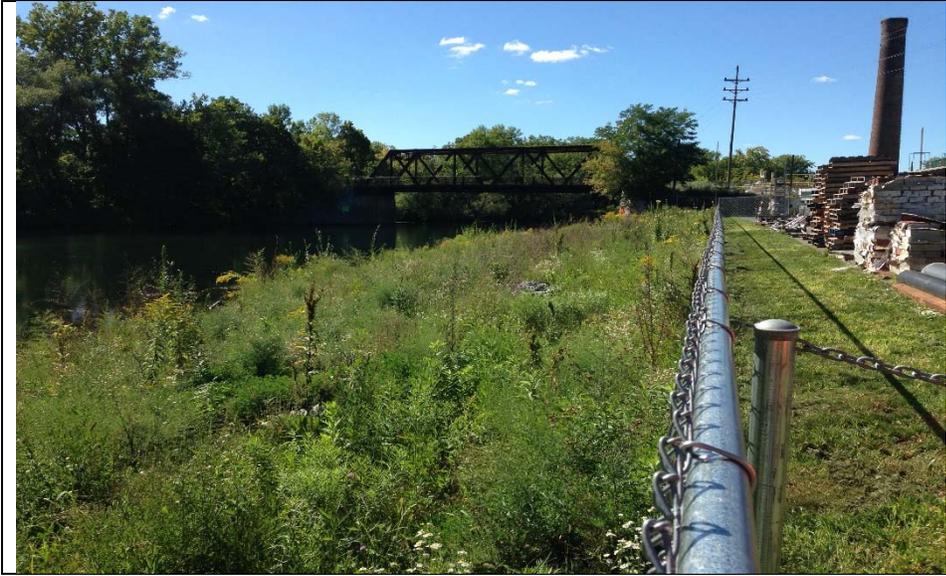
Gorham Street canal bank and fence looking west.

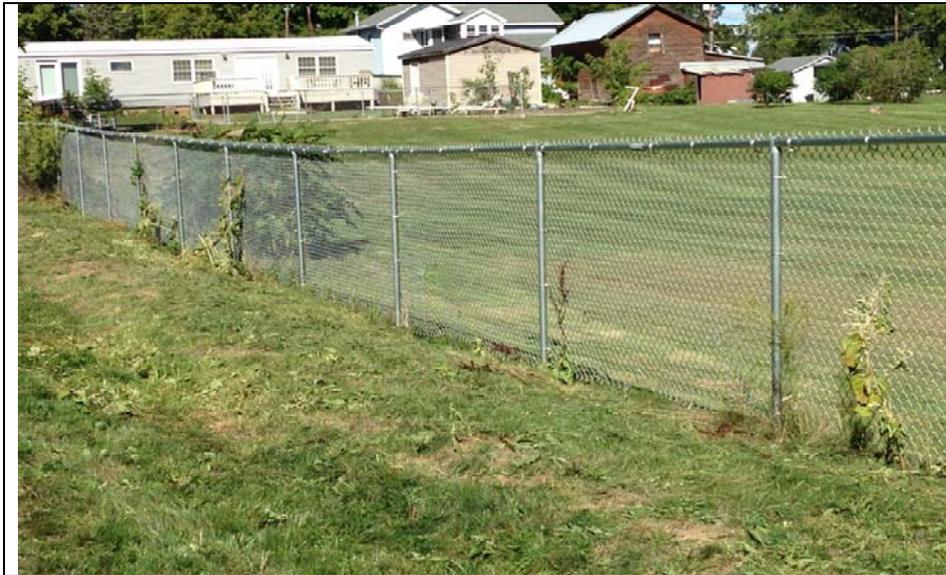
Gorham Street east fence line.

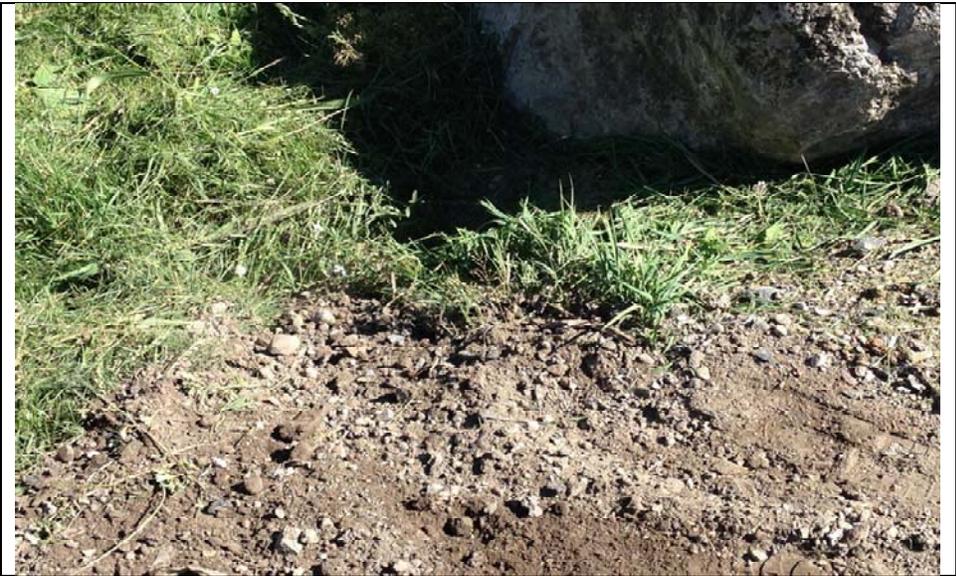
Animal burrow.

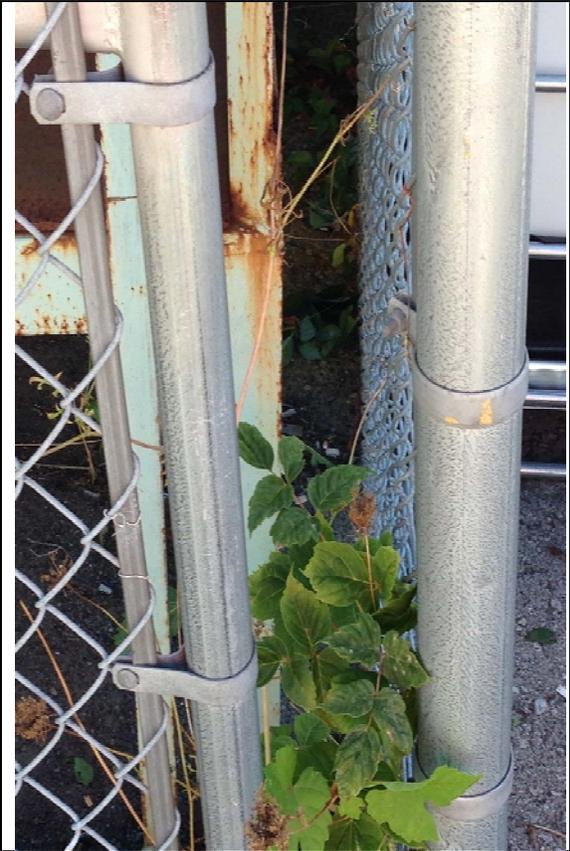
Vegetation in fence.

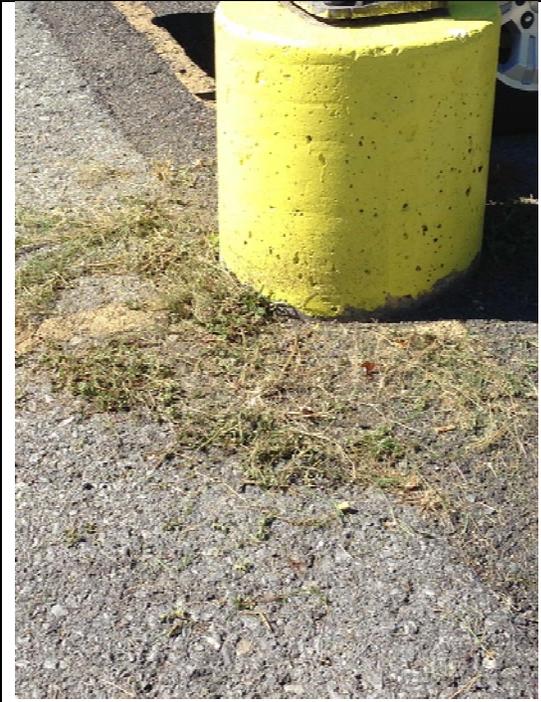
Vegetation in asphalt.

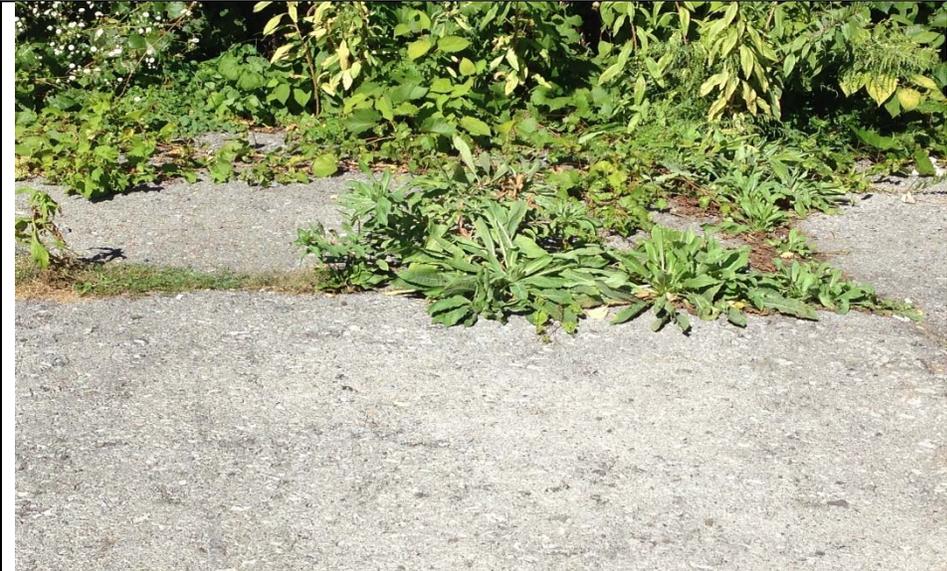
Vegetation in asphalt.

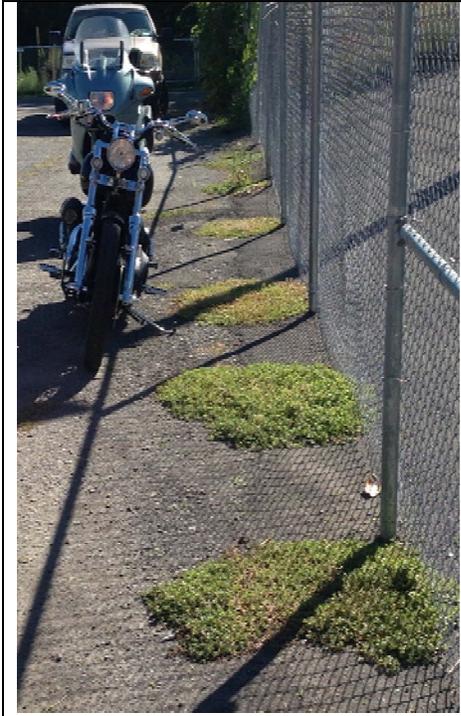
Vegetation in asphalt.

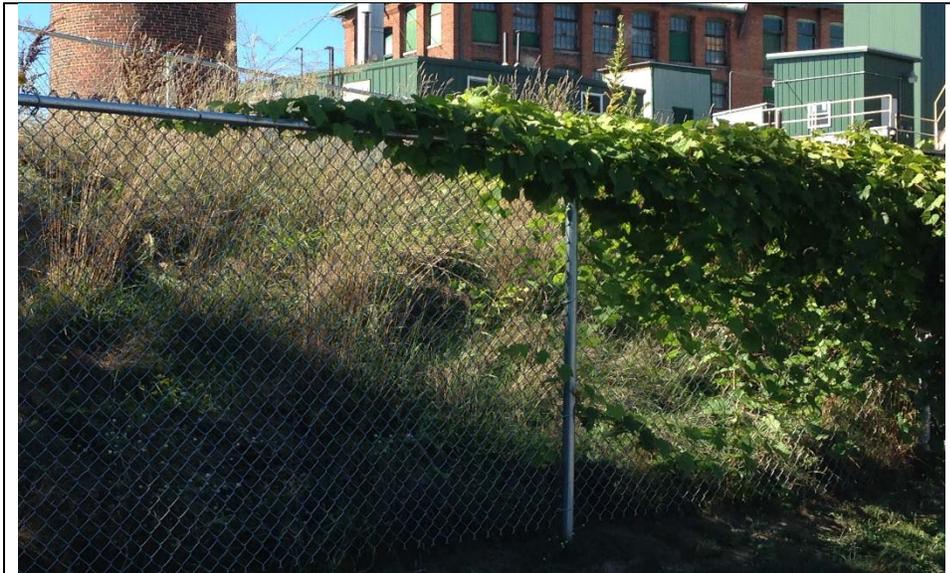
Vegetation covering fence along Gorham Street.

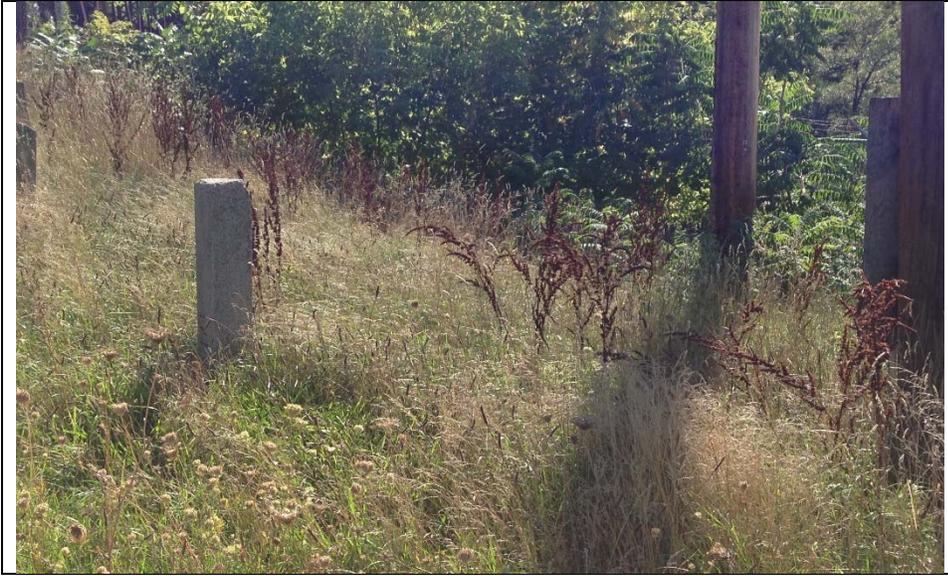
Gorham Street canal bank looking south toward canal on Evans Chemetics side.

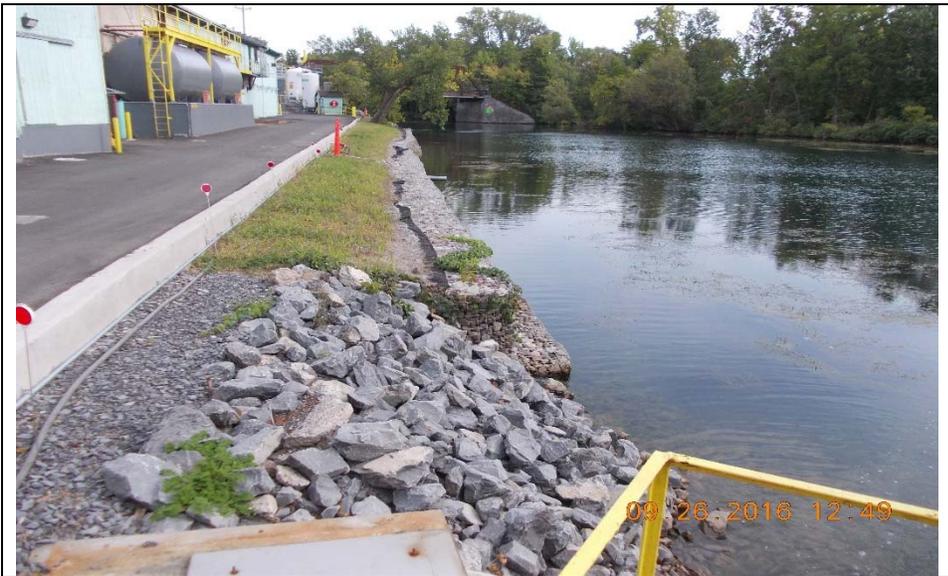
Gabion wall looking east.

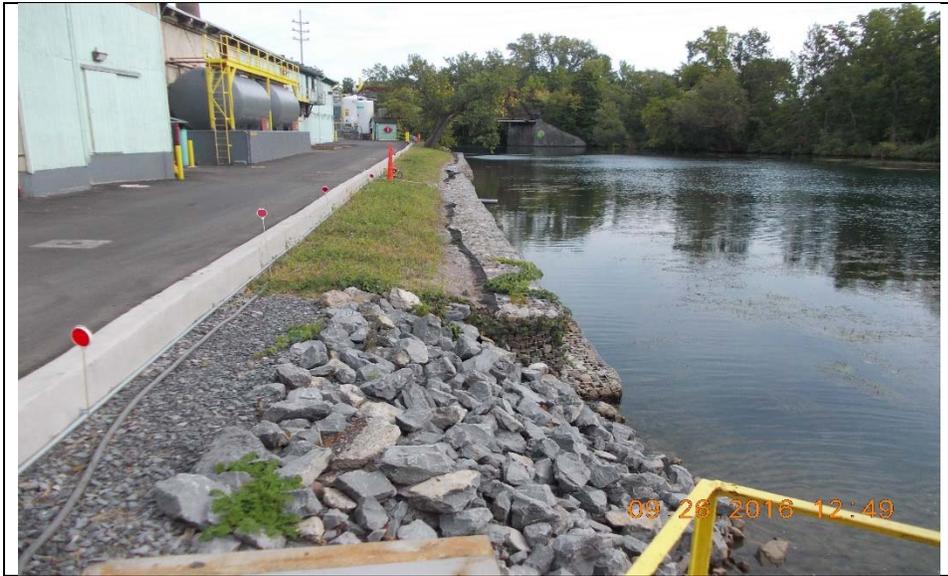
Gabion wall looking east.

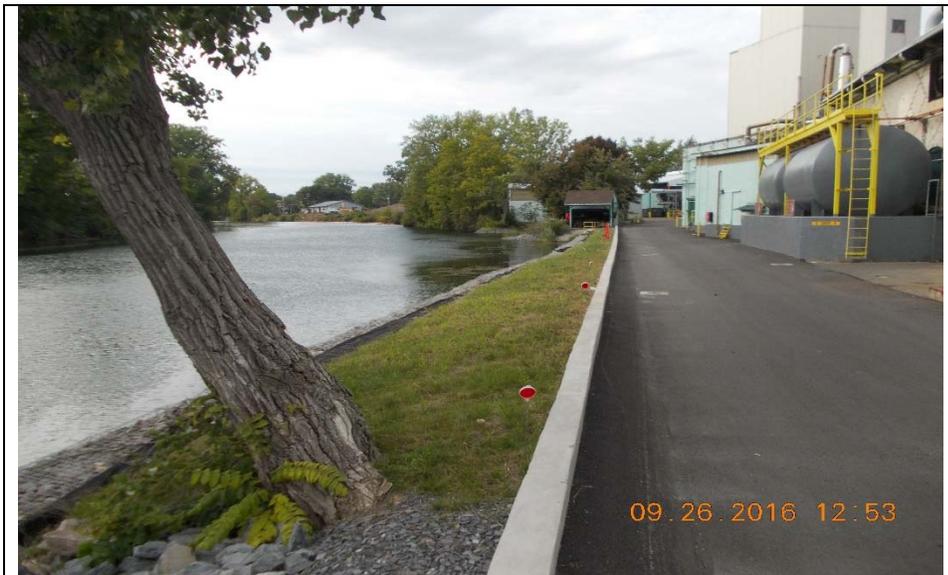
Gabion wall looking west.

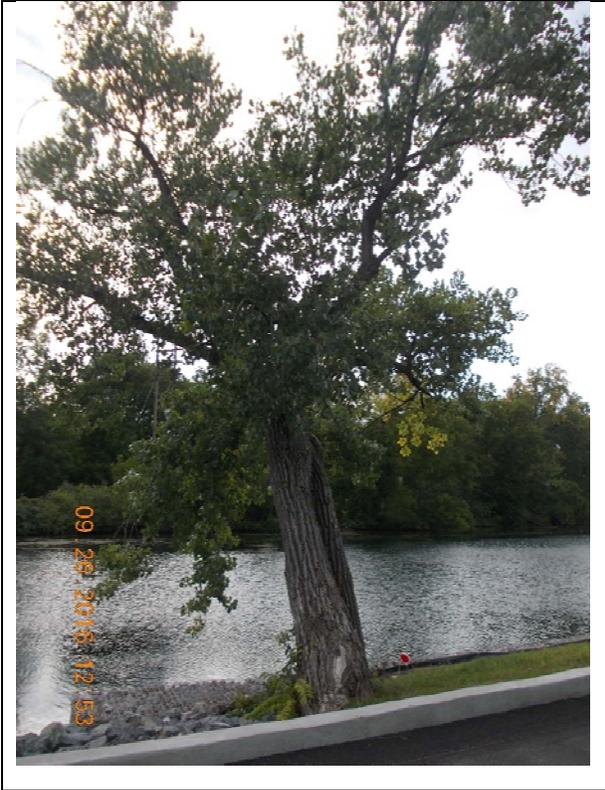
Lone tree at eastern end of gabion wall.

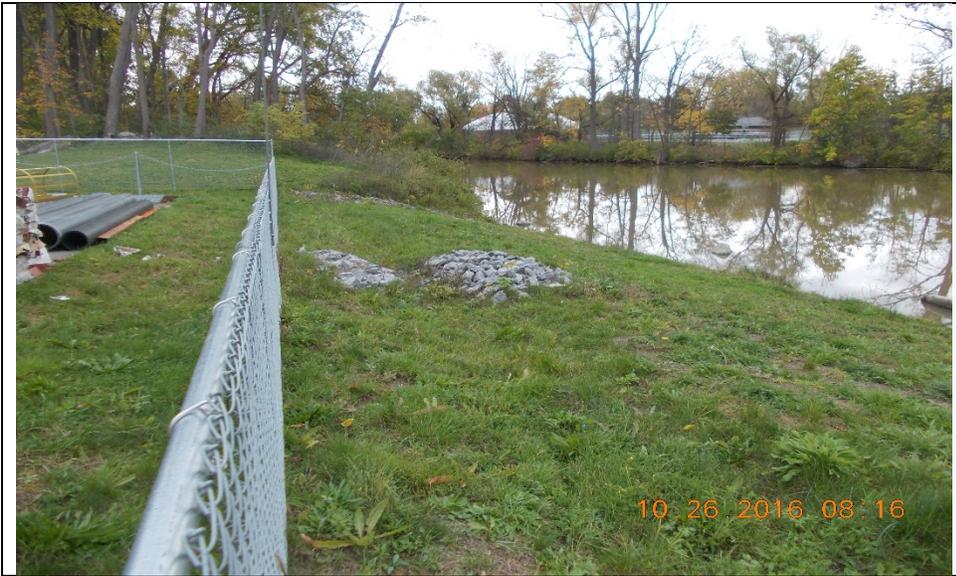
Eastern end of Gorham Street canal bank after mowing (looking east).

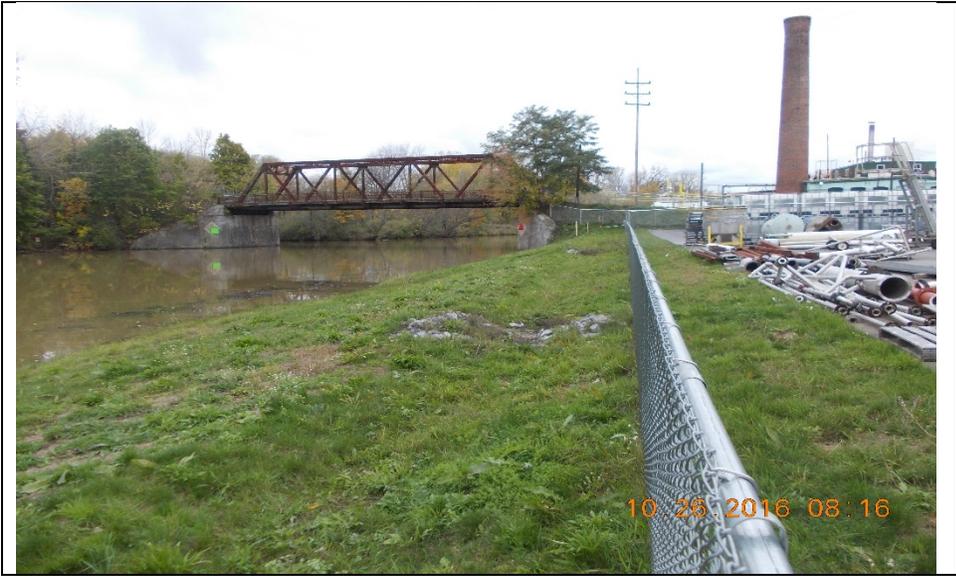
Eastern end of Gorham Street canal bank after mowing (looking west).

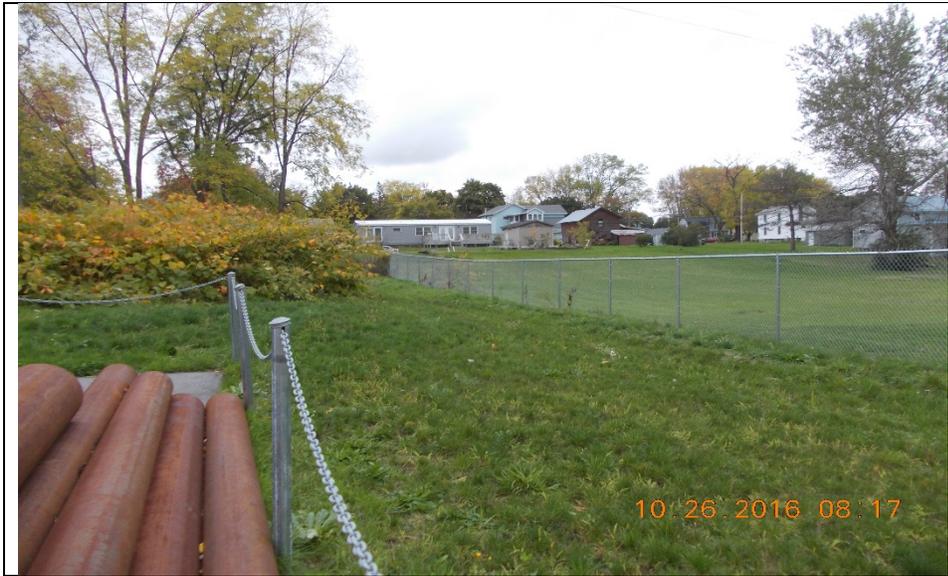
Eastern side of Gorham Street upland area after mowing (looking north).

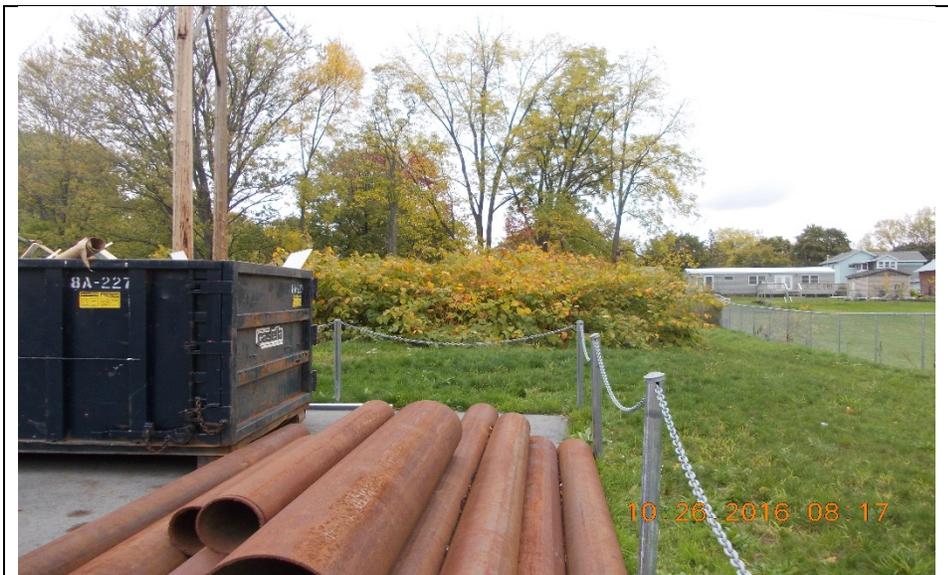
Eastern side of Gorham Street upland area after mowing (looking north).

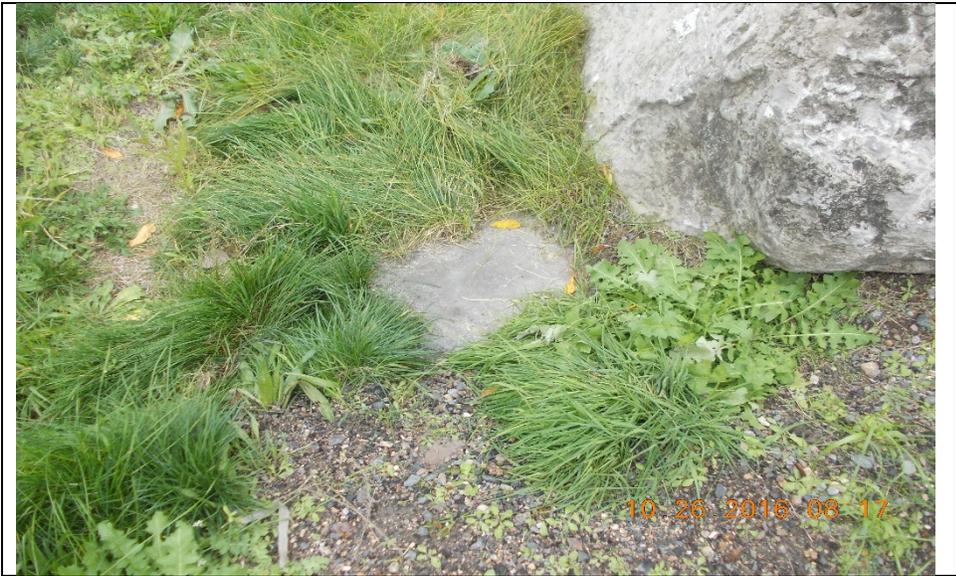
Animal burrow filled in with concrete.

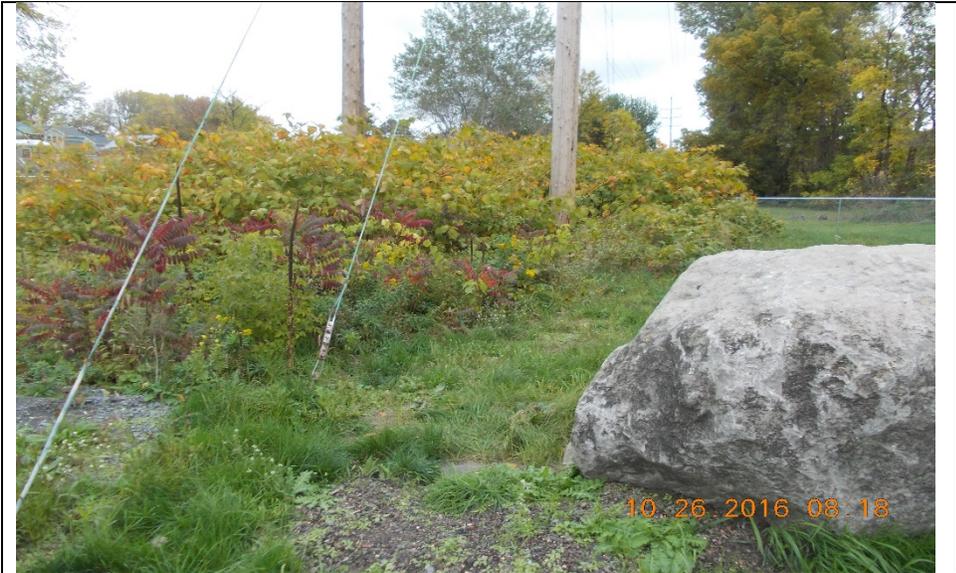
Animal burrow filled in with concrete. Removal of vegetation underneath power lines is prohibited by electrical utility.

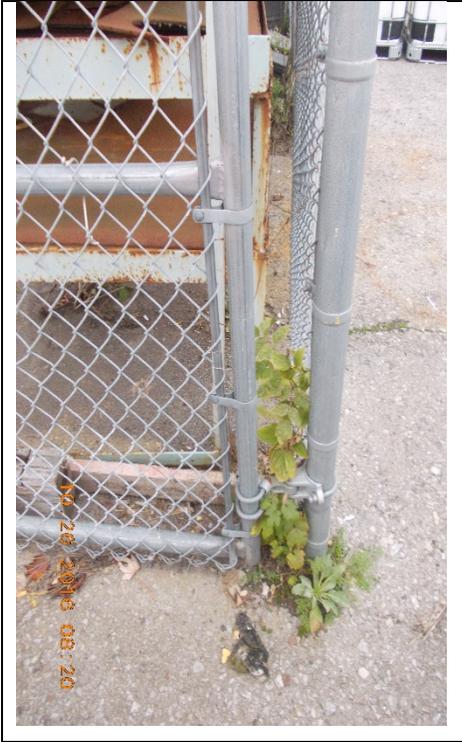
Vegetation in fence line.

Note: Vegetation was treated with herbicide on November 9, 2016

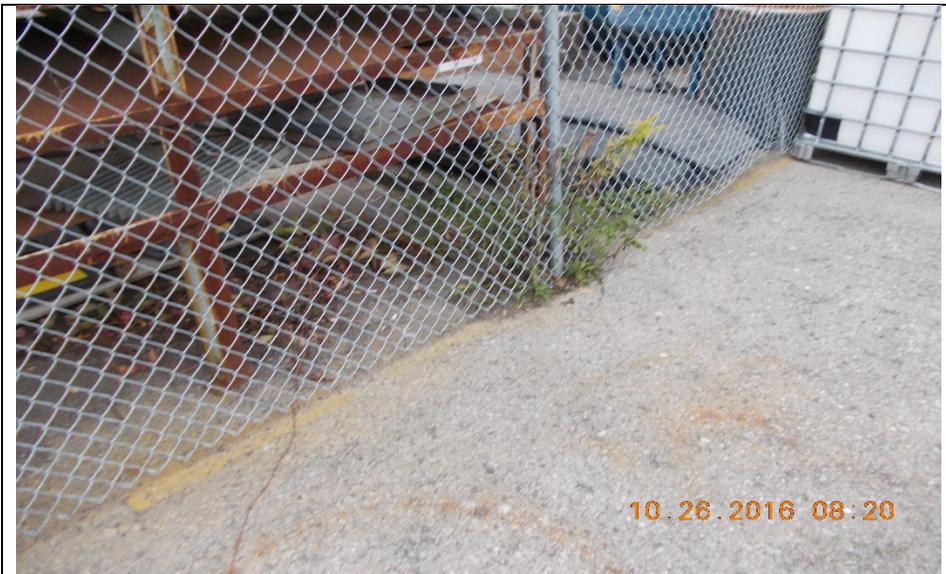
Vegetation in fence line.

Note: Vegetation was treated with herbicide on November 9, 2016

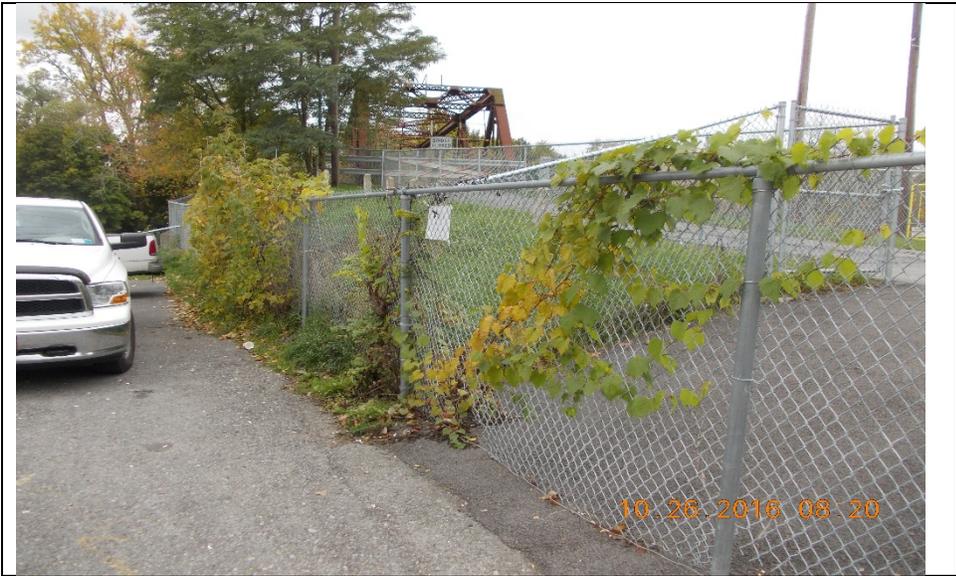
Vegetation in fence line along Gorham Street.

Note: Vegetation was treated with herbicide on November 9, 2016

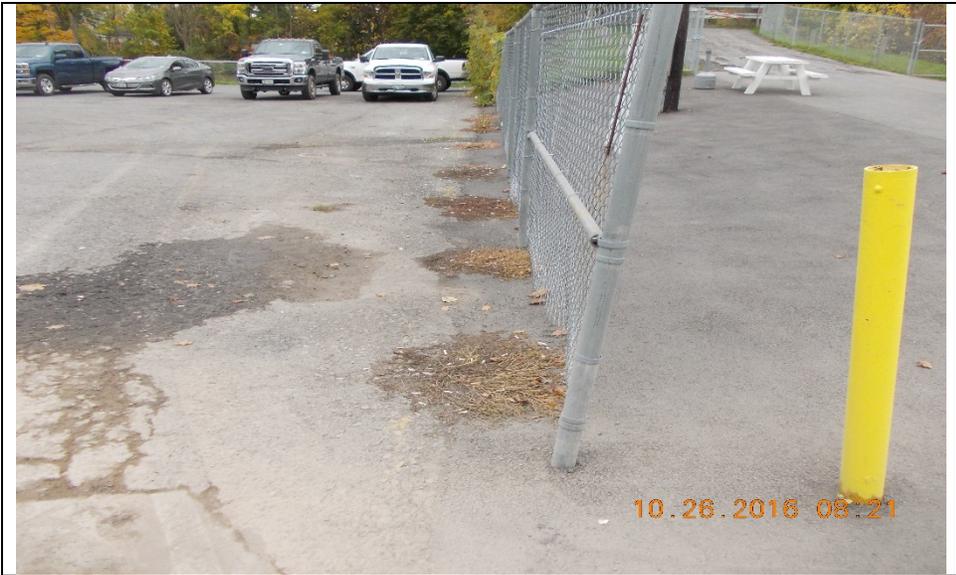
Vegetation in fence line and asphalt along Gorham Street.

Note: Vegetation was treated with herbicide on November 9, 2016

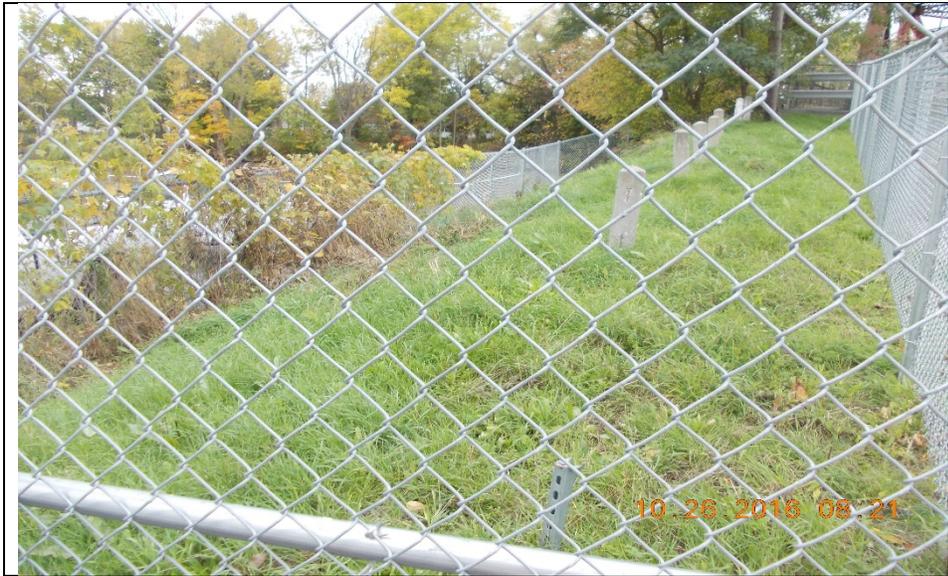
Western end of Gorham Street canal bank after mowing (looking west).

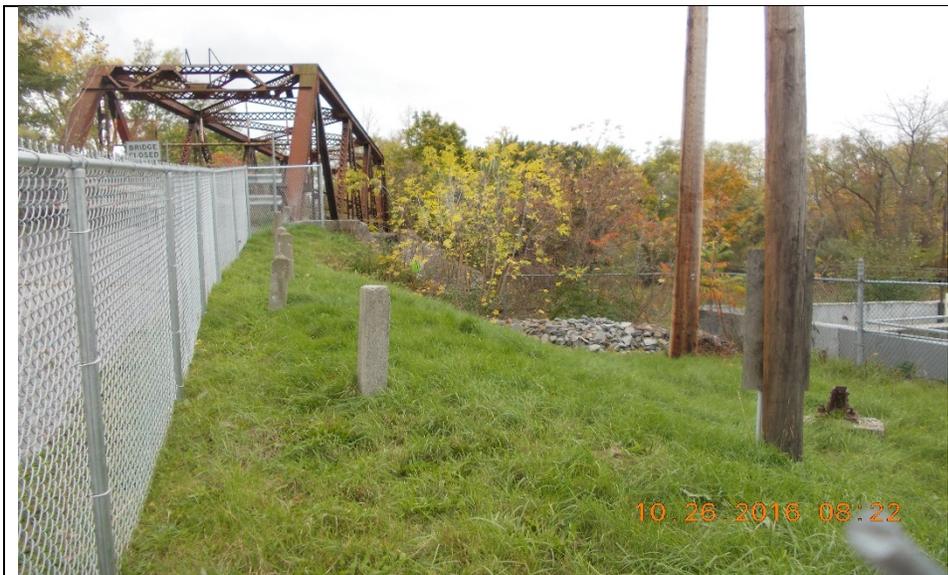
Western end of Gorham Street canal bank after mowing (looking east).
