# Interim Operations and Maintenance Plan/Periodic Review Report 2017, Gorham Street Area, Gabion Wall, and SWMU-1—Former Hampshire Chemical Corp. Facility, Waterloo, New York—Site No. 850001A

PREPARED FOR: Hampshire Chemical Corp. (HCC)  
PREPARED BY: CH2M HILL Engineers, Inc. (CH2M)  
DATE: December 6, 2017

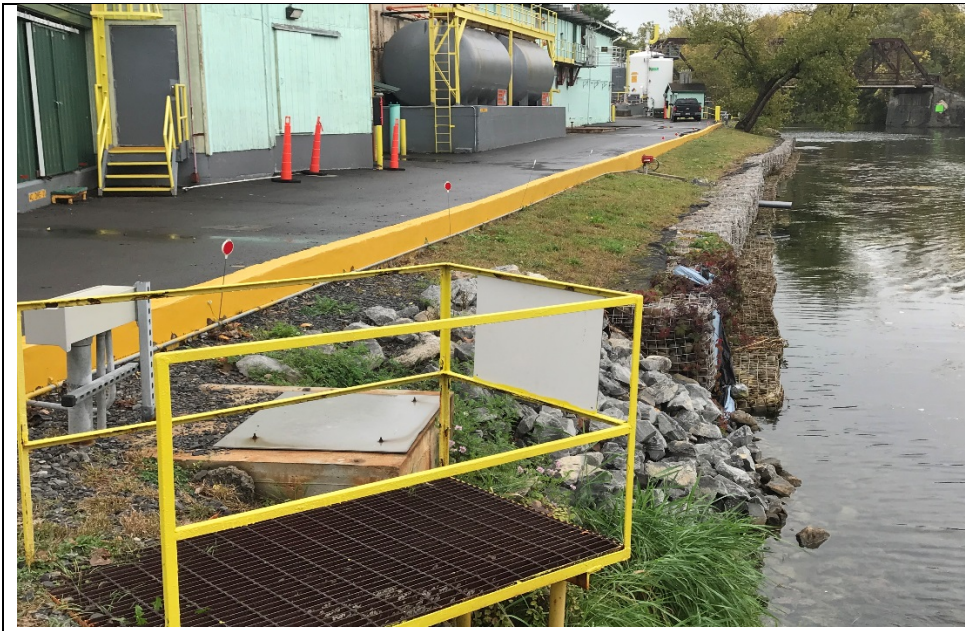
*Western end of Gabion Wall (looking east).*

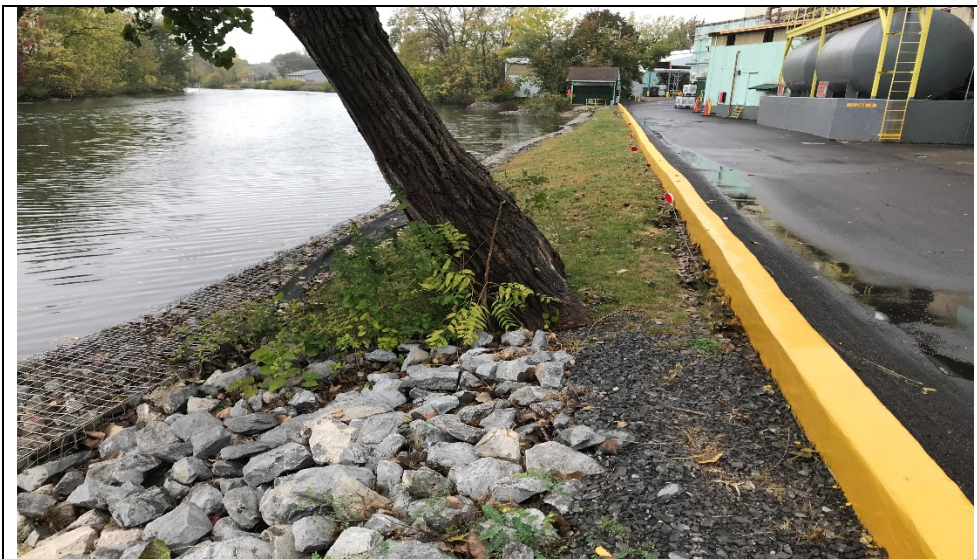
*Eastern end of Gabion Wall (looking west).*

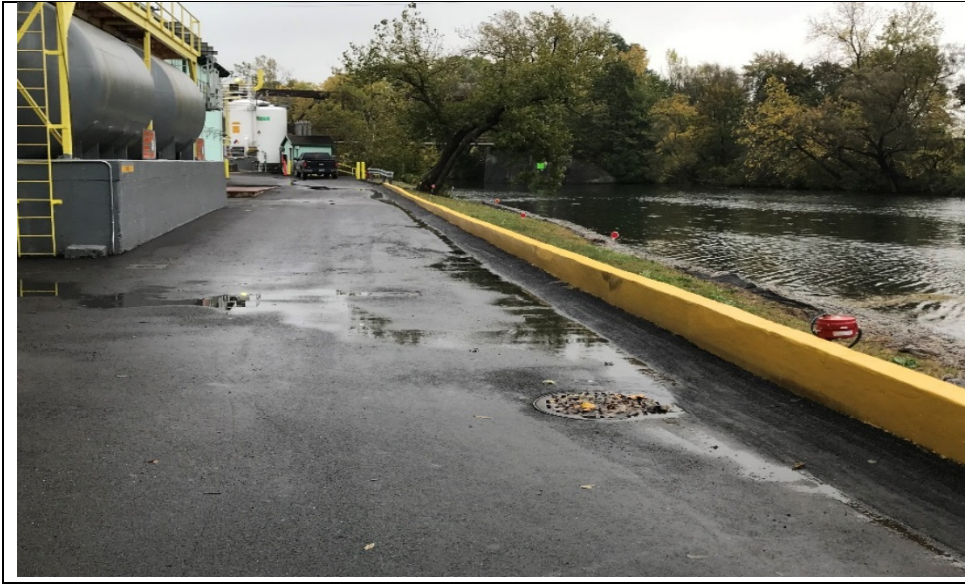
*Western end of Gabion Wall Access Road (looking east).*

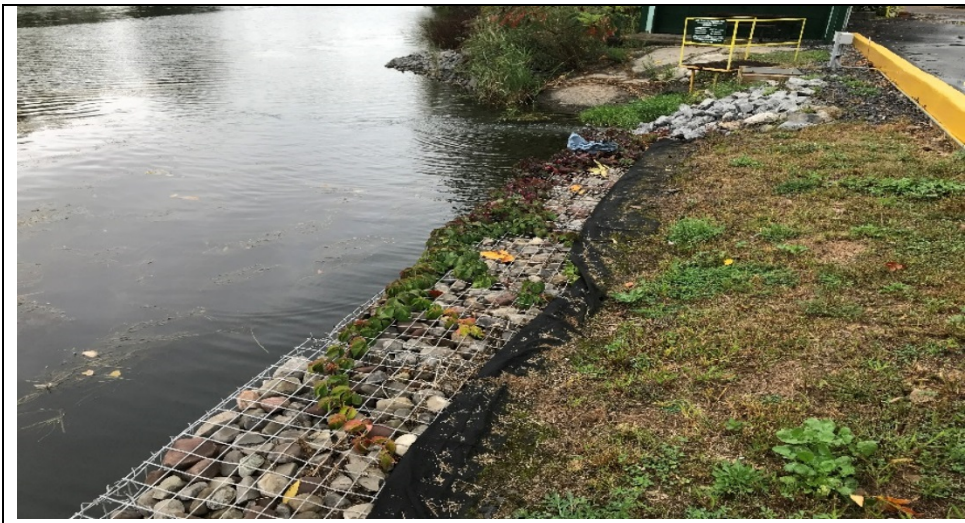
*Western end of Gabion Wall (looking west).*

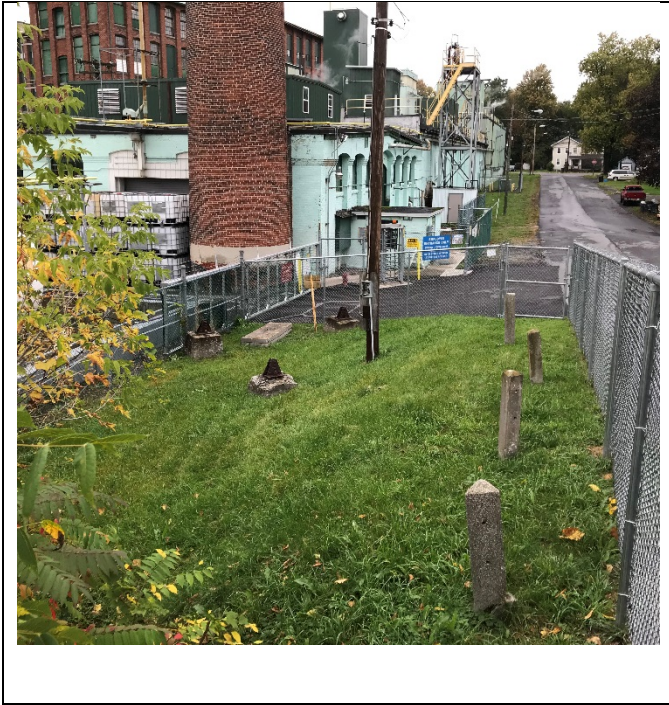
*Western side of Gorham Street upland area (looking north).*

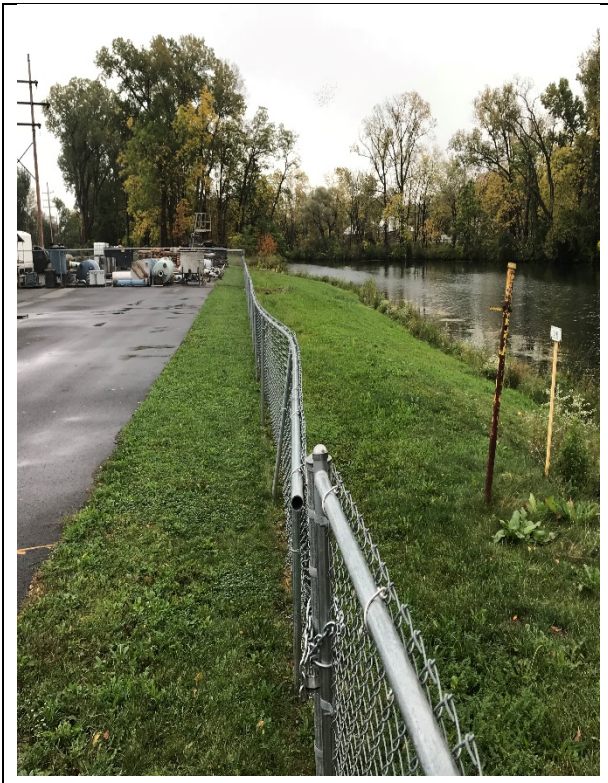
*Western end of Gorham Street bank (looking east).*

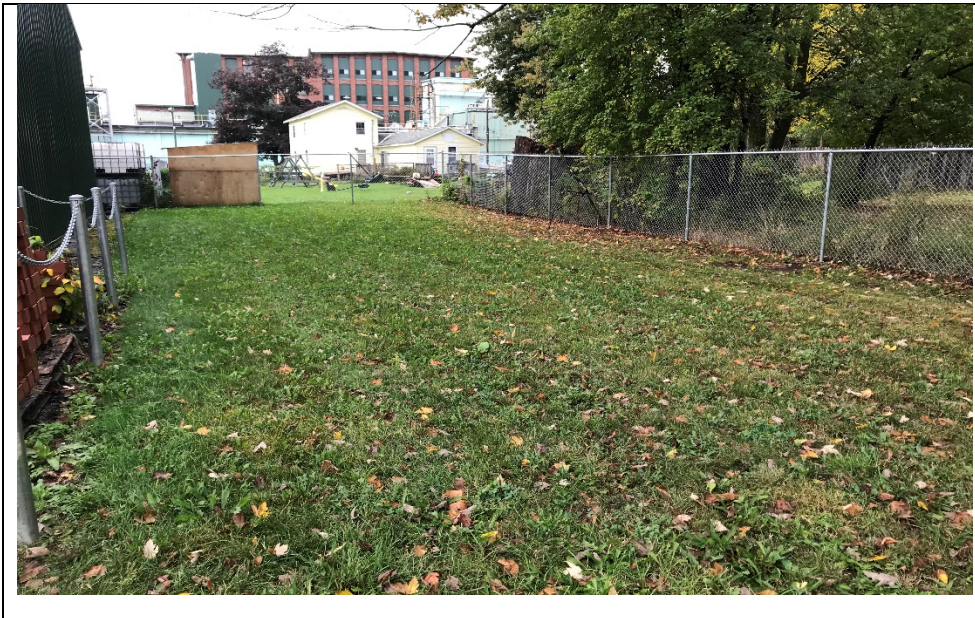
*Northern end of Gorham Street area (looking west).*

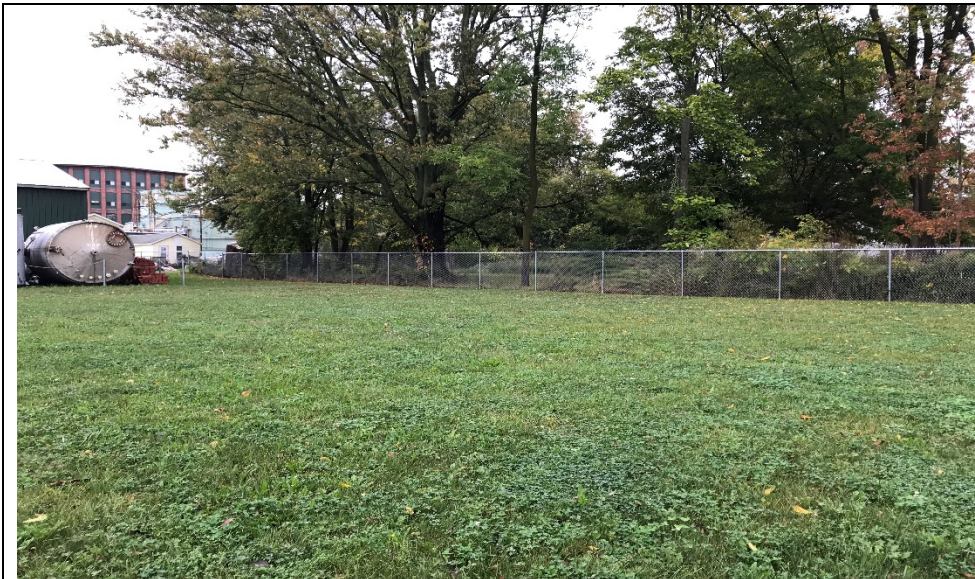
*Eastern end of Gorham Street area (looking west).*

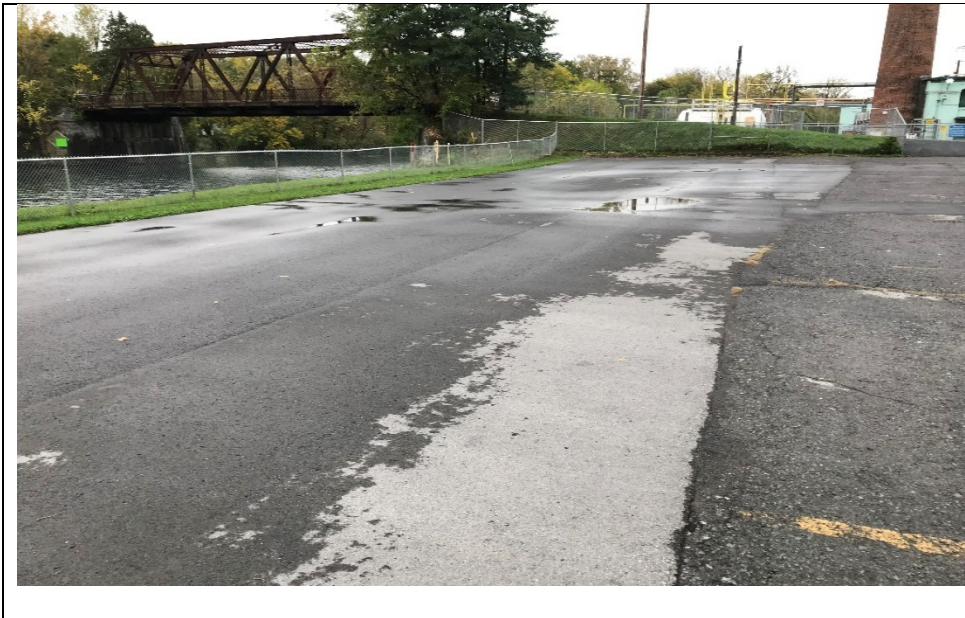
*Southern end of Gorham Street area asphalt cap (looking west).*

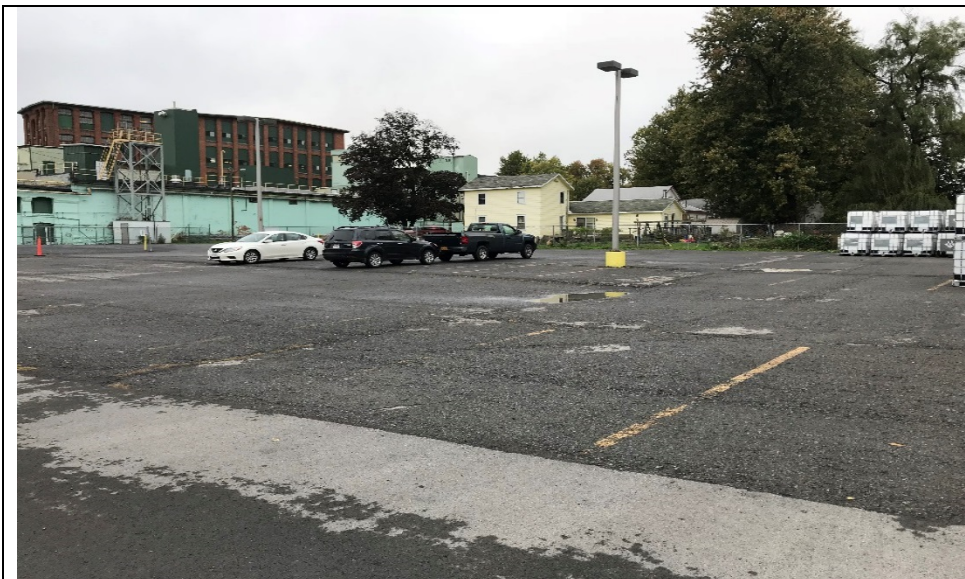
*Gorham Street area asphalt cap (looking north).*

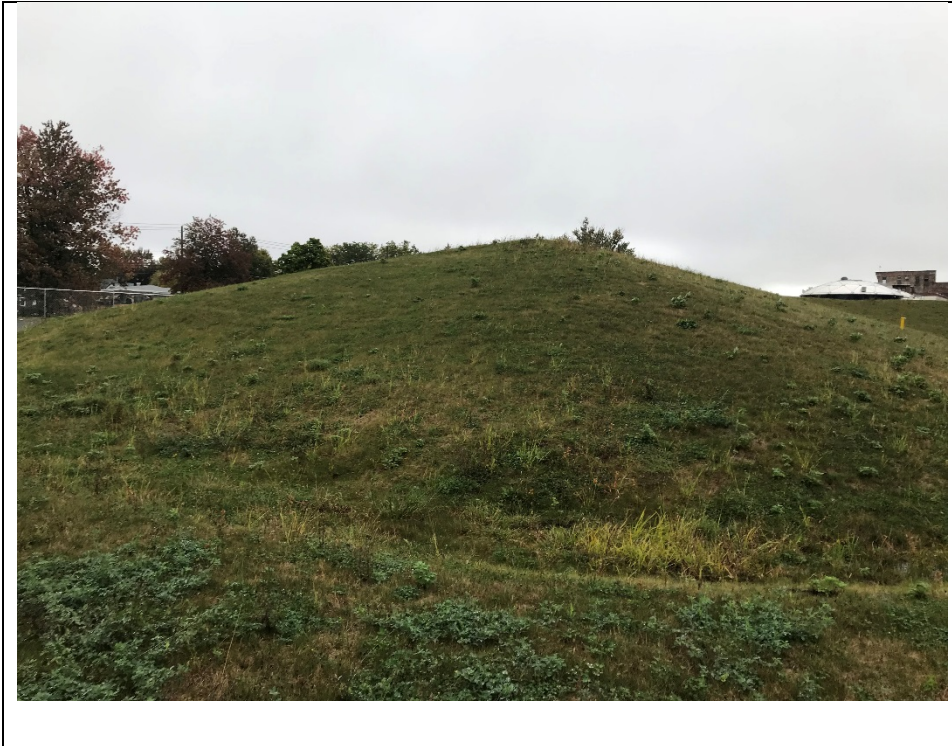
*Western side of SWMU-1 (looking east).*

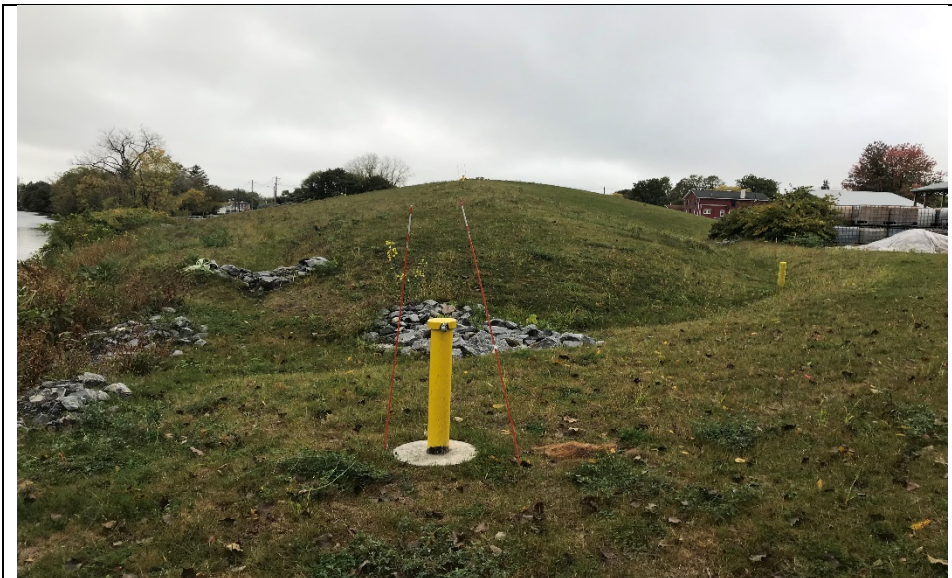
*Eastern end of South Side of SWMU-1 (looking west).*

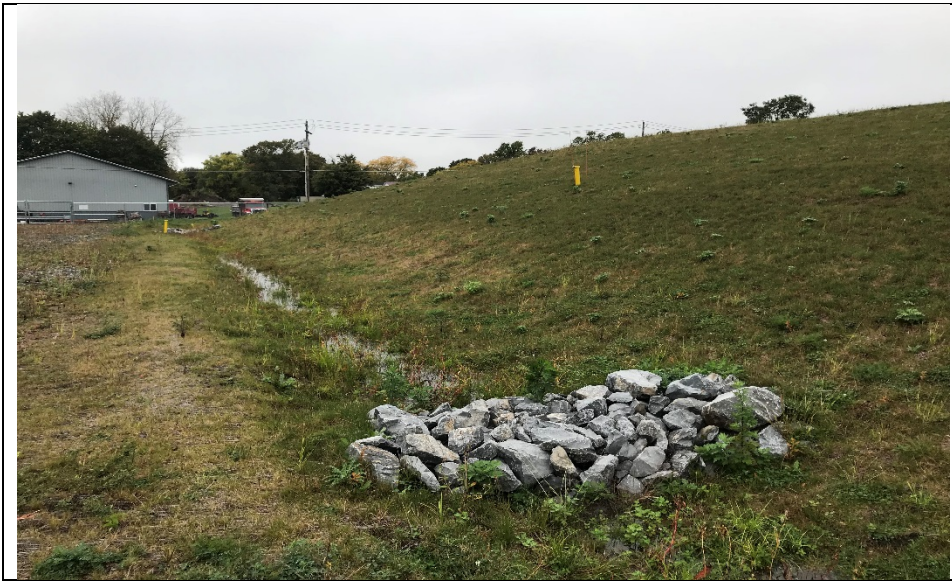
*Western end of south side of SWMU-1 (looking west).*

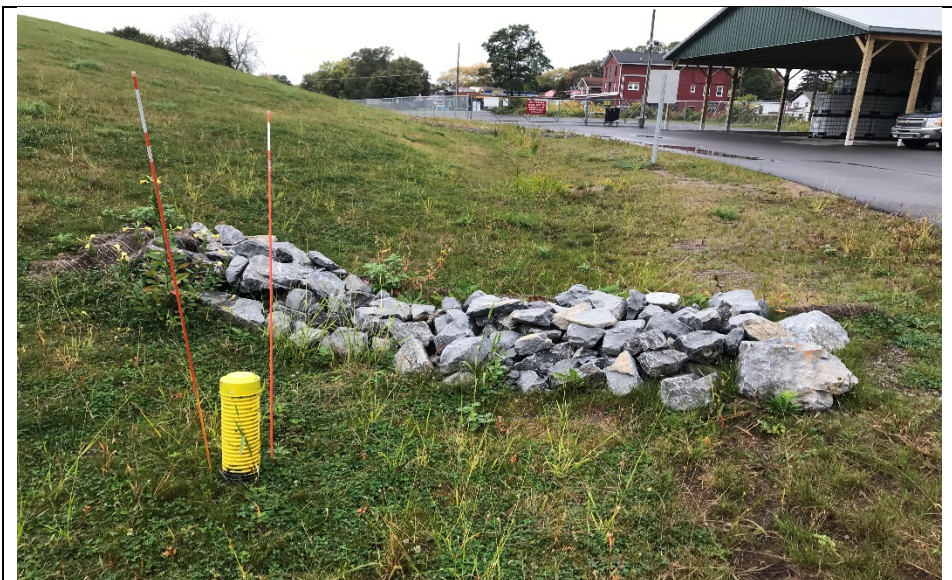
*Northern side of SWMU-1 (looking west).*

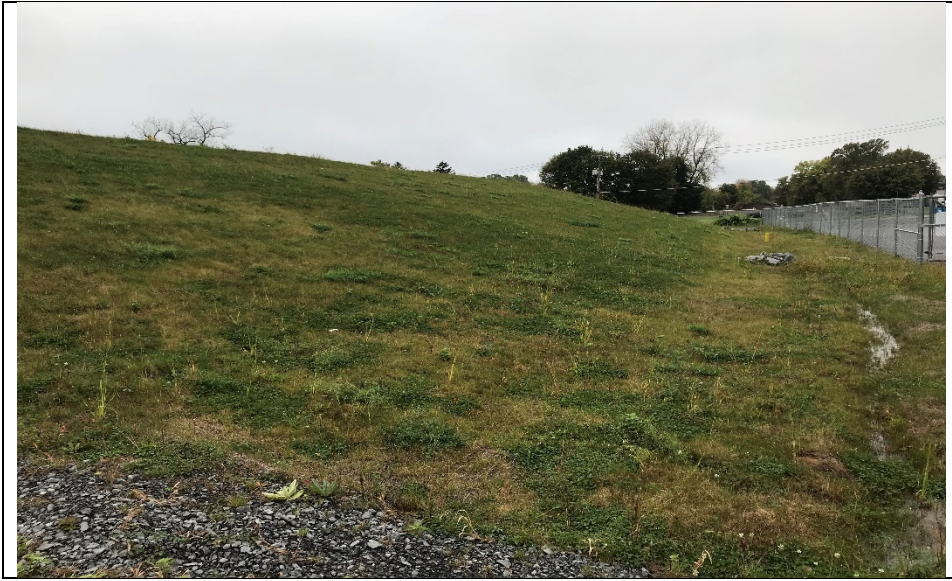
*Western end and north side of SWMU-1 drainage swale (looking west).*

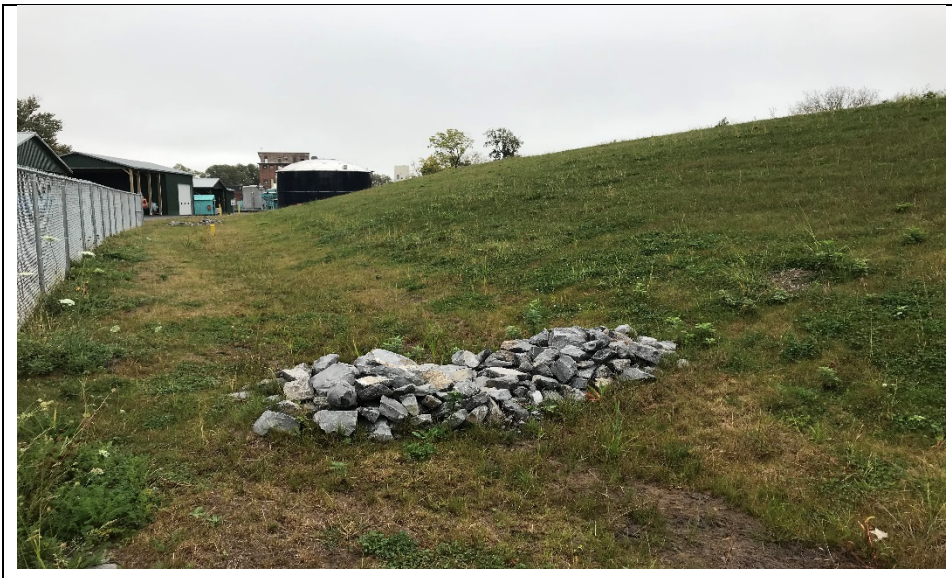
*Northern side of SWMU-1 drainage swale and rock check dam (looking east).*

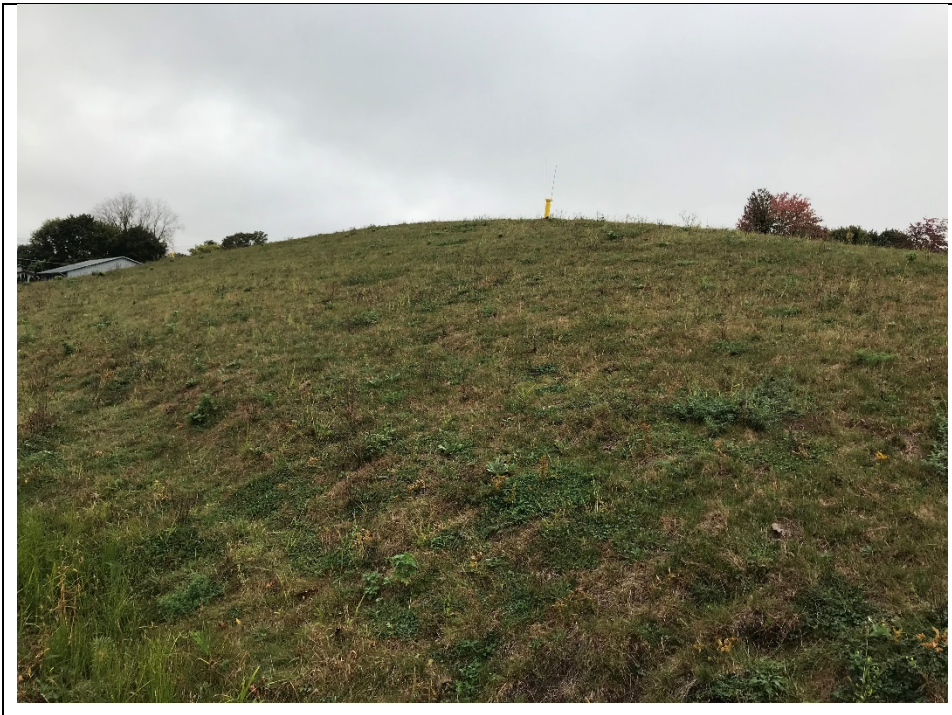
*Southern side of SWMU-1 (looking northwest).*

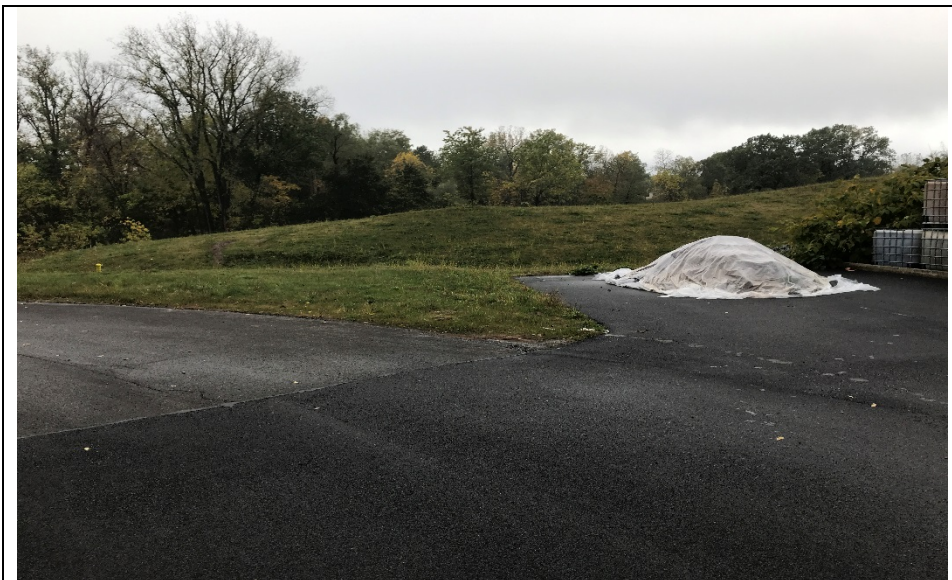
*Northern side and eastern end of SWMU-1 and asphalt cap area (looking south).*

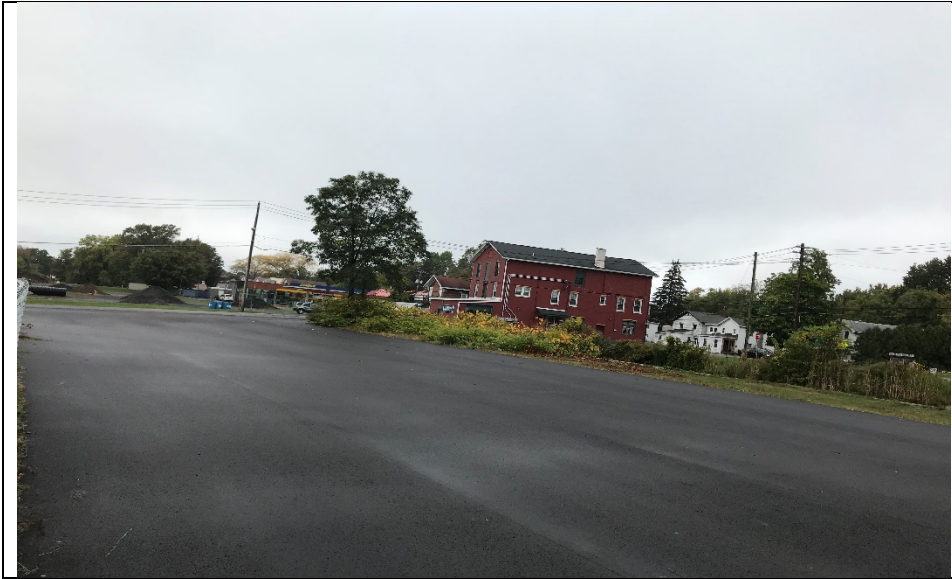
*Western end of asphalt cap (looking west).*

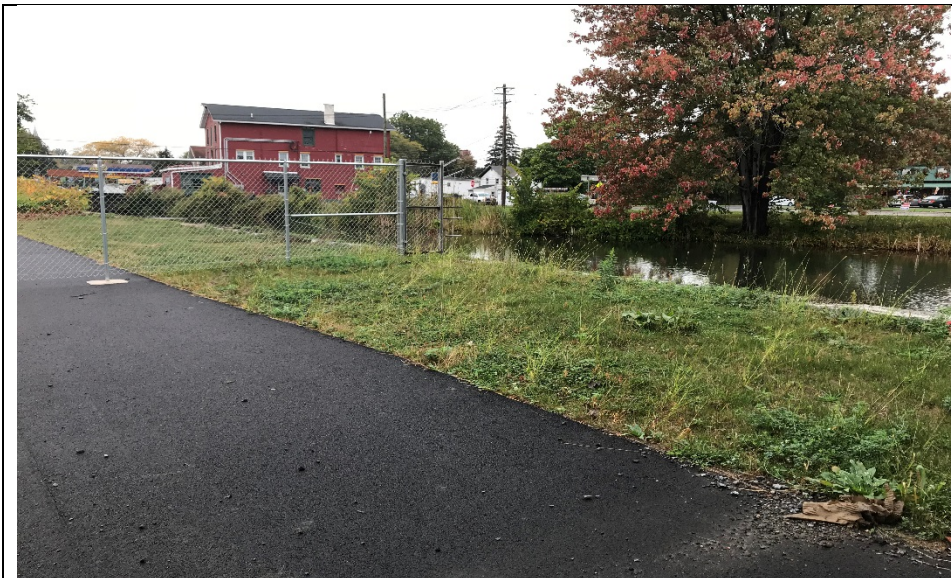
*Western end of asphalt cap (looking northwest).*

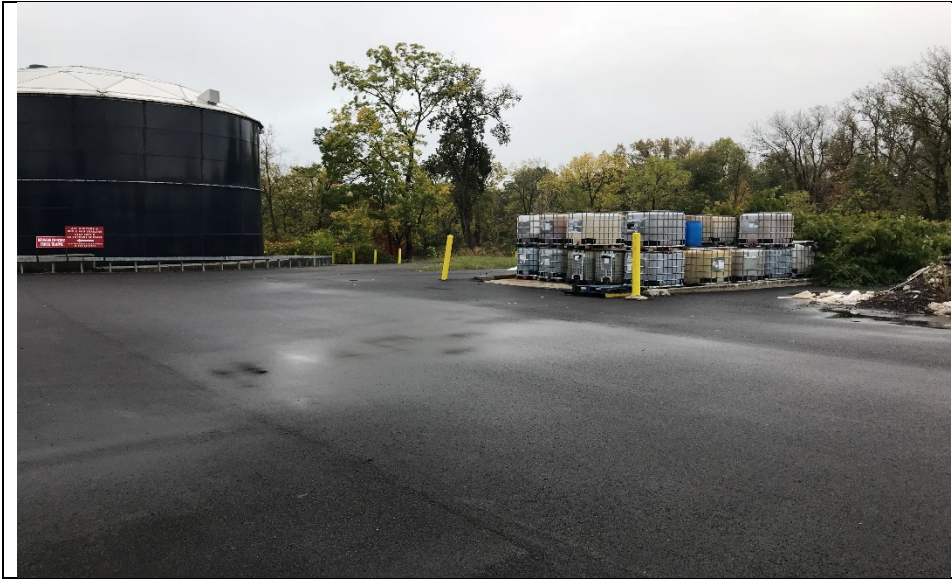
*Eastern end of asphalt cap (looking east).*

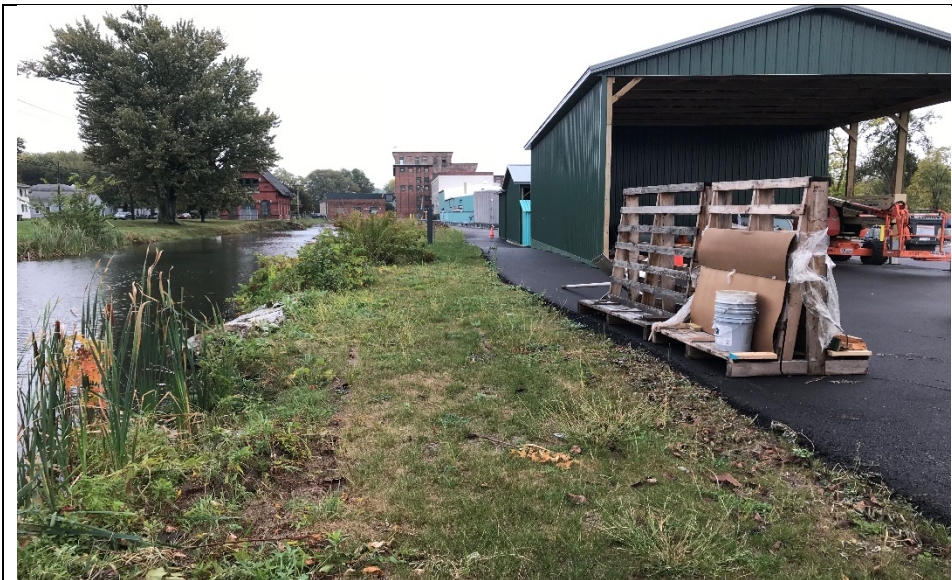
*North side of asphalt cap (looking east).*

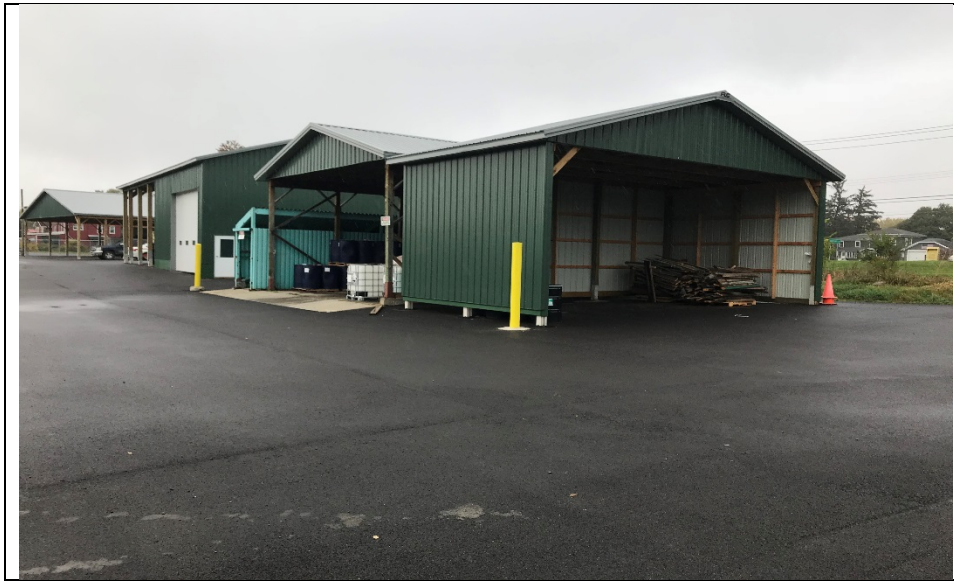
*North side of asphalt cap (looking west).*

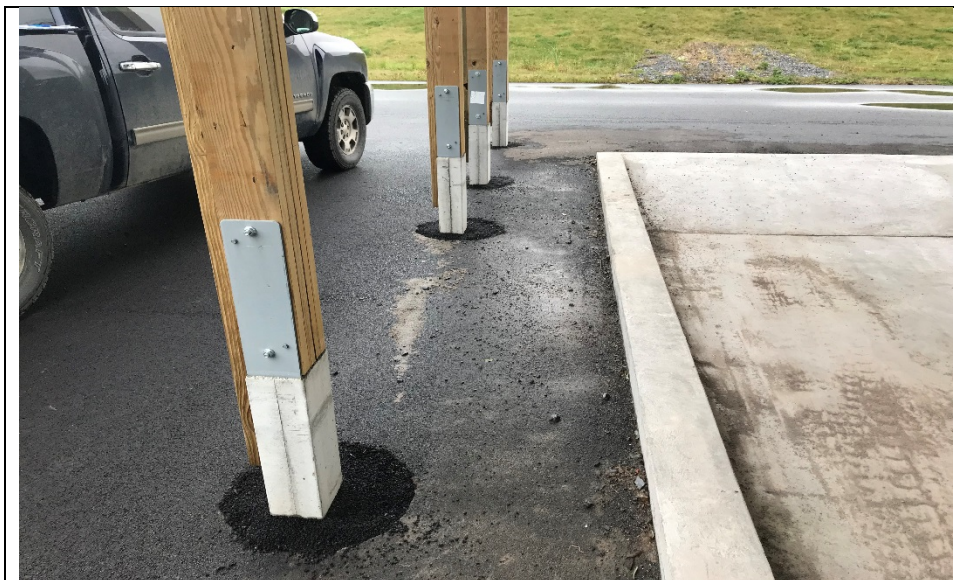
Additionally, two fence repairs were necessary due to snow-plowing impacts and were completed in summer 2017. Evans Chemetics constructed pole barns within the expanded asphalt area of SWMU-1 and the area where the poles had penetrated the asphalt were open during the spring visit; however, the issue was immediately addressed (summer 2017) and the areas were covered with asphalt, which was confirmed during the fall inspection.

*Sealed asphalt cap penetrations for new storage buildings.*

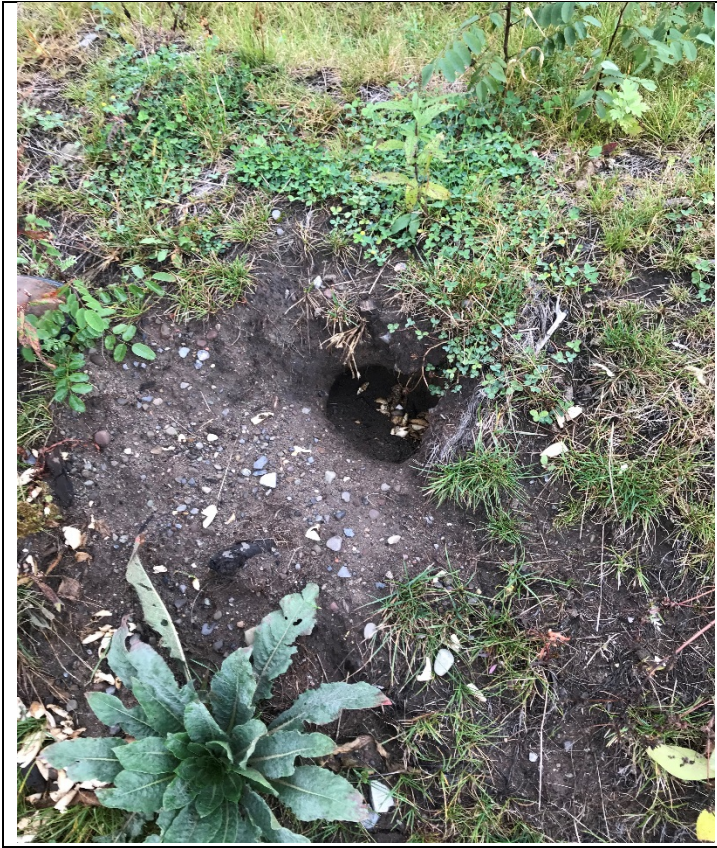
*Animal burrow (filled with topsoil on 11/18/2017)*

Issues discovered during the second (official site inspection) including spraying of the vines along the Gorham Street fence, spraying of the weeds in the parking lot, repairs to the fence, and removal of the vines on the gabion wall, which were completed by Evans Chemetics on November 3, 2017. Backfilling of the small burrows at SWMU-1 was completed by CH2M on November 8, 2017.

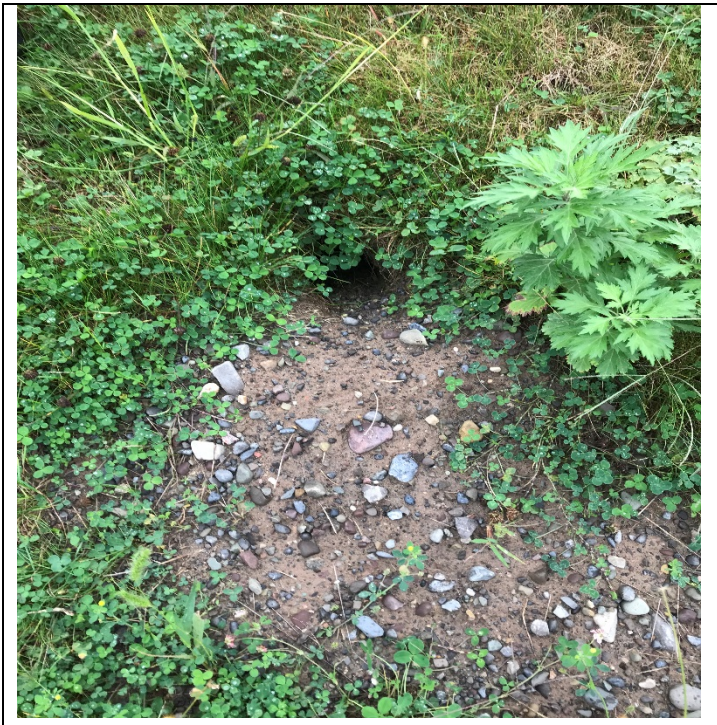
*Animal burrow (filled with topsoil on 11/18/2017)*

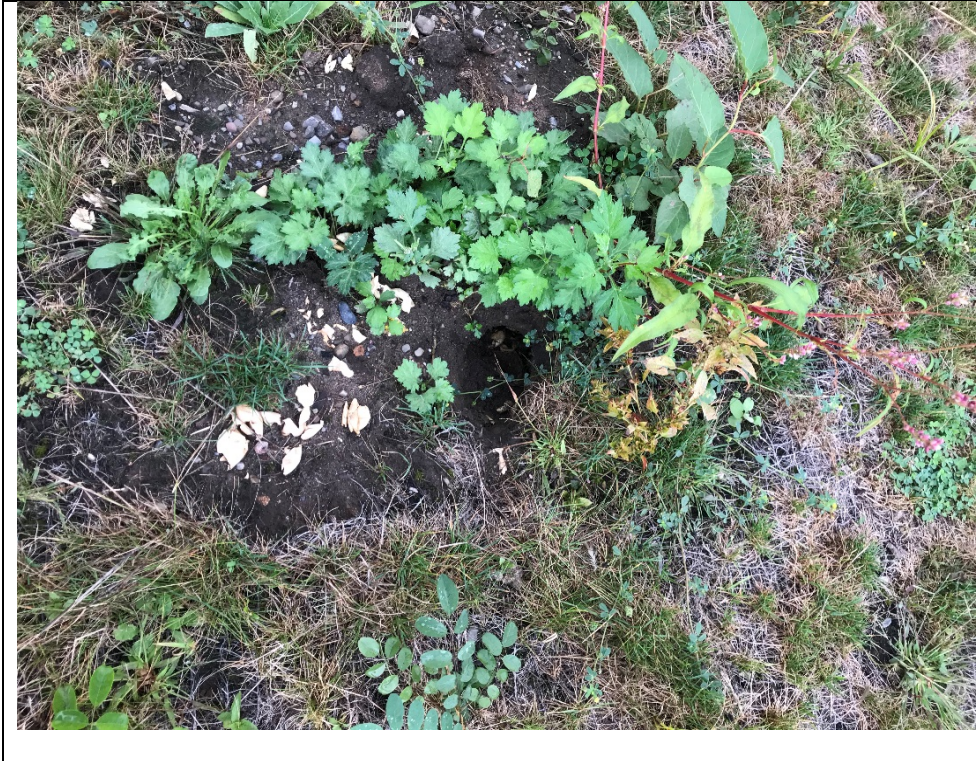
*Animal burrow (filled with topsoil on 11/18/2017)*
