Subject	Interim Operations and Maintenance Plan/Periodic Review Report 2019, Gorham Street Area, Gabion Wall, and SWMU-1
Project Name	Former Hampshire Chemical Corp. Facility, Waterloo, New York—Site No. 850001A
Attention	Hampshire Chemical Corp.
From	Jacobs Engineering Group Inc.
Date	January 2020

Interim Operations and Maintenance
Plan/Periodic Review Report 2019,
Gorham Street Area, Gabion Wall, and
SWMU-1
January 2020

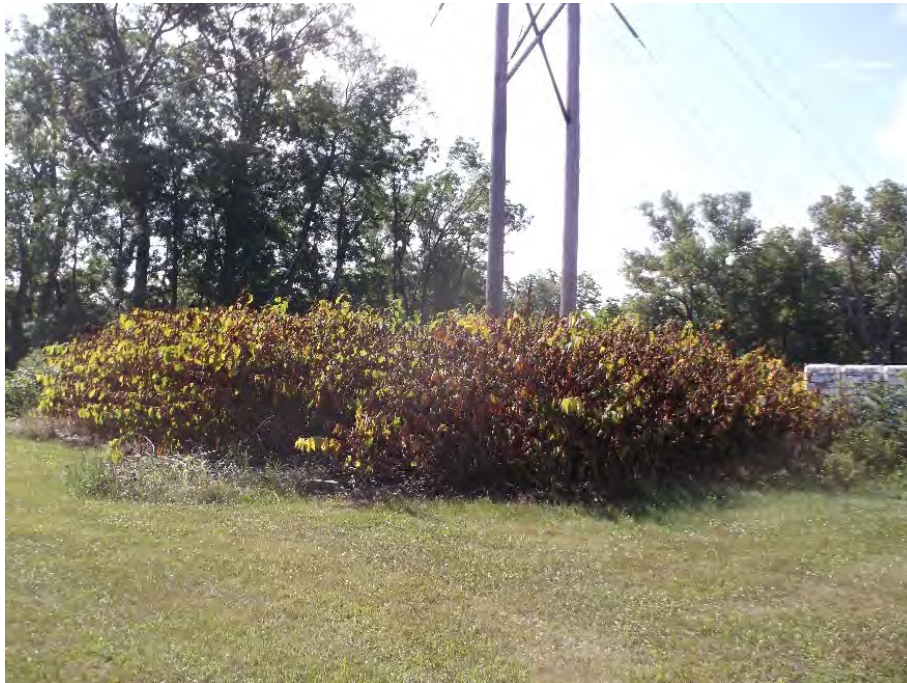
Photograph 1: View of power pole area (looking east) prior to Japanese knotweed eradication measures.

In general, the remaining issues that occurred in 2019 were associated with vegetation management. Additional effort was expended on eradicating Japanese knotweed, which included physical removal and herbicide application by Cardno Corporation. Japanese knotweed is a hardy invasive species and likely will take at least two seasons to eradicate.

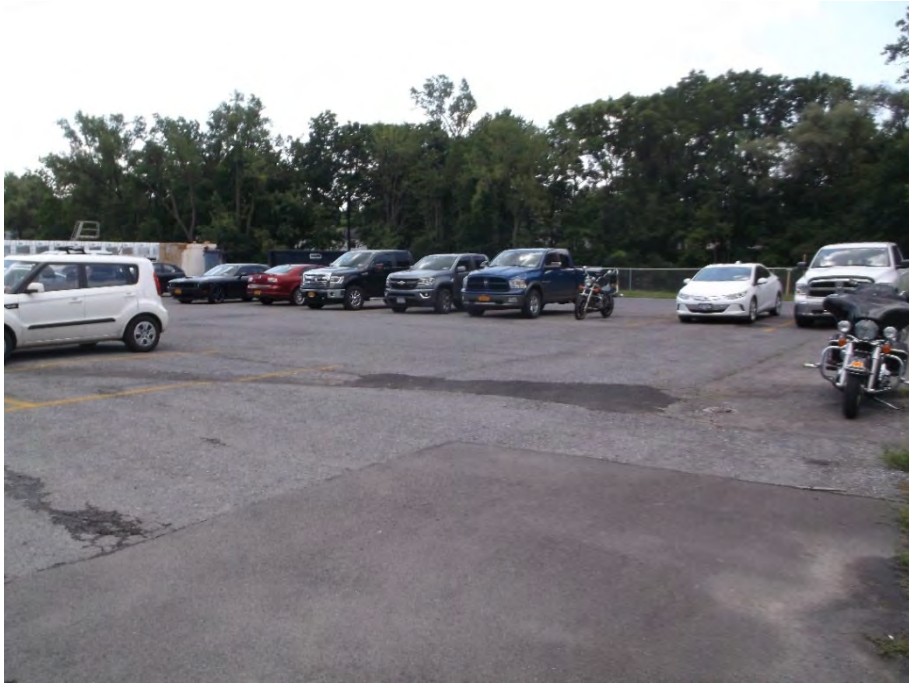
Photograph 2: View of Evans employee parking lot cover system (looking east) with evidence of repairs to enhance cover.

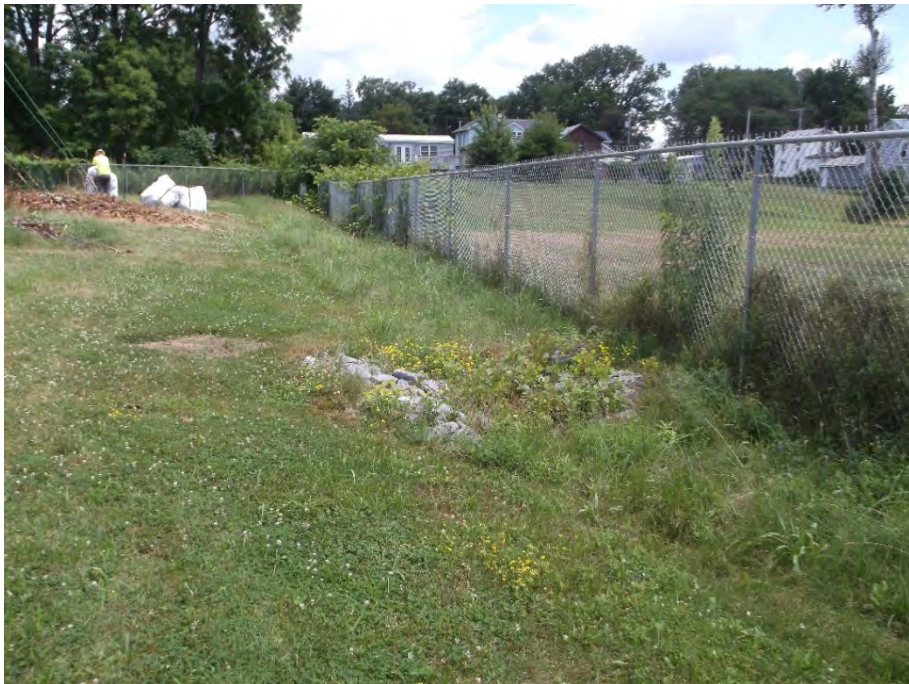
Photograph 5: View of cover system and swale with Japanese knotweed removal occurring near the power pole (looking north).

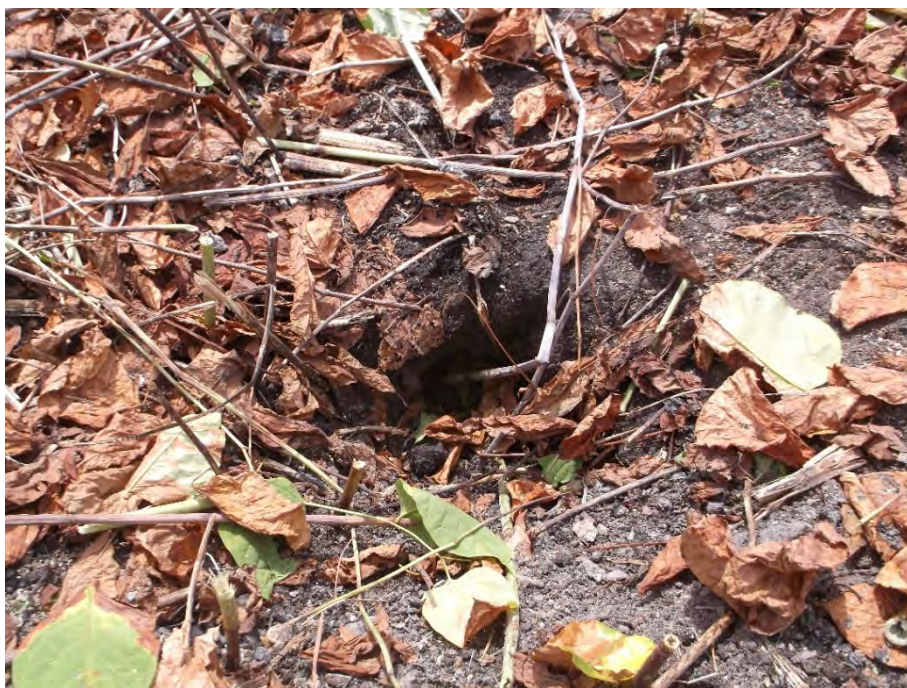
Three burrows were noted on Gorham Street and appear to be historical (seven groundhogs were removed from the area in summer 2017) and were covered by Japanese knotweed. The three burrows will be monitored in 2020 to determine if they are active.

Photograph 6: One of two groundhog burrows identified within the Japanese knotweed eradication area – the burrow does not appear to be active but will be monitored.

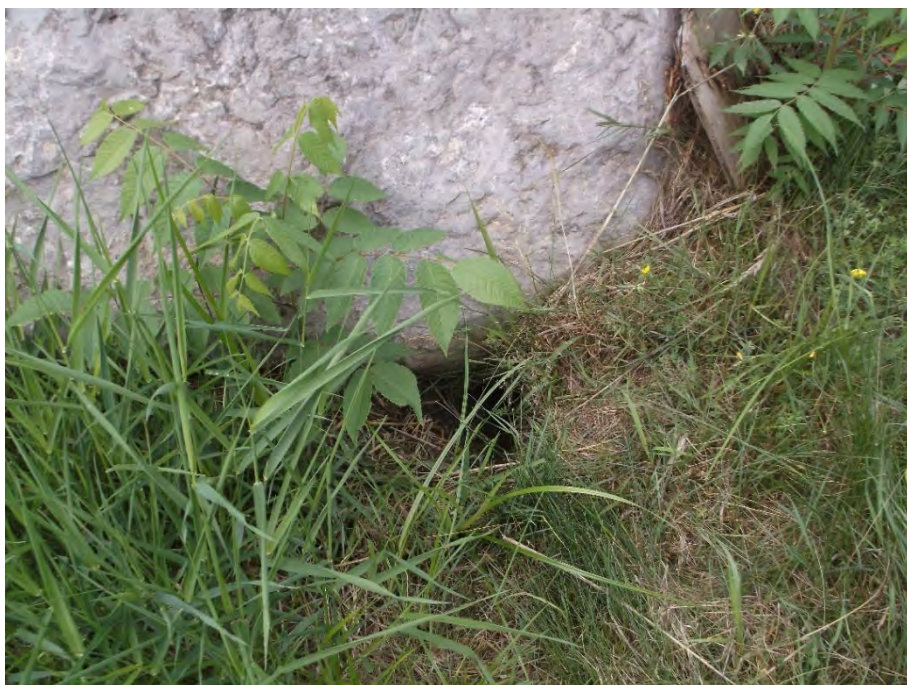
Photograph 7: Groundhog burrow identified near the edge of the boulder – the burrow does not appear to be active but will be monitored.

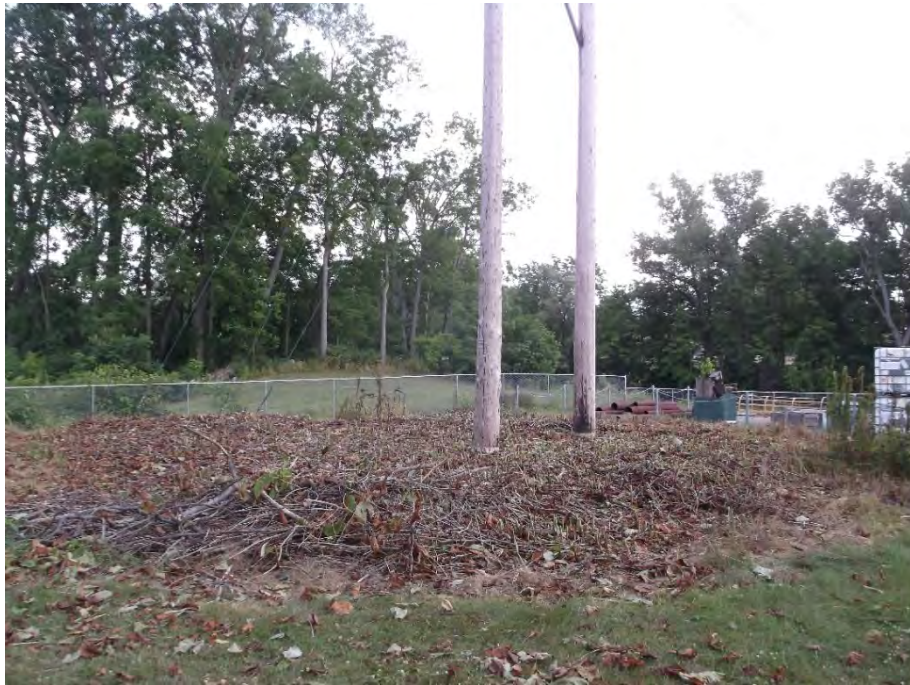
Photograph 8: View of power pole area after Japanese knotweed removal effort (looking southeast).

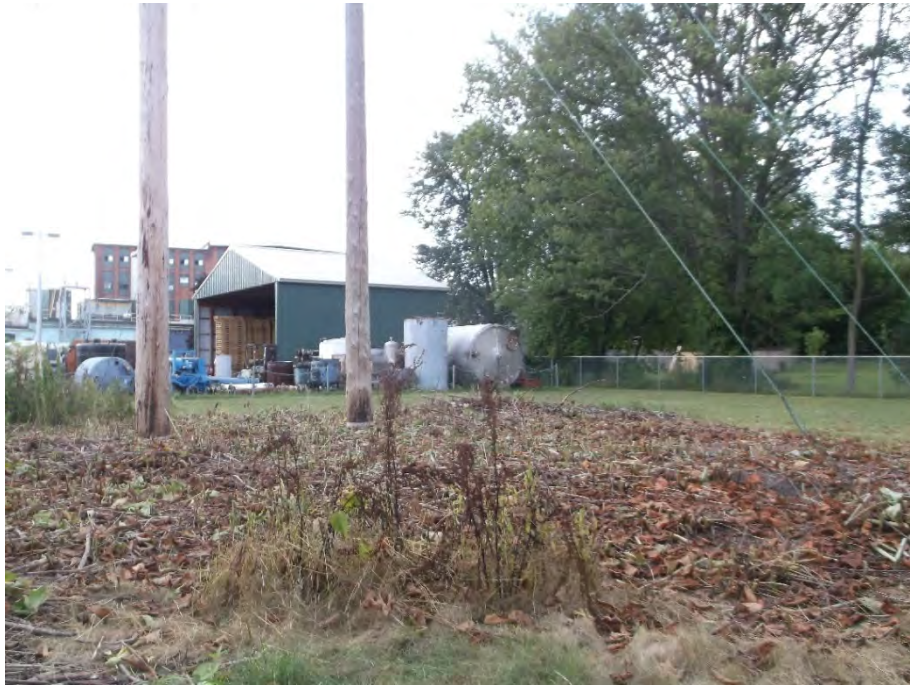
Photograph 10: View of pole area after Japanese knotweed removal (looking northwest).

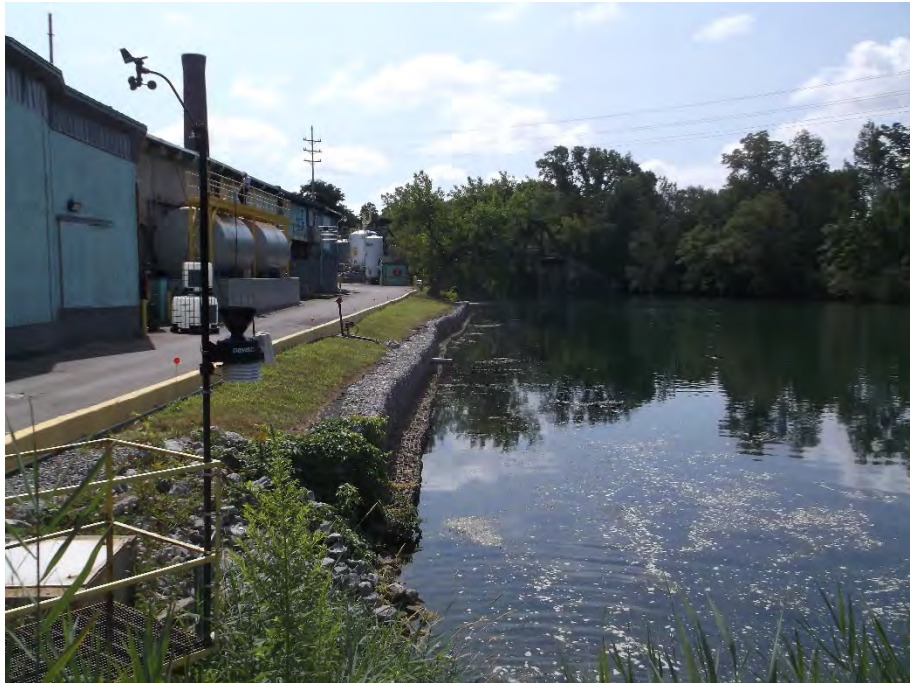
Minor grapevine growth along the western edge of the gabion wall was observed during the site inspection and had been cut. This area will be monitored, as the grapevine is hardy and has been a persistent (albeit minor) maintenance issue.

Photograph 11: View of gabion alignment (looking east) – grapevine in foreground was removed.

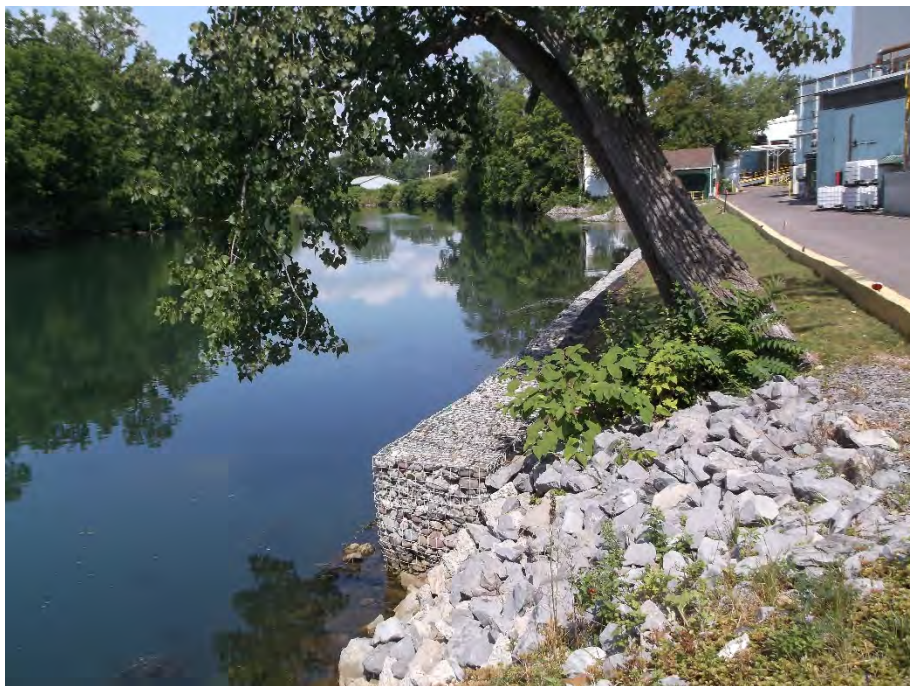
Photograph 14: View of gabion alignment (looking west) – rip-rap at termination for stormwater management.

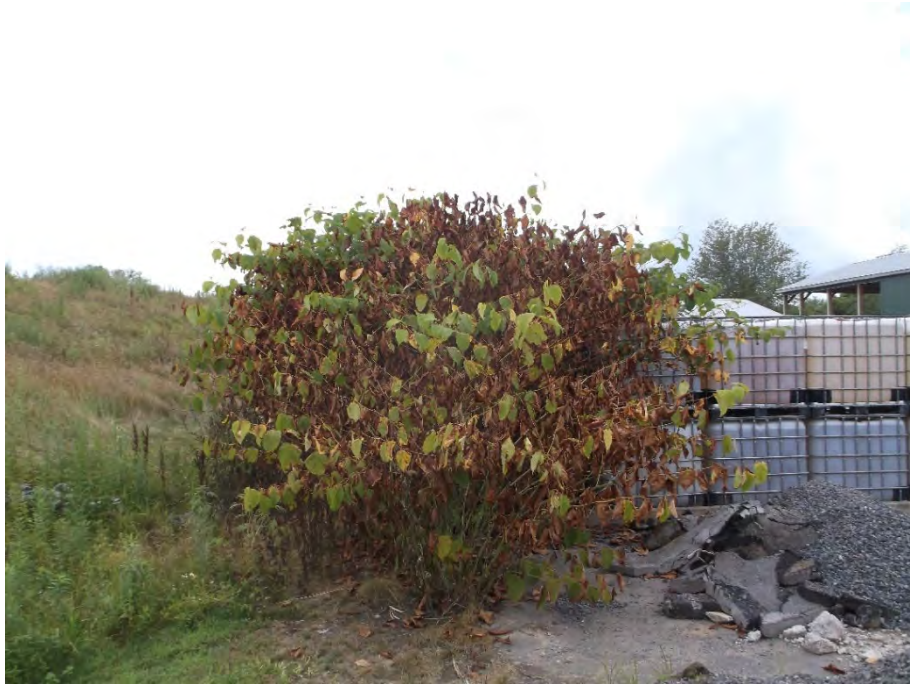
Photograph 155: Area of Japanese knotweed adjacent to tote storage area (looking west) prior to removal efforts.

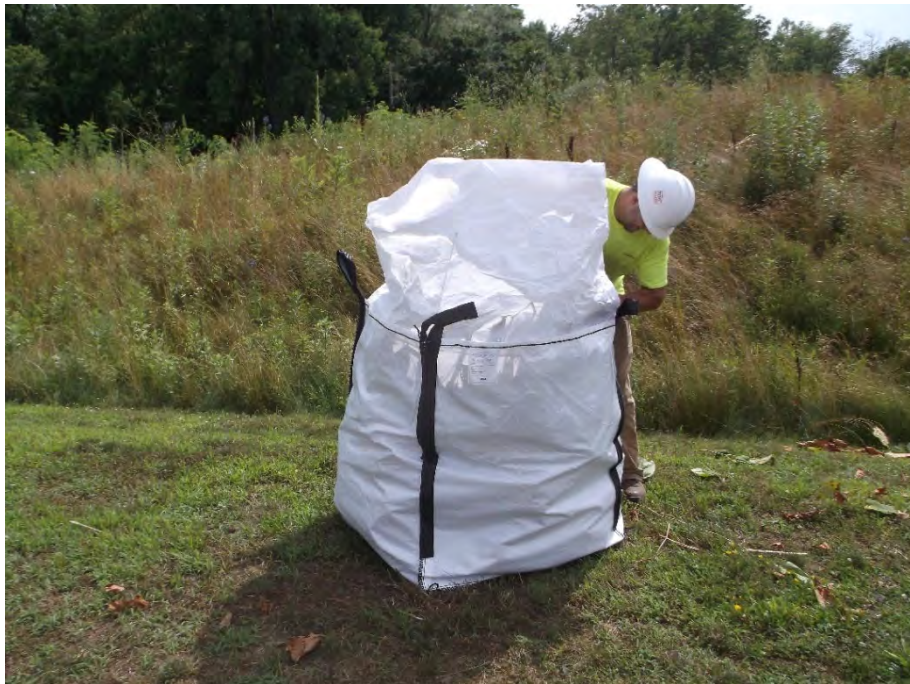
Photograph 16: Packing supersacks with Japanese knotweed biomass.

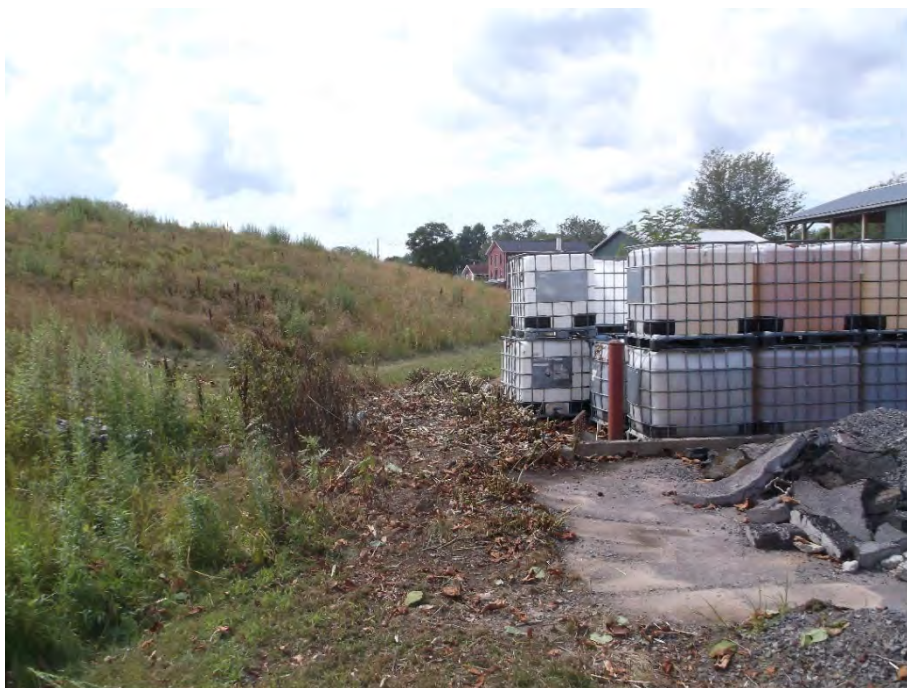
Photograph 17: Area of Japanese knotweed removal adjacent to tote storage area (looking west).

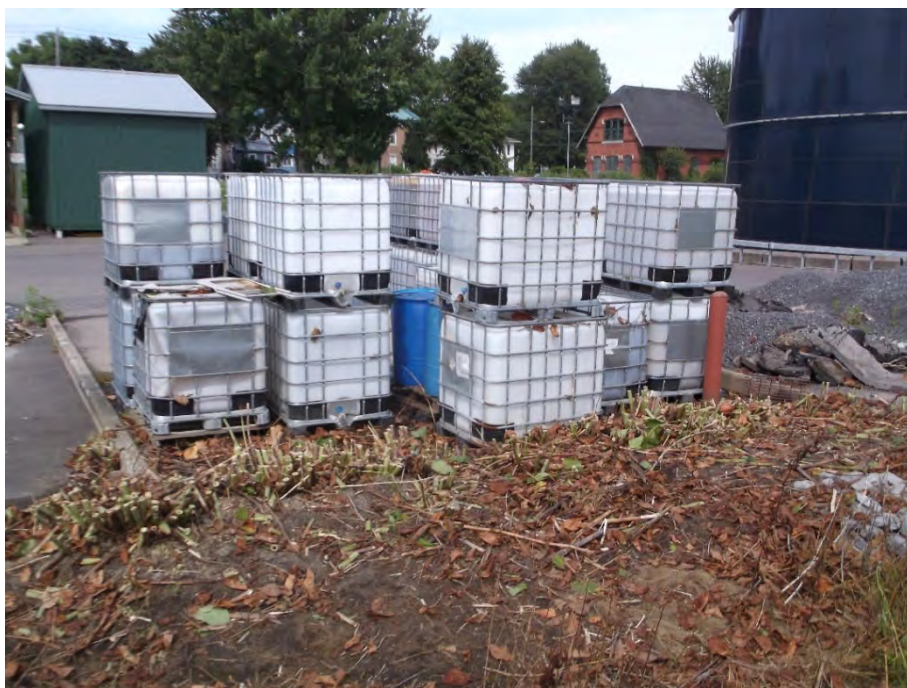
Photograph 18: Area of Japanese knotweed removal adjacent to tote storage area (looking north).
