Subject: Interim Operations and Maintenance Plan/Periodic Review Report 2020, Gorham Street Area, Gabion Wall, and SWMU-1, Former Hampshire Chemical Corp. Facility, Waterloo, New York- Site No. 850001A

Subject	Interim Operations and Maintenance Plan/Periodic Review Report 2020, Gorham Street Area, Gabion Wall, and SWMU-1
Project Name	Former Hampshire Chemical Corp. Facility, Waterloo, New York—Site No. 850001A
Attention	Hampshire Chemical Corp.
From	Jacobs Engineering Group Inc.
Date	February 2021

Project Title	Interim Operations and Maintenance Plan/Periodic Review Report 2019, Gorham Street Area, Gabion Wall, and SWMU1
Location	Former Hampshire Chemical Corporation Facility, Waterloo, New York—Site No. 850001A
Date	December 2020

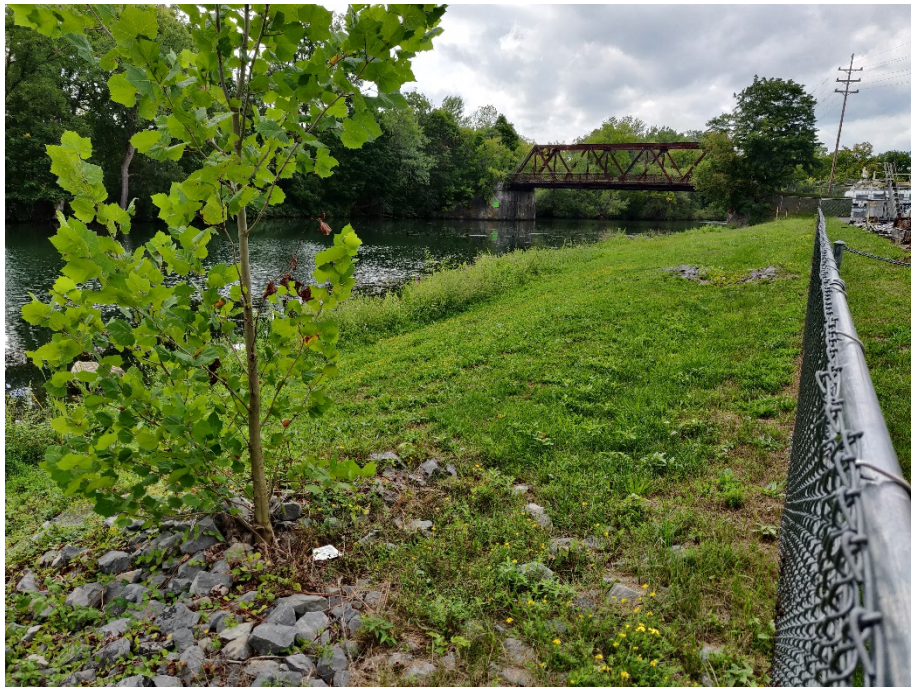
Photograph 1. View of cover system and fence along canal bank (looking west from southeastern corner).

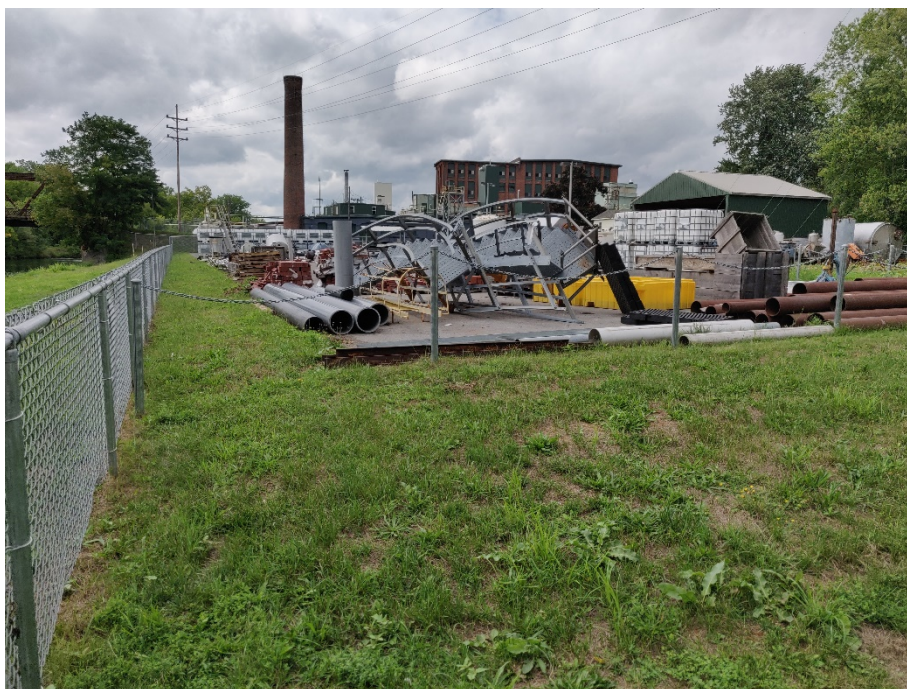
Photograph 1: View cover system and Evans' equipment laydown area (looking west from southeastern corner)

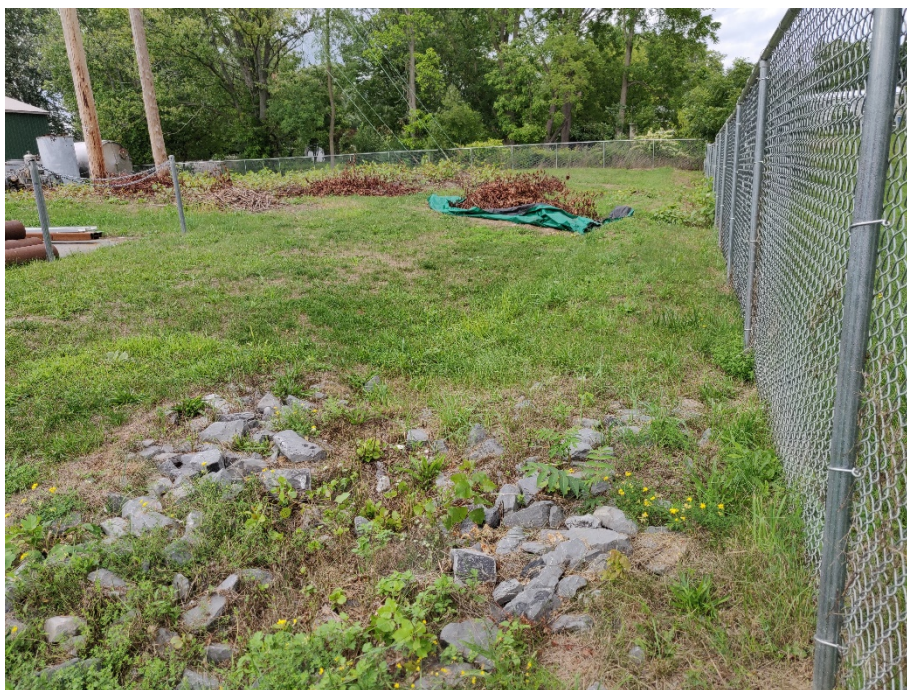
Photograph 2: View of cover system and swale with Japanese Knotweed removal occurring near the power pole (looking north from southeastern corner).

In general, the remaining issues that occurred in 2020 were associated with vegetation management. Additional effort was expended on eradicating Japanese knotweed, which included herbicide application by Cardno Corporation on September 4, 2020. Japanese knotweed is a hardy invasive species and may require further herbicide application and mechanical removal to eradicate.

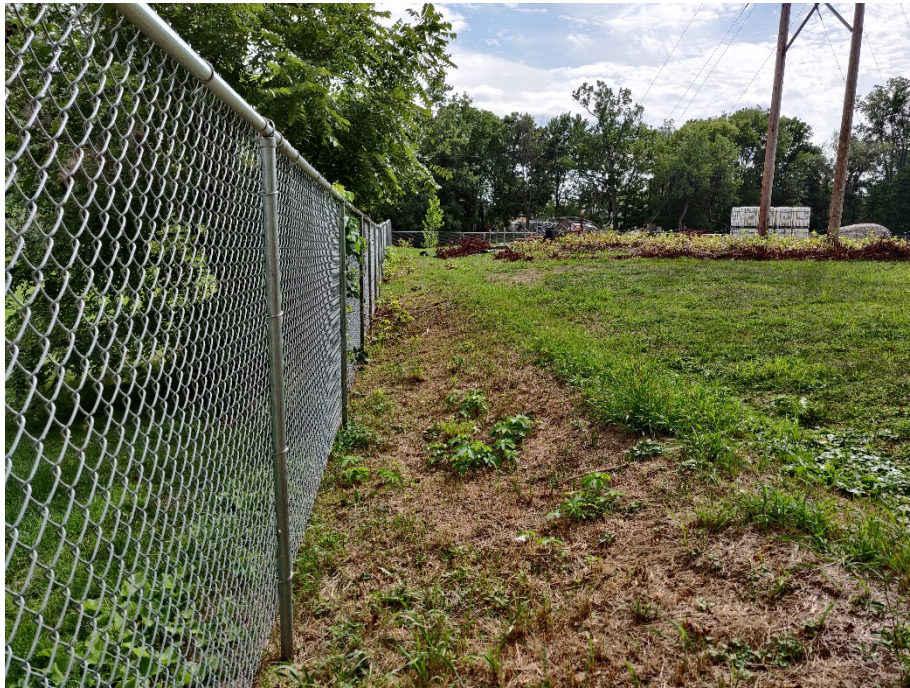
Photograph 4: View of cover system, fence, and power poles (looking south from northwestern corner).

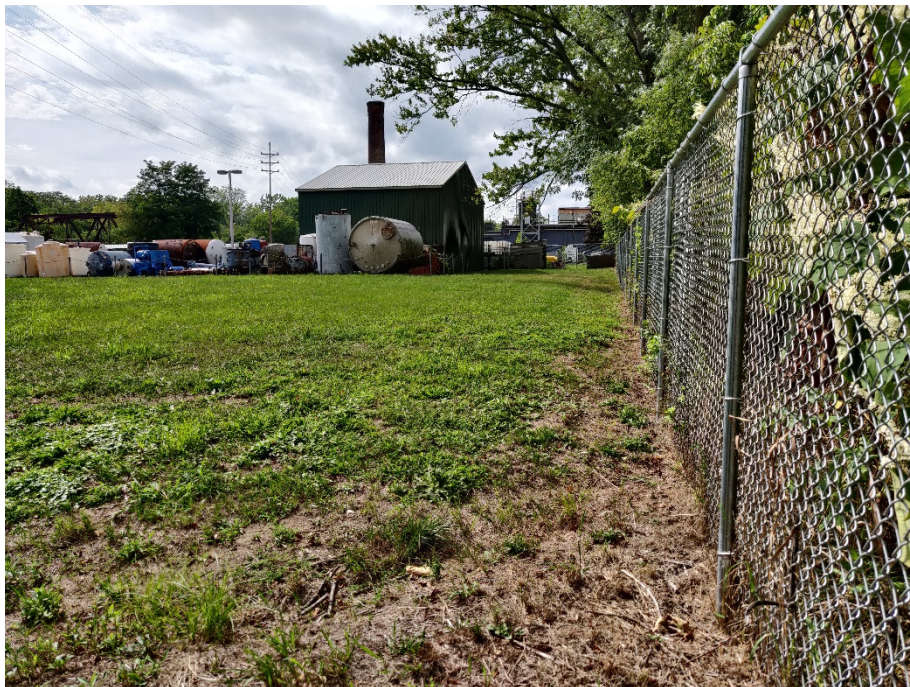
Photograph 5: View of cover system, fence, and Evans' equipment laydown area (looking west from northwestern corner).

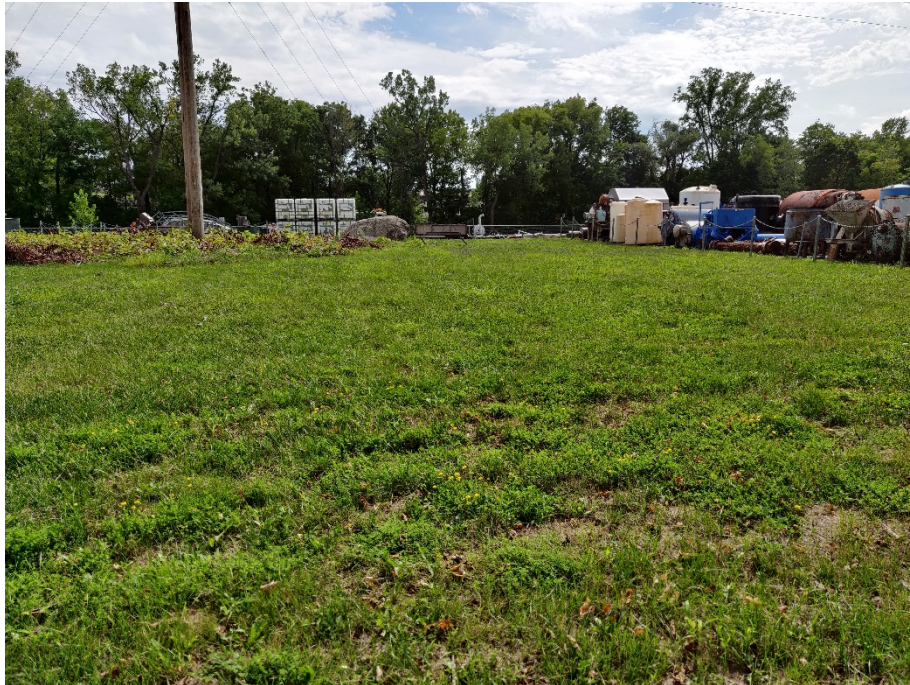
Photograph 6: View of cover system open area (looking south from the northern fence line).

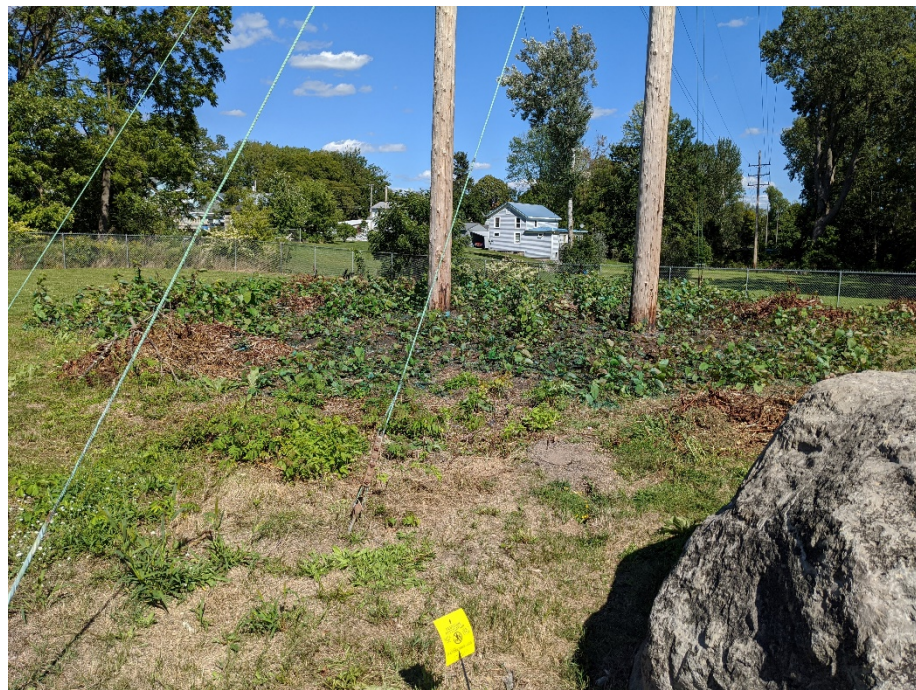
Photograph 7: View of Japanese Knotweed surrounding power poles shortly after f+ all 2020 herbicide application (looking northeast). The animal burrow is located on the far side of the foreground boulder.

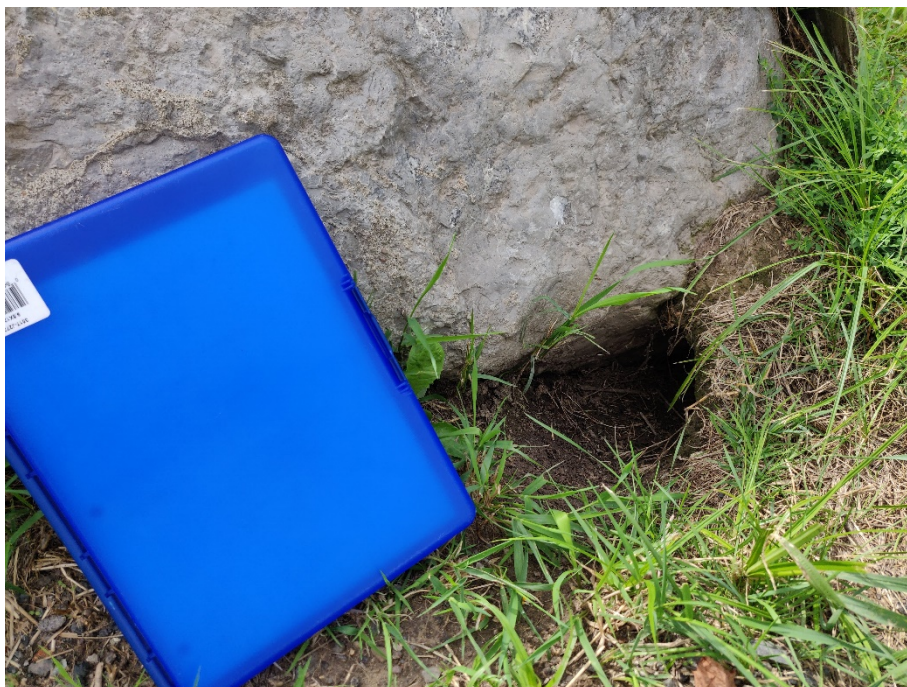
Photograph 8: Suspected groundhog burrow identified near the edge of the boulder (looking west). The burrow does not appear to be active but will be filled with gravel and monitored.

One burrow was noted on Gorham Street and appears to be historical (seven groundhogs were removed from the area in summer 2017) with no signs of active digging. The burrow was filled with gravel on November 19 and will be monitored to determine activity.

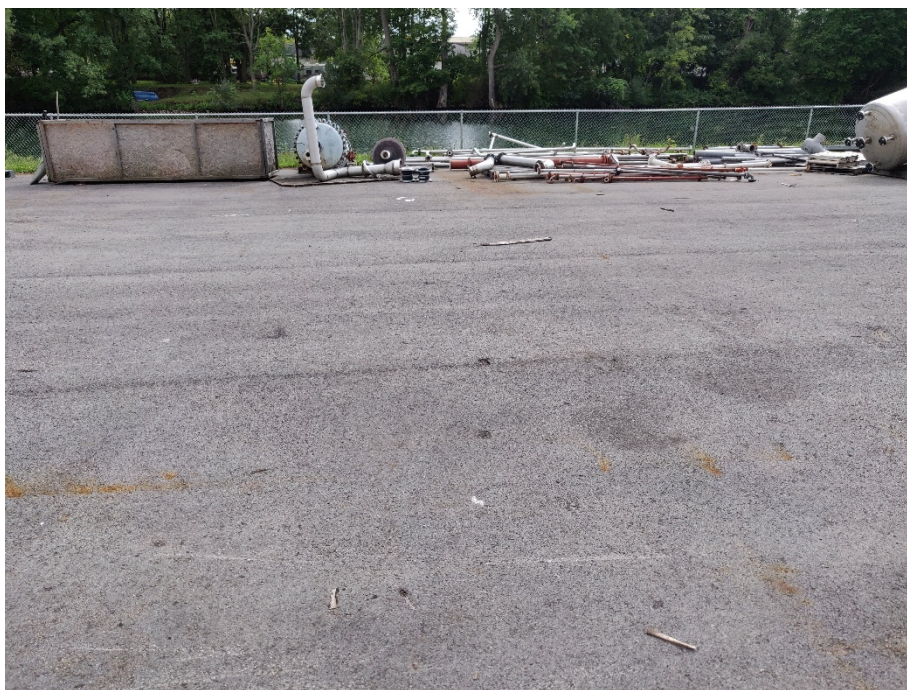
Photograph 9: View of fence and Evans' equipment laydown area (looking south).

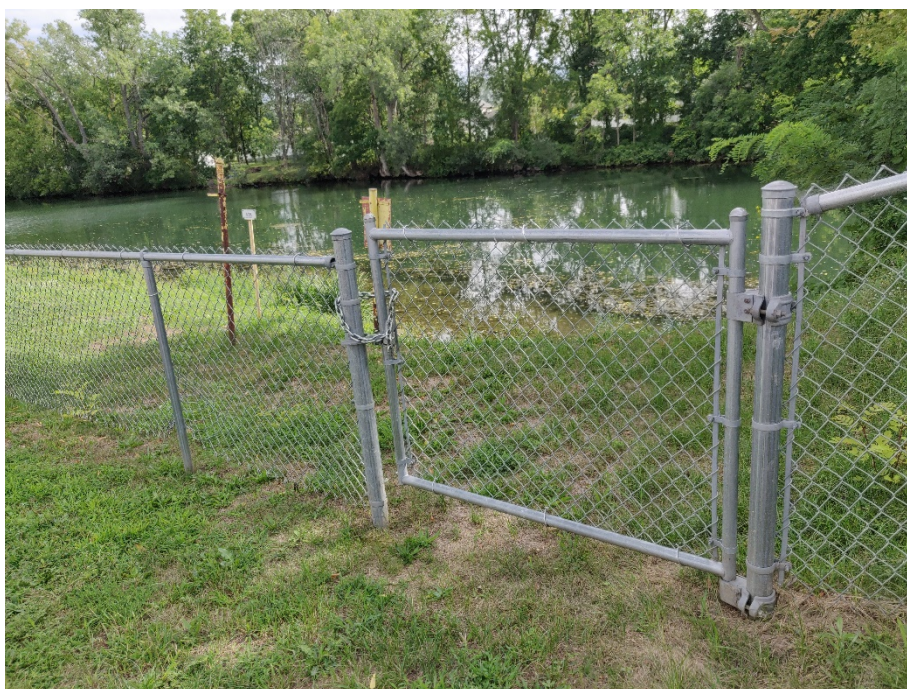
Photograph 10: View of cover system and perimeter fence gate to the canal bank (looking southwest).

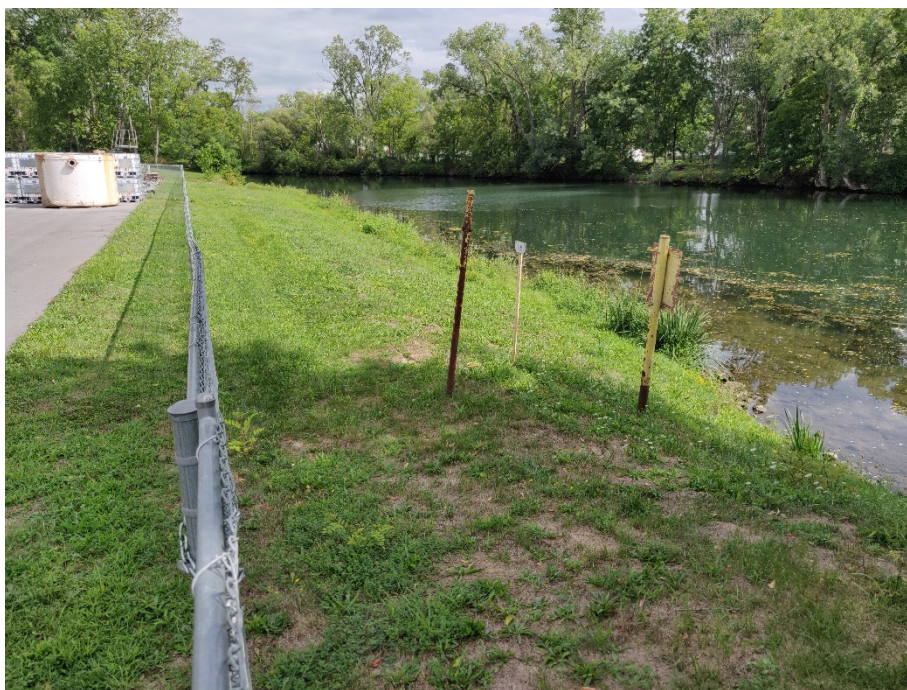
Photograph 11: View of cover system along the canal bank and perimeter fence (looking east).

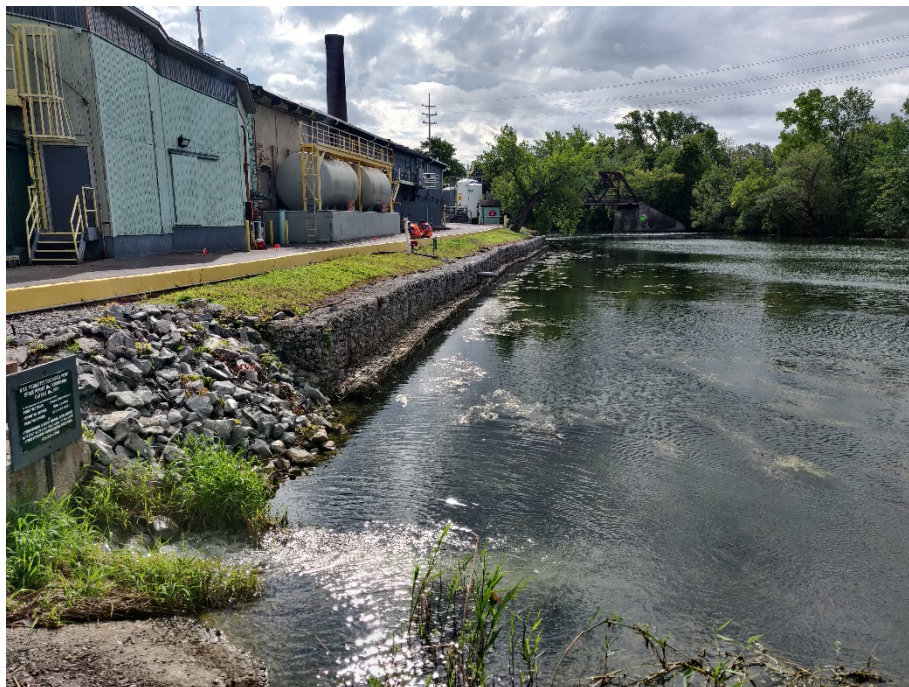
Photograph 12: View of gabion alignment, including the western terminus (looking east).

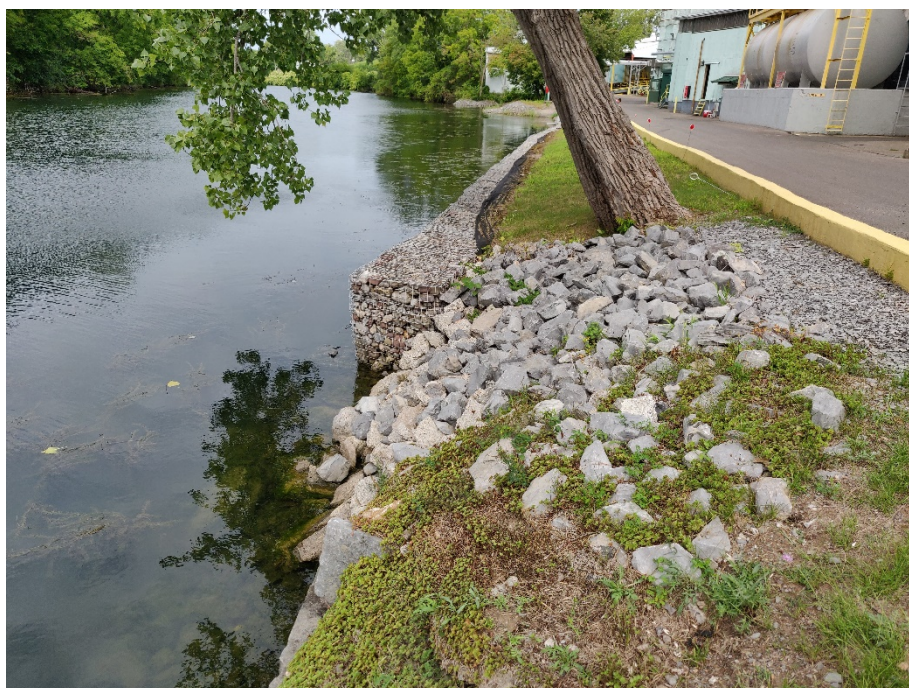
Photograph 13: View of gabion alignment, including the eastern terminus (looking west).

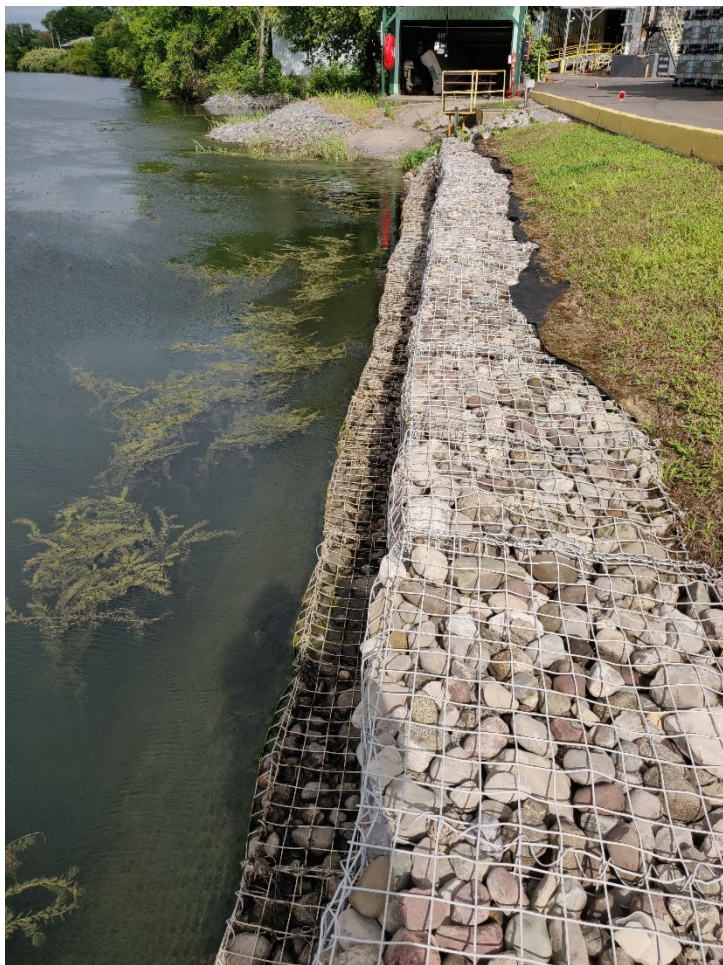
Photograph 14: View of gabion alignment including lower portion near waterline (looking west).

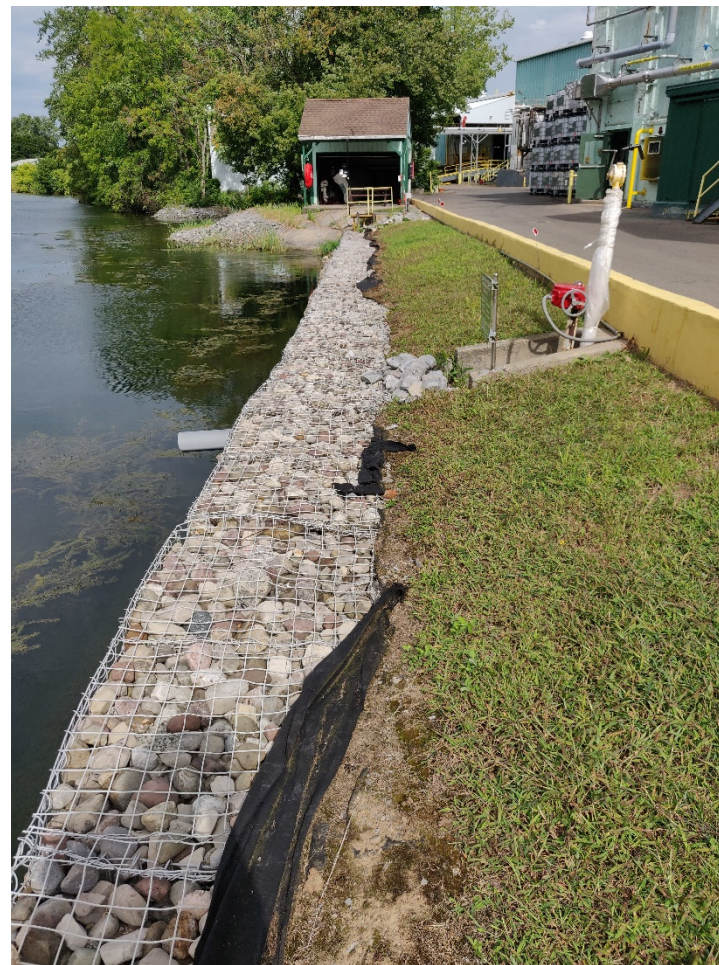
Photograph 15: View of gabion alignment, including stormwater control outfall (looking west).

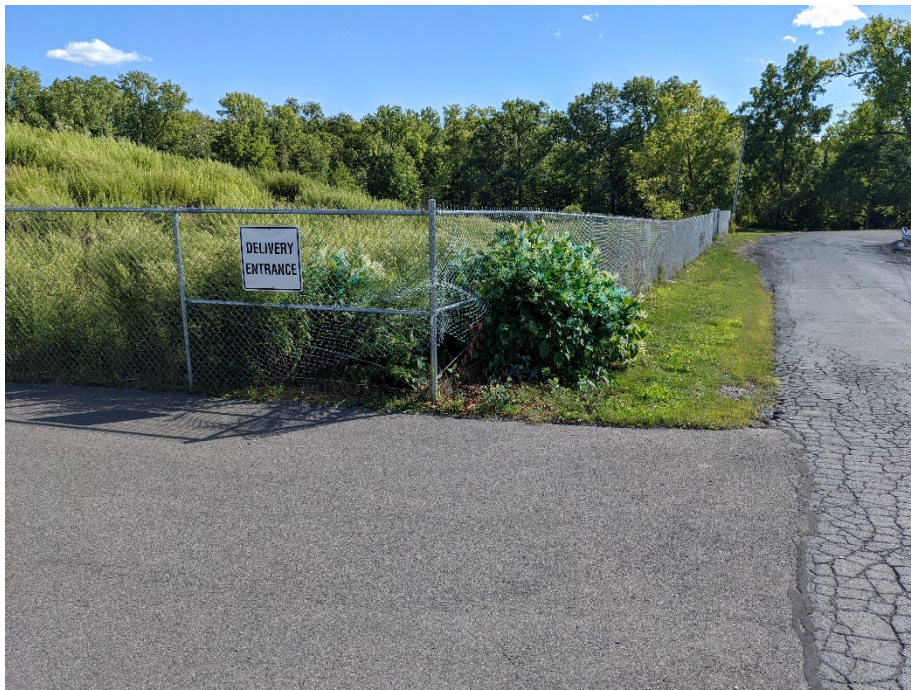
At SWMU-1 the northwest corner of the chain-link fence was damaged, possibly due to snow removal activities. The damage was limited to a section of chain-link mesh pulled away from the fence supports. However, the fence posts and rails were undamaged and the fence continued to provide overall site security until final repairs could be completed; in addition, Evan Chemetics' maintenance staff straightened the mesh to the extent possible without replacing the panel. A fencing contractor employed by Evans Chemetics replaced the damaged section of chain-link mesh on December 11, 2020.

Photograph 36: Damaged fence at northwestern corner along East Water Street prior to cutting vegetation (looking southeast).

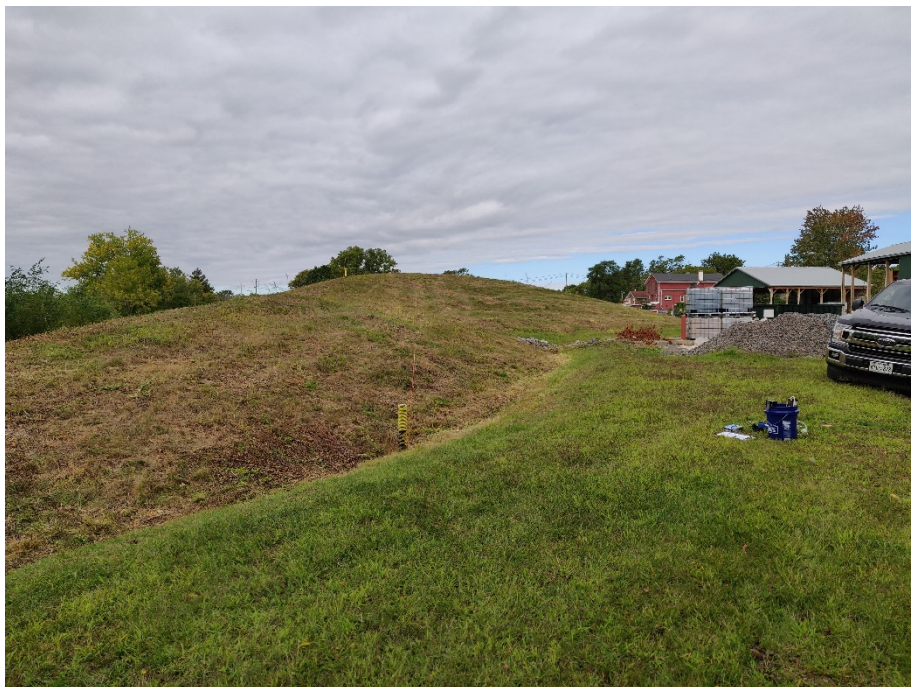
Photograph 16: Eastern area of cover system with GP-02 near blue bucket (looking west).

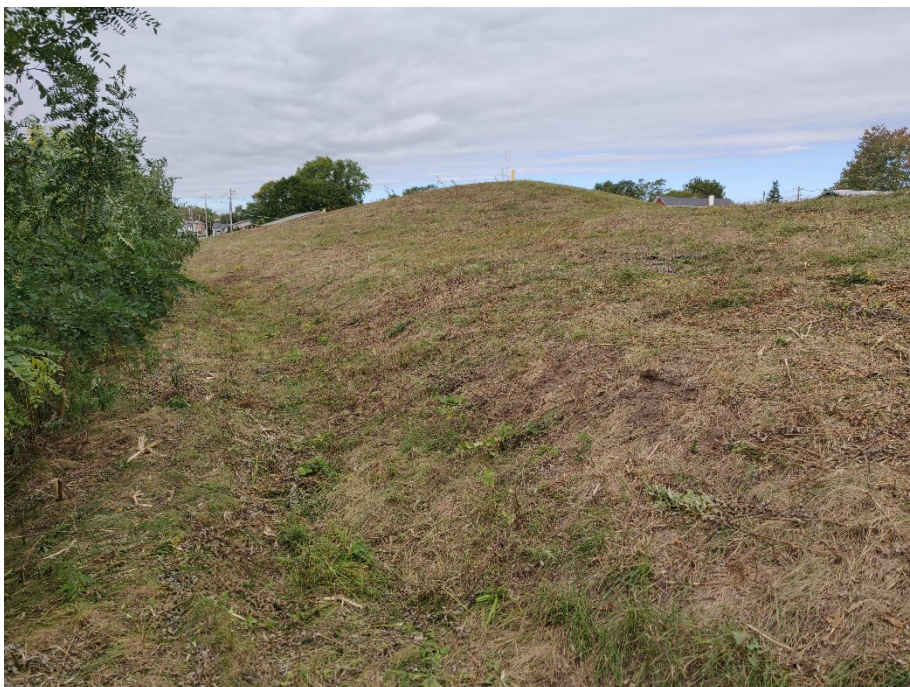
Photograph 17: Southeastern area of cover system and lower swale (looking west).

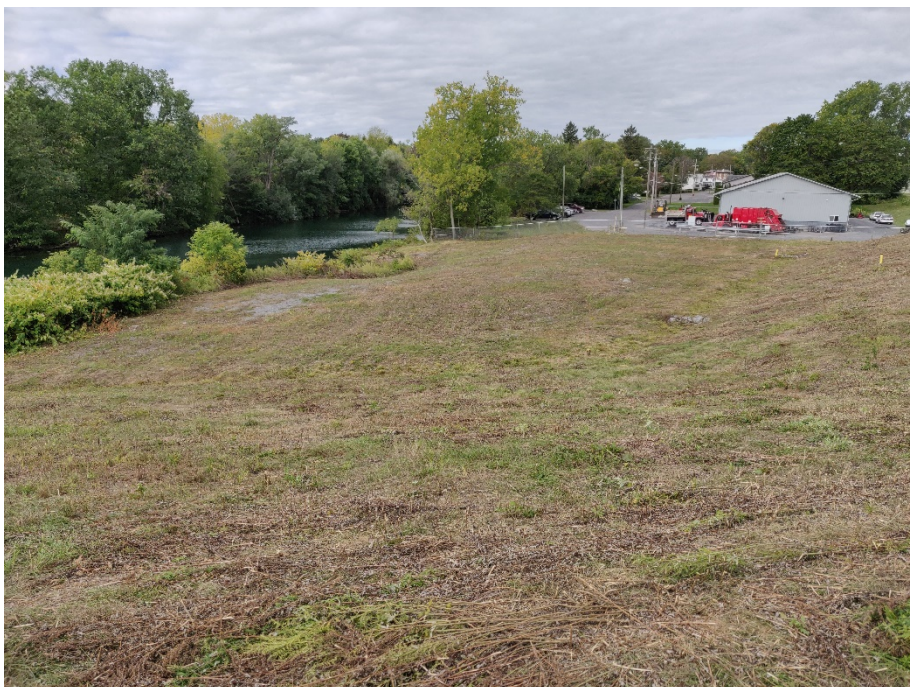
Photograph 18: Western area of cover system in foreground and former sediment treatment pad between base of the slope and canal (looking southwest).

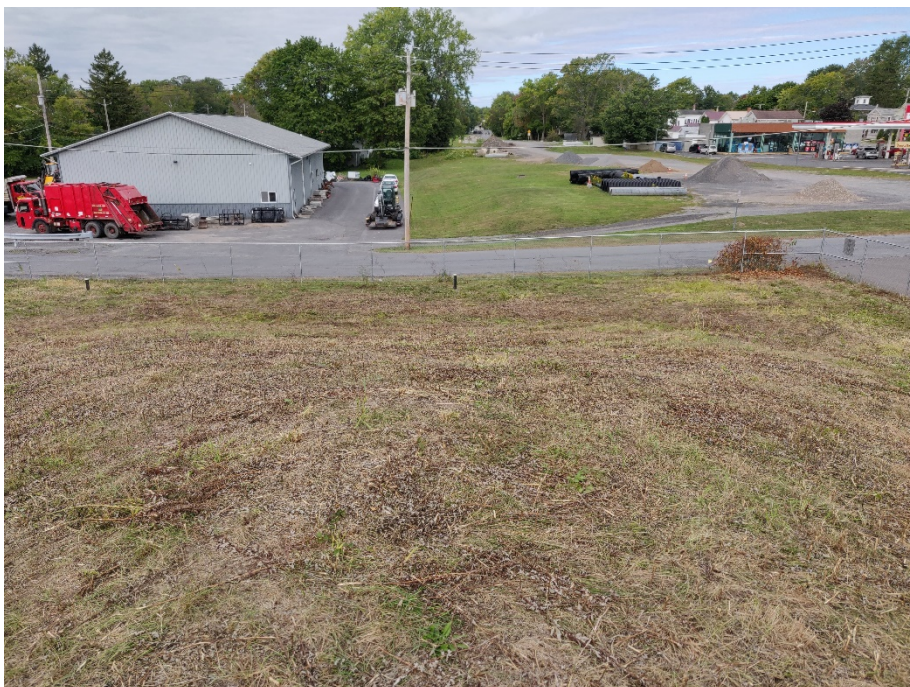
Photograph 19: Western portion of cover system with GP-01 and GP-04 vapor probes at the base of slope (looking west). The damaged corner of the perimeter fence is near the right-hand edge of the photograph.

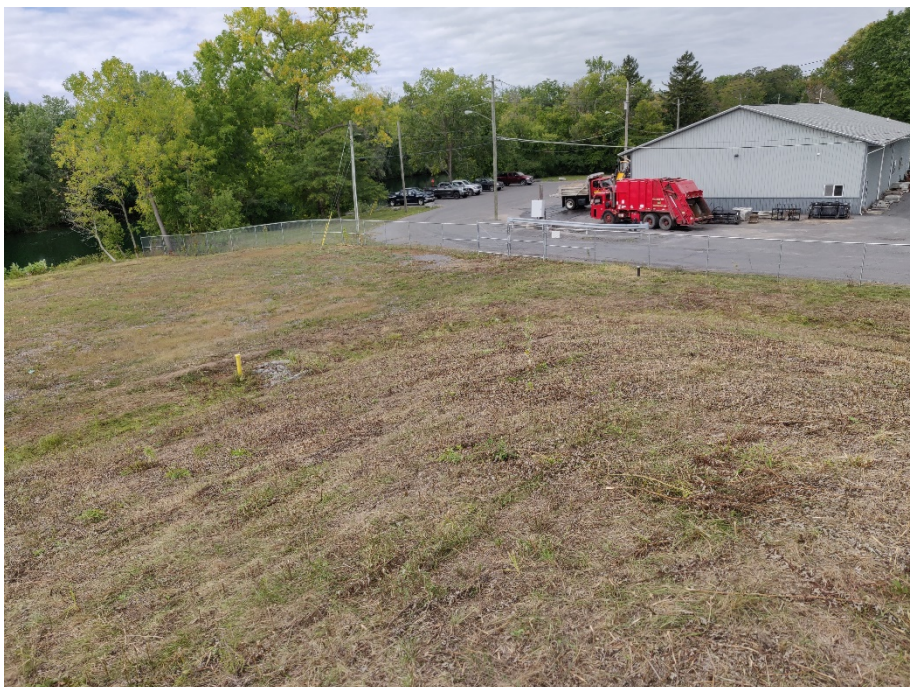
Photograph 20: Southwestern area of the cover system and former sediment treatment pad with monitoring well MW-18 in the yellow monument (looking southwest).

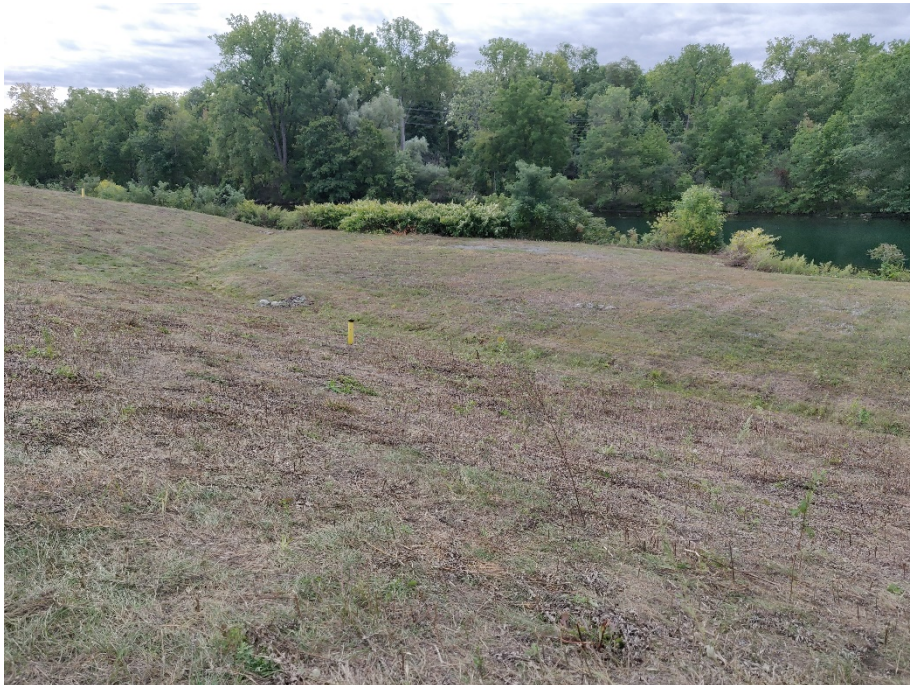
Photograph 21: Southern portion of cover system and former sediment treatment pad with monitoring well TW-01 in the yellow monument (looking southeast).

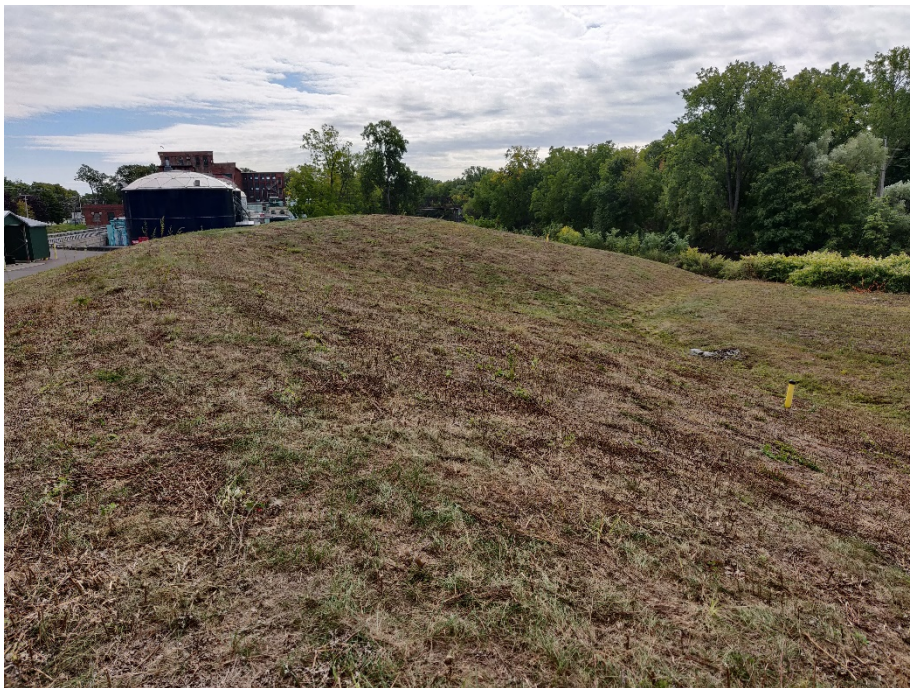
Photograph 22: Western area of the cover system with monitoring well TW-01 in the yellow monument (looking east).

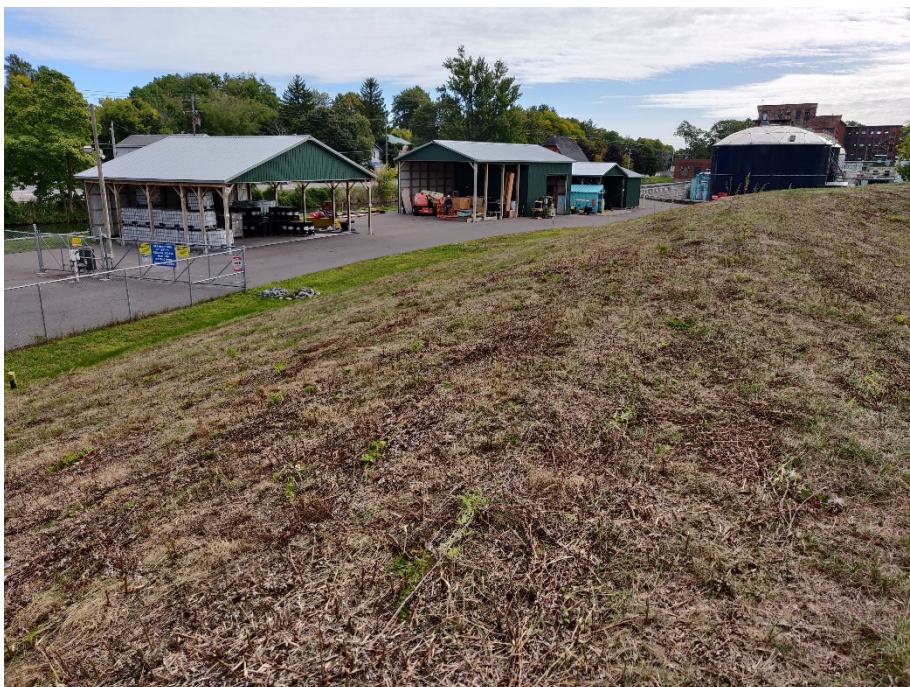
Photograph 23: Northern area of cover system near East Water Street gate to Evans' facility (looking northeast).

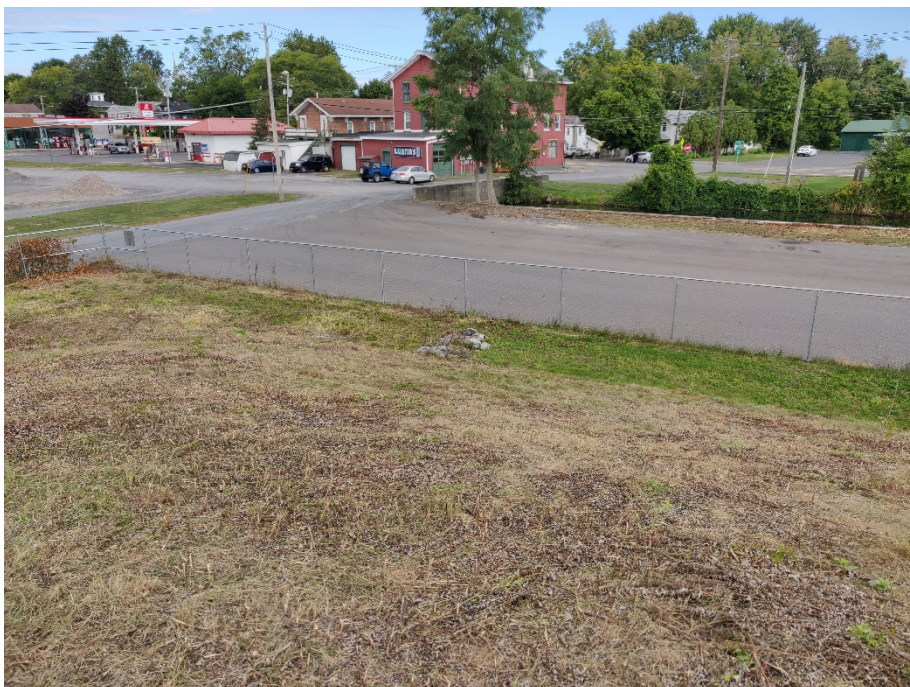
Photograph 24: Northwestern area of cover system and East Water Street entrance to the facility (looking northwest). The damaged corner of the perimeter fence is near the left-hand edge of the photograph.

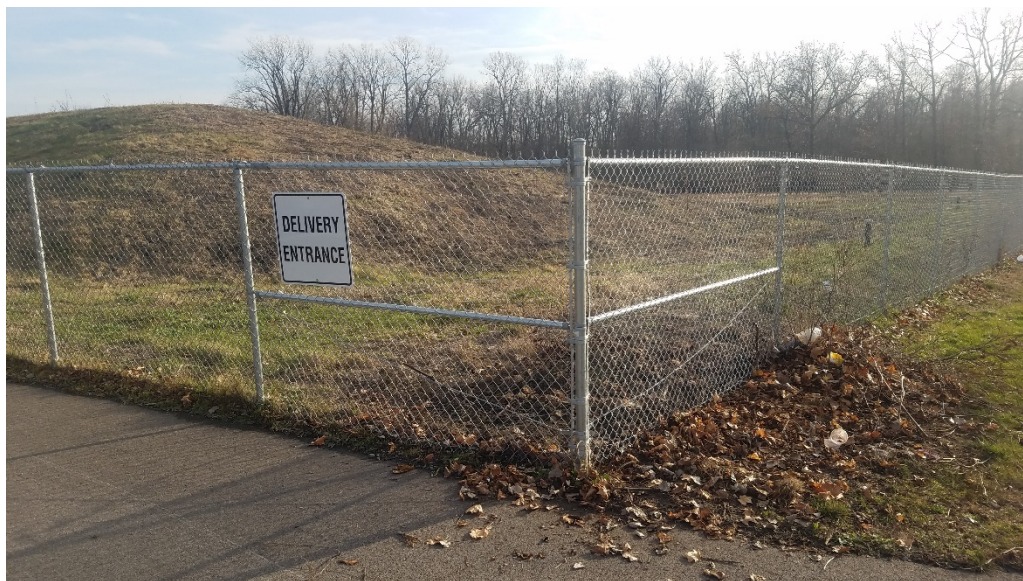
Photograph 25: Final, repaired fence at northwestern corner along East Water Street (looking southeast).
