Subject	Interim Operations and Maintenance Plan/Periodic Review Report 2021, Gorham Street Area, Gabion Wall, and SWMU-1
Project Name	Former Hampshire Chemical Corp. Facility, Waterloo, New York—Site No. 850001A
Attention	Hampshire Chemical Corp.
From	Jacobs Engineering Group Inc.
Date	November 2021

Project Title	Interim Operations and Maintenance Plan/Periodic Review Report 2021, Gorham Street Area, Gabion Wall, and SWMU1
Location	Former Hampshire Chemical Corporation Facility, Waterloo, New York—Site No. 850001A
Date	November 2021

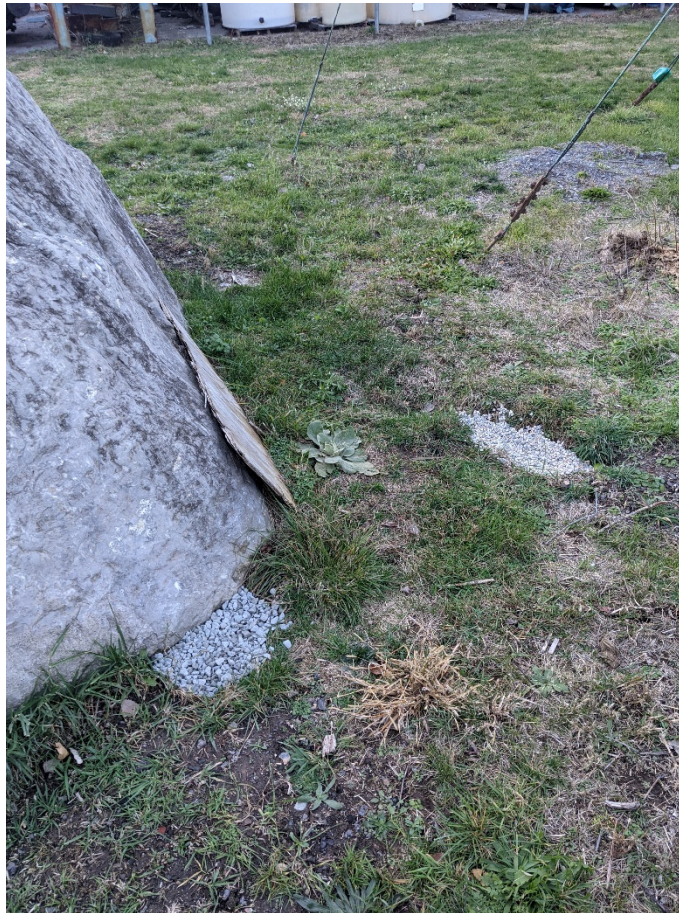
Photograph 1. Inactive groundhog burrows filled with gravel (looking northwest).

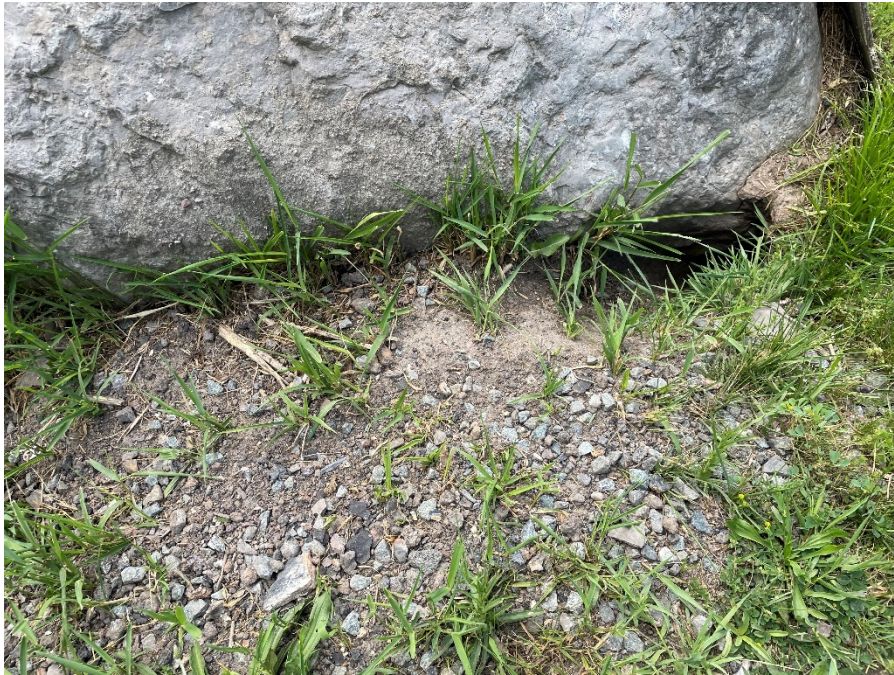
One burrow with signs of active digging was noted at Gorham Street during a May 2021 site. Two groundhogs were trapped and removed from the area in the summer of 2021 by Evans Chemetics. The burrow was refilled with gravel on August 19, 2021. In subsequent site visits the burrow will be monitored to determine activity.

Photograph 1: Groundhog burrow with signs of activity (removed gravel) (looking southwest).

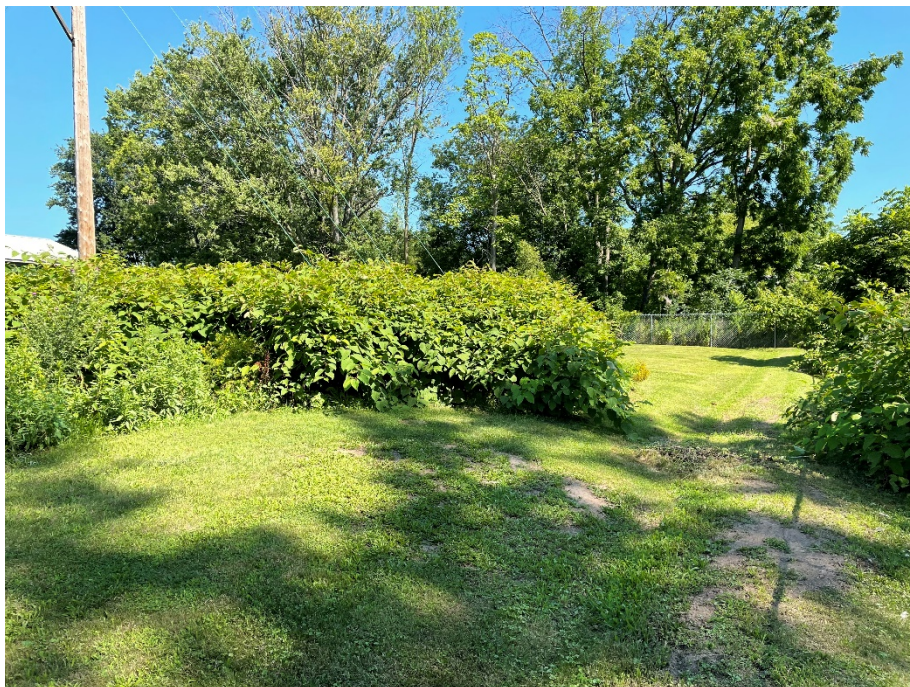
Photograph 5: View of cover system and swale with Japanese Knotweed occurring near the power pole (looking north from south-eastern corner).

In general, the remaining issues that occurred in 2021 were associated with vegetation management. Additional effort was expended on eradicating Japanese knotweed, which included herbicide application by Cardno Corporation on August 19, 2021. Japanese knotweed is a hardy invasive species and may require further herbicide application and mechanical removal to eradicate. After allowing time for the herbicide to penetrate the knotweed, mechanical removal of knotweed at Gorham Street and SWMU-1 is planned for fall 2021.

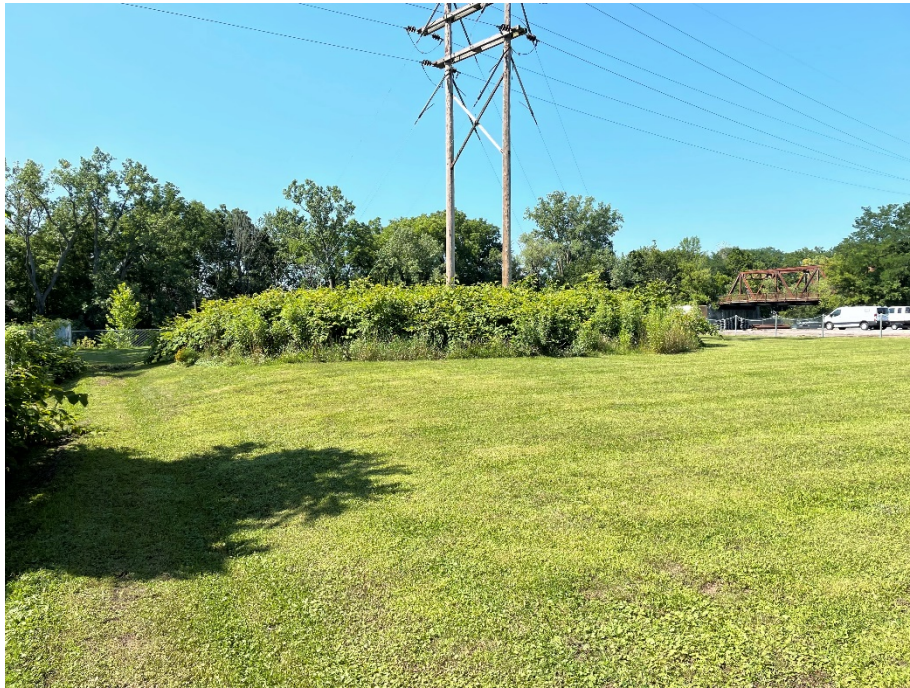
Photograph 6: View of cover system, fence, and power poles surrounded by Japanese Knotweed (looking south from north-eastern quadrant).

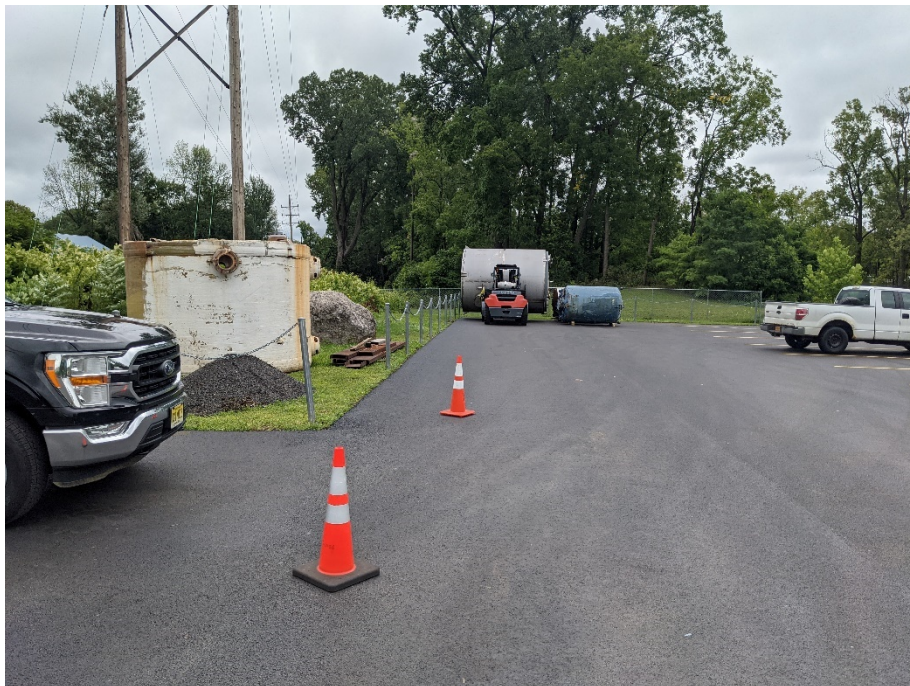
Photograph 11: View new asphalt over south-eastern cover system (looking east).

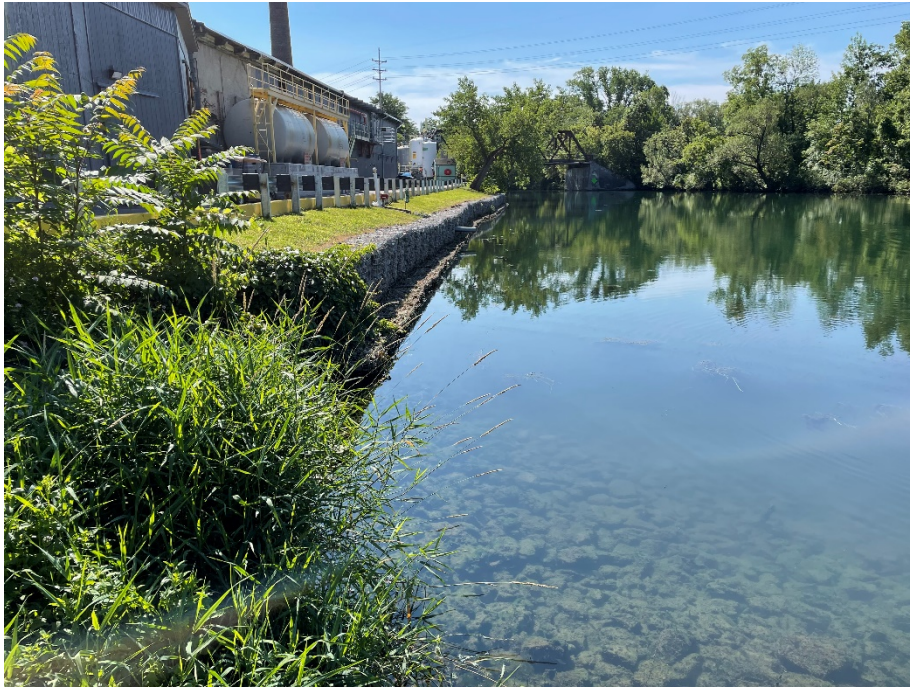
A minor amount of grape vine was growing on the western terminus of the gabion wall (Attachment 2). The grape vine is planned to be removed by Evans Chemetics in early October 2021.

Inspection	Comments
Erosion at top or back of gabion wall	<i>None</i>
Horizontal alignment (bulging)	<i>None</i>
Vertical alignment (drop or deflection of top of wall)	<i>None</i>
Gabion basket wire (damage or breaks)	<i>None</i>
Vegetation (on face or top of wall)	<i>Minor grape vine/brush western end</i>

Photograph 12: View of gabion alignment, including the western terminus (looking east).

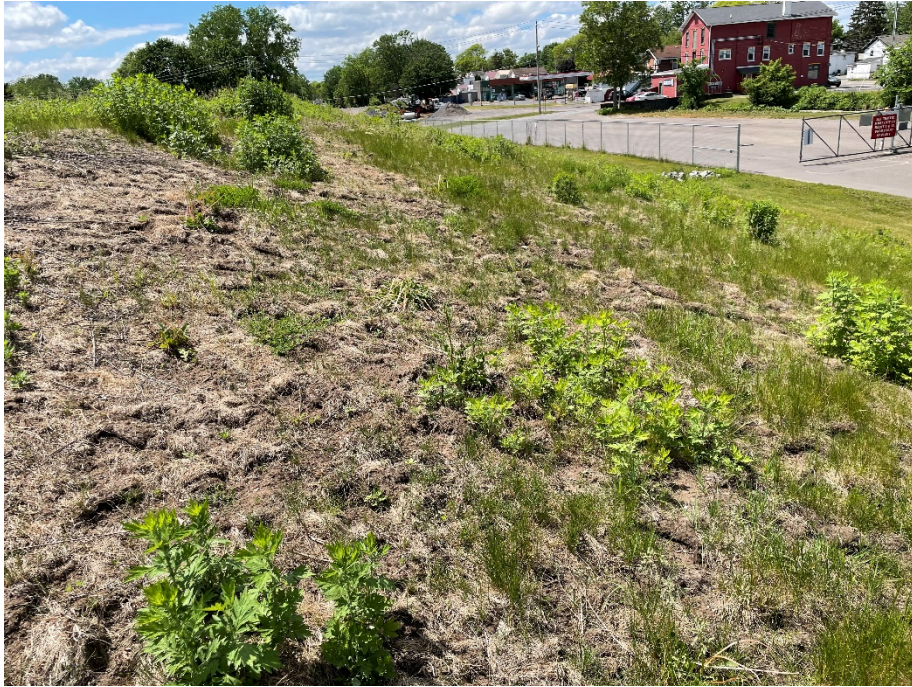
During a site visit in May 2021, relatively small areas of bare soil and stressed vegetation were noted on the upper slope of SWMU-1; however, no erosion was apparent (Attachment 2). These conditions are believed to be the result of unusually dry weather in late 2020 and early 2021. The areas showed signs of recovery in August 2021 and will be inspected again in fall 2021 to determine whether corrective action is necessary.

Photograph 36: Stressed vegetation along the upper slope (looking northwest).
