REPORT  
RCRA Facility Investigation (RFI)  
Report Addendum

Various Survey Tasks  
Former Phillips Display  
Components Facility  
Seneca Falls, New York  
for  
GTE Operations Support Incorporated

URS Job No.: 27010-040-007  
January 29, 2003

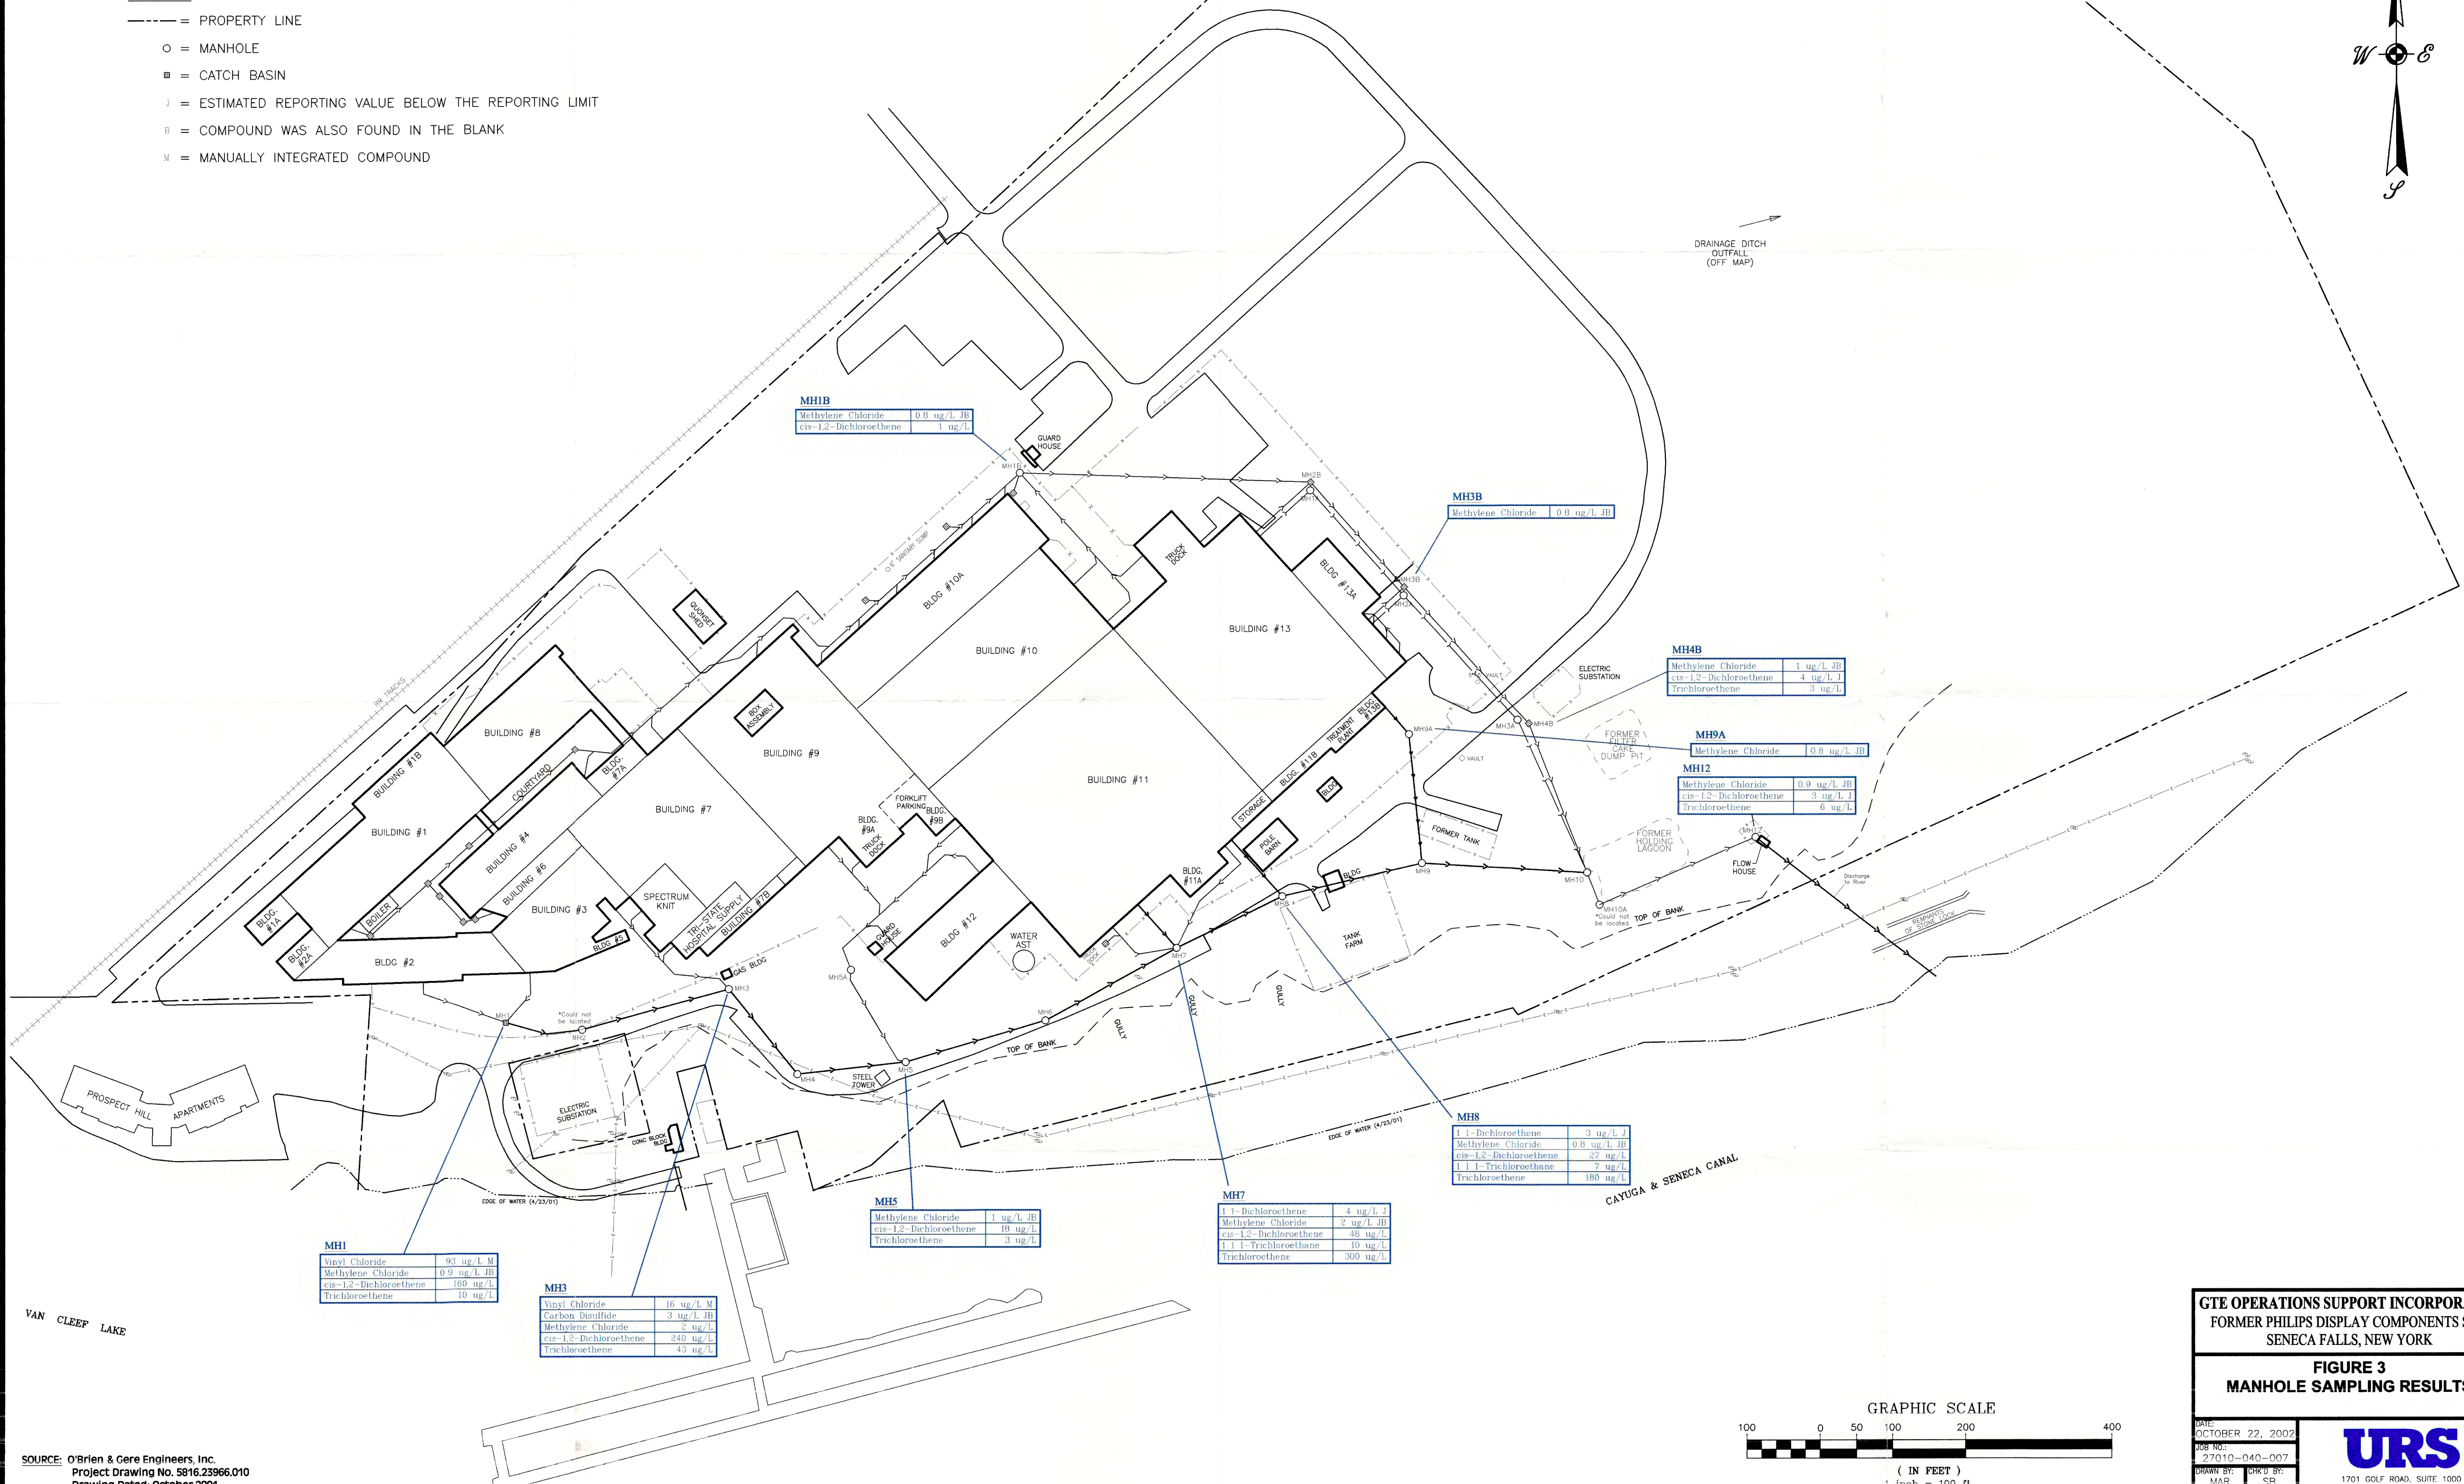
**FIGURE 3**  
**MANHOLE SAMPLING RESULTS**

Figure 3 shows the analytical results for those compounds that were detected above the instrument detection limits. Methylene chloride was detected above the detection limit in each of the ten manholes sampled and in the blank, although in no case was methylene chloride detected at or above the reporting level. Methylene chloride is considered a laboratory artifact not attributable to site conditions. However, TCE and several daughter products were detected in some of the samples, mostly those along the south side of the building rather than those along the north and east sides.

The concentrations in the water in the manholes seem to correspond to the two suspect areas of former TCE use and handling (see next section). Elevated VOC concentrations were found at manholes MH1 and MH3 before dropping off along the drain line to the west, and then spiking up again at MH7 before dropping off again. The mixture of the particular compounds also agrees with the historical timing of TCE use in these two areas. In the older section of the building near MH1 and MH3, TCE is found at lower concentrations relative to its daughter products (cis-1,2-dichloroethene and vinyl chloride), while at MH7, near a newer section of the building, TCE is the predominant VOC and its daughters are present at much lower relative concentrations.

It is likely that these compounds are entering the storm sewer system by infiltration from impacted soils and shallow groundwater. The two sections of sewer lines (one along the south and the other along the north and east) meet at MH10. Stormwater flows from here to the final manhole, MH12, adjacent to the flow house. This is the last available sampling point before the stormwater discharges to the Seneca River. The sample collected at MH12 contained very low levels of TCE and cis-1,2-dichloroethene (6 ug/L and 3 ug/L, respectively). Based on NYSDEC guidance, the criteria limit for discharge of TCE to surface water used for drinking purposes is 5 ug/L, but 40 ug/L for human consumption of fish. The Seneca River is not used as a drinking water source immediately downstream of the discharge point. The data from MH12 are lower than the results obtained by OBG from a sample at the flow house in June of 2001 (TCE at 44 ug/l and cis-1,2-dichloroethene at 10 ug/L). It is likely that the compound concentrations in the stormwater fluctuate over time, based on the rate and

The manhole sampling confirms that there is an issue with potential infiltration of site related constituents into the storm sewer system. It does not appear that the concentrations are high enough to be of immediate concern for river discharge, based on the understanding that the Seneca River is not used for drinking water immediately downstream.

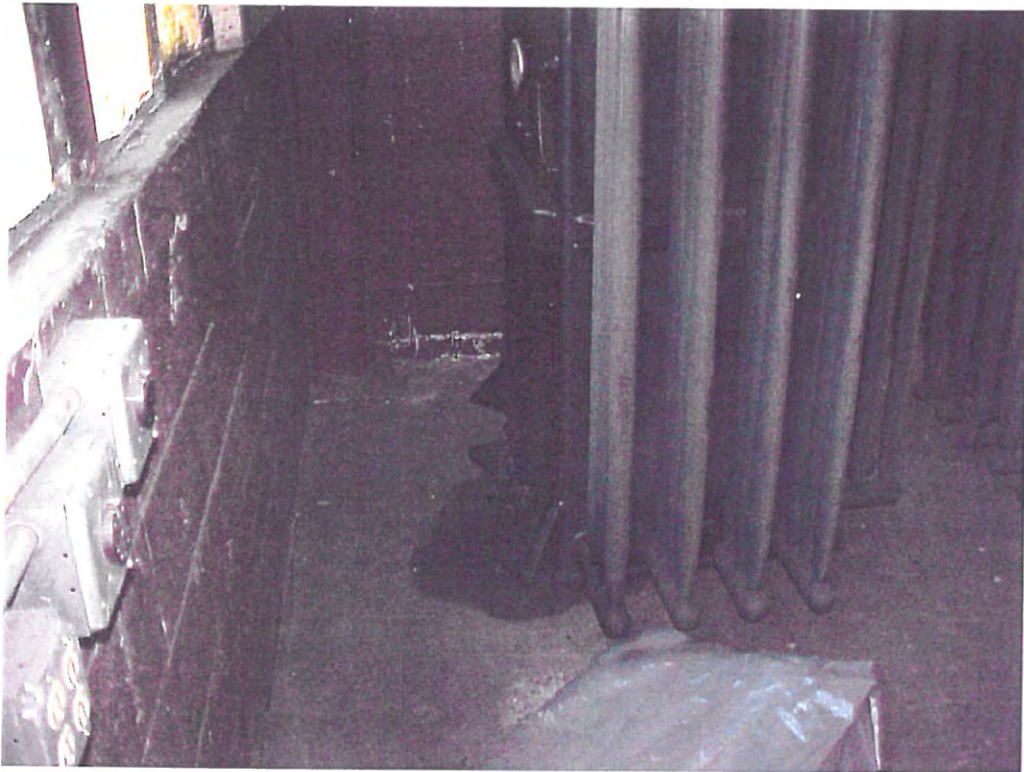
URS observed only two instances of stains and leaks – one at the rooftop transformer on Building 9 and another at the offline transformers stored in Building 8. The offline transformers in Building 8 are labeled as non-PCB. No staining or distressed vegetation was observed around the current transformer pads. No evidence of transformer leaks was observed around remnant pads from which transformers had been removed in prior years.

1. Transformer fluid leaking on floor in Building 8.

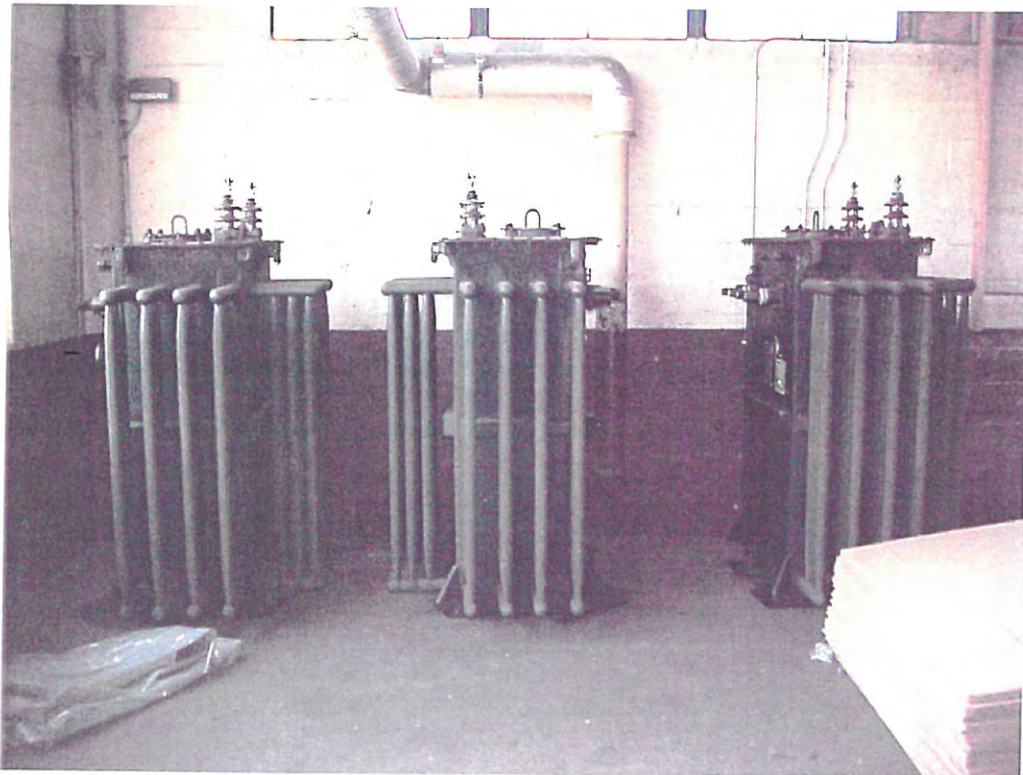
2. Three offline transformers stored in Building 8.

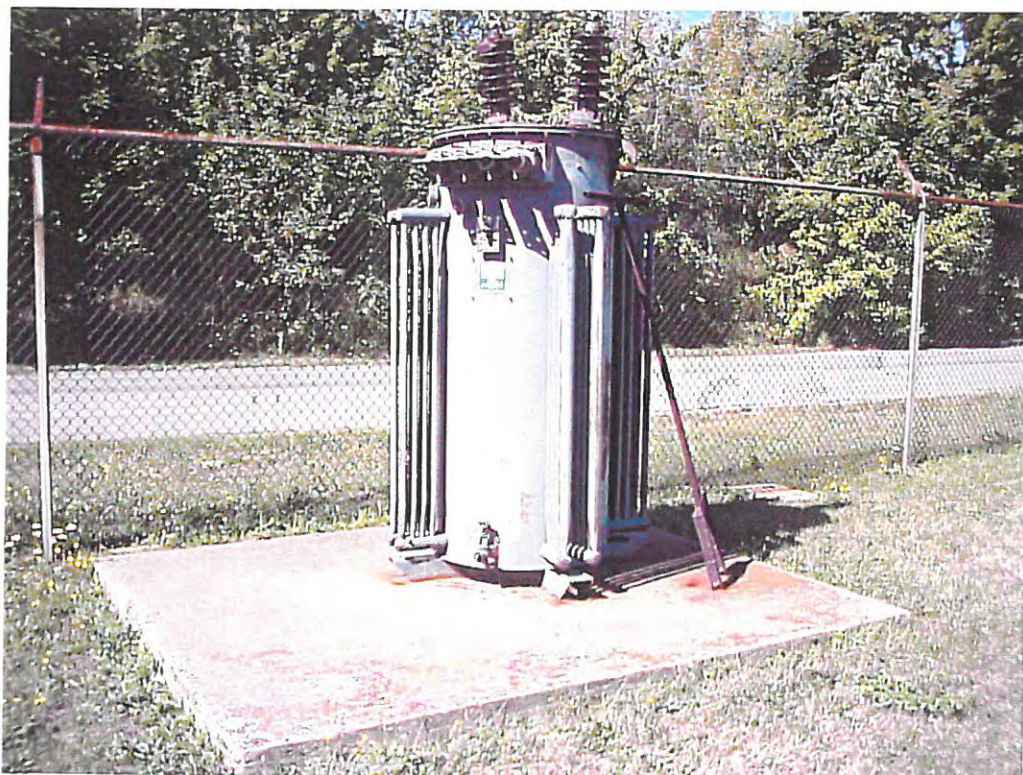
4. Offline transformer stored on former oxygen pad outside of Building 8.

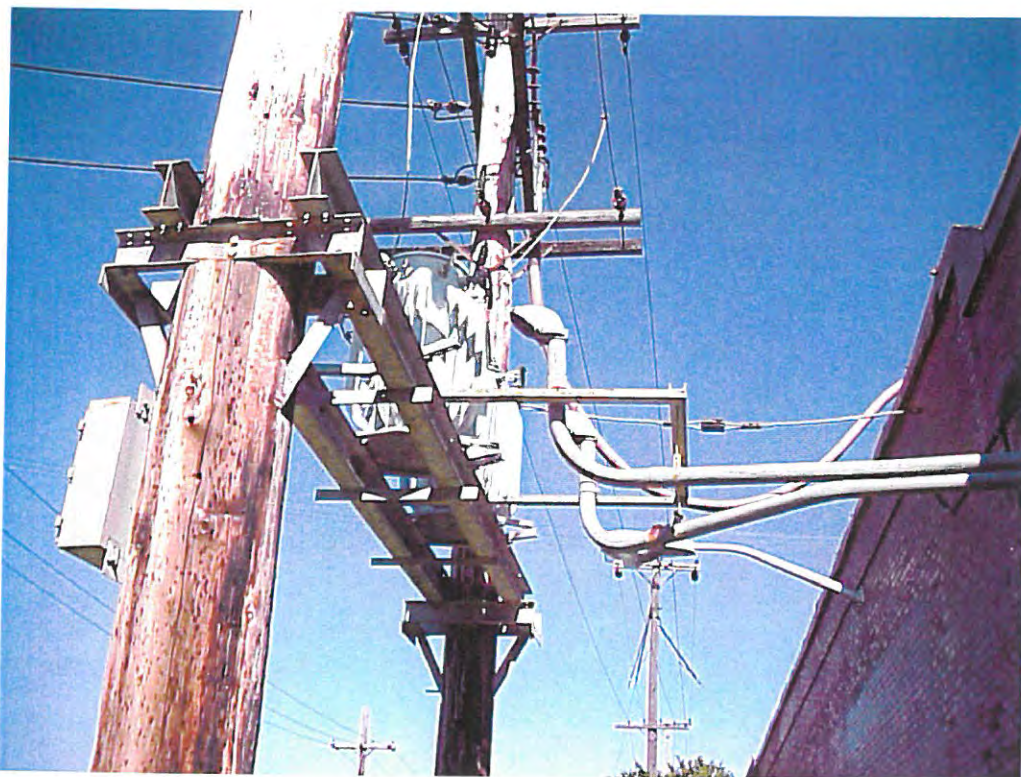
| Substation ID or location | Building # and direction | Status: Present or removed | Location (roof, pad, pole) | Transformer number and sizes (kVA) | Est. age (yrs.) | Live or dead | PCB status labels? (ppm) | Observations (staining, leaks, replacements) and comments |
|---|---|---|---|---|---|---|---|---|
| Sub. D | 7 - Northeast | Present | pole | 2-167 (3) | 25+ | D | Not marked | One missing - 3 originally |

5. Substation D (disconnected).

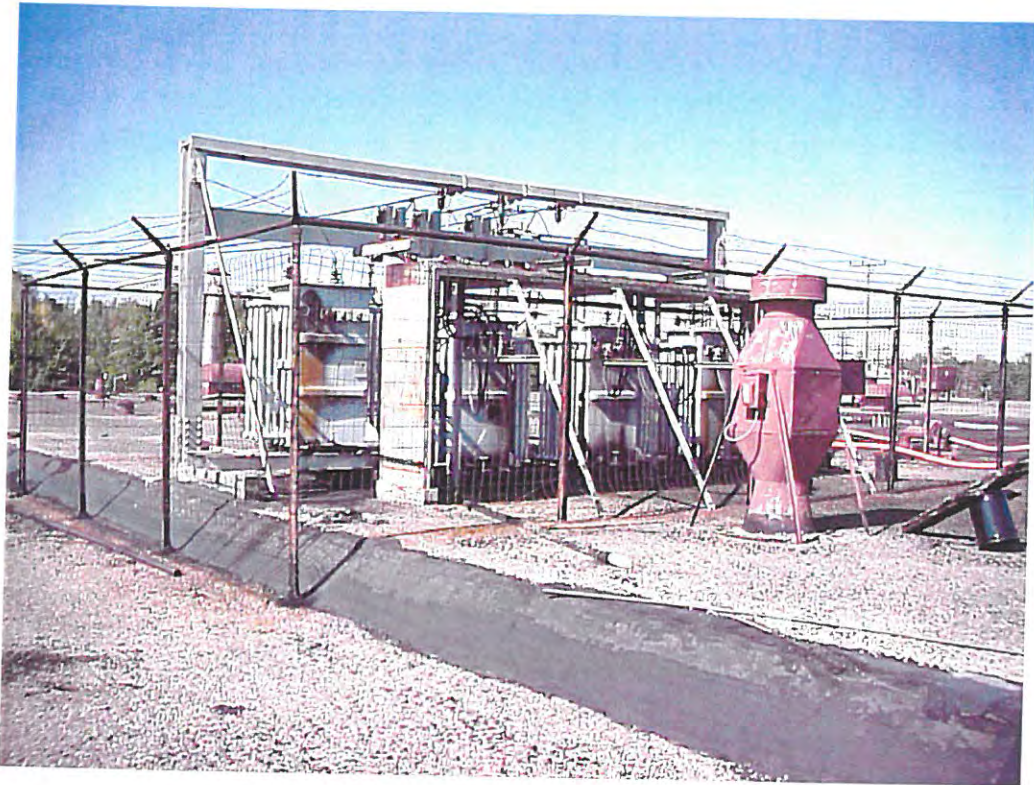
7. Another view of Substation F with three original transformers and fourth (to the left) added later.

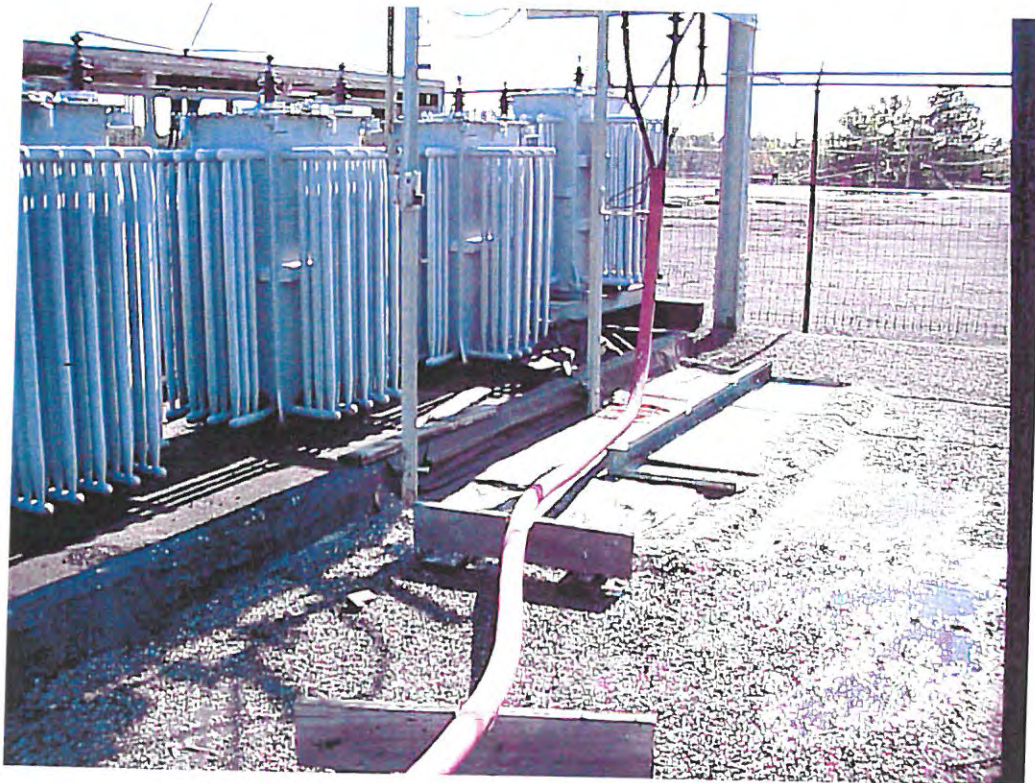
| Substation ID or location | Building # and direction | Status: Present or removed | Location (roof, pad, pole) | Transformer number and sizes (kVA) | Est. age (yrs.) | Live or dead | PCB status labels? (ppm) | Observations (staining, leaks, replacements) and comments |
|---|---|---|---|---|---|---|---|---|
| Sub. F | 9 - Center | Present | roof | 4-333 (3) | 50+ | L | <50 (only 3) | 3 originally, staining/leaks, one not labelled |

8. Back side of Substation F with oily staining in containment.

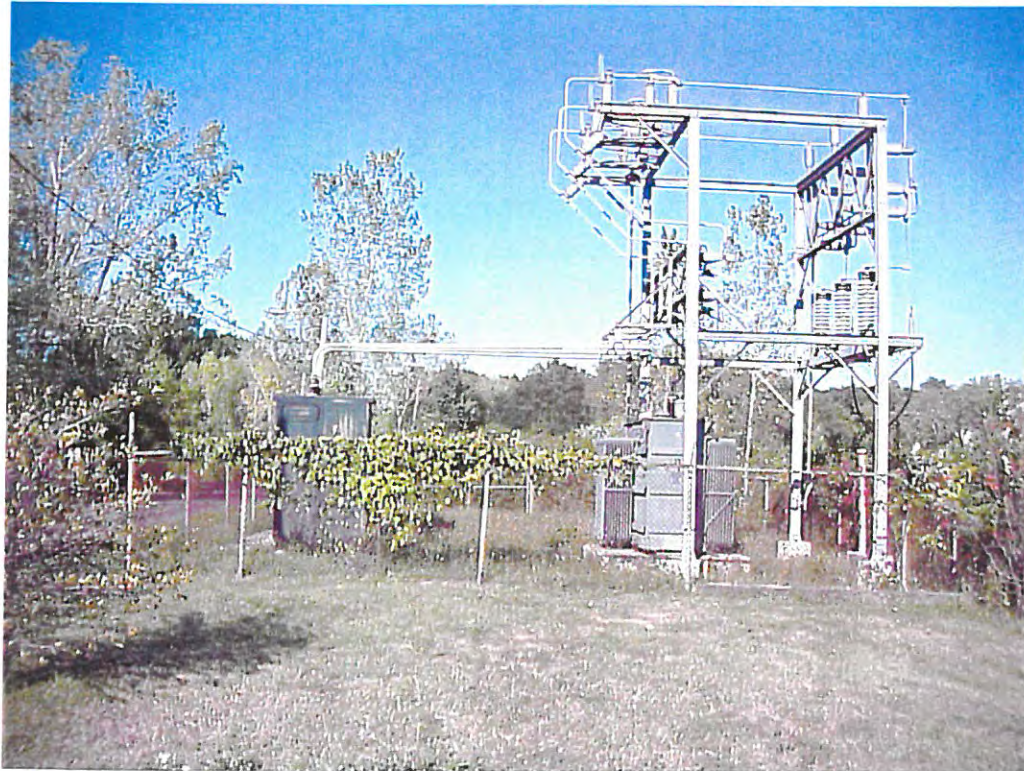
| Substation ID or location | Building # and direction | Status: Present or removed | Location (roof, pad, pole) | Transformer number and sizes (kVA) | Est. age (yrs.) | Live or dead | PCB status labels? (ppm) | Observations (staining, leaks, replacements) and comments |
|---|---|---|---|---|---|---|---|---|
| Sub. Z | 13 - Southeast | Present | pad | 1-2500 | 25+ | D | Assumed <50 | Sunbelt name, fence prevented access, assumed <50 based on age and staff statement |

14. Substation Z located southeast of Building 13 (may be owned by NYSE&G).

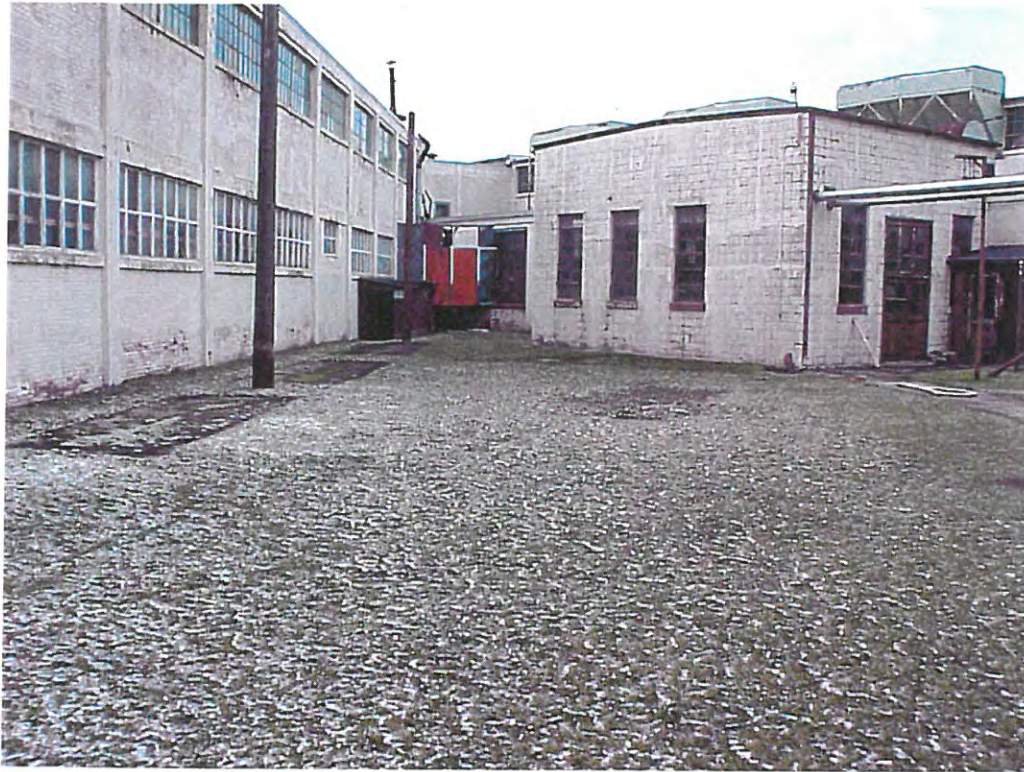
21. Concrete pads where former transformers existed along Building 2.

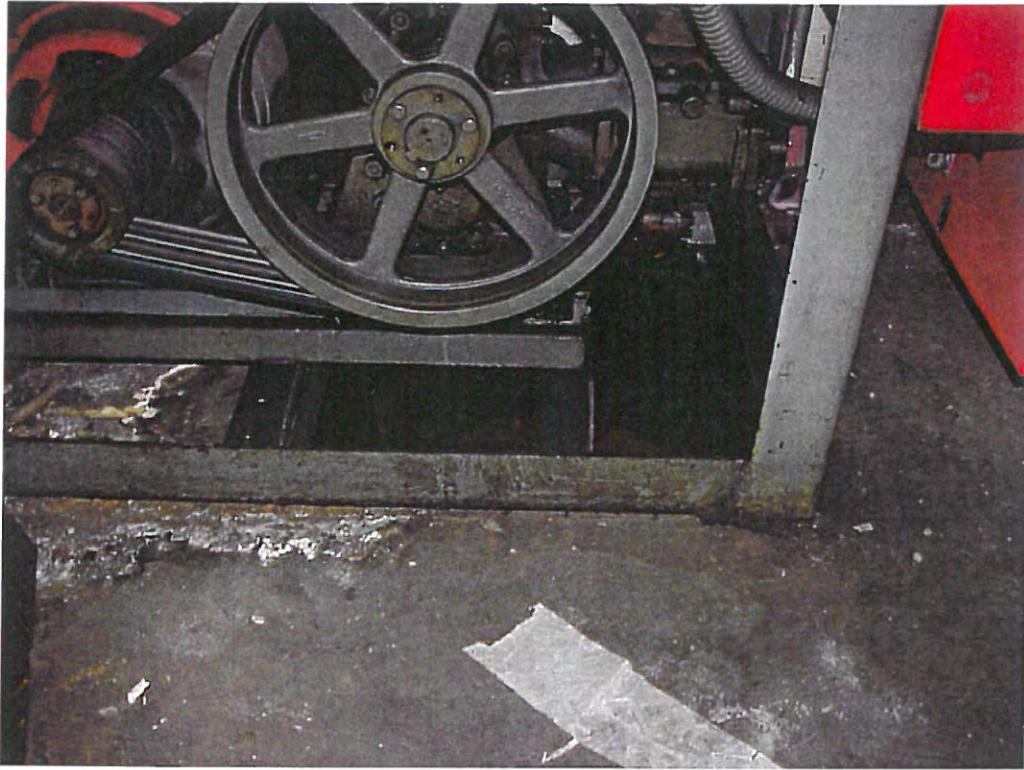
23. Closeup of hydraulic unit with tray below containing oil.

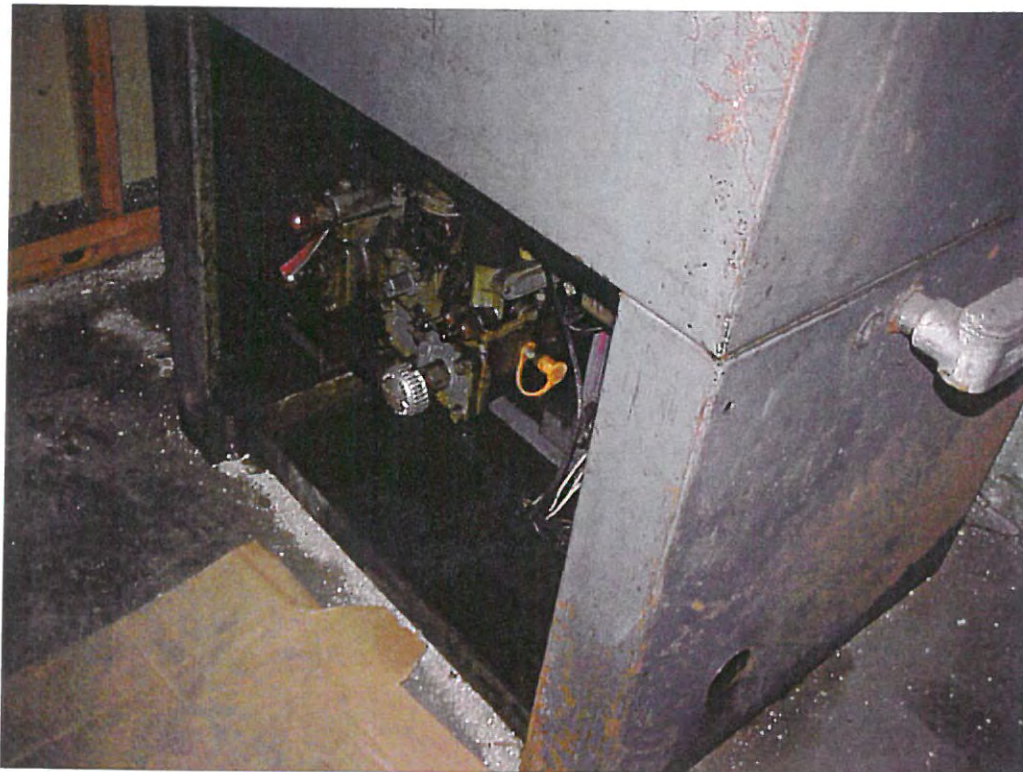
25. Hydraulic unit in Building 12 with Oil-Dri spread on the floor.

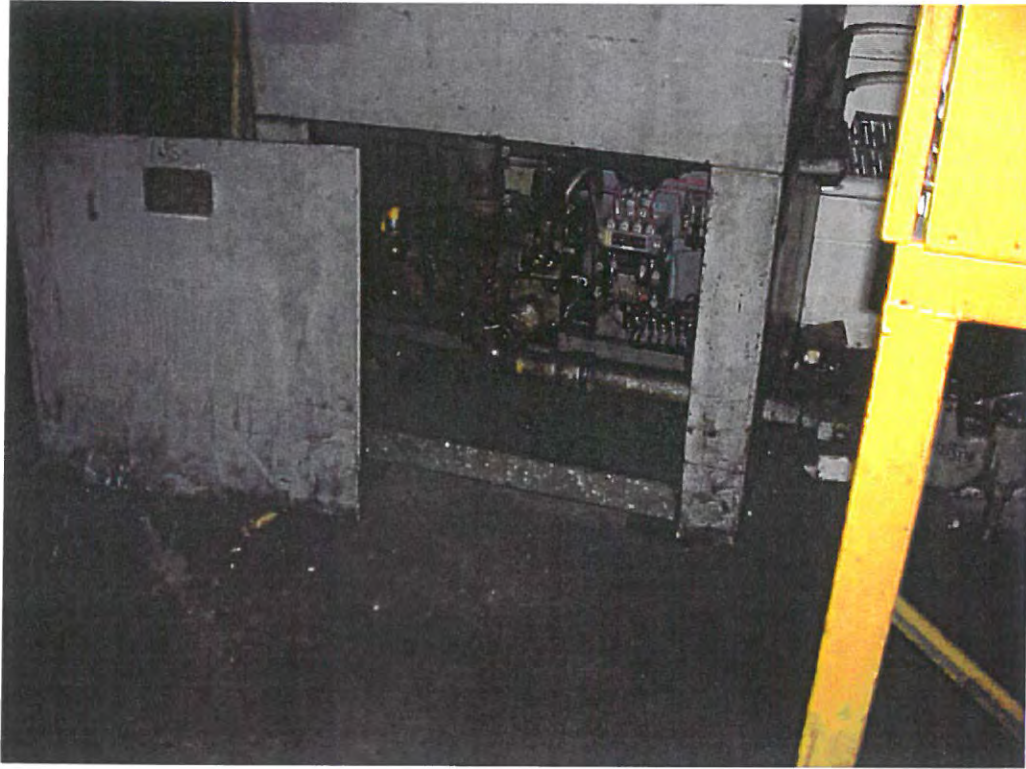
27. Closeup of oil-filled tray under the hydraulic unit.

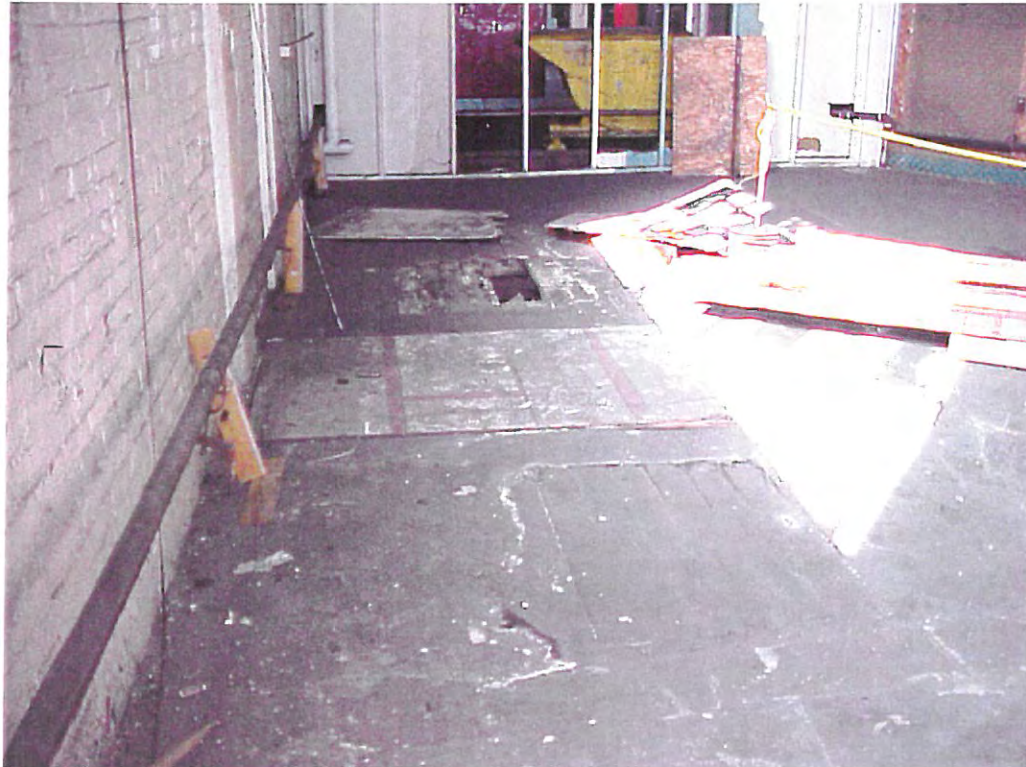
| Sump /Pit ID | OBG photo numbers | Location | Size LxWxD (ft) | Apparent function | Contents (liquids or sludge) and depth | Notes and observations | PID | Cracks or gaps present | Potential Environmental concerns |
|---|---|---|---|---|---|---|---|---|---|
| J | NA | S in Bldg. 3 inside | 18x7x5 | Unknown | Sludge, Water | Former test lab | 7 | N | Sludge present |

6. Covered pit in Building 3 containing sludge (unknown former use).

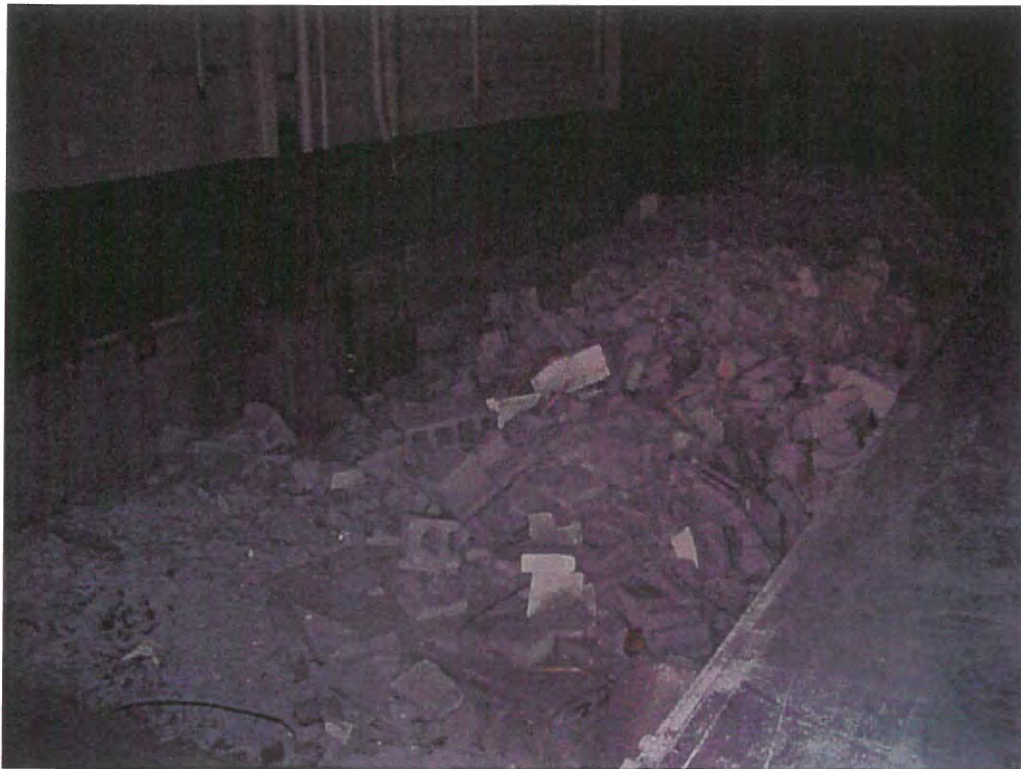
Pit R is the largest pit and is located in Building 11A. This pit was reportedly used to house annealing ovens when the plant was in operation. The pit was subsequently filled with demolition debris consisting primarily of mason blocks. A small amount of water appears to be present in the bottom and had a slight odor of stagnant water. It does not appear that this pit represents a serious environmental concern at this time.

| Sump /Pit ID | OBG photo numbers | Location | Size LxWxD (ft) | Apparent function | Contents (liquids or sludge) and depth | Notes and observations | PID | Cracks or gaps present | Potential Environmental concerns |
|---|---|---|---|---|---|---|---|---|---|
| R | 24 | S in Bldg. 11 inside | 40x12x8 | Annealing ovens | Concrete, water | Demo debris | 0 | Unk. | Stagnant water odor |

9. Debris-filled pit formerly used to house annealing ovens in Building 11A.

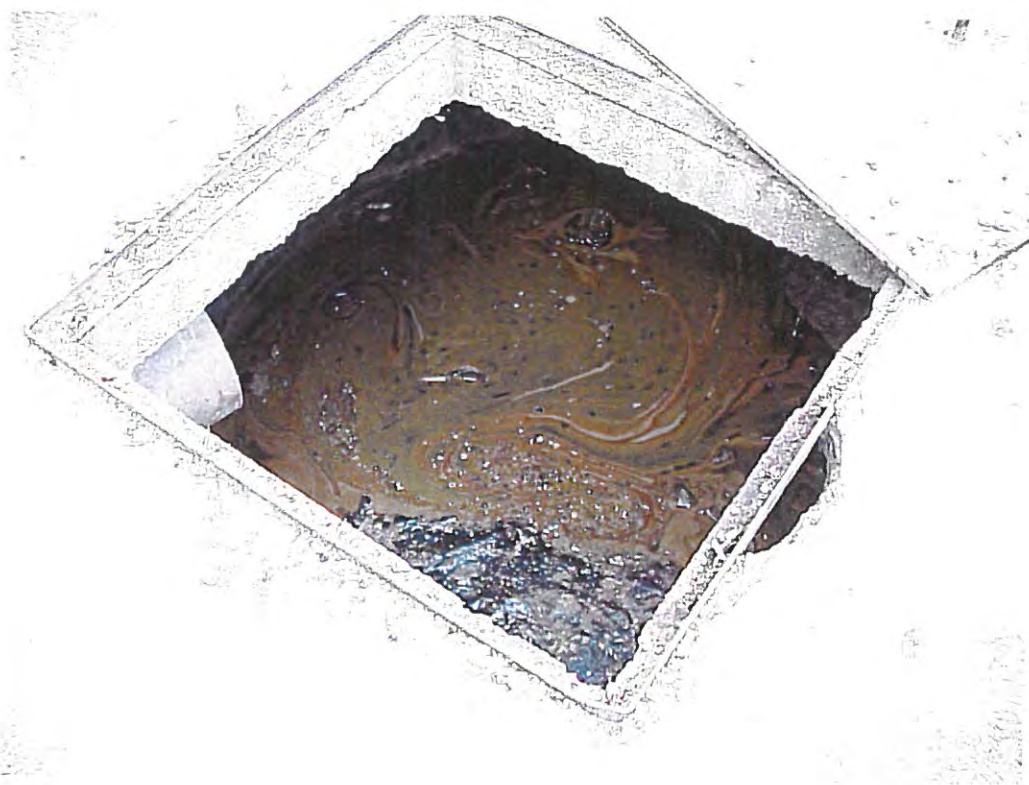
| Sump /Pit ID | OBG photo numbers | Location | Size LxWxD (ft) | Apparent function | Contents (liquids or sludge) and depth | Notes and observations | PID | Cracks or gaps present | Potential Environmental concerns |
|---|---|---|---|---|---|---|---|---|---|
| W | NA | S. of Bldg. 9B outside | 5dia.x3 | Unknown | Oily sludge | 3 pipes entering | 0 | Unk. | Full of oily sludge |

11. Oily water and sludge in pit near Building 9B.
