Re: 2024 Annual Site Inspection Report
NYSEG Seneca Falls Former MGP Site
187 Fall Street, Seneca Falls
Seneca County
Site No.: 850010

Subject: 2024 Annual Site Inspection Report
NYSEG Seneca Falls Former MGP Site
187 Fall Street
Seneca Falls, Seneca County, New York
NYSDEC Site No. 850010

NYSEG Seneca Falls Former MGP Site - NYSDEC Site No. 850010

NYSEG Seneca Falls Former MGP Site – October 3, 2024

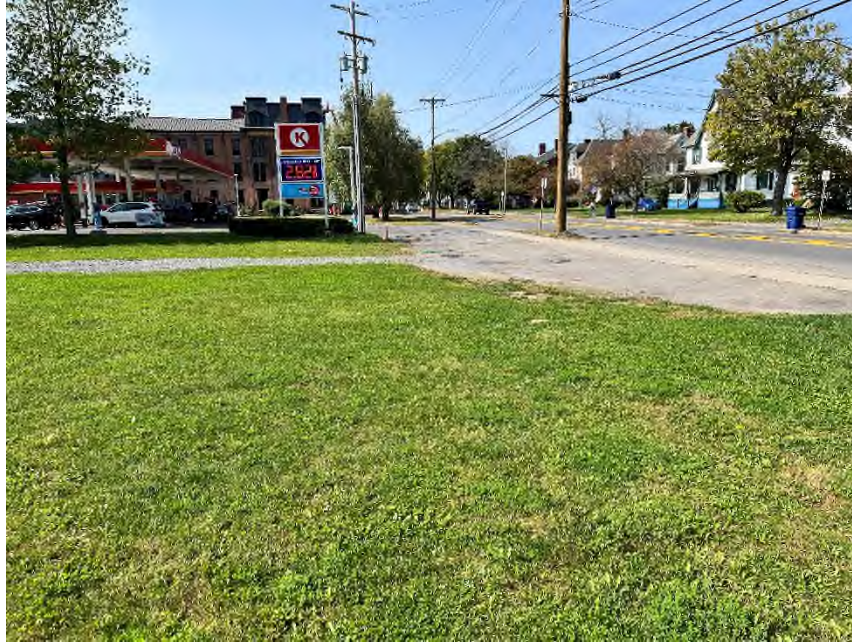
Northern, Upland Area of the Site - Viewing west.

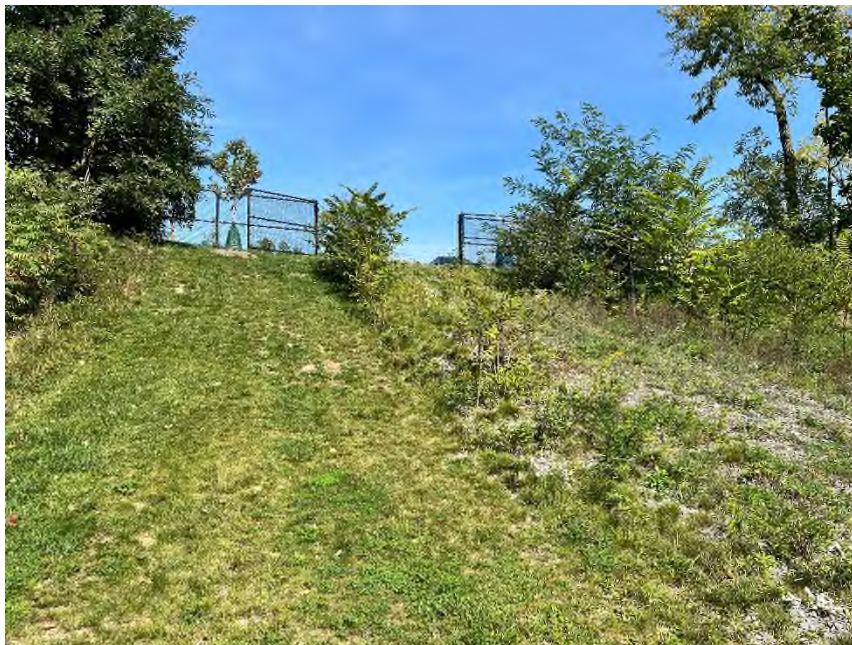
Access ramp, south side of Site - Viewing north

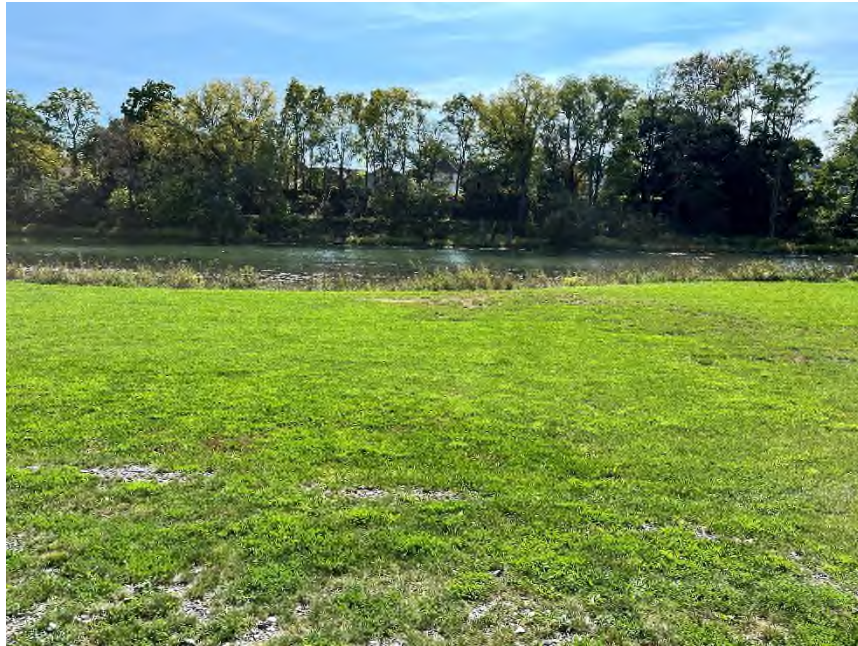
Lowland Area Near the Seneca River/Canal - Viewing south

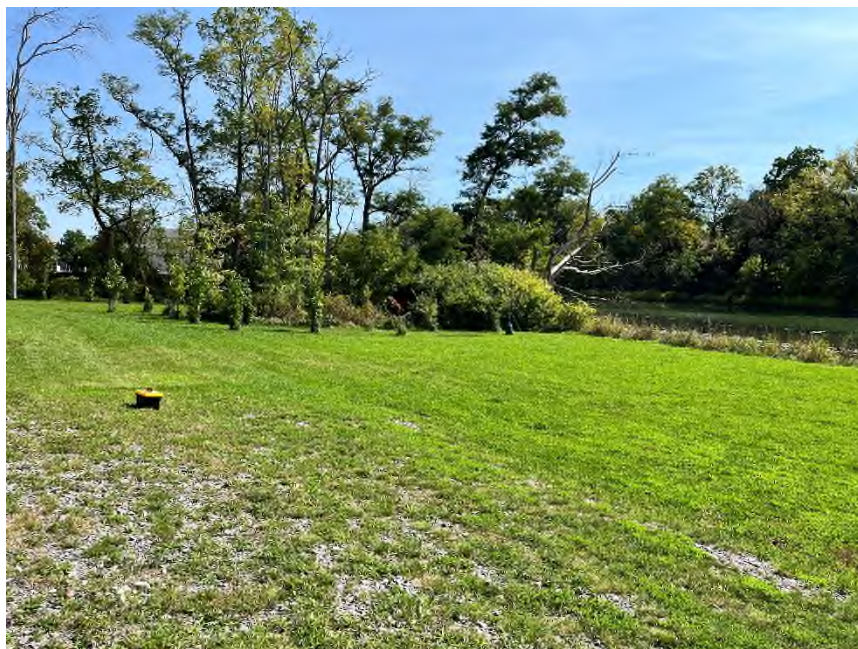
Lowland area – Viewing east-southeast

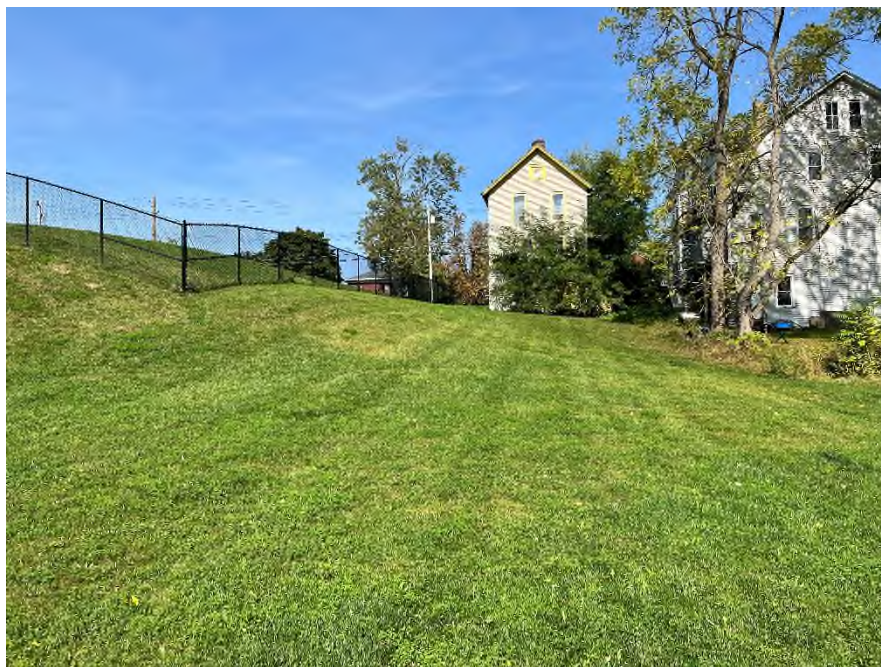
Eastern Portion of Lowland Area – Viewing North

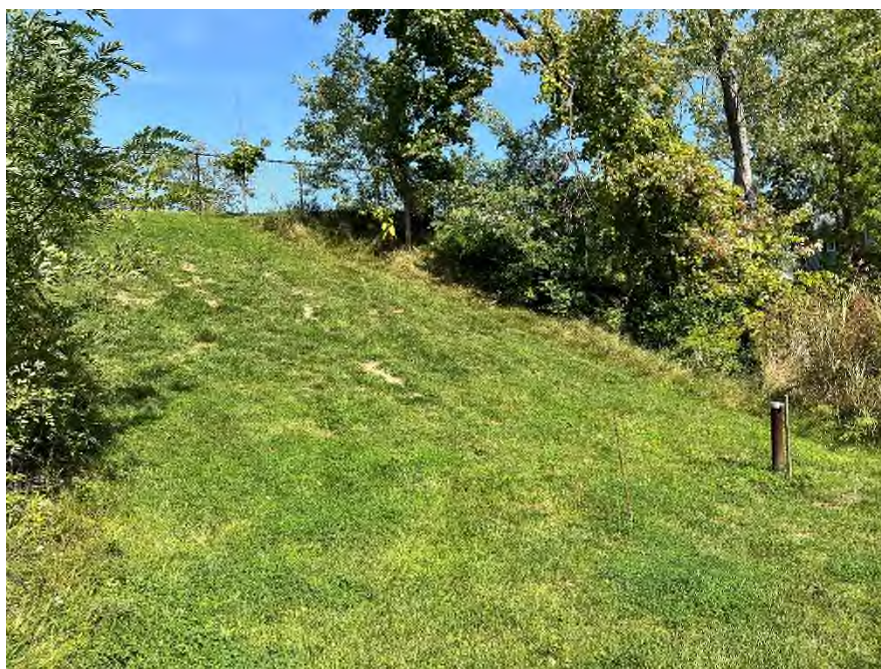
MW-3 towards fence line – Viewing northeast

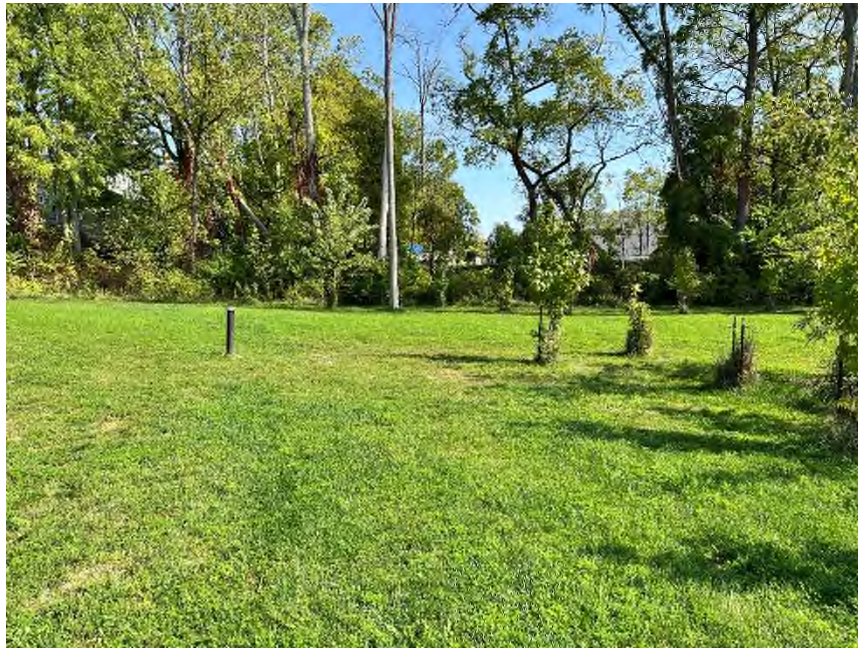
MW-4 towards property line - Viewing east.

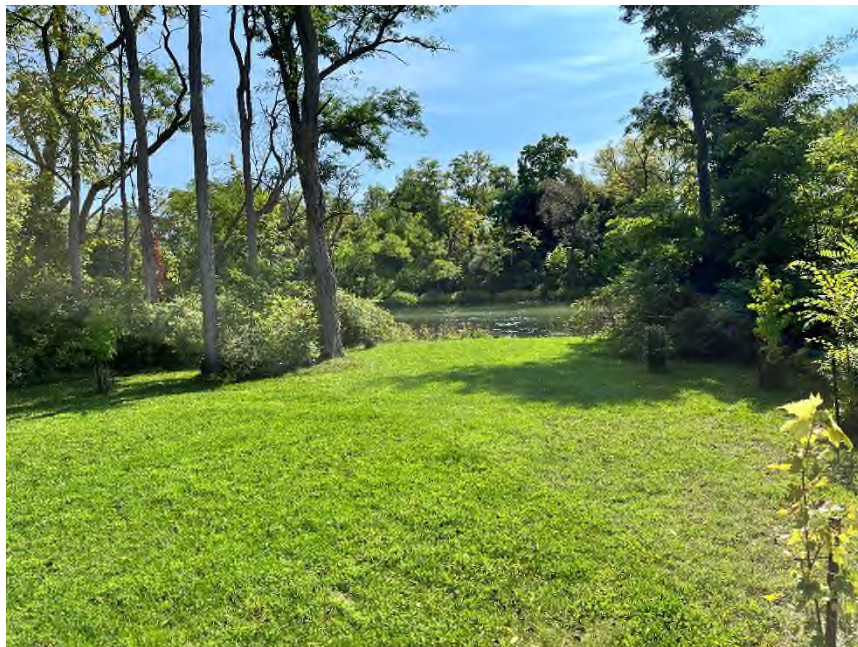
Lowland restoration towards canal – viewing south
