Periodic Review Report

*Urbana Landfill Site
Urbana, New York
NYSDEC Site No. 8-51-007*

July 2013

URBANA LANDFILL SITE
NYSDEC SITE NO. 8-51-007
URBANA, NEW YORK

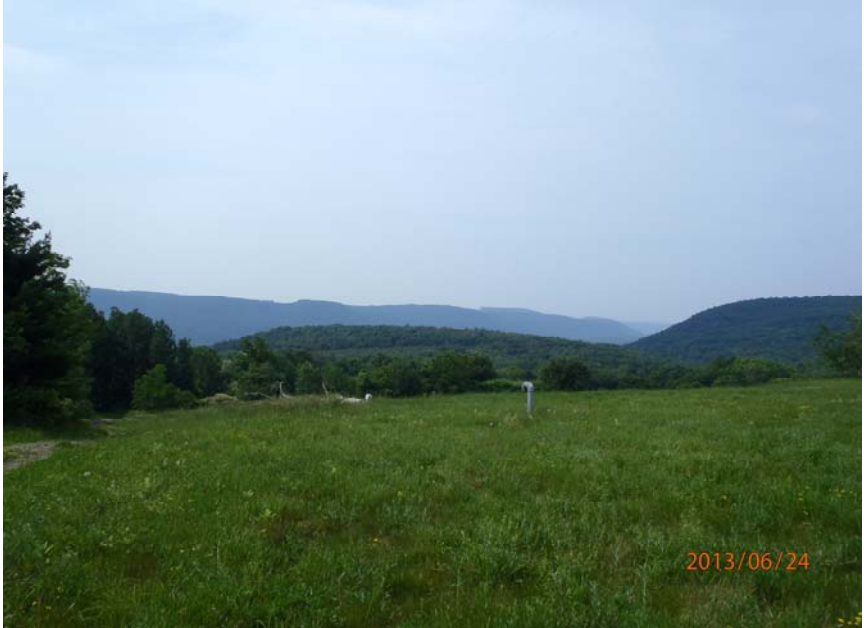
Client Name: Mercury Aircraft, Inc		Site Location: Town of Urbana Landfill- Urbana, New York	Project No.: 0001-001-300
Photo No. 1	Date 06/24/13

Direction Photo Taken: Southwest			
Description: Site Conditions- cover system on upper terrace of landfill area.

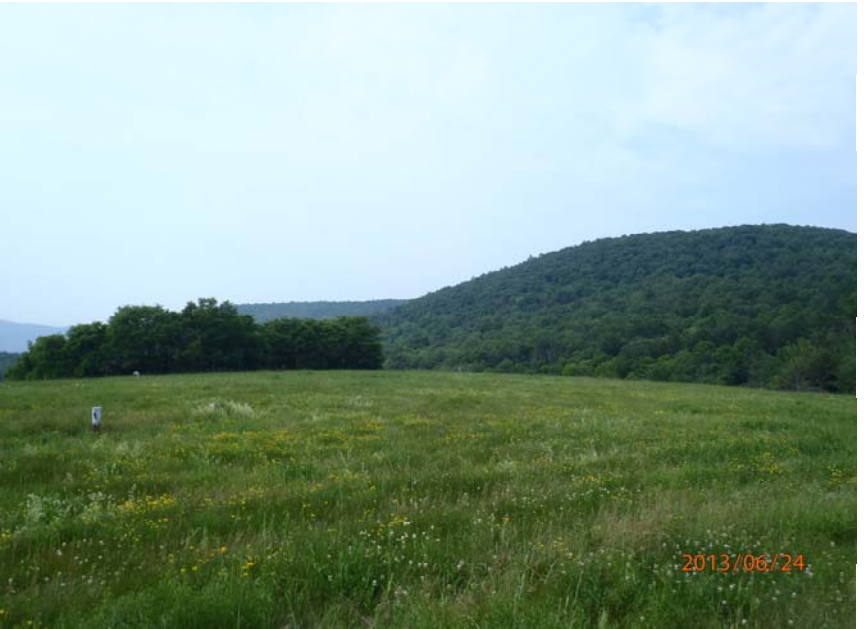
Photo No. 2	Date 06/24/13

Direction Photo Taken: Southwest			
Description: Site Conditions- cover system on upper terrace of landfill area.

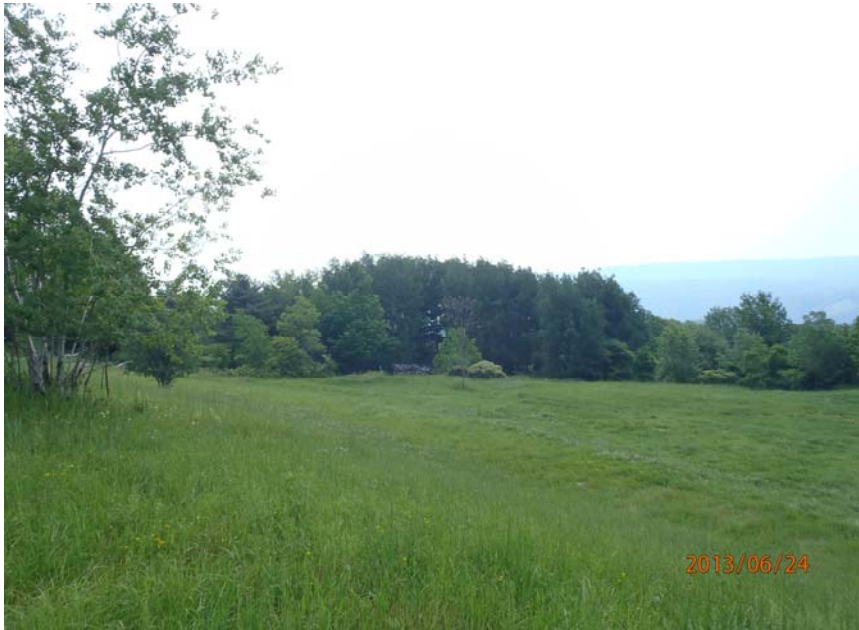
Client Name: Mercury Aircraft, Inc		Site Location: Town of Urbana Landfill- Urbana, New York	Project No.: 0001-001-300
Photo No. 3	Date 06/24/13

Direction Photo Taken: West			
Description: Site Conditions- cover system on middle terrace of landfill area.

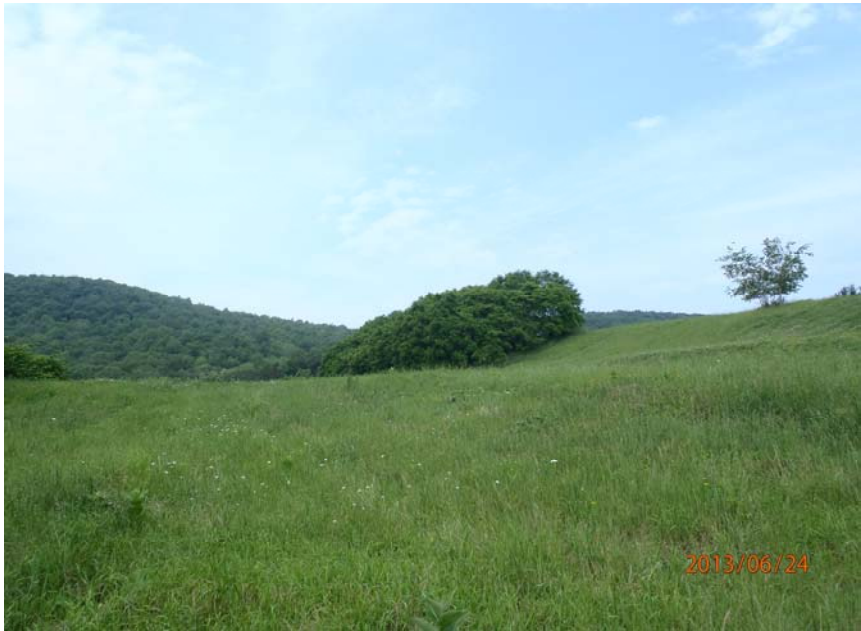
Photo No. 4	Date 06/24/13

Direction Photo Taken: West		
Description: Site Conditions- cover system on middle terrace of landfill area.

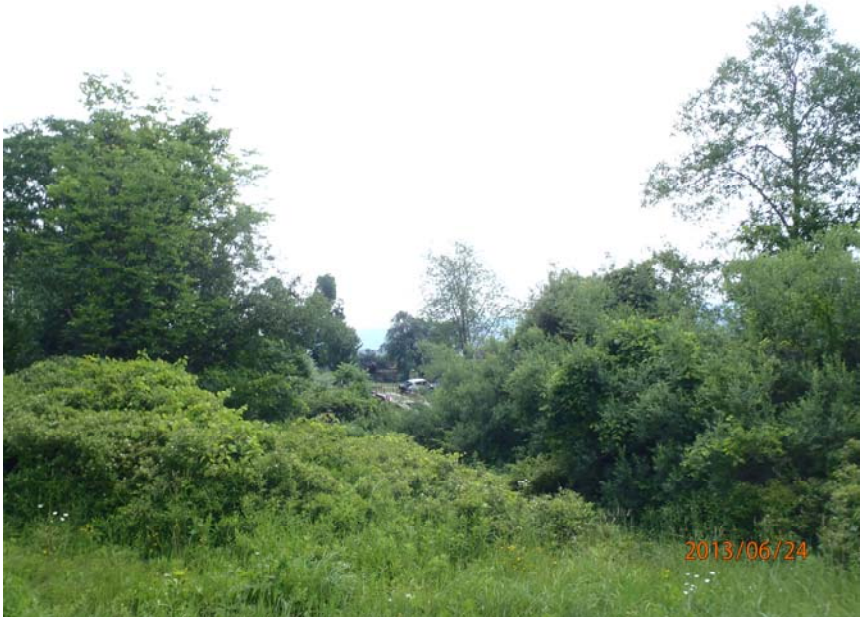
Client Name: Mercury Aircraft, Inc		Site Location: Town of Urbana Landfill- Urbana, New York	Project No.: 0001-001-300
Photo No. 5	Date 06/24/13

Direction Photo Taken: Northeast			
Description: Site Conditions- cover system on lower terrace 2 of landfill area.

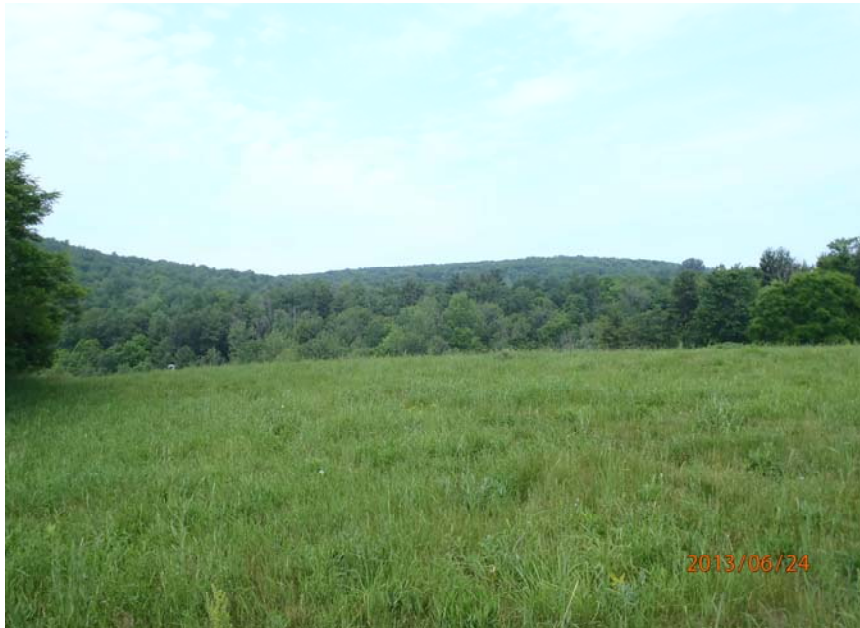
Photo No. 6	Date 06/24/13

Direction Photo Taken: North		
Description: Site Conditions- cover system on lower terrace 1 of landfill area.

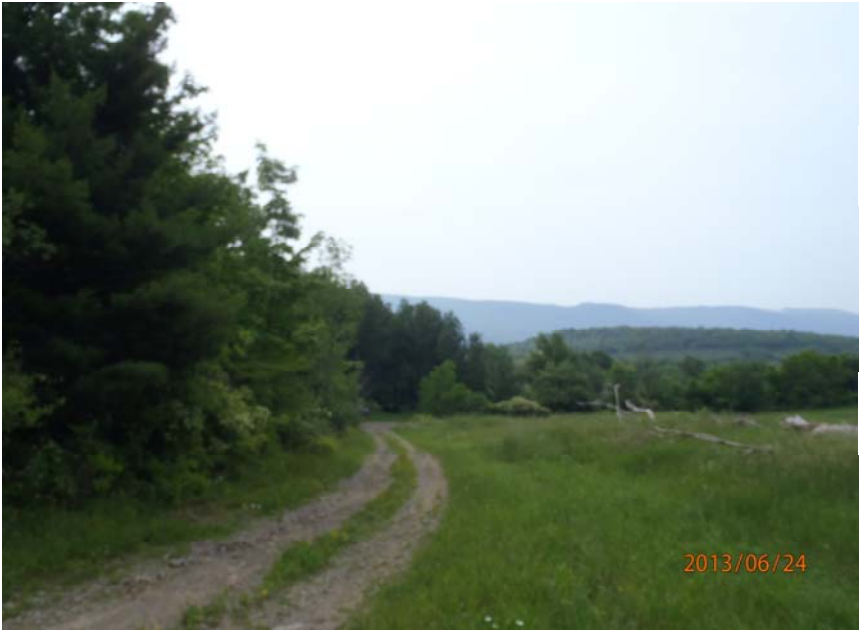
Client Name: Mercury Aircraft, Inc		Site Location: Town of Urbana Landfill- Urbana, New York	Project No.: 0001-001-300
Photo No. 7	Date 06/24/13

Direction Photo Taken: West			
Description: Site Conditions - Landfill access road.

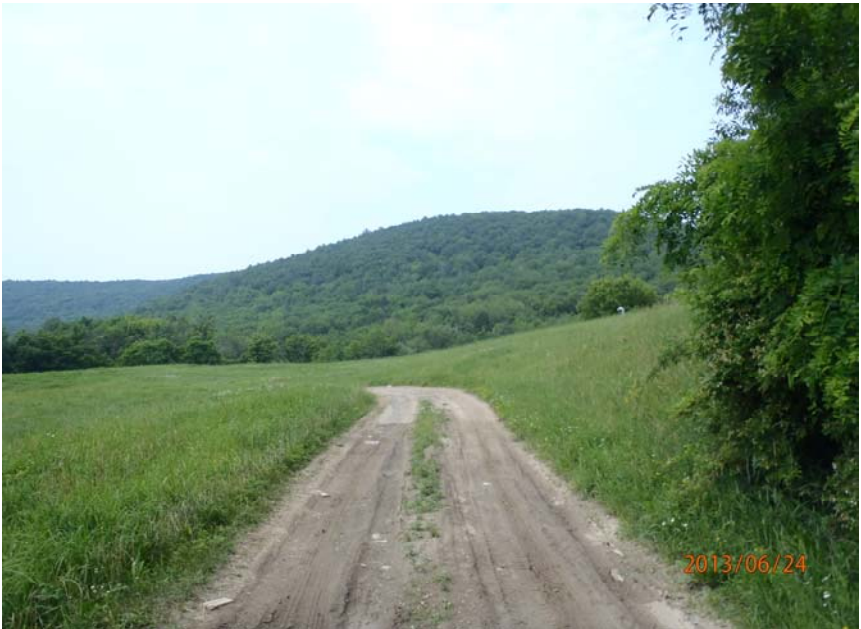
Photo No. 8	Date 06/24/13

Direction Photo Taken: North			
Description: Site Conditions - Landfill access road.

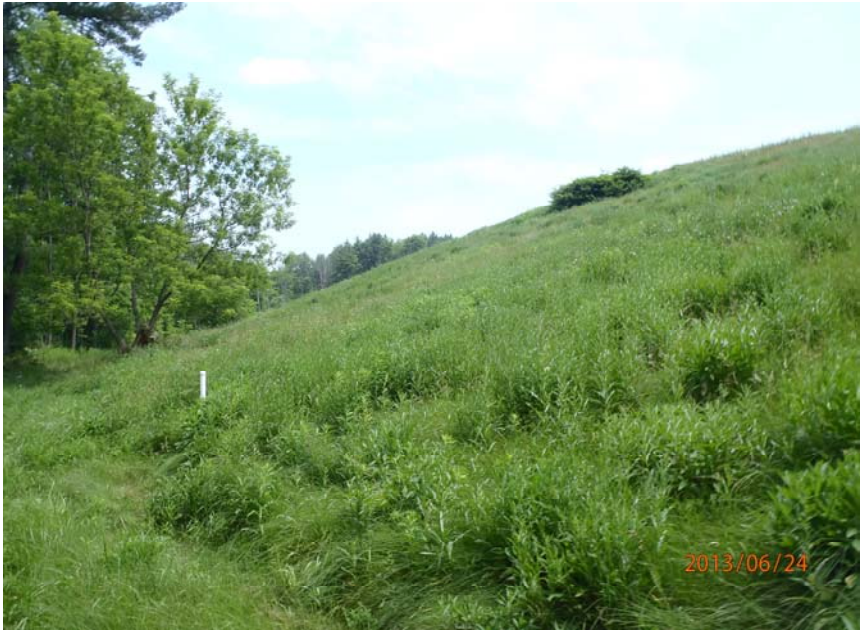
Client Name: Mercury Aircraft, Inc		Site Location: Town of Urbana Landfill- Urbana, New York	Project No.: 0001-001-300
Photo No. 9	Date 06/24/13

Direction Photo Taken: North			
Description: Site Conditions- cover system on western terrace of landfill area.

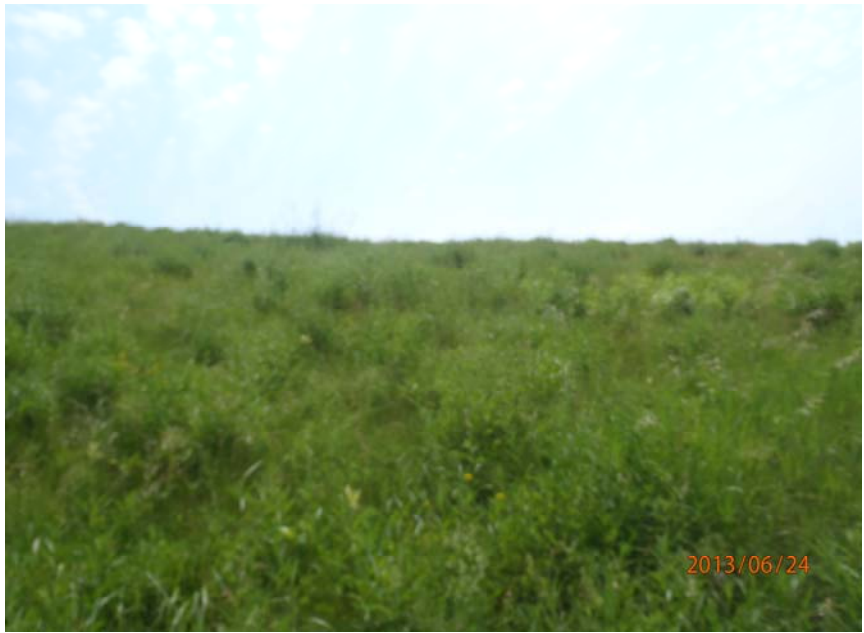
Photo No. 10	Date 06/24/13

Direction Photo Taken: North		
Description: Site Conditions- cover system on western terrace of landfill area.

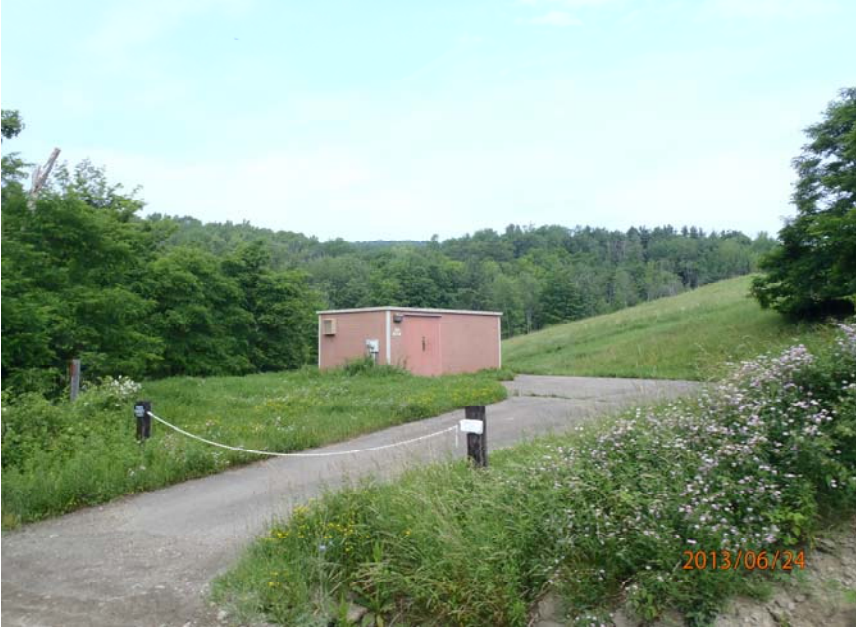
Client Name: Mercury Aircraft, Inc		Site Location: Town of Urbana Landfill- Urbana, New York	Project No.: 0001-001-300
Photo No. 11	Date 06/24/13

Direction Photo Taken: Northwest			
Description: Site Conditions- Groundwater Treatment System Building.
