# Periodic Review Report

*Urbana Landfill Site  
Urbana, New York  
NYSDEC Site No. 8-51-007*

July 2014  
Revised October 2014

Benchmark Environmental Engineering & Science, PLLC  
2558 Hamburg Turnpike, Suite 300  
Buffalo, NY 14218  
(716)856-0599

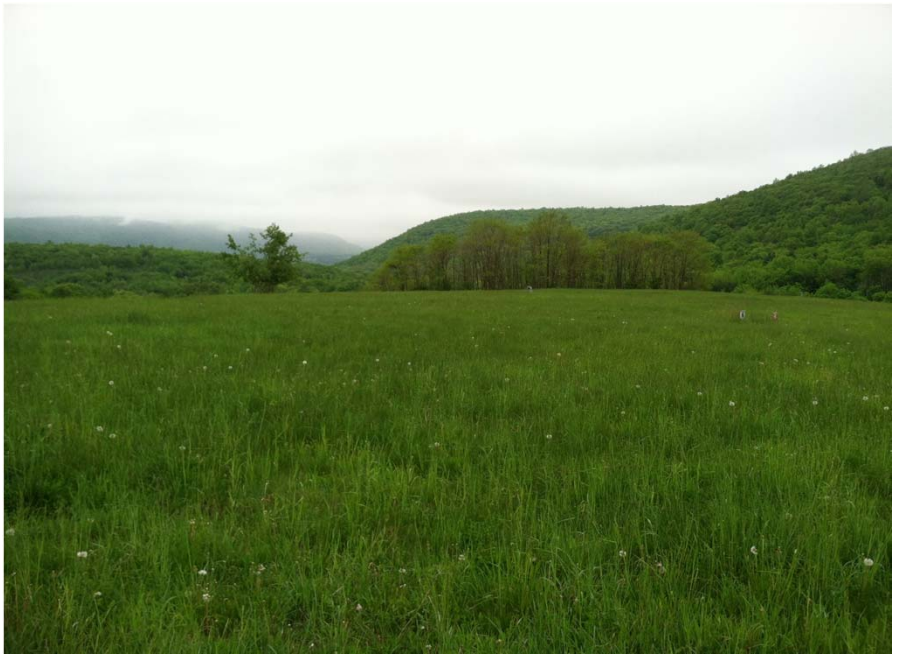
| <b>Photo No.</b><br>1 | <b>Date</b><br>05/29/14 | | |

| <b>Description:</b><br>Site Conditions- cover system on upper terrace of landfill area. | | | |

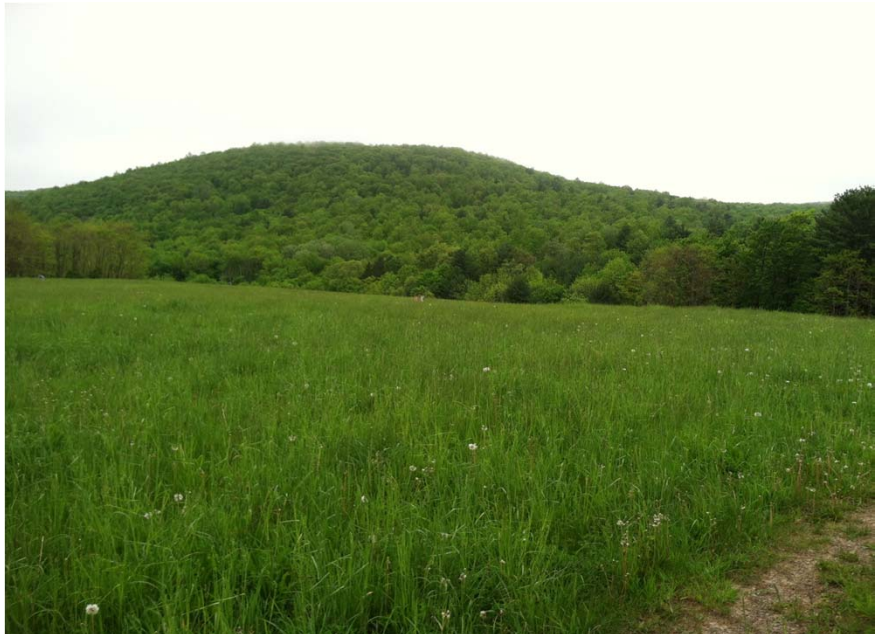
| <b>Photo No.</b><br>2 | <b>Date</b><br>05/29/14 | |

| <b>Description:</b><br>Site Conditions- cover system on upper terrace of landfill area. | | |

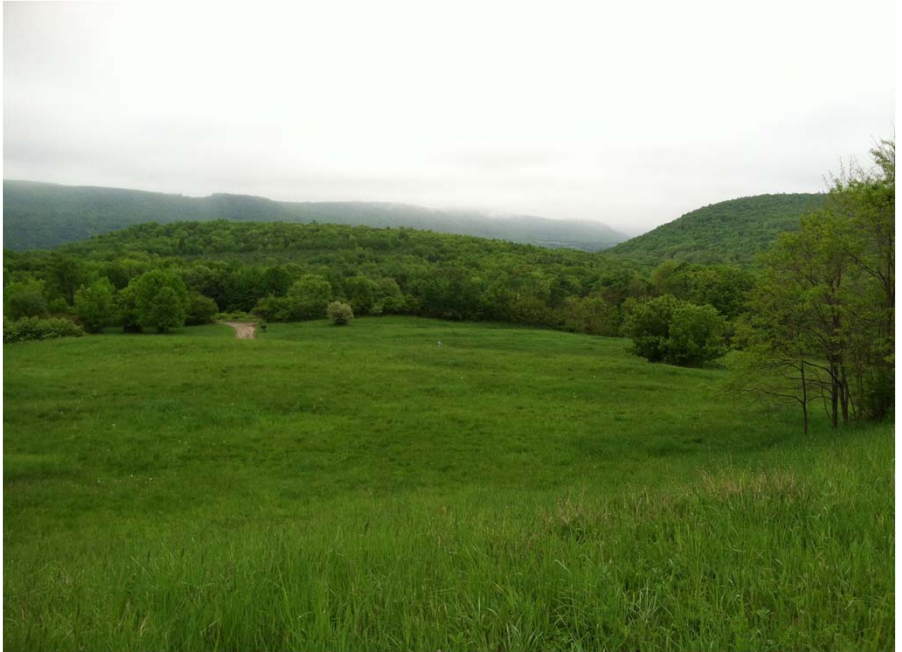
| <b>Photo No.</b><br>3 | <b>Date</b><br>05/29/14 | | |

| <b>Description:</b><br>Site Conditions- cover system on middle terrace of landfill area. | | | |

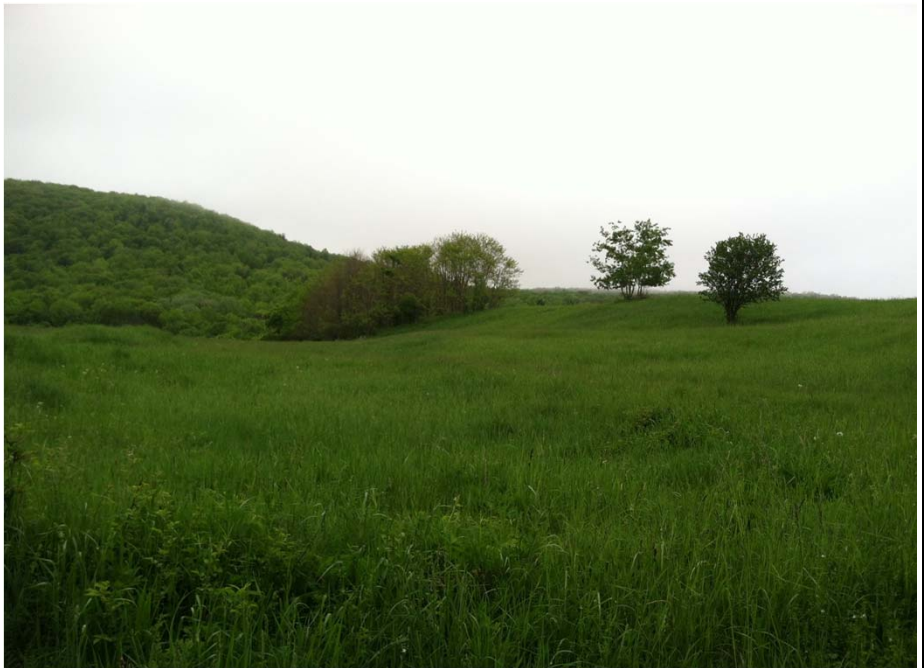
| <b>Photo No.</b><br>4 | <b>Date</b><br>05/29/14 | |

| <b>Description:</b><br>Site Conditions- cover system on middle terrace of landfill area. | | |

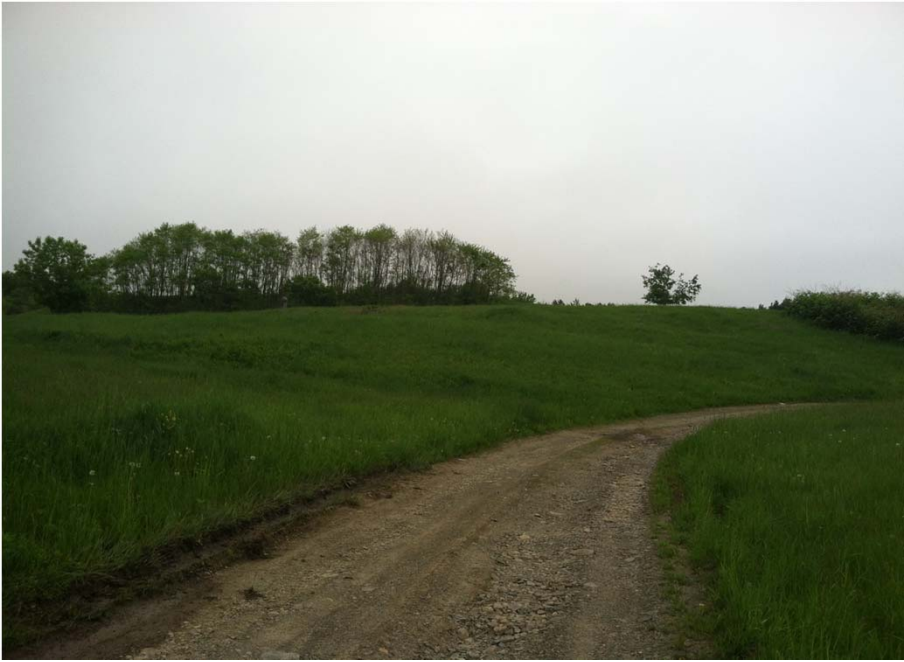
| <b>Photo No.</b><br>5 | <b>Date</b><br>05/29/14 | | |

| <b>Description:</b><br>Site Conditions- cover system on lower terrace 2 of landfill area. | | | |

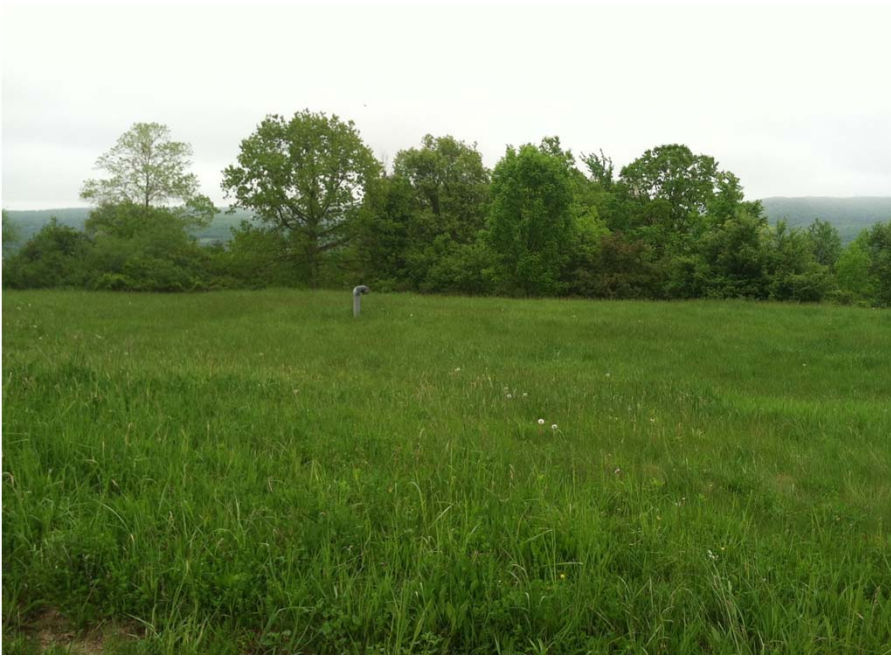
| <b>Photo No.</b><br>6 | <b>Date</b><br>05/29/14 | |

| <b>Description:</b><br>Site Conditions- cover system on lower terrace 1 of landfill area. | | |

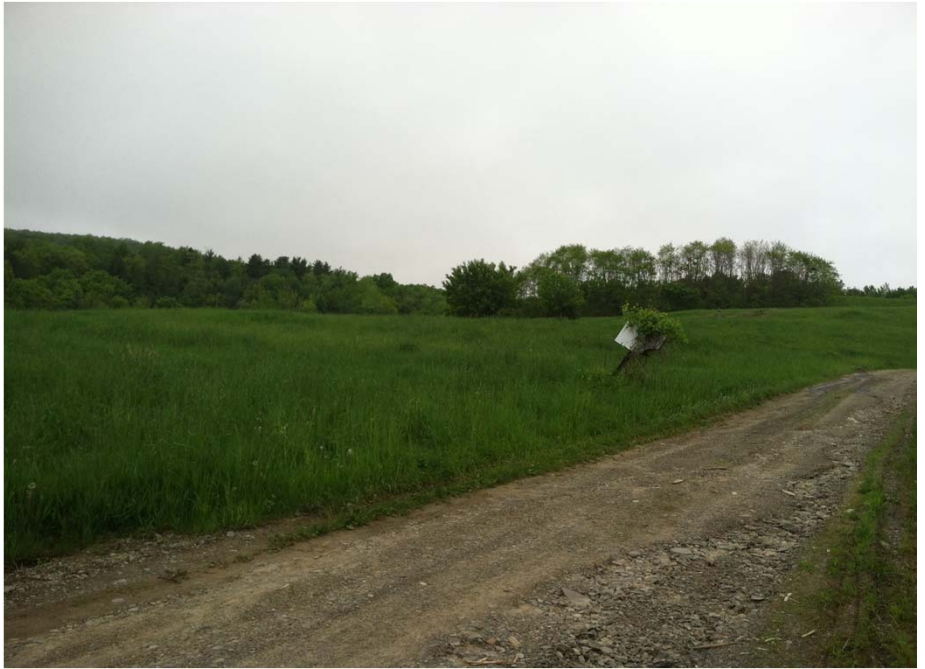
| <b>Photo No.</b><br>7 | <b>Date</b><br>05/29/14 | | |

| <b>Description:</b><br>Site Conditions - Landfill access road. | | | |

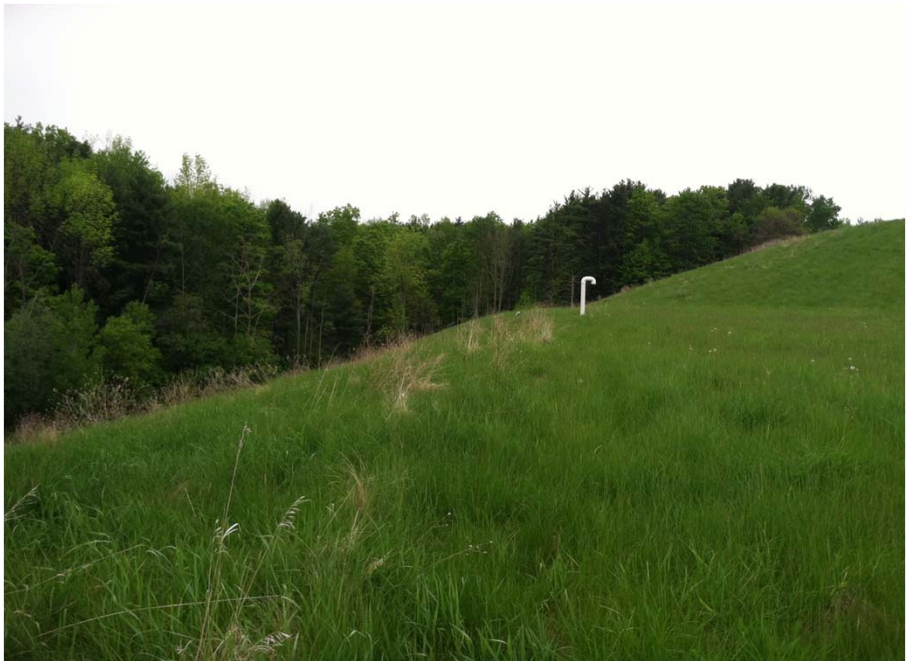
| <b>Photo No.</b><br>8 | <b>Date</b><br>05/29/14 | |

| <b>Description:</b><br>Site Conditions- cover system on western terrace of landfill area. | | |

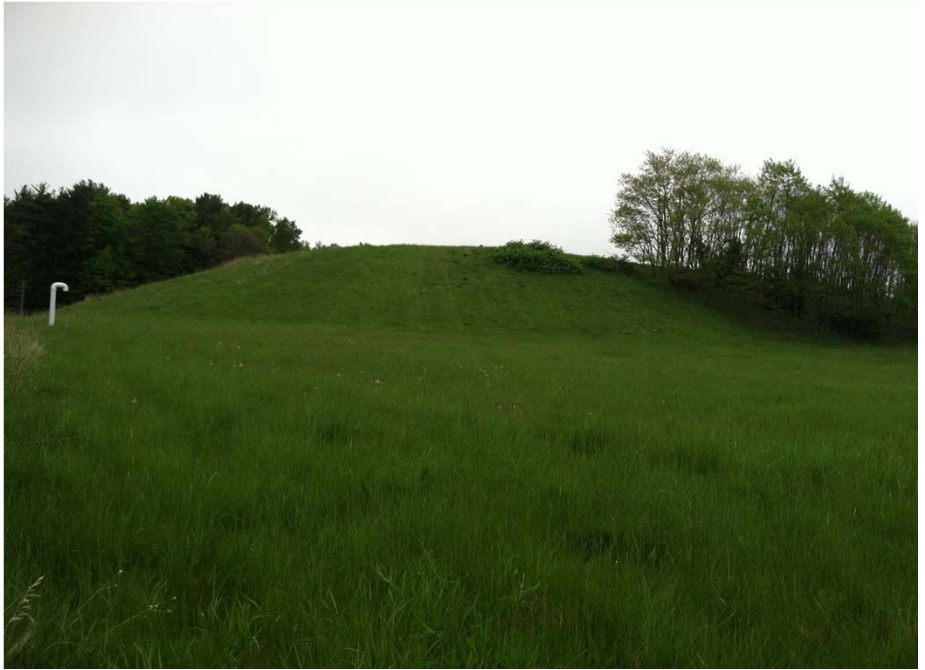
| <b>Photo No.</b><br>9 | <b>Date</b><br>05/29/14 | | |

| <b>Description:</b><br>Site Conditions- cover system on western terrace of landfill area. | | | |

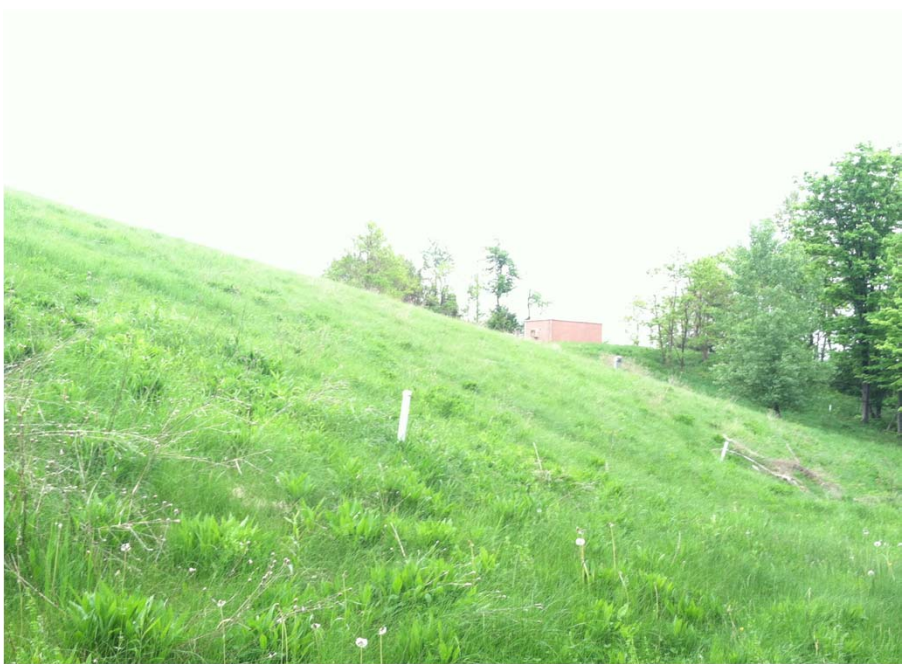
| <b>Photo No.</b><br>10 | <b>Date</b><br>05/29/14 | |

| <b>Description:</b><br>Site Conditions- cover system on western terrace of landfill area. | | |

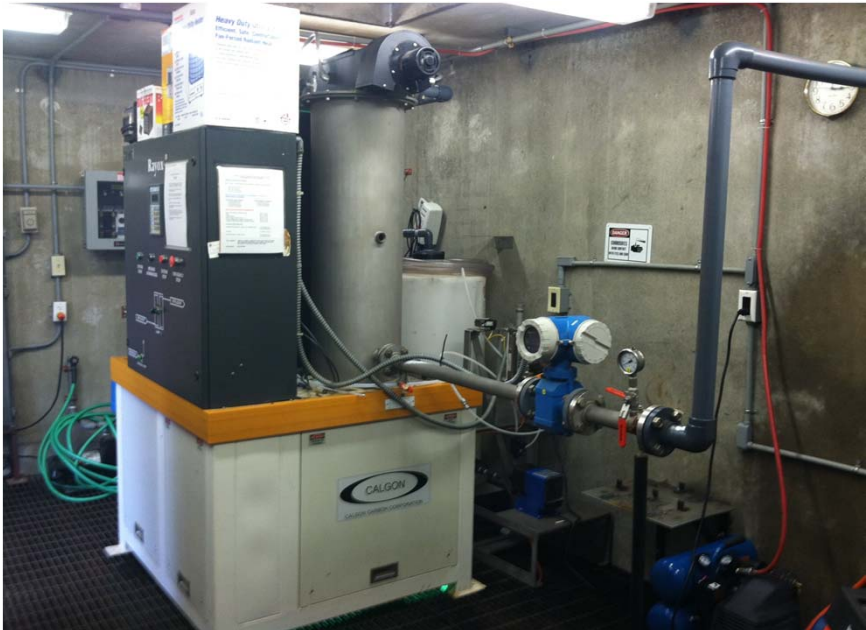
| <b>Photo No.</b><br>11 | <b>Date</b><br>05/29/14 | | |

| <b>Description:</b><br>Site Conditions- Groundwater Treatment System. | | | |

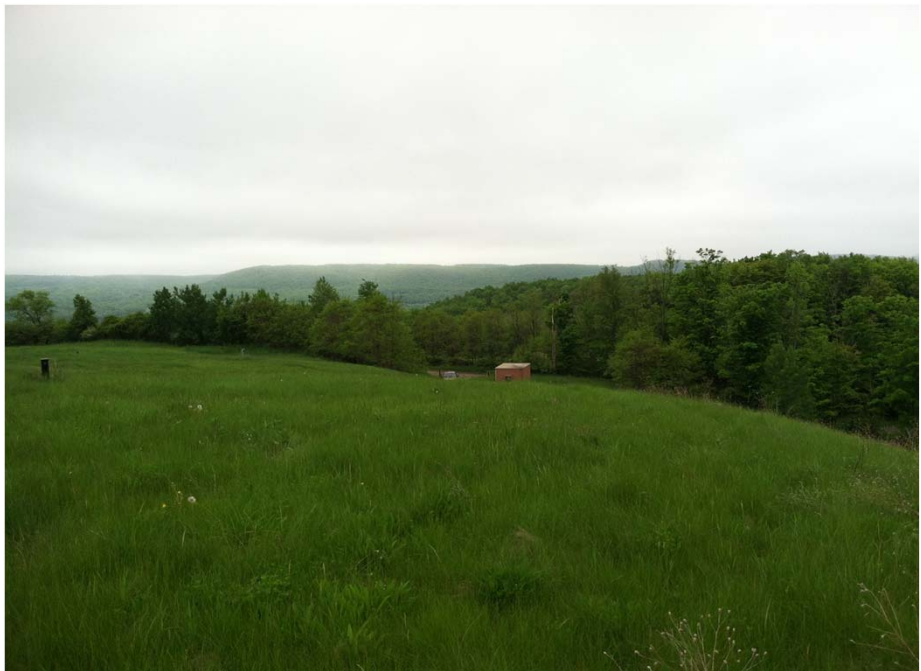
| <b>Photo No.</b><br>12 | <b>Date</b><br>05/29/14 | |

| <b>Description:</b><br>Site Conditions- Groundwater Treatment System Building. | | |
