Periodic Review Report

*Urbana Landfill Site
Urbana, New York
NYSDEC Site No. 8-51-007*

July 2015

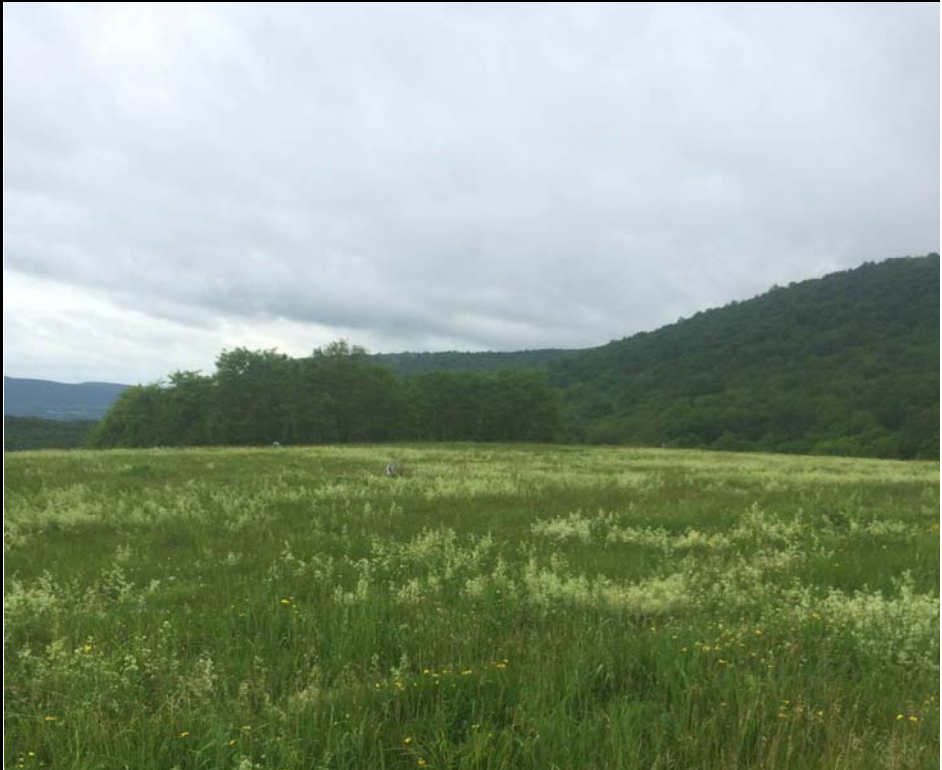
Client Name: Mercury Aircraft, Inc		Site Location: Town of Urbana Landfill- Urbana, New York	Project No.: 0001-001-300
Photo No. 1	Date 06/16/15

Direction Photo Taken: Southwest			
Description: Site Conditions- cover system on upper terrace of landfill area.

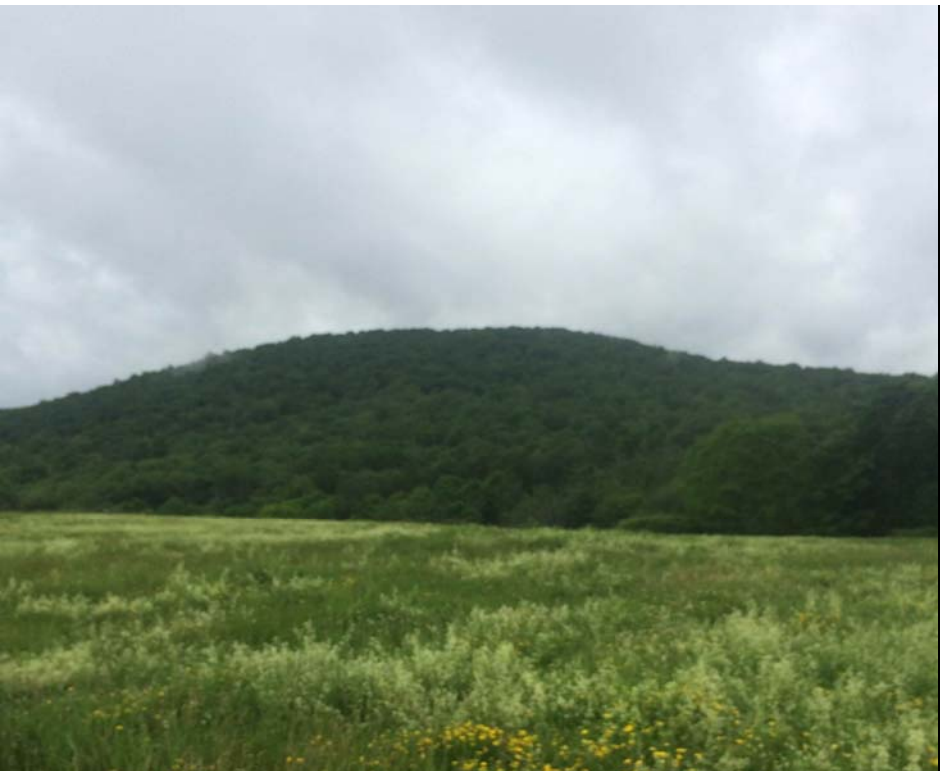
Photo No. 2	Date 06/16/15

Direction Photo Taken: West		
Description: Site Conditions- cover system on upper terrace of landfill area.

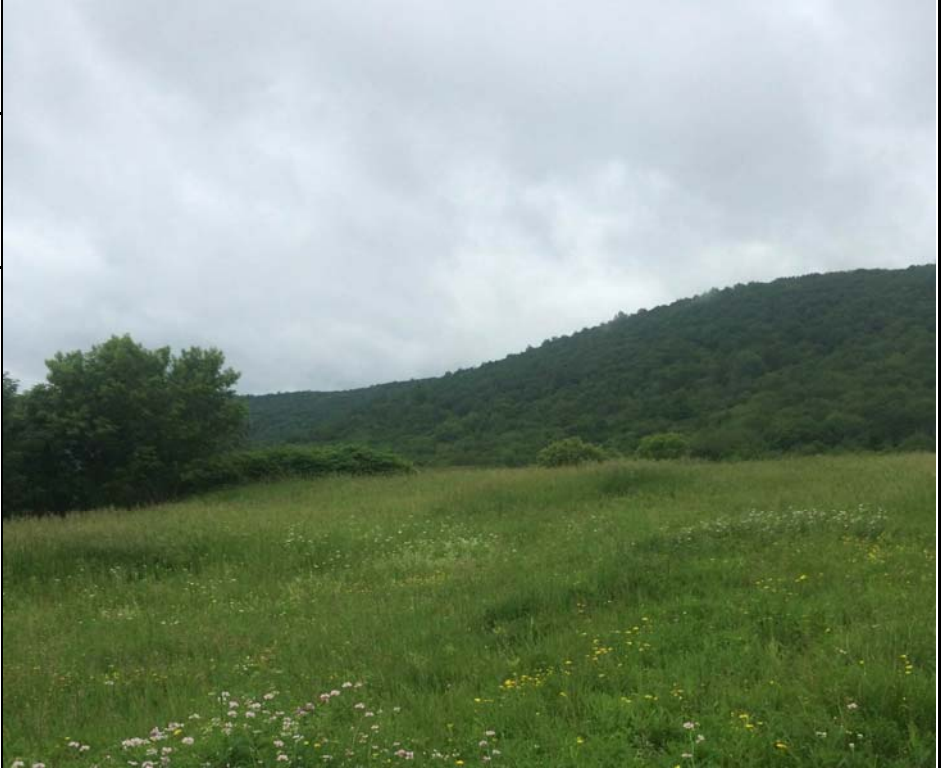
Client Name: Mercury Aircraft, Inc		Site Location: Town of Urbana Landfill- Urbana, New York	Project No.: 0001-001-300
Photo No. 3	Date 06/16/15

Direction Photo Taken: West			
Description: Site Conditions- cover system on middle terrace of landfill area.

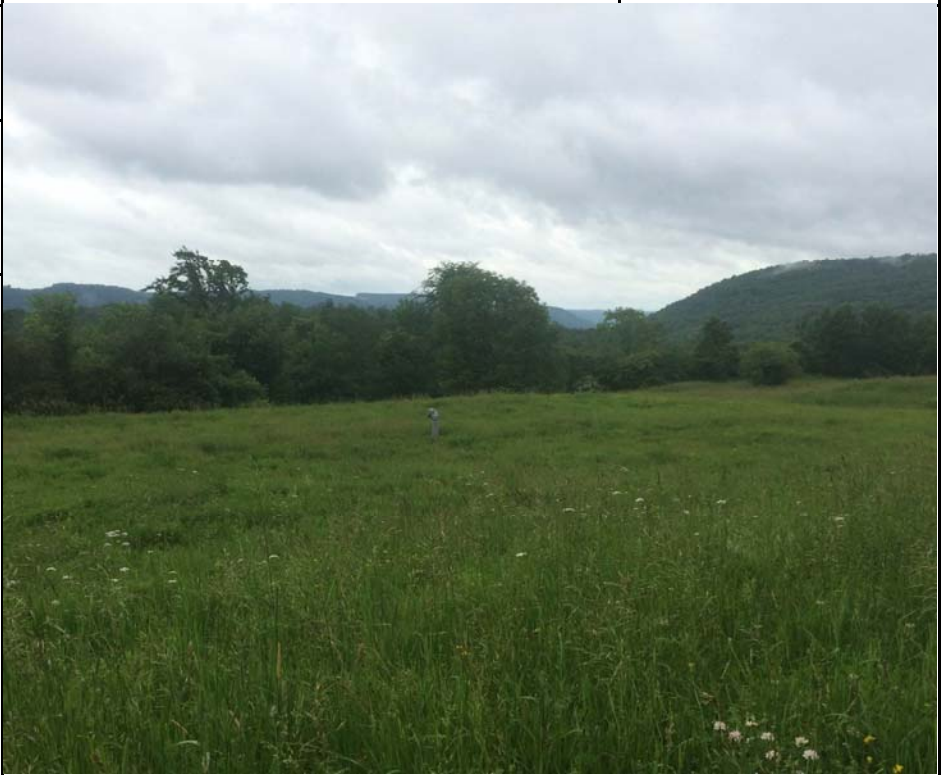
Client Name: Mercury Aircraft, Inc		Site Location: Town of Urbana Landfill- Urbana, New York	Project No.: 0001-001-300
Photo No. 5	Date 06/16/15

Direction Photo Taken: South			
Description: Site Conditions- cover system on lower terrace 2 of landfill area.

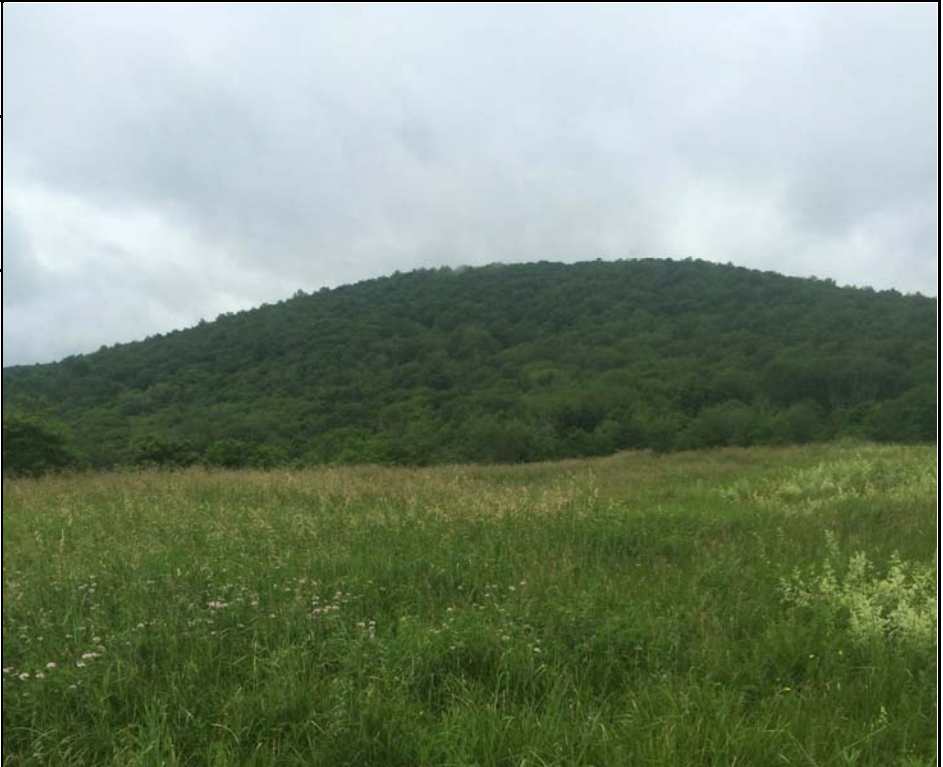
Photo No. 6	Date 06/16/15

Direction Photo Taken: West		
Description: Site Conditions- cover system on lower terrace 1 of landfill area.

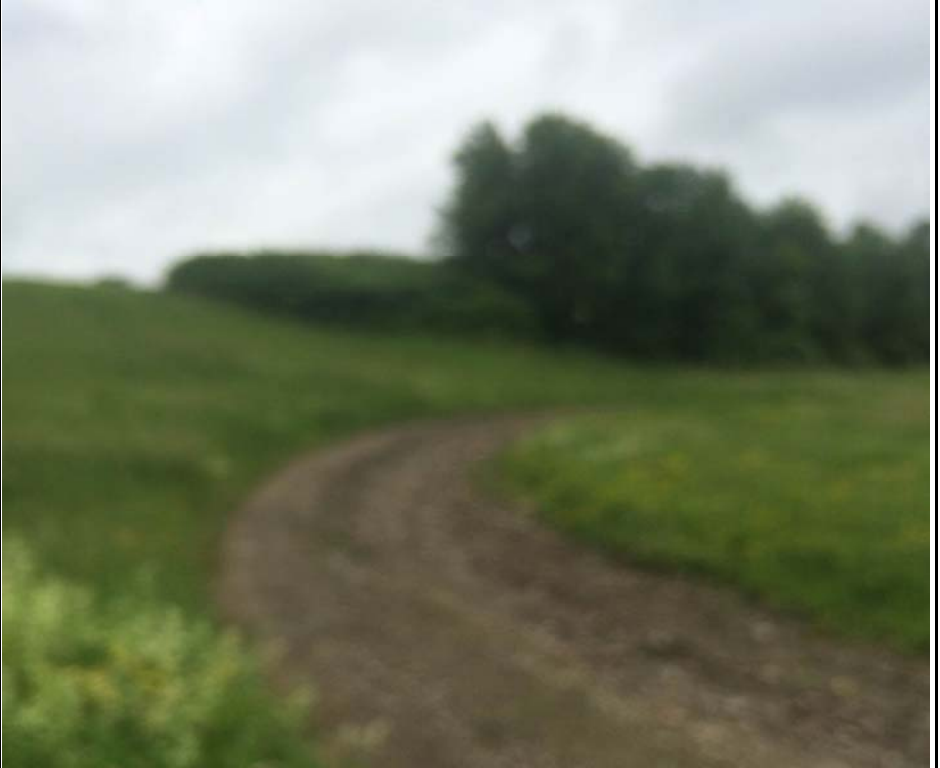
Client Name: Mercury Aircraft, Inc		Site Location: Town of Urbana Landfill- Urbana, New York	Project No.: 0001-001-300
Photo No. 7	Date 06/16/15

Direction Photo Taken: North/Northeast			
Description: Site Conditions - Landfill access road.

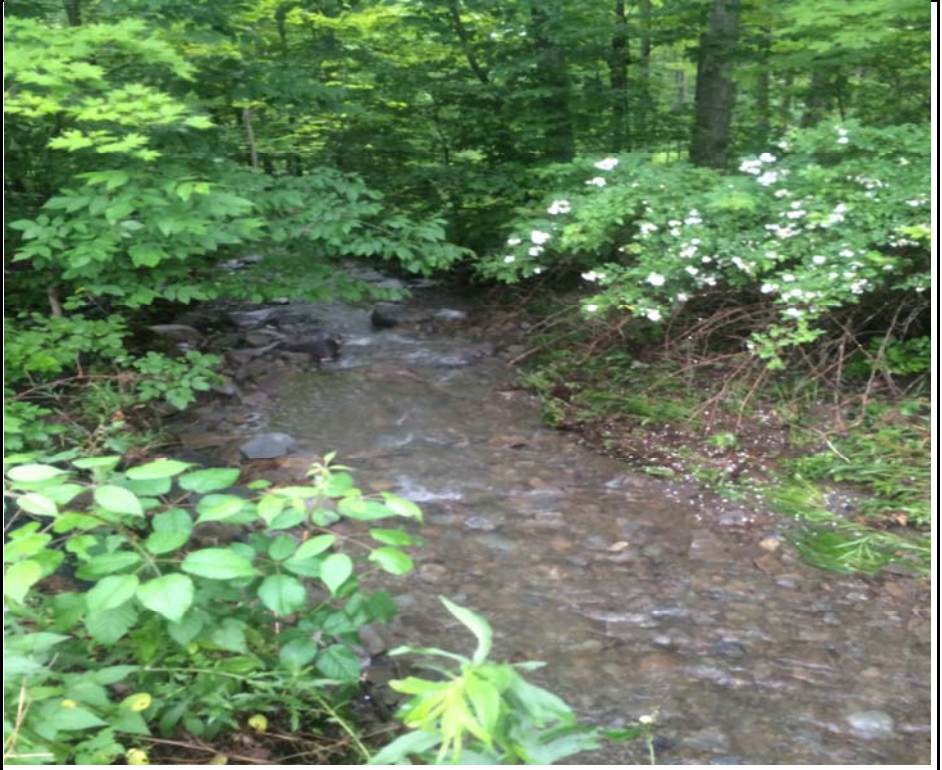
Client Name: Mercury Aircraft, Inc		Site Location: Town of Urbana Landfill- Urbana, New York	Project No.: 0001-001-300
Photo No. 9	Date 06/16/15

Similar to the cover system, inspection of the stream bank stabilization was performed on June 16th 2014. The inspection indicated that vegetation has grown into the riprap and stone bedding (as expected), but no encroachment of the stream toward the landfill has occurred.

Direction Photo Taken: South/ Southwest			
Description: Stabilized creek
