**CONSTRUCTION COMPLETION REPORT
SOIL VAPOR EXTRACTION IRM
LOOHNS CORNING SITE
SITE # 851028**

WORK ASSIGNMENT NO. D004434-35

**MACTEC Engineering and Consulting, PC
Portland, Maine**

MAY 2012

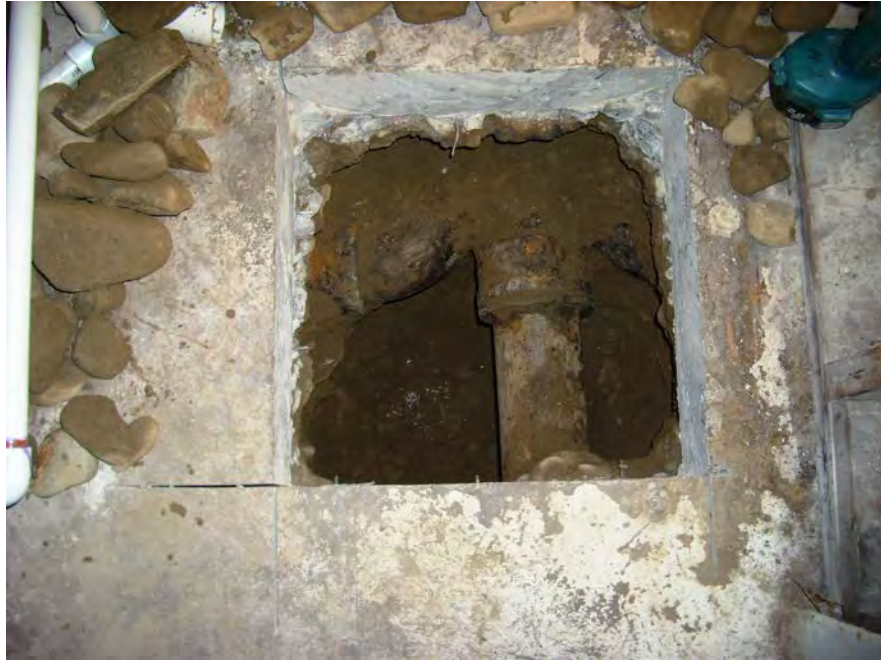
SVE Floor Cut Opening

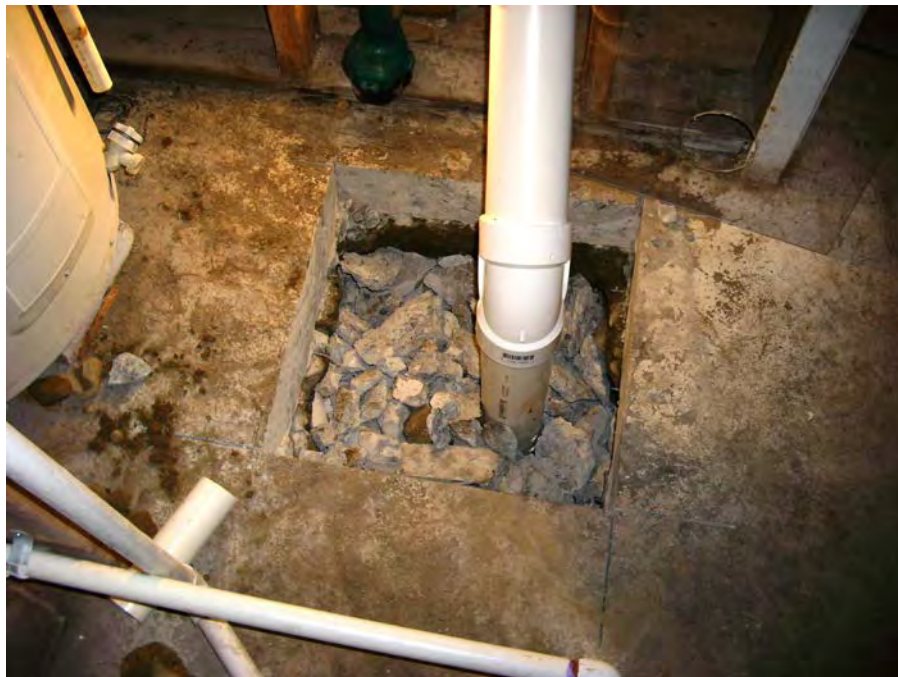
SVE Riser with Stone Fill

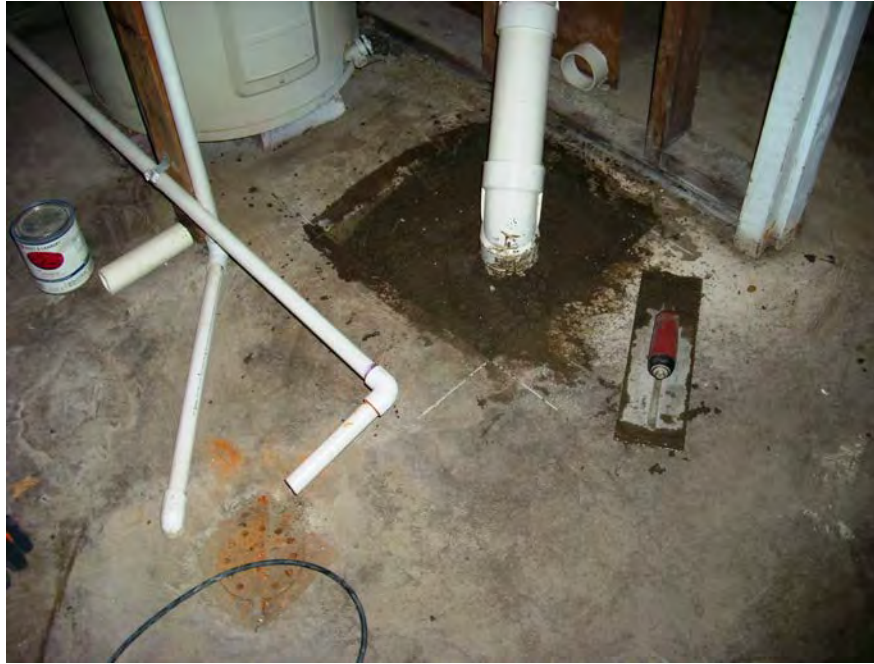
SVE Riser with Grout Seal

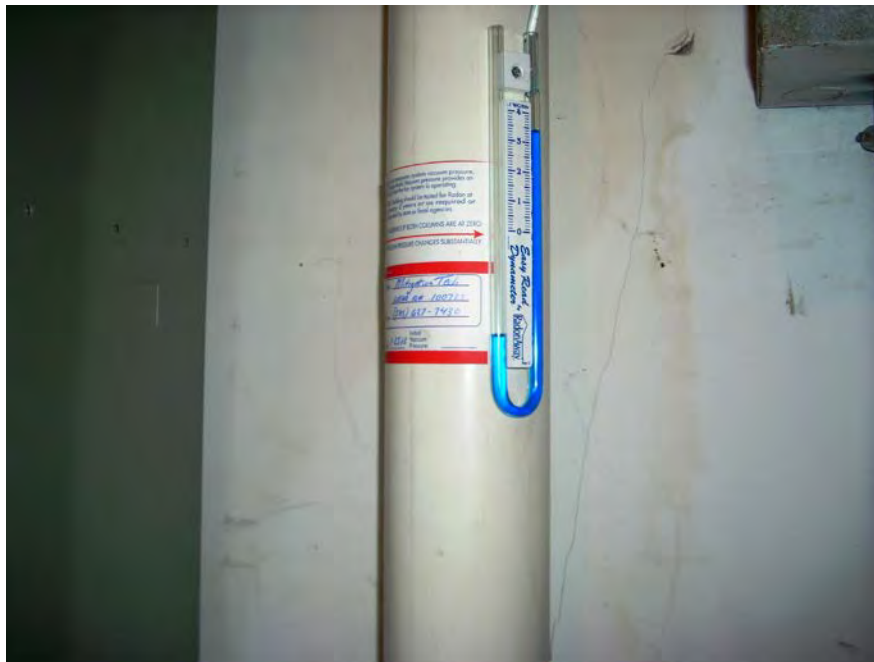
The manometer reading at the suction point was 3.5”wci.

Installed Manometer

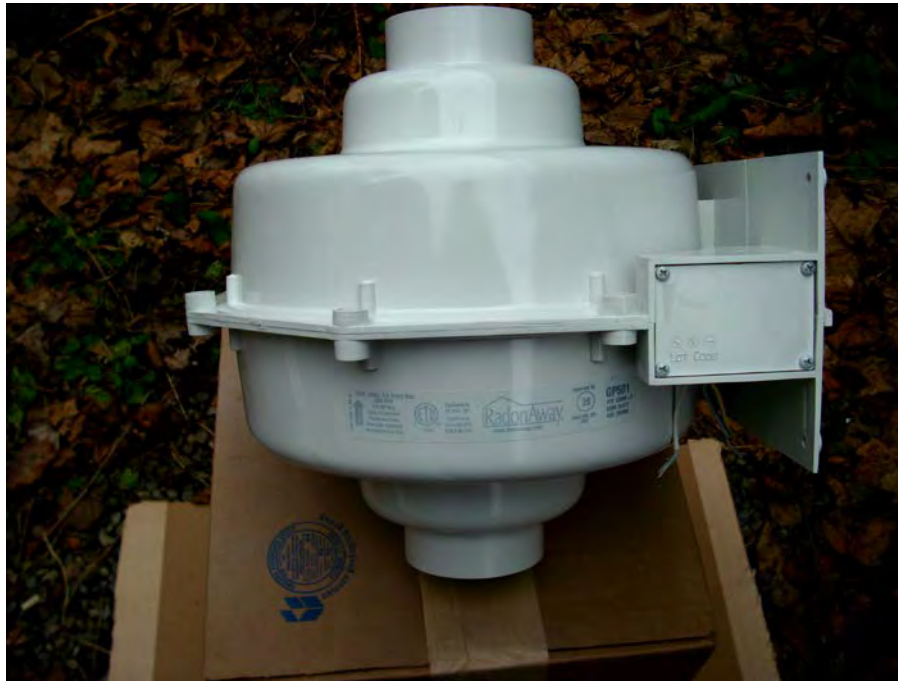
Radonaway GP501 Fan

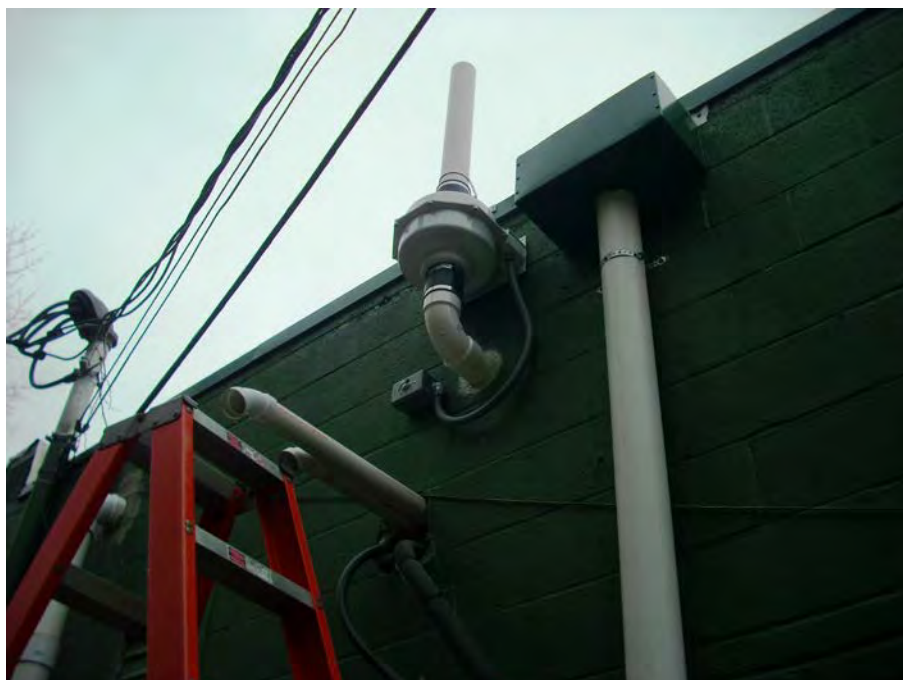
Installed Fan Exterior

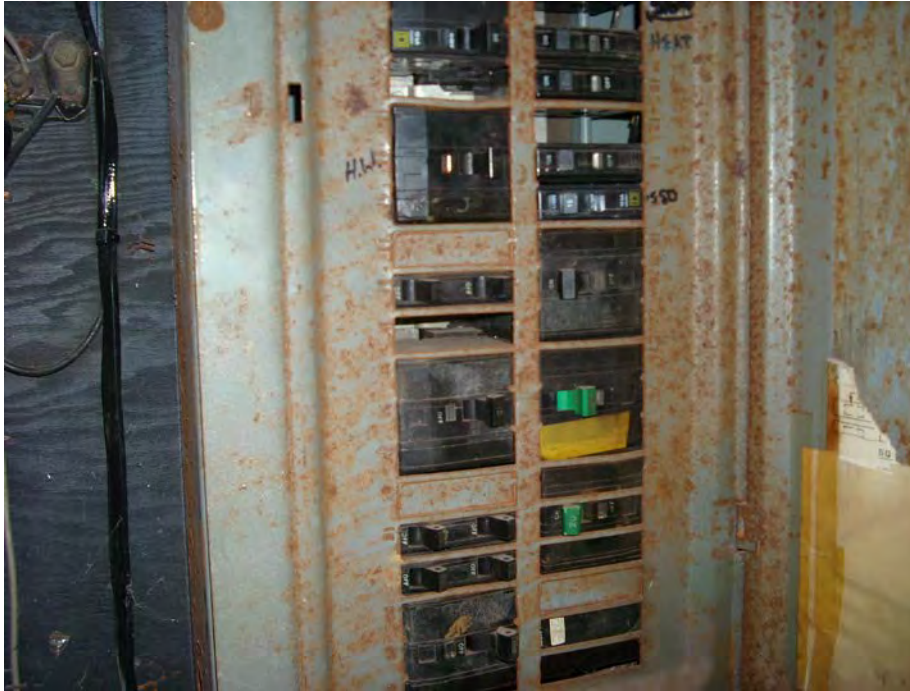
Electrical Panel with SVE Breaker Marked
