VOLUME I OF II
SITE CHARACTERIZATION
REPORT

124 VICTORY HIGHWAY
PAINTED POST, NEW YORK

August 2009

PALMERTON GROUP
Environmental Consulting Services
6296 Fly Road, East Syracuse, New York 13057

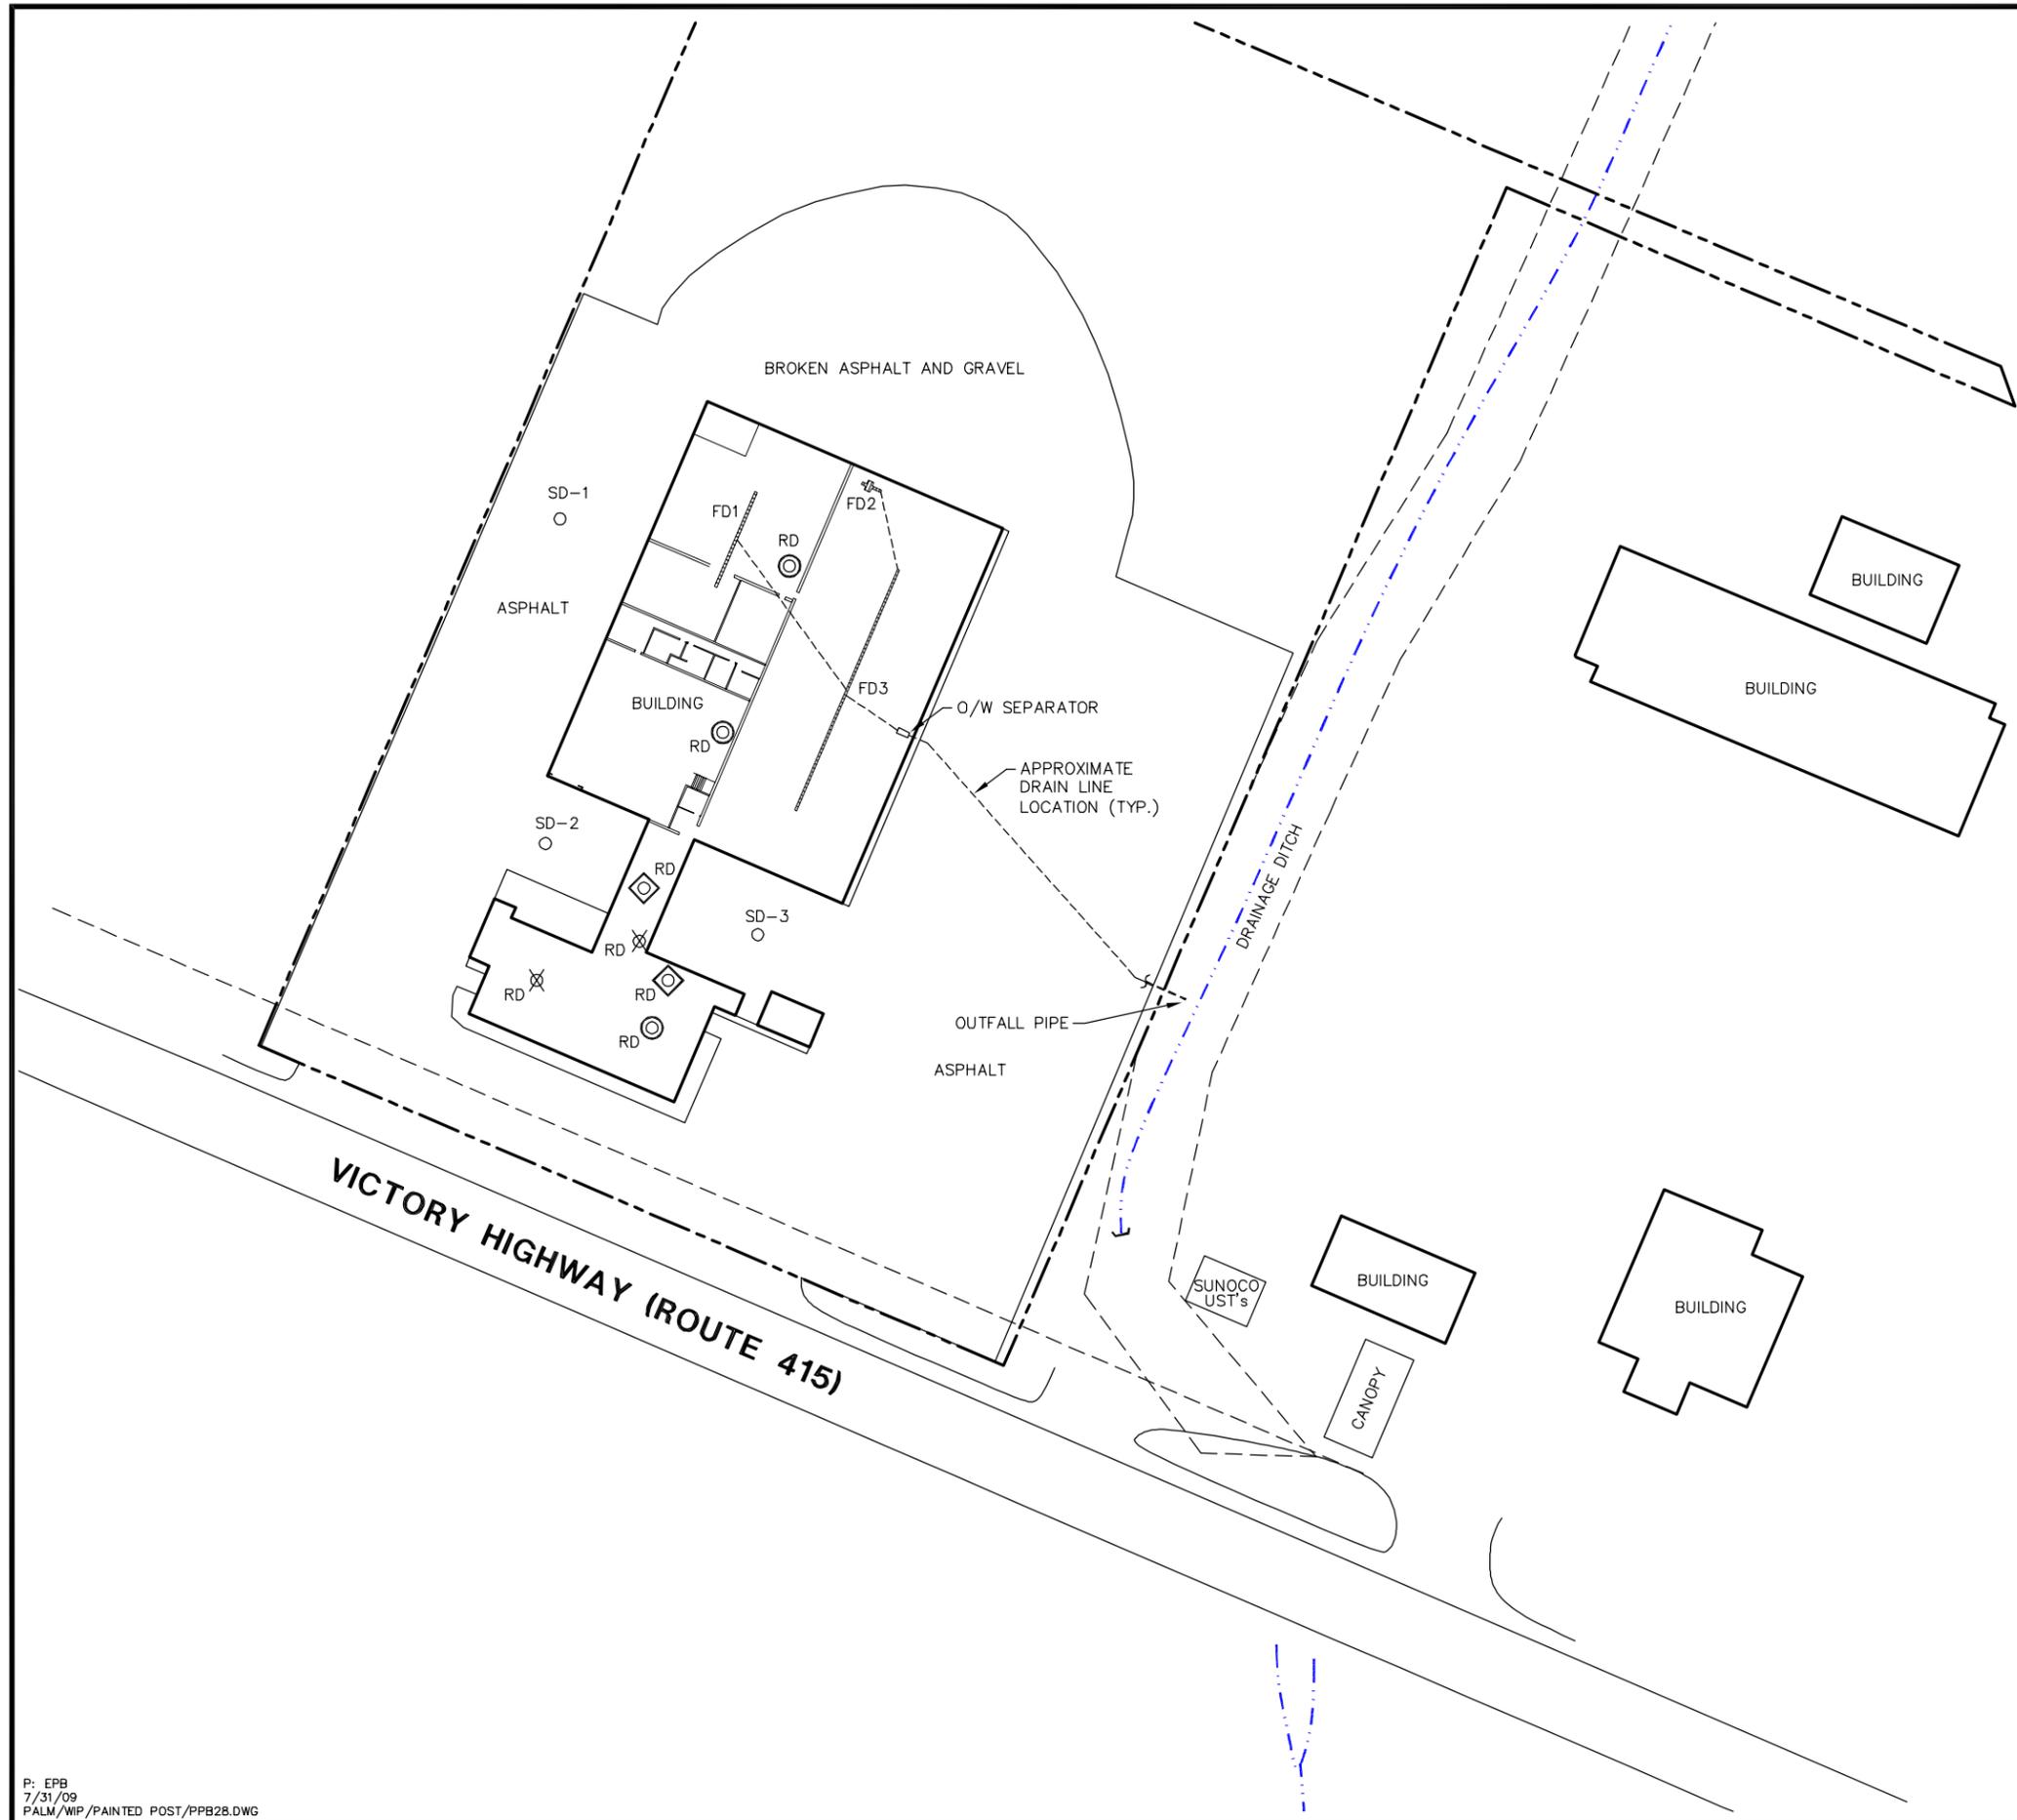
FIGURE
6

The exterior drainage system consists of two parts, the building roof drains and the three parking lot area surface drains (see Figure 6). To investigate the roof drains, water was first introduced through garden hose to the two roof drains in the northern portion of the roof while at the same time observations were made of the septic collection tank and the drainage outfall pipe in the drainage ditch. After a few minutes of pumping water, clear water was observed to run into the drainage ditch.

- All of the interior sumps were found to have been connected at one time (currently plugged), ultimately leading to an oil-water separator which was found to have been connected to an exterior drain pipe and outfall at the drainage ditch along the eastern property boundary.
- The parking lot surface drains were determined to be dry wells and not connected to each other or any off-site drainage.

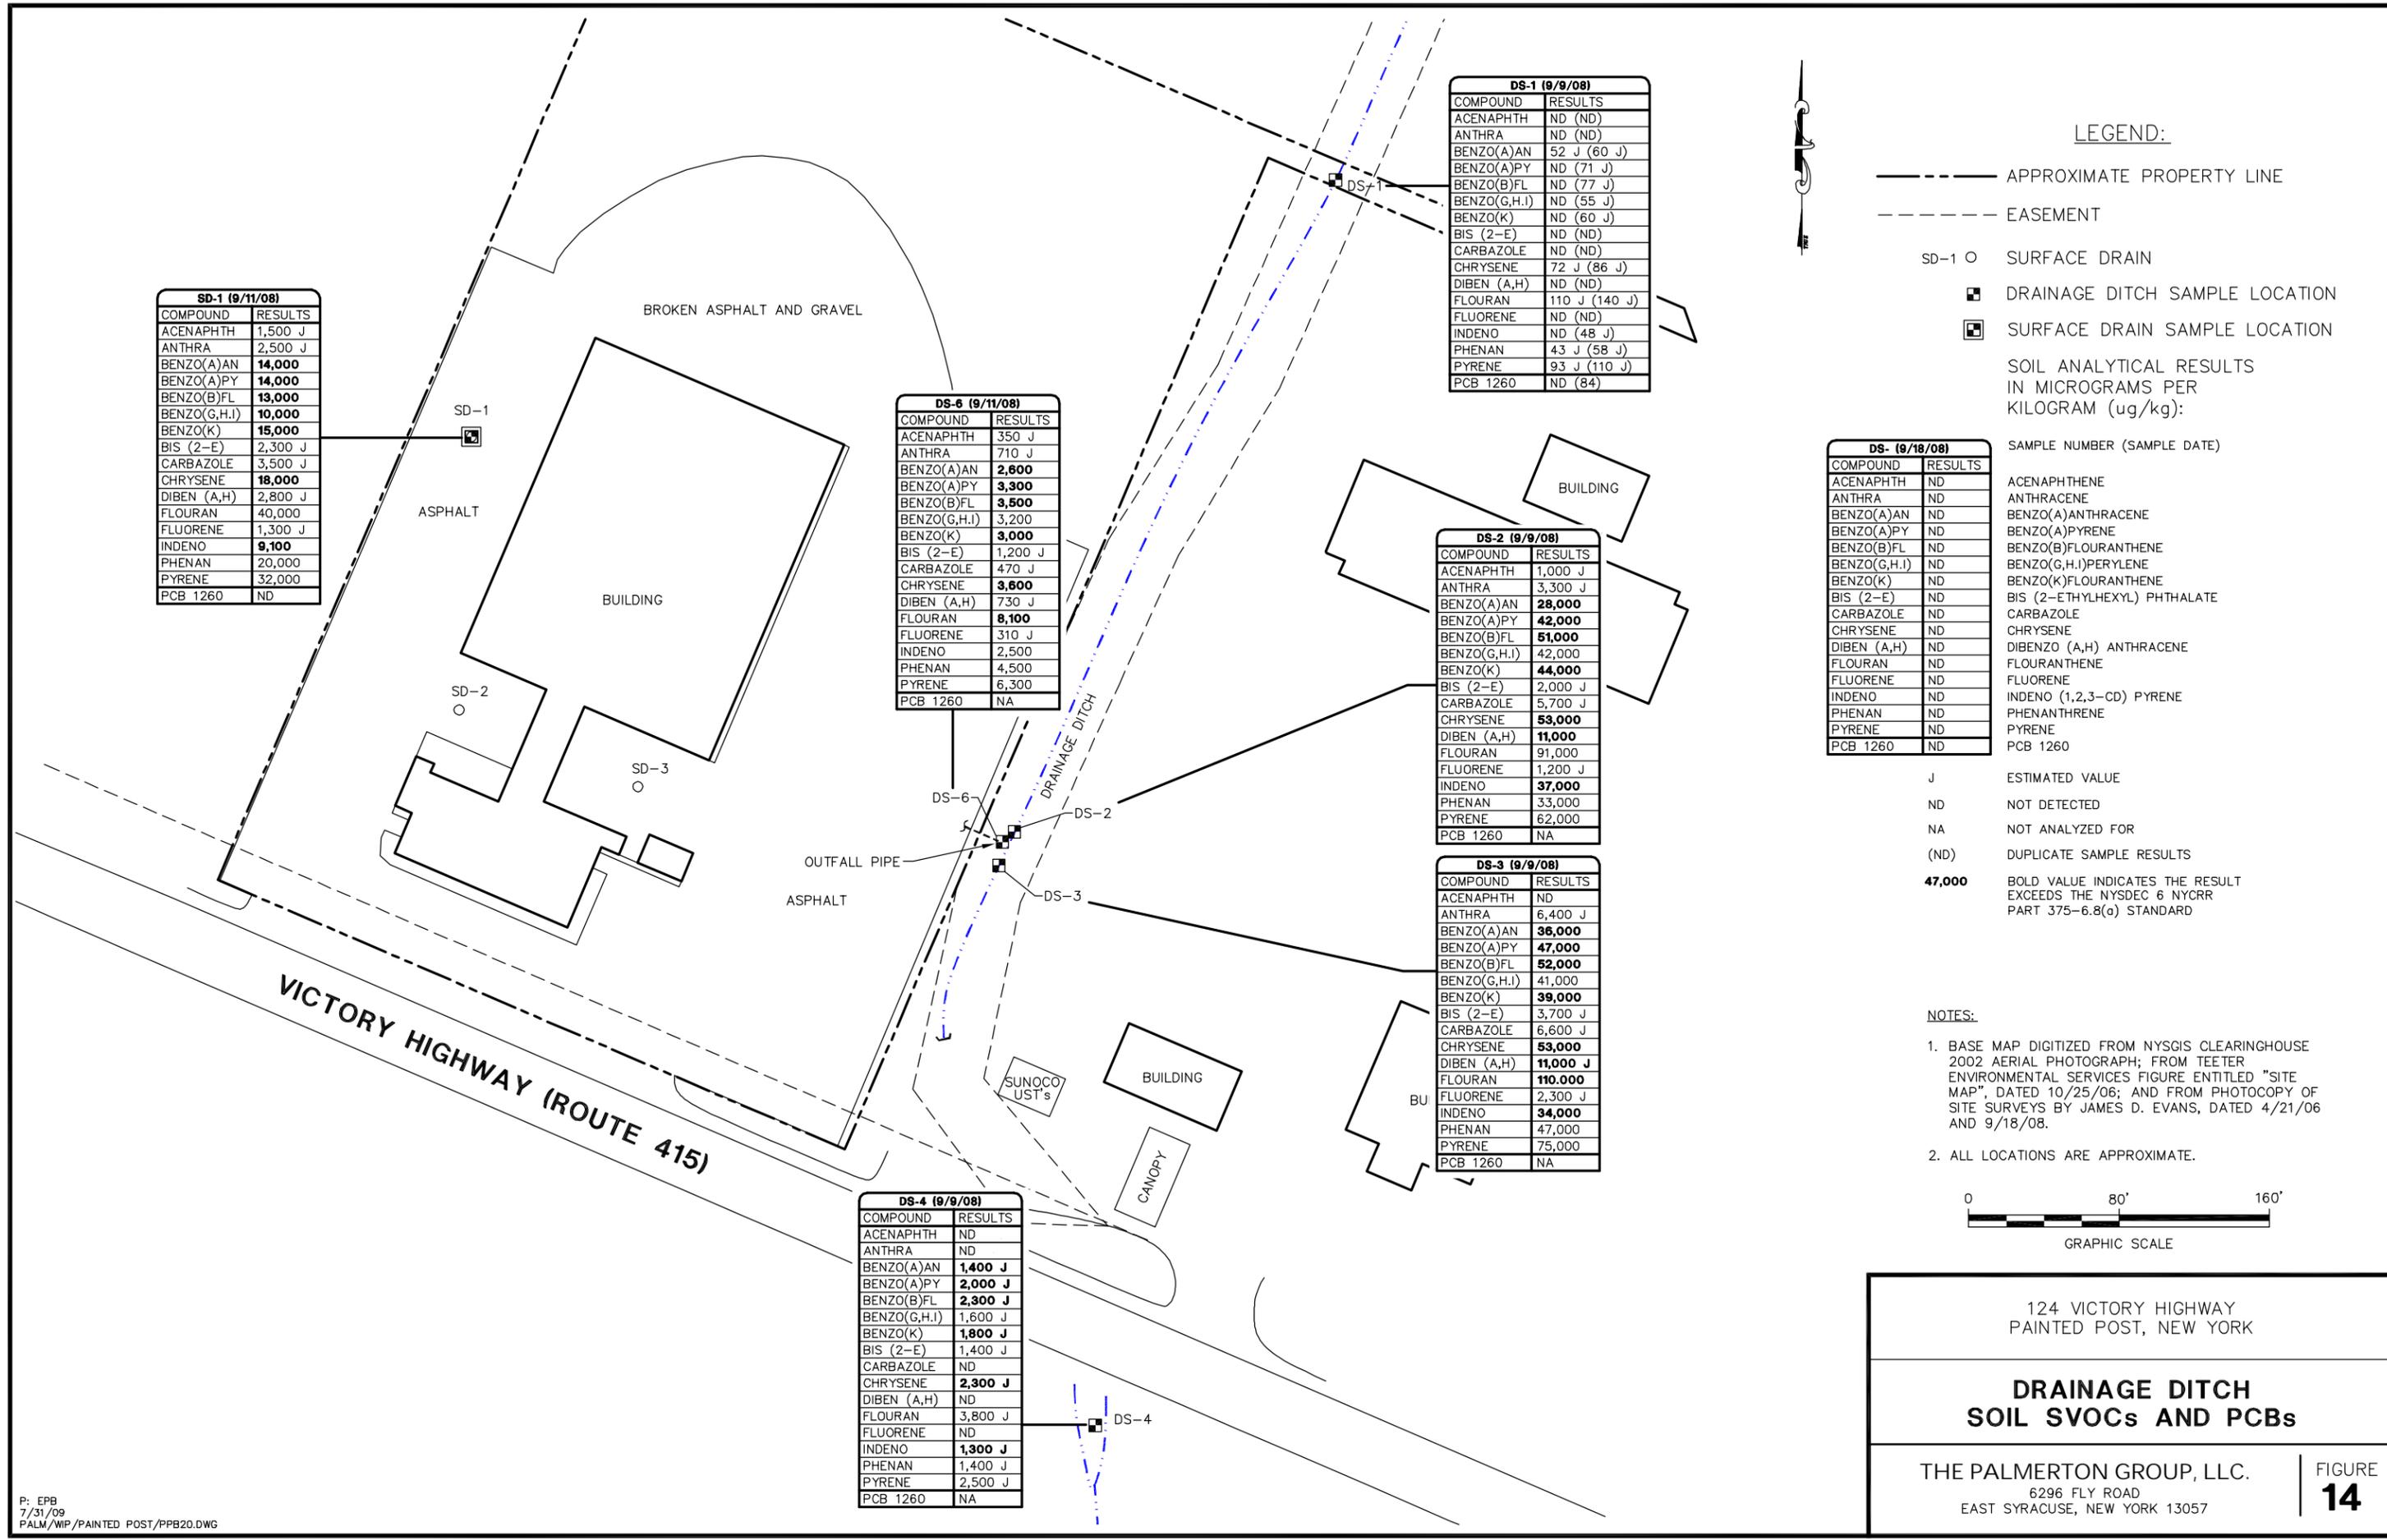
SVOC concentrations were detected above NYSDEC 6NYCRR Part 375-6.8(a) Unrestricted Soil Use Cleanup Objectives in samples DS-2, DS-3, DS-4 and DS-6. Samples DS-2, DS-3 and DS-6 were collected in the area of the drainage outfall pipe. SVOC concentrations in these samples may be attributed to the previous activities at the site (recreational vehicle repair and automotive).

Levels of six SVOCs (benzo(a)anthracene, benzo(a)pyrene, benzo(b)fluoranthene, benzo(k)fluoranthene, chrysene and indeno(1,2,3-CD)pyrene) were found in the debris sample SD-1 above NYSDEC 6NYCRR Part 375-6.8(a) Unrestricted Soil Use Cleanup Objectives. This information is summarized in Table 6B and illustrated on Figure 14.

- Although the soil in the drainage ditch contains several SVOCs exceeding NYSDEC cleanup criteria, the sampling and analytical data indicate the SVOC impacts appear to be localized and limited in volume. The recommendations are to remove these soil at the same time as the above proposed UST area IRM; and
- Preliminary soil vapor sampling indicates the presence of VOCs beneath the building slab. To better characterize soil vapor and the potential exposure pathway, sampling of sub-slab soil vapor during the heating season with accompanied indoor and outdoor air sampling is recommended.
