**DAILY INSPECTION REPORT - No. 001**  
**(Corning Post Creek) Site No. 851053**

NYSDEC Division of Environmental Remediation

Department of Environmental Conservation		<b>Contract No. D009811-29</b> <b>DEC Insp. –</b> <b>DEC PM – Robert Strang</b> <b>Contractor Supt. –</b> <b>Engineer PM – Matt Vetter</b> <b>Engineer Insp. – Joseph Moffitt</b>	
<b>Site Location: Corning, NY</b>					
<b>Weather Conditions</b>					
<b>General Description</b>	Cloudy	AM	Partly Cloudy	PM	
<b>Temperature</b>	31 F	AM	39 F	PM	
<b>Wind</b>	12 MPH W	AM	8 MPH WSW	PM	
<b>Health &amp; Safety</b> <b>If any box below is checked “Yes”, provide explanation under “Health &amp; Safety Comments”.</b>					
Were there any changes to the Health & Safety Plan?				*Yes	No X NA
Were there any exceedances of the perimeter air monitoring reported on this date?				*Yes	No X NA
Were there any nuisance issues reported/observed on this date?				*Yes	No X NA
<b>Health &amp; Safety Comments</b> Dash Card created for site. Integral conducted internal safety meeting with Parratt-Wolff No CAMP exceedances reported to Parsons by Integral

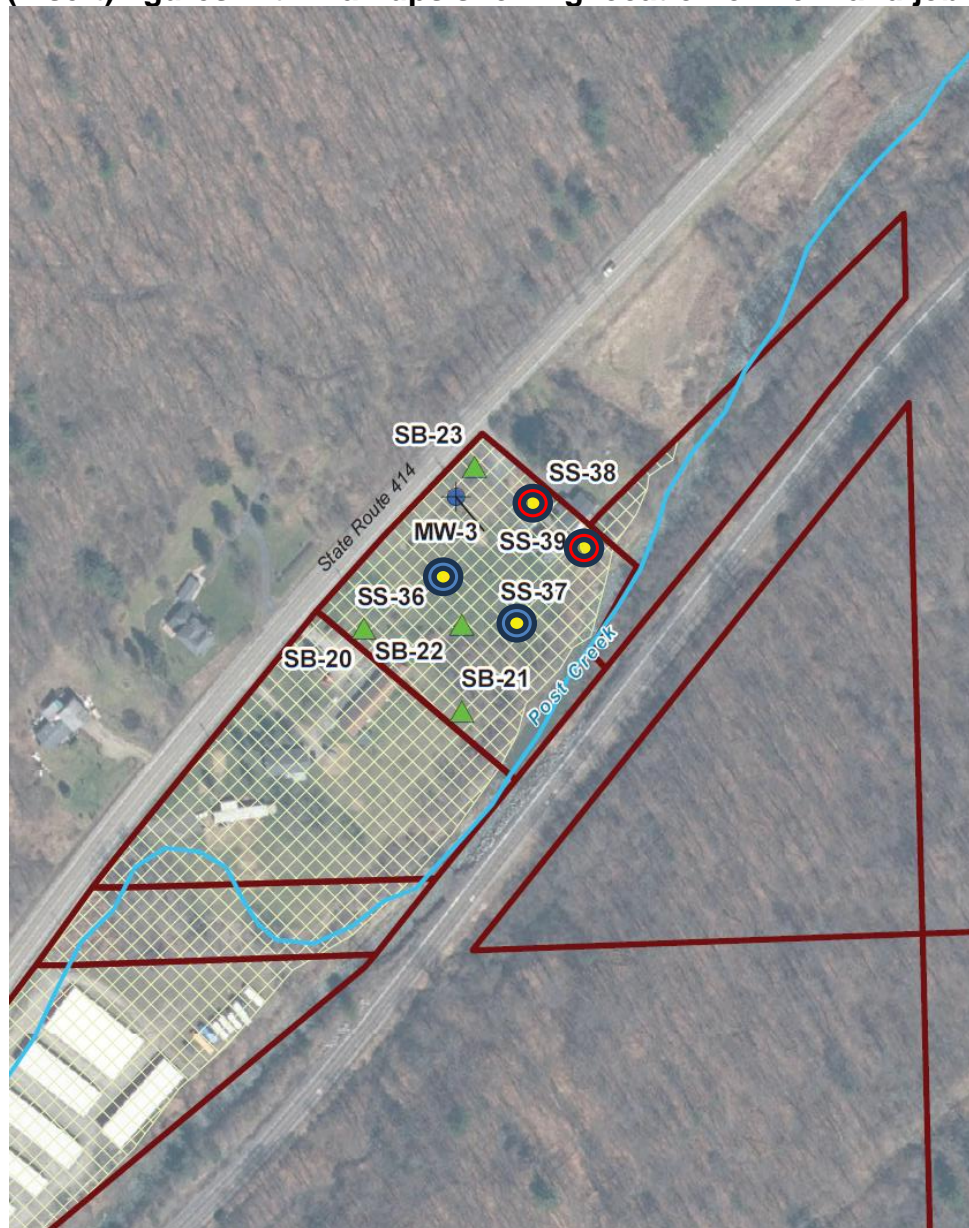
Work was performed at SS-36,37,38,39. locations with ABG are indicated with red circles, locations without are indicated with blue circles.

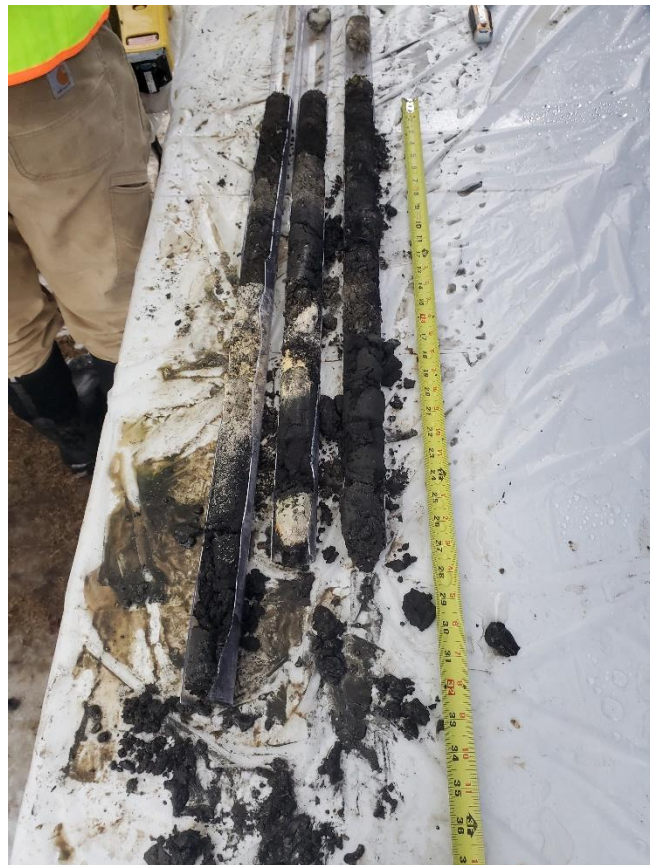
*Picture 4*

Additional runs of SS-39 with ash and brick present at bottom of runs.

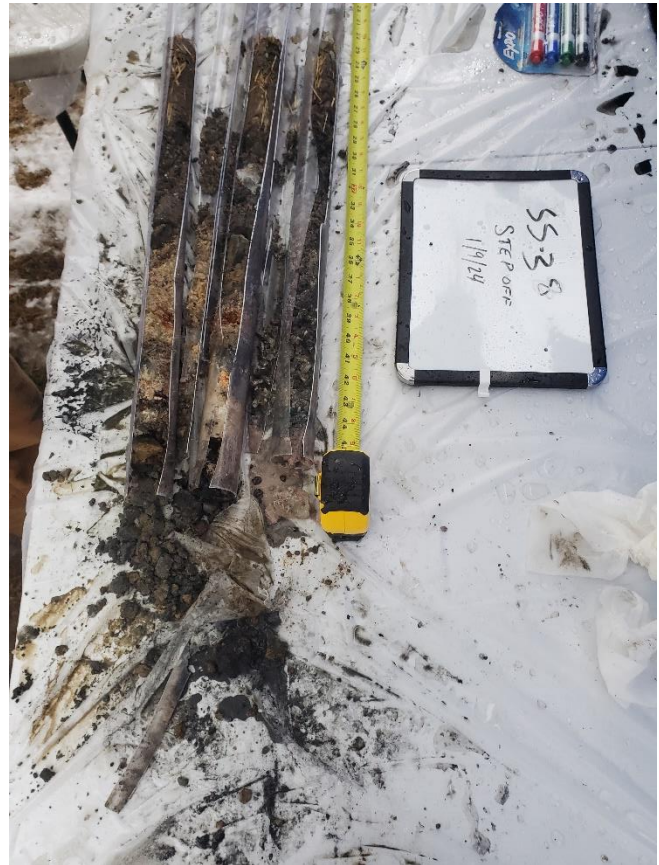
*Picture 6*

First 3 runs of SS-38 with clear layer of ABG layer starting at roughly 1 FT BGS. Fill includes, ash, brick, and glass including thermometer tubing

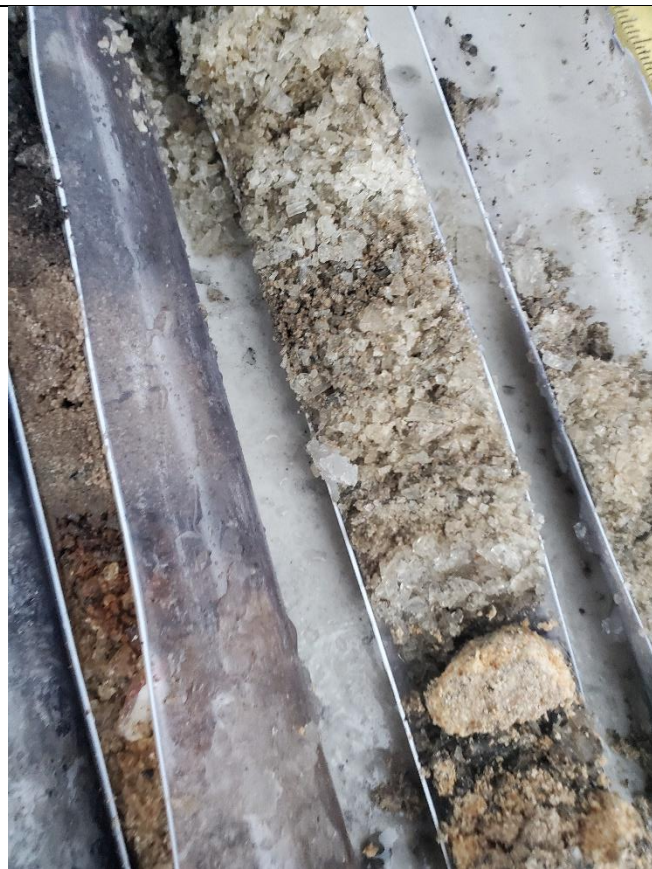
*Picture 8*

Glass and ash layer overlying brick in SS-38

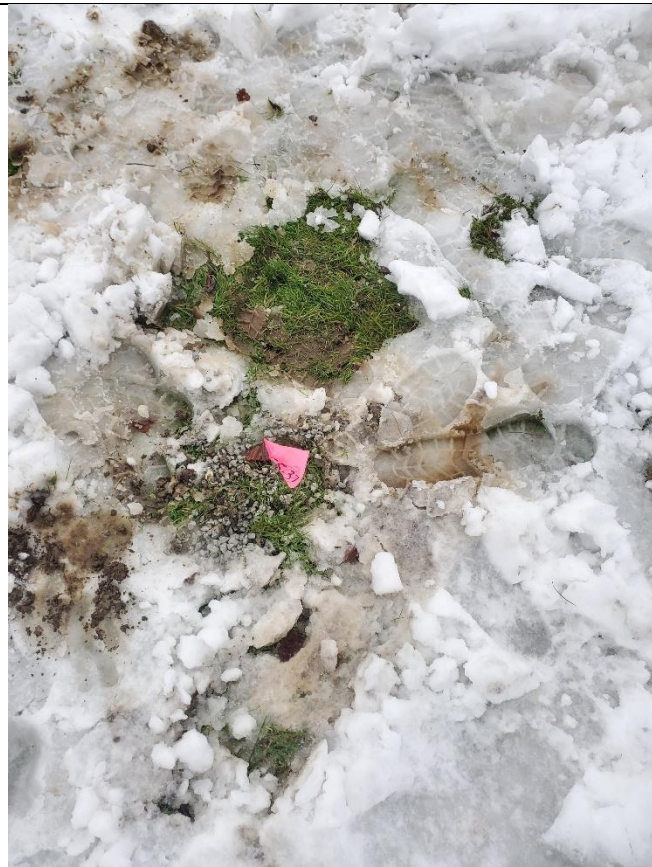
*Picture 10*

SS-37 backfilled with bentonite hole plug

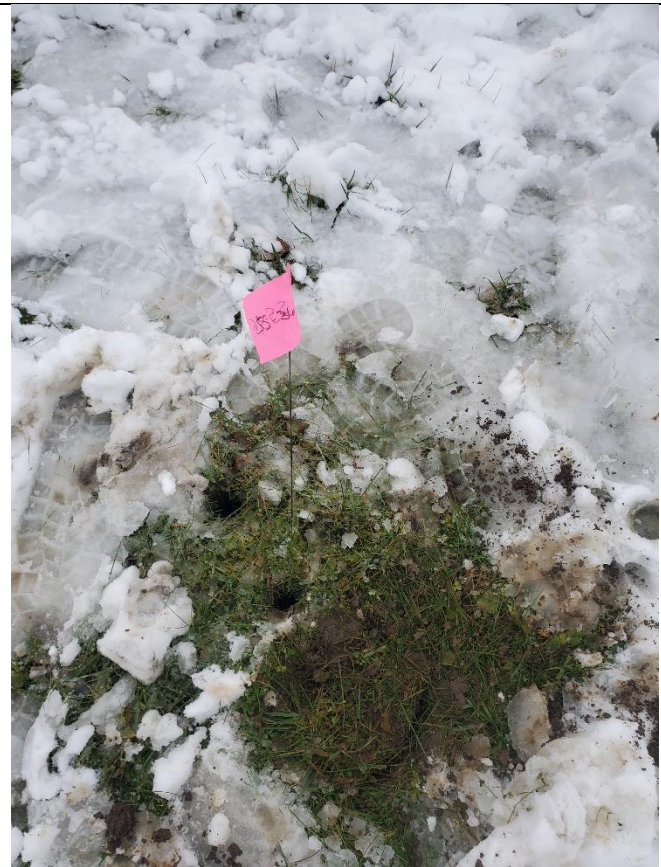
Picture 12  
SS-36 prior to backfilling

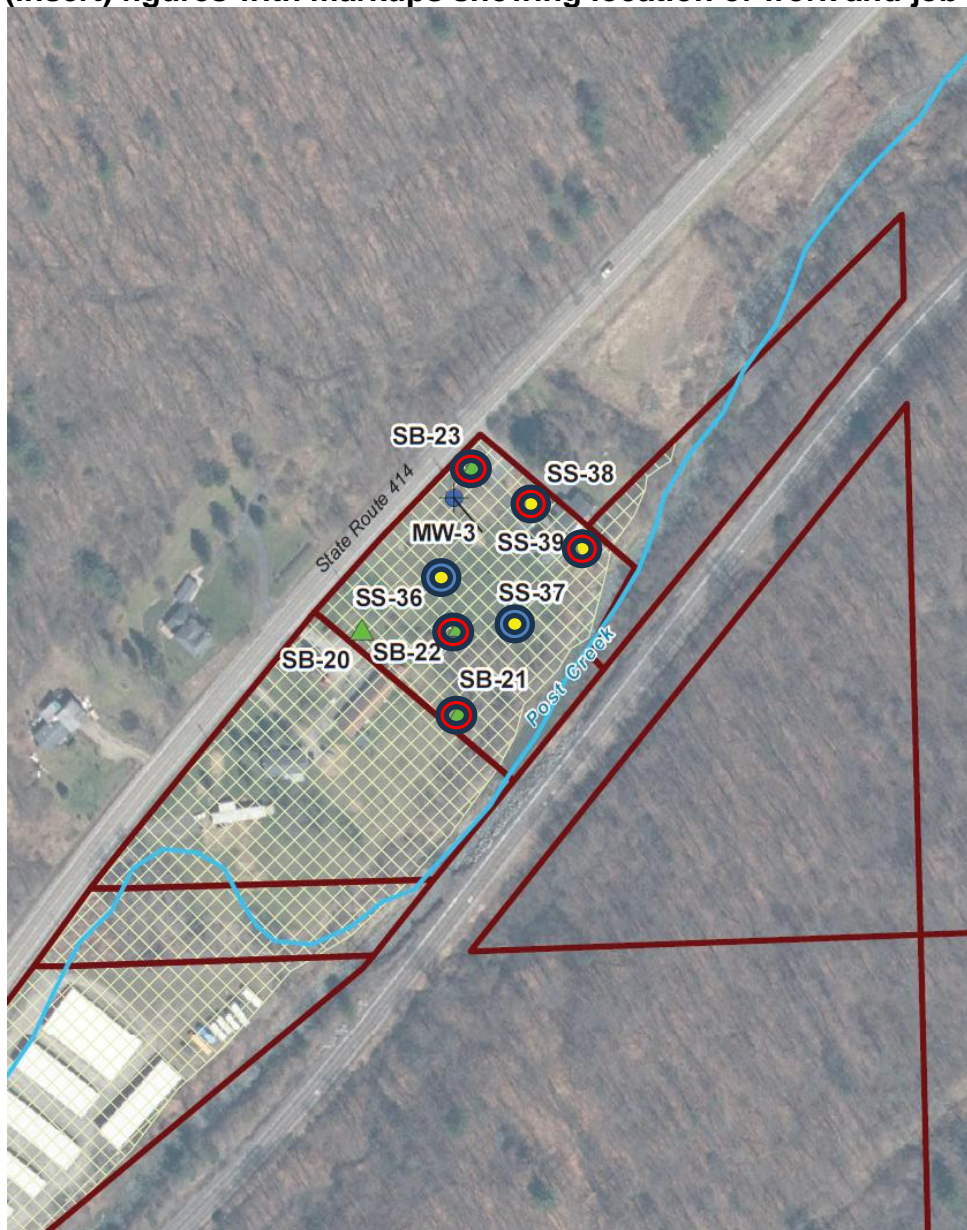
Work was performed at SB-21,22,23 locations with ABG are indicated with red circles, locations without are indicated with blue circles.

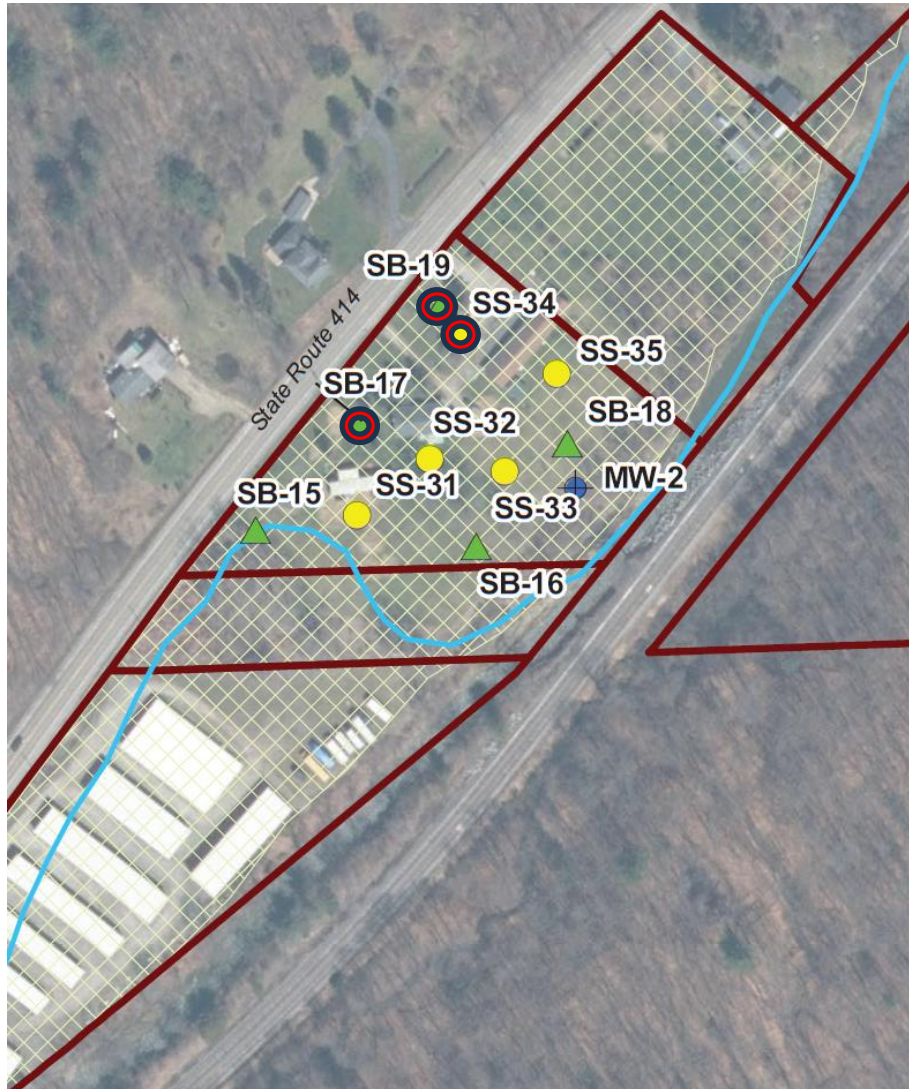
Work was performed at SB-17,19 locations with ABG are indicated with red circles.

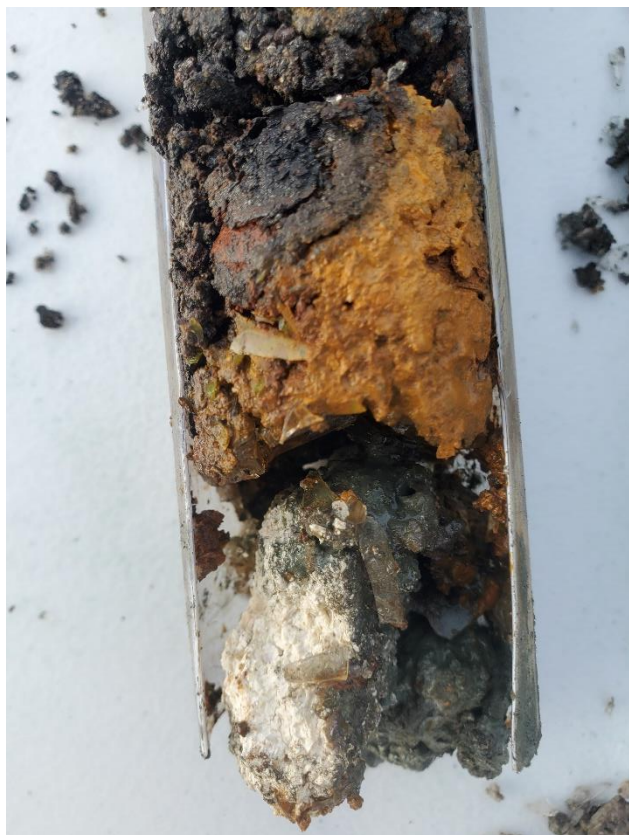
*Picture 3*

Close up of SB-19 with orange staining, green and clear glass shards, and white furnace brick visible.

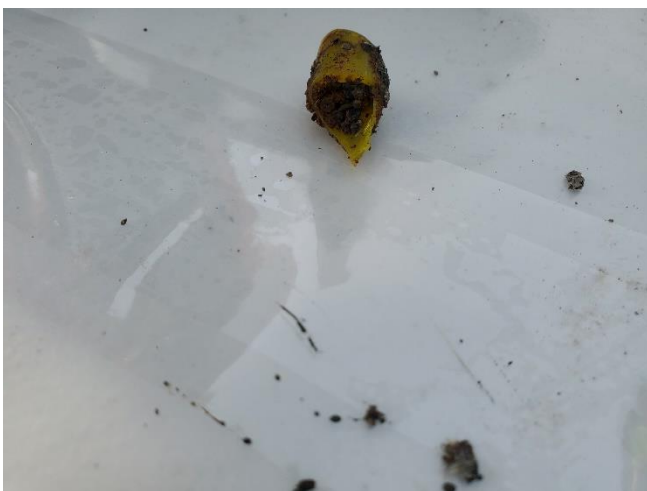
*Picture 4*

Green hollow tubing recovered in SB-19.

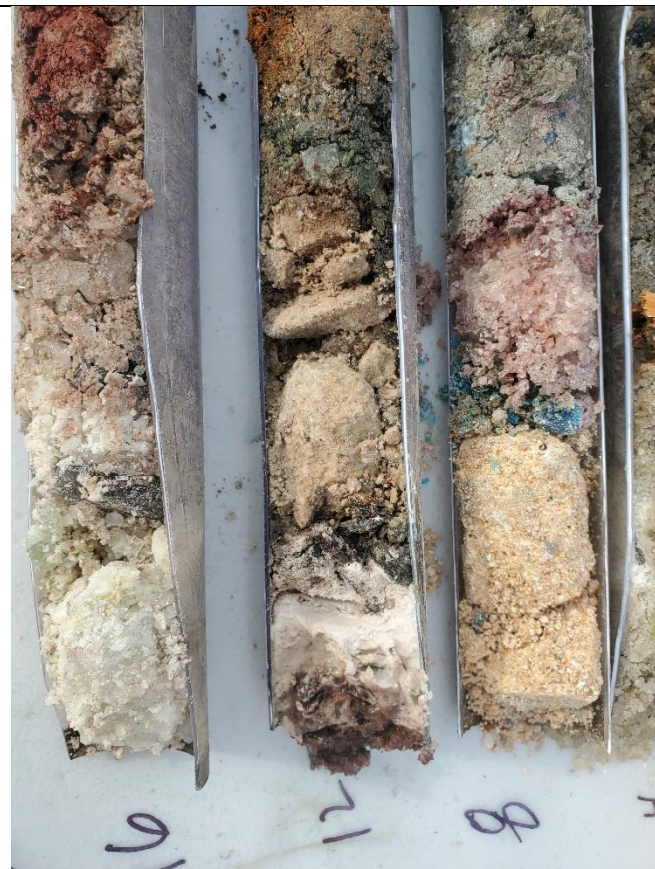
Picture 10

Close up of cores from SB-17, brick, multiple colors of glass and cullet present, white and tan ash present.

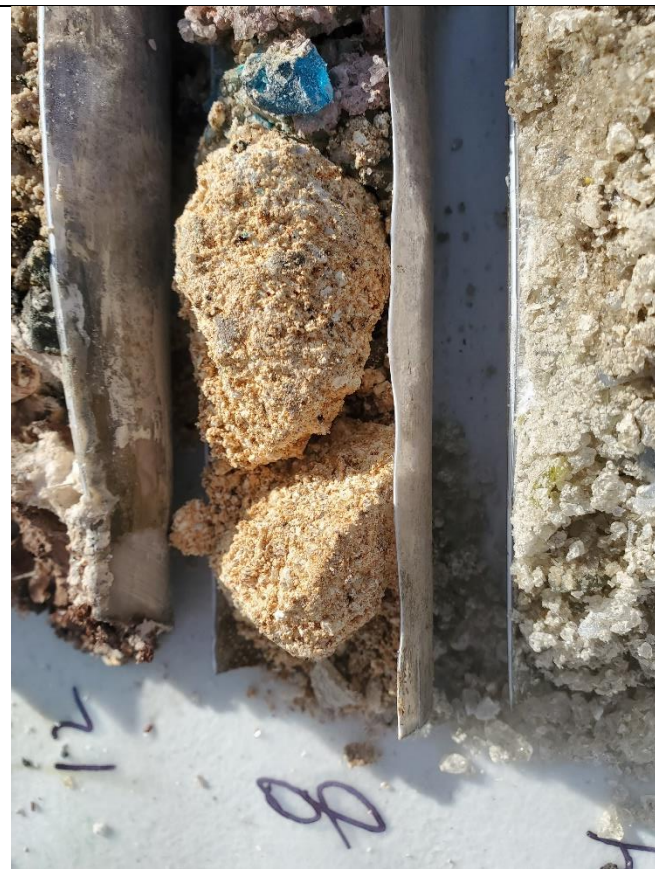
Picture 12

Close up of SB-17 offset from 8 FT depth, tan furnace brick and blue cullet visible.

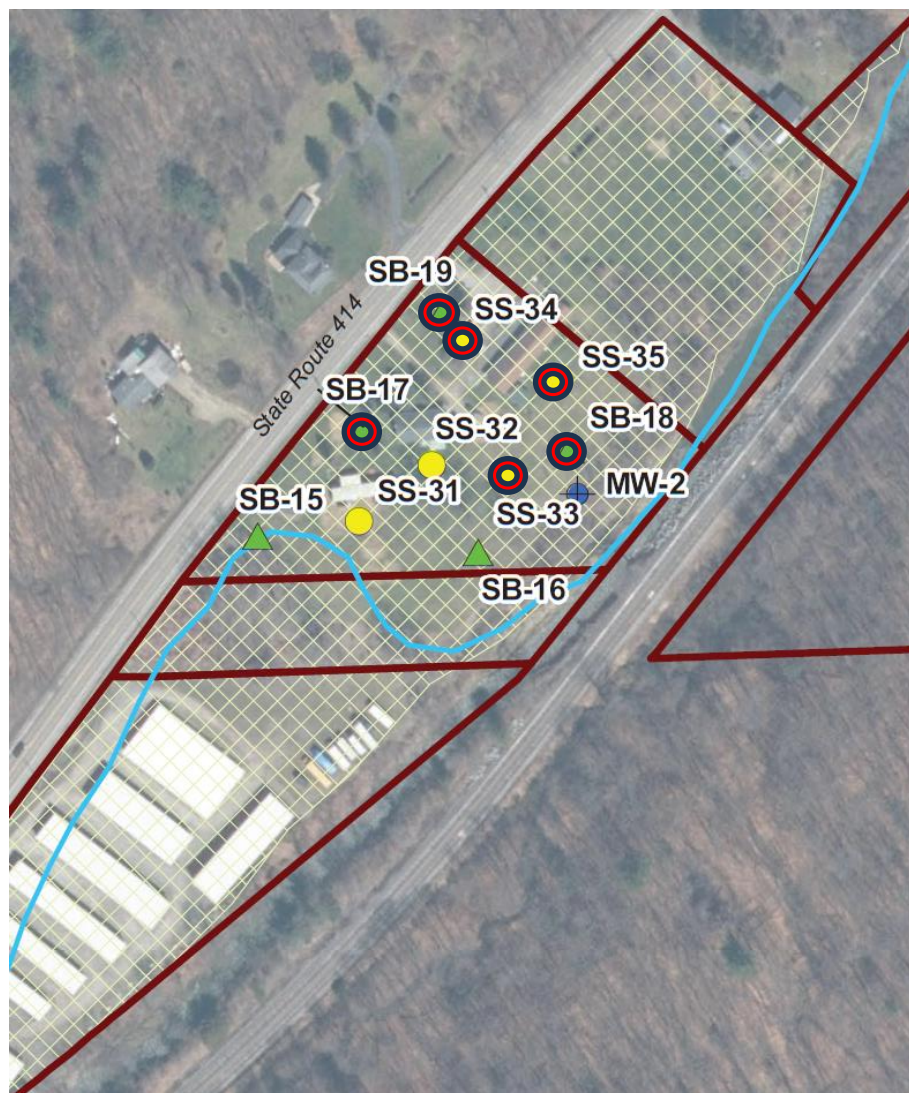
Work was performed at SB-18, and SS-33,35 locations with ABG are indicated with red circles.

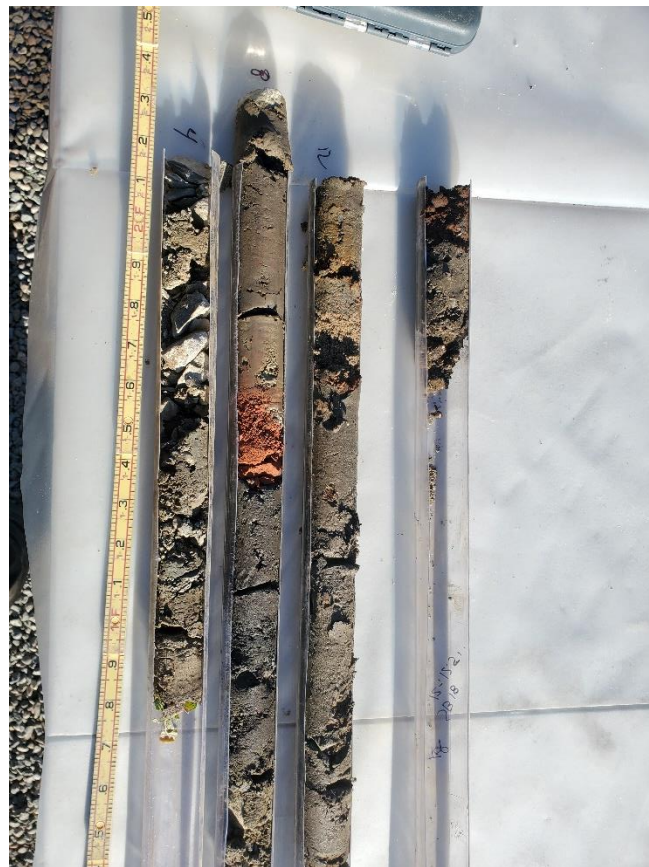
*Picture 4*

SB-18 first run of 0-16 FT BGS. Red brick visible

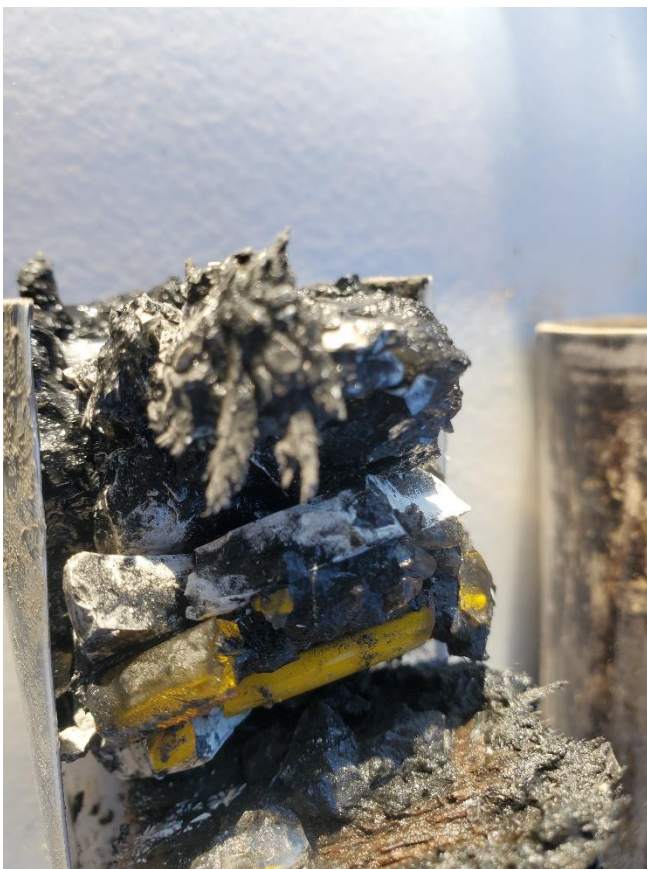
*Picture 6*

Close up of yellow thermometer tubing, wood, and white glass shards from SB-18

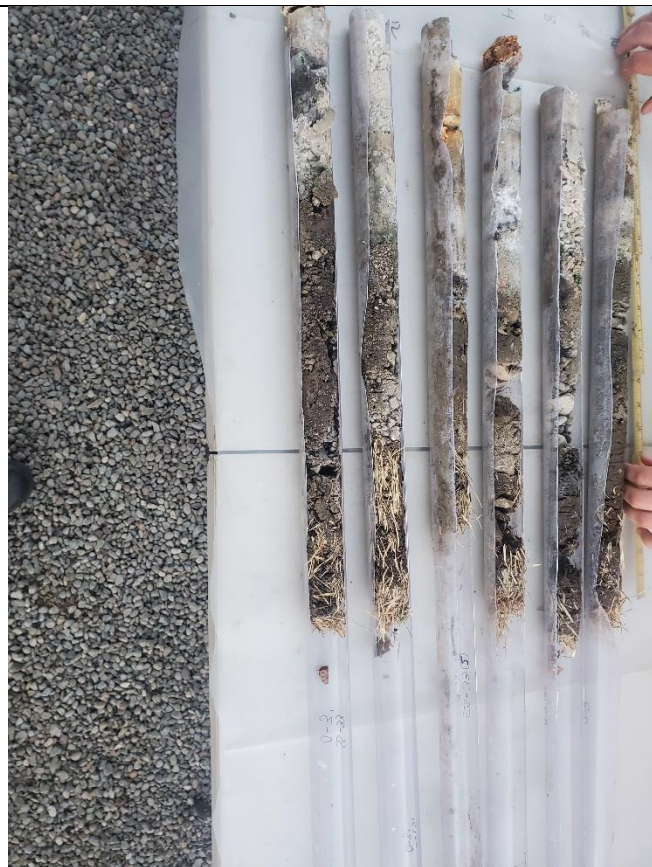
*Picture 8*

SS-37, first 6 runs at location, distinct ABG layer starting at 1 to 1.5 foot depth

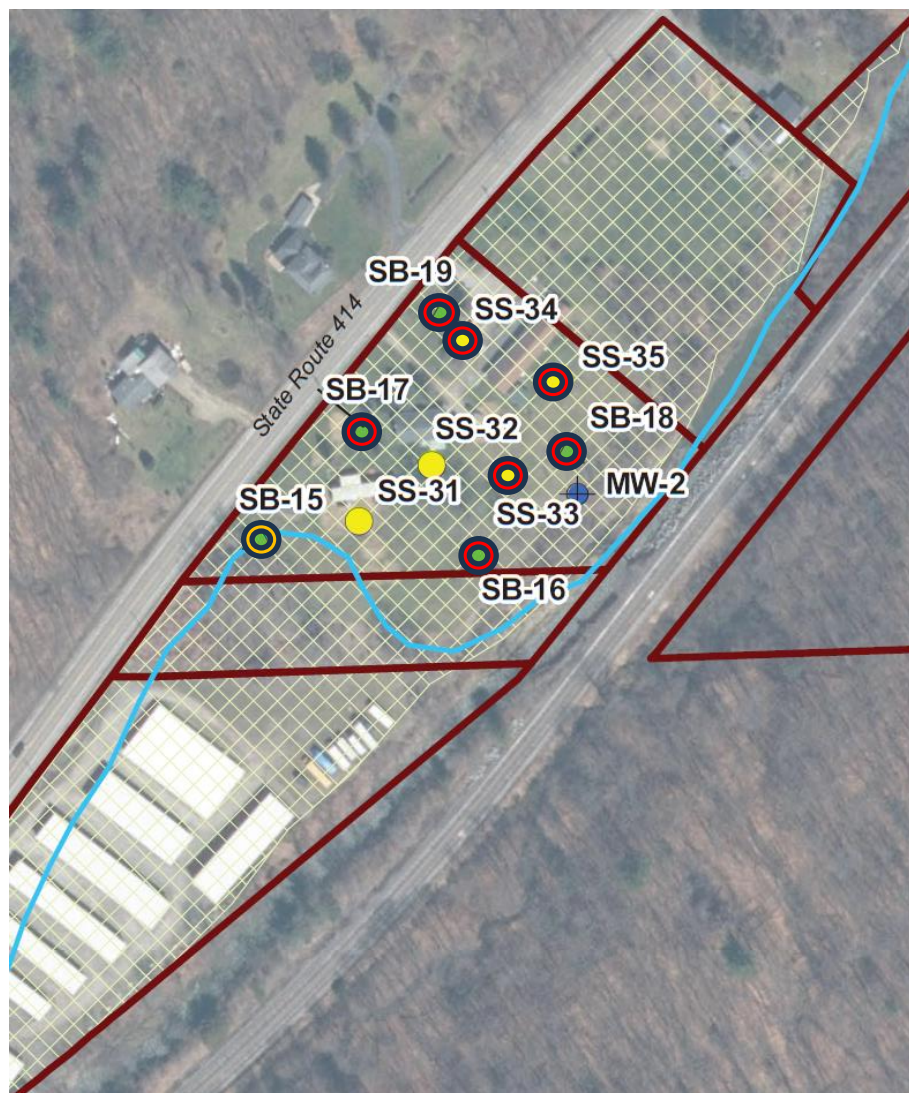
Work was performed at SB-15,16 locations with ABG are indicated with red circles. Orange circle indicates non-native fill.

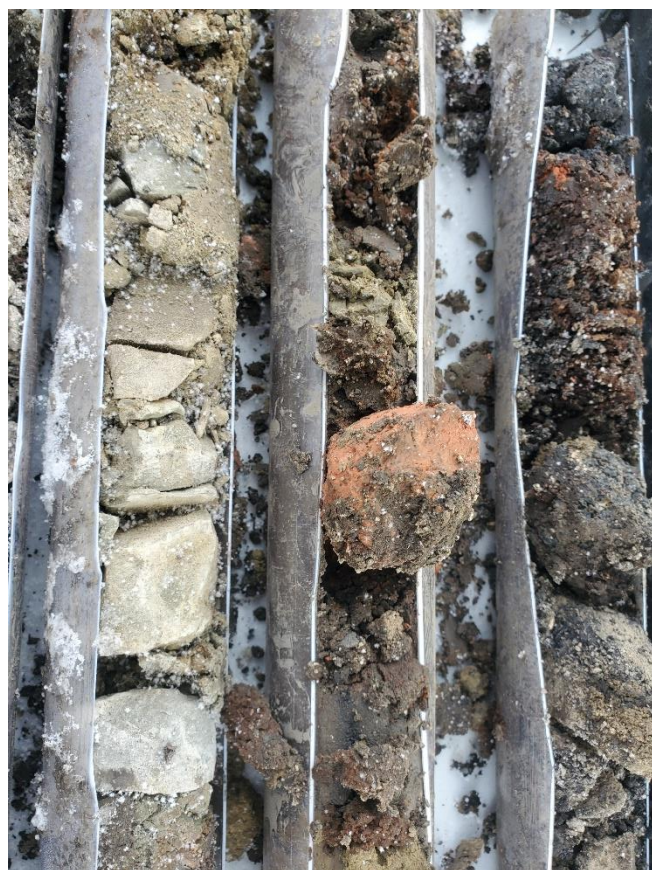
*Picture 6*

Close up of light red brick from SB-16 12-16 FT core

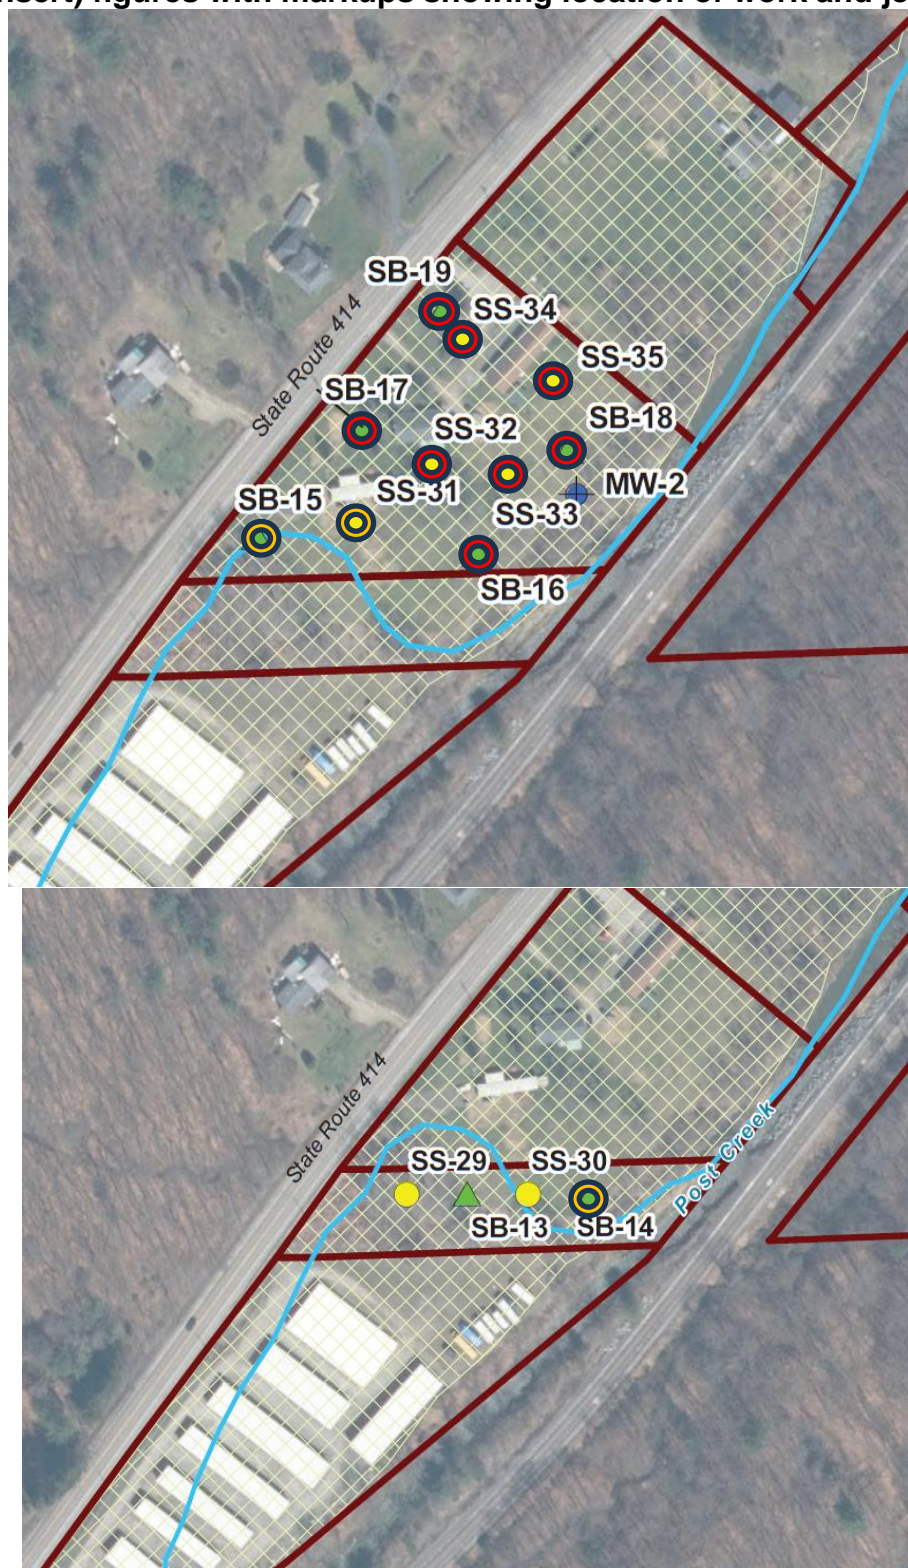
Work was performed at SB-14, SS-21,32 locations with ABG are indicated with red circles.  
Orange circle indicates non-native fill.

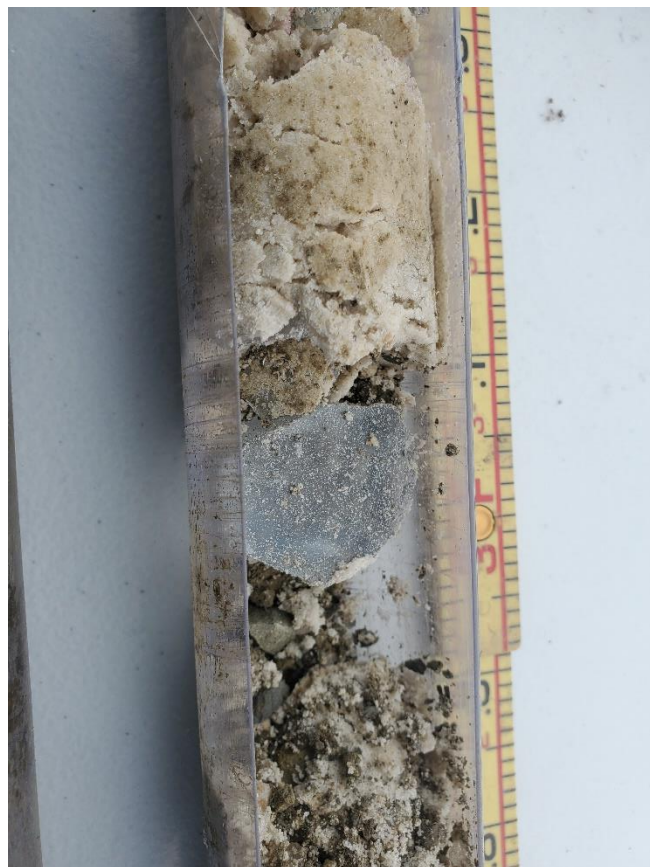
*Picture 4*

Close up of glass cullet in SS-32.

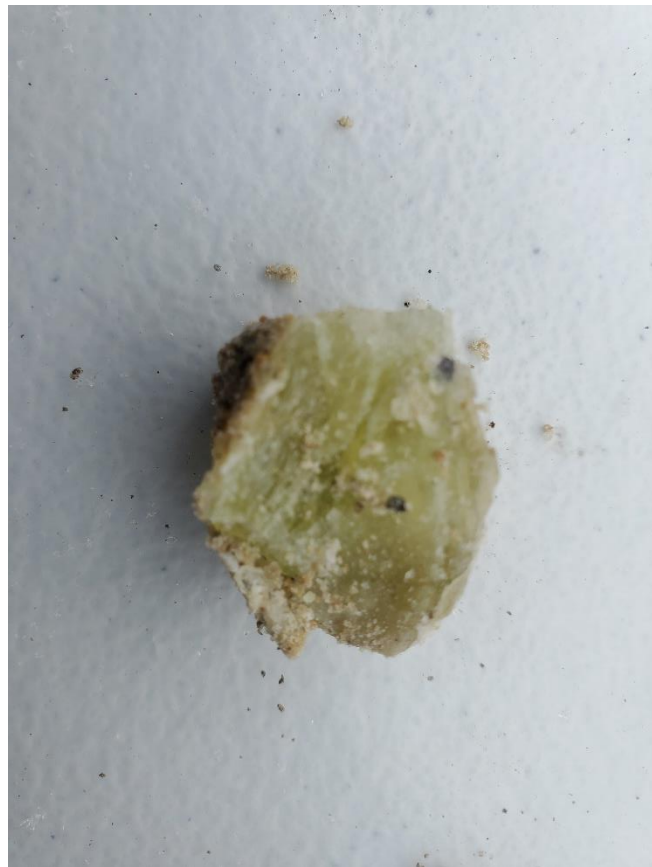
*Picture 6*

Close up of green glass recovered from SS-32.

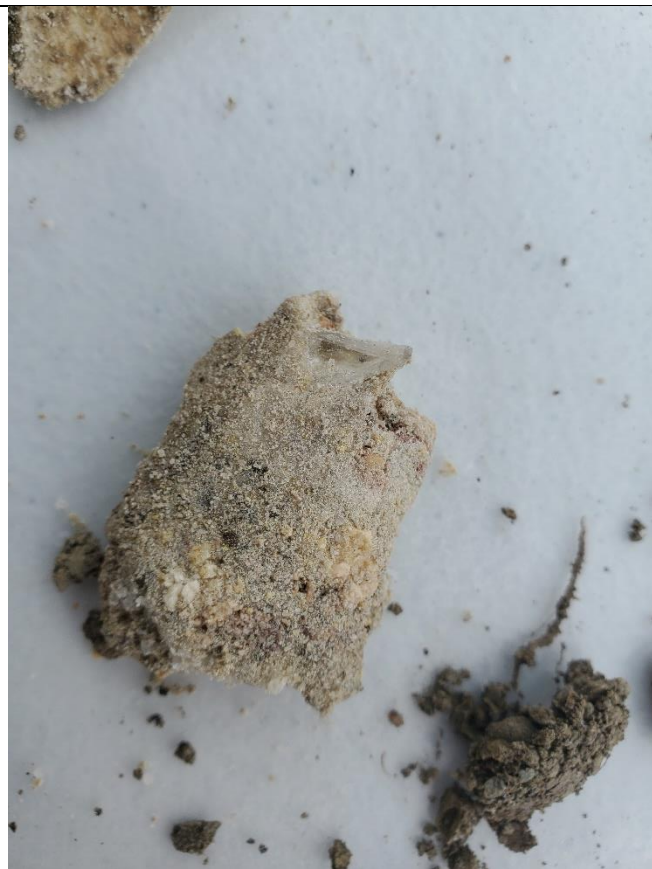
*Picture 8*

Close up of white furnace brick from SS-32.

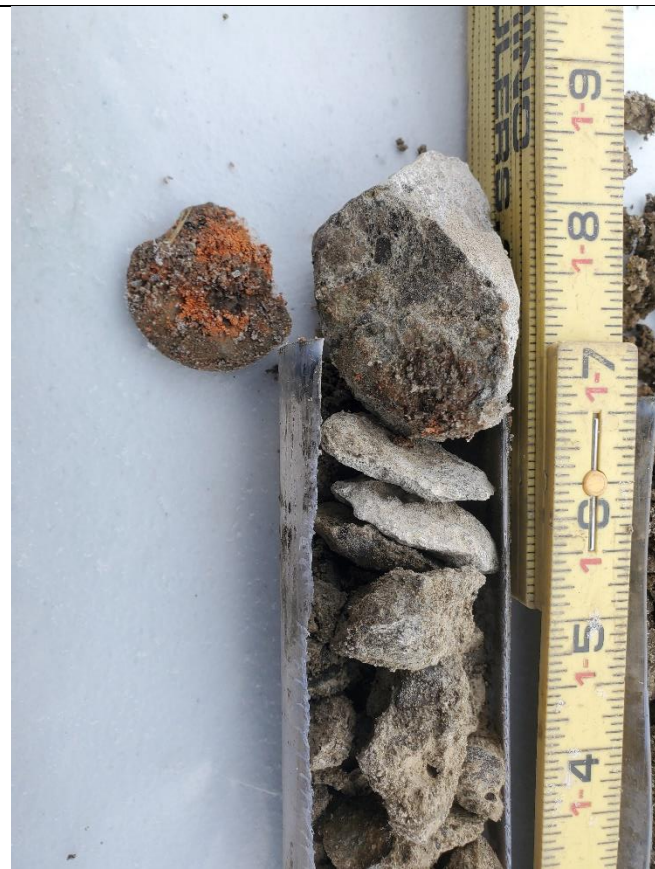
*Picture 10*

Close up of red brick and concrete fragments from bottom of SS-31.

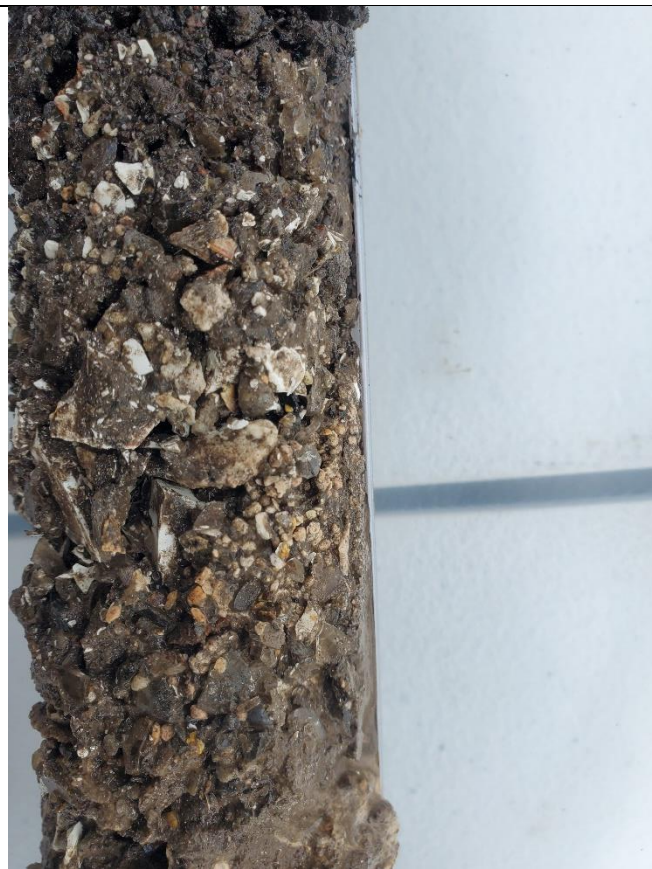
*Picture 14*

Close up white glass material from SB-14 from 16-20 FT BGS.

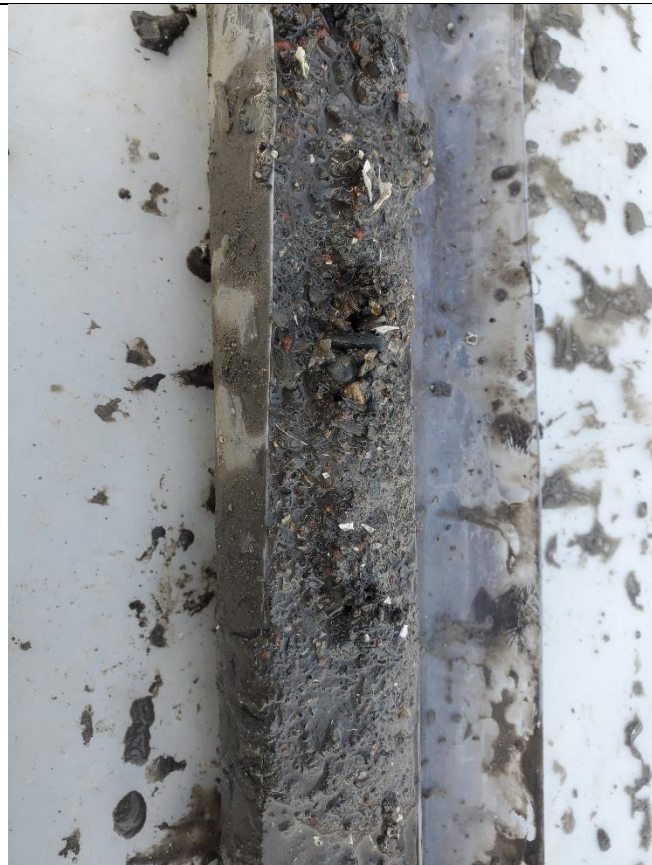
*Picture 16*

Close up of fill material from 24-30 FT section  
of SB-14

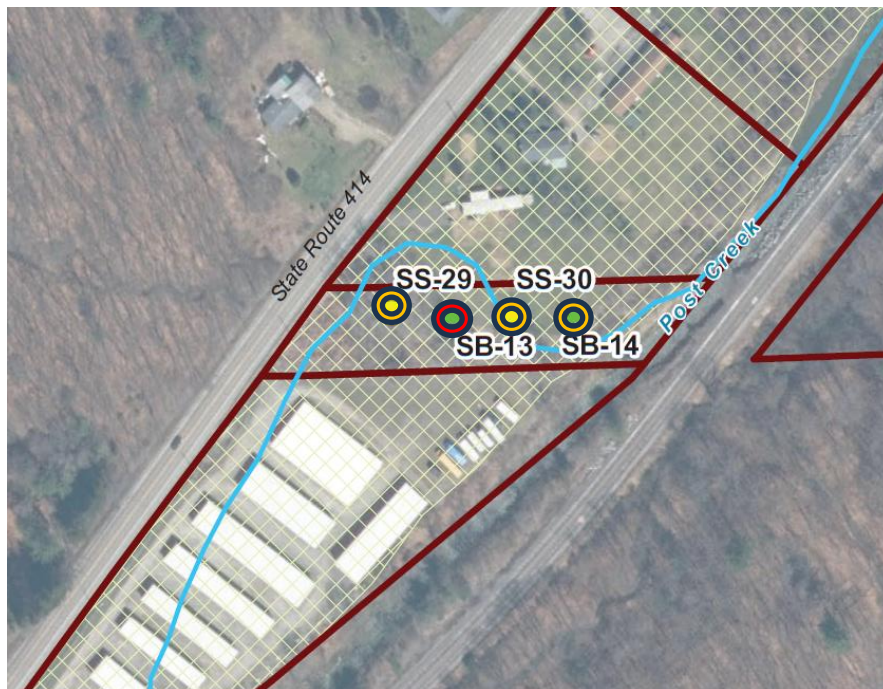
Work was performed at SB-13, SS-29,30 locations with ABG are indicated with red circles.  
Orange circle indicates non-native fill.

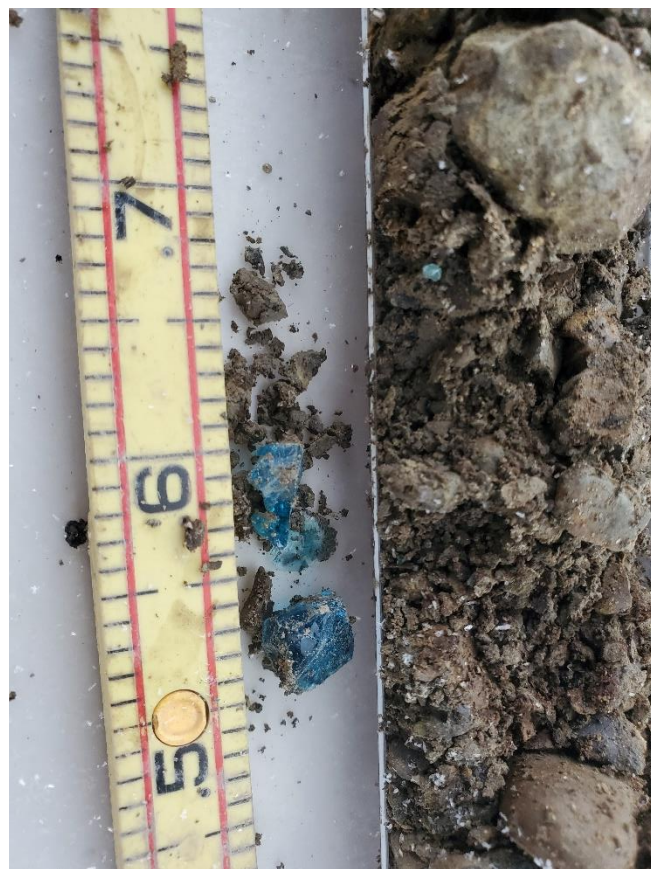
*Picture 2*

Close up of blue glass shards from 5 FT BGS from SB-13

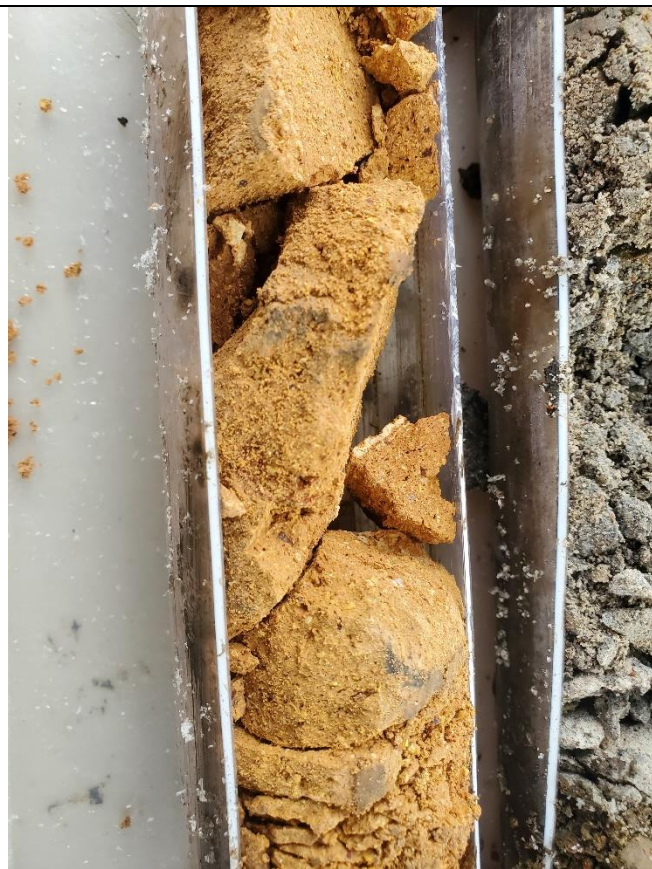
*Picture 4*

Close up of tan furnace brick from SB-13  
from 12-15 FT core.

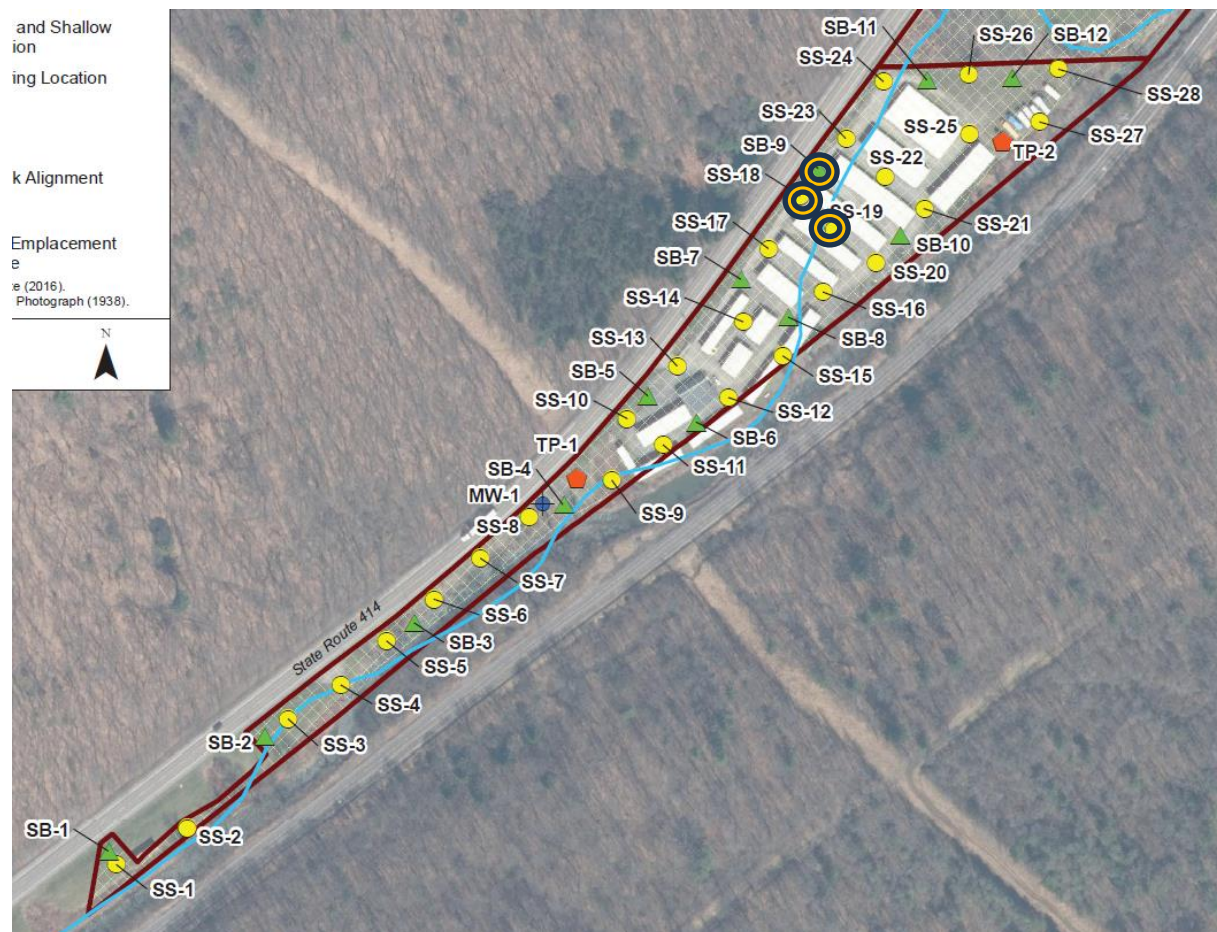
**Work was performed at SB-09,10, SS-19,18. circle indicates non-native fill.**

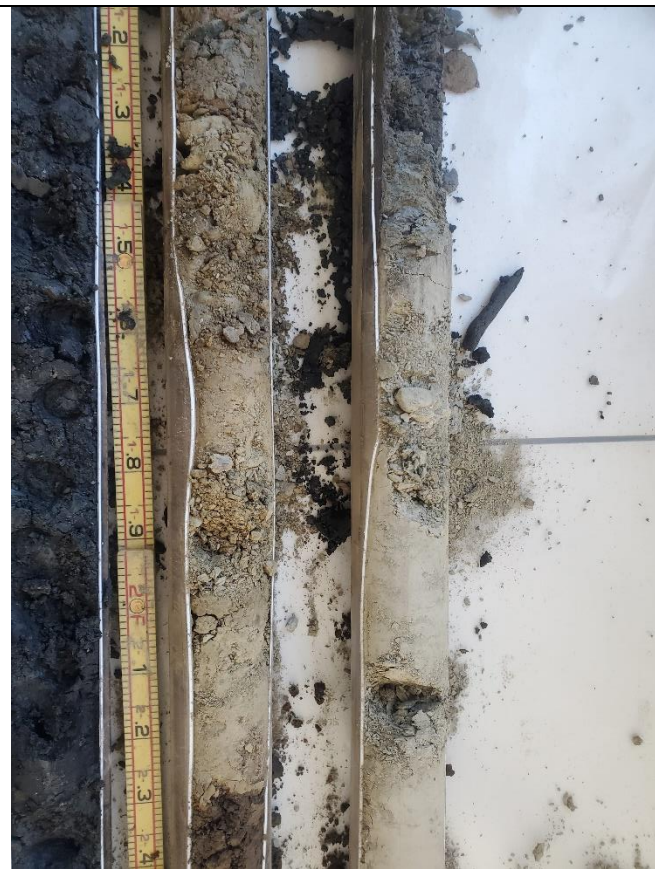
*Picture 4*

SB-09 weathered bedrock at 19.5 FT BGS.

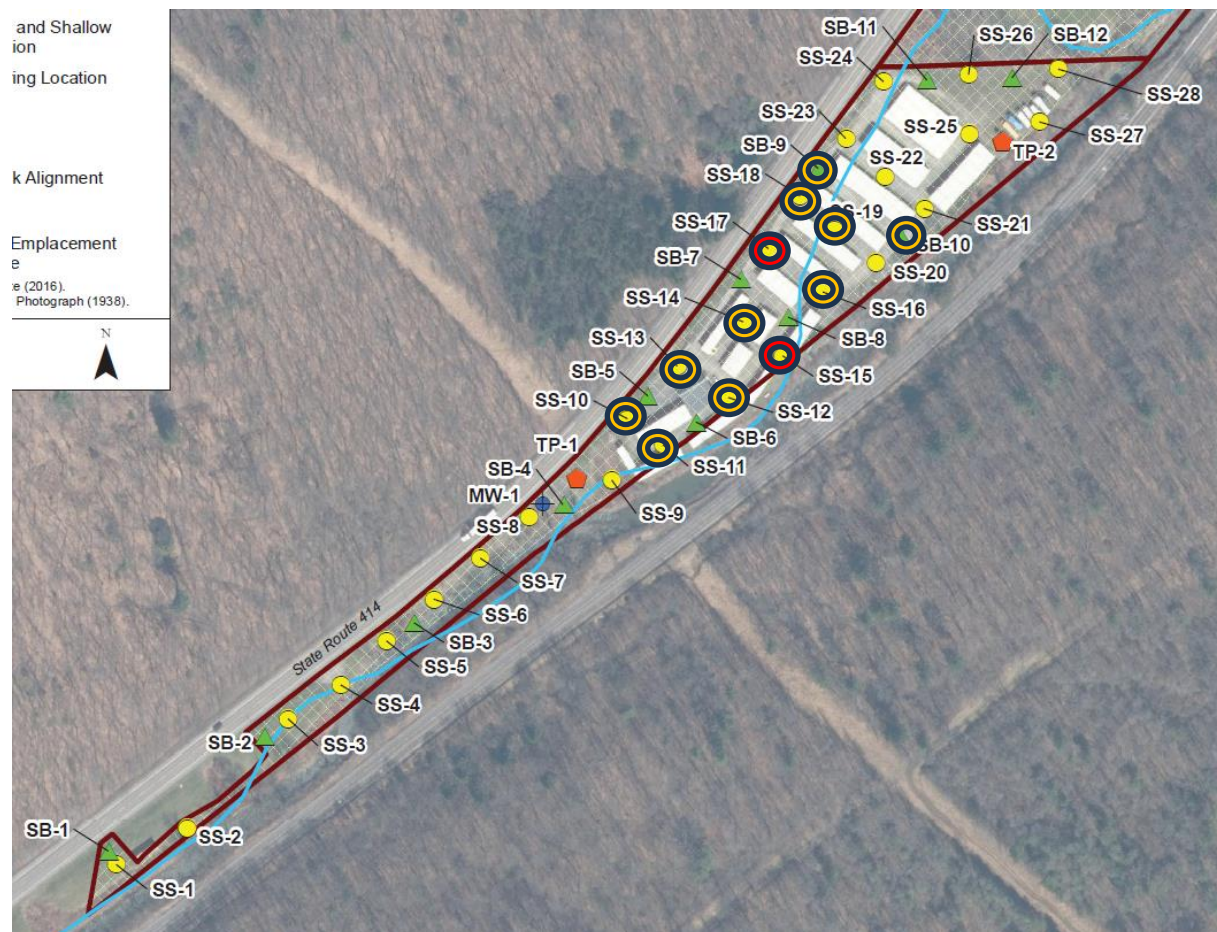
Work was performed at SS-10 through SS-17; red circle indicates possible ABG fill; orange circle indicates non-native fill.
