**DAILY INSPECTION REPORT - No. 001**  
**(Corning Post Creek) Site No. 851053**

NYSDEC Division of Environmental Remediation

Department of Environmental Conservation		<b>Contract No. D009811-29</b> <b>DEC Insp. –</b> <b>DEC PM – Robert Strang</b> <b>Contractor Supt. –</b> <b>Engineer PM – Matt Vetter</b> <b>Engineer Insp. – Joseph Moffitt</b>	
<b>Site Location: Corning, NY</b>					
<b>Weather Conditions</b>					
<b>General Description</b>	Cloudy	AM	Partly Cloudy	PM	
<b>Temperature</b>	31 F	AM	39 F	PM	
<b>Wind</b>	12 MPH W	AM	8 MPH WSW	PM	
<b>Health &amp; Safety</b> <b>If any box below is checked “Yes”, provide explanation under “Health &amp; Safety Comments”.</b>					
Were there any changes to the Health & Safety Plan?				*Yes	No X NA
Were there any exceedances of the perimeter air monitoring reported on this date?				*Yes	No X NA
Were there any nuisance issues reported/observed on this date?				*Yes	No X NA
<b>Health &amp; Safety Comments</b> Dash Card created for site. Integral conducted internal safety meeting with Parratt-Wolff No CAMP exceedances reported to Parsons by Integral

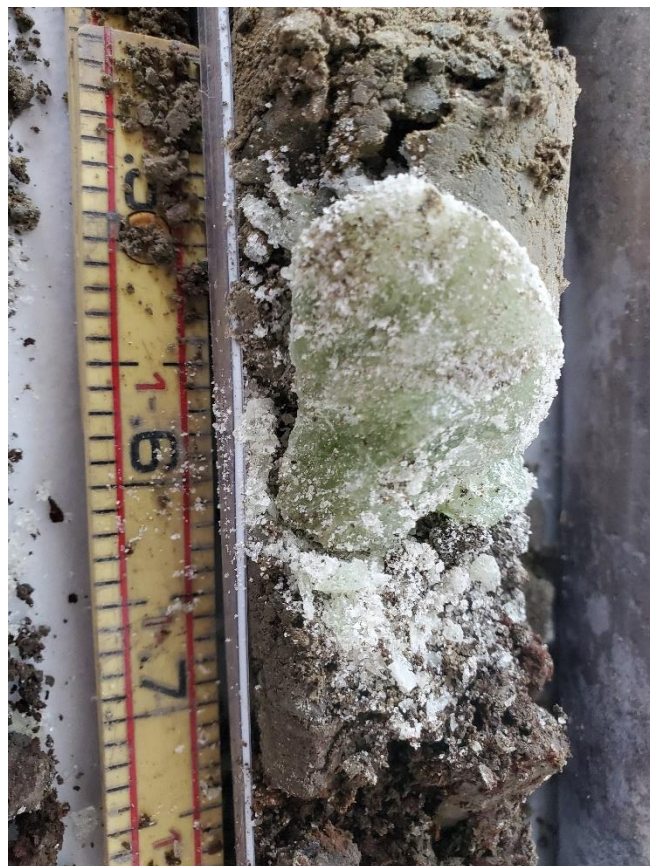
*Picture 2*

Close up of green cullet from SS-17

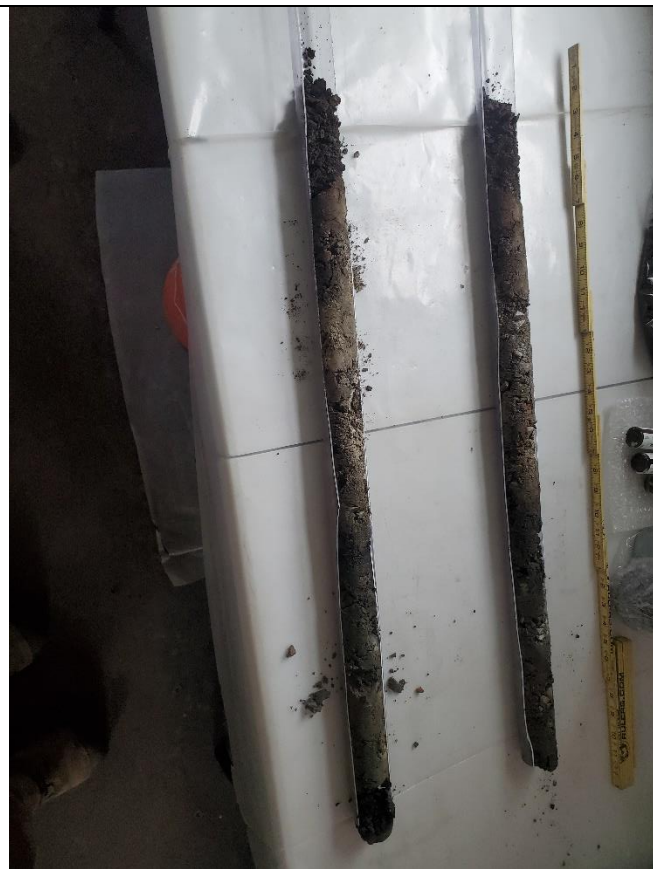
*Picture 4*

SB-16, first two cores recovered, no visible ABG layer

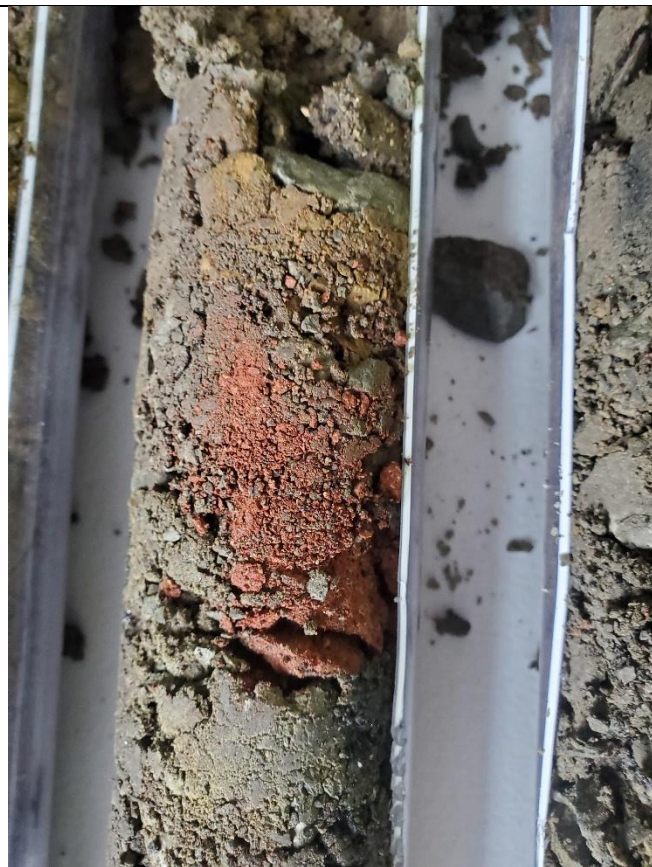
*Picture 10*

SS-13 red brick dust and fragments.

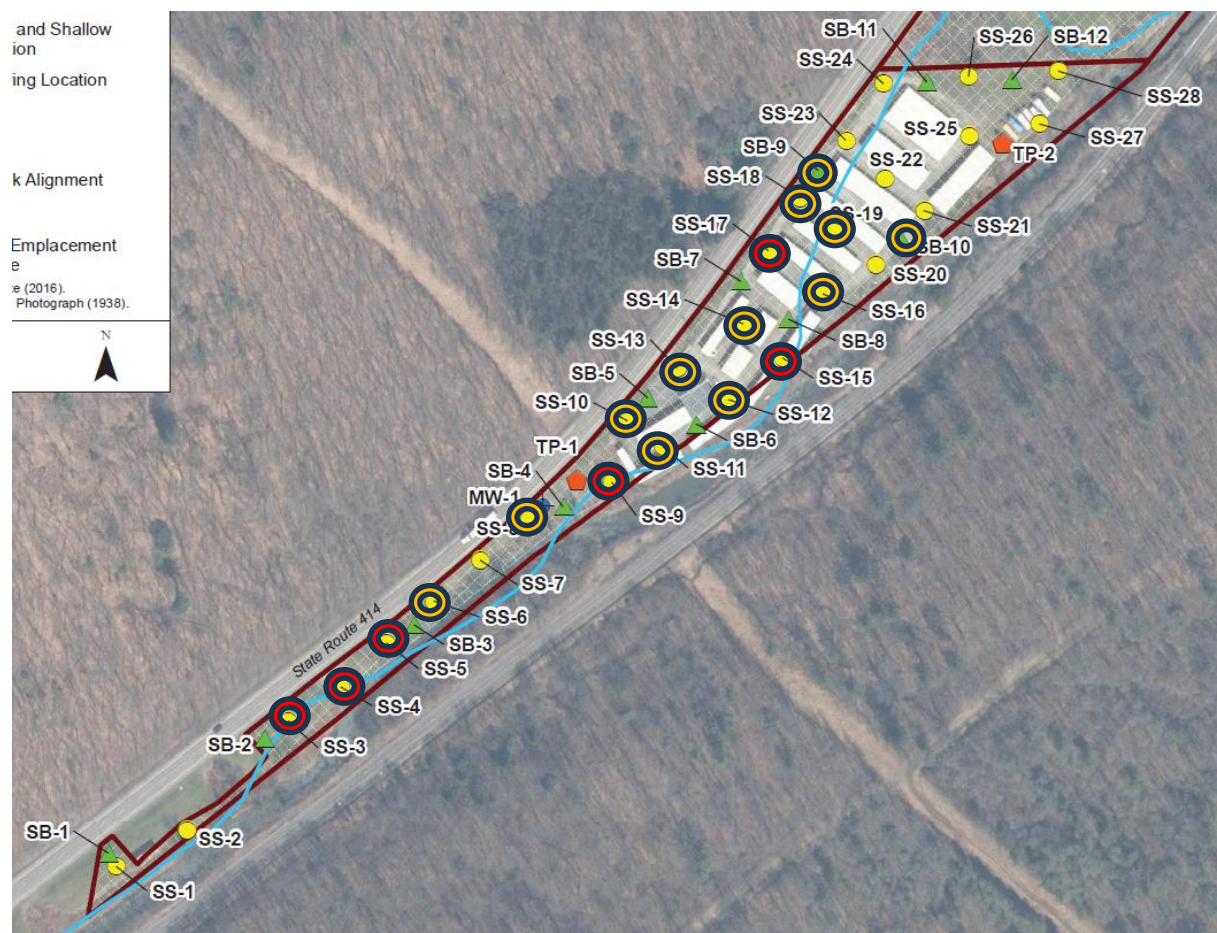
**Work was performed at SS-3,4,5,6,8,9; red circle indicates possible ABG fill; orange circle indicates non-native fill.**

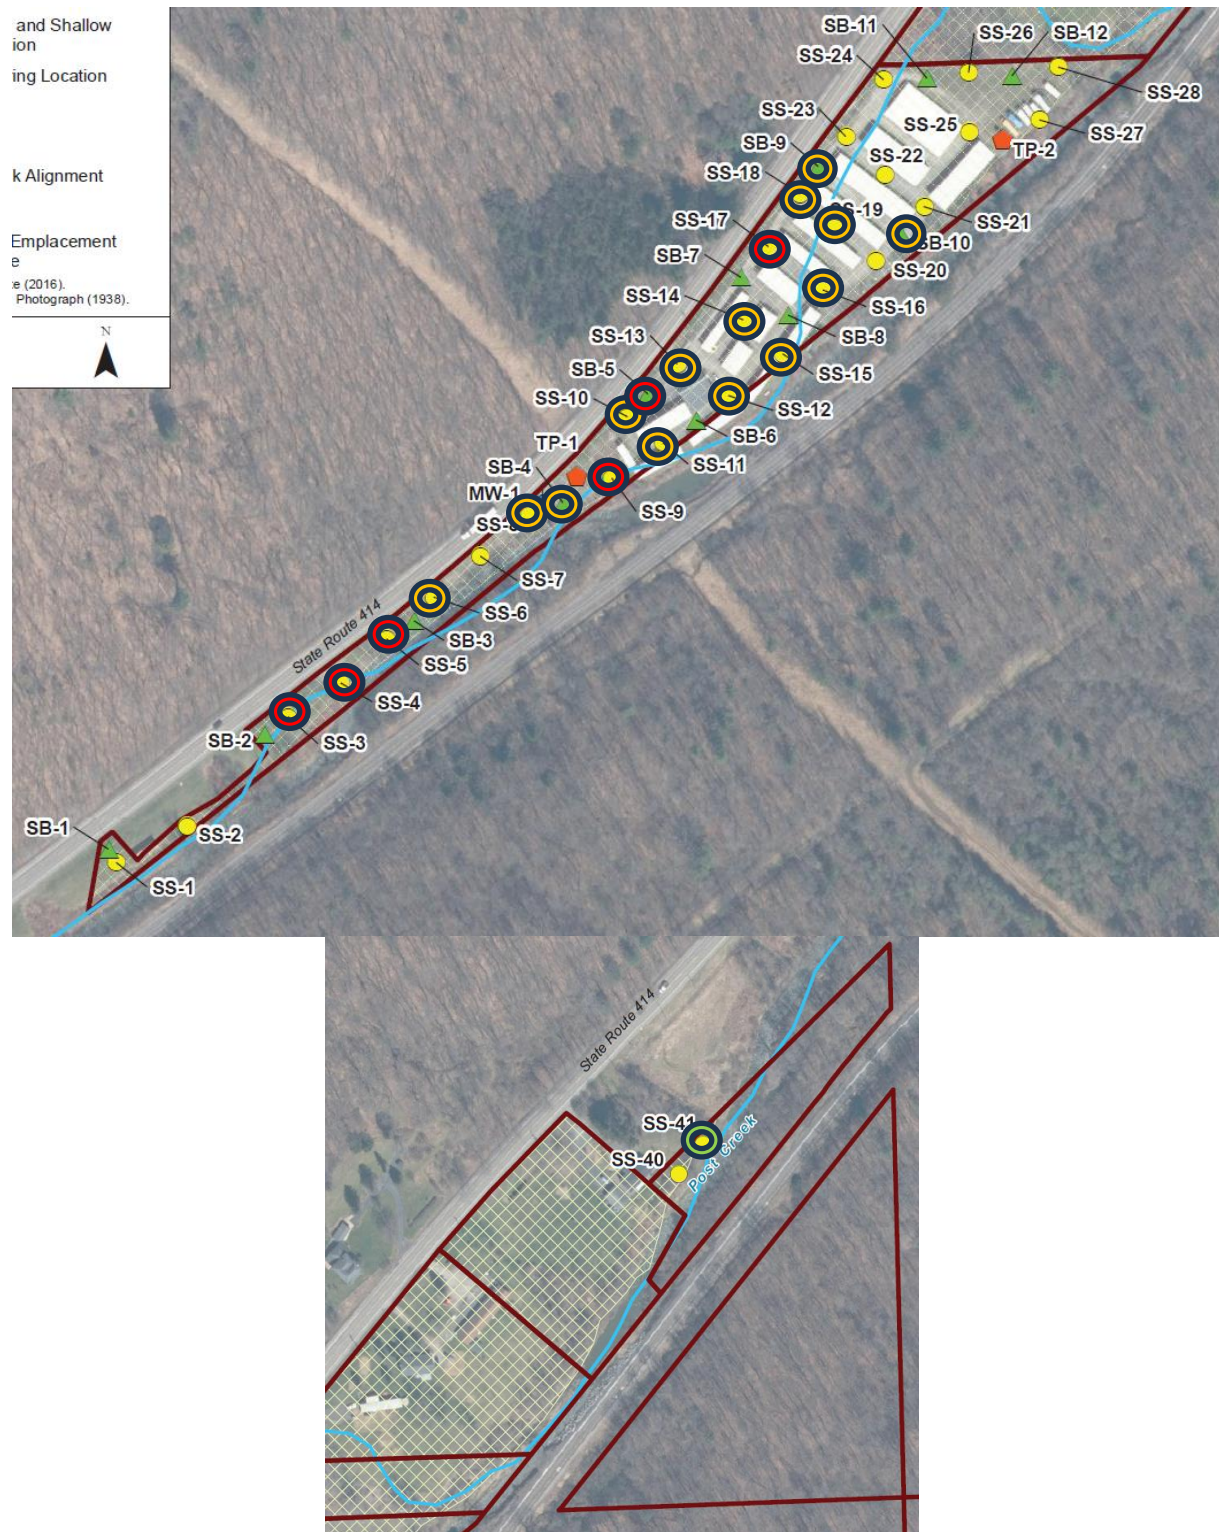
Work was performed at SS-41, SB-05, and SB-04; red circle indicates possible ABG fill; orange circle indicates non-native fill; green indicates no identified fill.

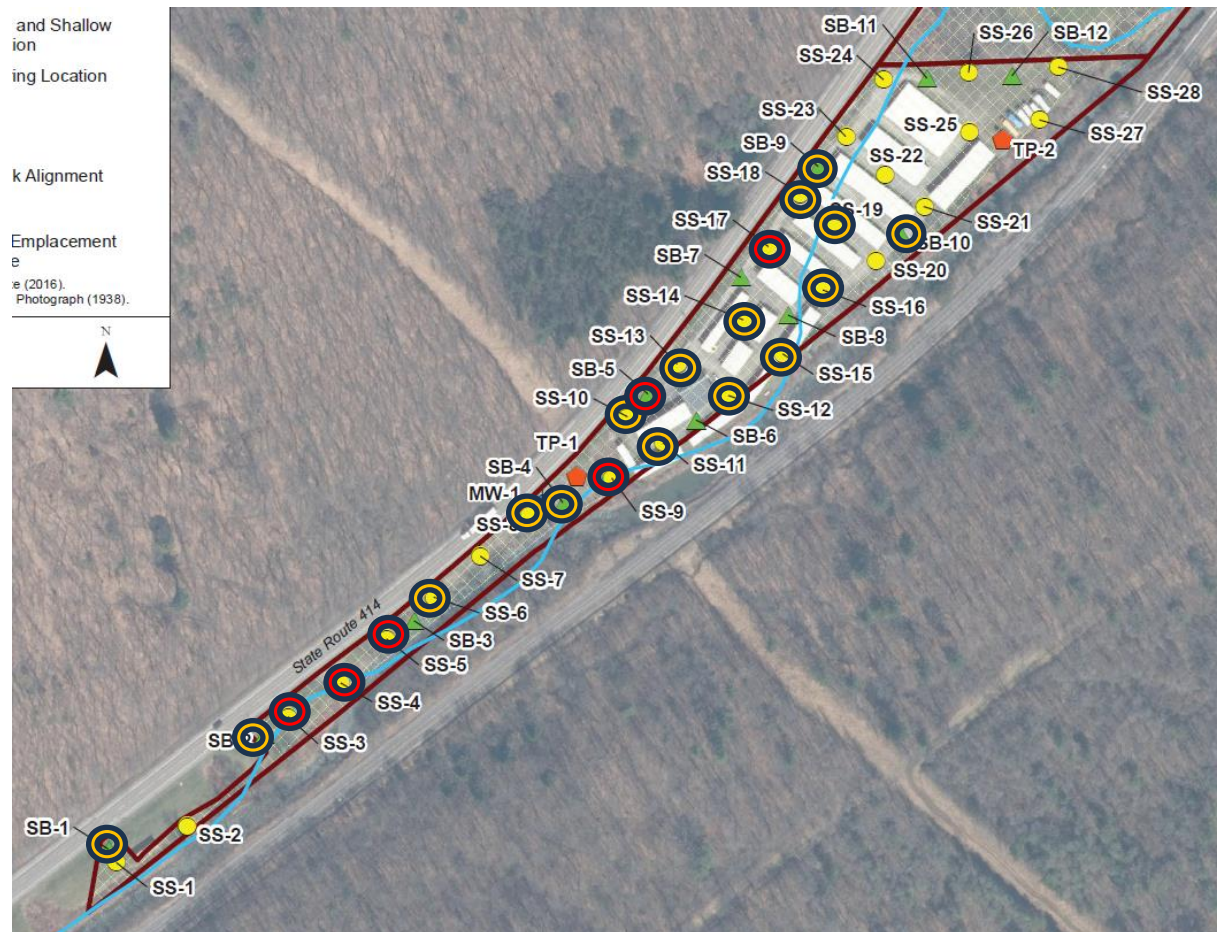
Work was performed at SB-01, and SB-02; red circle indicates possible ABG fill; orange circle indicates non-native fill.

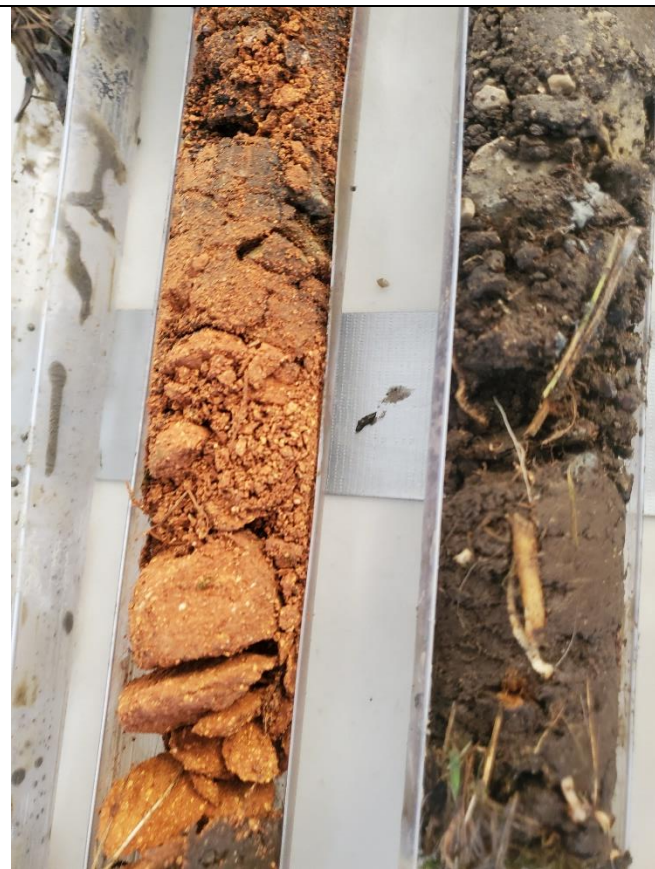
*Picture 4*

SB-02 close up of orange brick from 0-4 FT core

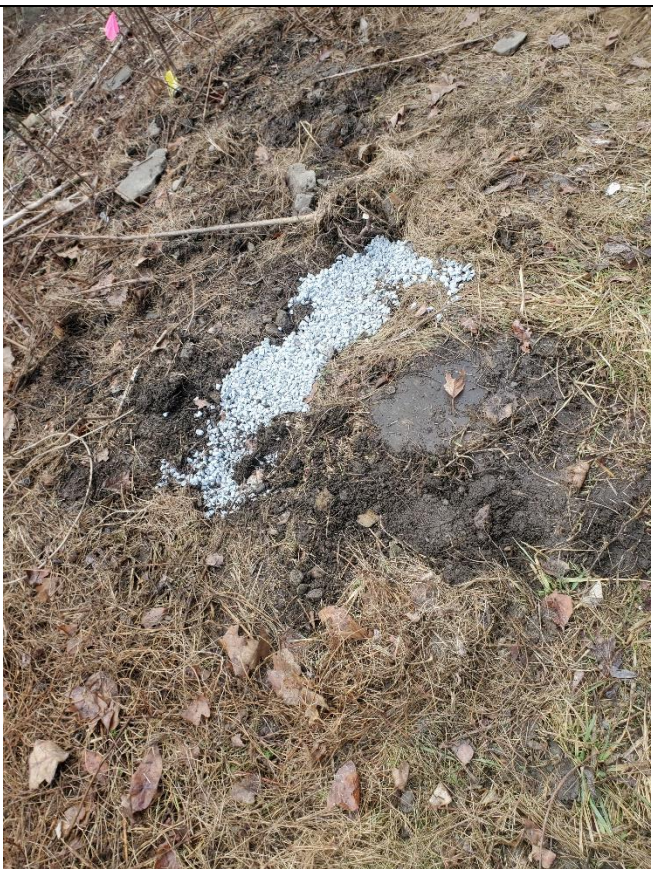
Picture 4  
View looking Southwest: Bentonite chip backfills at SS-07.
