**Remedial Investigation Report Addendum  
Gibson Scrapyard  
NYSDEC Site No. 851058**

**Glass Manufacturing Waste Characterization**

May 2024  
Version: FINAL  
EA Project No. 1602505

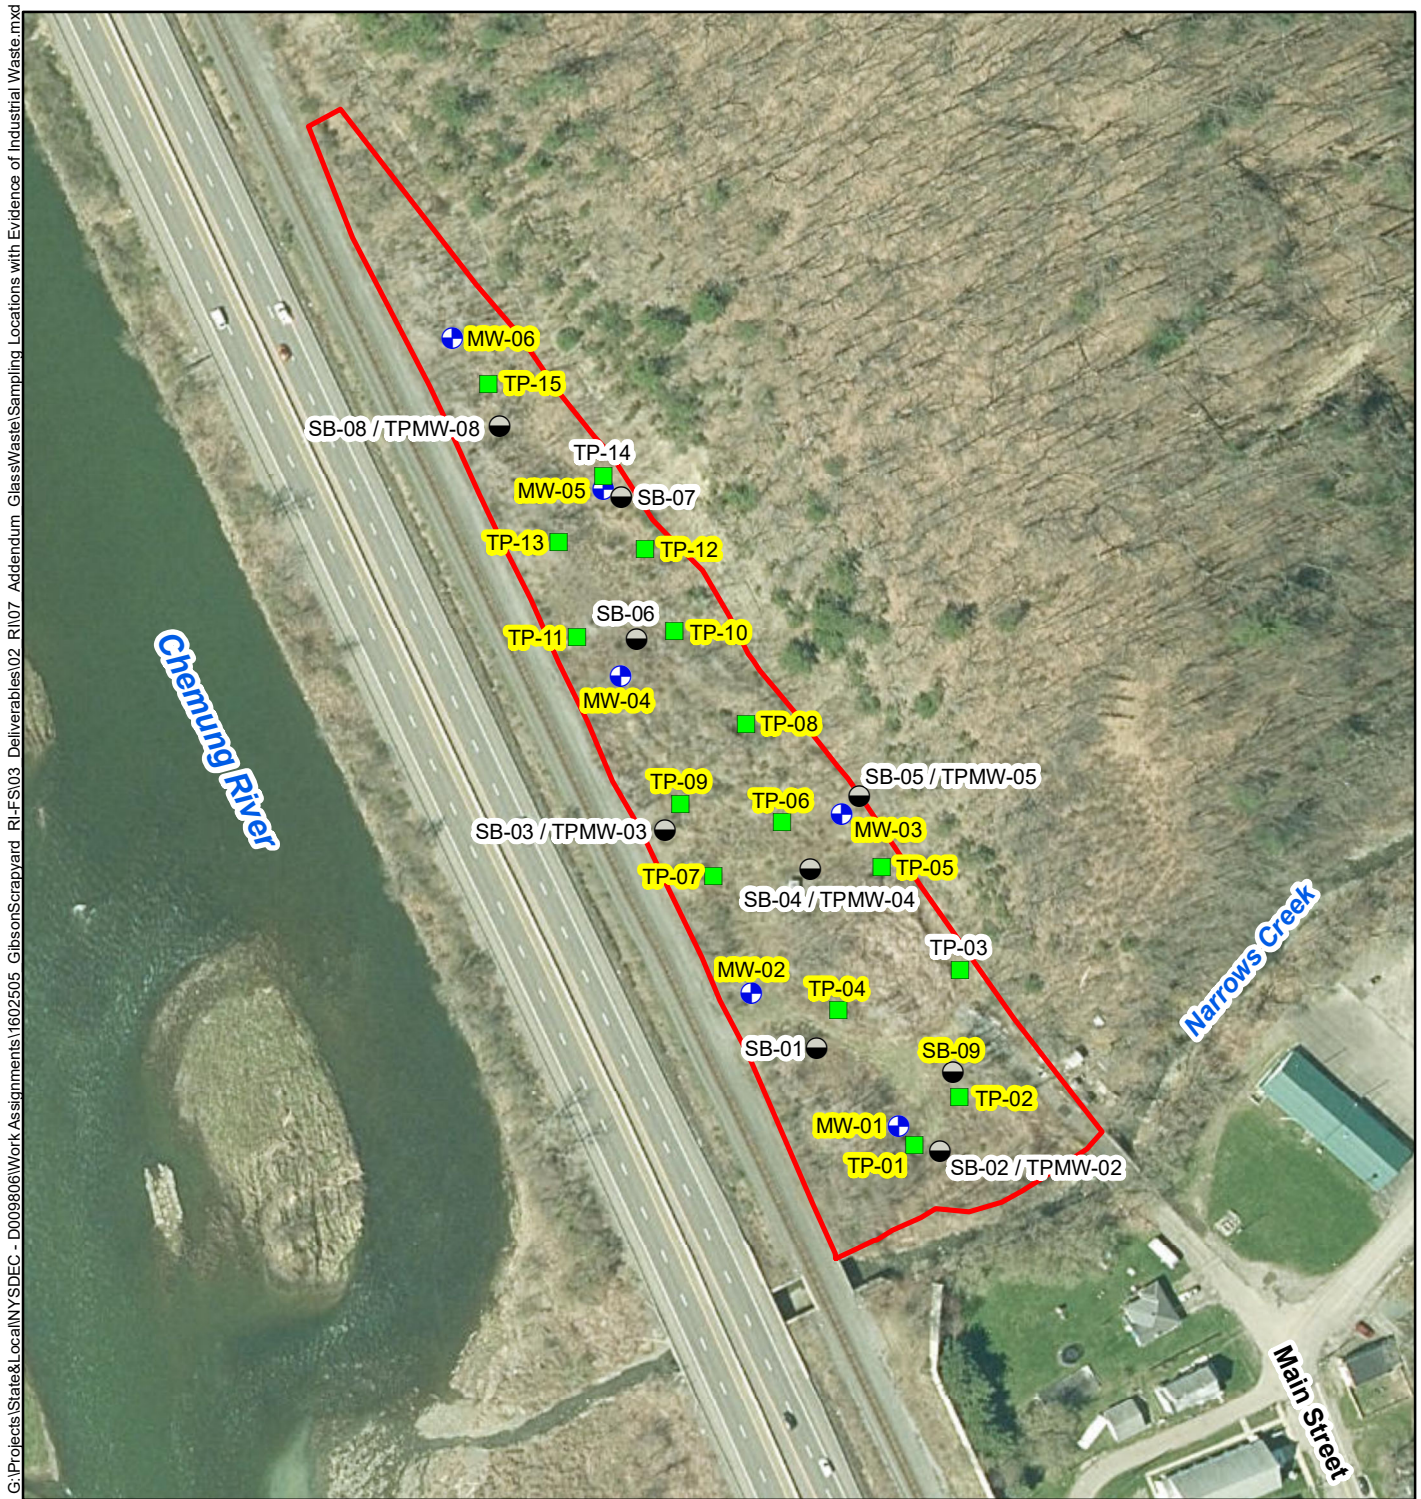
**Figure 1**  
**SAMPLING LOCATIONS WITH EVIDENCE OF**  
**GLASS MANUFACTURING WASTE**  
Gibson Scrapyard (NYSDEC Site 851058) Gibson, NY

**Note:**  
Highlighted sampling locations indicate areas with potential evidence of industrial waste from former glass manufacturing in Corning, New York.

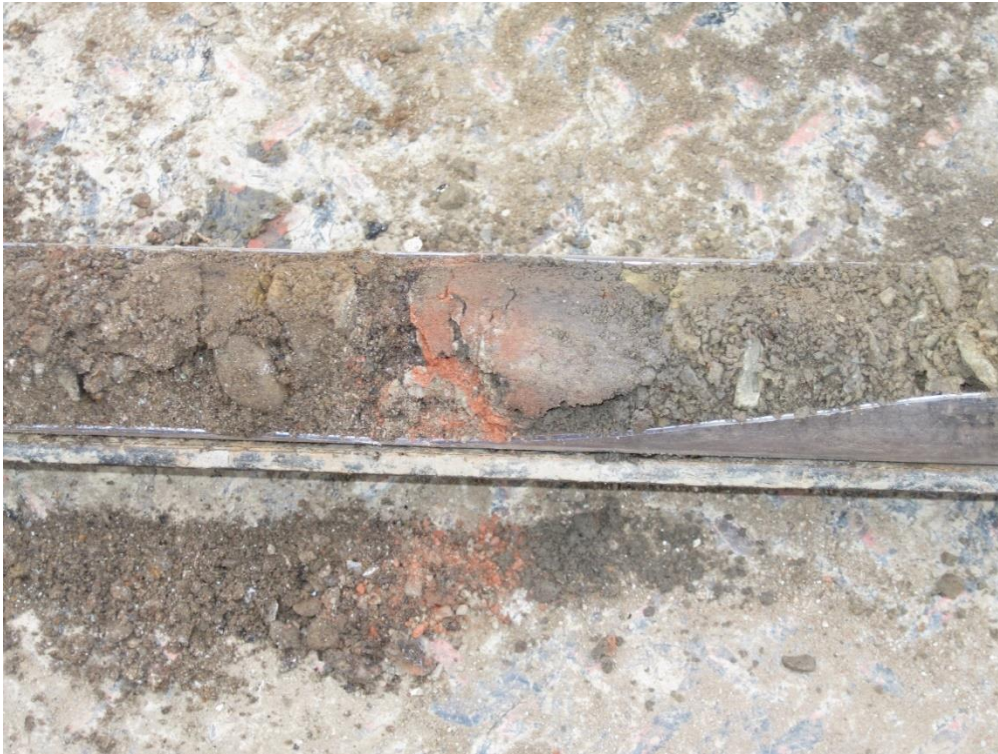
| <b>Photo Name:</b> | "Macrocore2" | <b>Photograph 1</b> |

| <b>Description:</b> | Brick fragments; evidence of in-situ waste | |

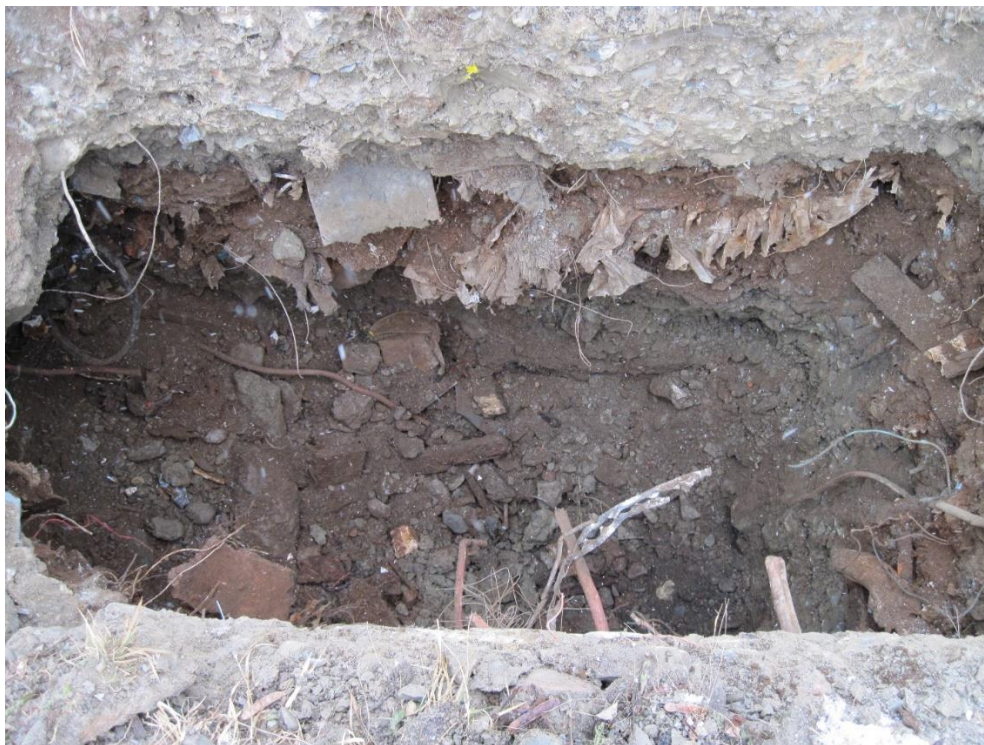
| <b>Photo Name:</b> | "TP01 debris" | <b>Photograph 2</b> |

| Document Date | Document Title | Date Material Found | Material Description (from text/photo) | Location on Site | Category of Waste | Photo Number* |
|---|---|---|---|---|---|---|
| | | 2/17/2010 | brick | TP-01 | in-situ waste | Photo 2, Photo 3 |

| <b>Description:</b> | Brick fragments; evidence of in-situ waste | |

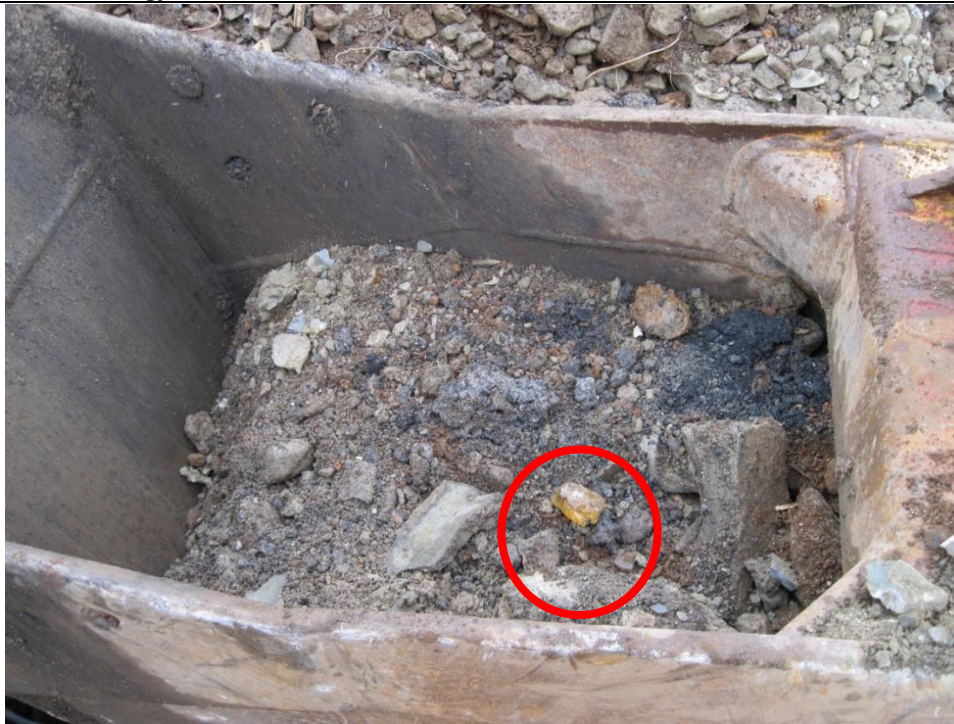
| <b>Photo Name:</b> | “TP01 excavated soil2” | <b>Photograph 3</b> |

| <b>Description:</b> | Yellow glass fragment, black ash; evidence of in-situ waste and glass cullet | |

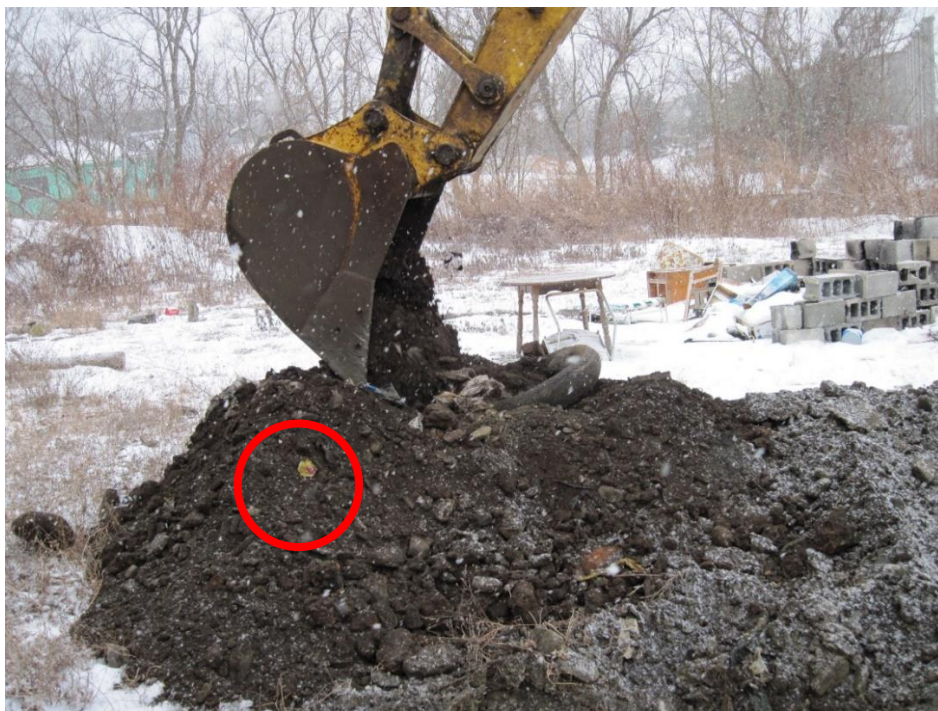
| <b>Photo Name:</b> | “TP02 excavated soil1” | <b>Photograph 4</b> |

| Document Date | Document Title | Date Material Found | Material Description (from text/photo) | Location on Site | Category of Waste | Photo Number* |
|---|---|---|---|---|---|---|
| | | 2/17/2010 | black fill | TP-02 | in-situ waste | Photo 4 |

| <b>Description:</b> | Yellow glass fragments; possible evidence of glass (cullet) | |

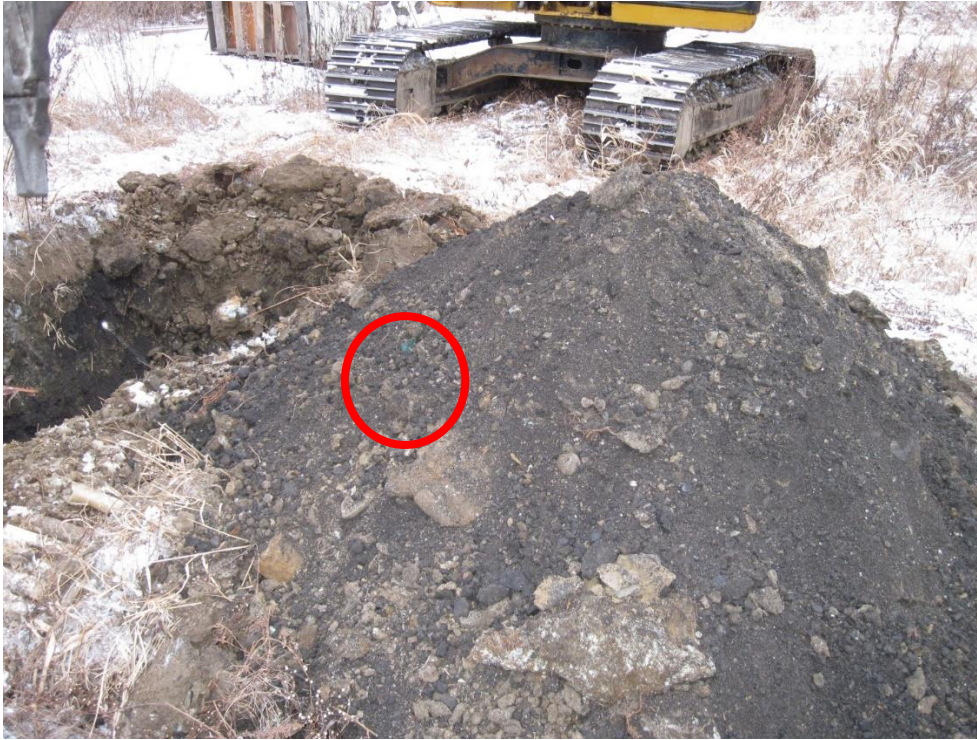
| <b>Photo Name:</b> | "TP04 excavated soil1" | <b>Photograph 5</b> |

| Document Date | Document Title | Date Material Found | Material Description (from text/photo) | Location on Site | Category of Waste | Photo Number* |
|---|---|---|---|---|---|---|
| | | 2/18/2010 | black fill, glass | TP-04 | in-situ waste, glass (cullet) | Photo 5 |

| <b>Description:</b> | Green glass fragment, black ash; evidence of in-situ waste and glass (cullet) | |

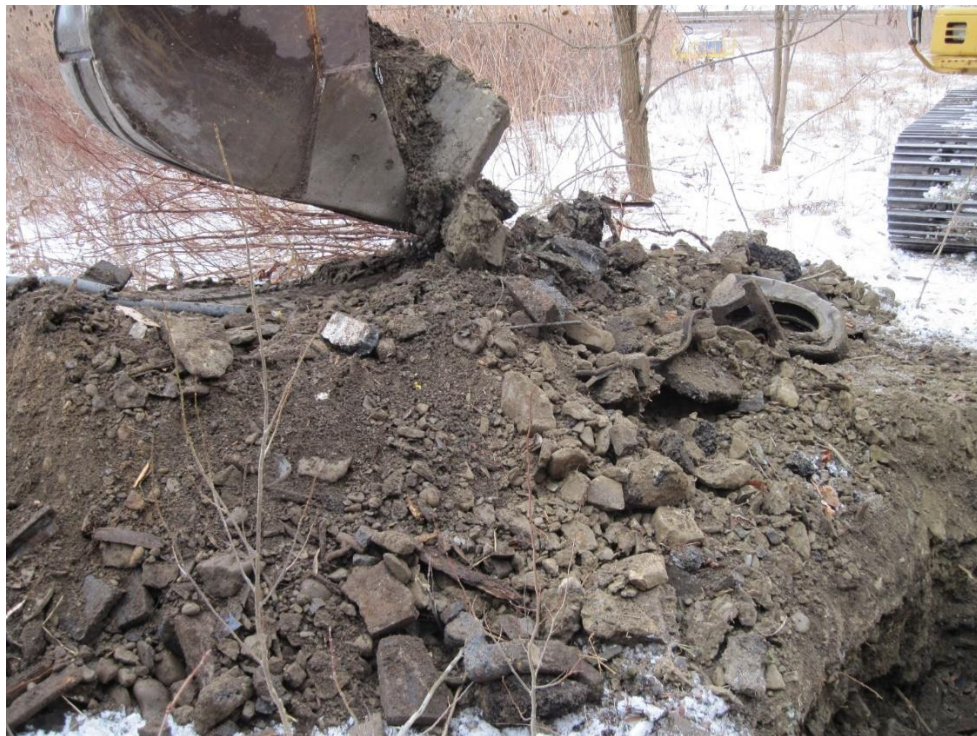
| <b>Photo Name:</b> | "TP05 excavated soil1" | <b>Photograph 6</b> |

| Document Date | Document Title | Date Material Found | Material Description (from text/photo) | Location on Site | Category of Waste | Photo Number* |
|---|---|---|---|---|---|---|
| | | 2/18/2010 | brick | TP-05 | in-situ waste | Photo 6 |

| <b>Description:</b> | Brick fragments; evidence of in-situ waste | |

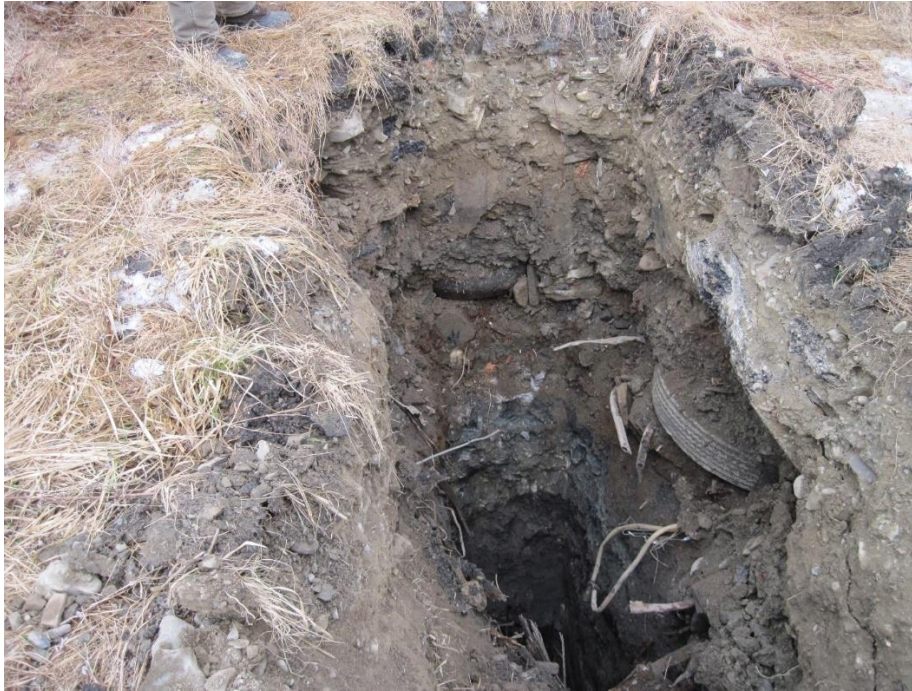
| <b>Photo Name:</b> | “TP06 wall4” | <b>Photograph 7</b> |

| Document Date | Document Title | Date Material Found | Material Description (from text/photo) | Location on Site | Category of Waste | Photo Number* |
|---|---|---|---|---|---|---|
| | | 2/18/2010 | black fill, brick, glass | TP-06 | in-situ waste, glass (cullet) | Photo 7 |

| <b>Description:</b> | Black ash; evidence of in-situ waste | |

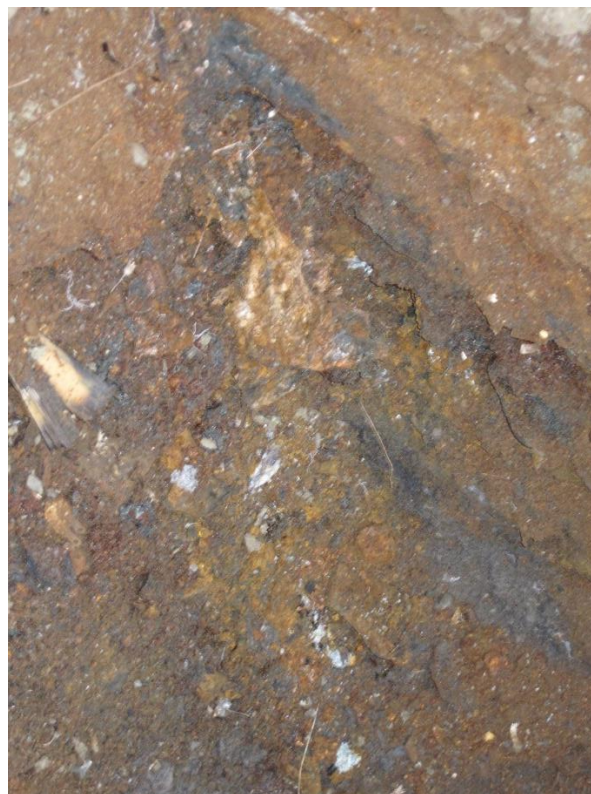
| <b>Photo Name:</b> | “TP07 pit” | <b>Photograph 8</b> |

| Document Date | Document Title | Date Material Found | Material Description (from text/photo) | Location on Site | Category of Waste | Photo Number* |
|---|---|---|---|---|---|---|
| | | 2/18/2010 | black ash fill, brick | TP-07 | in-situ waste | Photo 8, Photo 9 |

| <b>Description:</b> | Black ash; evidence of in-situ waste | |

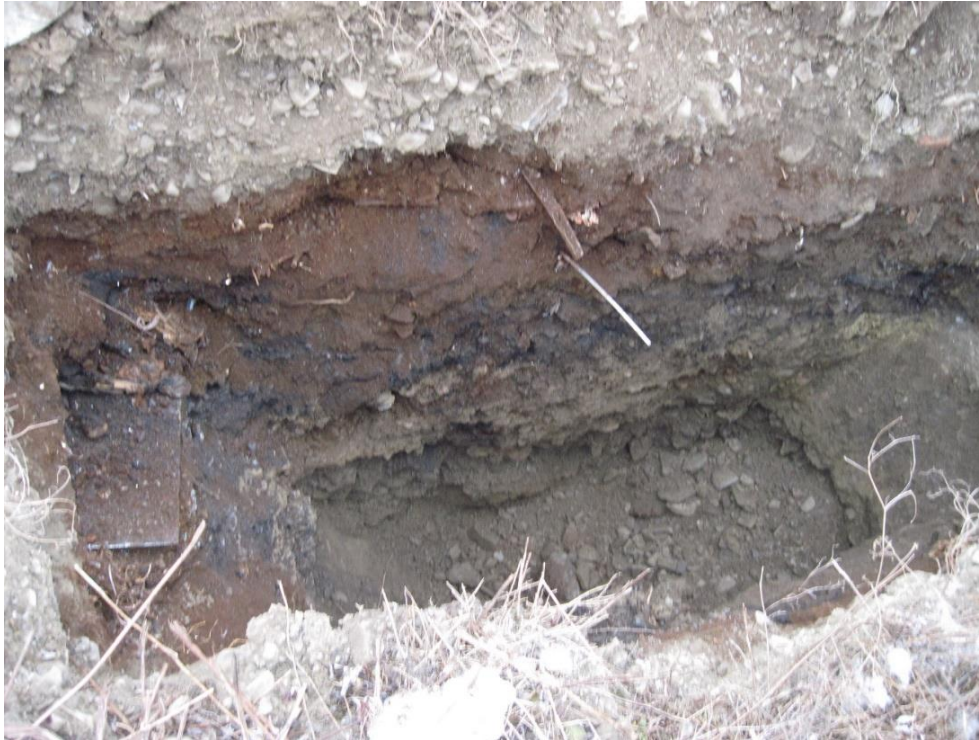
| <b>Photo Name:</b> | “TP07 wall1” | <b>Photograph 9</b> |

| <b>Description:</b> | Black ash; evidence of in-situ waste | |

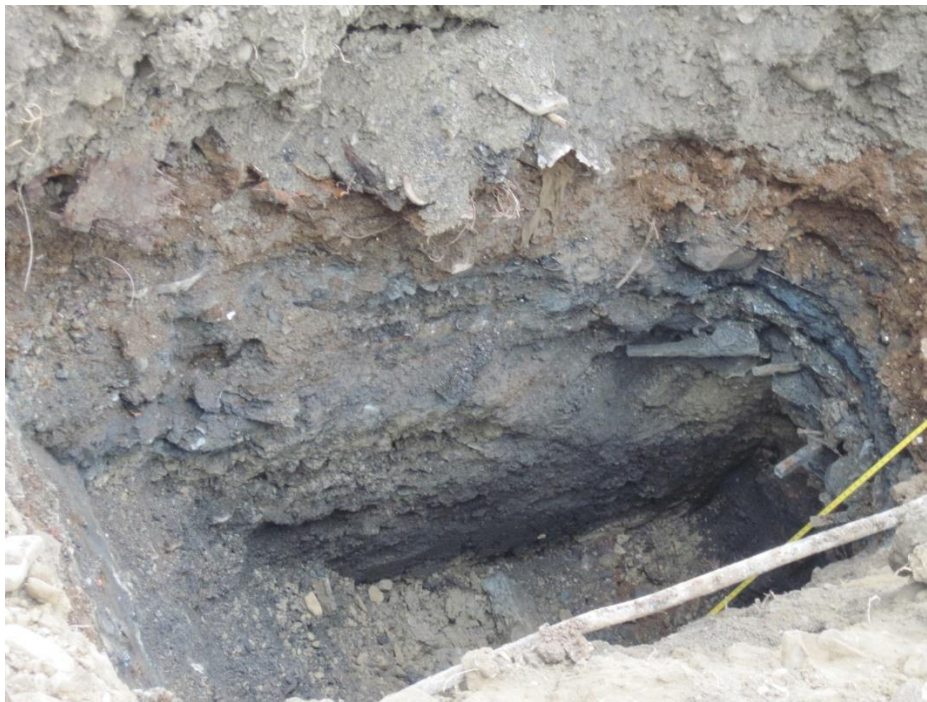
| <b>Photo Name:</b> | “TP08 sidewall2” | <b>Photograph 10</b> |

| Document Date | Document Title | Date Material Found | Material Description (from text/photo) | Location on Site | Category of Waste | Photo Number* |
|---|---|---|---|---|---|---|
| | | 2/19/2010 | black ash fill, brick | TP-08 | in-situ waste | Photo 10 |

| <b>Description:</b> | Black ash; evidence of in-situ waste | |

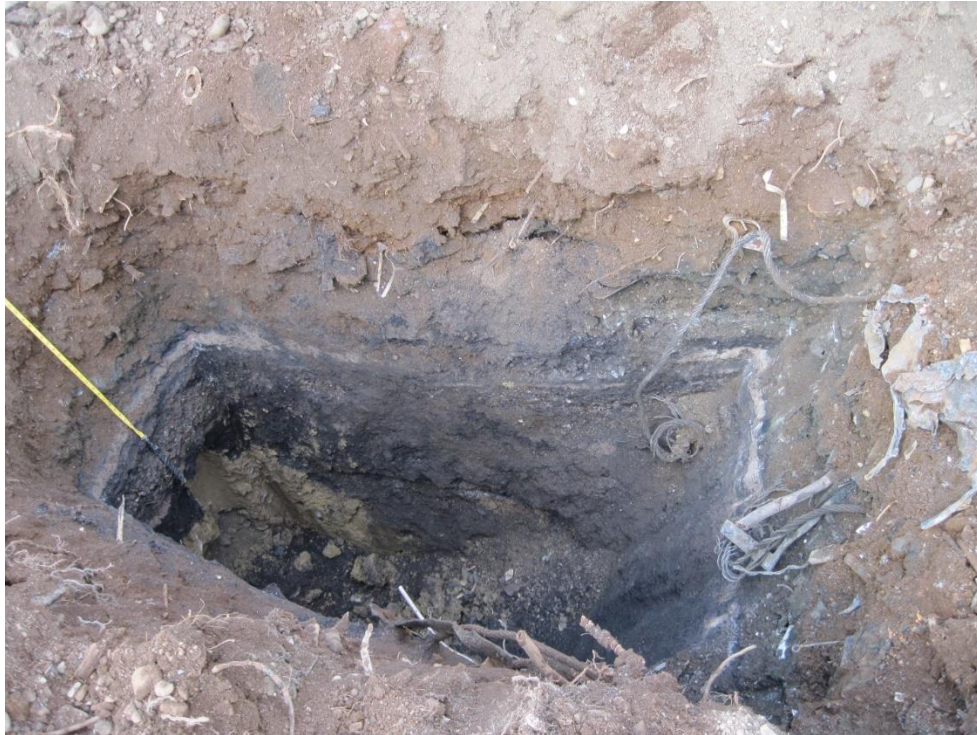
| <b>Photo Name:</b> | "TP09 sidewall1" | <b>Photograph 11</b> |

| Document Date | Document Title | Date Material Found | Material Description (from text/photo) | Location on Site | Category of Waste | Photo Number* |
|---|---|---|---|---|---|---|
| | | 2/19/2010 | black ash | TP-09 | in-situ waste | Photo 11 |

| <b>Description:</b> | Black ash; evidence of in-situ waste | |

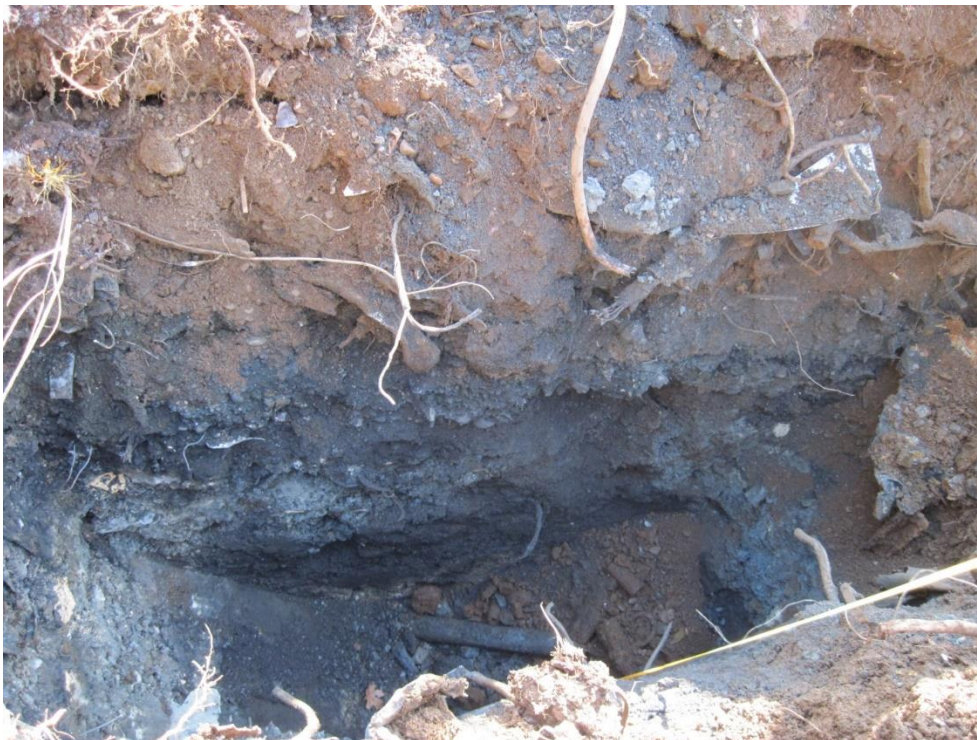
| <b>Photo Name:</b> | "TP10 sidewall2" | <b>Photograph 12</b> |

| Document Date | Document Title | Date Material Found | Material Description (from text/photo) | Location on Site | Category of Waste | Photo Number* |
|---|---|---|---|---|---|---|
| | | 2/19/2010 | black silt fill, glass, brick | TP-10 | in-situ waste, glass (cullet) | Photo 12 |

| <b>Description:</b> | Black ash; evidence of in-situ waste | |

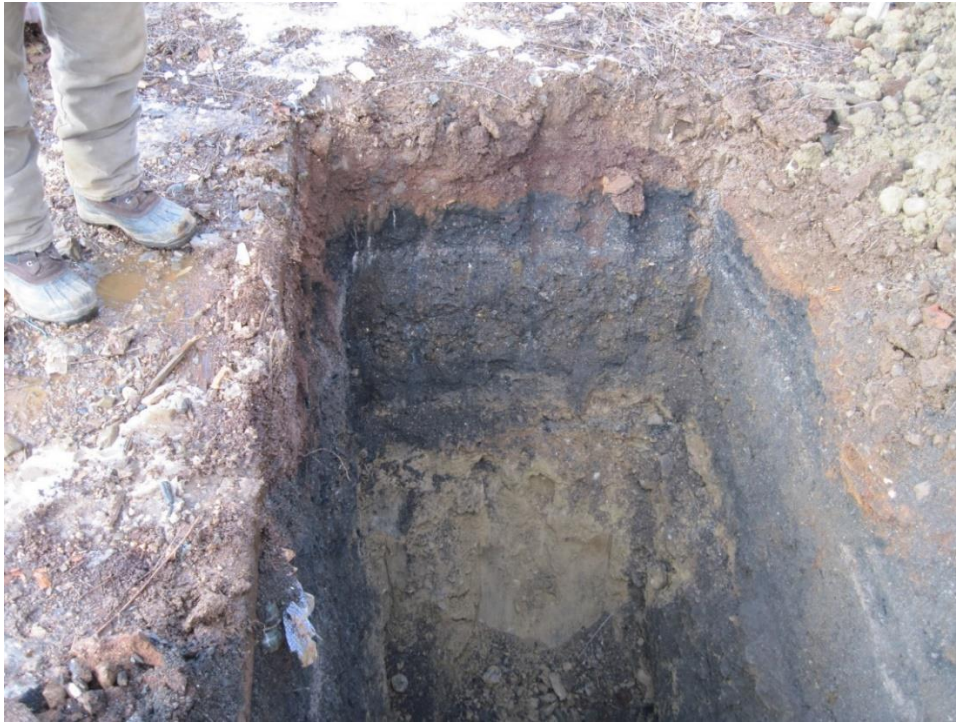
| <b>Photo Name:</b> | "TP11 frontwall" | <b>Photograph 13</b> |

| Document Date | Document Title | Date Material Found | Material Description (from text/photo) | Location on Site | Category of Waste | Photo Number* |
|---|---|---|---|---|---|---|
| | | 2/19/2010 | black burnt soil, brick, glass | TP-11 | in-situ waste | Photo 13 |

| <b>Description:</b> | Black ash; evidence of in-situ waste | |

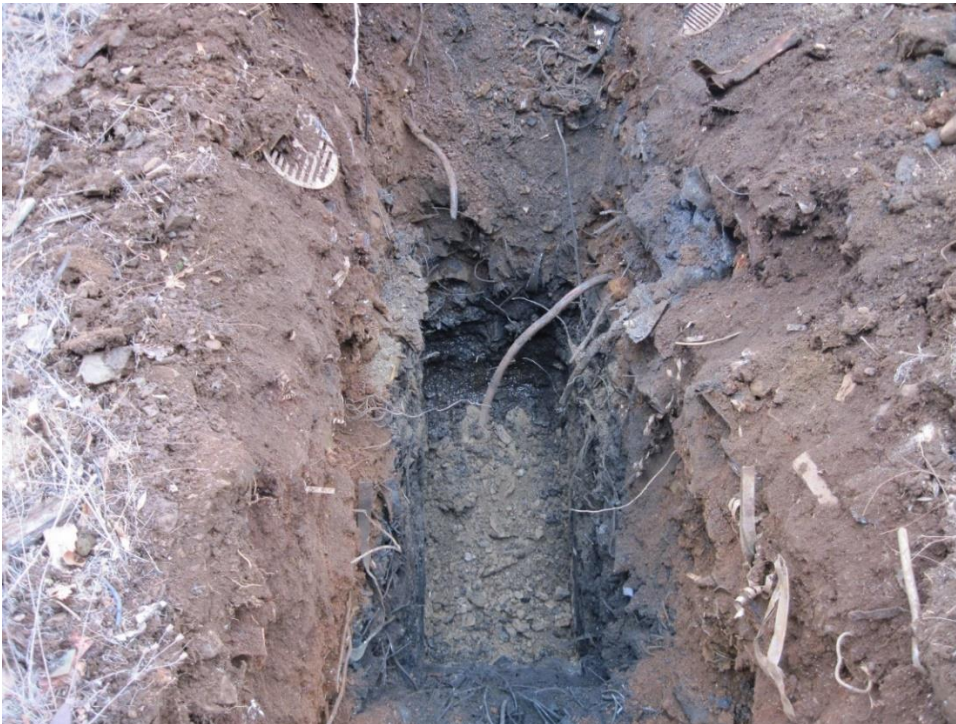
| <b>Photo Name:</b> | "TP12 pit 3" | <b>Photograph 14</b> |

| Document Date | Document Title | Date Material Found | Material Description (from text/photo) | Location on Site | Category of Waste | Photo Number* |
|---|---|---|---|---|---|---|
| | | 2/22/2010 | brick, black ash | TP-12 | in-situ waste | Photo 14 |

| <b>Description:</b> | Black ash; evidence of in-situ waste | |

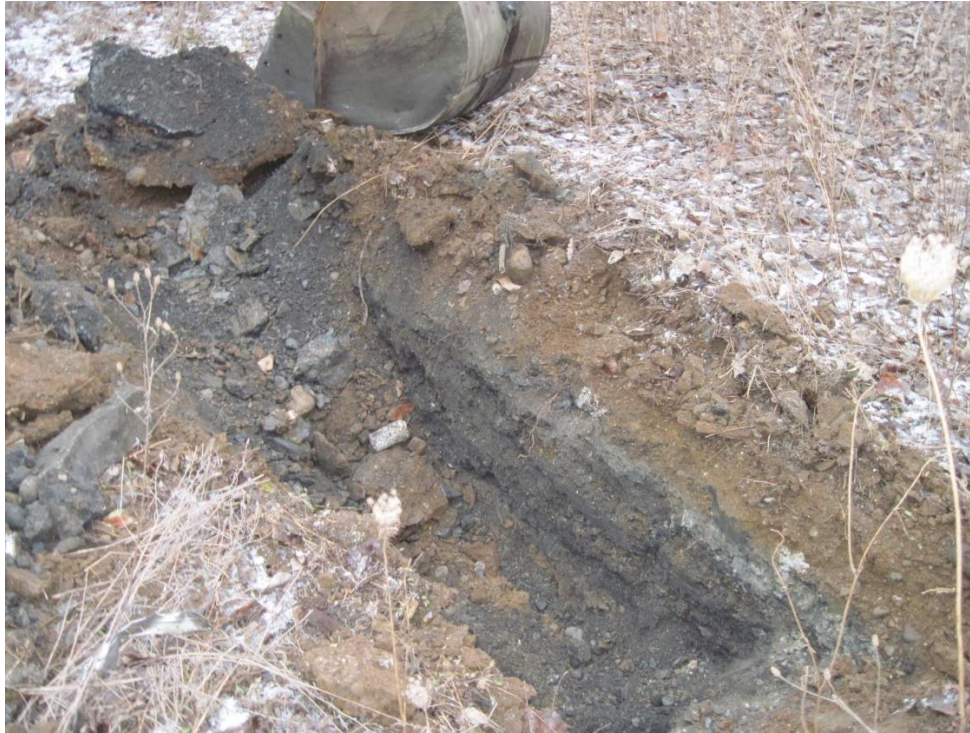
| <b>Photo Name:</b> | “TP13 excavation2” | <b>Photograph 15</b> |

| Document Date | Document Title | Date Material Found | Material Description (from text/photo) | Location on Site | Category of Waste | Photo Number* |
|---|---|---|---|---|---|---|
| | | 2/23/2010 | black ash | TP-13 | in-situ waste | Photo 15 |

| <b>Description:</b> | Black ash; evidence of in-situ waste | |

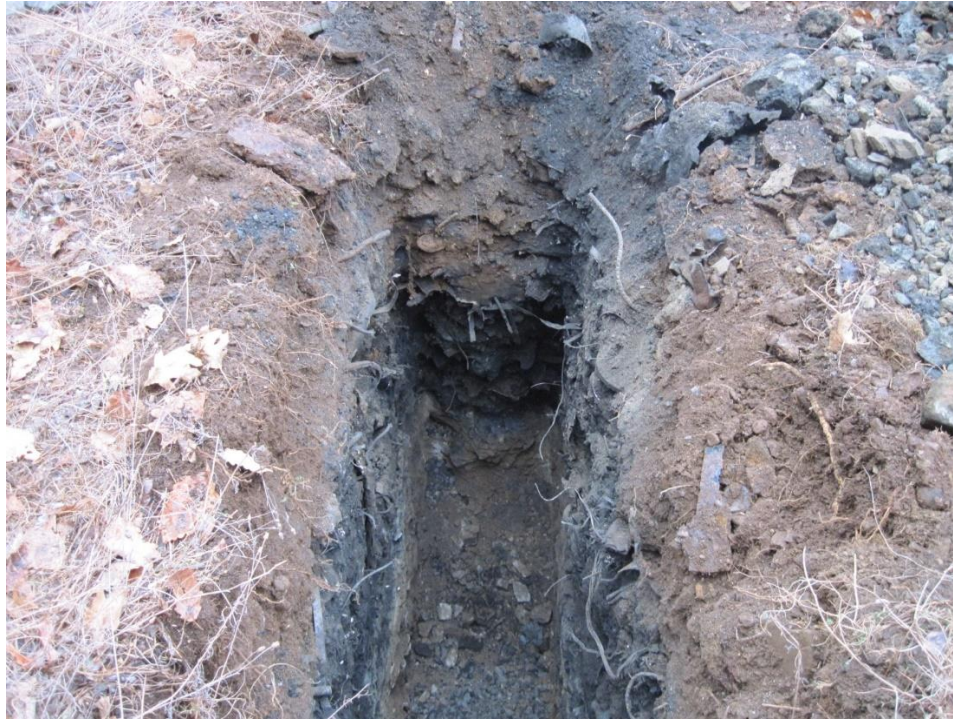
| <b>Photo Name:</b> | “TP14 backwall” | <b>Photograph 16</b> |

| <b>Description:</b> | Black ash; evidence of in-situ waste | |

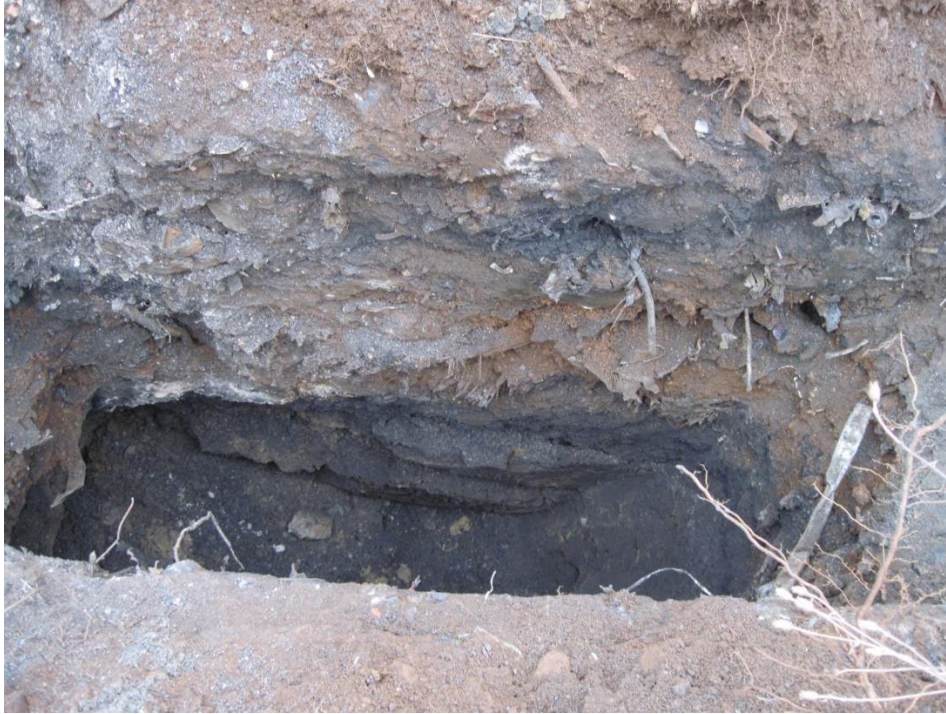
| <b>Photo Name:</b> | “TP15 sidewall1” | <b>Photograph 17</b> |

| Document Date | Document Title | Date Material Found | Material Description (from text/photo) | Location on Site | Category of Waste | Photo Number* |
|---|---|---|---|---|---|---|
| | | 2/23/2010 | black ash, brick, glass | TP-15 | in-situ waste, glass (cullet) | Photo 17 |

| <b>Description:</b> | Black ash; evidence of in-situ waste | |

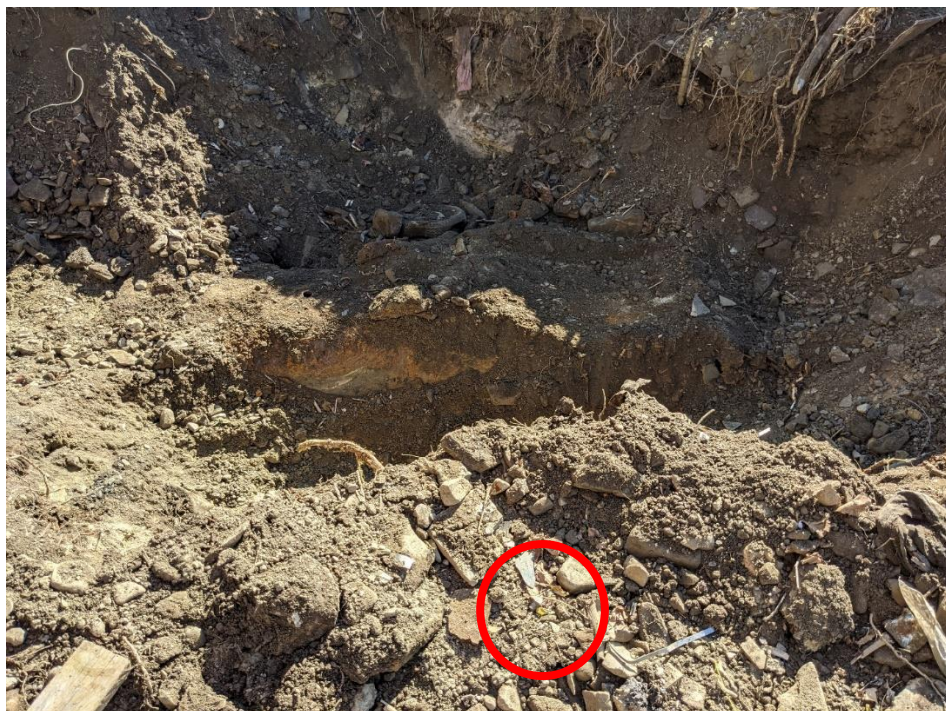
| <b>Photo Name:</b> | “PXL_20201110_164810714” | <b>Photograph 18</b> |

In November 2020, an underground storage tank (UST) found at test pit TP-05 was removed. Photographs from this field activity (**Appendix B**) show evidence of yellow glass in the excavated soil.

| <b>Description:</b> | Yellow glass fragment; evidence of glass (cullet) | |

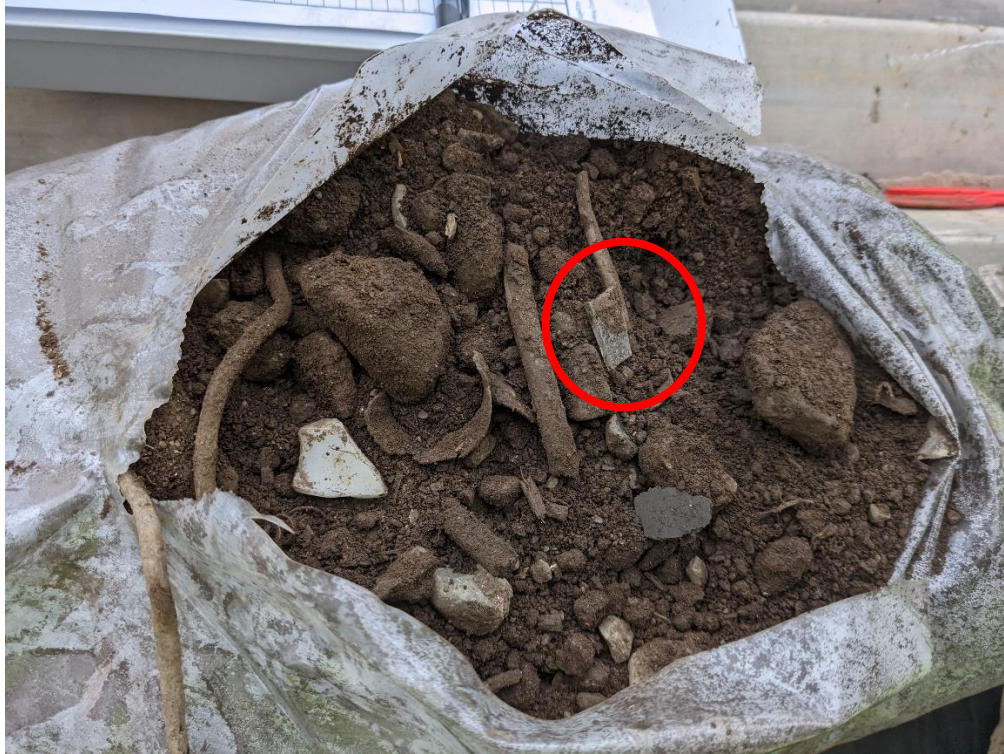
| <b>Photo Name:</b> | "PXL 20210106 192348336" | <b>Photograph 19</b> |

In January 2021, photographs from installation of monitoring well MW- 01 (**Appendix B**) show evidence of glass found in the boring.

| <b>Description:</b> | Glass fragment; evidence of glass | |
