#### DAILY INSPECTION REPORT - No. x

Area Wide Study, Site No.

Date: 08/19/2025

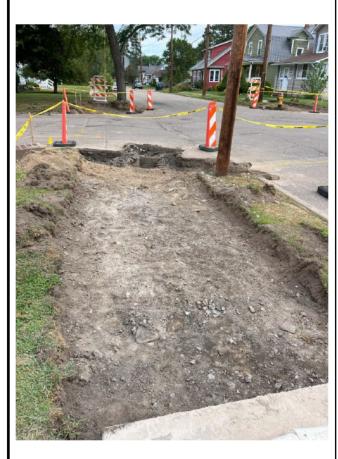
#### Picture 1

View facing north: Excavation on the southwest corner of Onondaga Stand Cutler Ave. Ash and glass cullet are visible in the bottom of the excavation.

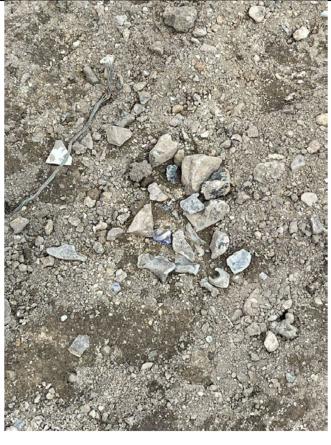
#### Picture 2

View facing down: Small pile of cullet found the base of the excavation for the ADA ramps.

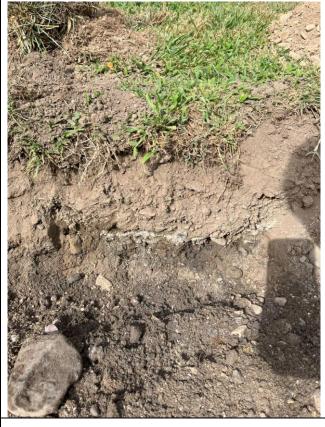
#### Picture 5

View facing north: Northeast corner of Onondaga St and Cutler Ave. No ABG observed in the open excavation.

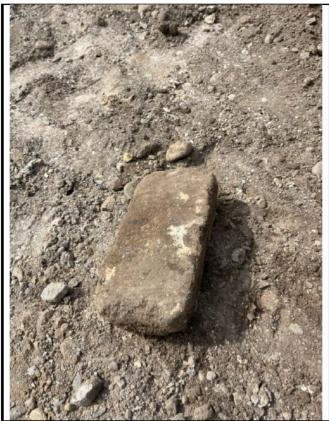
Picture 7

View facing down: Intact furnace brick observed in the bottom of the excavation for ADA ramps in the southwest corner of Onondaga St and Cutler Ave.

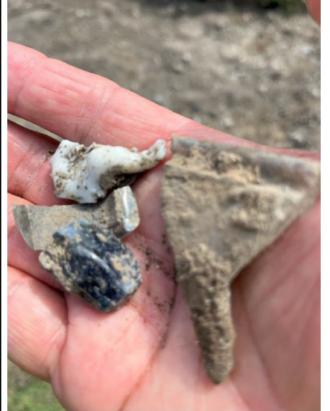
Picture 8

View facing down: Cullet and glass observed in the bottom of the excavation for ADA ramps in the southwest corner of Onondaga St and Cutler Ave.
