# PERIODIC REVIEW REPORT MARCH 2021 – FEBRUARY 2022

## RANDO MACHINE CORPORATION SITE MONITORING PROGRAM MACEDON, NEW YORK 14502

NYSDEC Site No. 859014

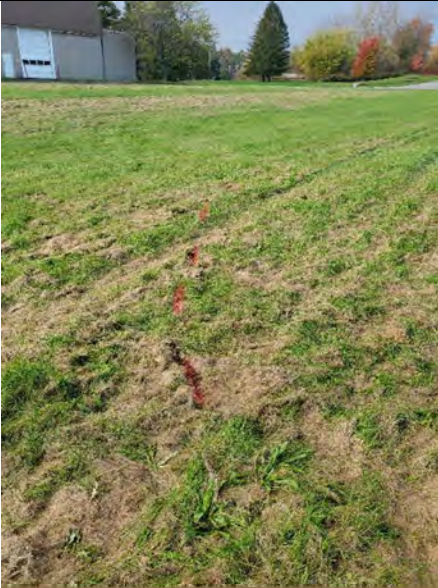
**Photo 1:** View of the subsurface obstructions marked out by Greencastle; assumed to be large field stones left within the swale embankment area near B412-OW-D's future location.

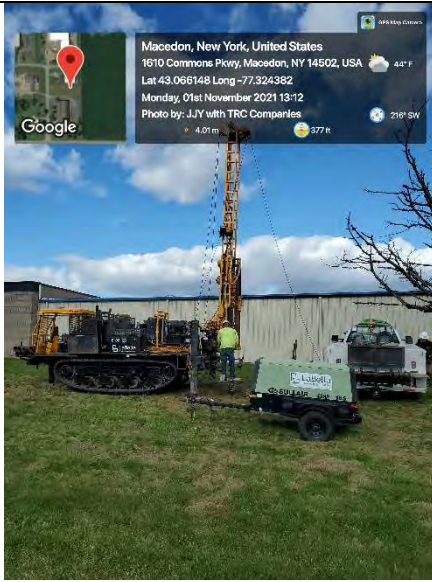
**Photo 1:** LaBella driving the well casing into the soil for B412-OW-D's installation.

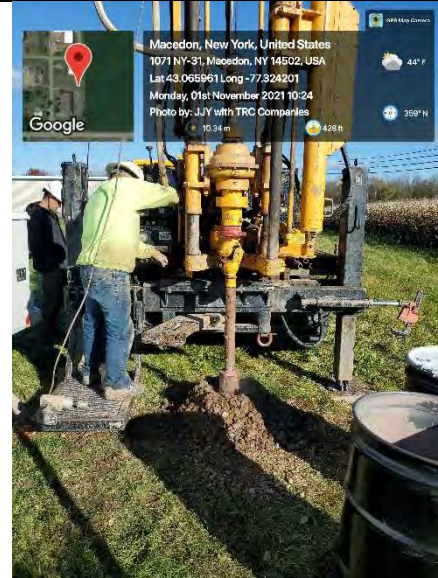
**Photo 4:** LaBella driving the well casing into the soil for B412-OW-E's installation.

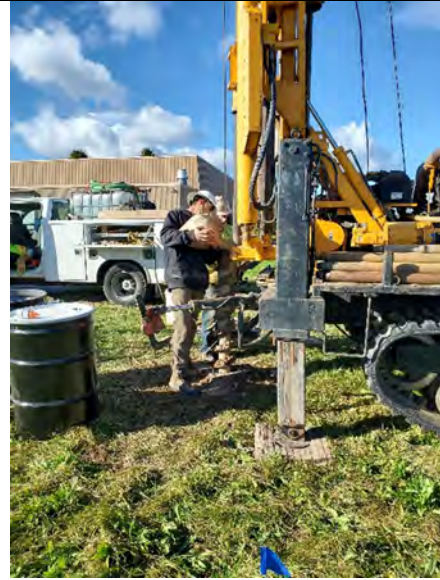
**Photo 6:** B412-OW-E receiving grout for casing stabilization.

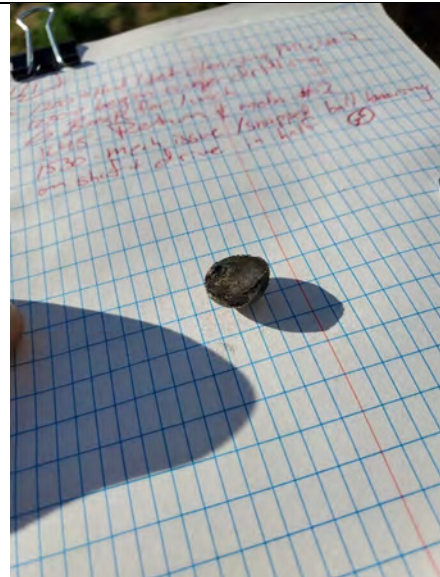
**Photo 8:** Sheered ball bearing from when mechanical issues arose at the B412-OW-D location.

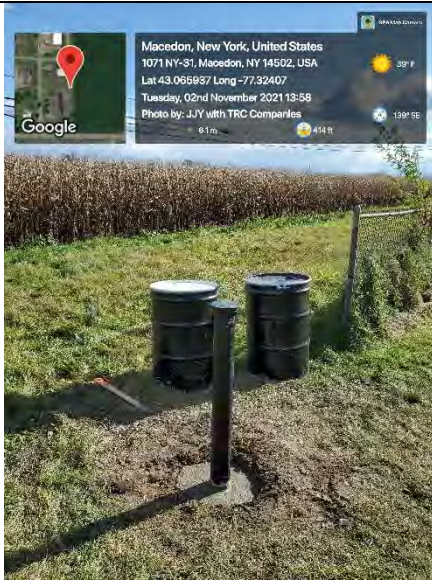
**Photo 1:** Final vicinity shot of B412-OW-E and its staged drums of soil excavation; grouted in place.

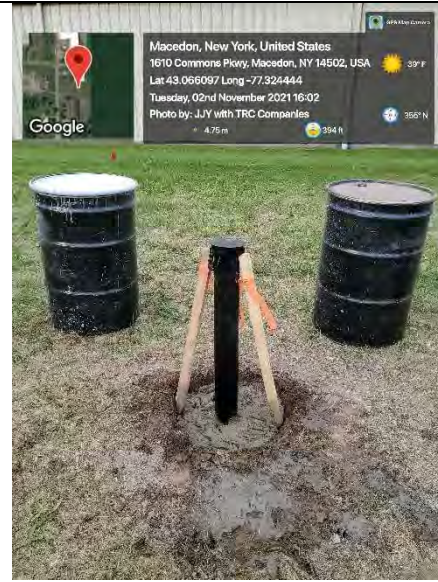
**Photo 2:** Final vicinity shot of B412-OW-D and its staged drums of soil excavation; grouted in place.

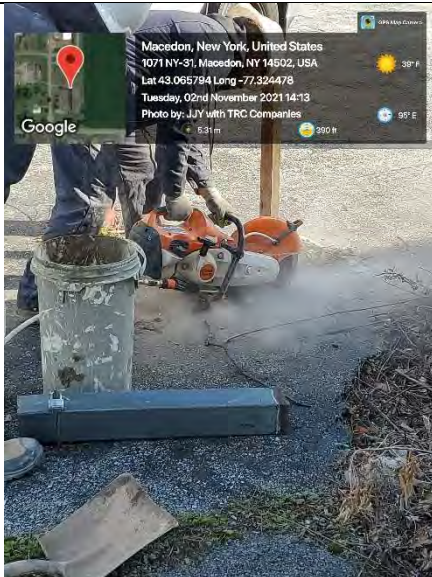
**Photo 3:** LaBella cutting the asphalt area around the base of B206-OW-C in order to replace the riser.

By 1415, LaBella began to cut out the 2-ft x 2-ft area around the base of B206-OW-C in order to pour the new base and riser; this finished around 1530. Following B206-OW-C's repair efforts, LaBella began to stage the soil drums by their associated bore locations, wrapping the day's efforts up around 1600.

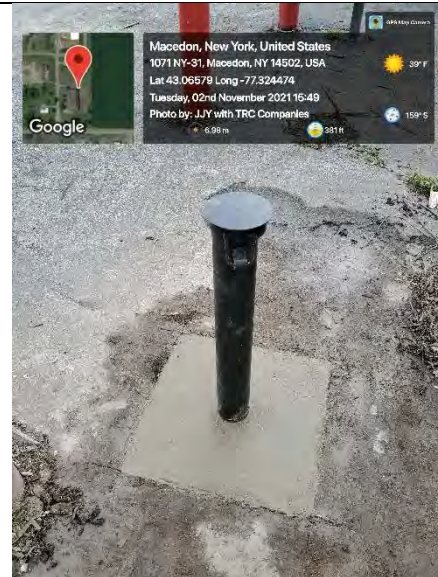
**Photo 4:** Final vicinity shot of B206-OW-C and its new riser and cap; grouted in place.

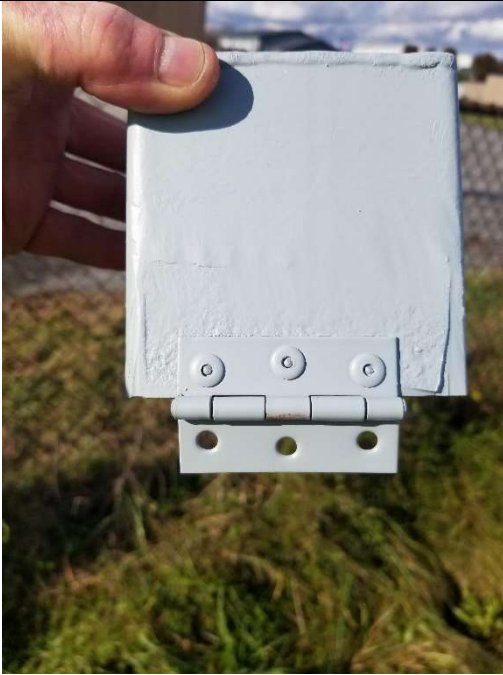
**Photo 5:** B103-OW-A's new cap and hinge; as fabricated by LaBella.

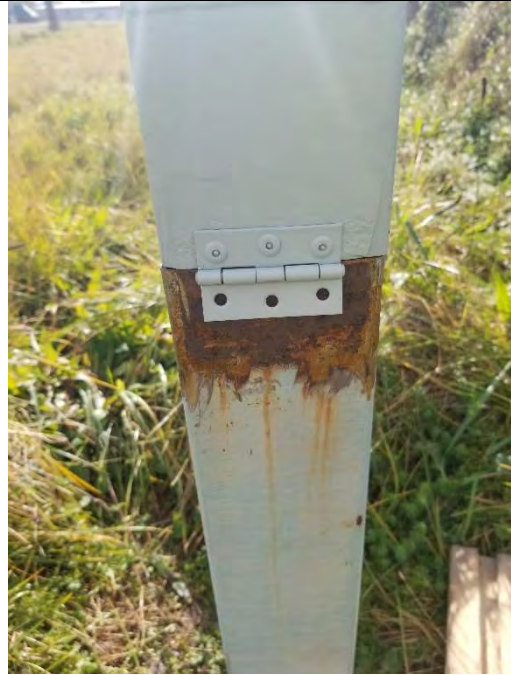
**Photo 6:** B103-OW-A's new cap and hinge; staged in the mount position.

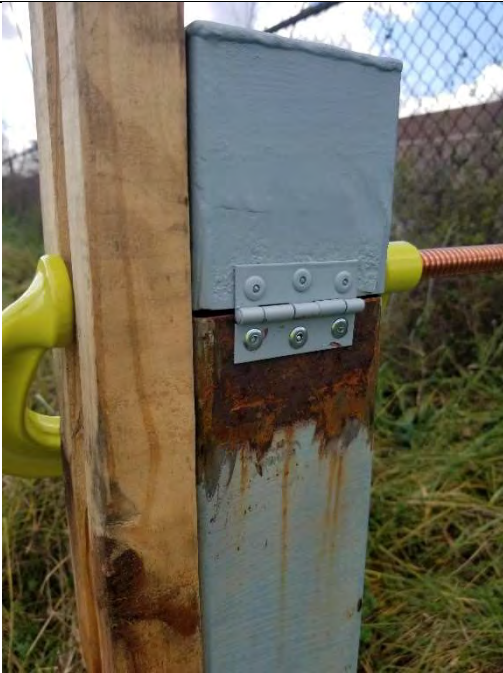
**Photo 7:** B103-OW-A's new cap and hinge; attached to the riser in the final position.

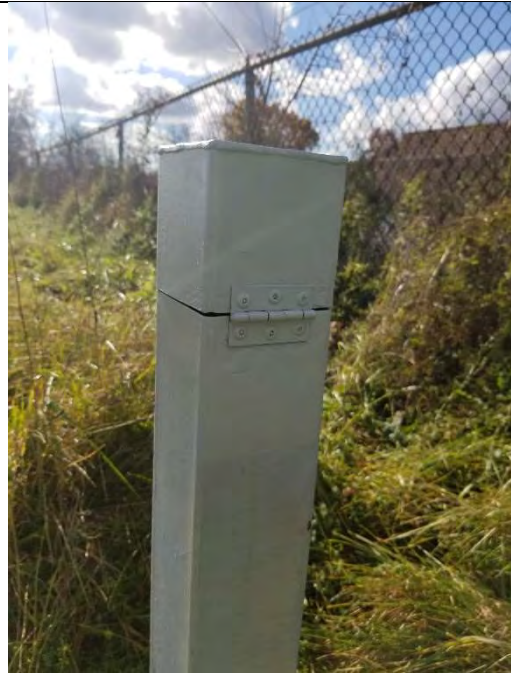
**Photo 8:** Final vicinity shot of B103-OW-A's new cap and hinge.
