October 30, 2023

Re: 2023 Site Inspection Letter Report
NYSEG Newark Former MGP Site
Corner of Water and Geneva Streets
Village of Newark, Wayne County, New York
NYSDEC Site No. 859021

Site Inspection Photographs
NYSEG Newark Former MGP Site - Newark, NY
NYSDEC Site No. 859021
June 1, 2023

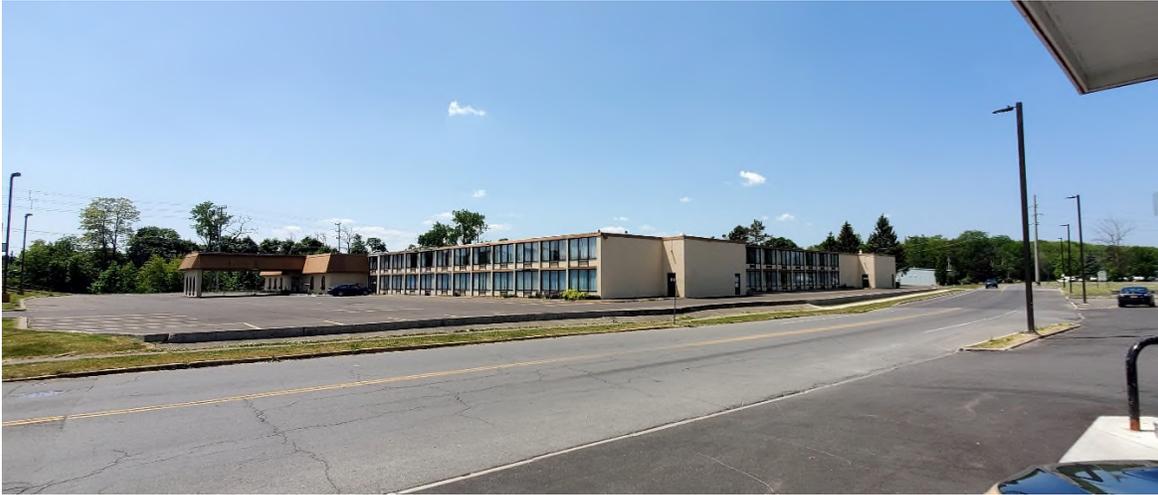
Photo 1 – Looking southwest at an overview of the Site, including the northeast corner and northern portion of across West Shore Blvd..

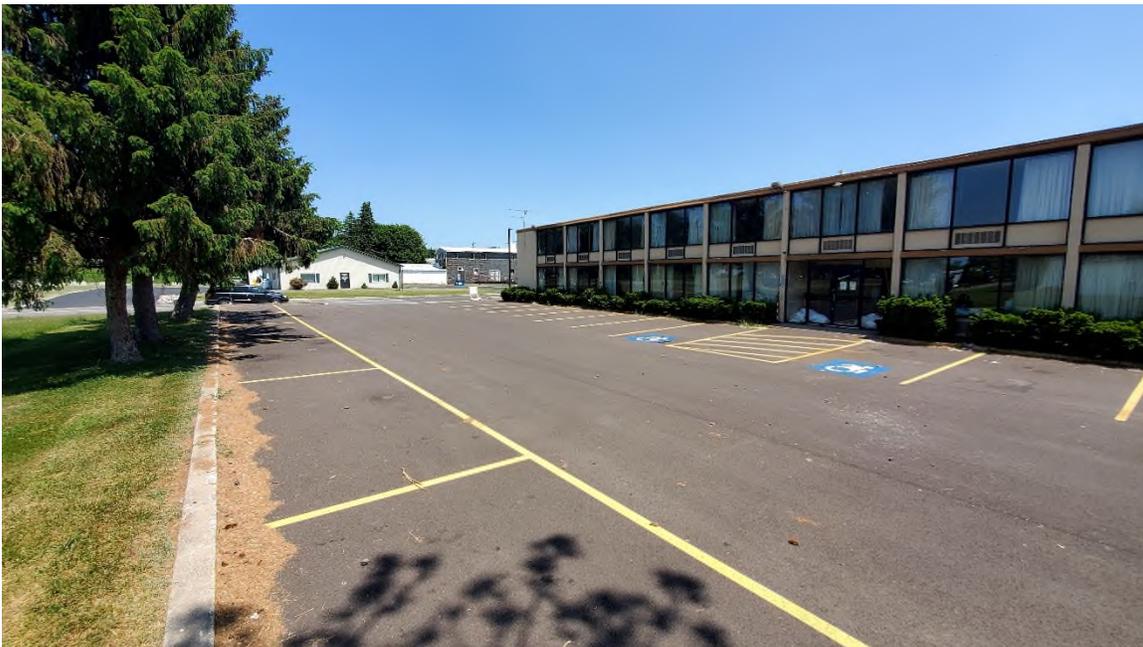
Photo 2 – Looking north across the west and northwest portion of the Site.

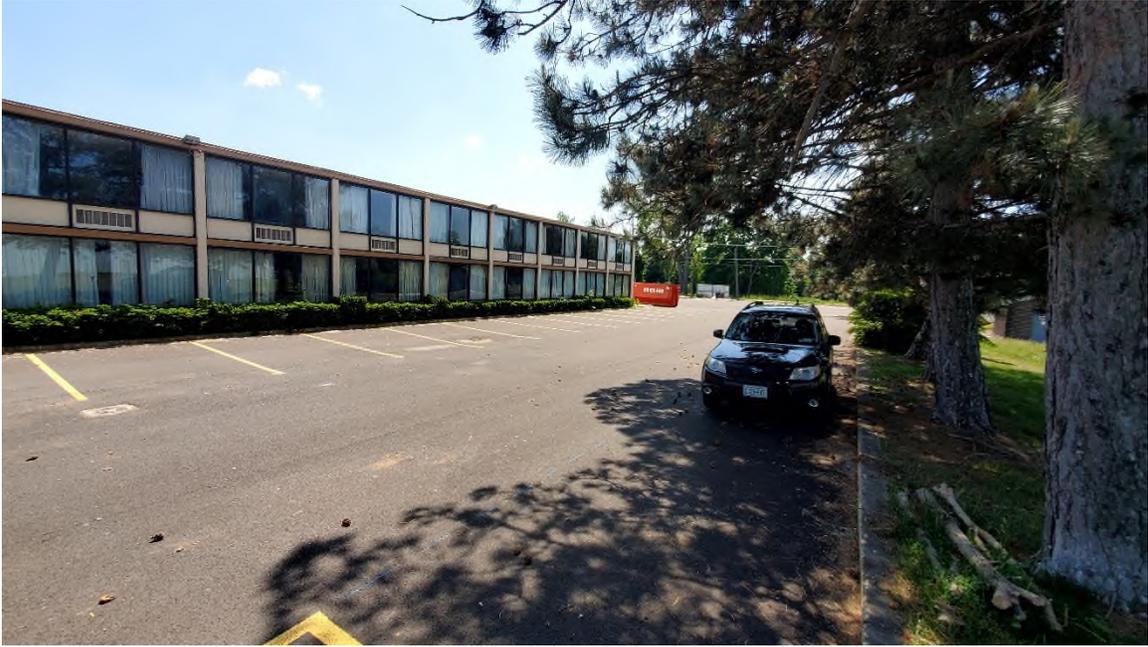
Photo 3 – Looking southeast across the west portion of the Site. MW-10-01 visible in the asphalt parking lot on the left.

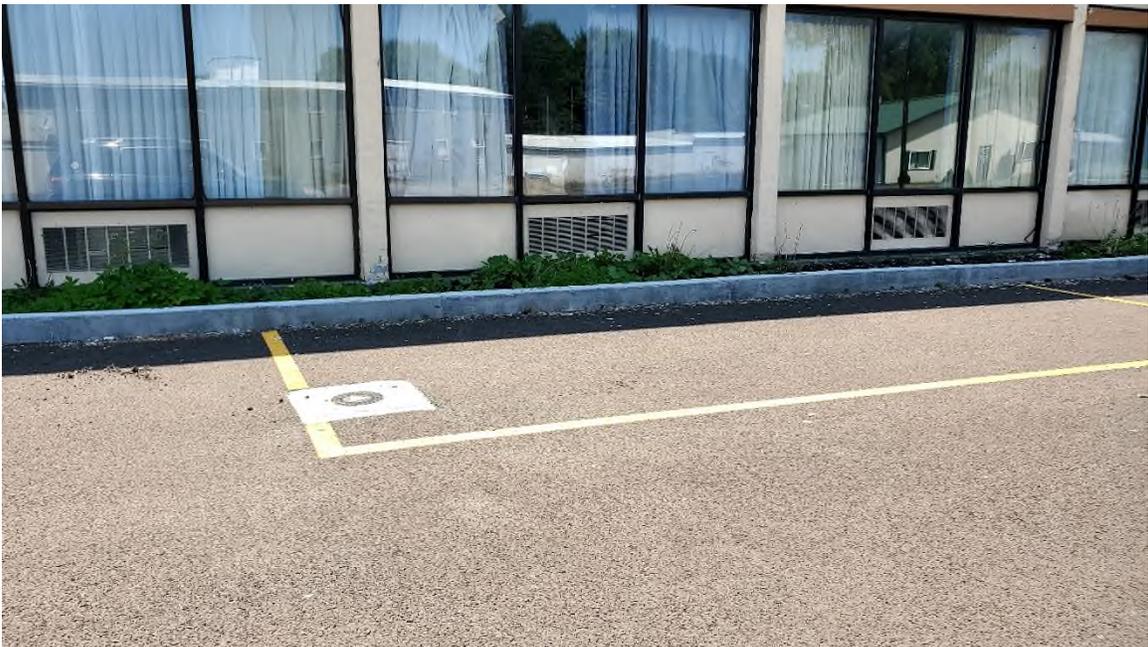
Photo 4 – Looking south at MW-22-01 and the asphalt Site cover system.

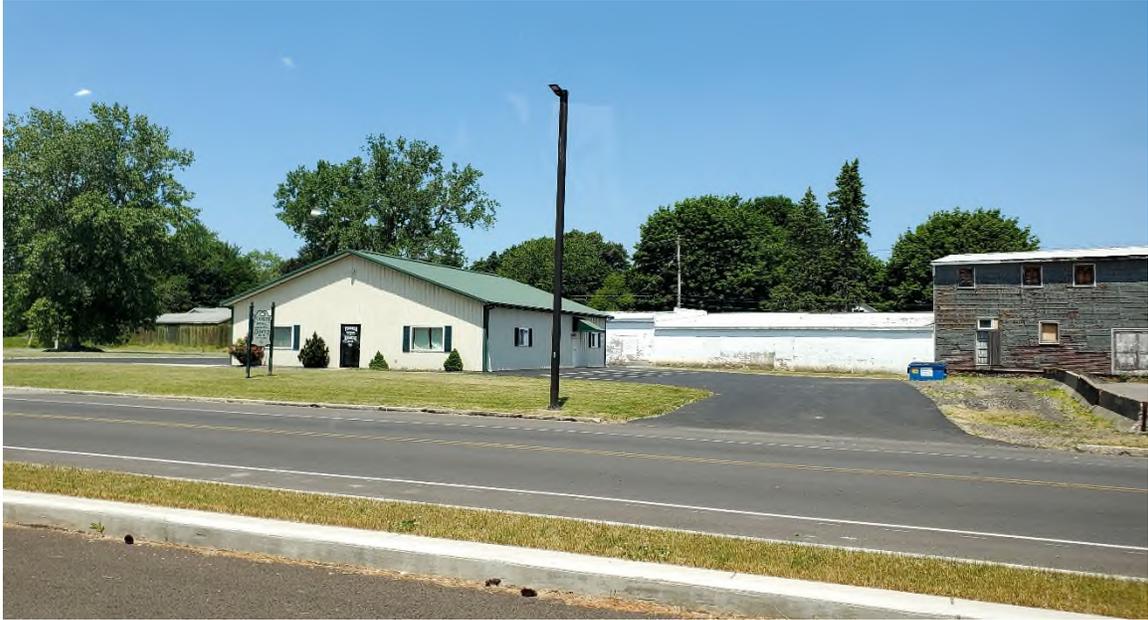
Photo 5 – Looking north across the central and northern portions of the Site.

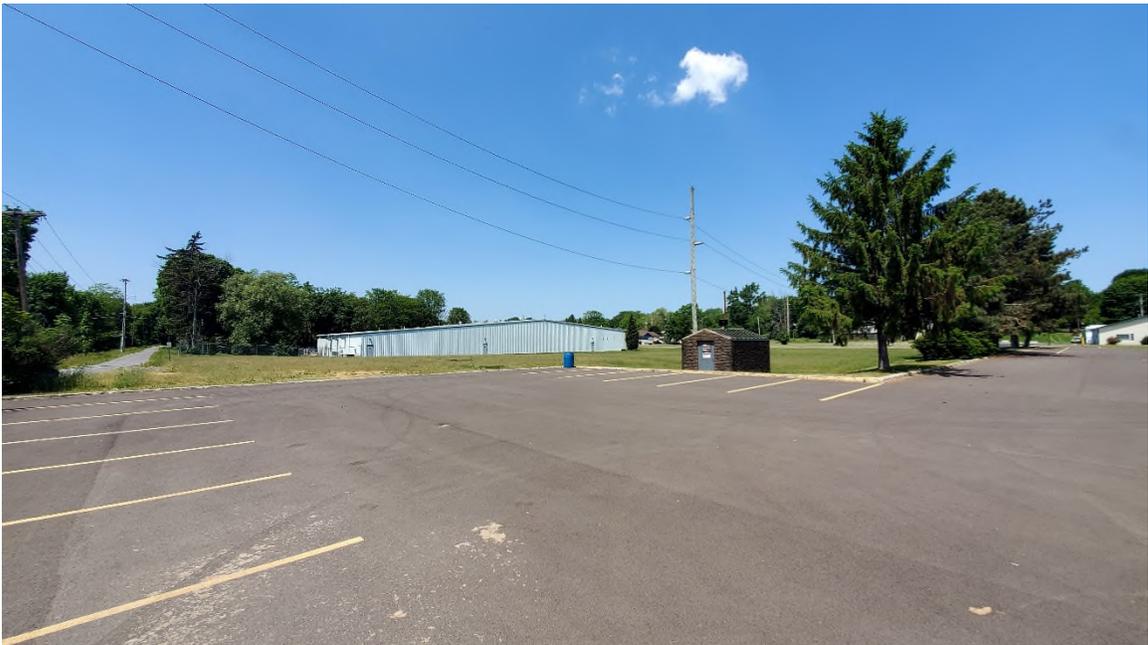
Photo 6 – Looking northwest at the NYSEG gas regulator building and IDW (purge water from groundwater sampling) drum staged on asphalt pavement near the NYSEG-owned property located southwest of the Site.
