# Second Five-Year Site Management Report

Former J.T. Baker Site

Penn Yan, New York

March 2024

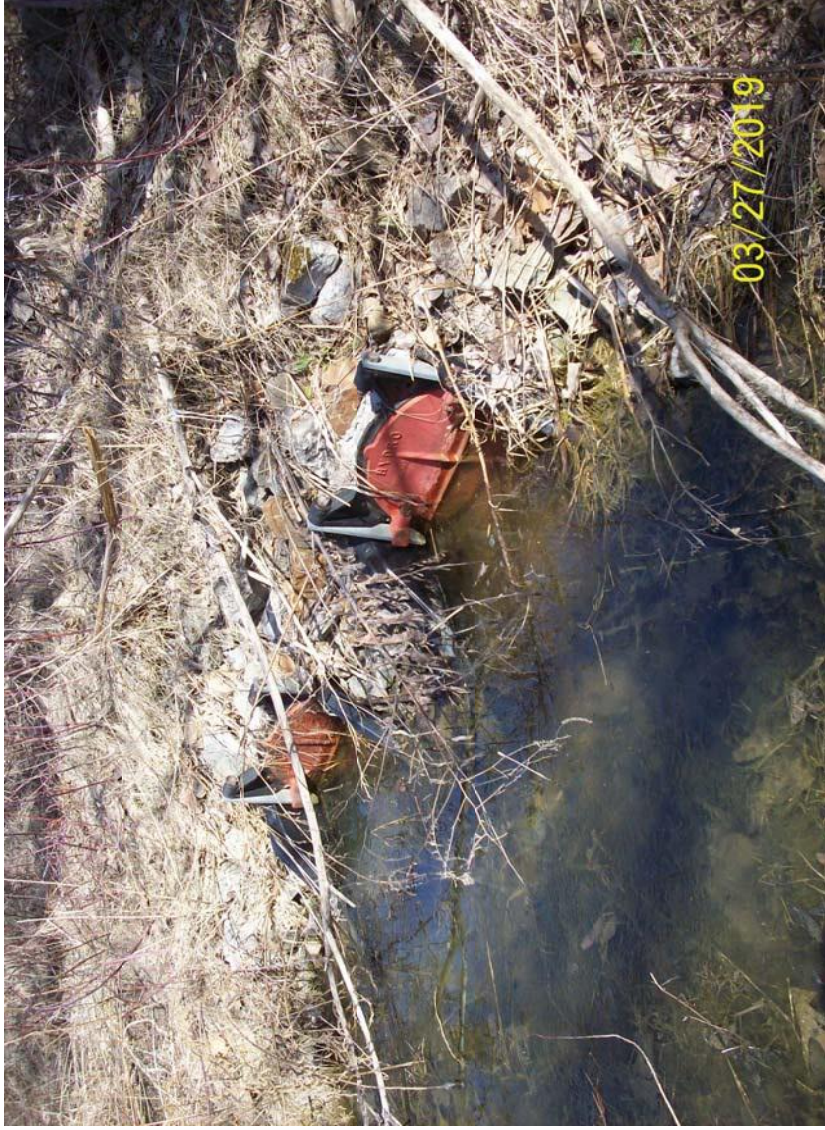
| ITEM | EXAMPLES OF TYPES OF PROBLEMS | TRIGGER LEVEL (if applicable) | STATUS* | OBSERVATIONS | DATE AND NATURE OF REPAIRS/ MAINTENANCE |
|---|---|---|---|---|---|
| <i>Flap Gates</i> | Leakage; deterioration; malfunction. | Any leakage; any corrosion or deterioration that affects structural integrity; inoperability. | Acceptable | No sediment observed at flap gates, and gates operate freely. | Not Applicable |

Photo #1: Flap gates, looking northwest.

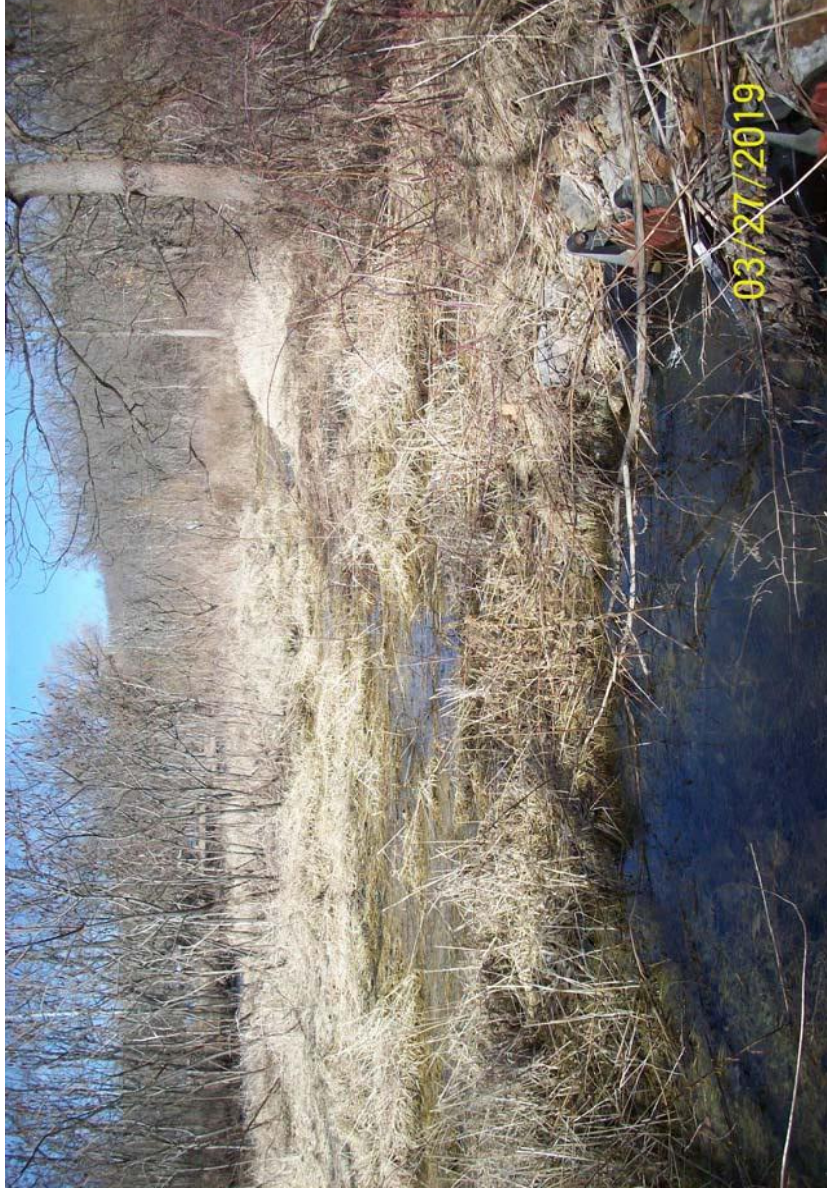
Photo #2: Looking west along Keuka Lake Outlet floodwaters, over flap gates.

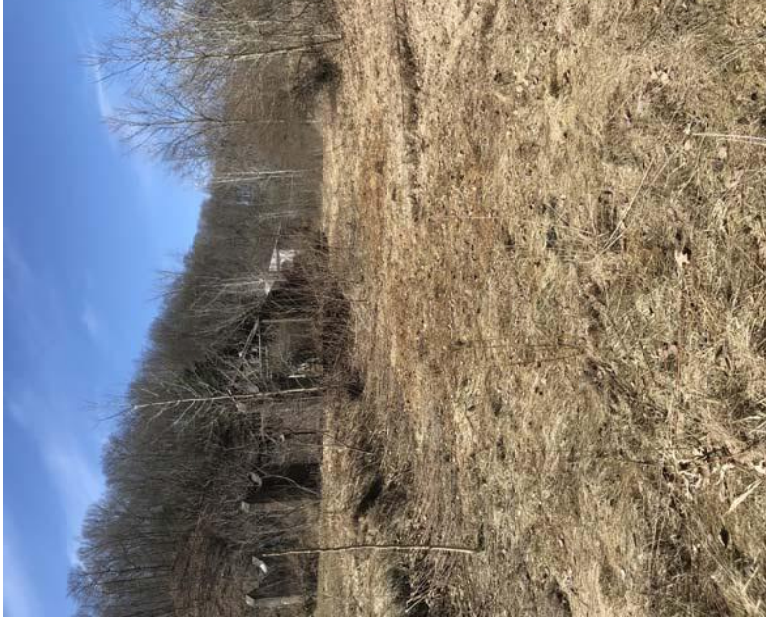
| ITEM | EXAMPLES OF TYPES OF PROBLEMS | TRIGGER LEVEL (if applicable) | STATUS* | OBSERVATIONS | DATE AND NATURE OF REPAIRS/ MAINTENANCE |
|---|---|---|---|---|---|
| <i>Cover Material</i> | Settlement; subsidence; erosion; failure to maintain 3 to 5 percent slope; exposed waste materials. Evidence of physical disturbance. | Ponding over more than 25% of area. | Acceptable | No settlement or subsidence observed; no ponding observed | Not Applicable |

Photo #3: Former Structure 6 Excavation Area, looking west.

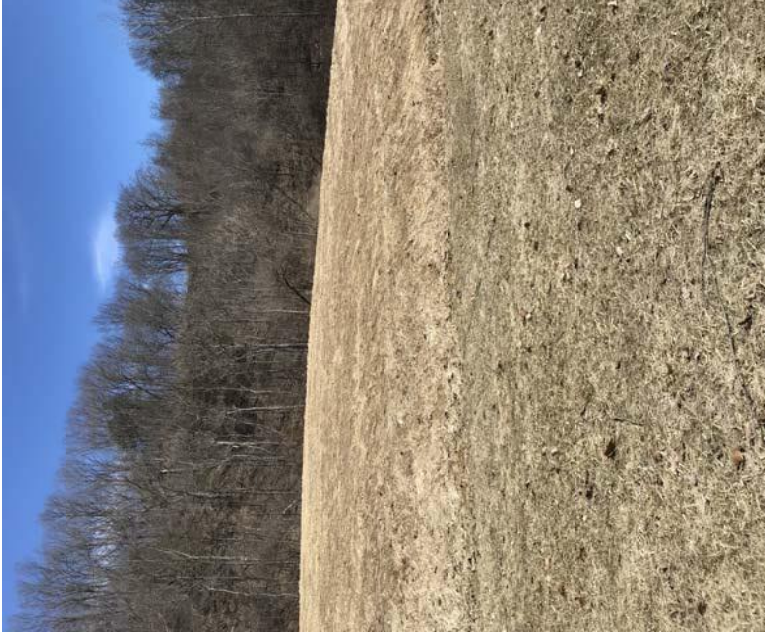
| ITEM | EXAMPLES OF TYPES OF PROBLEMS | TRIGGER LEVEL (if applicable) | STATUS* | OBSERVATIONS | DATE AND NATURE OF REPAIRS/ MAINTENANCE |
|---|---|---|---|---|---|
| <i>Cover Material</i> | Settlement; subsidence; erosion; failure to maintain 3 to 5 percent slope; exposed waste materials. Evidence of physical disturbance. | Ponding over more than 25% of area (18,750 square feet). | Acceptable | No settlement or subsidence observed; no ponding observed | Not Applicable |

Photo #4: West Disposal Area, looking northeast.

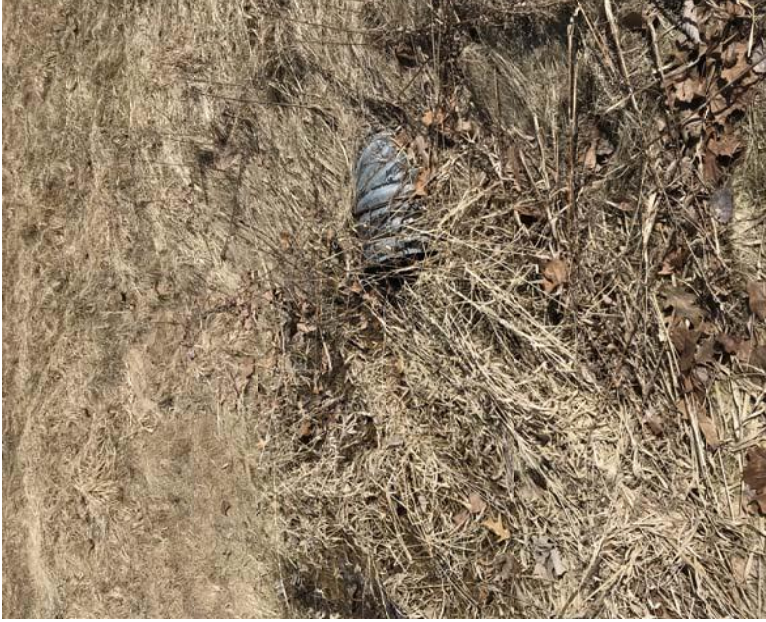
| ITEM | EXAMPLES OF TYPES OF PROBLEMS | TRIGGER LEVEL (if applicable) | STATUS* | OBSERVATIONS | DATE AND NATURE OF REPAIRS/ MAINTENANCE |
|---|---|---|---|---|---|
| <i>Culverts</i> | Corrosion; deterioration; siltation; blockage; clogging. | Any clogs or deterioration that affects structural integrity or flow. | Acceptable | No corrosion, deterioration or blockages observed | Not Applicable |

Photo #5: West Disposal Area, run-off conveyance channel culvert east of drainage culverts leading to Outlet.

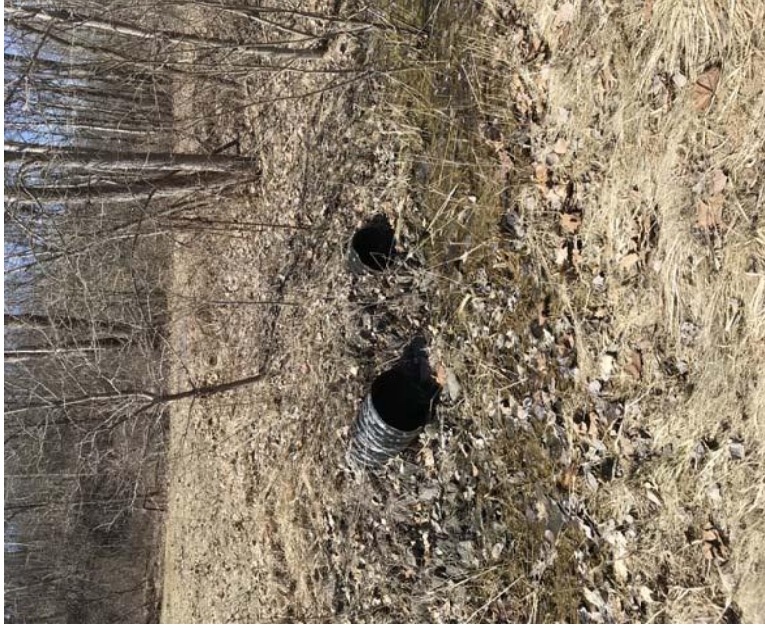
Photo #6: West Disposal Area, run-off conveyance channel culverts leading to Outlet, looking southwest.

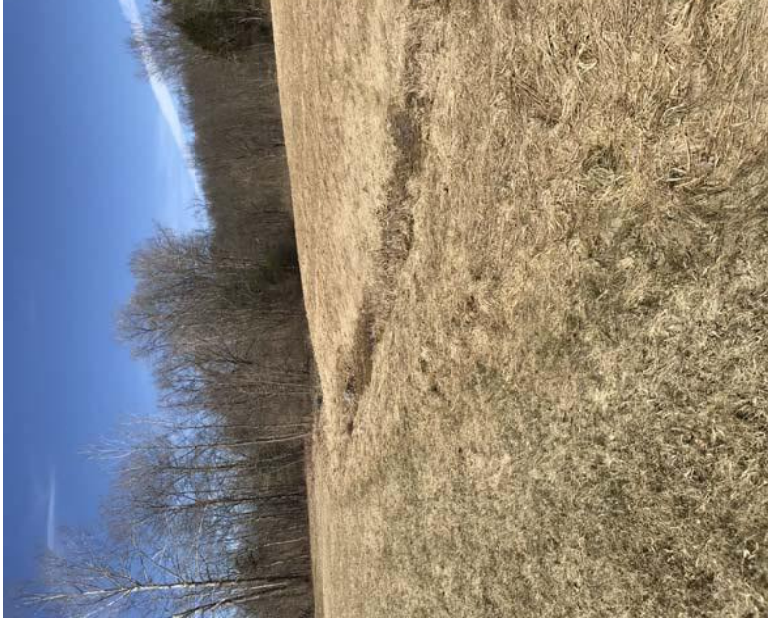
| ITEM | EXAMPLES OF TYPES OF PROBLEMS | TRIGGER LEVEL (if applicable) | STATUS* | OBSERVATIONS | DATE AND NATURE OF REPAIRS/ MAINTENANCE |
|---|---|---|---|---|---|
| <i>Run-off Conveyance Channels</i> | Obstruction to flow; bank erosion; deterioration; excessive siltation; inadequate protective vegetation; loose riprap or missing riprap. | Any clogging or obstructions to flow; greater than 10% of area (600 square feet) devoid of vegetation. | Acceptable | Vegetation is dormant, but good; little to no standing water, no visible obstructions | Not Applicable |

Photo #7: West Disposal Area, looking to the west at run-off conveyance channels on south side.

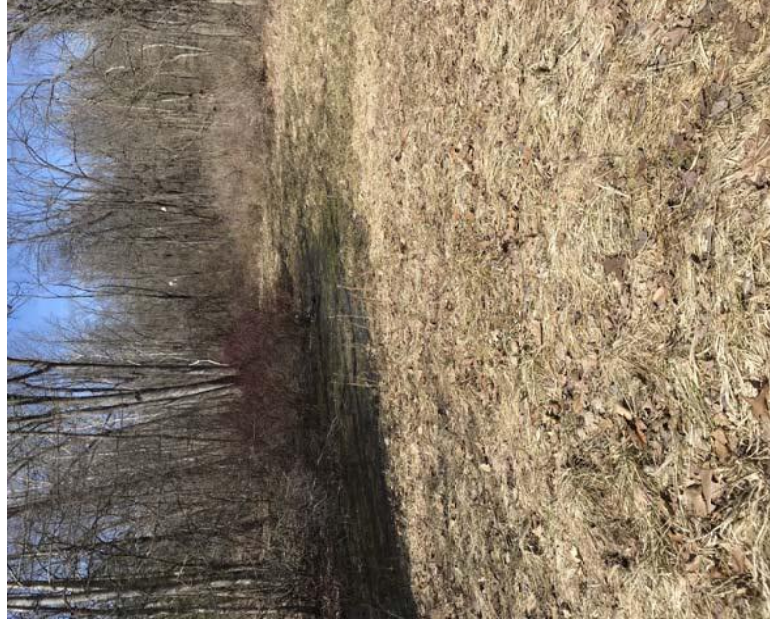
Photo #8: Looking west at run-off conveyance channel on west side of West Disposal Area.

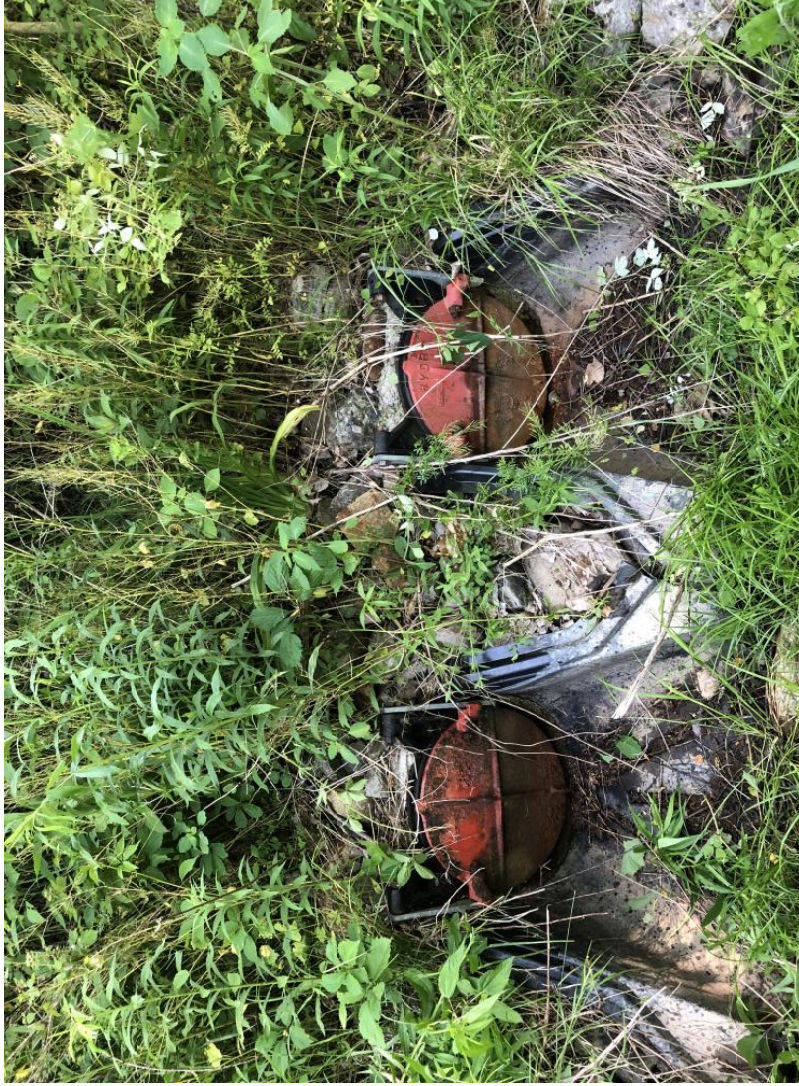
| Have there been any changes since the last inspection? If yes, note the changes. | | |
|---|---|---|
| <i>Flap Gates</i> | | X<br>No sediment observed at flap gates, and gates operate freely. |

Photo #1: Outlet of West Disposal Area Drainage, looking north at flap gates.

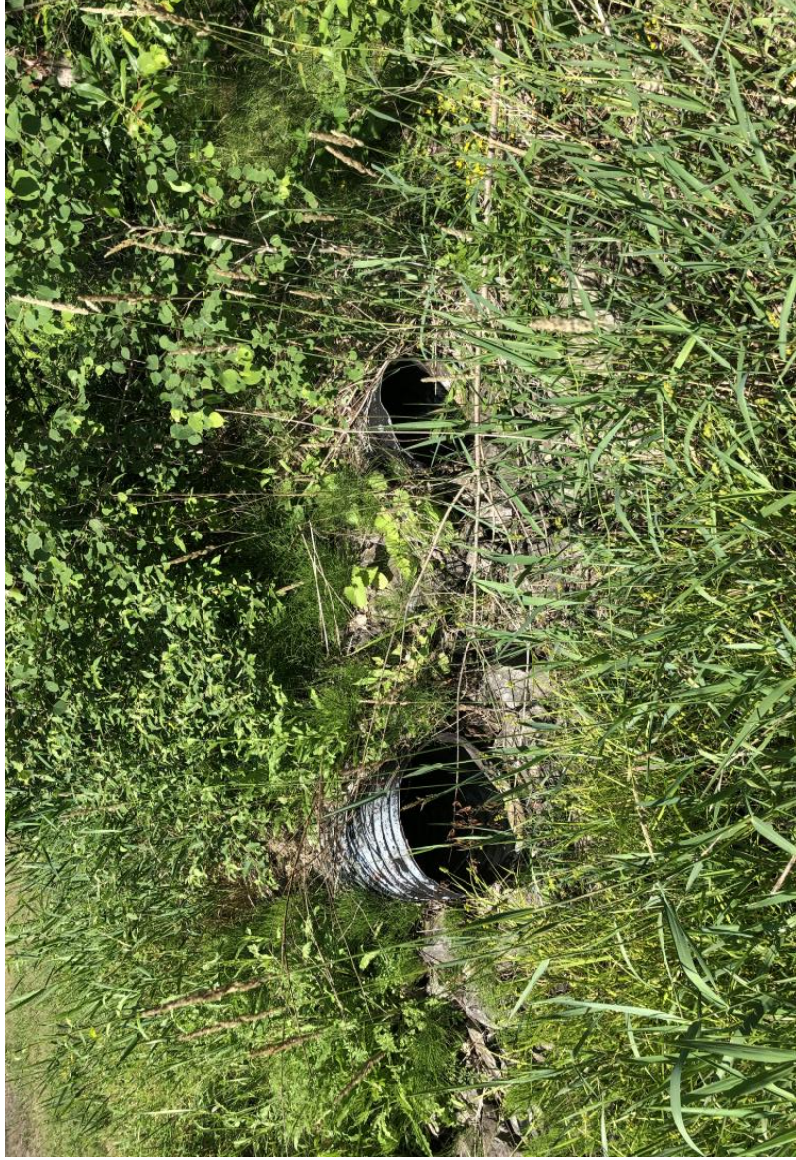
| Have there been any changes since the last inspection? If yes, note the changes. | | |
|---|---|---|
| <i>Culverts</i> | | X<br>Culverts are in good condition |

Photo #2: Drainage culvert pipes from West Disposal Area to Outlet, looking south.

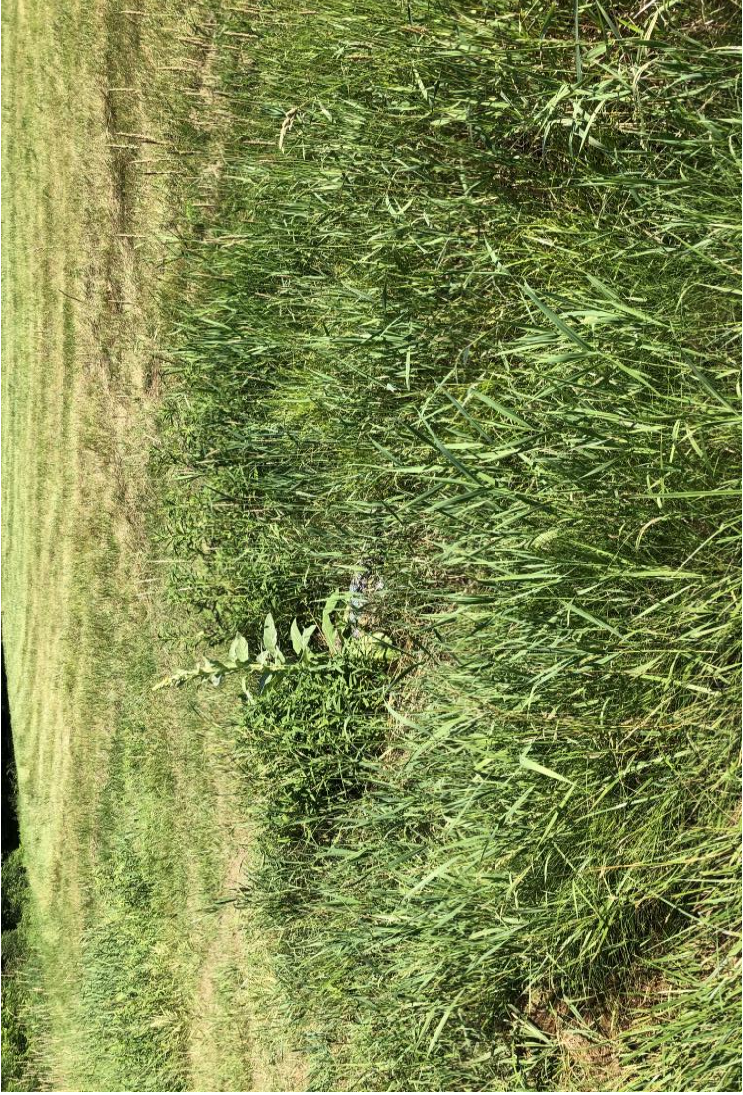
Photo #3: West Disposal Area, run-off conveyance channel culvert, looking northwest

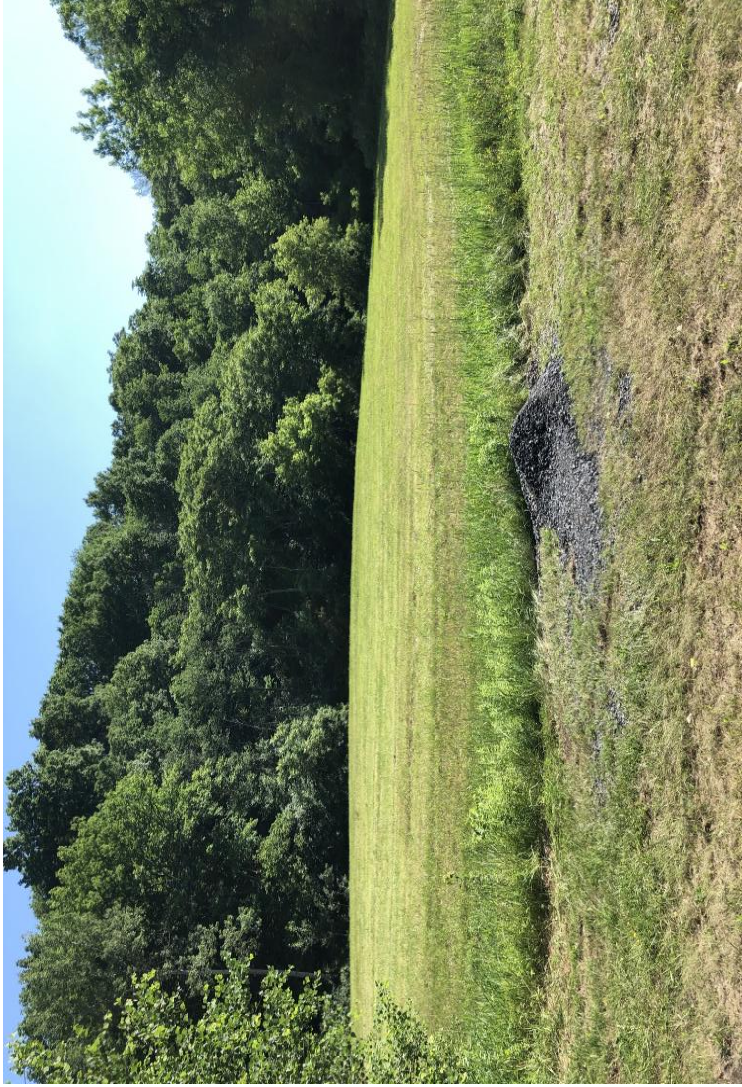
Photo #4: West Disposal Area, looking northeast.

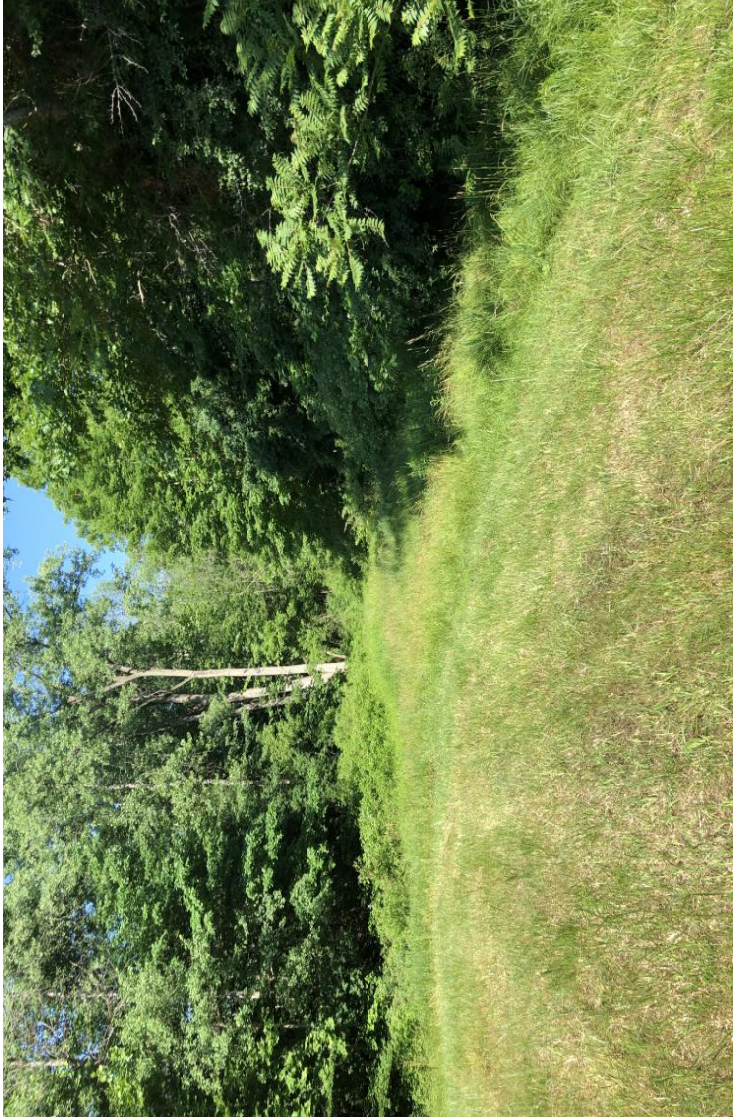
Photo #5: West end of West Disposal Area.

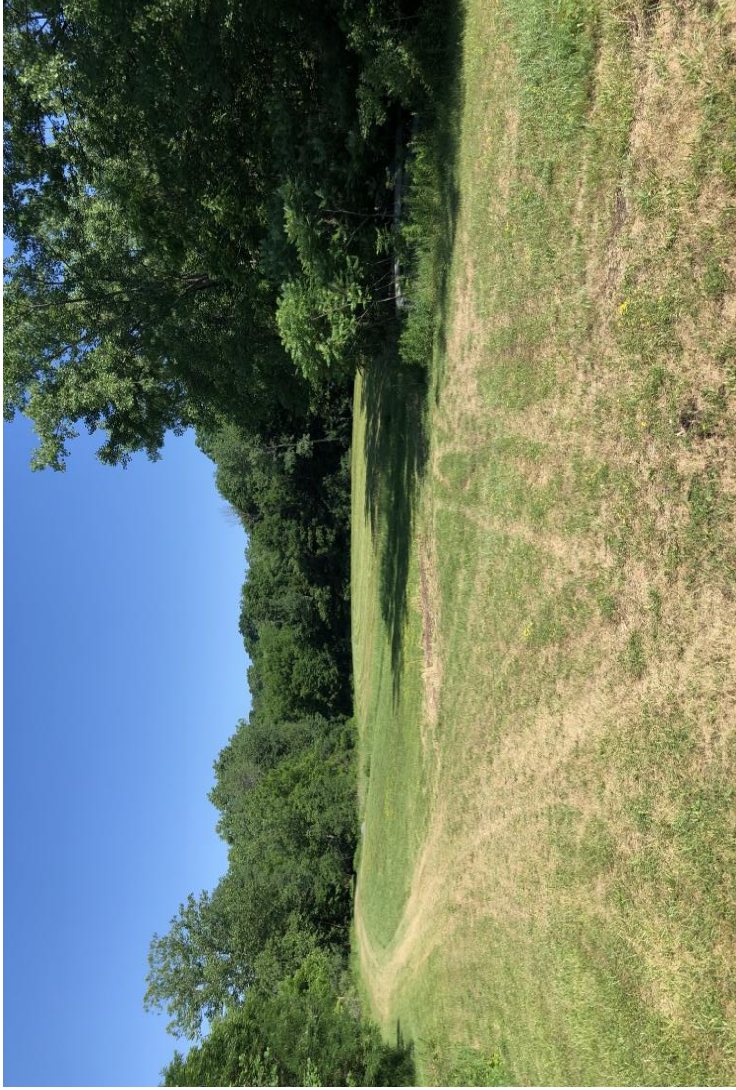
Photo #6: West Disposal Area, looking northwest.

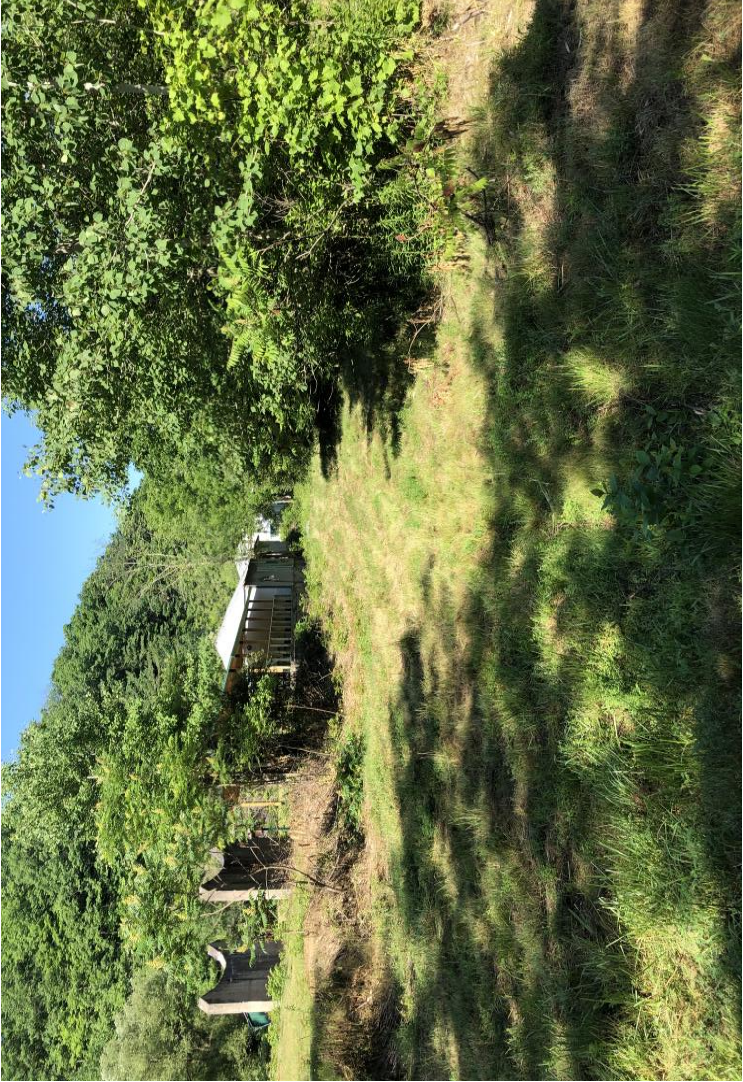
Photo #7: Former Structure 6 Area, looking west

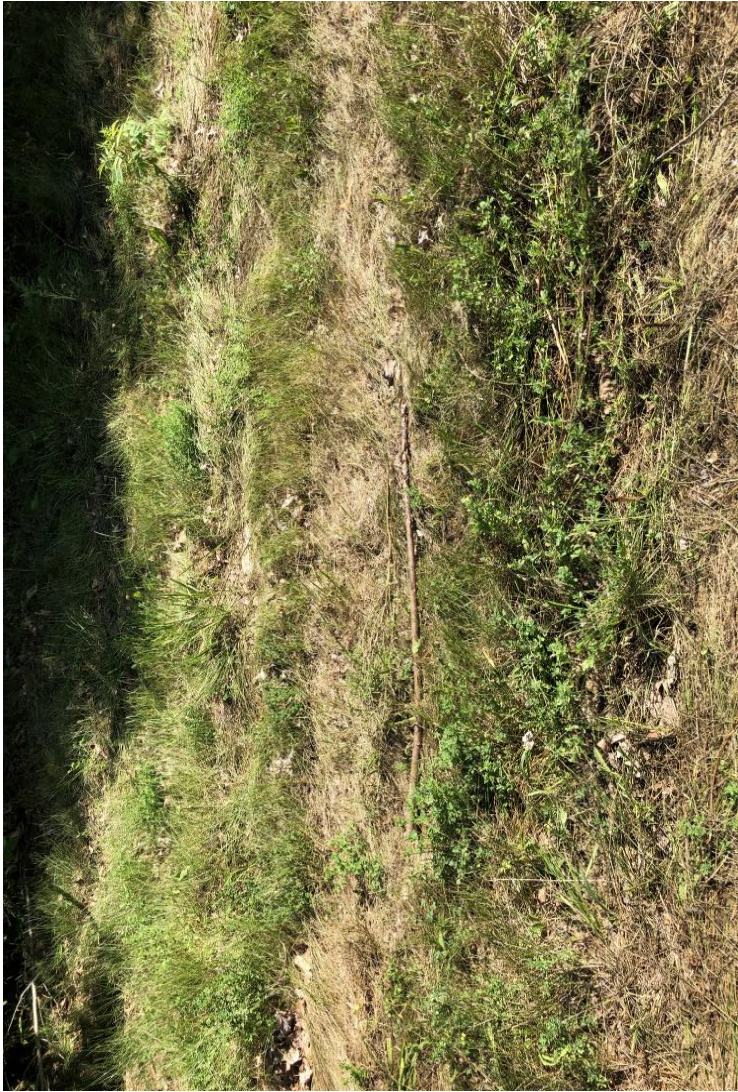
Photo #8: Vegetative Cover within Former Structure 6 Area.

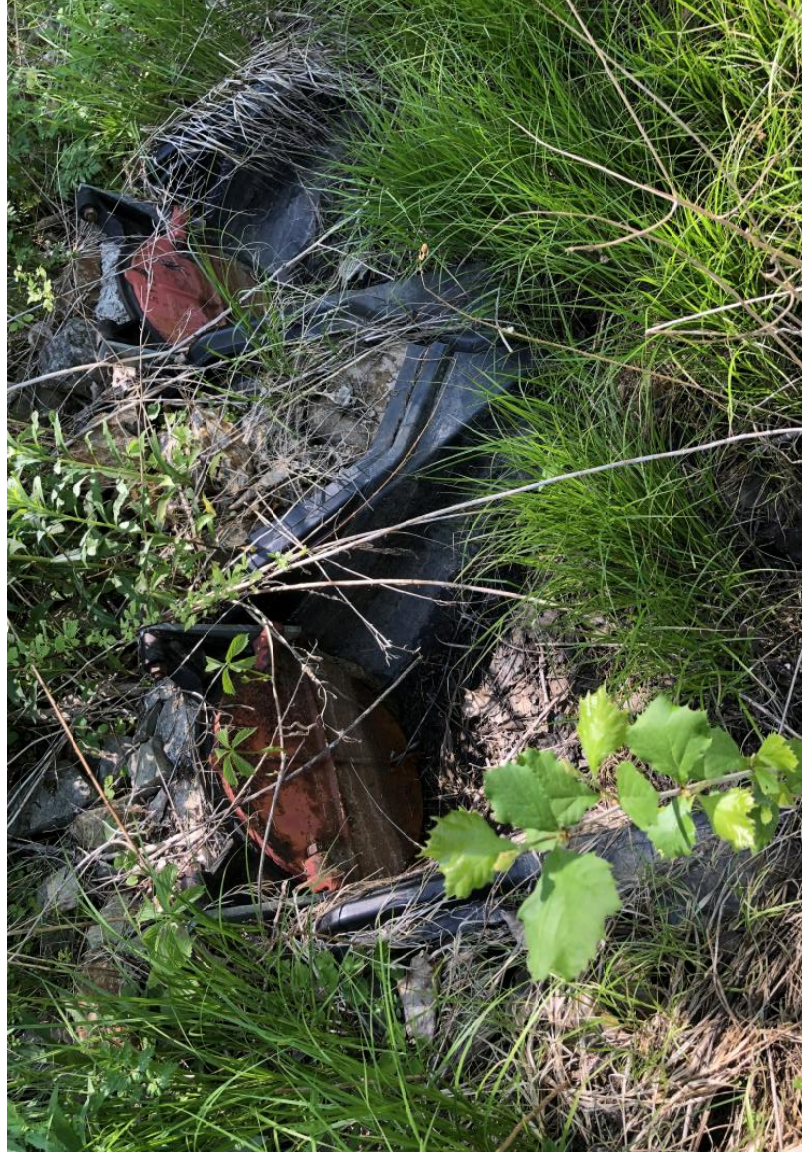
| Have there been any changes since the last inspection? If yes, note the changes. | | |
|---|---|---|
| | | Minimal sediment observed at flap gates, and gates operate freely. |

Photo #1: Outlet of West Disposal Area Drainage, looking north at flap gates.

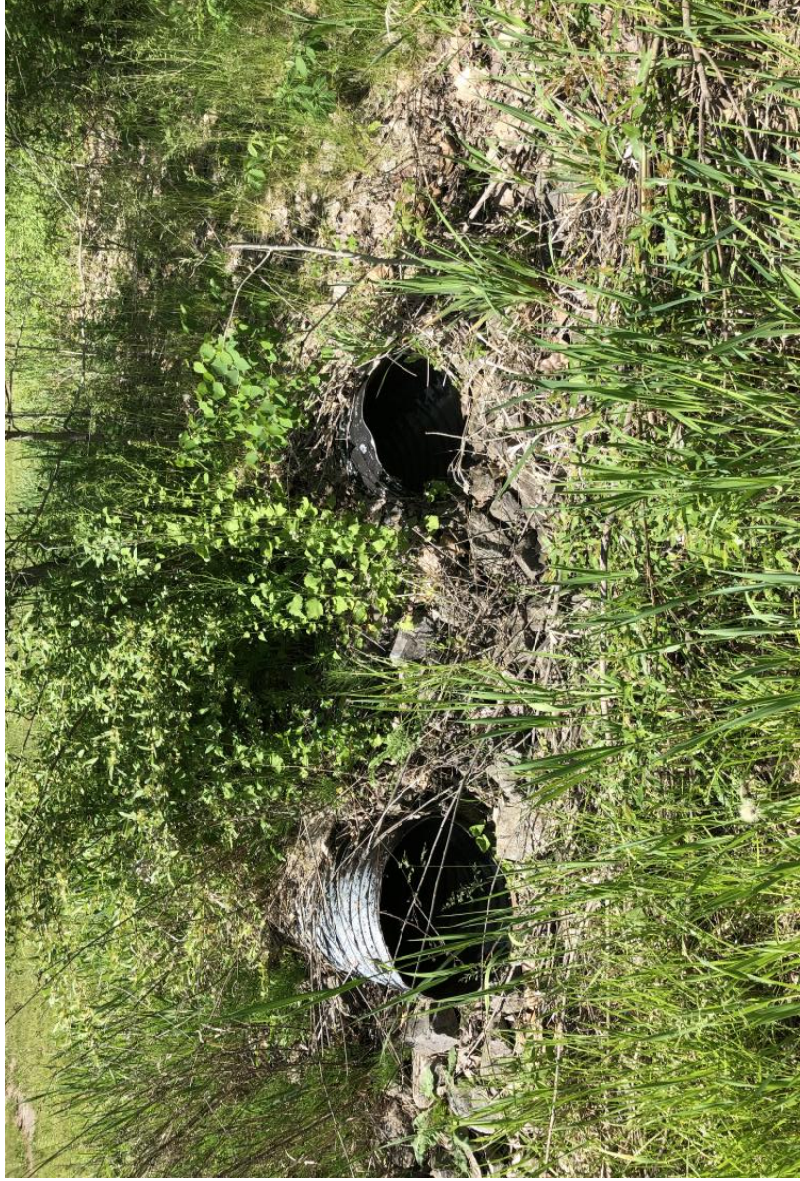
| Have there been any changes since the last inspection? If yes, note the changes. | | |
|---|---|---|
| | | Culverts are in good condition |

Photo #2: Drainage culvert pipes from West Disposal Area to Outlet, looking south.

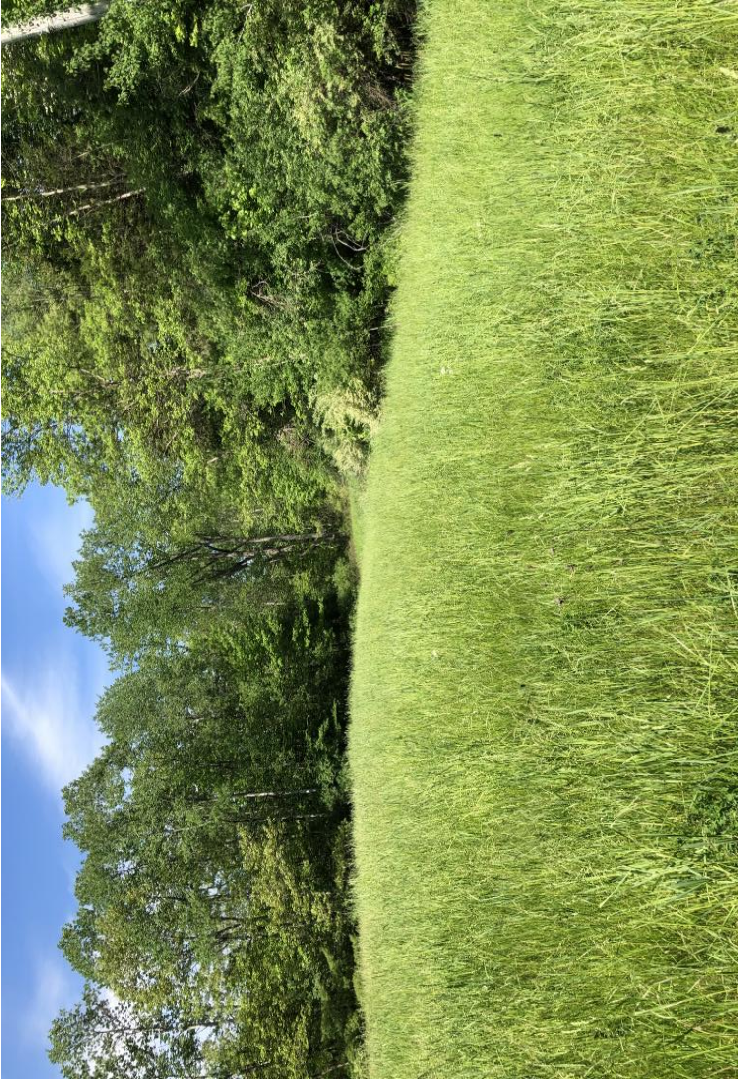
Photo #3: West Disposal Area, west end, looking west.

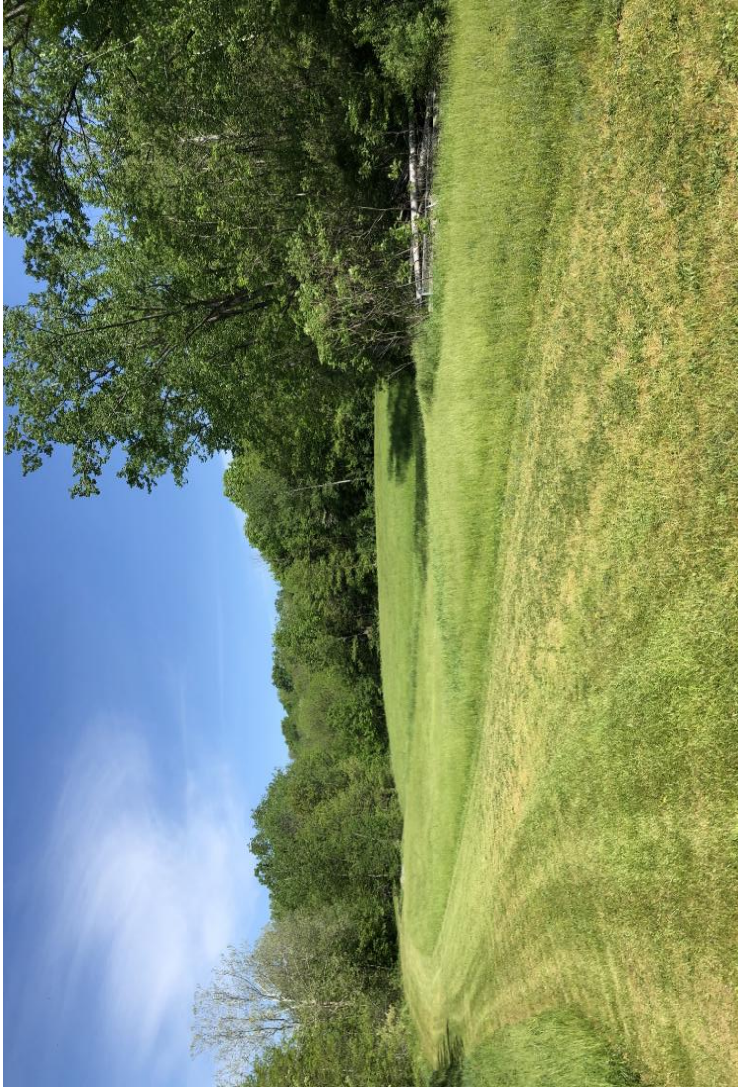
Photo #4: West Disposal Area, looking northwest.

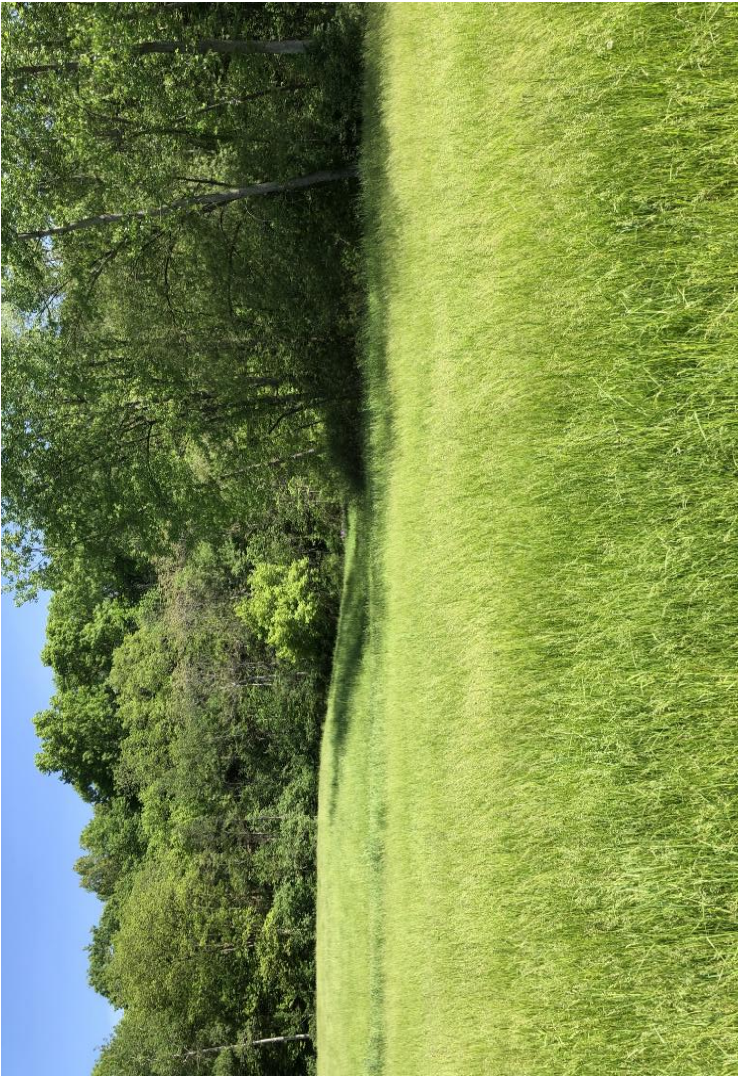
Photo #5: East end of West Disposal Area.

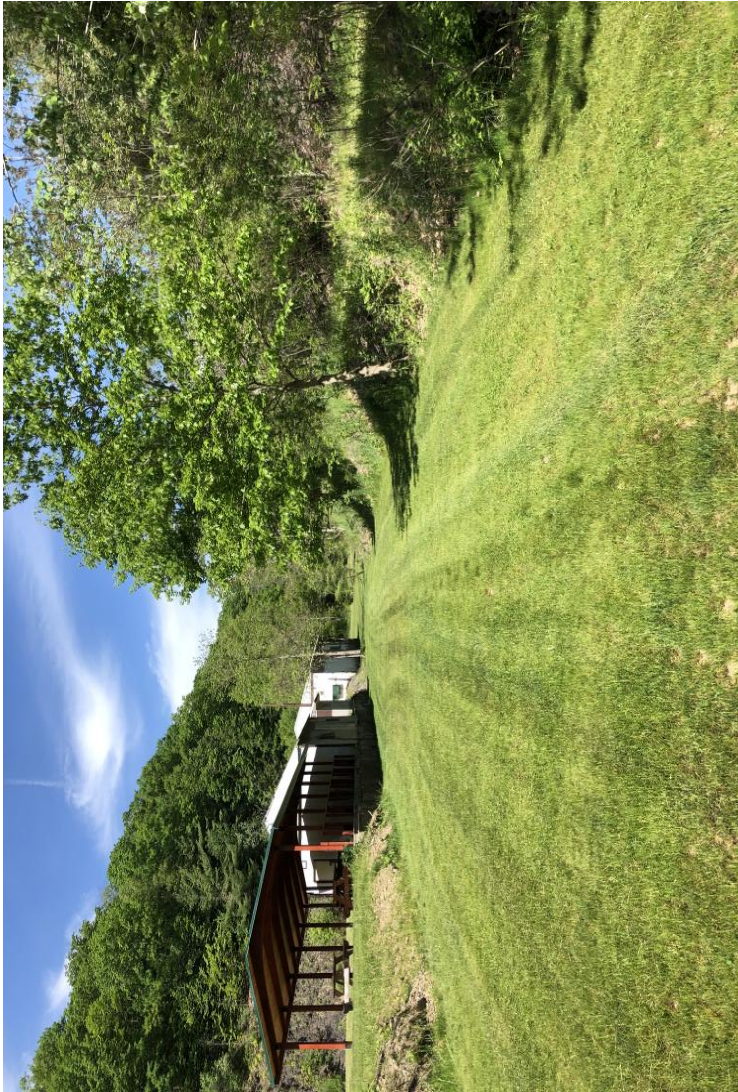
| Have there been any changes since the last inspection? If yes, note the changes. | | |
|---|---|---|
| | | Cover is in great condition, vegetation is healthy. Friends of the Outlet confirmed that additional topsoil was placed over area and seeded. |

Photo #6: Former Structure 6 Excavation Area, looking west.

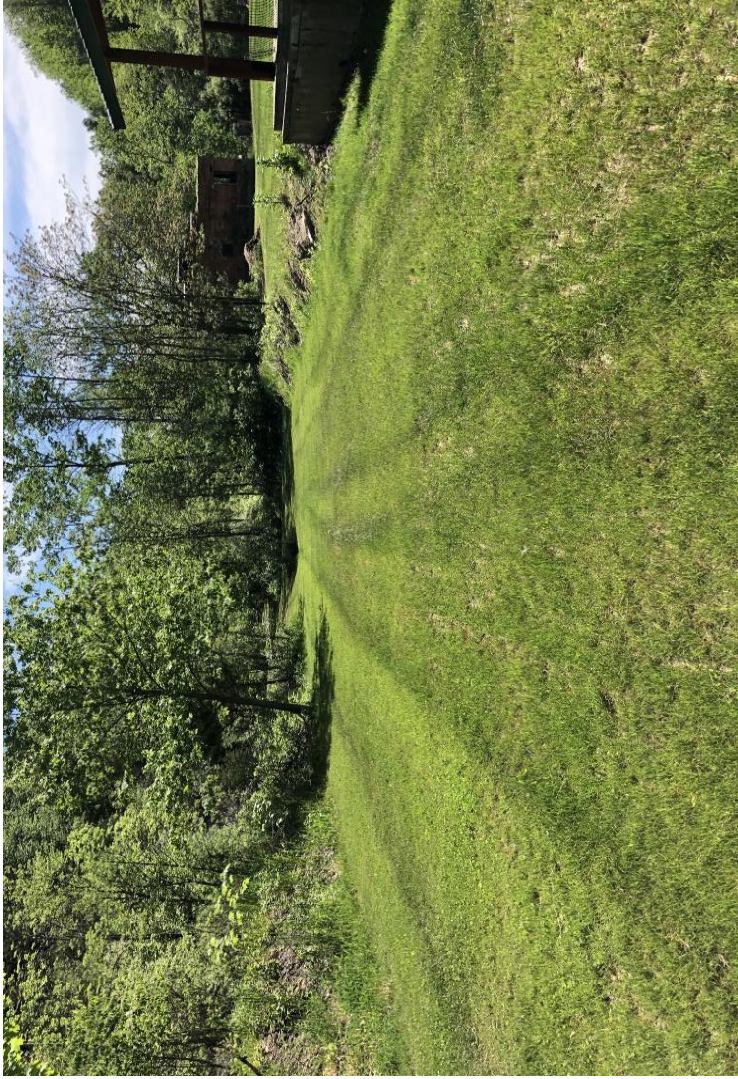
Photo #7: Former Structure 6 Excavation Area, looking east.

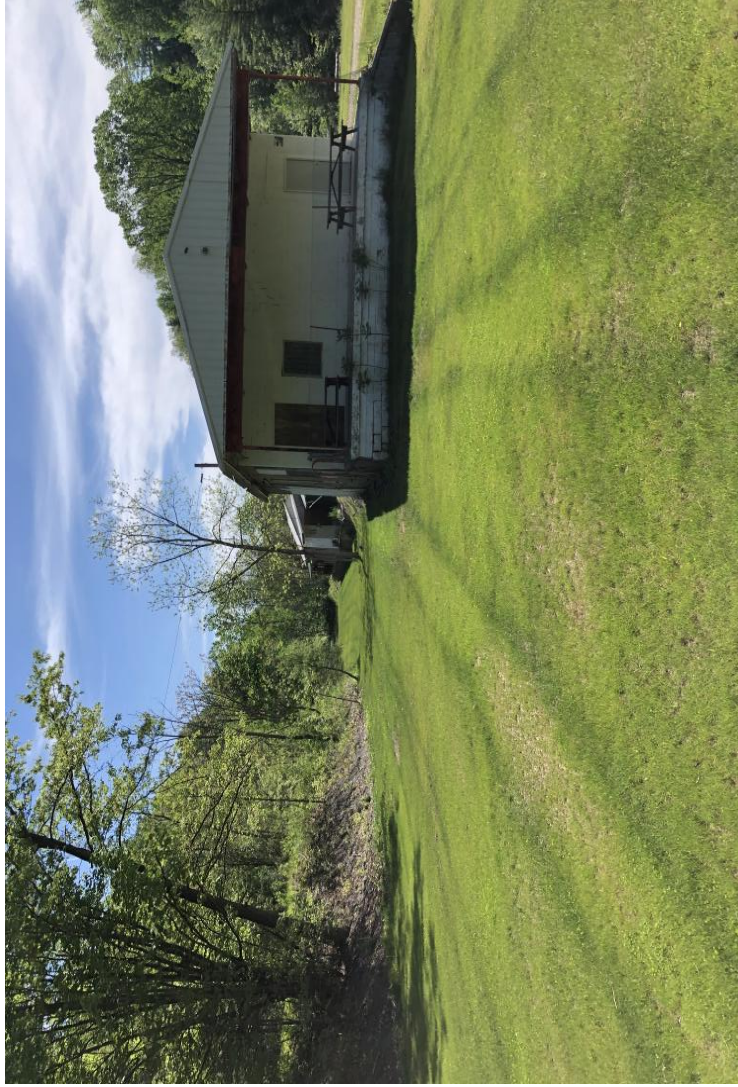
Photo #8: Recently cleared area, looking east, with Former Structure 6 Area in the distance.

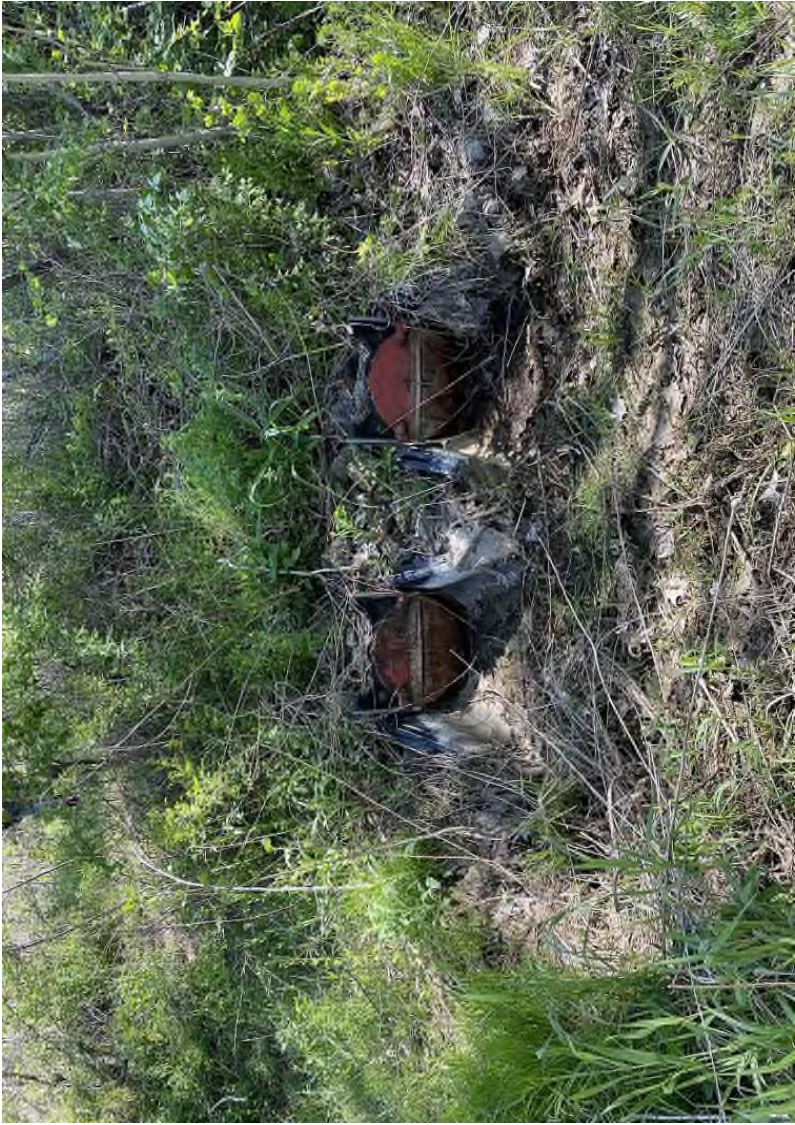
| Have there been any changes since the last inspection? If yes, note the changes. | | |
|---|---|---|
| | | Minimal sediment observed at flap gates, and gates operate freely. |

Photo #1: Outlet of West Disposal Area Drainage, looking north at flap gates.

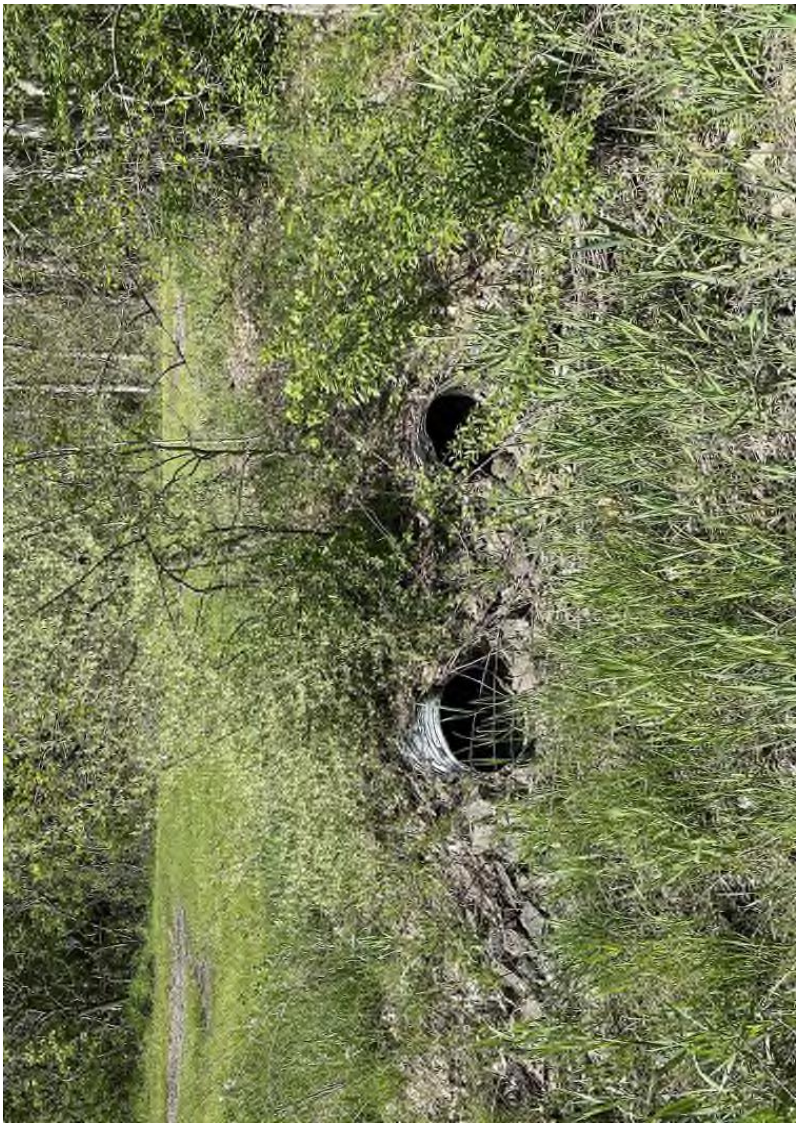
| Have there been any changes since the last inspection? If yes, note the changes. | | |
|---|---|---|
| | | Culverts are in good condition |

Photo #2: Drainage culvert pipes from West Disposal Area to Outlet, looking south.

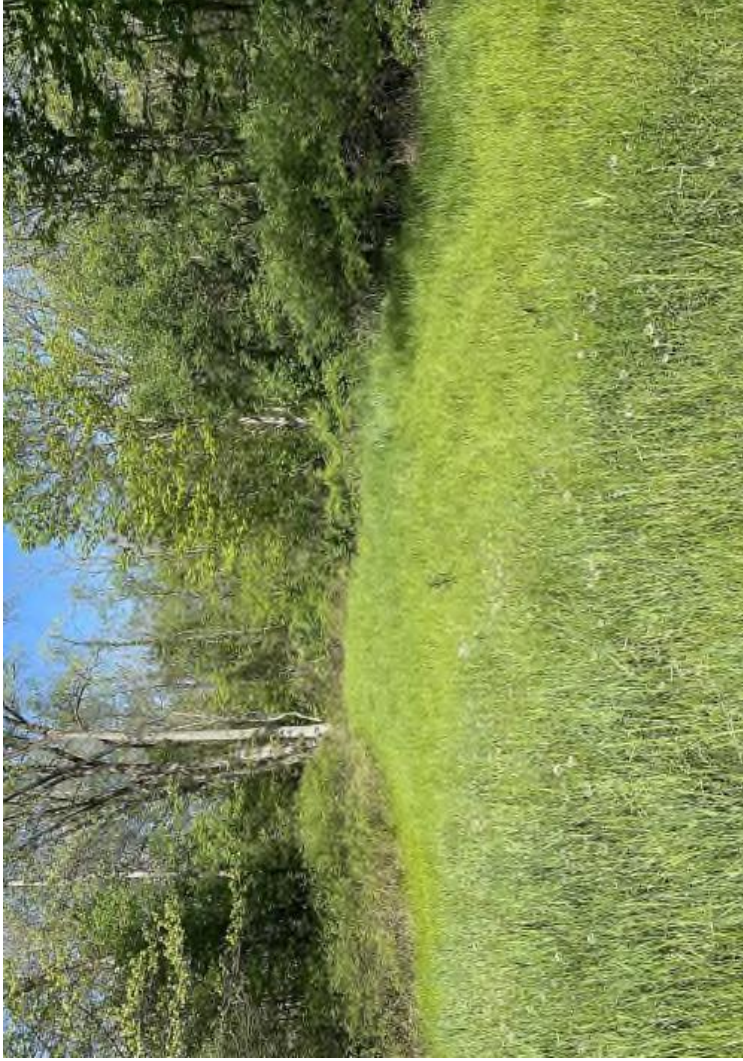
Photo #3: West Disposal Area, west end, looking west.

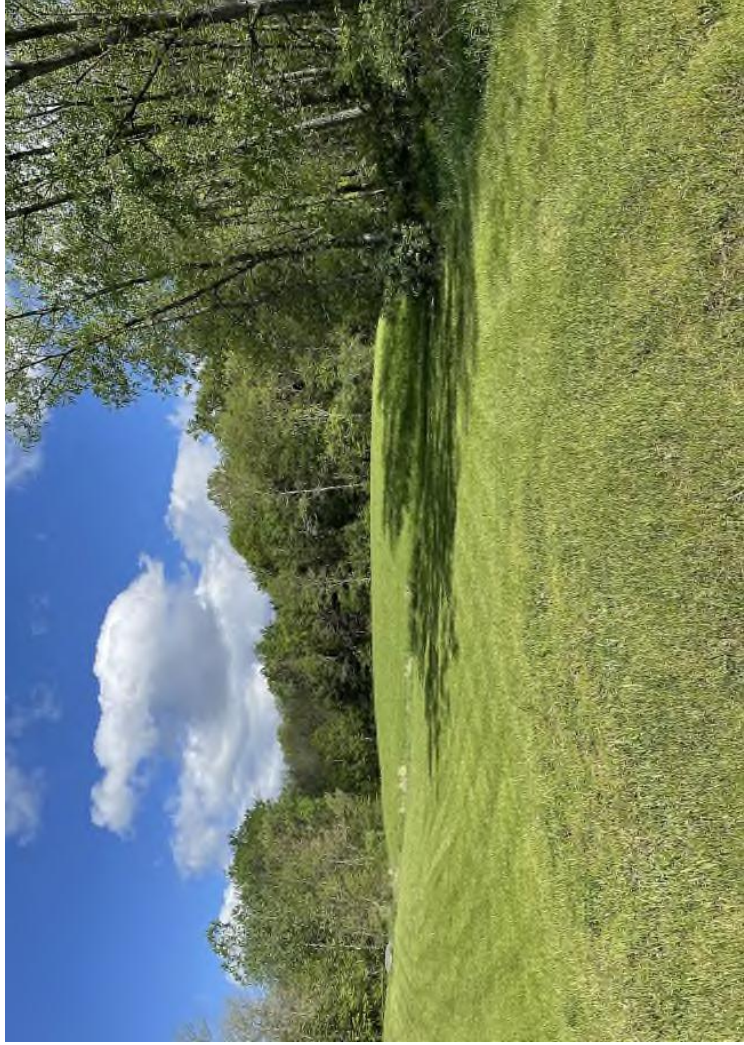
Photo #4: West Disposal Area, looking northwest.
