# Second Five-Year Site Management Report

Former J.T. Baker Site

Penn Yan, New York

March 2024

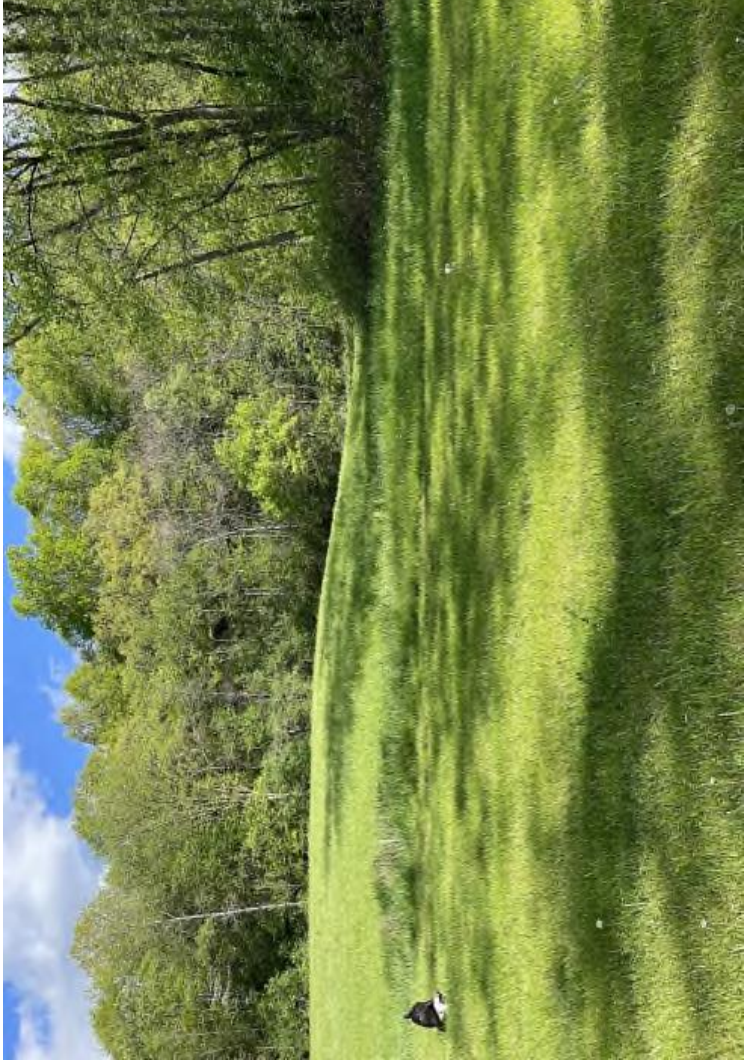
| ITEM | EXAMPLES OF TYPES OF PROBLEMS | TRIGGER LEVEL (if applicable) | STATUS* | OBSERVATIONS | DATE AND NATURE OF REPAIRS/ MAINTENANCE |
|---|---|---|---|---|---|
| <u>Site Wide</u><br><i>Abandoned Groundwater Monitoring Wells</i> | Land subsidence | Land subsidence. | Modified | Minimal subsidence observed | Approximately 2-3" of subsidence observed at location of abandoned monitoring wells on the southeast side of West Disposal Area. Topsoil and grass seed placed on May 24, 2022 |

Photo #5: East end of West Disposal Area.

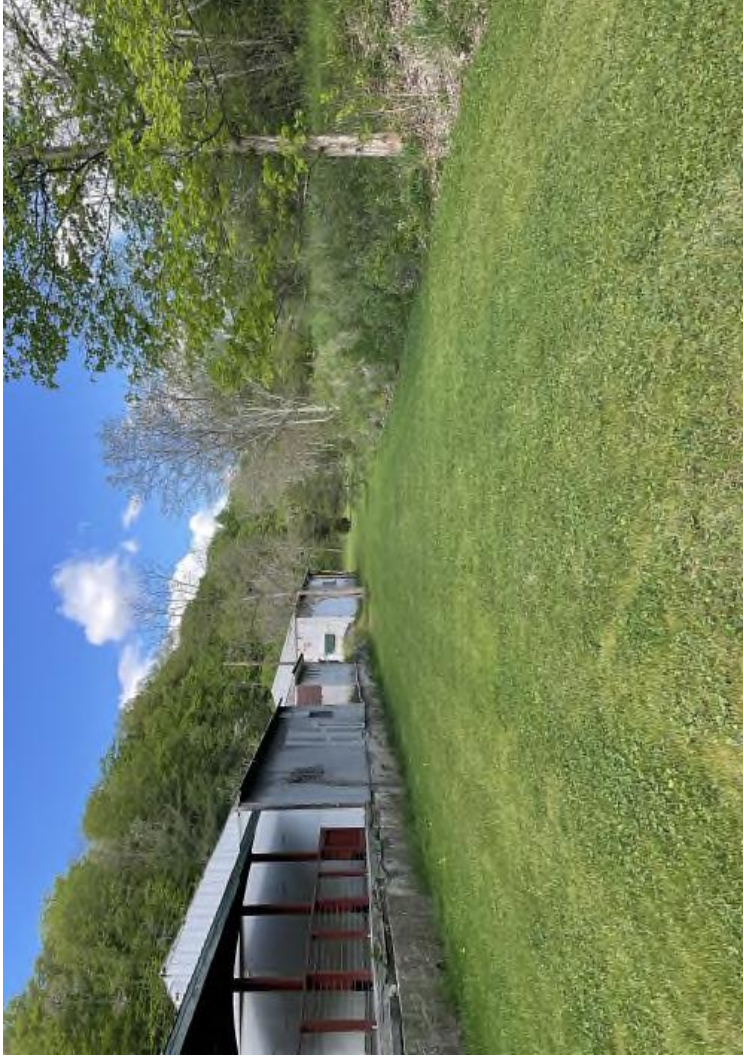
Photo #6: Former Structure 6 Excavation Area, looking west.

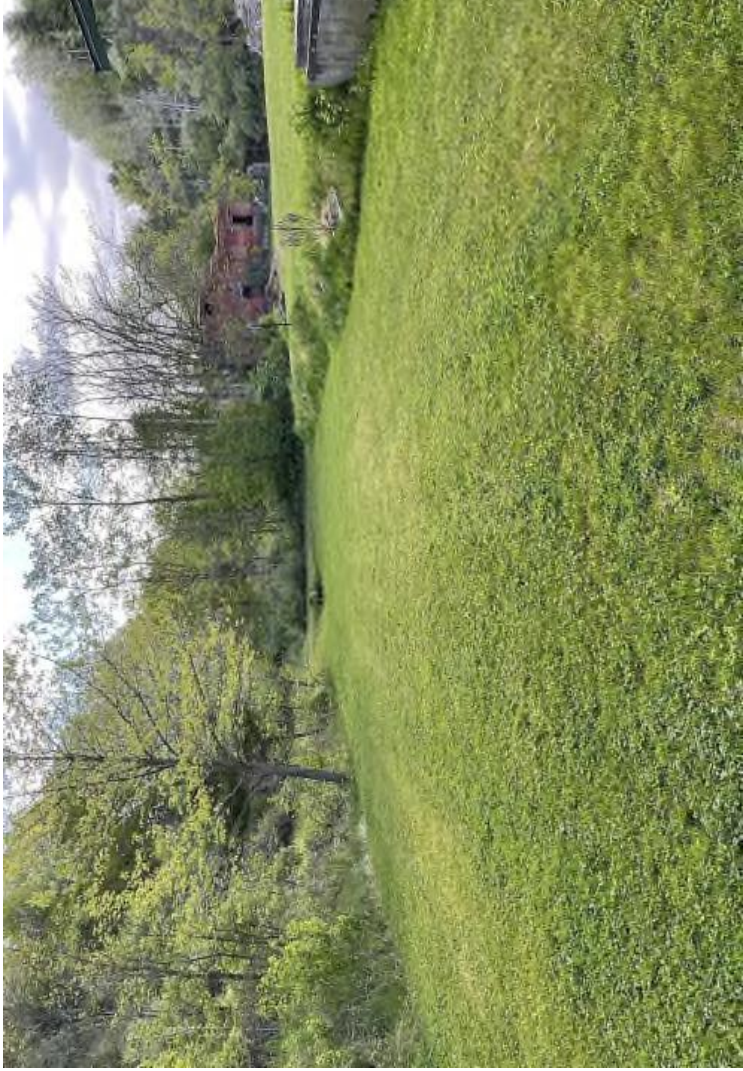
Photo #7: Former Structure 6 Excavation Area, looking east.

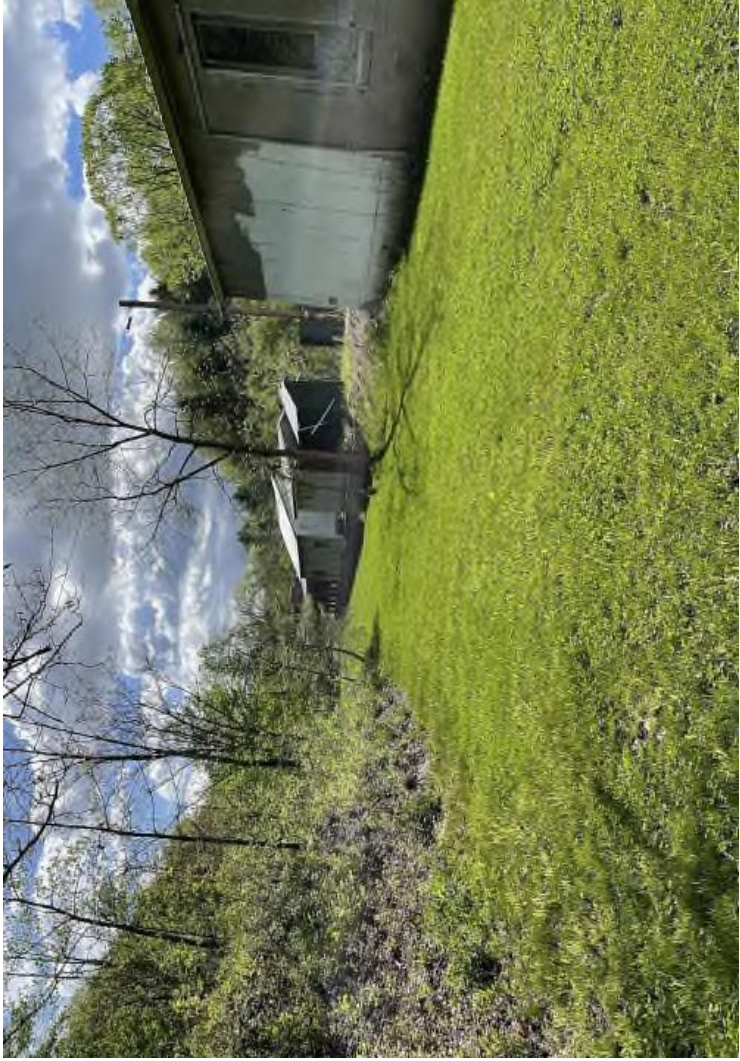
Photo #8: Recently cleared area, looking east, with Former Structure 6 Area in the distance.

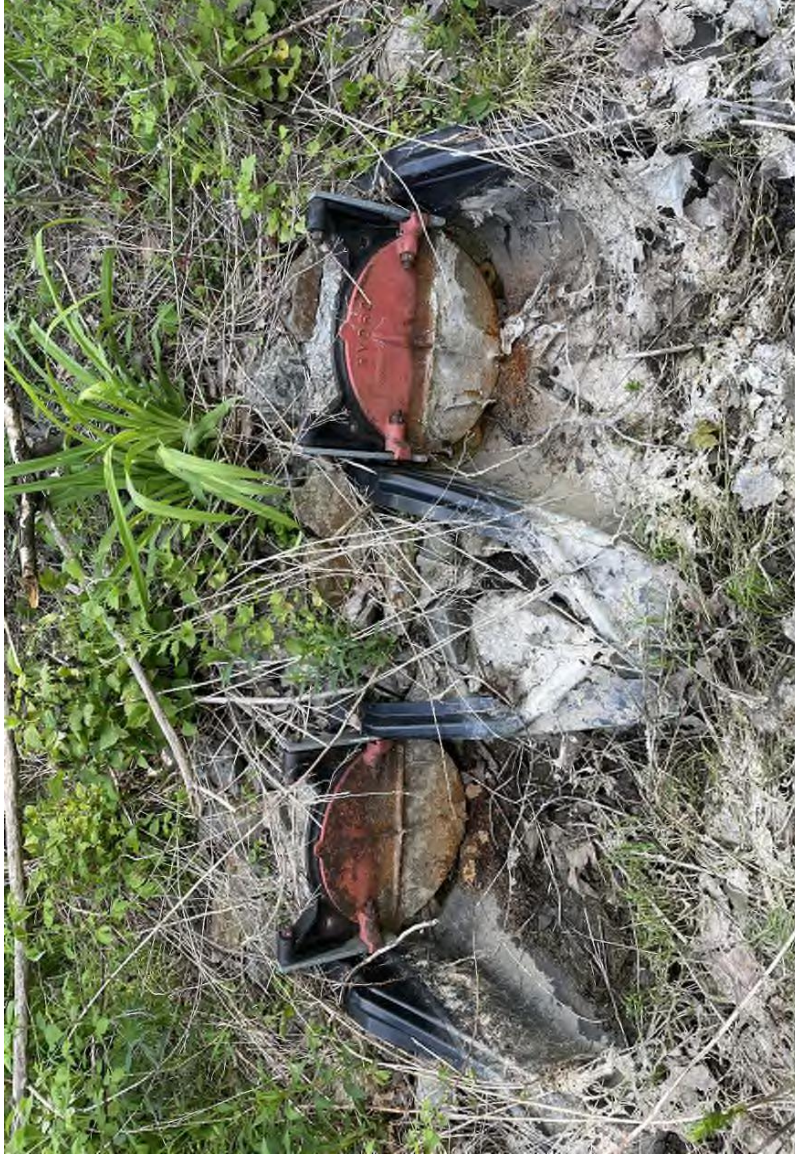
| ITEM | EXAMPLES OF TYPES OF PROBLEMS | TRIGGER LEVEL (if applicable) | STATUS* | OBSERVATIONS | DATE AND NATURE OF REPAIRS/ MAINTENANCE |
|---|---|---|---|---|---|
| <i>Flap Gates</i> | Leakage; deterioration; malfunction. | Any leakage; any corrosion or deterioration that affects structural integrity; inoperability. | Acceptable | Minimal sediment observed at flap gates, and gates operate freely. | Not Applicable |

Photo #1: Outlet of West Disposal Area Drainage, looking north at flap gates.

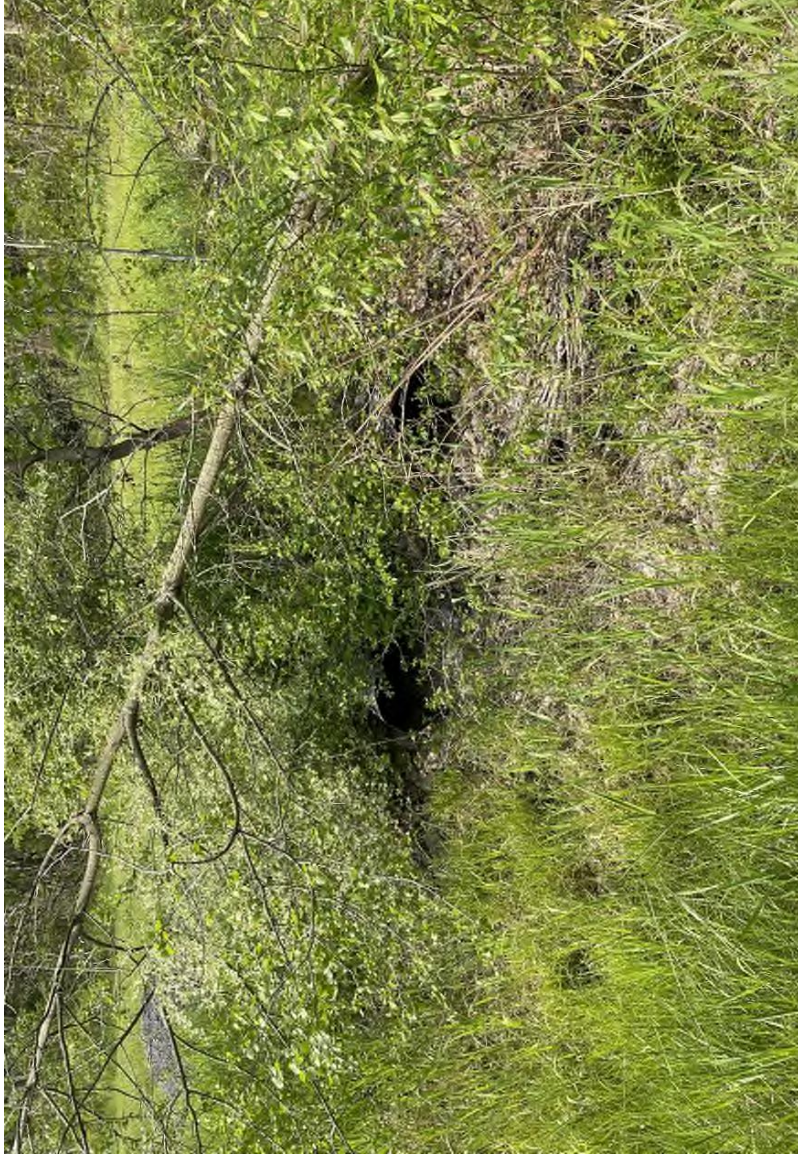
| ITEM | EXAMPLES OF TYPES OF PROBLEMS | TRIGGER LEVEL (if applicable) | STATUS* | OBSERVATIONS | DATE AND NATURE OF REPAIRS/ MAINTENANCE |
|---|---|---|---|---|---|
| <i>Culverts</i> | Corrosion; deterioration; siltation; blockage; clogging. | Any clogs or deterioration that affects structural integrity or flow. | Acceptable | No corrosion, deterioration or blockages observed | Not Applicable |

Photo #2: Drainage culvert pipes from West Disposal Area to Outlet, looking south.

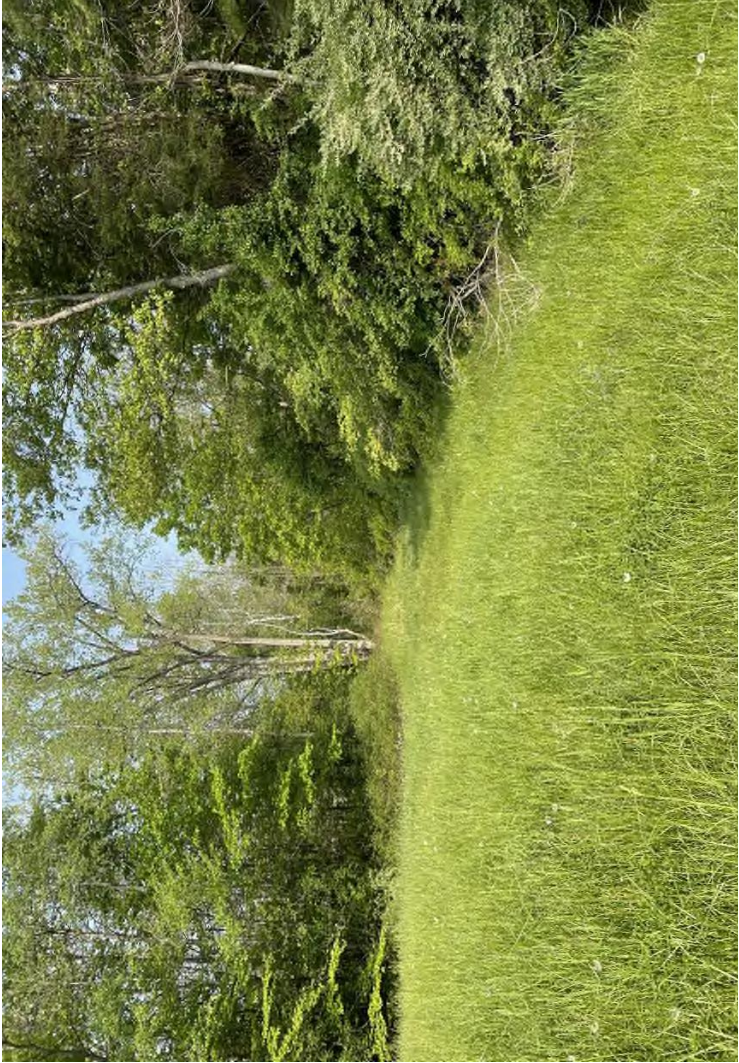
Photo #3: West Disposal Area, west end, looking west.

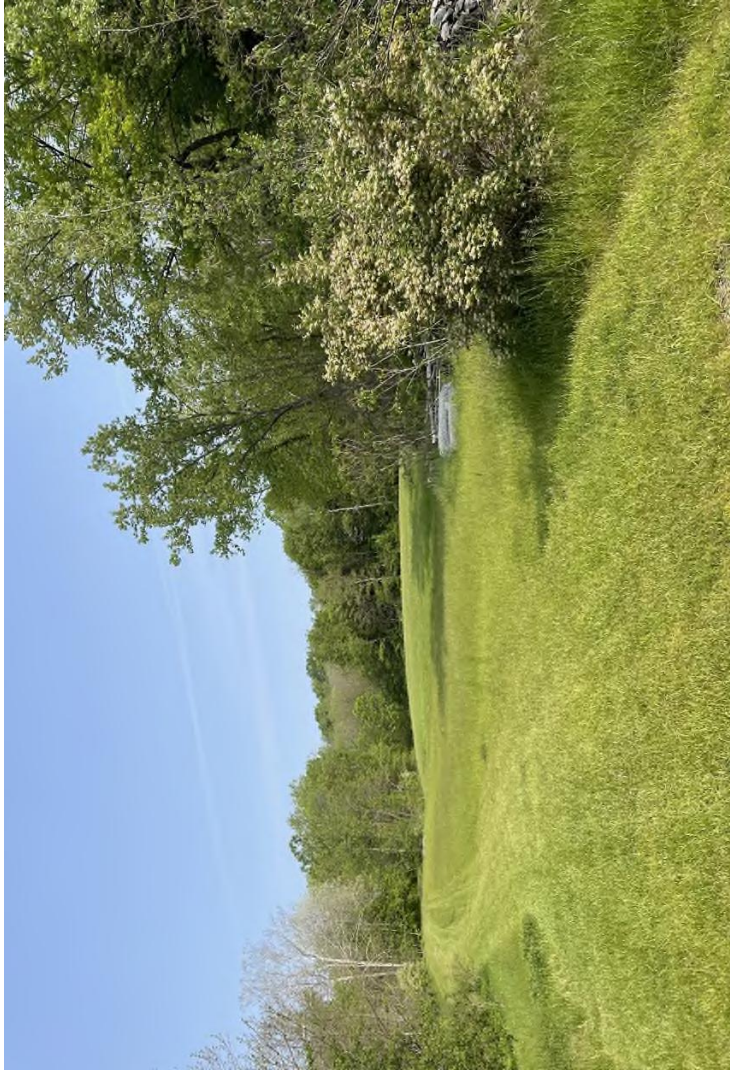
Photo #4: West Disposal Area, looking northwest.

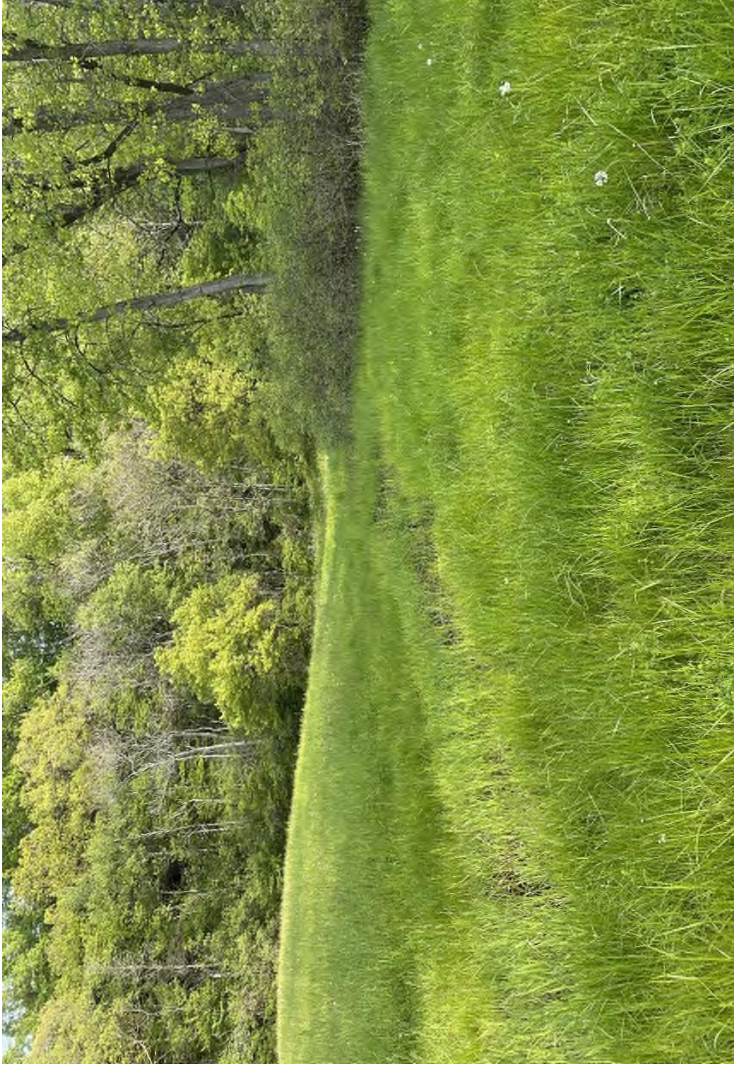
Photo #5: East end of West Disposal Area.

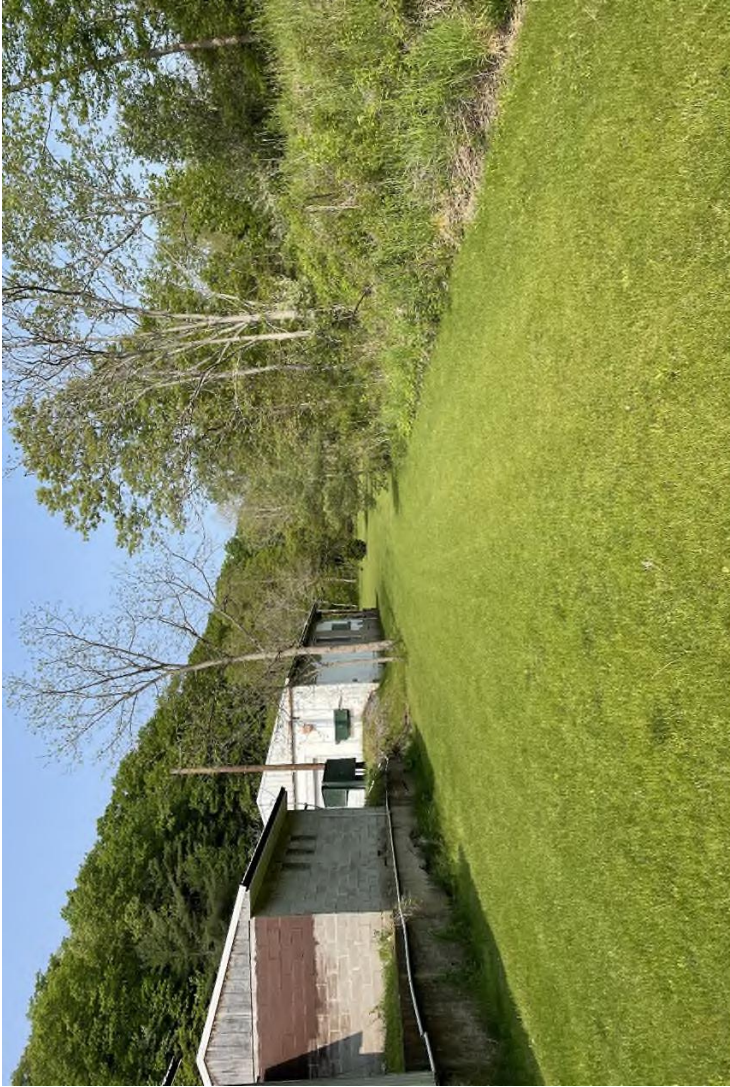
Photo #6: Former Structure 6 Excavation Area, looking west.

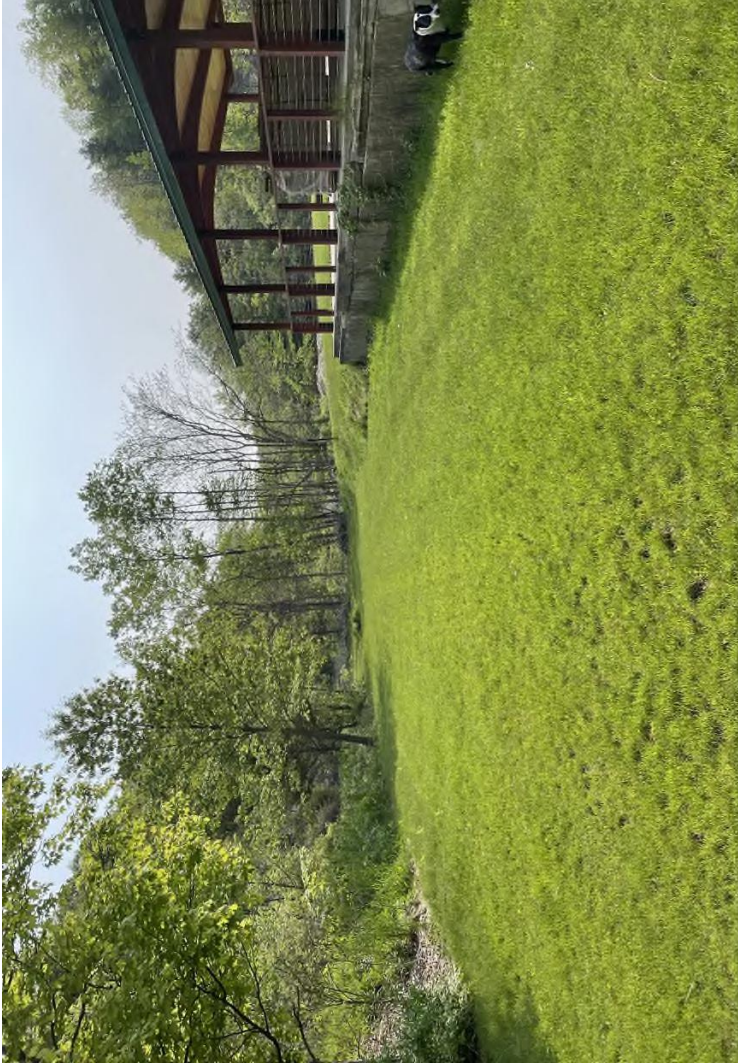
Photo #7: Former Structure 6 Excavation Area, looking east.

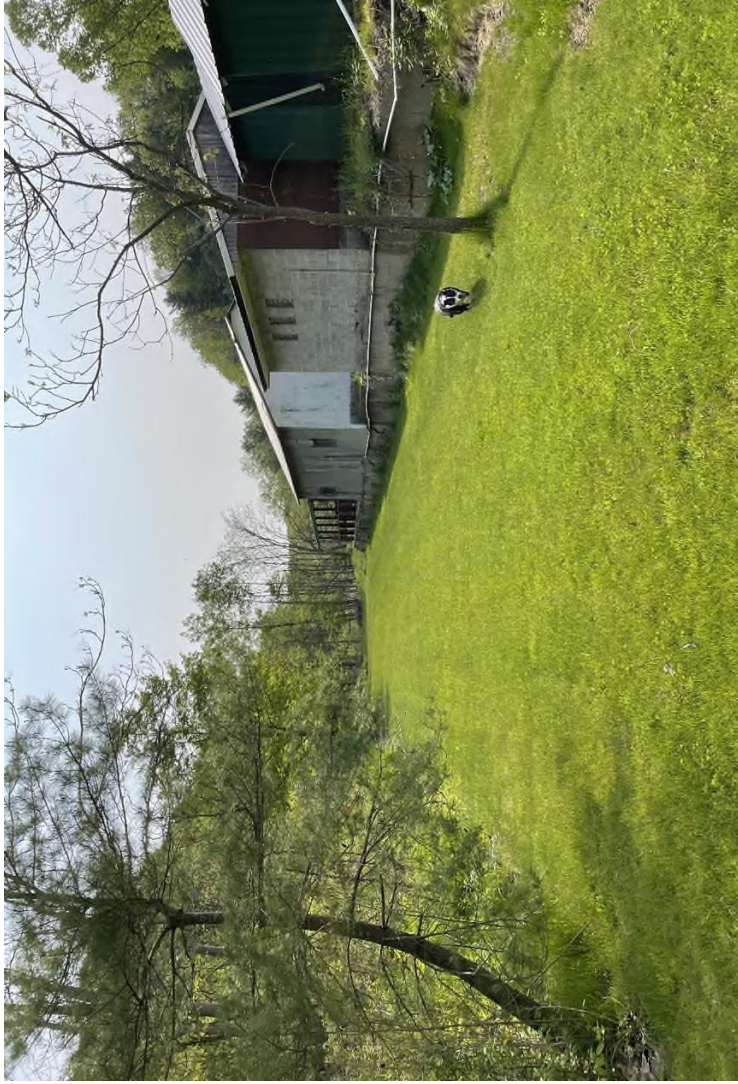
Photo #8: Cleared area west of Former Structure 6 Area, with Former Structure 6 Area in the distance.
