Penn Yan Former MGP Site
150 Water Street, Penn Yan, NY

Erosion and Sediment Control

Name of Inspector: George Fischer
10/9/2017

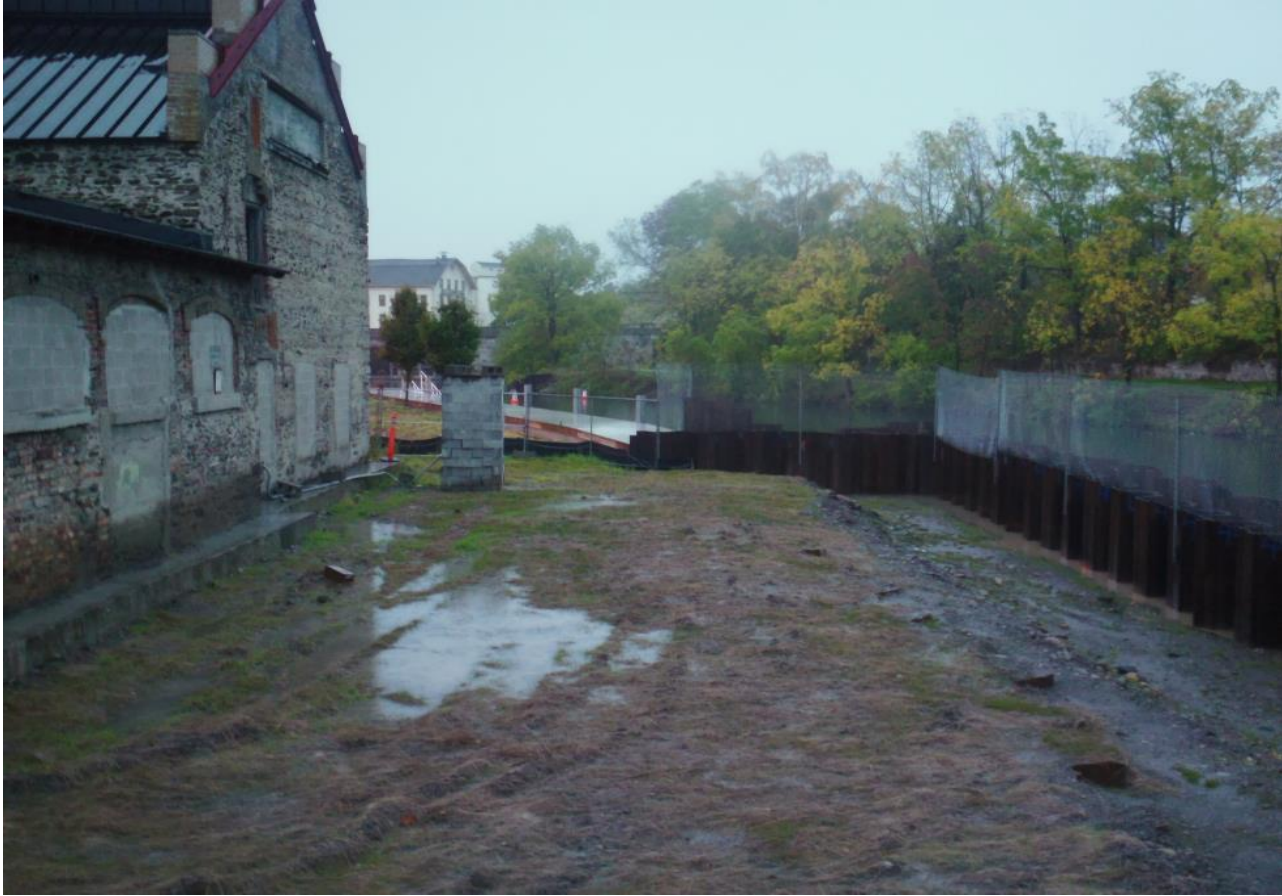
View of south side of building looking east
