Penn Yan Former MGP Site
150 Water Street, Penn Yan, NY

Erosion and Sediment Control

Name of Inspector: George Fischer
10/12/2017

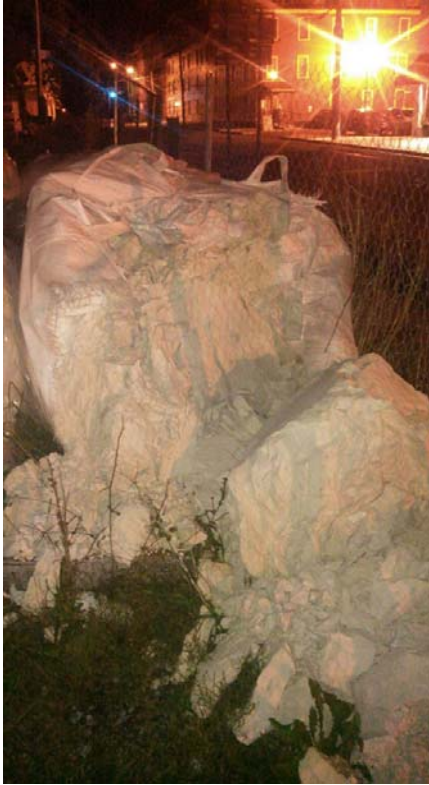
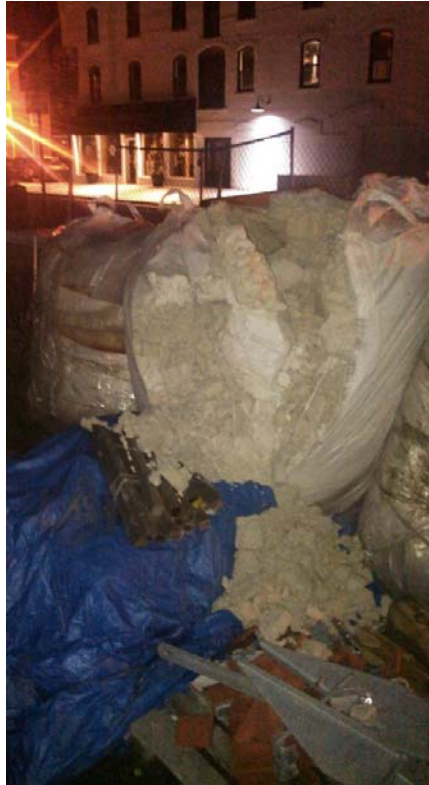
Inspection completed during temporary shut-down. Seeded areas filling in with plant growth, no damage to silt fence. The super sacks of LKD were observed to have split open. Severson was informed and will schedule a crew to cover the damaged super sacks to prevent further leaks.
