Penn Yan Former MGP Site
150 Water Street, Penn Yan, NY

Erosion and Sediment Control

Name of Inspector: George Fischer
10/20/2017

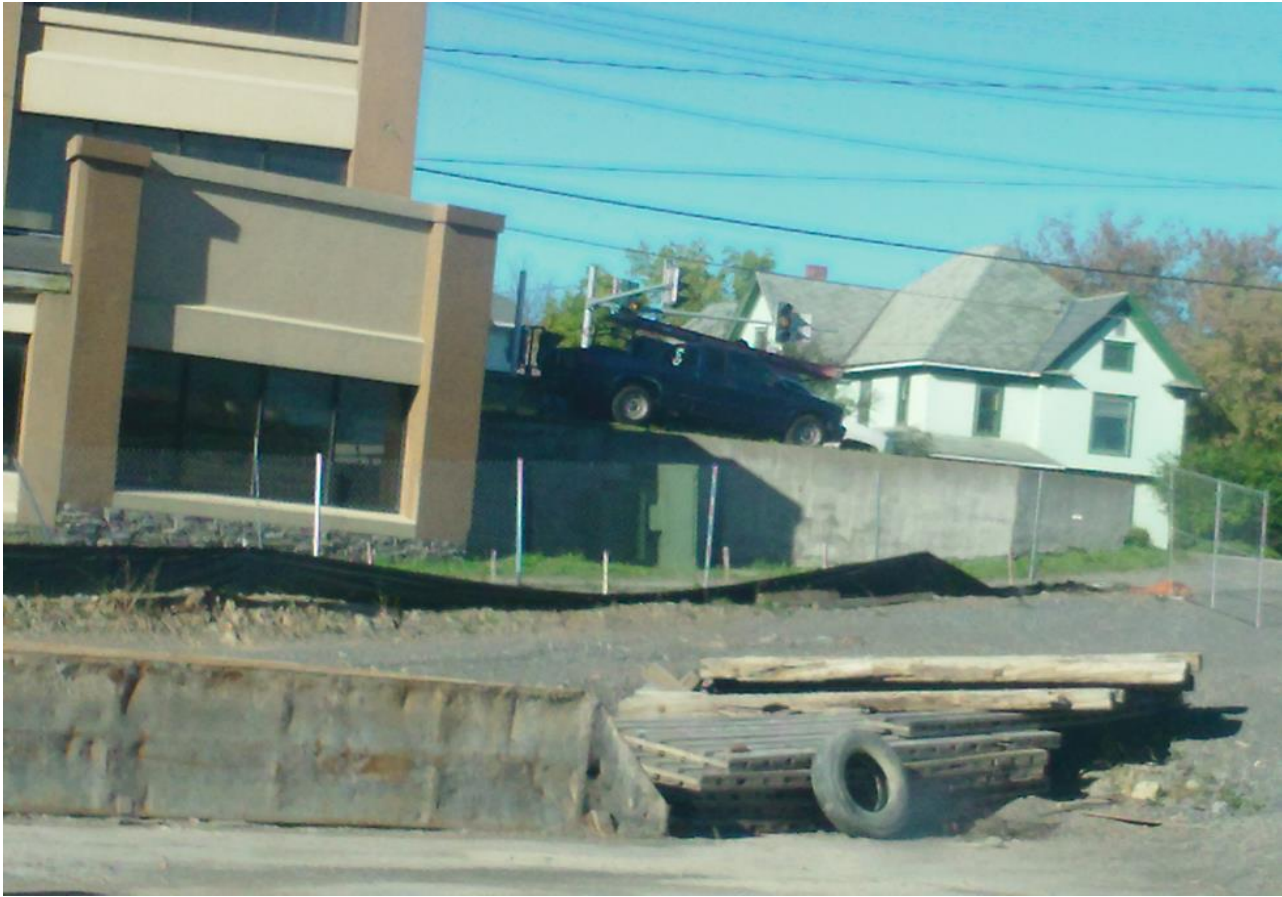
Are all the erosions controls functioning properly?	YES - Comment	NO – Comment
	YES	
Is any silt fence in need of repair or replacement?	YES - Picture forwarded to SES - small section of silt fence on upper west side of site has pulled away from stakes	
Are any storm drain inlet protections in need of repair or replacement?		N/A
Is there any potentially contaminated water migrating off-site?		No
Are any hay bales in need of repair or replacement?		N/A

Silt fence along west side of site in need of repair
