Penn Yan Former MGP Site
150 Water Street, Penn Yan, NY

Erosion and Sediment Control

Name of Inspector: George Fischer
10/26/2017

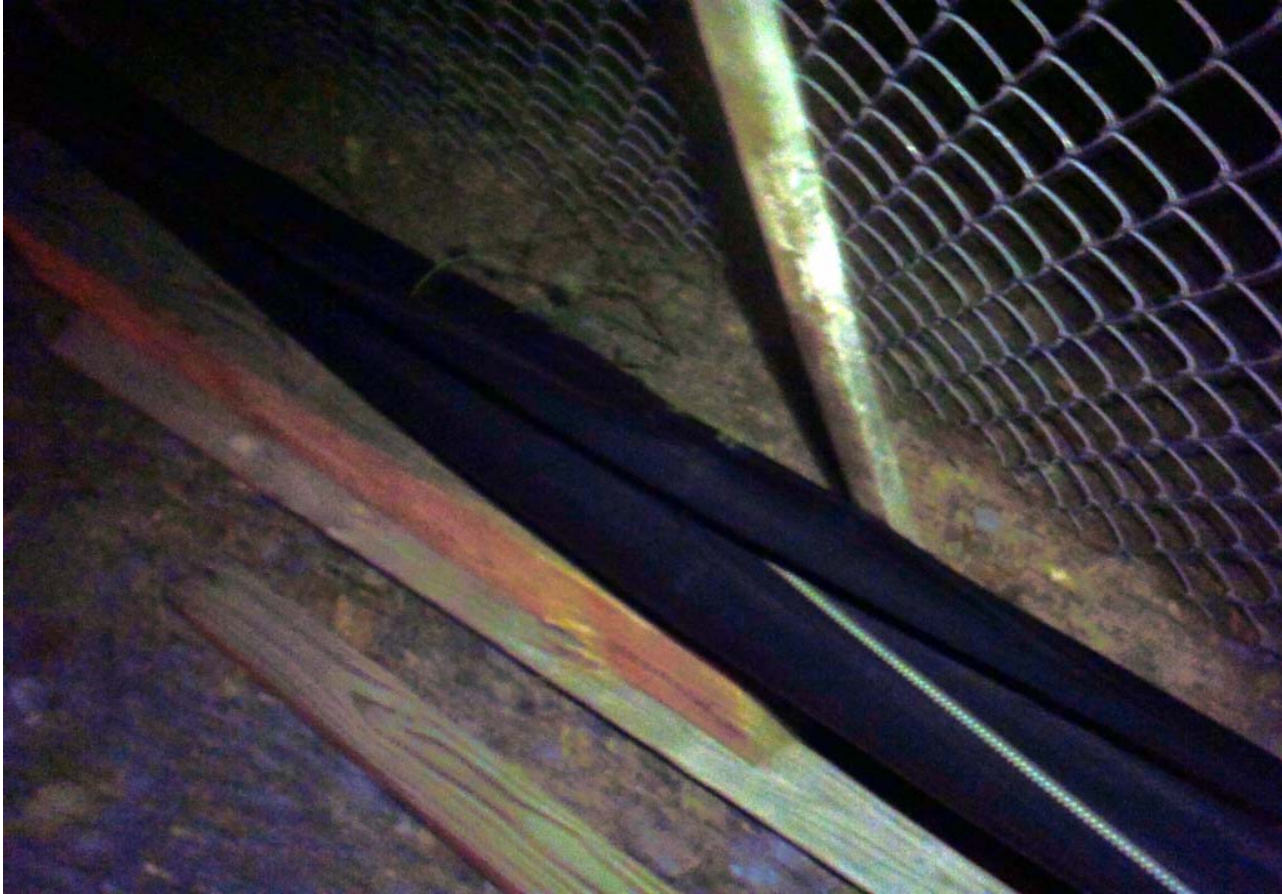
Are all the erosions controls functioning properly?	YES - Comment	NO – Comment
	YES	
Is any silt fence in need of repair or replacement?	YES - Picture forwarded to SES - small section of silt fence on upper west side of site has pulled away from stakes	
Are any storm drain inlet protections in need of repair or replacement?		N/A
Is there any potentially contaminated water migrating off-site?		No
Are any hay bales in need of repair or replacement?		N/A

Silt fence along west side of site in need of repair
