Penn Yan Former MGP Site  
150 Water Street, Penn Yan, NY

## Erosion and Sediment Control

Name of Inspector: George Fischer  
11/10/2017

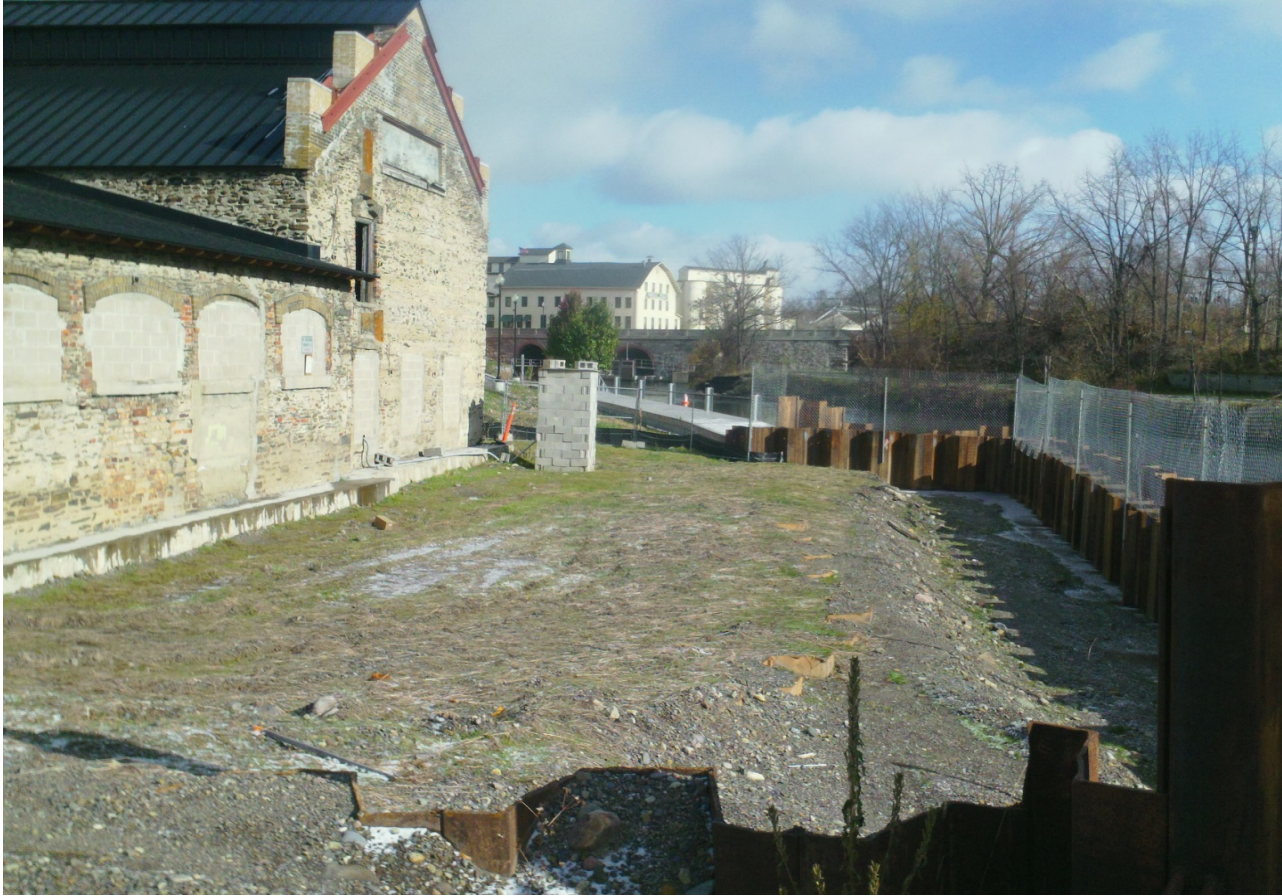
Inspection completed during temporary shut-down. Seeded areas filling in with plant growth, no damage to silt fence observed.

South side of former MGP structure
