Penn Yan Former MGP Site
150 Water Street, Penn Yan, NY

Erosion and Sediment Control

Name of Inspector: George Fischer
12/21/2017

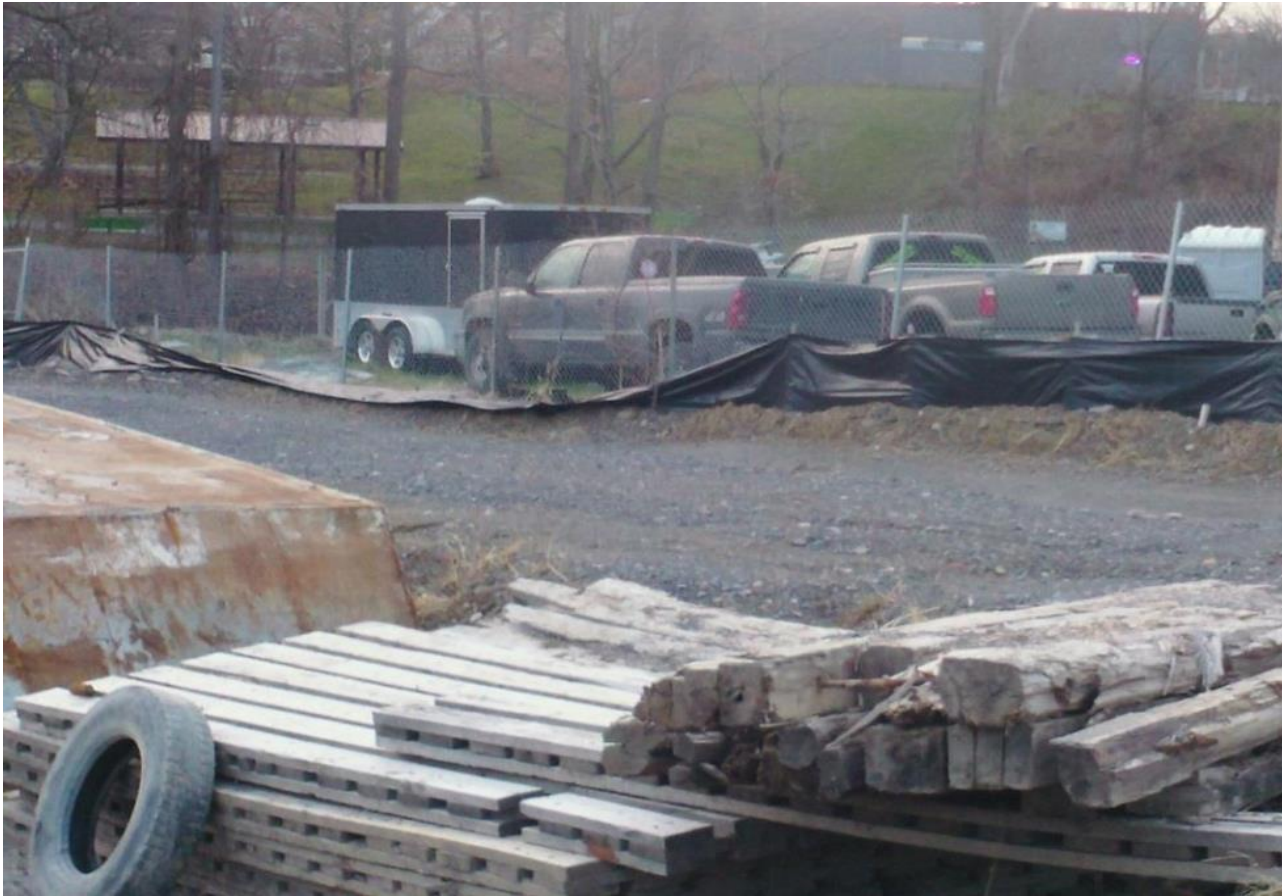
Are all the erosions controls functioning properly?	YES - Comment	NO – Comment
		NO - silt fence at west side of site collapsed due to snow
Is any silt fence in need of repair or replacement?		Yes, see above
Are any storm drain inlet protections in need of repair or replacement?		N/A
Is there any potentially contaminated water migrating off-site?		No
Are any hay bales in need of repair or replacement?		N/A

Silt fence along west side of site collapsed.

Comments:
Condition of runoff at all points of discharge from the site (pipe, culverts and ditches)	N/A
Condition of all natural water bodies which receive runoff	Clear, partially frozen
Corrective action to repair E&S	Email sent to SES
Construction activity not in line with SWPPP	N/A
