Penn Yan Former MGP Site
150 Water Street, Penn Yan, NY

Erosion and Sediment Control

2/5/2018

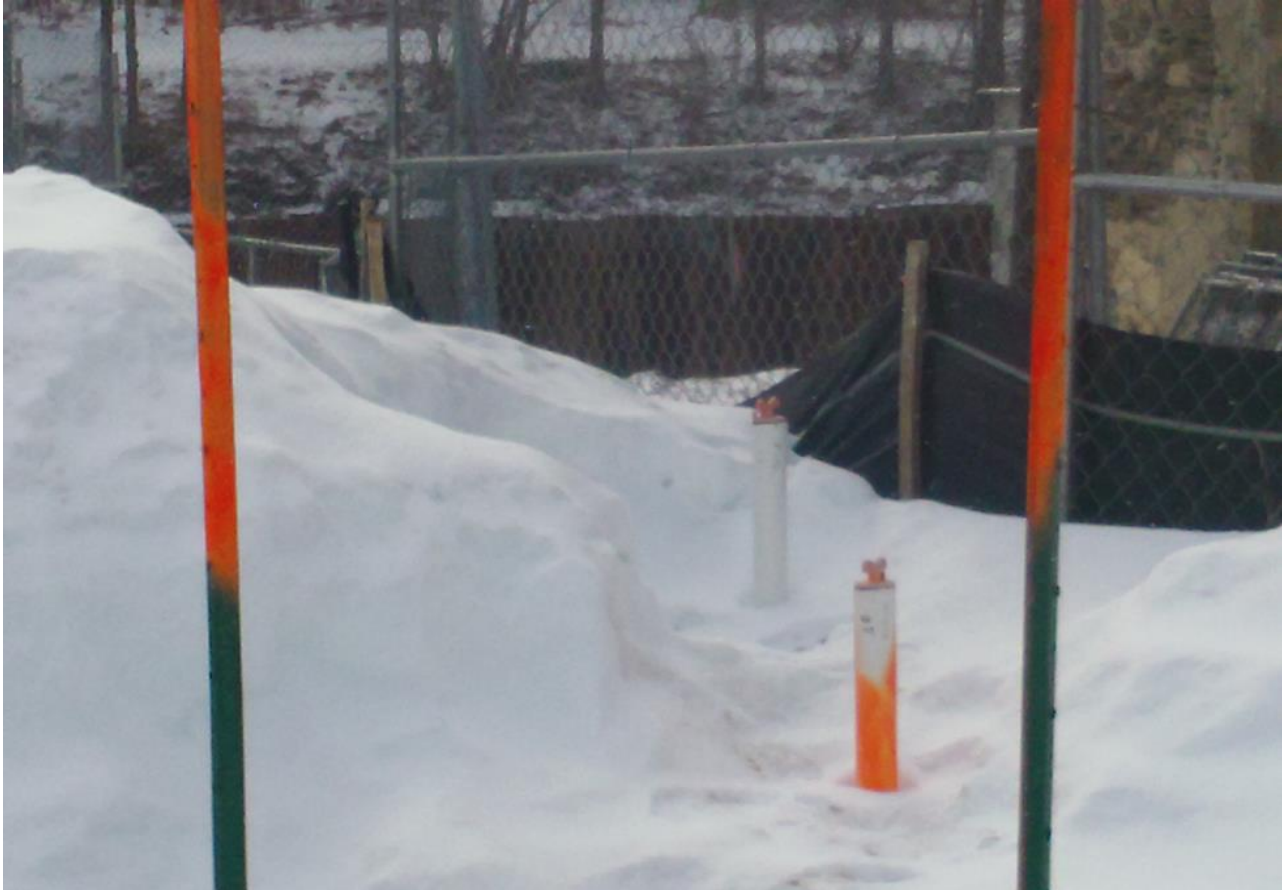
Inspection completed during temporary shut-down. Site frozen and snow covered. Silt fence at upper west side of site starting to pull from stakes. AECOM will notify SES to repair during the next scheduled site visit. Photo below of plowed under silt fence on east side.
