Penn Yan Former MGP Site
150 Water Street, Penn Yan, NY

Erosion and Sediment Control

7/12/2018

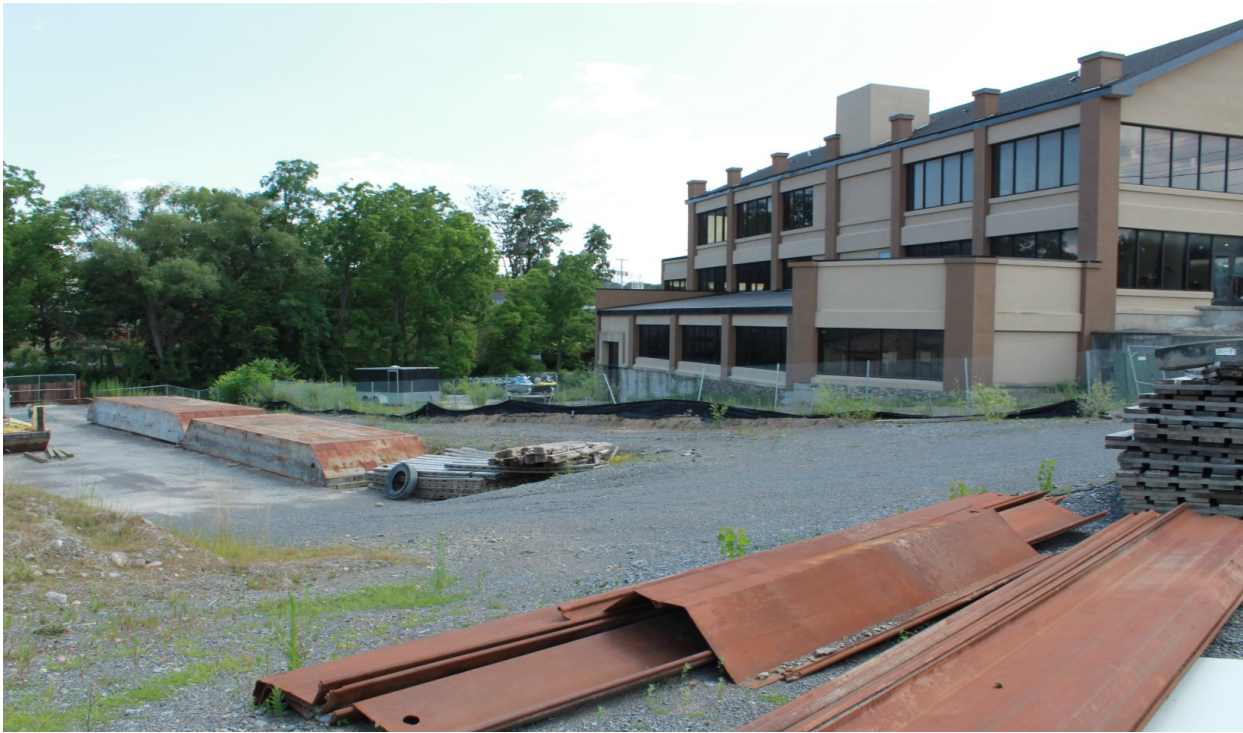
Are all the erosion controls functioning properly?	YES - Comment	NO – Comment
	YES - some silt fence on west side of site and south side of laydown yard pulled from stakes but are on uphill side of site.	
Is any silt fence in need of repair or replacement?	Yes, see above.	
Are any storm drain inlet protections in need of repair or replacement?		N/A
Is there any potentially contaminated water migrating off-site?		No
Are any hay bales in need of repair or replacement?		N/A
