# DAILY OBSERVATION REPORT

Report No.: 174

D&B Project File: 3150-31

<b>D&amp;B Engineers and Architects, P.C.</b>	<b>Contractor PM: Matt Thorpe</b>
	<b>NYSDEC PM: Gerry Pratt</b>
<b>Site Location: 150 Water Street, Penn Yan, NY 14527</b>	<b>NYSDEC Chief Inspector: Scott Deyette</b>
	<b>Construction Manager: Tony Certo</b>
	<b>Project Engineer: AECOM</b>
	<b>Remedial Contractor: Severson</b>
	<b>Air Monitoring: AECOM</b>
	<b>Health &amp; Safety: Ben Faery</b>

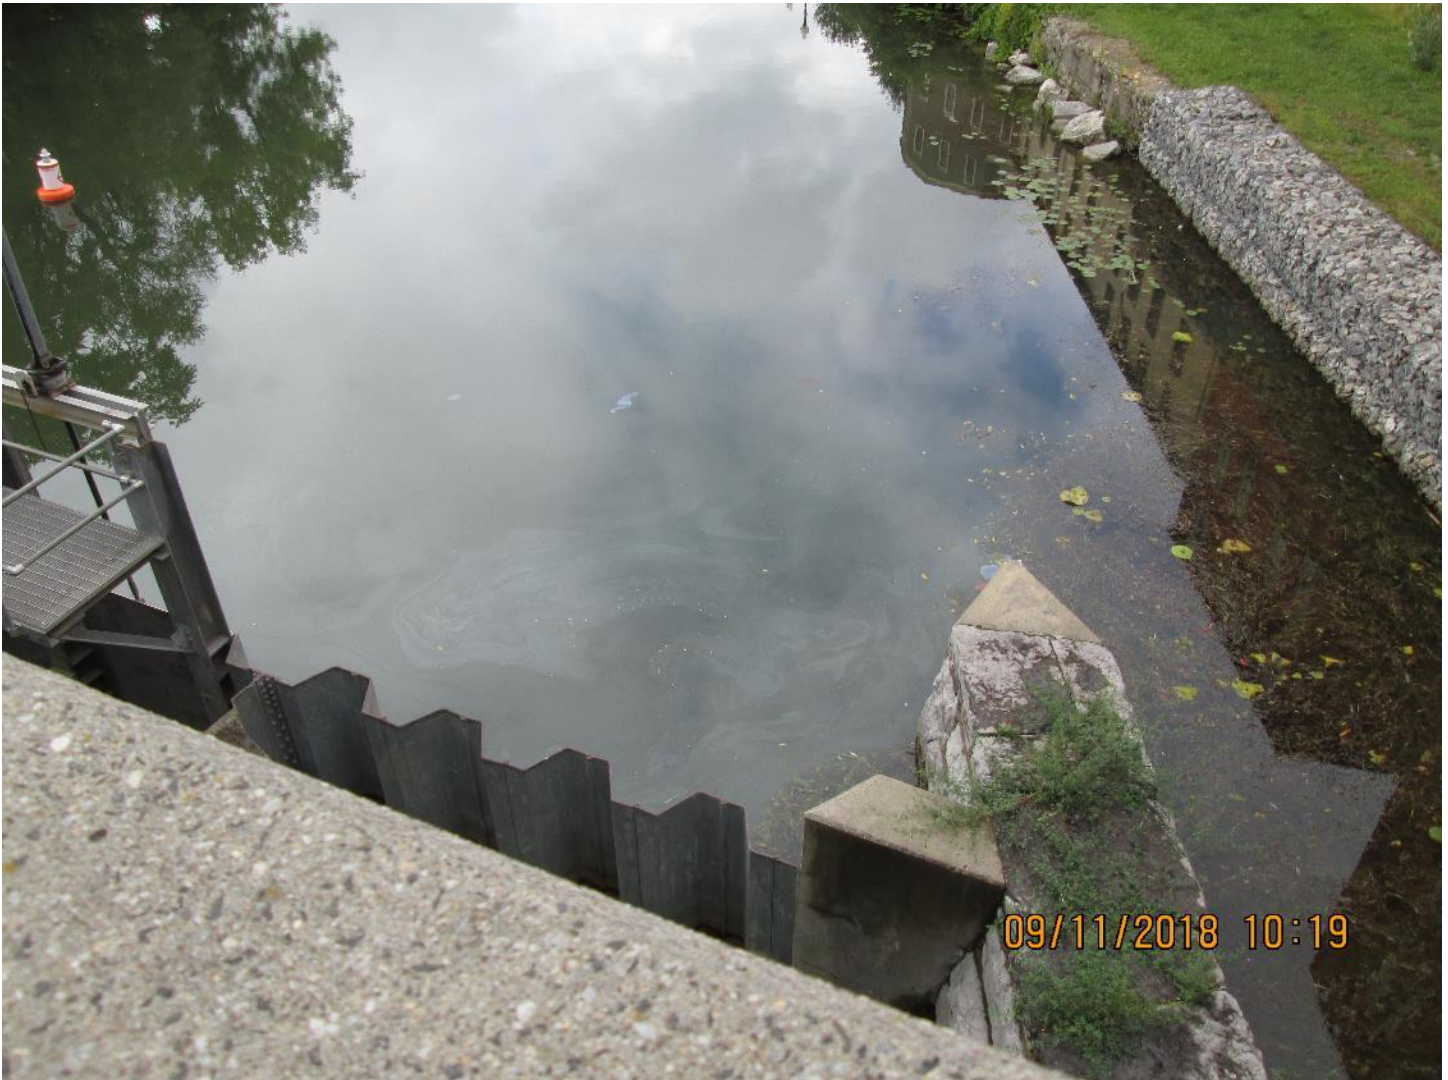
AECOM reported visible sheen on the water at the outlet control structure, southeast of the MGP site. This was confirmed by D&B Engineers. There was no other sheen visible along the outlet. This sheen is consistent with previous observations at the site.

**Photo 1:** Sheen visible at the outlet control structure facing west.

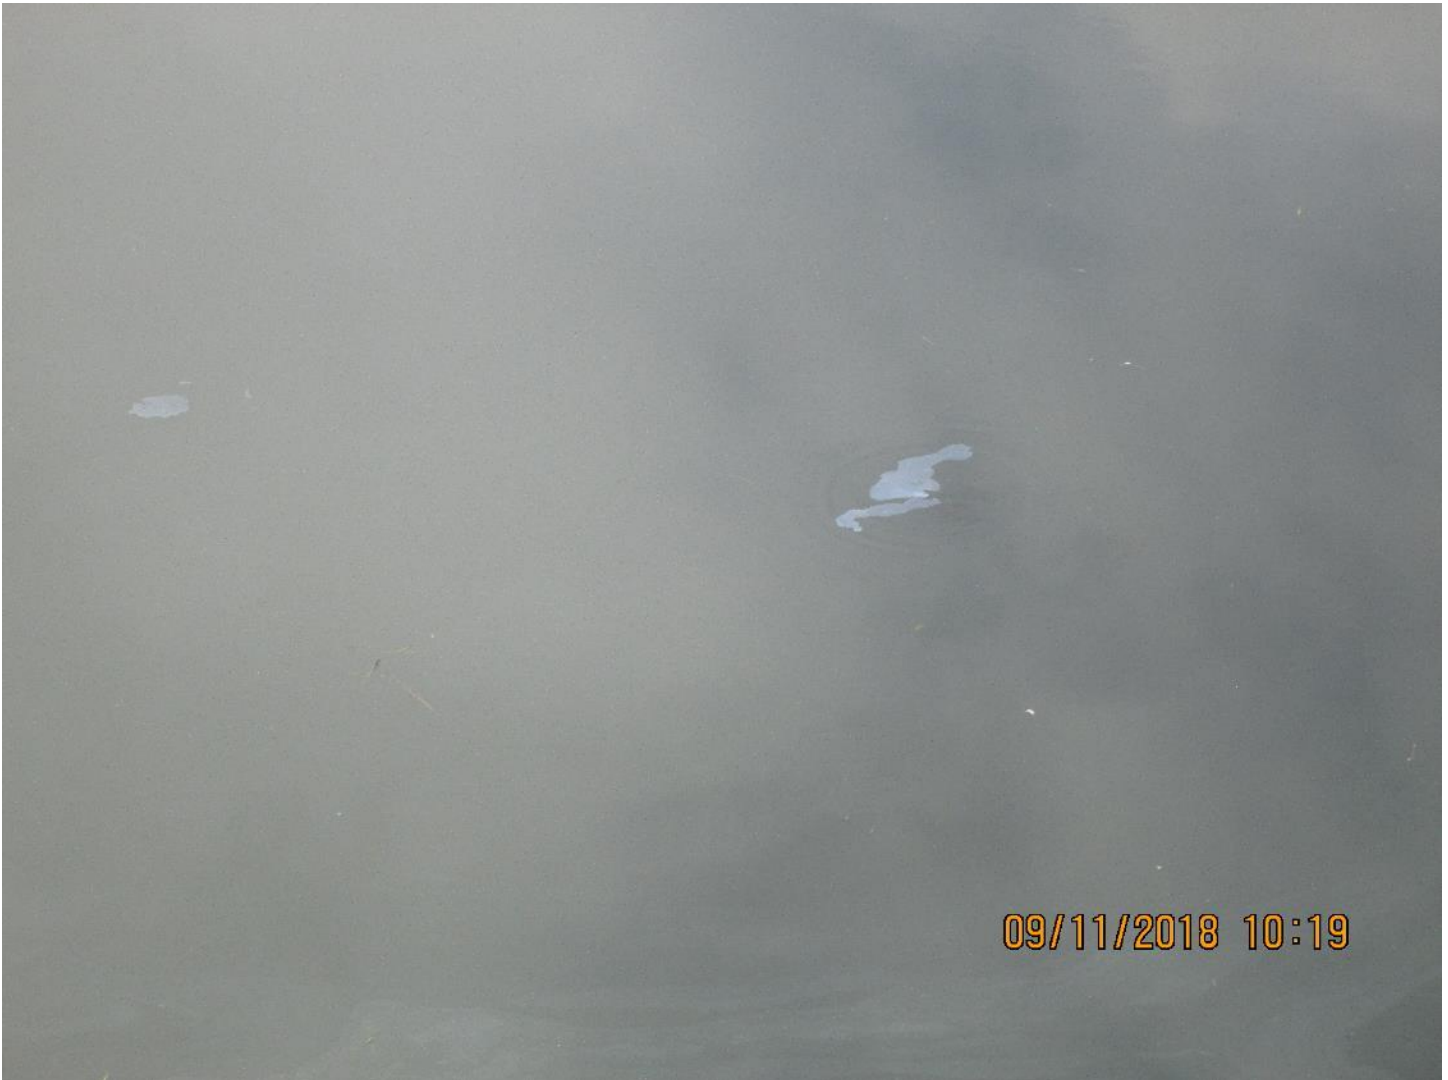
**Photo 2:** Sheen visible at the outlet control structure facing west.

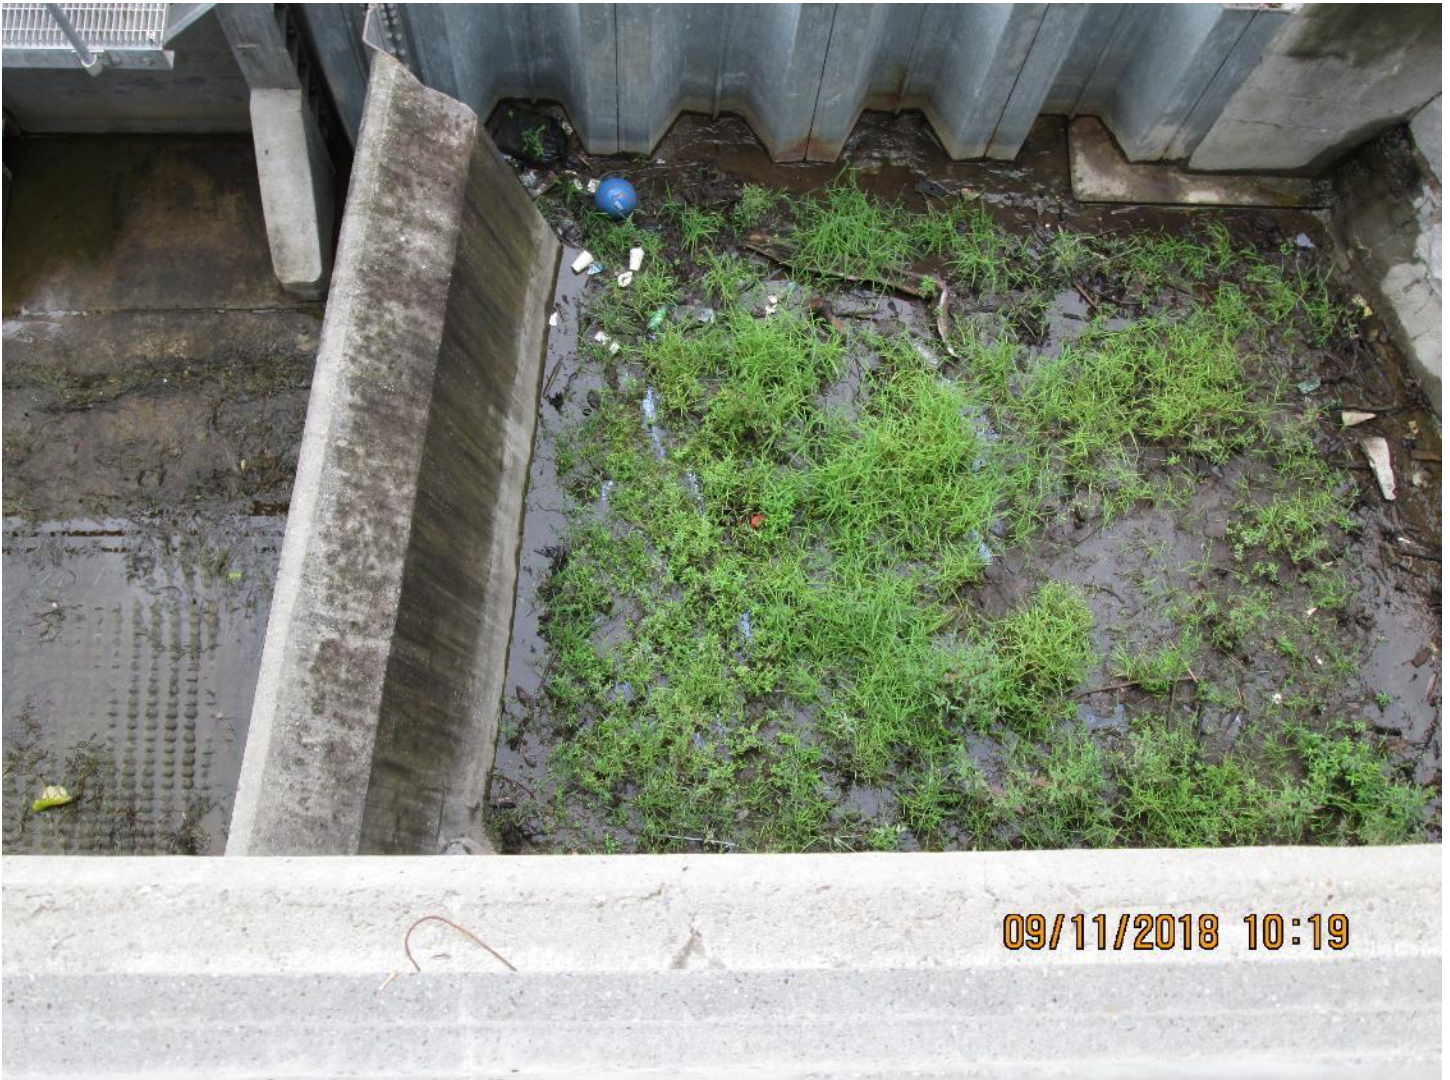
**Photo 3:** Sheen visible at the outlet control structure facing west.

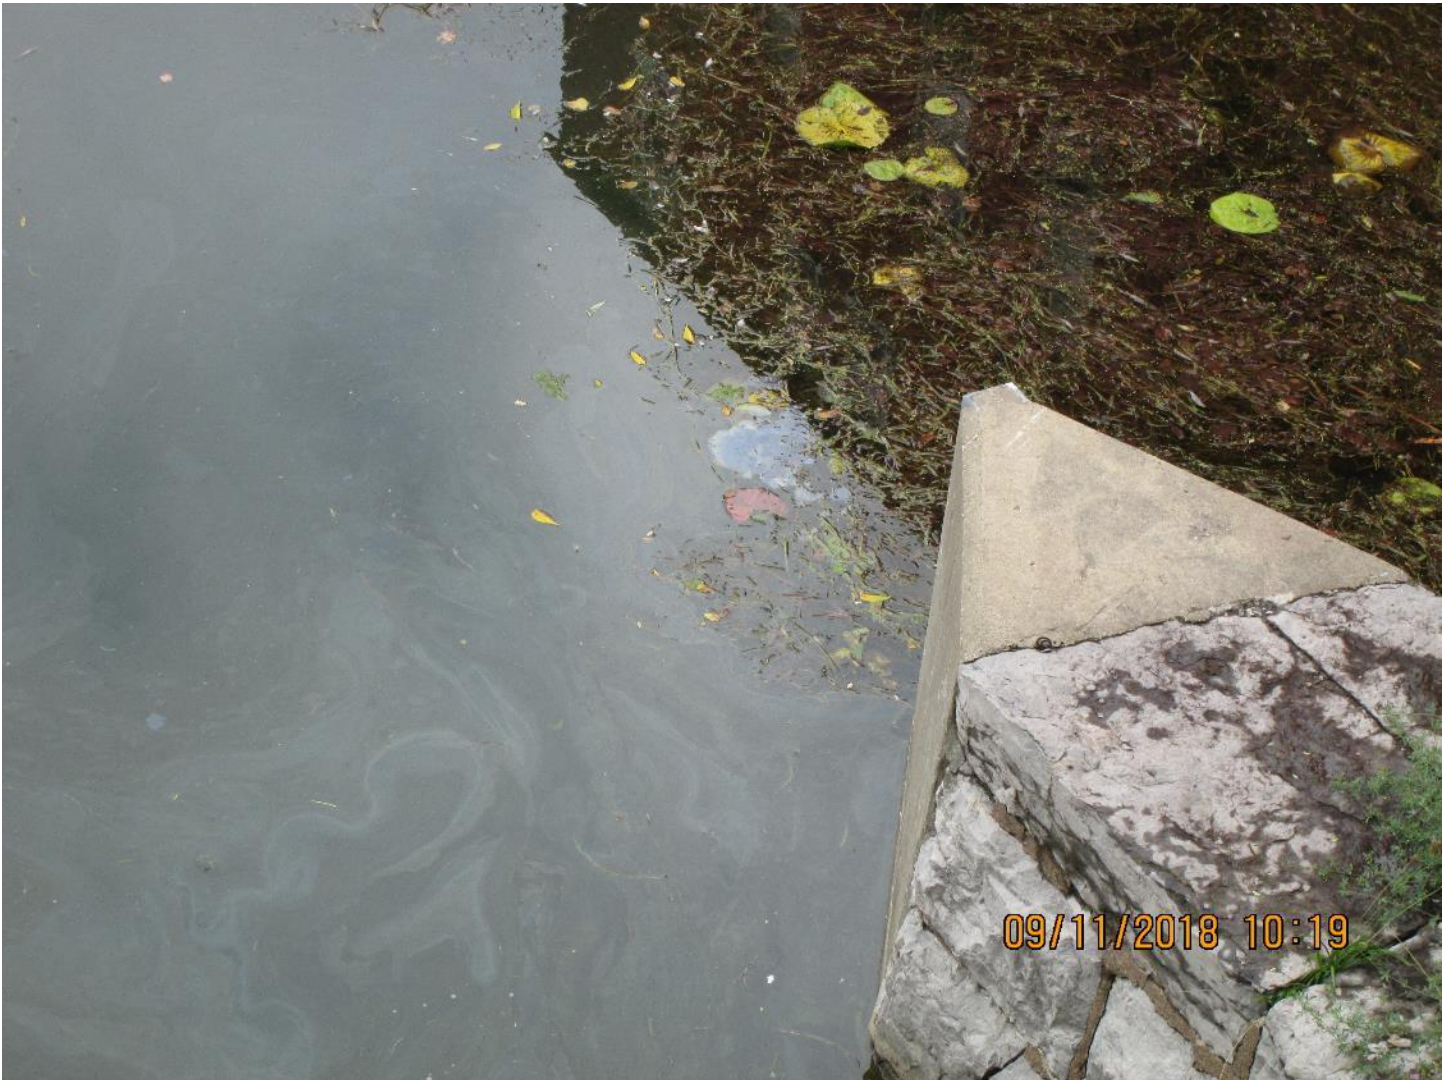
**Photo 4:** Sheen visible at the outlet control structure facing northwest.

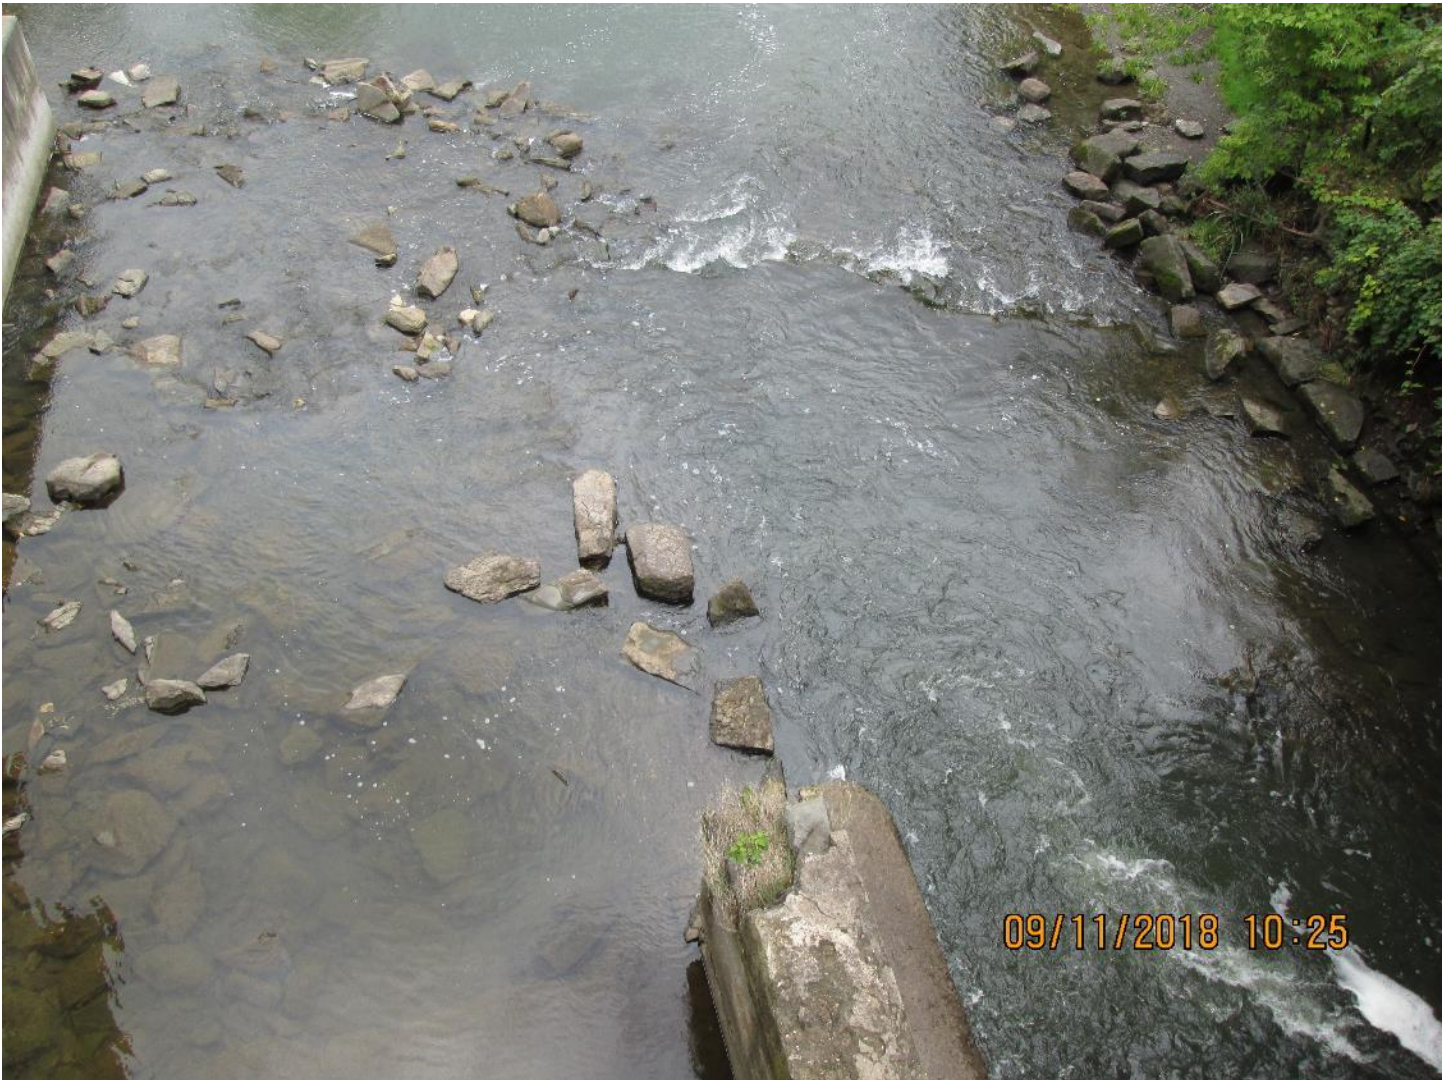
**Photo 5:** East side of the outlet control structure, no visible sheen. Facing east.

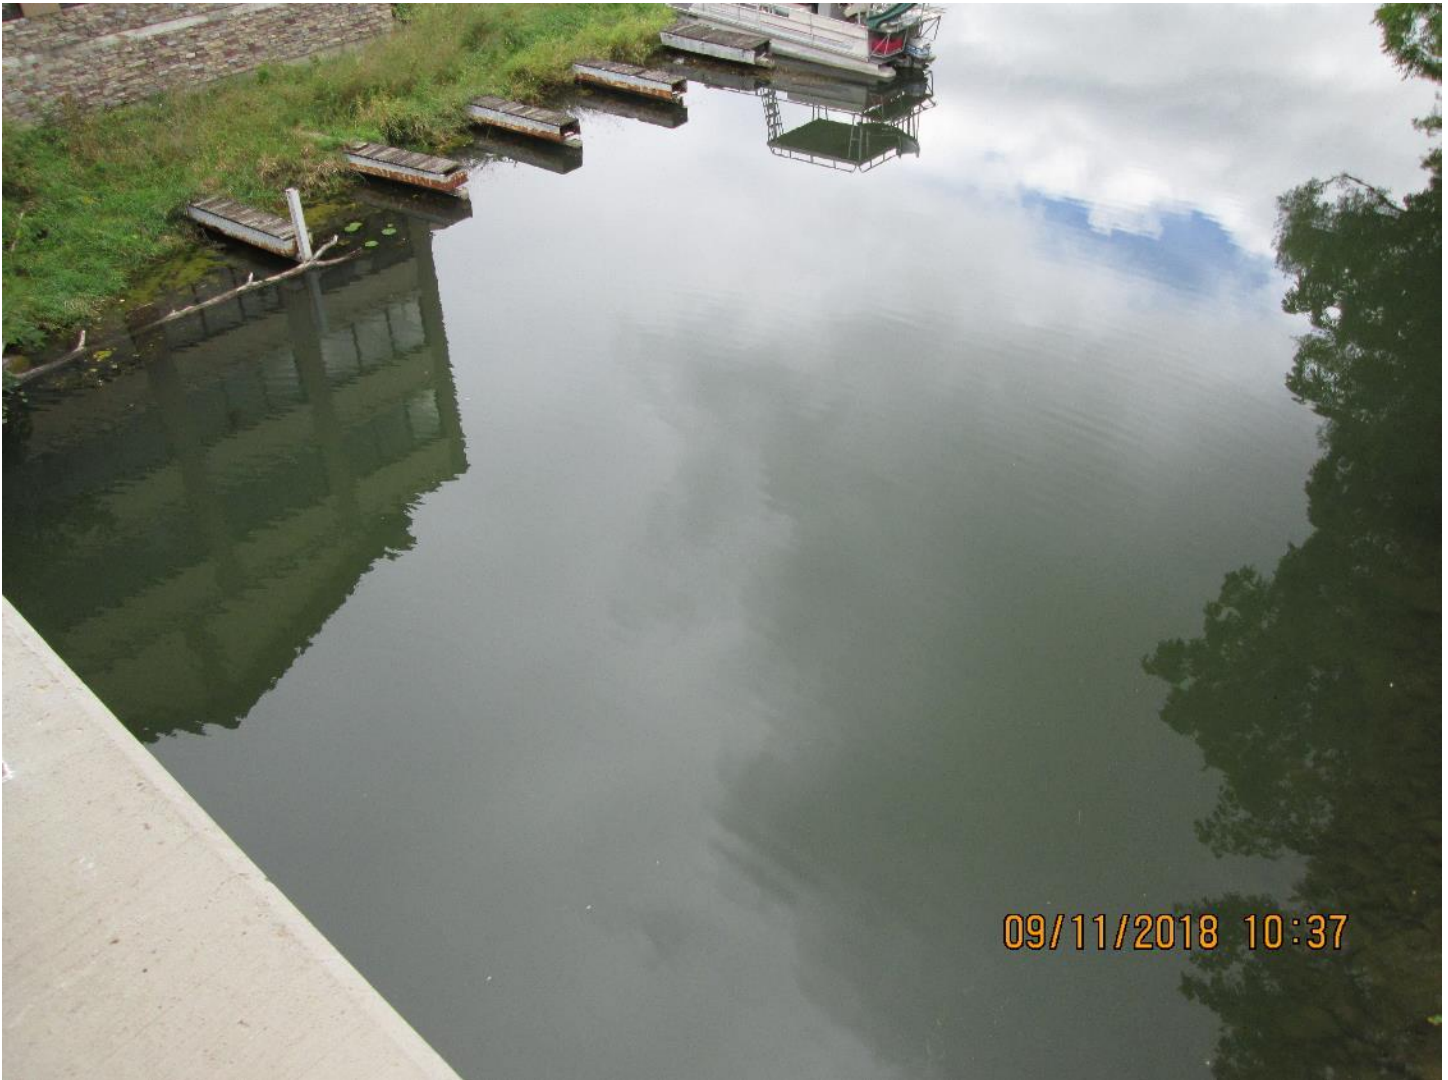
**Photo 6:** View from Liberty St bridge southwest of the MGP site, no visible sheen. Facing northeast.

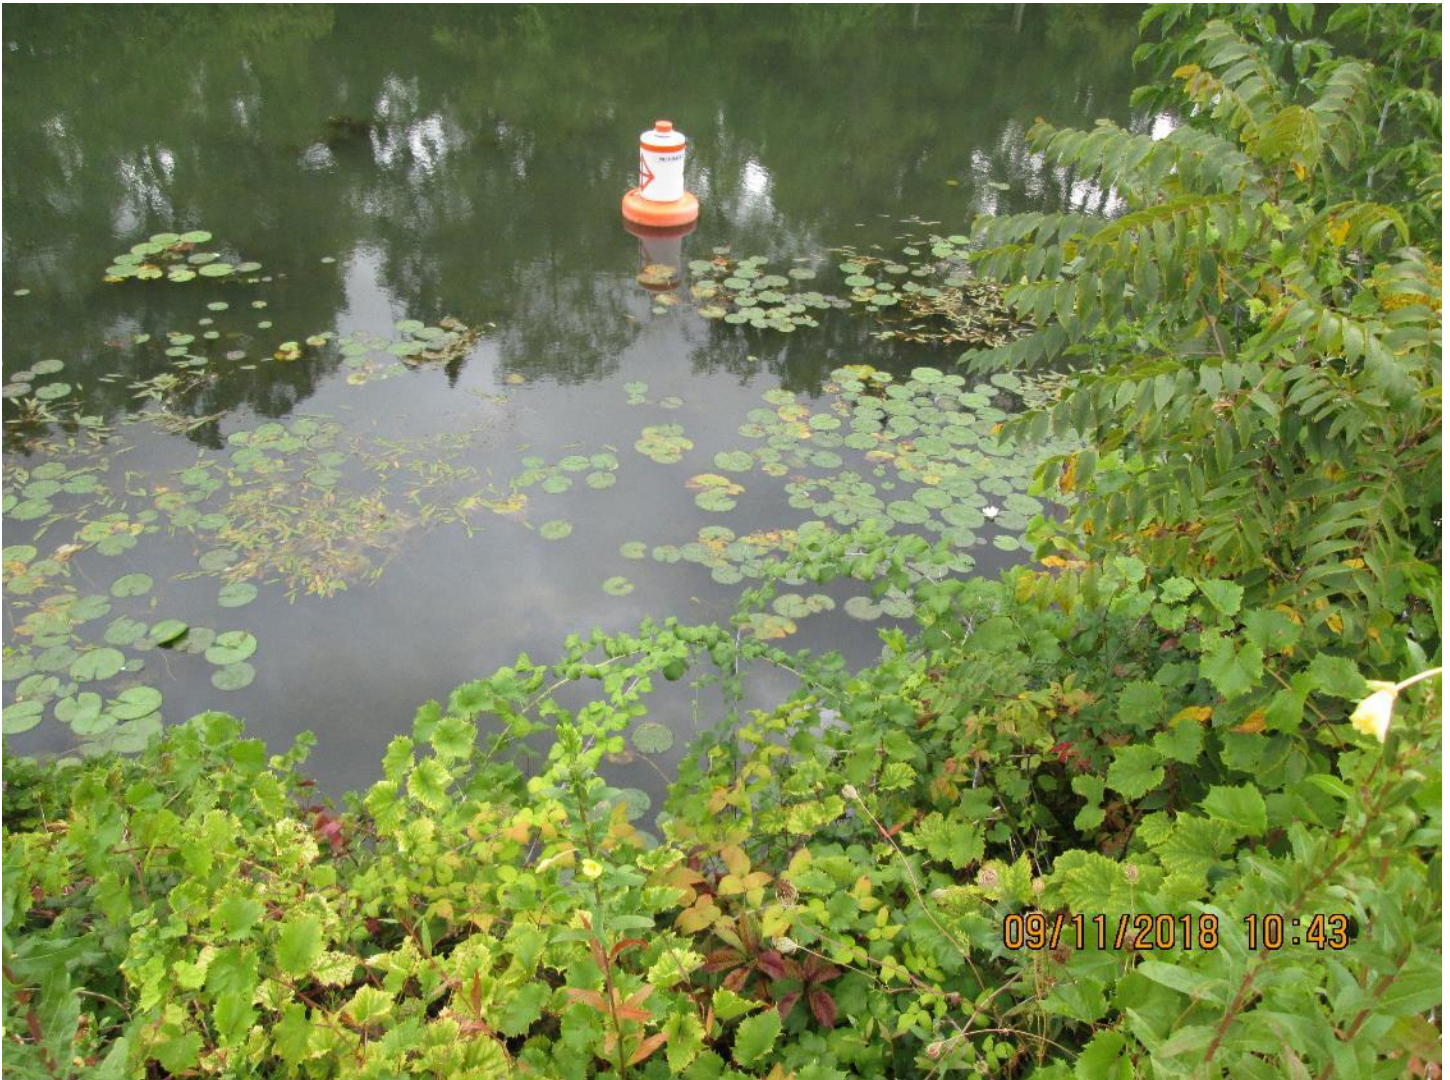
**Photo 7:** View of the outlet near the outfall piping southeast of the MGP site, no visible sheen. Facing south.

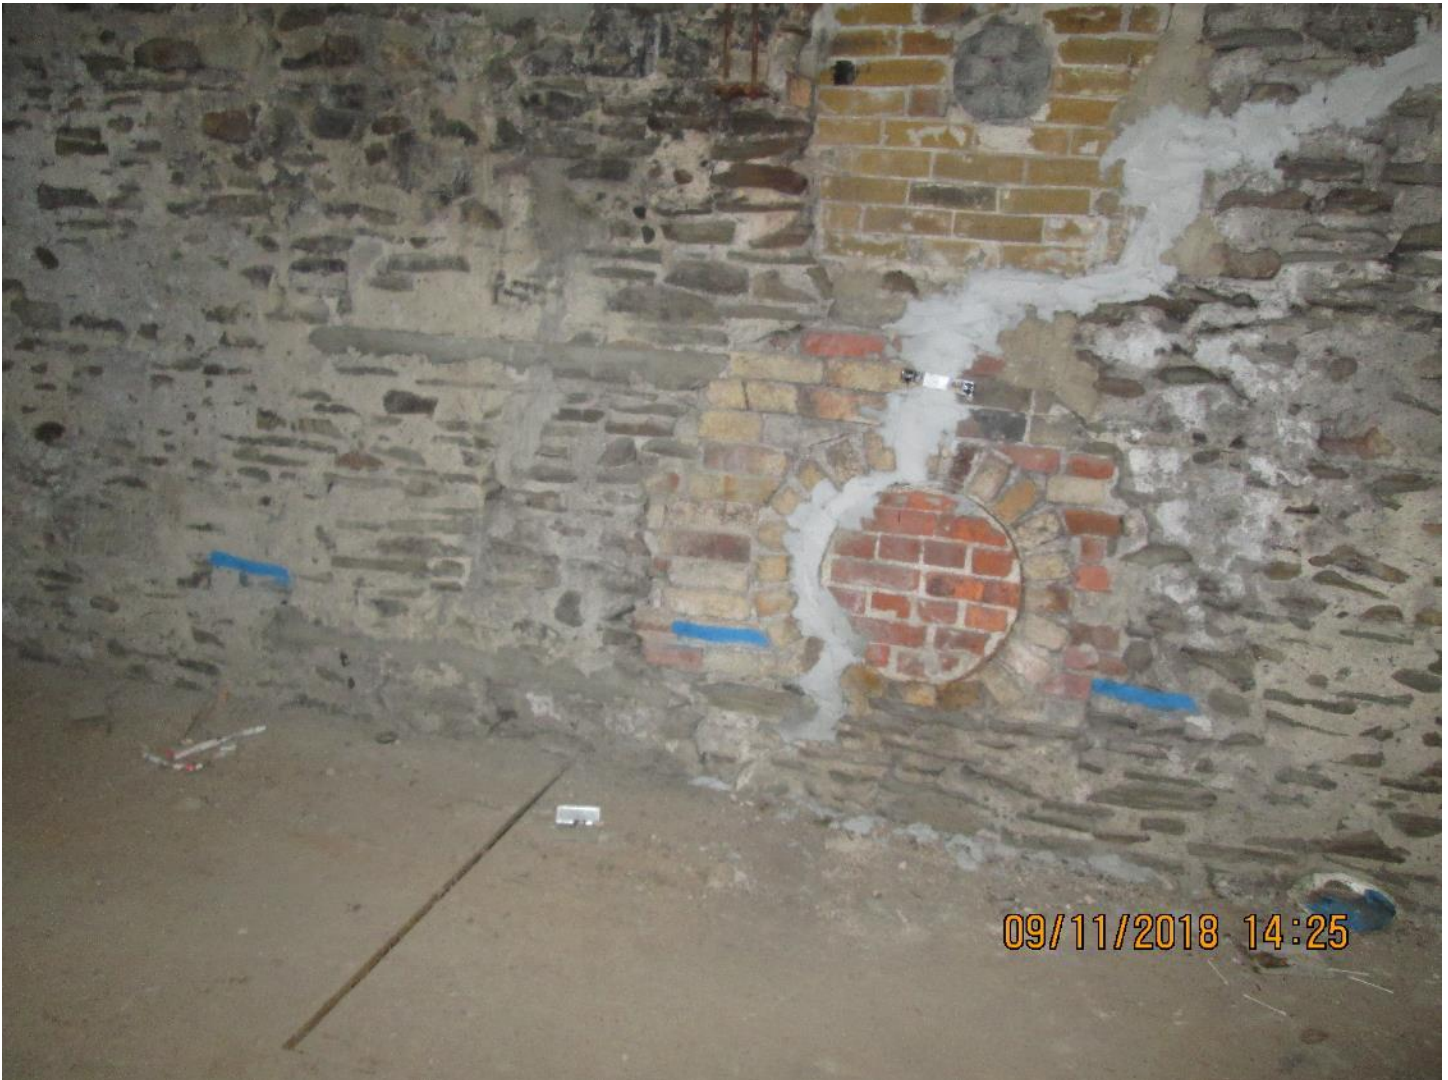
**Photo 8:** View of the level markings on the second floor of the MGP for AECOM's liquid level settlement system.

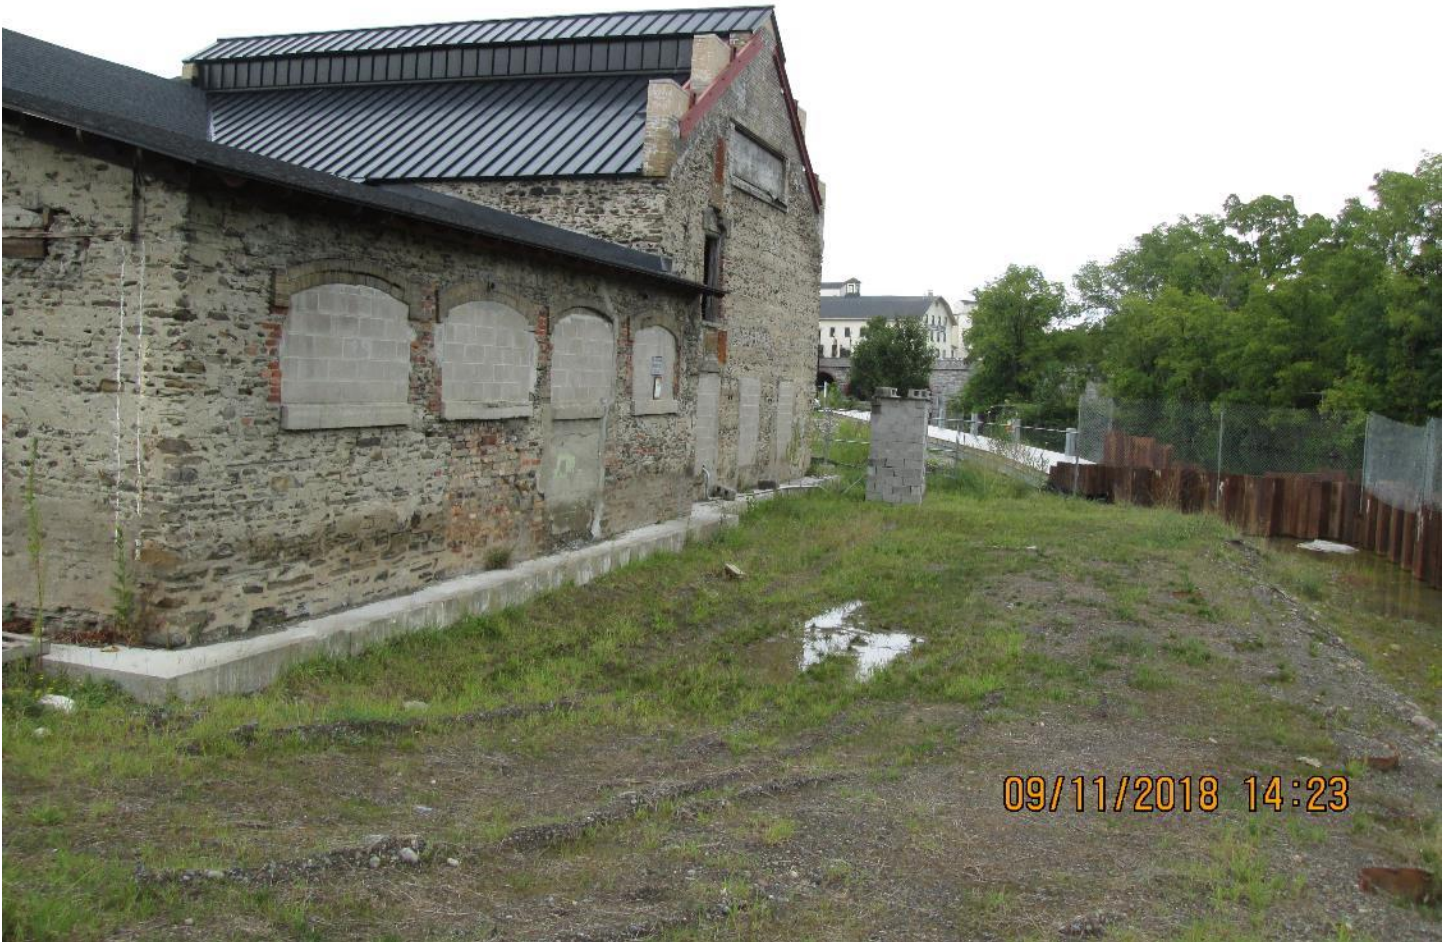
**Photo 9:** View of the southside of the MGP building, facing east.
