**Subject: NYSEG - Penn Yan Water Street MGP Remediation Project (Site No. 862009)  
Keuka Lake Outlet Sheen Investigation**

NYSEG Penn Yan Water Street Manufactured Gas Plant NYSDEC Site # 8-62-009		<b>Proposed Sheen          Investigation Area</b>
DATE: 7/30/2019	DRWN:	FIGURE 1

**SHEEN INVESTIGATION**

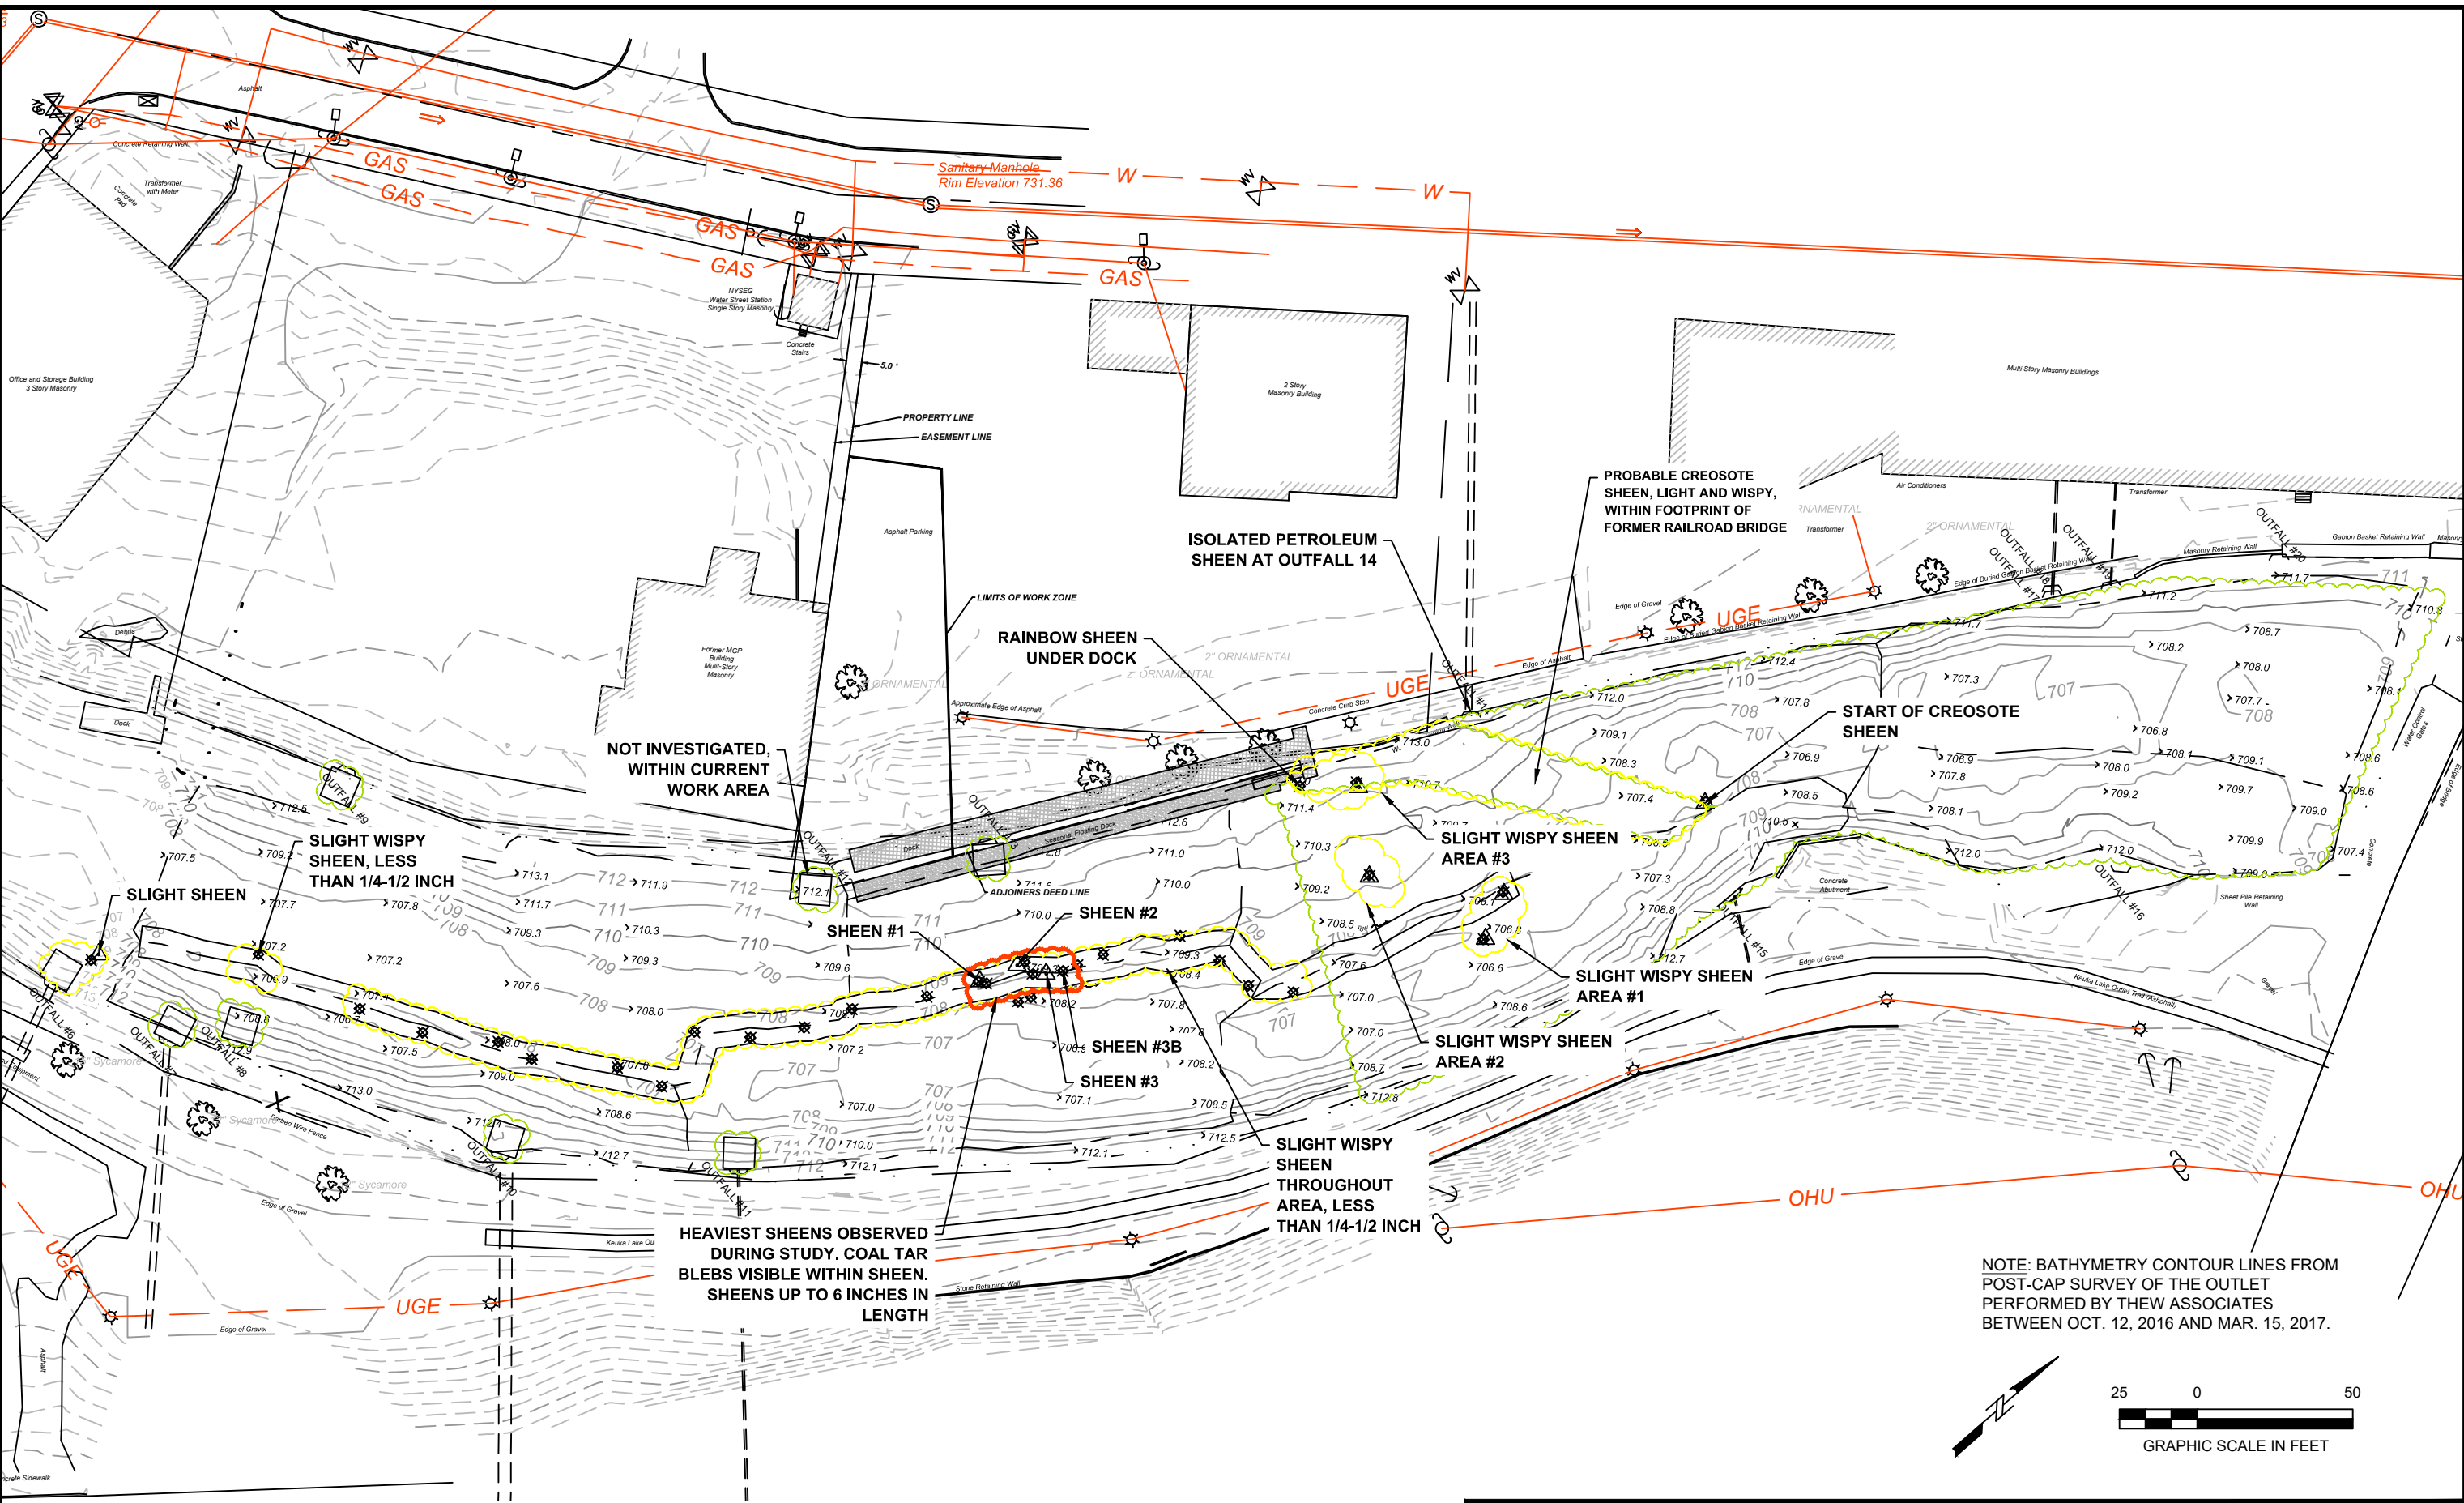
**FIGURE 2**

Light wispy sheens were observed along nearly the entire centerline alignment of the former sheets. There were areas of ~20 feet long and ~30 feet long near the upstream end of the alignment where no sheens were observed. These sheens do not appear to be indicative of large amounts of contamination left behind during dredging, but rather trivial amounts likely resulting from conducting the work in the wet.

An approximately 30-foot by 10-foot area that produced heavier sheen with occasional coal tar was delineated during the investigation. It is shown on Figure 2 in the approximate center of the Outlet. Sheens from this area expanded to approximately six inches in length and typically had a darker coal tar bleb in the middle. It is very likely the sheens observed floating down the Outlet are originating from this area. Probes were advanced approximately five feet away in all directions from the area shown on Figure 2 and either no sheen or only a slight wispy sheen was observed. Stakes were driven and surveyed at three locations in this area, Sheen #1 and Sheen #2, and Sheen #3. Heavier sheen was also noted at GPS location Sheen#3B, but its occurrence could not be replicated when driving the survey stakes and advancing probes around them, the point shown may be offset due to GPS float/precision and more likely it is closer to the staked and surveyed Sheen #3 location.

- Light wispy sheen was encountered at two locations near the former centerline alignment of the dredging cell divider sheeting. These sheens seemed isolated, probes five feet away in all directions from the two points did not indicate any sheen. Two stakes were driven in this area and shown on Figure 2 as Slight Wispy Sheen Area #1.

- A light wispy sheen was noted approximate 20 feet west of the former centerline sheet alignment. This was also isolated, probes five feet away in all directions did not indicate any sheen. Shown on Figure 2 as Slight Wispy Sheen Area #2.

- A rainbow sheen was encountered underneath the ramp to the floating dock and a slight sheen was observed approximately 20 feet east, these may or may not be connected multiple releases observed from Outfall #14 during remedial construction at the site. The rainbow sheen appeared to be from a light petroleum product. Shown on Figure 2 as Slight Wispy Sheen Area #3 and Rainbow Sheen Under Dock.

- A slight sheen was noted within the area probed next to Outfall #6.
- As discussed in the Downstream Area above, an isolated probable petroleum sheen was encountered adjacent to Outfall #14. Note this may also be associated with the sheen observed near the dock ramp and between the dock and Outfall #14.

Most of the observed impacts do not appear to be attributable to the former MPG site or warrant follow-up actions. The one exception being the approximately 30-foot by 10-foot area that produced heavier sheen. This area is likely dredge residual which “windrowed” around the dredge bucket or from portions of the cell divider sheeting which could not be scraped during dredging. Alternatives for addressing this one area of potent residual contamination include:

- No action/monitor;
- Capping with Auquablok®;
- Vacuum dredge removal using a “Vac Truck” and vacuum boxes based onshore and conducted with a boat and crew in the outlet;
- Excavator-based dredging from a barge.

- No action, or simply continued monitoring, is not considered a viable option as it does not reduce the likelihood of sheens continuing to appear in the Outlet.
- Capping will result in a net change (restriction) of the Outlet channel which would require modification to the project permits and associated regulatory review and approval.
- Vacuum dredge removal would produce large volumes of potentially impacted water requiring treatment prior to discharge. This would require engineering design for water management and mobilization of additional storage/treatment infrastructure.
- Dredging using a barge-mounted excavator would be consistent with the existing Remedial Design and permits. While additional equipment would need to be mobilized to the site execution of this

alternative is possible this construction season and would require the least modification to existing permits.

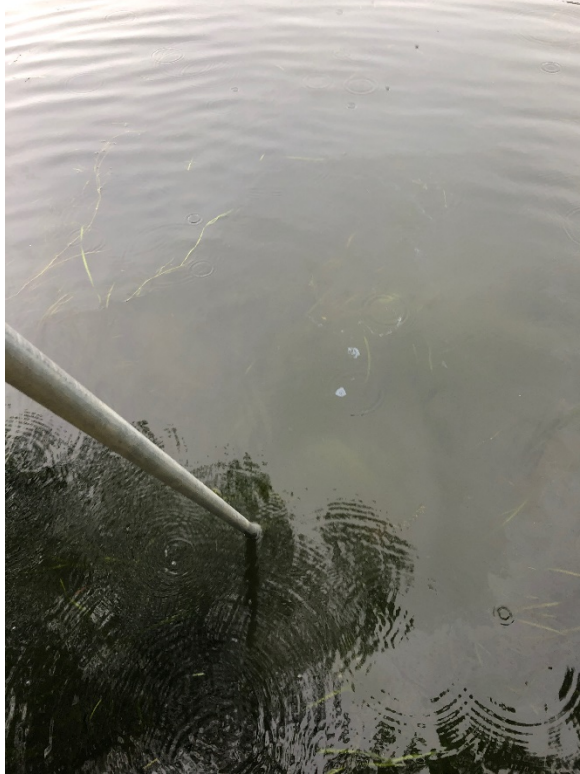
Slight sheen observed at  
Outfall #6

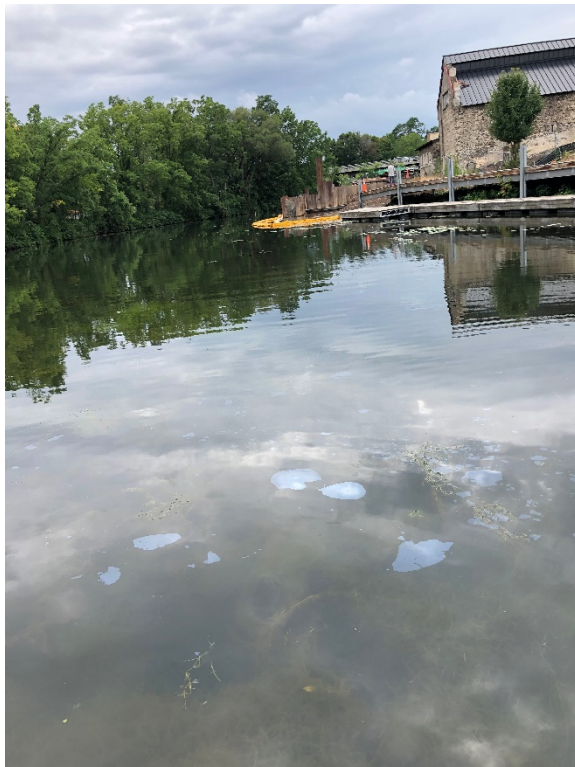
Sheen observed floating  
downstream from  
upstream source

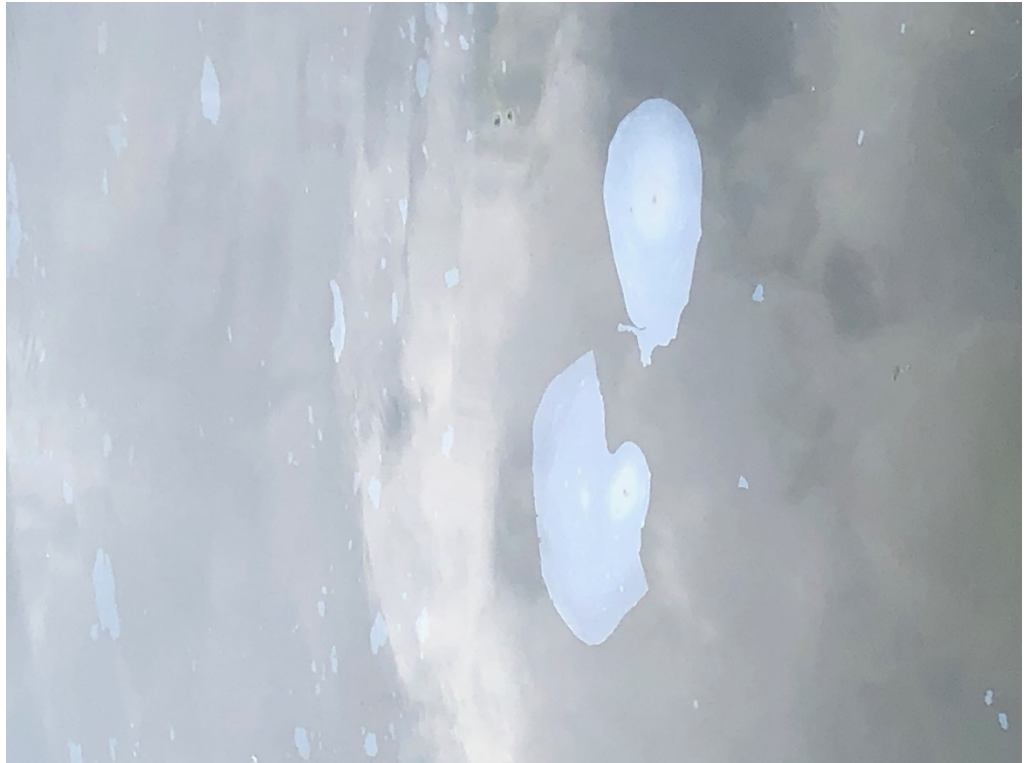
Sheen observed floating  
downstream from  
upstream source

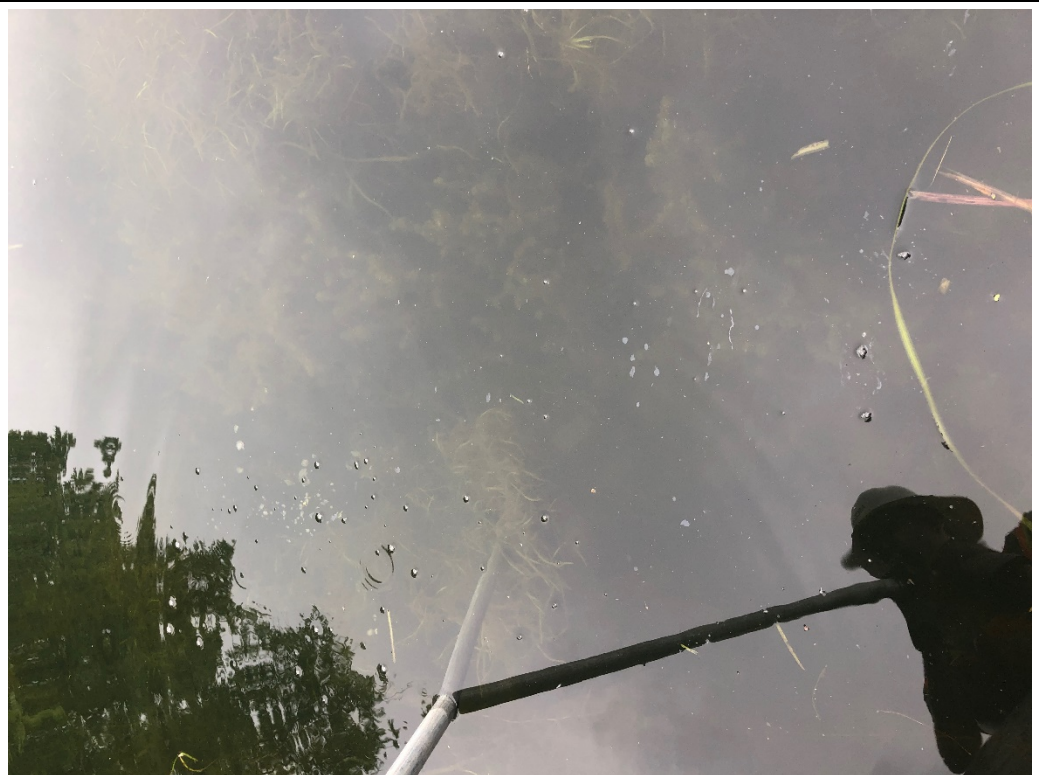
observations during the dredging work these are likely the product of creosote residuals from the railroad bridge materials.

Slight wispy sheen  
observed while probing  
within footprint of former  
railroad bridge area.

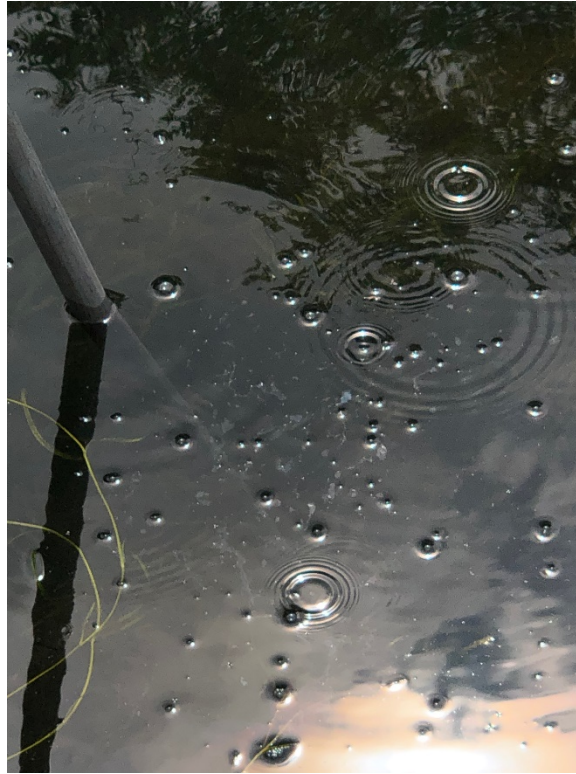
Slight wispy sheen observed while probing within footprint of former railroad bridge area.

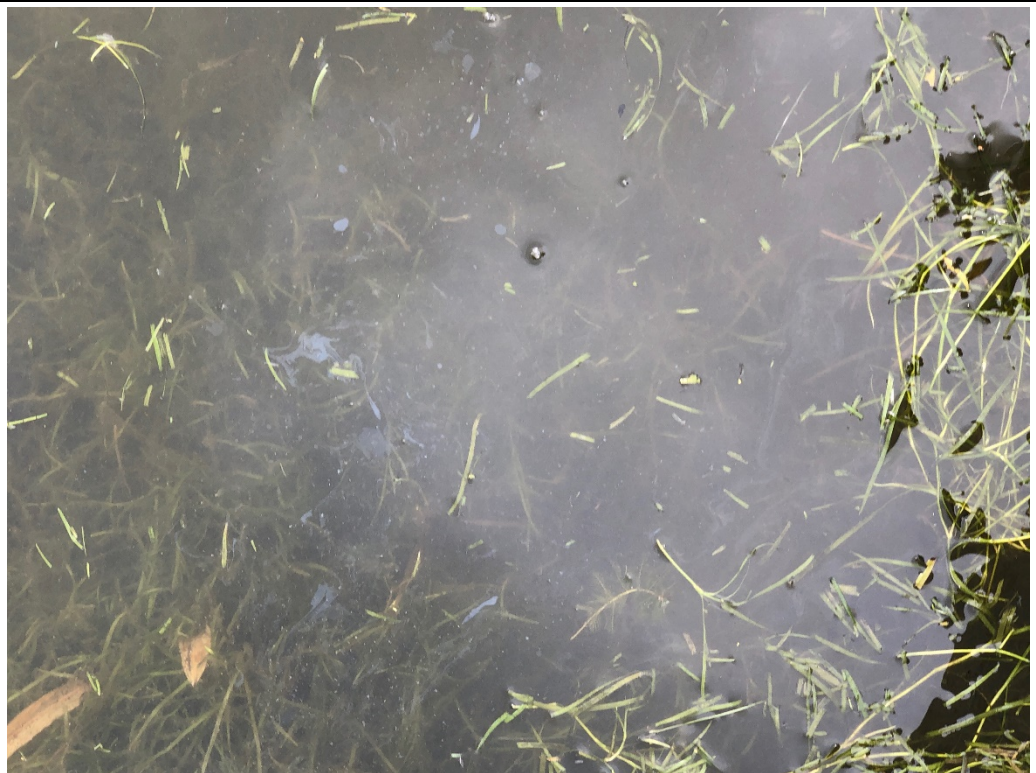
Sheen observed approximately 10 feet downstream of dock end, 10 feet from shore. Noted on Figure 2 as Light Wispy Sheen Area #3

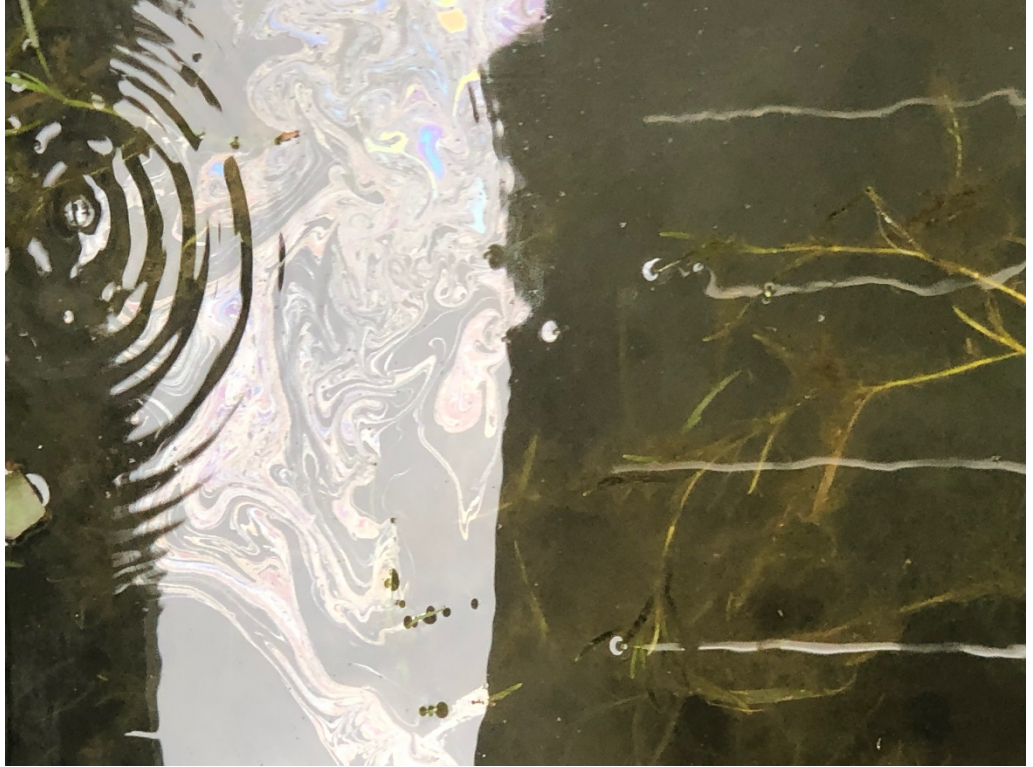
**Description:**  
Rainbow sheen observed under dock ramp.

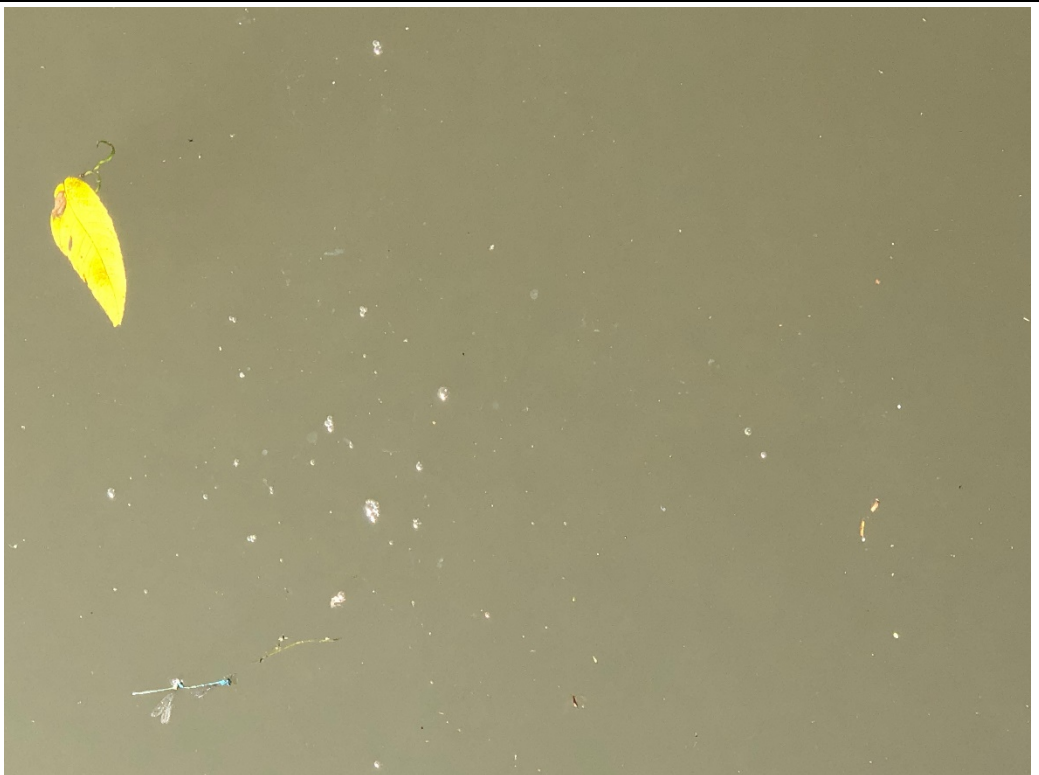
**Description:**  
Typical slight wispy sheen observed along centerline of sheets transect. Fine and discontinuous.

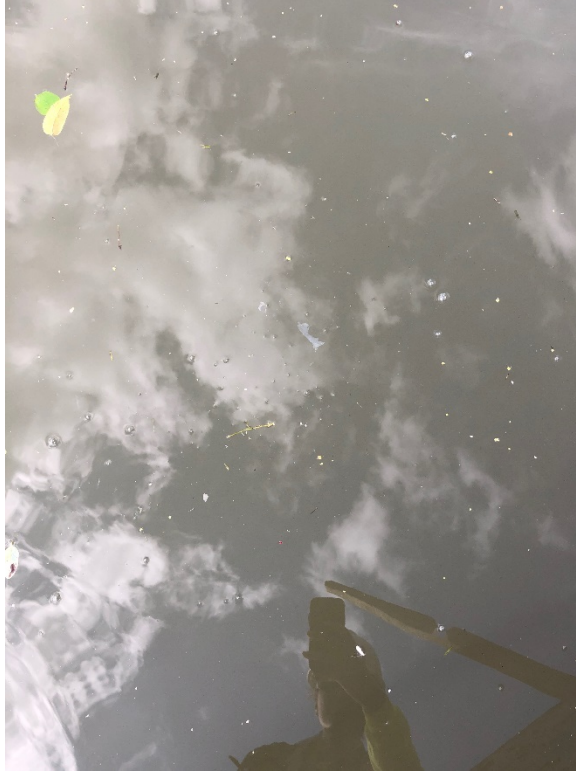
**Description:**  
Typical slight wispy sheen observed along centerline of sheets transect. Fine and discontinuous.

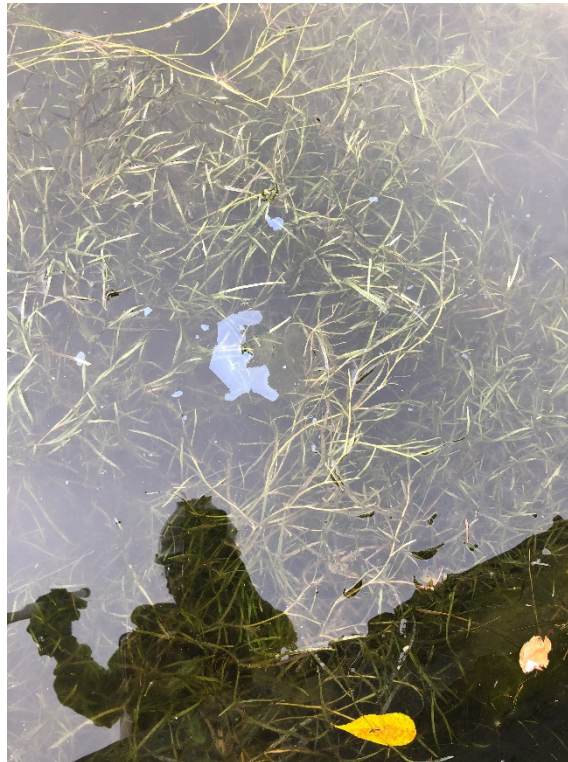
**Description:**  
Heavy sheen (Sheen #3B). Located along centerline of former sheeting alignment, near upstream end of floating docks.

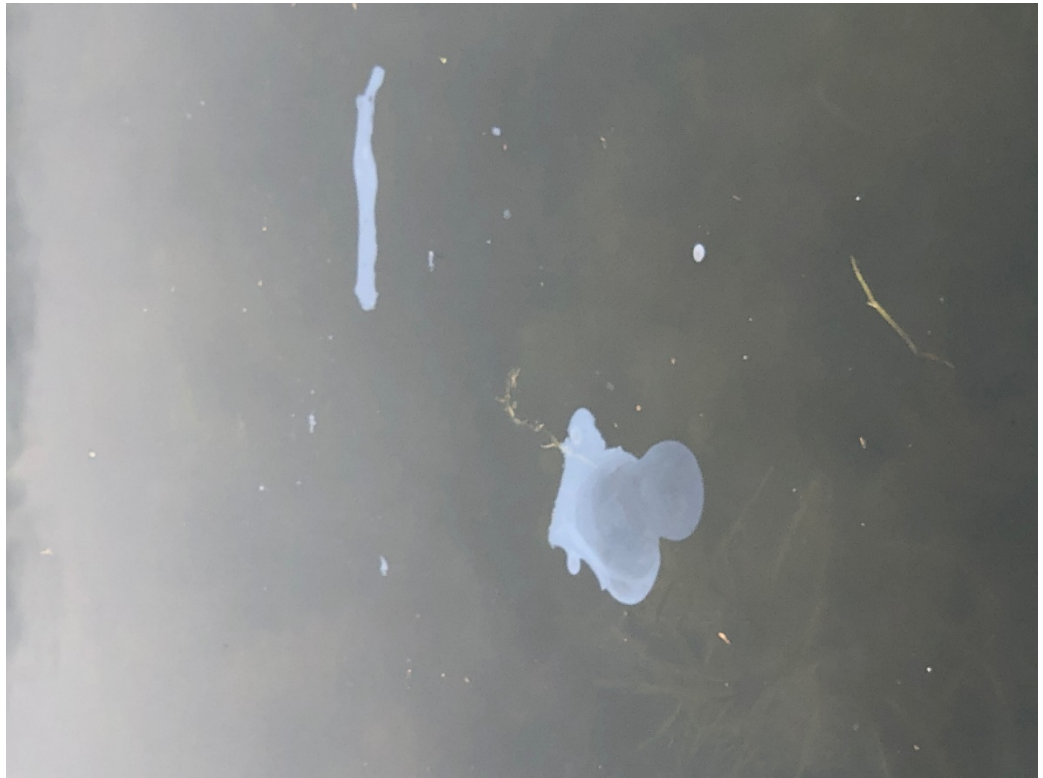
Heavy sheen (Sheen #1).  
Located along centerline  
of former sheeting  
alignment, near upstream  
end of floating docks.

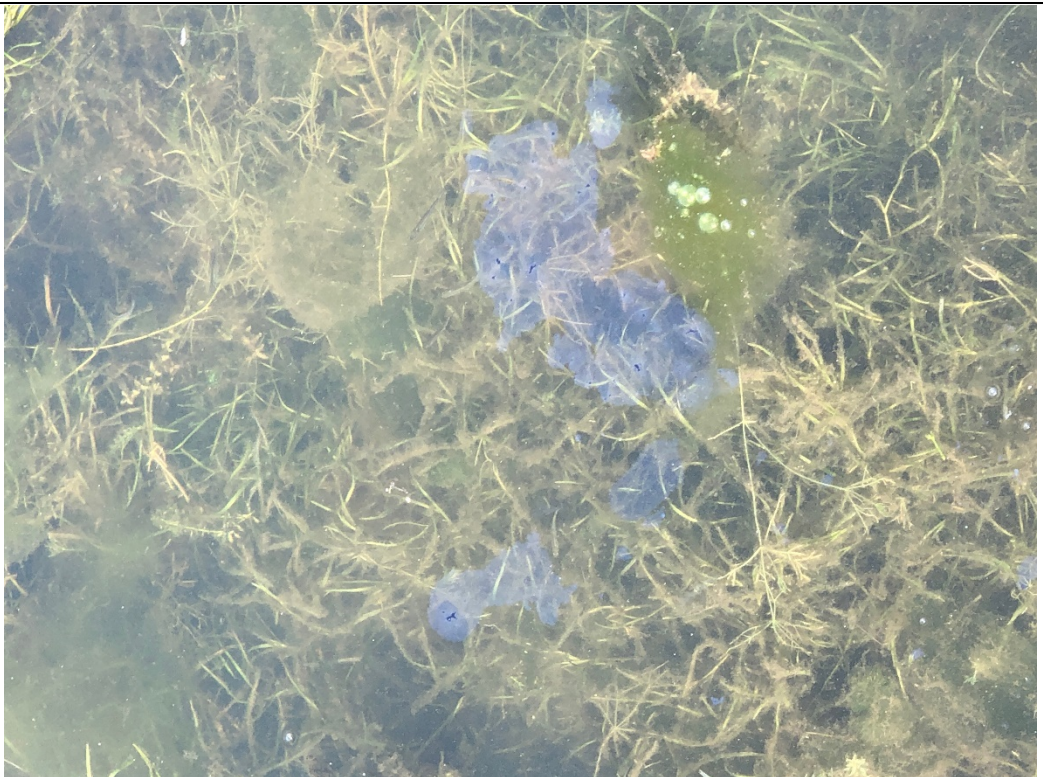
Heavy sheen (Sheen #3).  
Located along centerline  
of former sheeting  
alignment, near upstream  
end of floating docks.

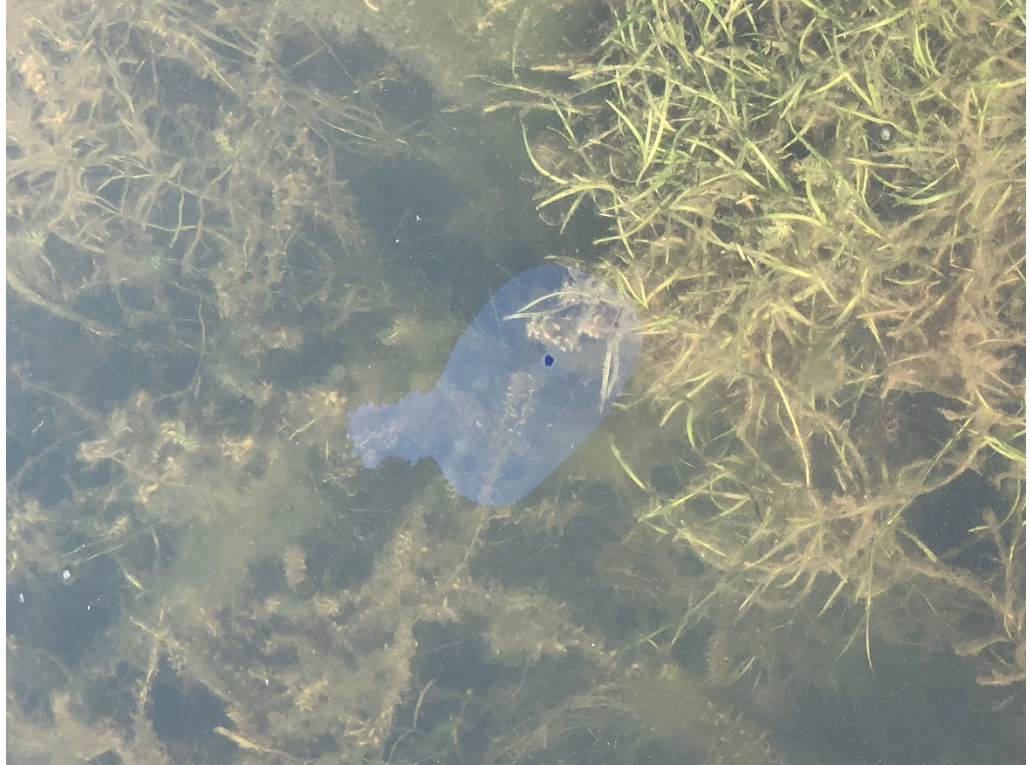
Heavy sheen (Sheen #1).  
Coal Tar bleb noted  
while driving stake to  
mark location.

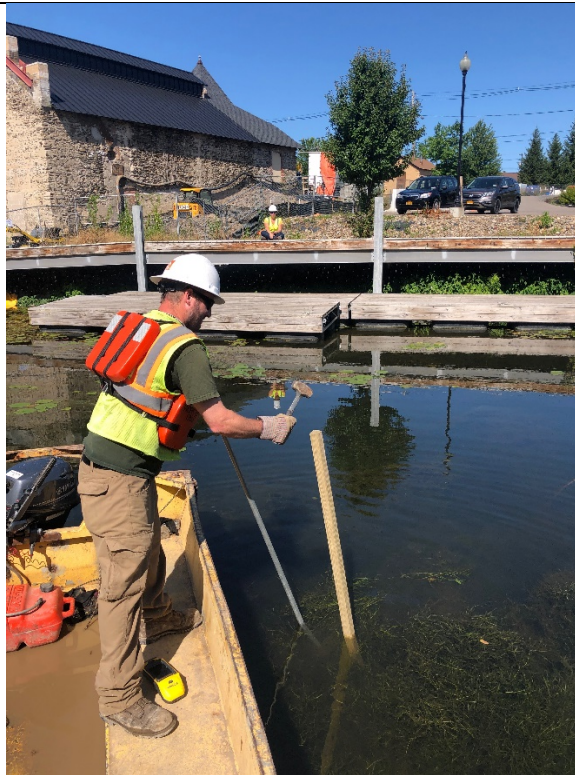
Driving stake to mark  
heavy sheen location.

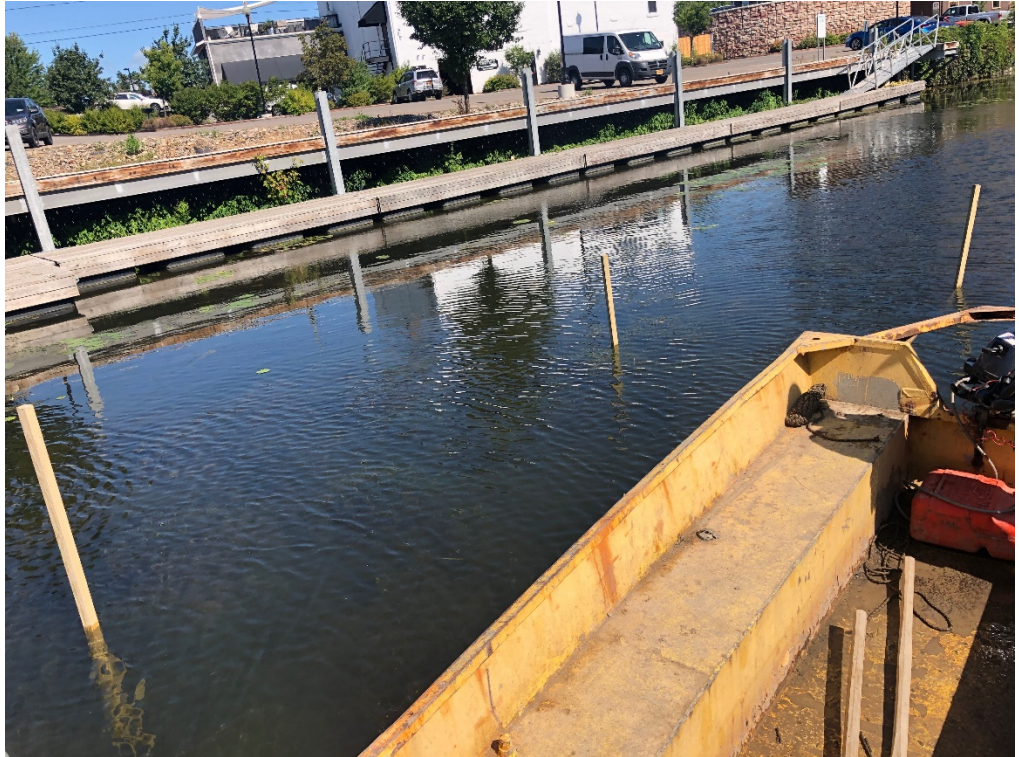
Stakes for heavy sheen locations. Sheens # 1, 2, and 3 (From left to right).

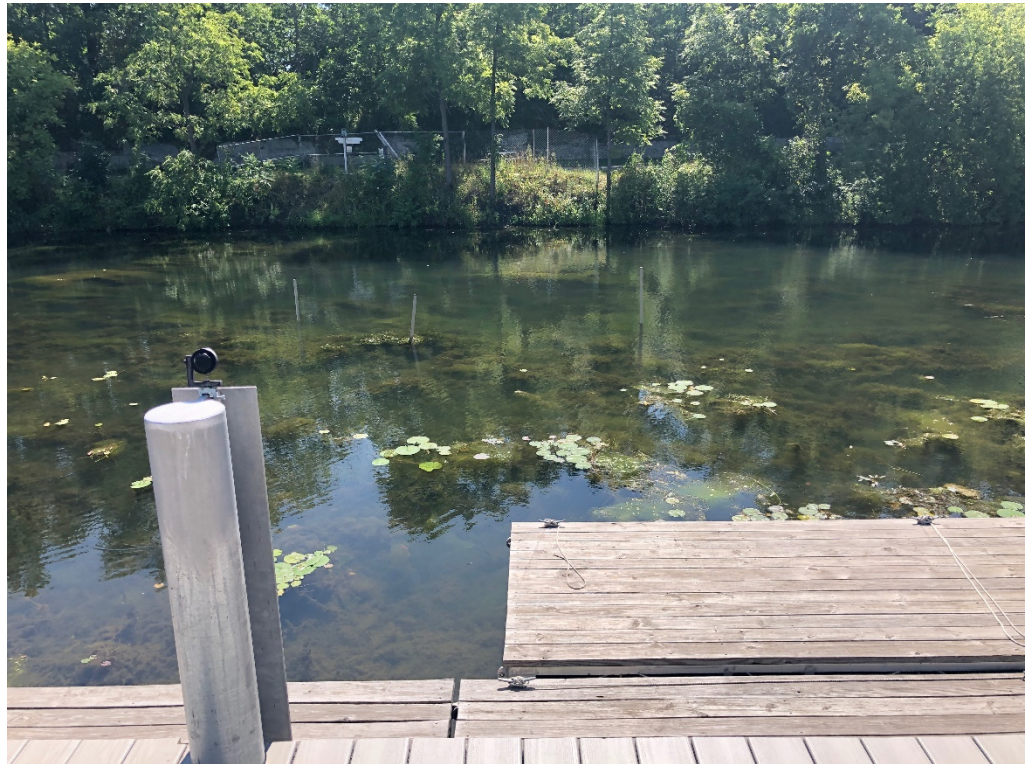
Stakes for heavy sheen locations. Sheens # 3, 2, and 1 (From left to right). Stake not driven at Sheen #3B location from day prior as no sheen was observed on this day. Due to GPS accuracy, point may actually be closer to Staked point #3.
