# 2022 Restoration Monitoring Report

**Penn Yan Former Manufactured Gas Plant Site**  
**NYSDEC Site Number: 862009**

May 2023

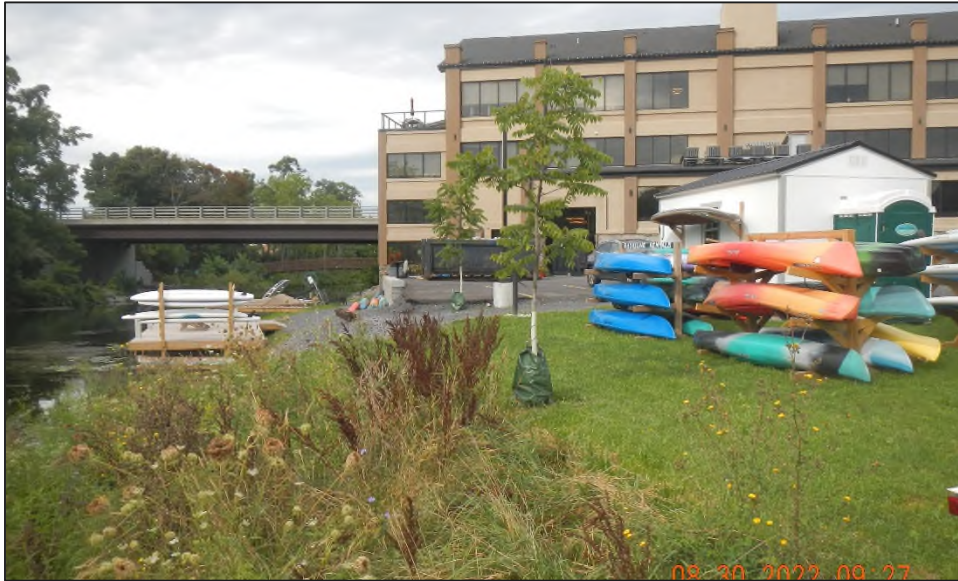
**Photo: 1**

During the Restoration Monitoring event, Arcadis personnel observed two black walnut trees and one silver maple tree (i.e., consistent with the tree types that AECOM planted in 2019) in the bank area. The trees appeared to be in good health, fully leaved, and exhibited no signs of stress or herbivory. Tree photographs are included in Appendix A (see Photos 1 and 2).

**Description:** Planted and healthy black walnut trees (*Juglans nigra*). Photographed at Liberty St. bridge, facing southwest.

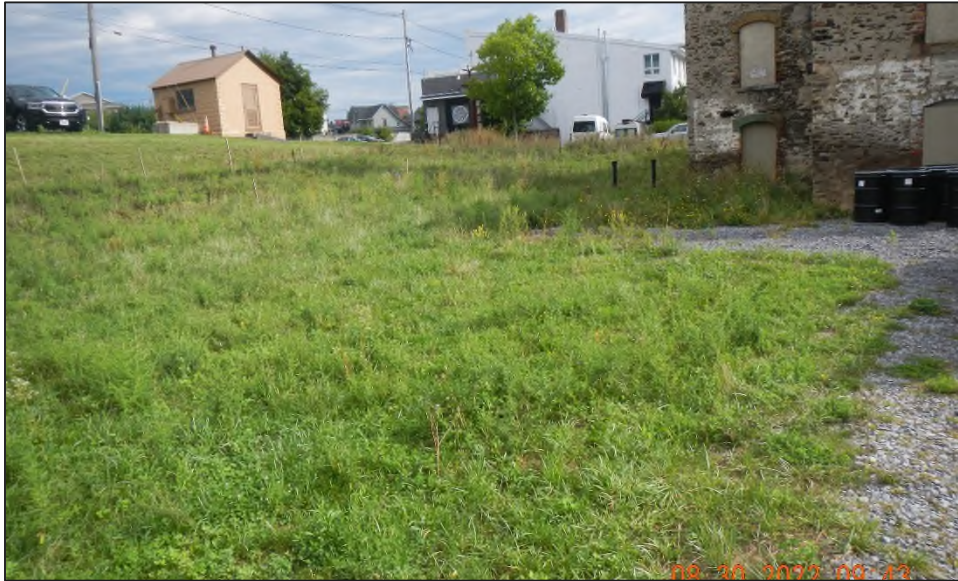
**Description:** Restored  
upland area. Facing north;  
former MGP Building in the  
background

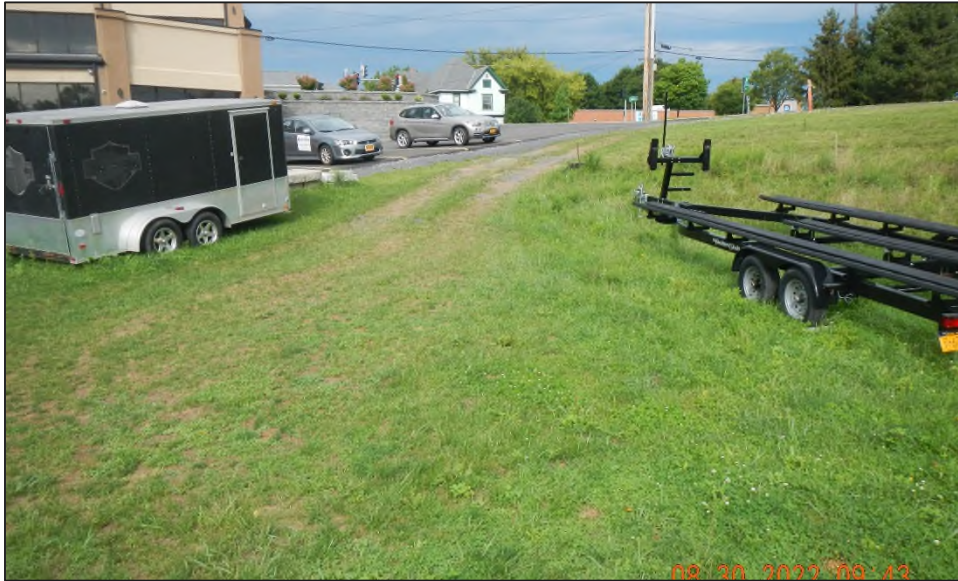
**Photo: 5**

**Description:** Restored  
upland area. Facing east;  
Water Street in background.

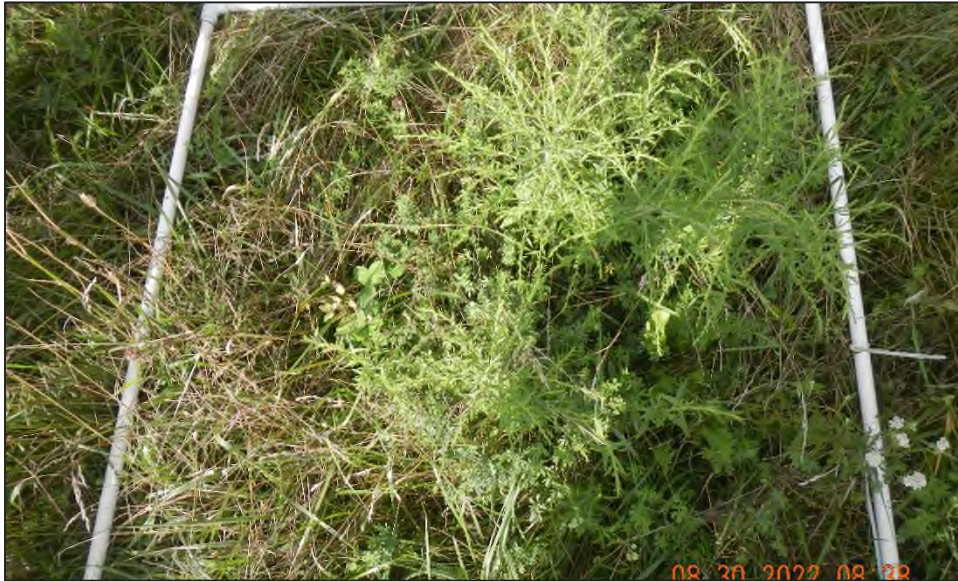
**Photo: 7**

Upland area quadrat results (UP-1, UP-2, and UP-3) indicate that overall vegetative cover was approximately 90%. The relative target species percent cover (i.e., native species) was approximately 48%, with the remaining 36% accounting for naturalized or introduced species. Invasive species observed within the quadrats included spotted knapweed (*Centaurea stoebe*), which accounted for approximately 5.6% of the relative percent cover. The species richness ranged from eight to nine herbaceous species observed. Birds-foot trefoil (*Lotus corniculatus*) and grass (*Poa sp.*) were the two dominant herbaceous plant species observed.

**Description:** Upland vegetation quadrat UP-1.

- Overseed the upland area. Vegetative cover in the upland area is relatively stable at 90% but is slightly less than the 95% performance standard for this restored area. Overseeding using an upland seed mix similar to the one used during restoration activities should be applied in the fall of 2023, at a rate of 30 pounds per acre, to fill in any thin patches observed. Additionally, spotted knapweed observed in the upland restoration area may require maintenance and control during future visits, as its presence is slightly greater than 5%. This will continue to be monitored and, if needed, manual plant removal during late spring of 2024 will be recommended to target this species.

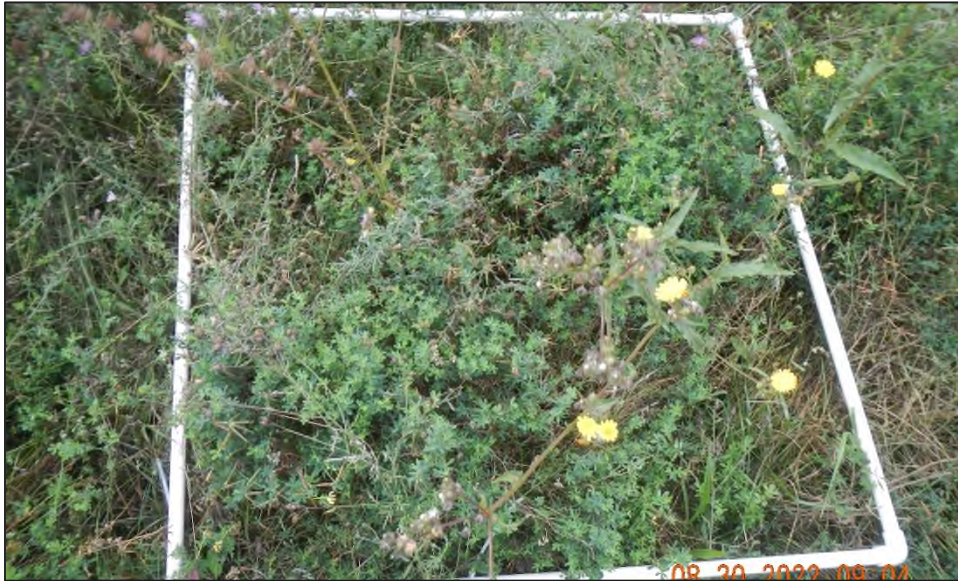
**Photo: 9**

**Description:** Upland vegetation quadrat UP-3.

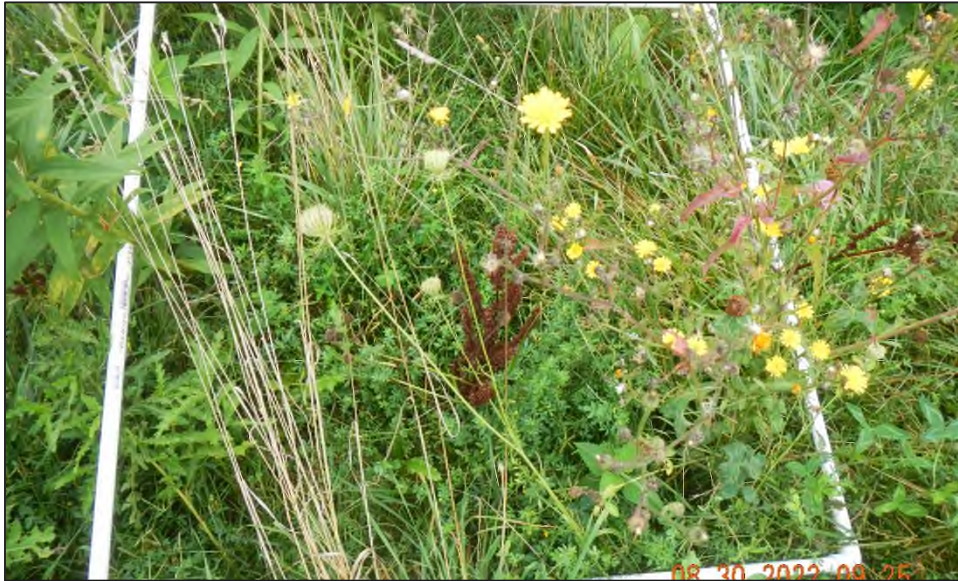
**Photo: 11**

Bank area quadrat results (BK-1, BK-2, and BK-3) indicate that overall vegetative cover was approximately 98%. The relative target species percent cover was approximately 53%, with the remaining 45% accounting for naturalized or introduced species. No invasive species were observed within the quadrats. The species richness ranged from eight to 11 herbaceous species observed. Birds-foot trefoil and grass were the two dominant herbaceous plant species observed, similar to the upland results.

**Description:** Bank  
vegetation quadrat BK-2.

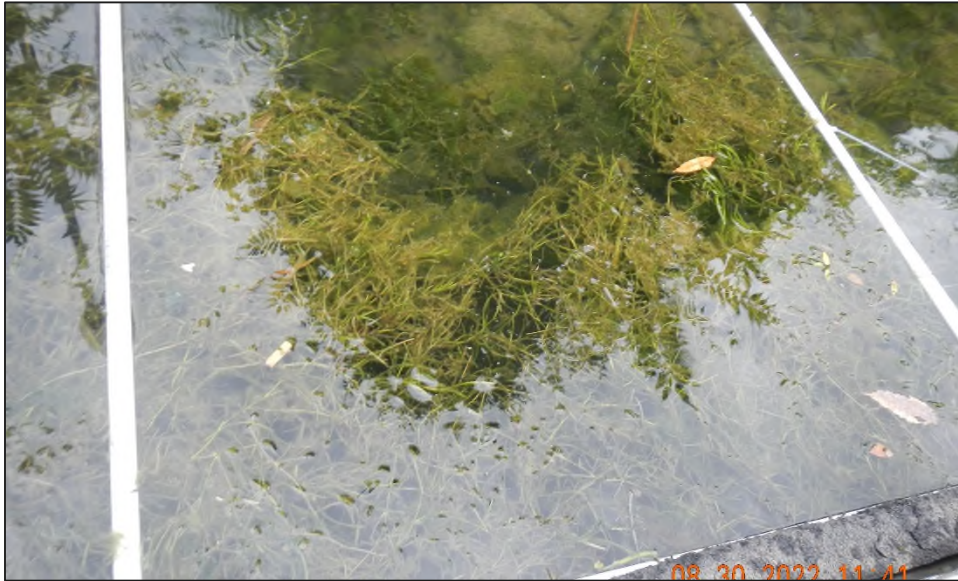
**Photo: 13**

Area 1 quadrat results (Table 3a) indicate that overall vegetative cover was approximately 63%. The relative target species percent cover was approximately 73%. Eurasian watermilfoil (*Myriophyllum spicatum*) was the only invasive species observed within the quadrats and accounted for approximately 25% of the relative cover. The species richness ranged from three to four species observed within each quadrat. Eight distinct species were observed across the Area 1 transect. Water star grass (*Heteranthera dubia*) and Eurasian watermilfoil were the two observed dominant herbaceous plant species.

**Description:** Example submerged aquatic vegetation quadrat from SAV Area 1. A total of 5 quadrats surveyed in SAV Area 1.

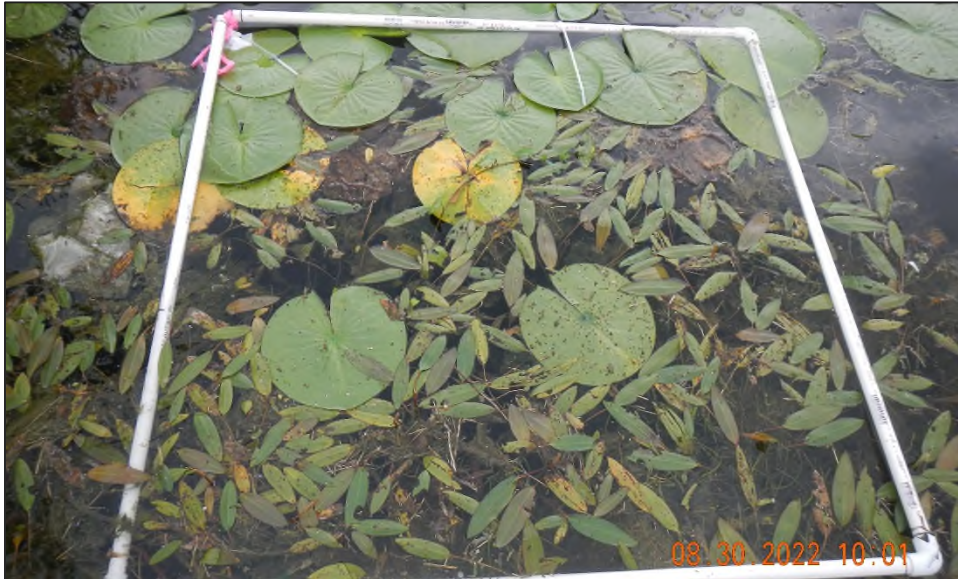
**Photo: 15**

Area 3 quadrat results (Table 3c) indicate that overall vegetative cover was approximately 84%. The relative target species percent cover was approximately 85%. Eurasian watermilfoil was the only invasive species observed within the quadrats and accounted for approximately 16% of the relative cover. The species richness ranged from one to six species observed within each quadrat. Seven distinct species were observed across the Area 3 transect. White water-lily and long-leaved pondweed were the two observed dominant herbaceous plant species.

**Description:** Example submerged aquatic vegetation quadrat from SAV Area 3. A total of 5 quadrats surveyed in SAV Area 3.

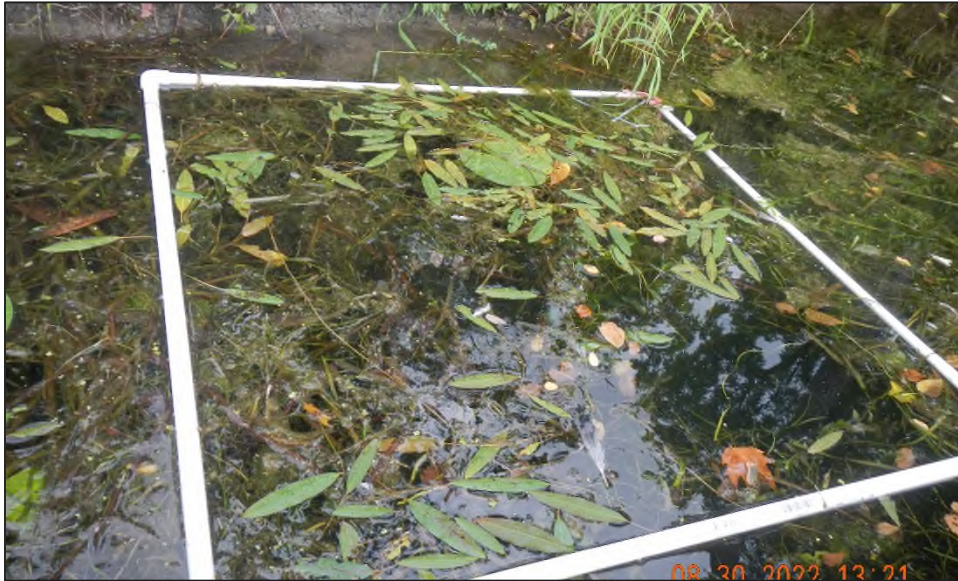
**Photo: 17**

Area 5 quadrat results (Table 3e) indicate that overall vegetative cover was approximately 72%. The relative target species percent cover was approximately 93%. Eurasian watermilfoil was the only invasive species observed within the quadrats and accounted for approximately 7.4% of the relative cover. The species richness ranged from two to six species found within each quadrat. Nine distinct species were observed across the Area 5 transect. Water star grass and eelgrass (*Vallisneria spiralis*) were the two observed dominant herbaceous plant species.

**Description:** Example submerged aquatic vegetation quadrat from SAV Area 5. A total of 5 quadrats surveyed in SAV Area 5.

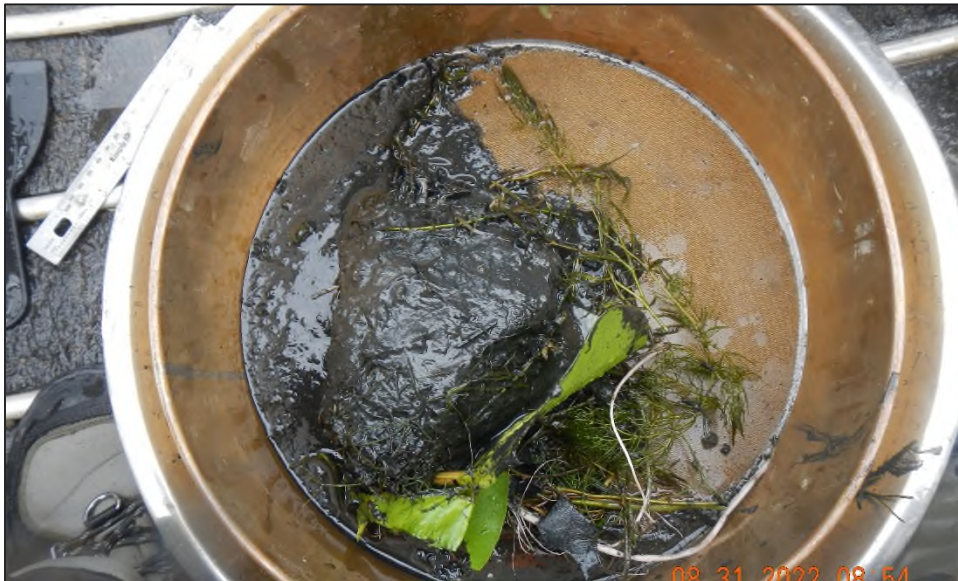
**Photo: 19**

Restored substrates observed during sampling are a mix of predominately fine to coarse gravels with sands and silts. Organic materials include varying amounts of both fine and coarse particulate organic matter (i.e., leaf fragments, detritus, woody debris) and shell fragments (primarily zebra mussels and snail shells). Depositional silts and finer organic materials were observed in higher percentages within the shoreline of Cell 6A and Cell 2 when compared to sample locations in other cells. The remaining restored sediment cells had less fine-grained material and were typically composed of fine to coarse gravels and sand. Representative substrate photographs are included in Appendix A (Photographs 19 through 22).

**Description:** Benthic sample  
Cell 2-B prior to being  
sieved.

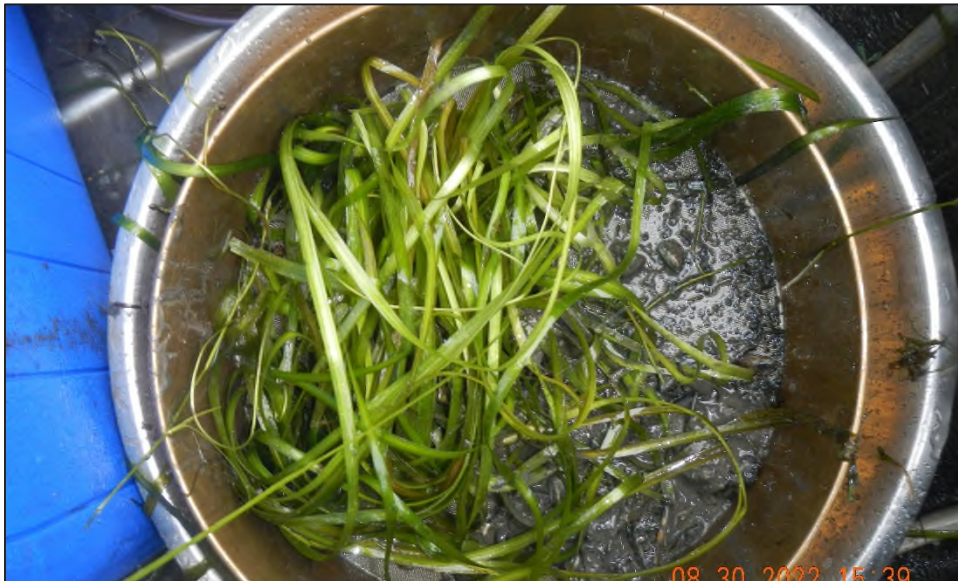
**Photo: 21**

**Description:** Benthic sample  
Cell 5B-B prior to being  
sieved.
