New York State Electric & Gas

2023 Restoration Monitoring Report

Penn Yan Former Manufactured Gas Plant Site
Penn Yan, New York
NYSDEC Site Number: 862009

December 2023

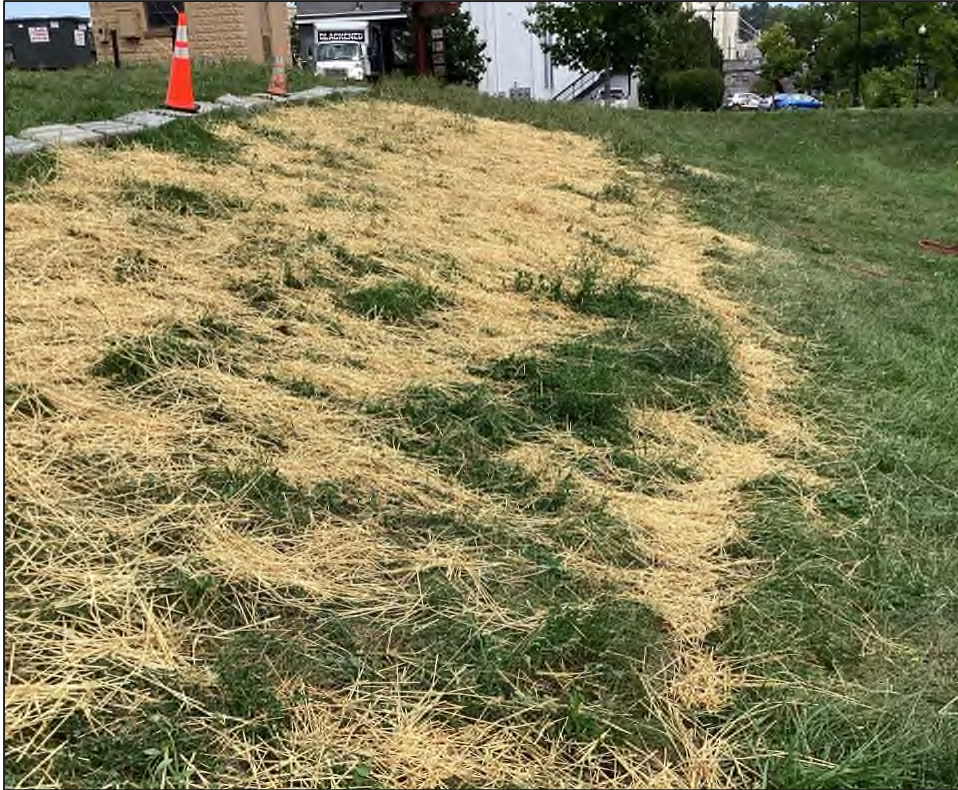
Photo: 1

Description: Upland area
reseeded with native grass
seed mix and covered with
straw. Facing northeast.

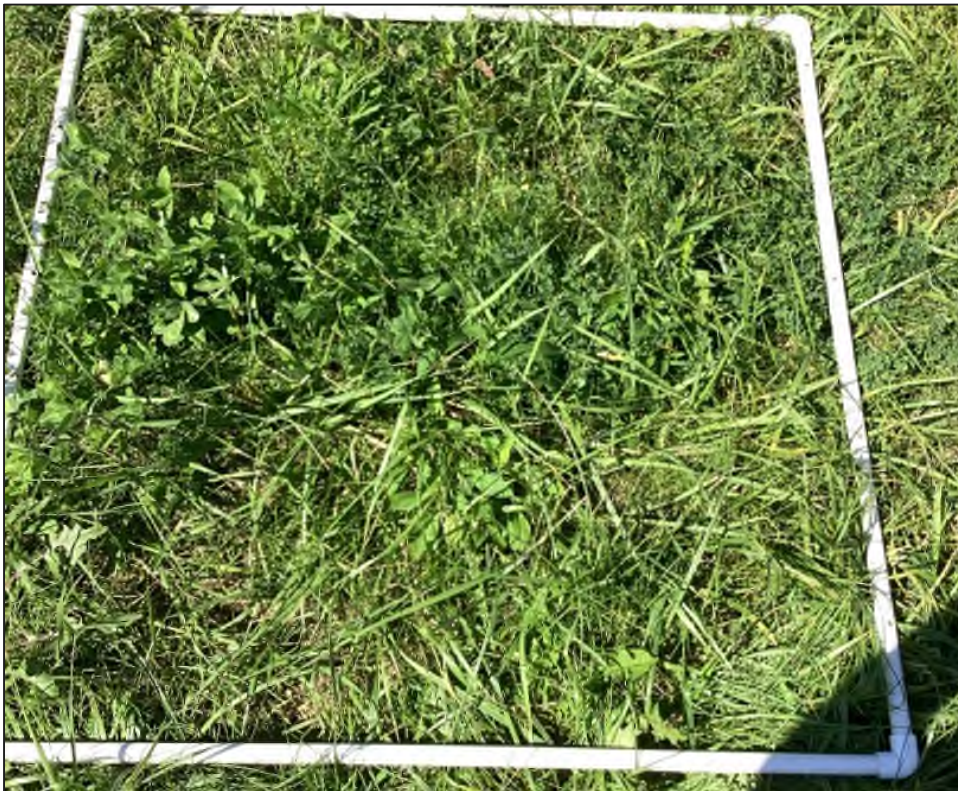
Photo: 2

Upland area quadrat results (UP-1, UP-2, and UP-3) indicate that overall vegetative cover was approximately 90%. The relative target species percent cover (i.e., native species) was approximately 70%, with the remaining 30% accounting for naturalized or introduced species. Invasive species observed within the quadrats included spotted knapweed (*Centaurea stoebe*), which accounted for approximately 0.8% of the relative percent cover. The species richness ranged from eight to ten herbaceous species observed. Birds-foot trefoil (*Lotus corniculatus*) and Kentucky bluegrass (*Poa pratensis*) were the two dominant herbaceous plant species observed within the quadrats.

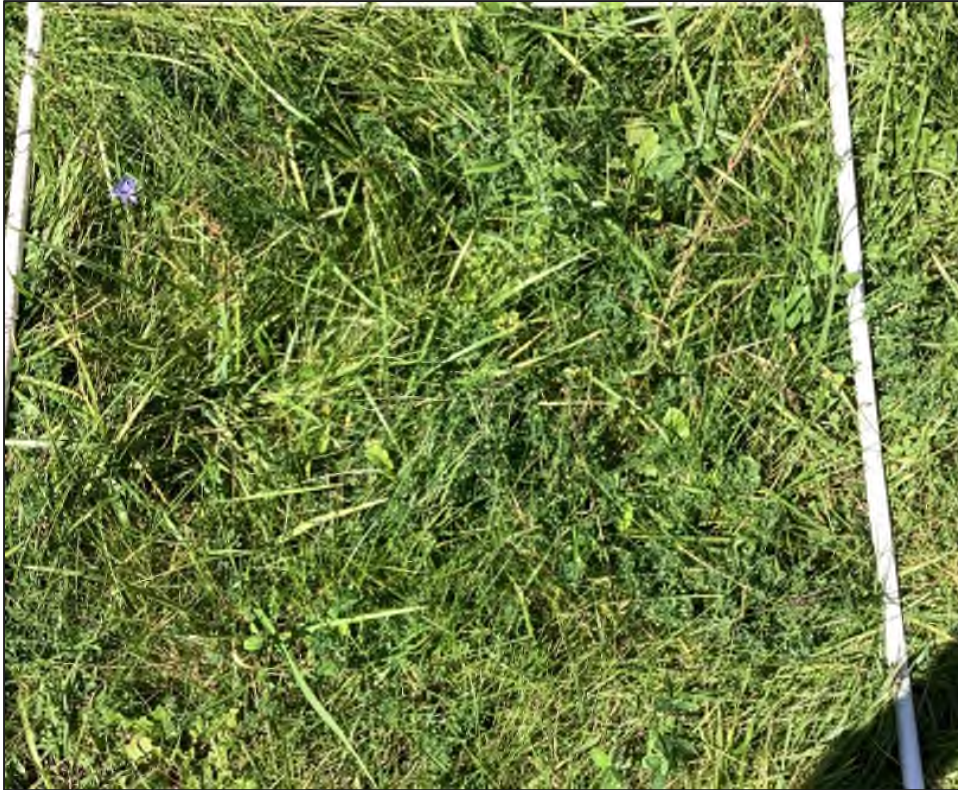
Photo: 3

Description: Upland
vegetation quadrat UP-2

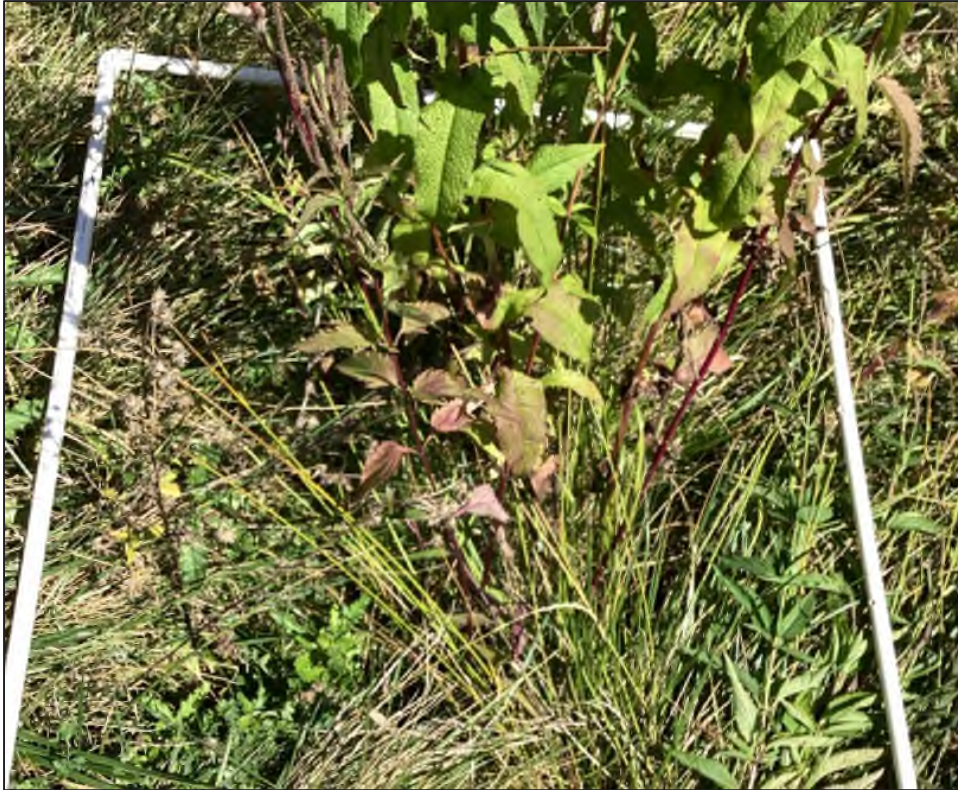
Photo: 5

Bank area quadrat results (BK-1, BK-2, and BK-3) indicate that overall vegetative cover was approximately 94%. The relative target species percent cover was approximately 72%, with the remaining 28% accounting for naturalized or introduced species. Invasive species observed within the quadrats included Canadian thistle (*Cirsium arvense*), which accounted for approximately 18%. The species richness ranged from five to ten herbaceous species observed. Riverbank rye (*Elymus riparius*), Canadian thistle, and Birds-foot trefoil were the three dominant herbaceous plant species observed within the quadrats.

Description: Bank
vegetation quadrat BK-1

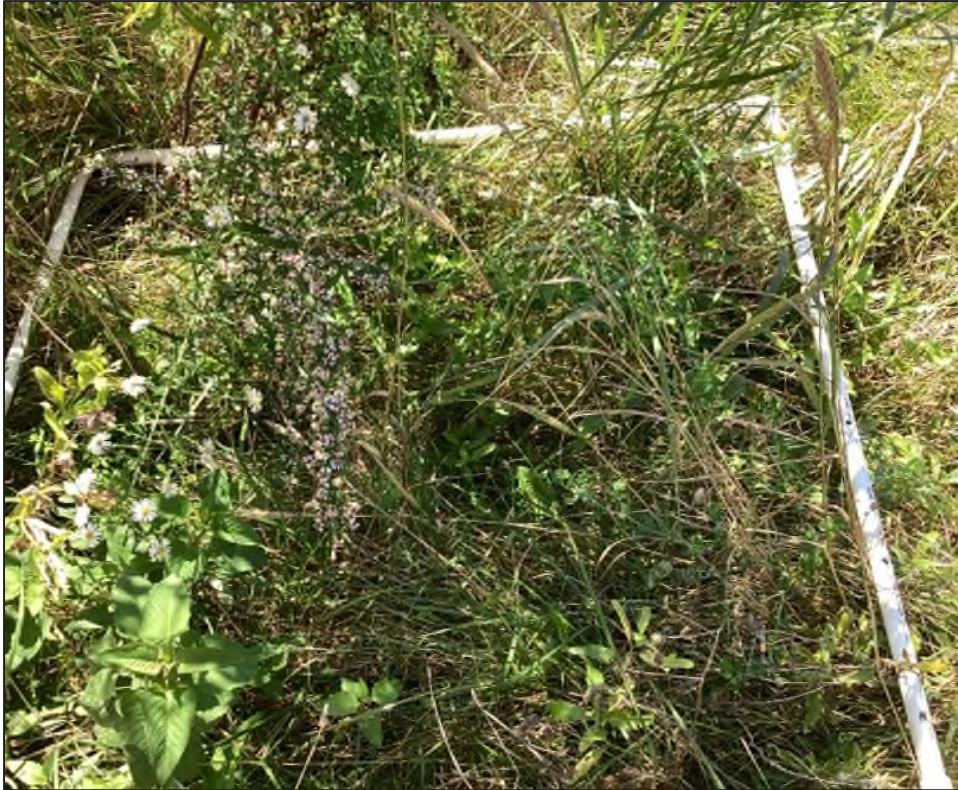
Photo: 7

Description: Bank
vegetation quadrat BK-3

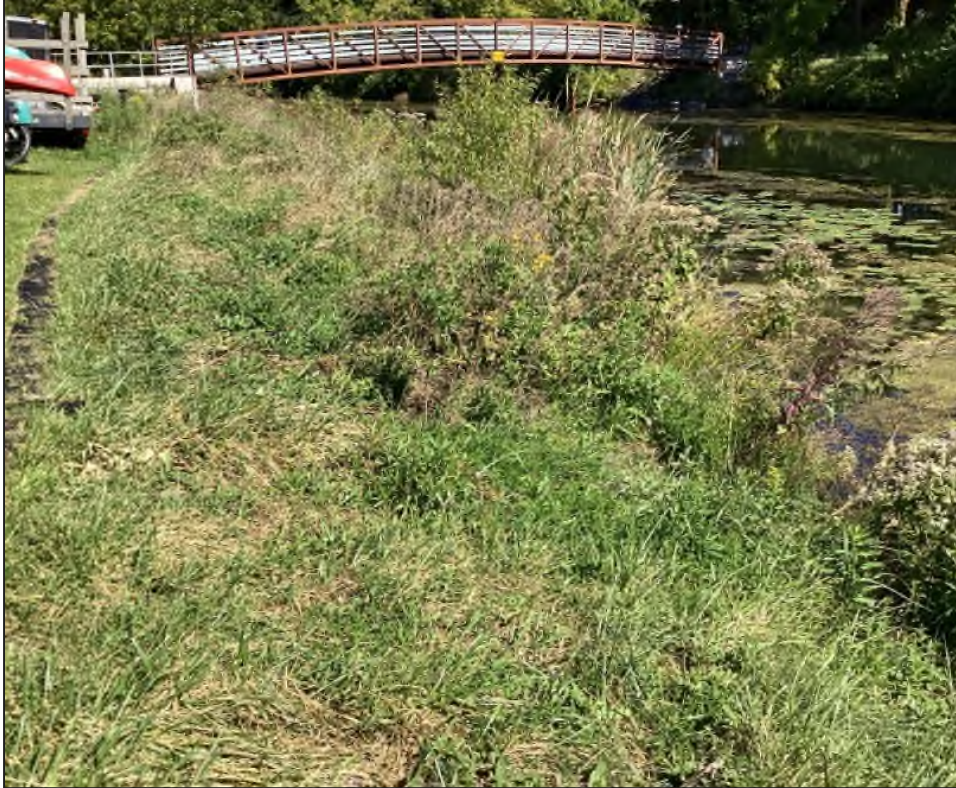
Photo: 9

Description: Restored bank area. Facing east; Keuka Lake Outlet Trail Bridge in background.

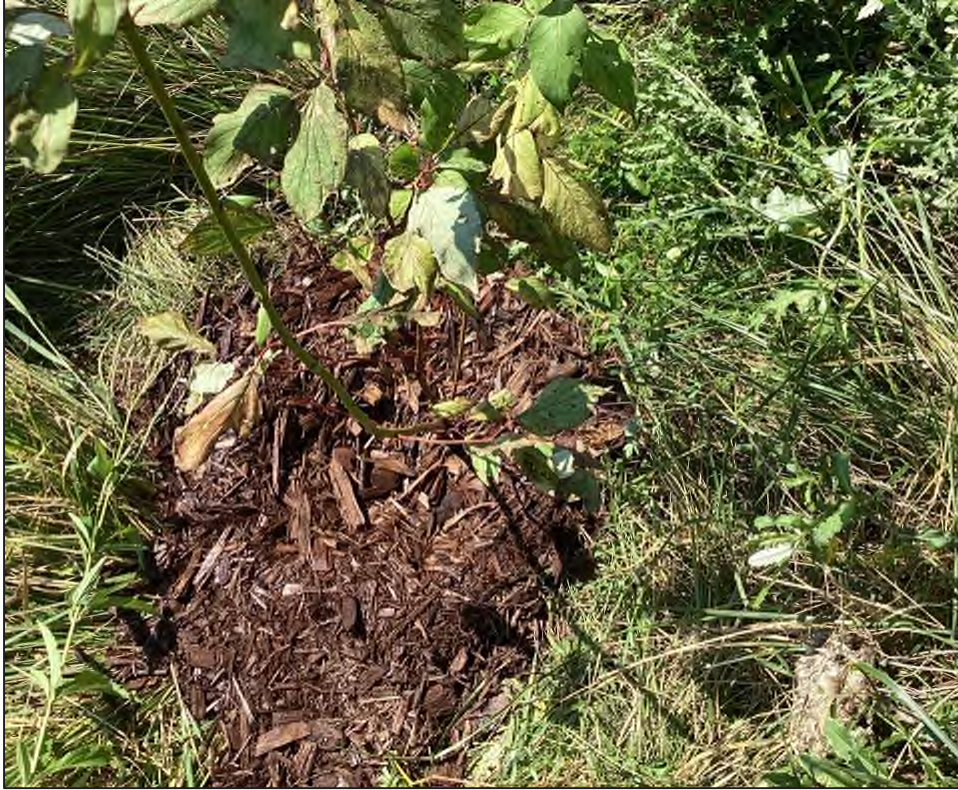
Photo: 11

During the Restoration Monitoring event, the 13 replacement shrubs planted on September 6, 2023, were observed to be in good condition. Photographs 11 to 13 in Appendix A provide a representative picture for each species of the replacement shrubs installed.

Description: Planted red-osier dogwood (*Cornus sericea*) in restored bank.

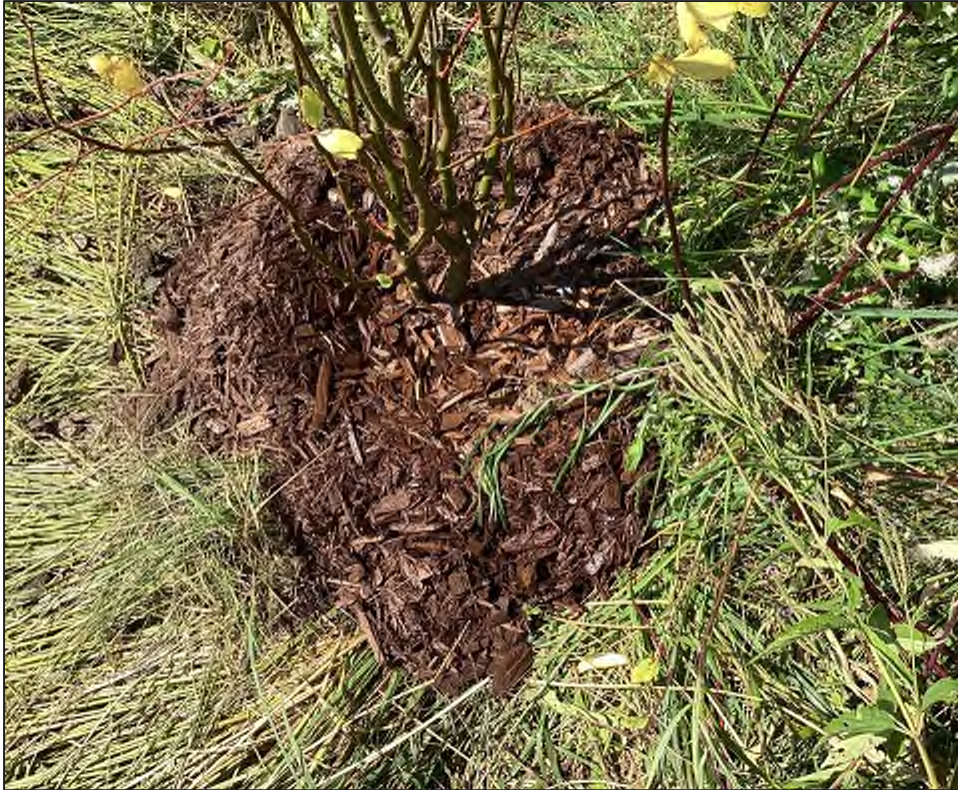
Photo: 13

Description: Planted pussy willow (*Salix discolor*) in restored bank.

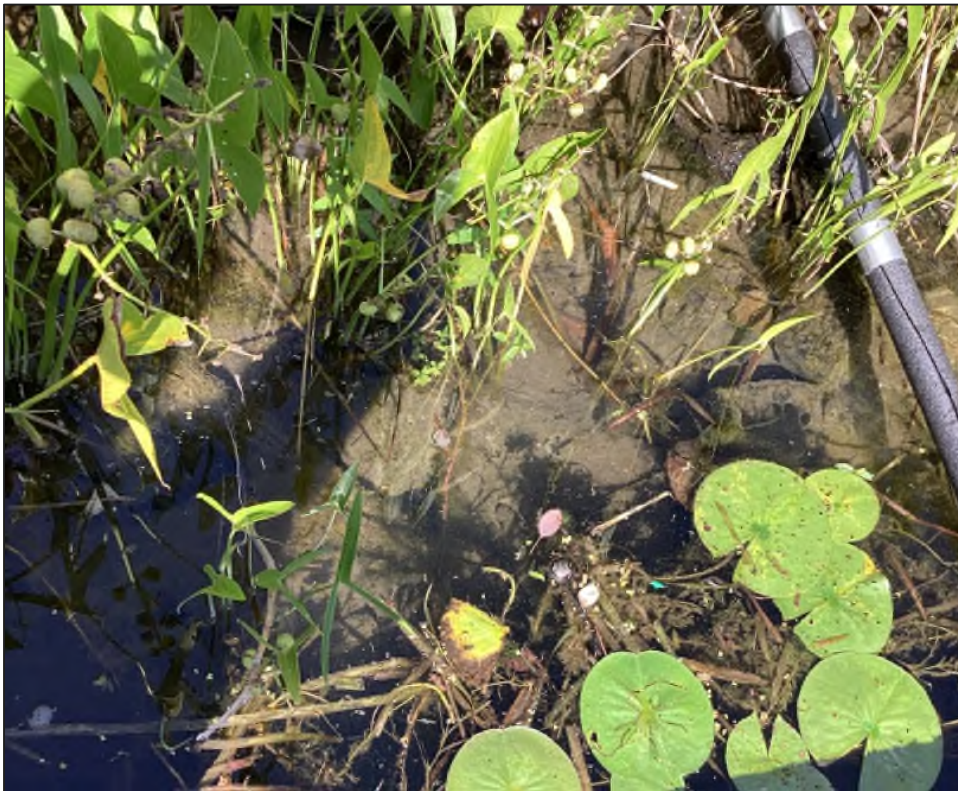
Photo: 14

Area 1 quadrat results (Table 3a) indicate that the overall vegetative cover was approximately 58%. The relative target species percent cover was approximately 93%. Eurasian watermilfoil (*Myriophyllum spicatum*) was the only invasive species observed within the quadrats and accounted for approximately 7% of the relative cover. The species richness ranged from two to eight species observed within each quadrat. Thirteen distinct species were observed across the Area 1 transect. Coontail (*Ceratophyllum demersum*), wild celery, and water star grass (*Heteranthera dubia*) were the three dominant herbaceous plant species observed.

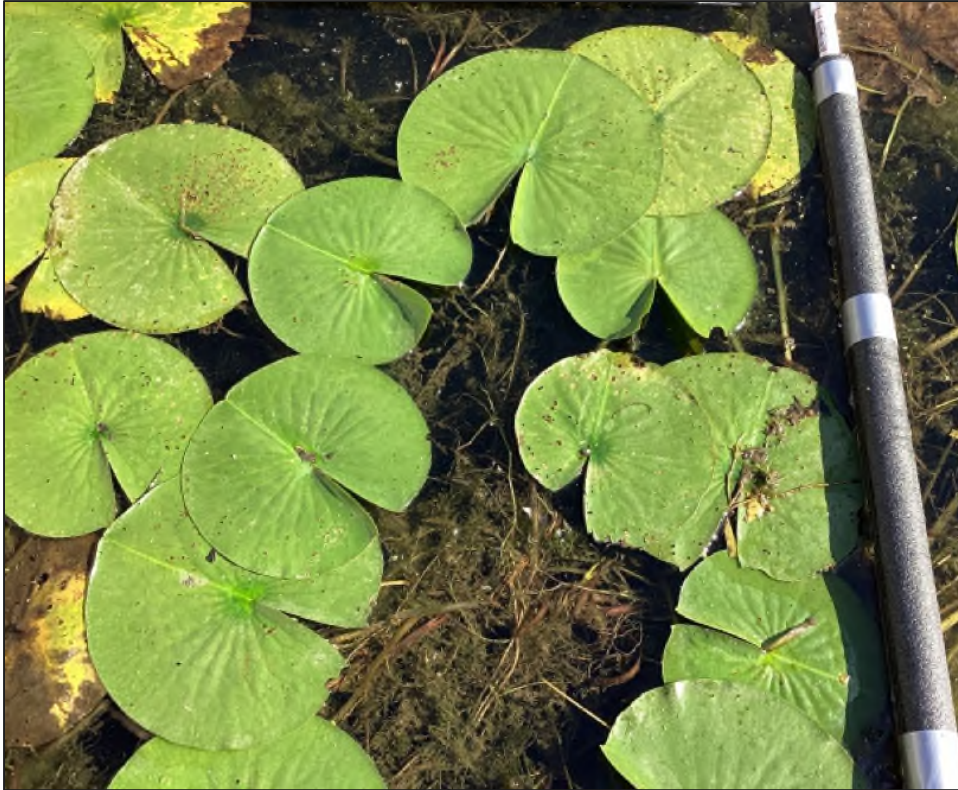
Photo: 15

Area 2 quadrat results (Table 3b) indicate that the overall vegetative cover was approximately 81%. The relative target species percent cover was approximately 95%. Eurasian watermilfoil was the only invasive species observed within the quadrats and accounted for approximately 5% of the relative cover. The species richness ranged from three to eight species found within each quadrat. Eleven distinct species were observed across the Area 2 transect. White water-lily and coontail were the two dominant herbaceous plant species observed.

Description: Example of submerged and floating aquatic vegetation from SAV Area 2. A total of 5 quadrats surveyed in SAV Area 2.

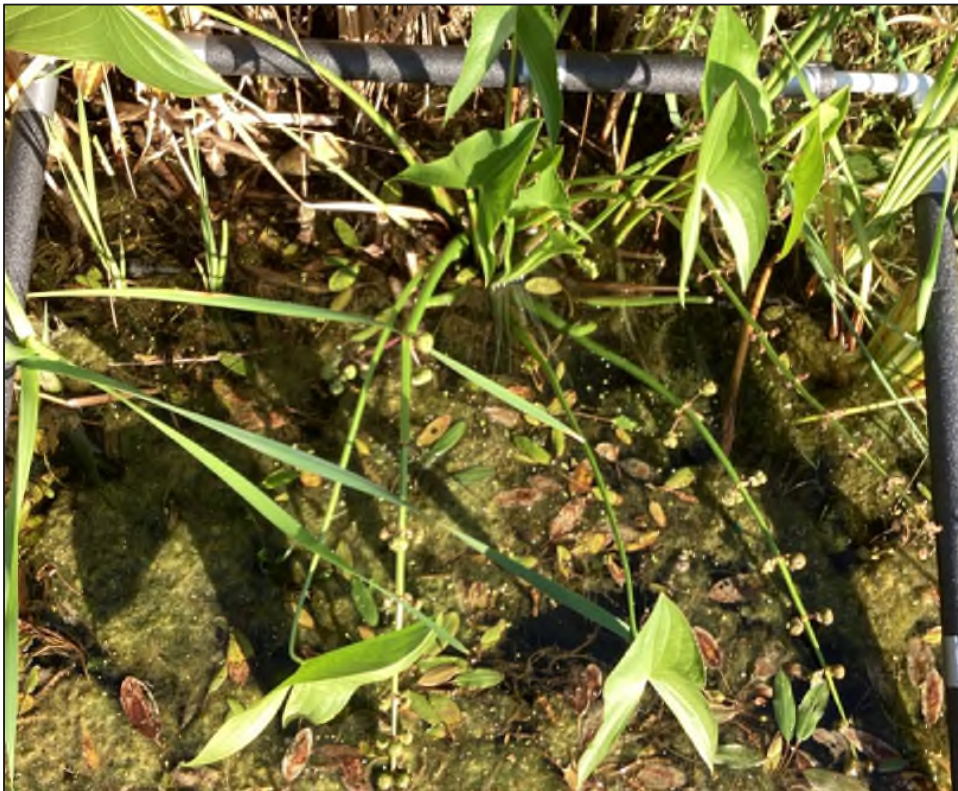
Photo: 16

Area 3 quadrat results (Table 3c) indicate that the overall vegetative cover was approximately 77%. The relative target species percent cover was approximately 87%. Eurasian watermilfoil was the only invasive species observed within the quadrats and accounted for approximately 13% of the relative cover. The species richness ranged from five to eight species observed within each quadrat. Eleven distinct species were observed across the Area 3 transect. Long-leaved pondweed, filamentous green algae (*Spyrogyra* and *Cladophora* spp.), and white water-lily were the three dominant herbaceous plant species observed.

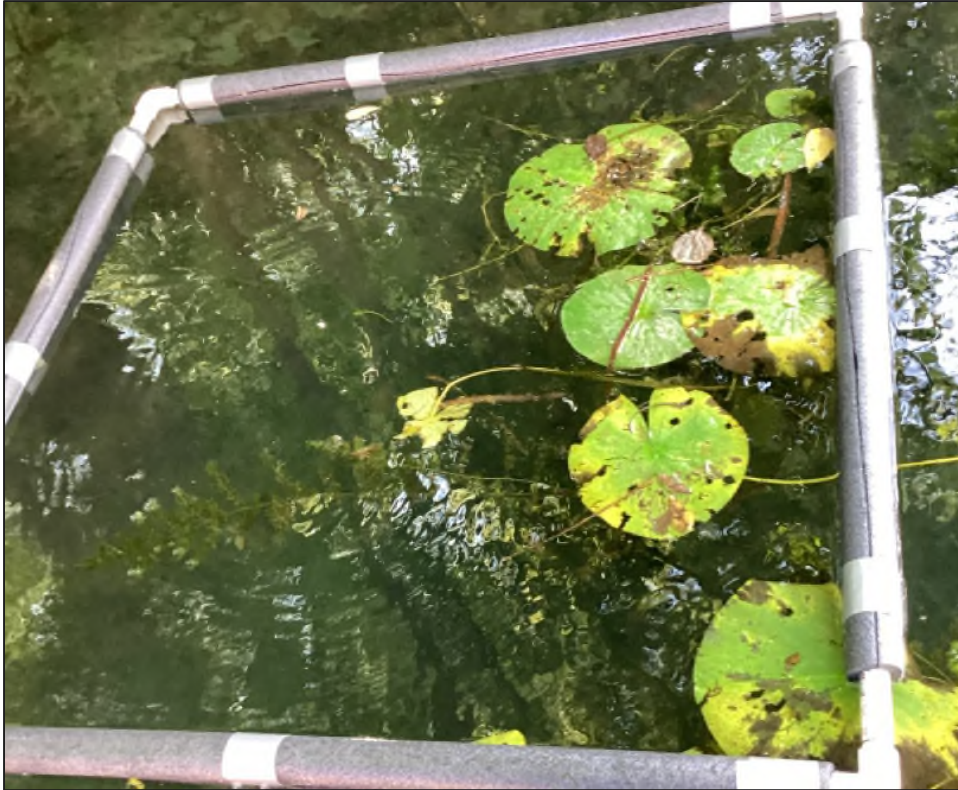
Photo: 17

Area 4 quadrat results (Table 3d) indicate that the overall vegetative cover was approximately 48%. The relative target species percent cover was approximately 99%. Eurasian watermilfoil was the only invasive species observed within the quadrats and accounted for approximately 1% of the relative cover. The species richness ranged from three to five species found within each quadrat. Ten distinct species were observed across the Area 4 transect. Coontail and white water-lily were the two dominant herbaceous plant species observed.

Description: Example of submerged and floating aquatic vegetation from SAV Area 4. A total of 5 quadrats surveyed in SAV Area 4.

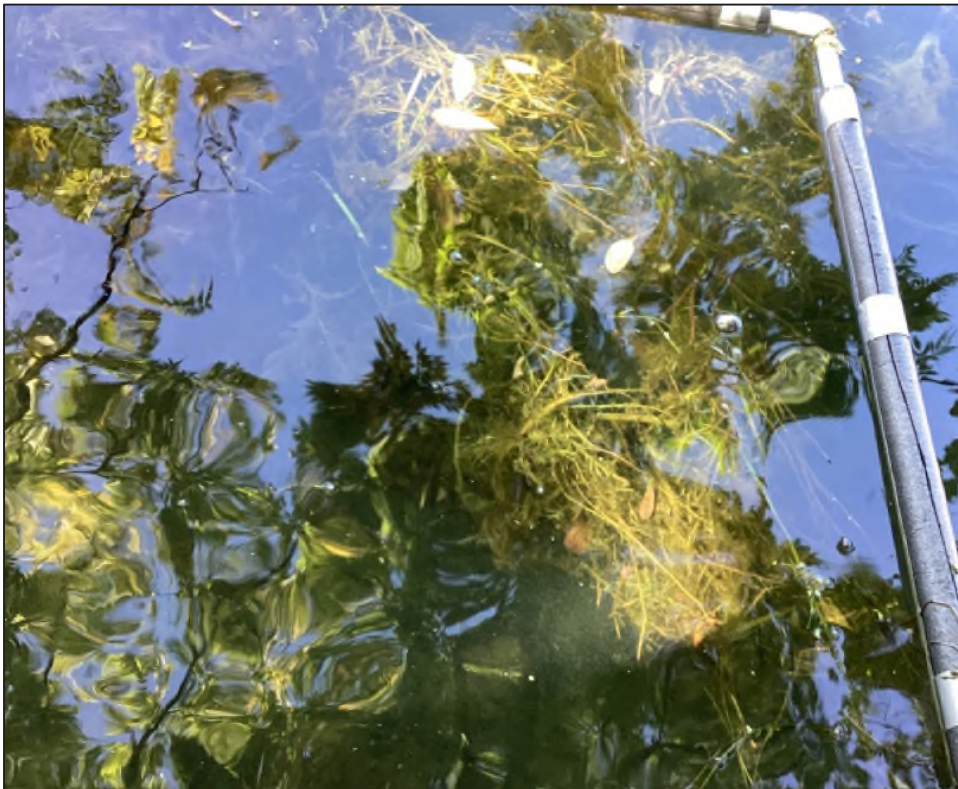
Photo: 18

Area 5 quadrat results (Table 3e) indicate that the overall vegetative cover was approximately 40%. The relative target species percent cover was approximately 95%. Eurasian watermilfoil was the only invasive species observed within the quadrats and accounted for approximately 5% of the relative cover. The species richness ranged from three to five species found within each quadrat. Ten distinct species were observed across the Area 5 transect. Water star grass and wild celery were the two dominant herbaceous plant species observed.

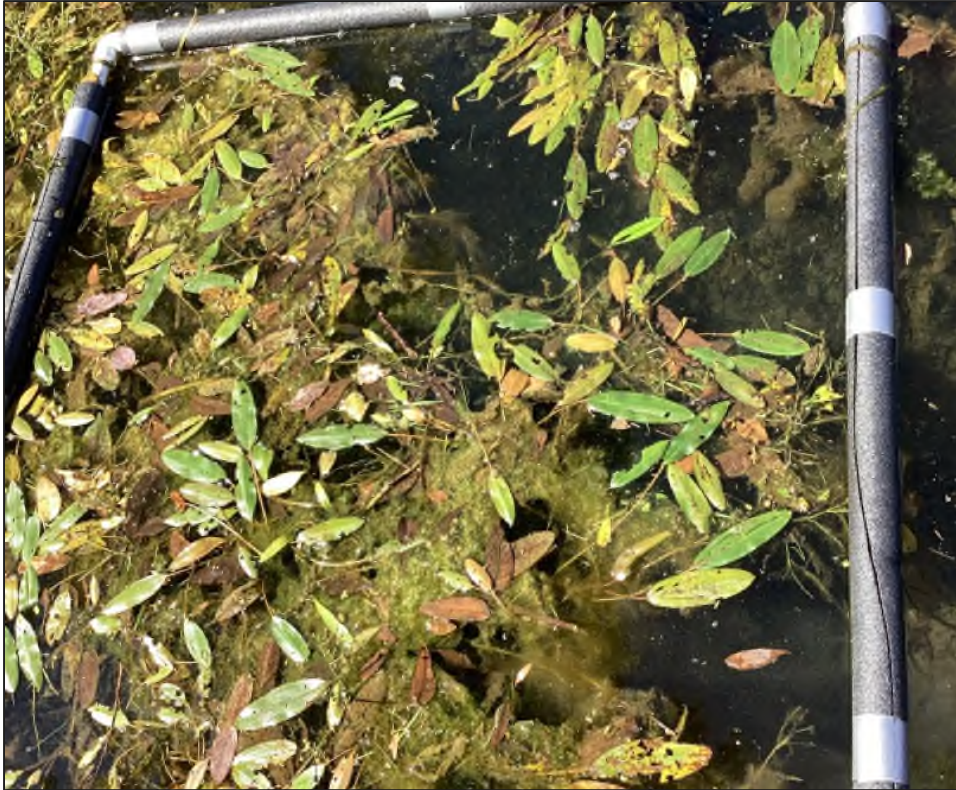
Photo: 19

Area 6 quadrat results (Table 3f) indicate that the overall vegetative cover was approximately 46%. The relative target species percent cover was approximately 96%. Eurasian watermilfoil was the only invasive species observed within the quadrats and accounted for approximately 4% of the relative cover. The species richness ranged from three to five species found within each quadrat. Ten distinct species were observed across the Area 6 transect. Wild celery, water star grass, long-leaved pondweed, and filamentous green algae were the four dominant herbaceous plant species observed.
