New York State Electric & Gas

2025 Restoration Monitoring Report

Penn Yan Former Manufactured Gas Plant Site
Penn Yan, New York
NYSDEC Site Number: 862009

March 2026

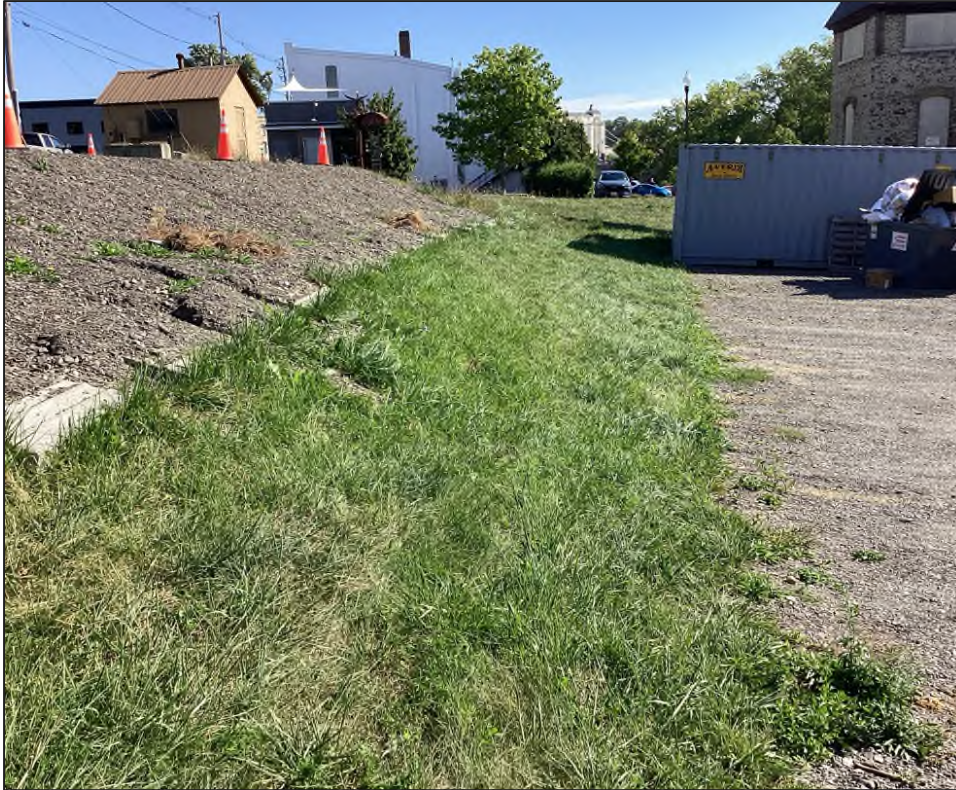
Photo: 1

Description: Former seeded upland area. Photograph shows current 2025 conditions with extent of parking lot expansion.

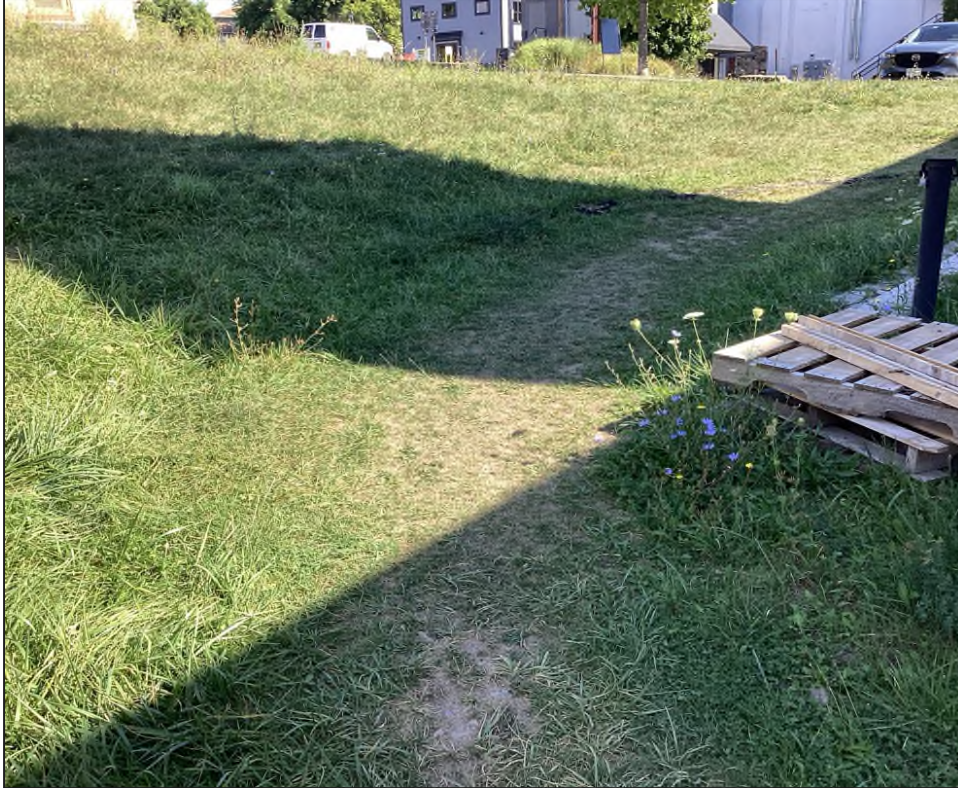
Photo: 3

Upland area quadrat results (UP-1, UP-2, and UP-3) indicate that overall vegetative cover was approximately 94%. The relative target species % cover (i.e., native species) was approximately 68%, with the remaining 26% accounting for naturalized or introduced species. Invasive species observed within the quadrats included spotted knapweed (*Centaurea stoebe*), which accounted for approximately 0.8% of the relative % cover. The species richness ranged from six to 12 herbaceous species observed. Birds-foot trefoil (*Lotus corniculatus*), red fescue (*Festuca rubra*), and perennial rye (*Lolium perenne*) were the three dominant herbaceous plant species observed within the quadrats. Some areas of upland vegetation appeared to have been impacted by human, dog, or other wildlife activity (see Photo 3).

Description: Path resulting
from high public use in the
upland area north of former
gas house.

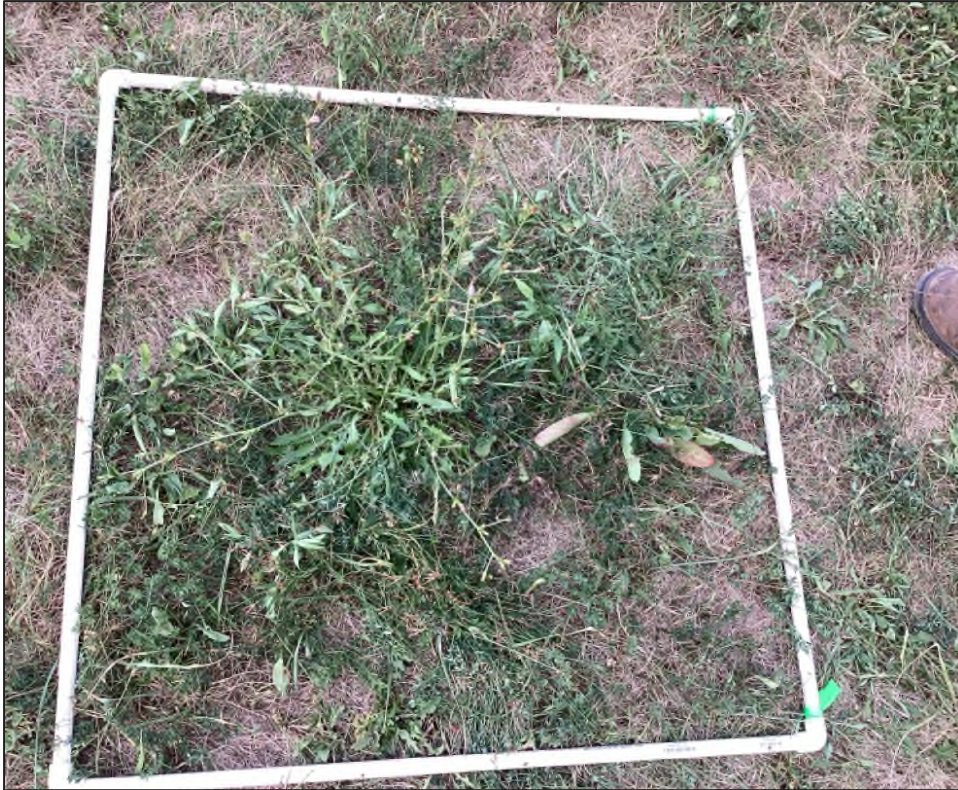
Photo: 5

Description: Upland vegetation quadrat UP-2.

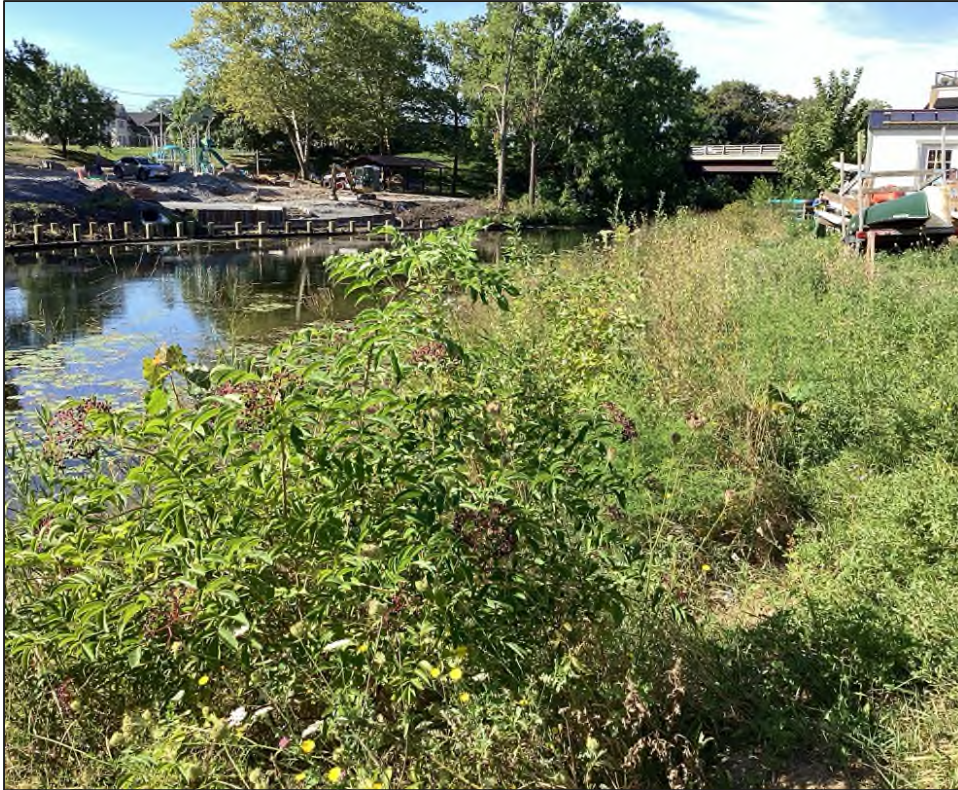
Photo: 7

Description: Looking
southwest along restored bank
area.

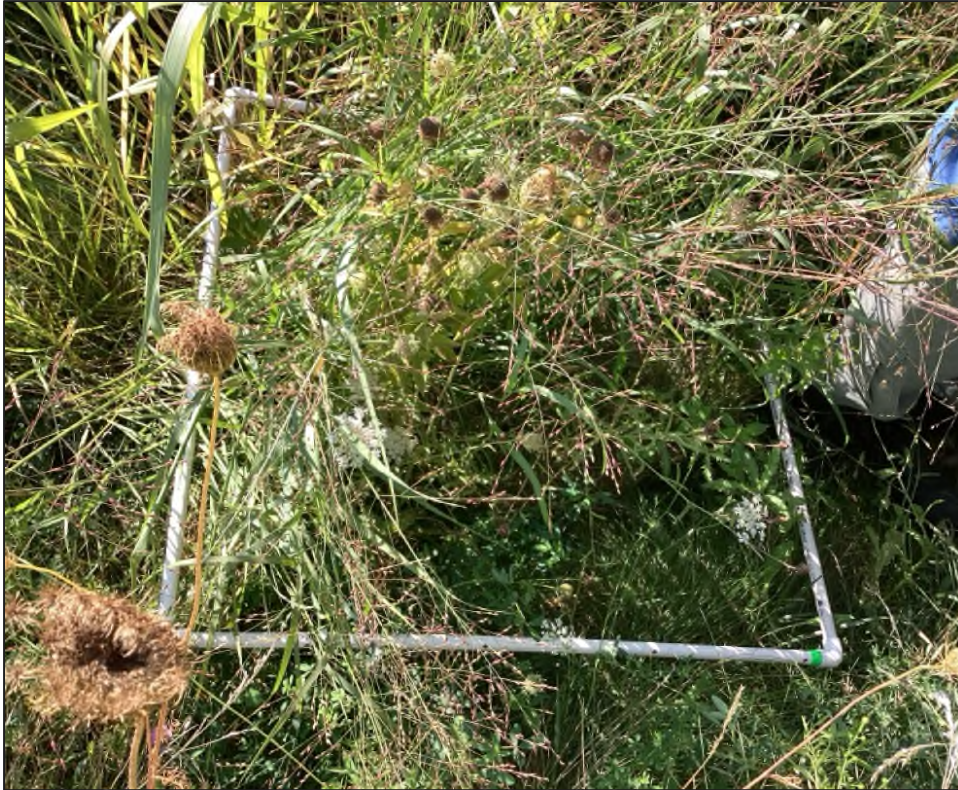
Photo: 9

Description: Bank vegetation quadrat BK-1.

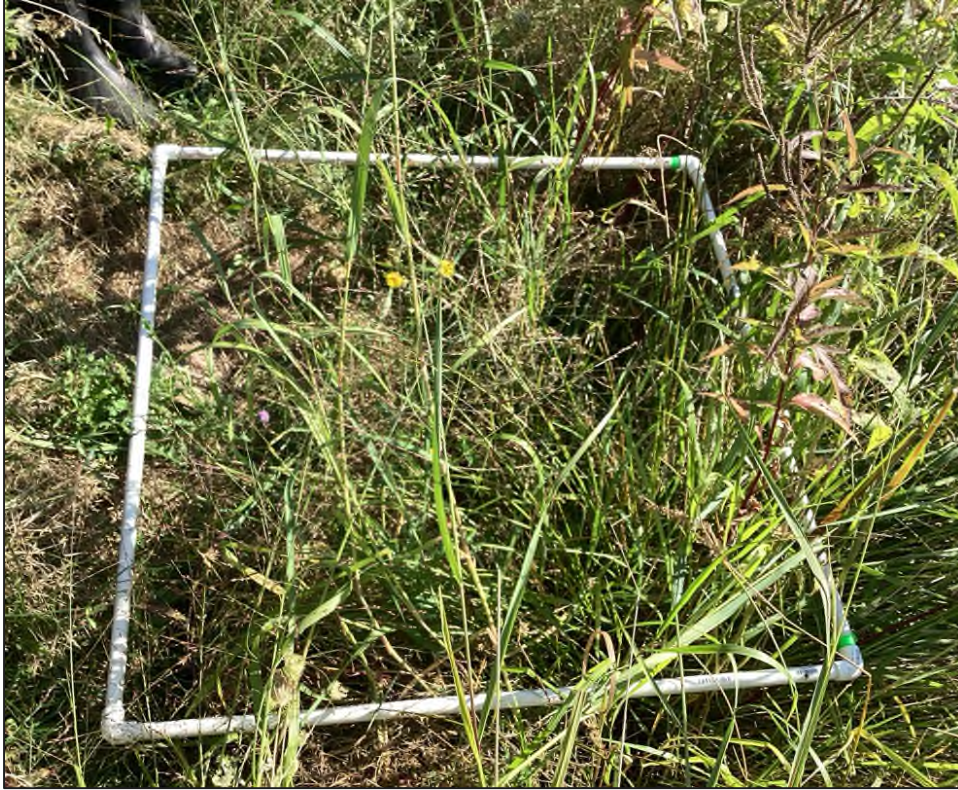
Photo: 11

Description: Bank vegetation quadrat BK-3.

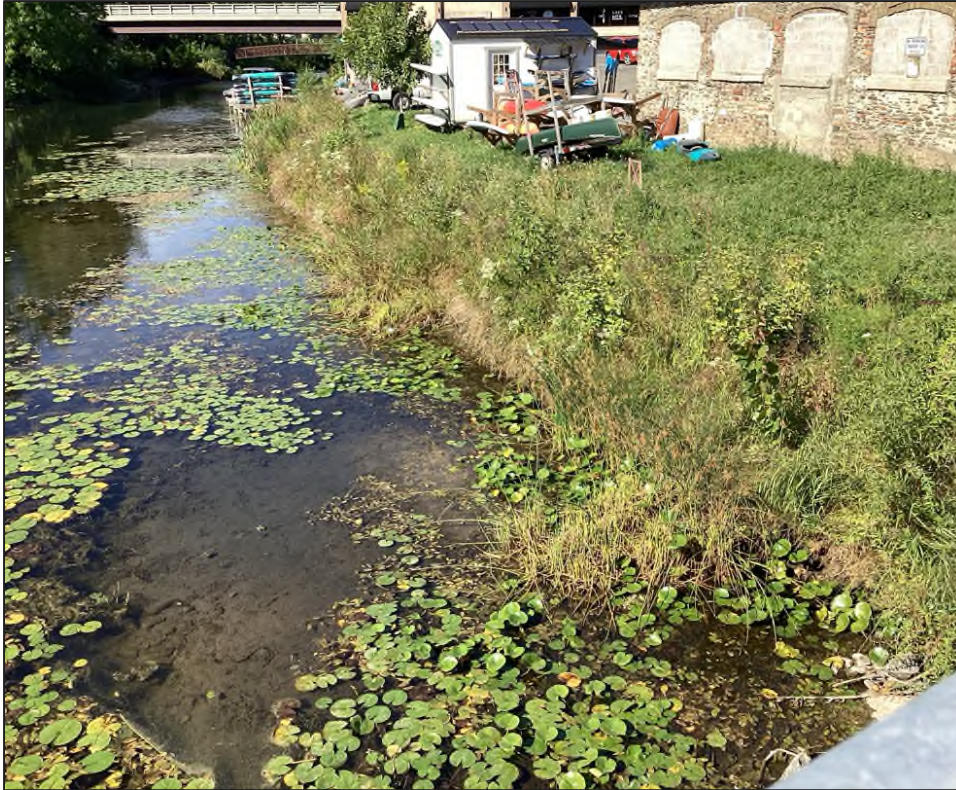
Photo: 13

Area 3 quadrat results (Table 3c) indicate that the overall vegetative cover was approximately 77%. The relative target species % cover was approximately 81%. Eurasian watermilfoil was the only invasive species observed within the quadrats and accounted for approximately 19% of the relative cover. The species richness ranged from four to nine species observed within the quadrats. Eleven distinct species were observed across the Area 3 transect. White water-lily and Eurasian watermilfoil were the two dominant herbaceous plant species observed.

Description: Looking southwest into restored bank area and SAV Area 3 with submerged, emergence, and floating aquatic vegetation.

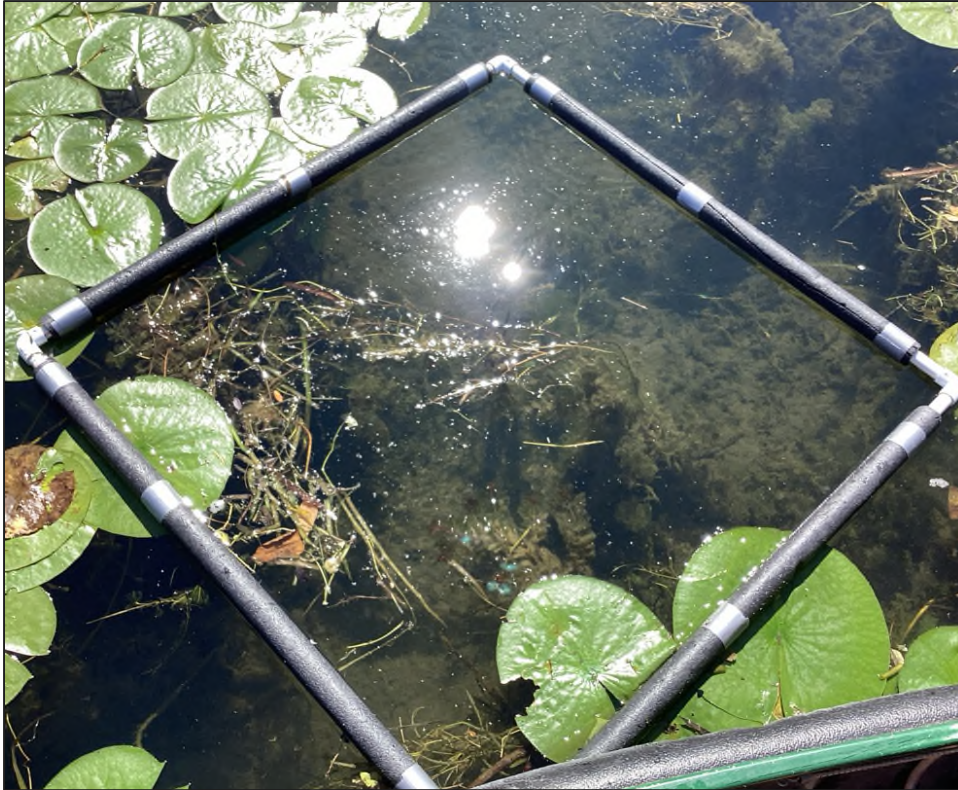
Photo: 15

Area 2 quadrat results (Table 3b) indicate that the overall vegetative cover was approximately 84%. The relative target species % cover was approximately 85%. Eurasian watermilfoil was the only invasive species observed within the quadrats and accounted for approximately 15% of the relative cover. The species richness ranged from

Description: Example of submerged and floating aquatic vegetation from SAV Area 2. A total of five quadrats surveyed in SAV Area 2.

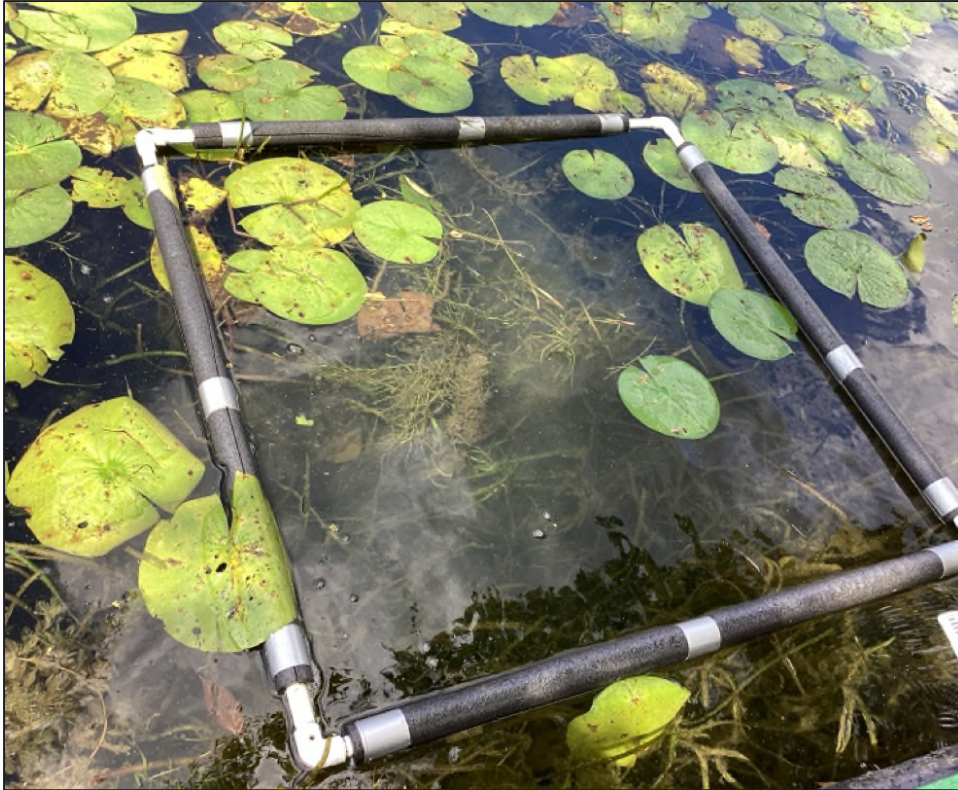
Photo: 17

Area 4 quadrat results (Table 3d) indicate that the overall vegetative cover was approximately 70%. The relative target species % cover was approximately 77%. Eurasian watermilfoil and curly pondweed (*Potamogeton crispus*) were the only invasive species observed within the quadrats and accounted for approximately 23% of the relative cover. The species richness ranged from three to seven species observed within the quadrats. Twelve distinct species were observed across the Area 4 transect. White water-lily and wild celery were the two dominant herbaceous plant species observed.

Description: Example of submerged and floating aquatic vegetation from SAV Area 4. A total of five quadrats surveyed in SAV Area 4.
