FIELD INSPECTION REPORT

Date: August 1 & 2, 2006
Site Name: Pattons Bus Bee
Site Number: 902014
Location: Alfred Station, Allegany County
Project Engineer: Michael Hinton, NYSDEC - Buffalo
Contractor: OP-TECH Environmental

Patton's Busy Bee Tank Repairs
BBT1 North and South & BBT2 South
Photo Index and Description

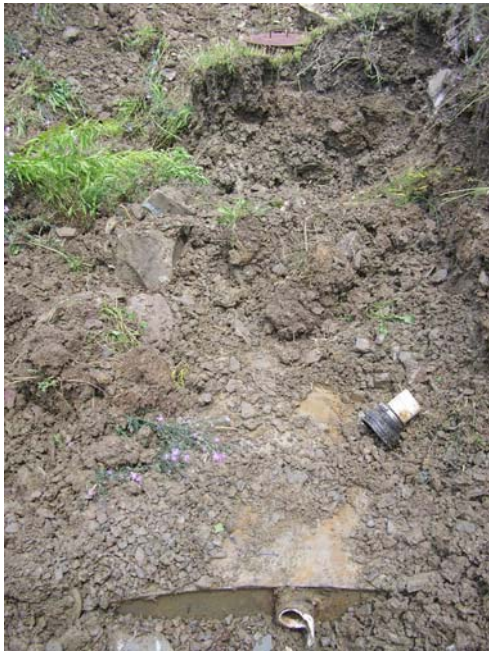
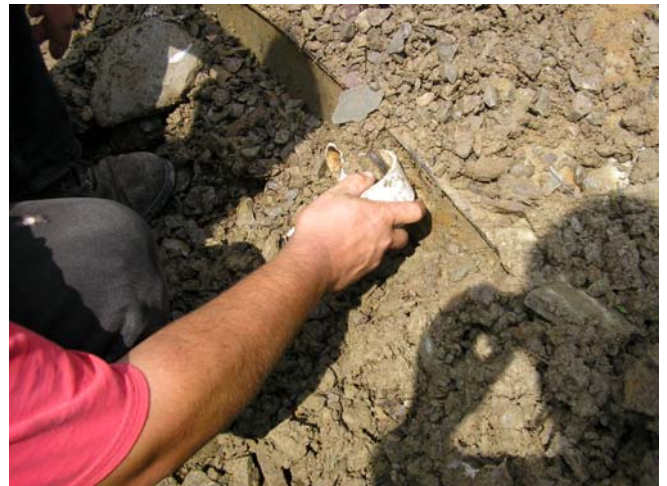
001 and 004: Inlet to BBT1-North.

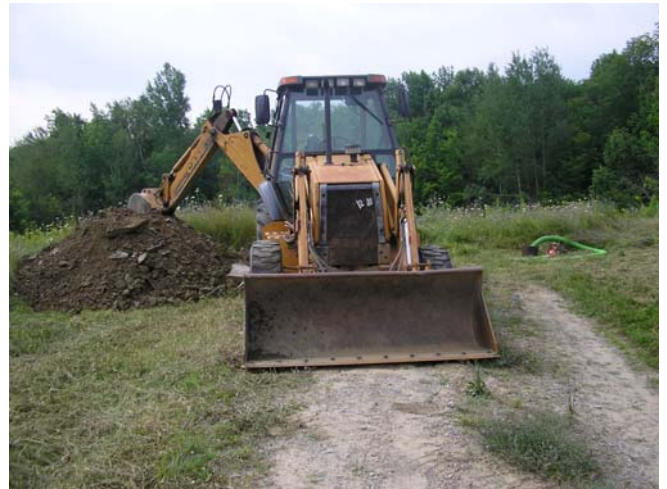
002

002: Excavating Equipment and Initial Setup.

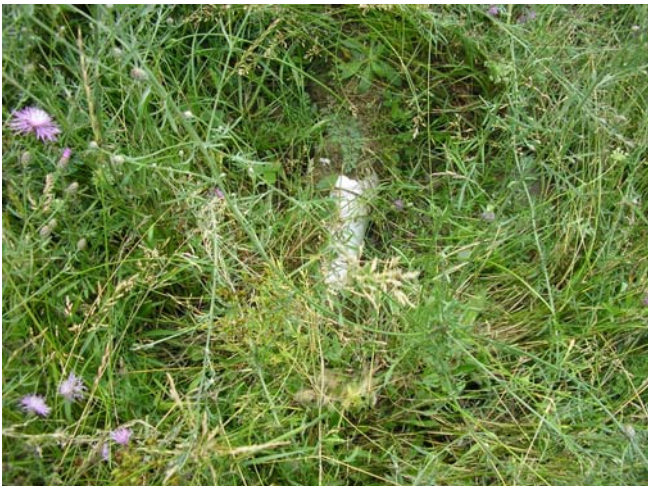
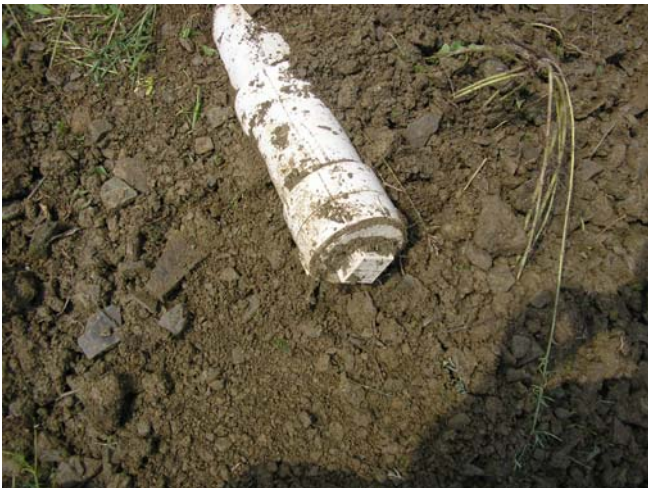
003 and 007: 4" PVC leachate pipe from landfill to BBT1-South. Plugged. Set up to use as clean out. "T" piping is present below earth in picture 007. Leachate feeds BBT1-South and then BBT1-North, after BBT1-South is full.

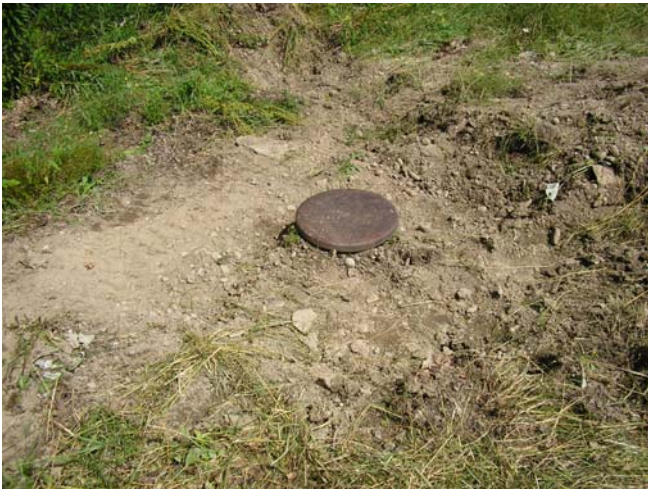
005

005: Riser and cover to tank BBT2-North.

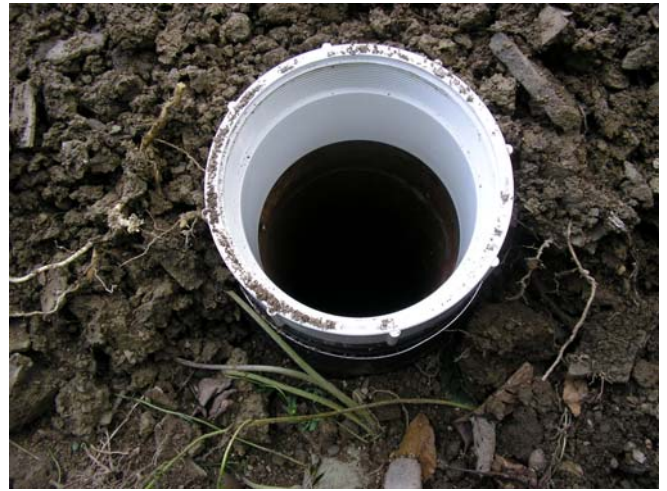
006

006: New 4" PVC Riser on BBT2-South.

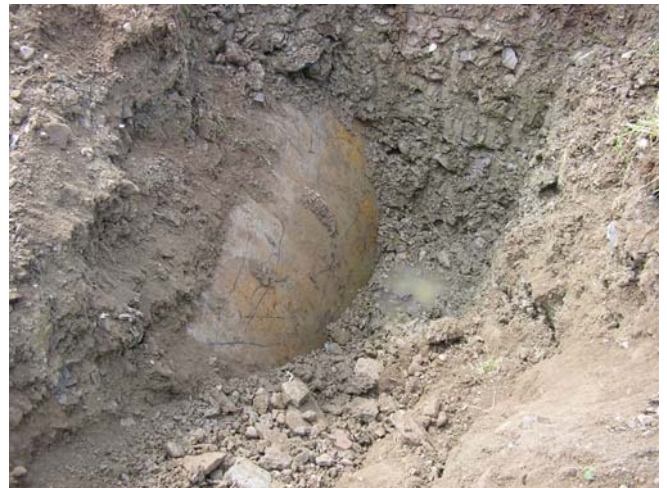
008

008: Tank external to BBT1 North.

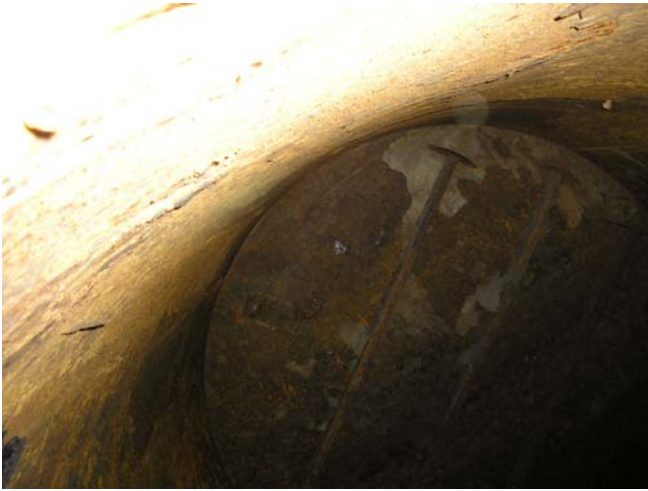
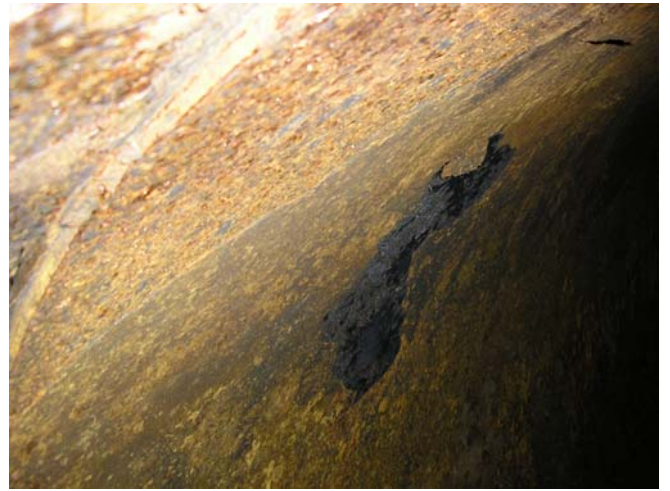
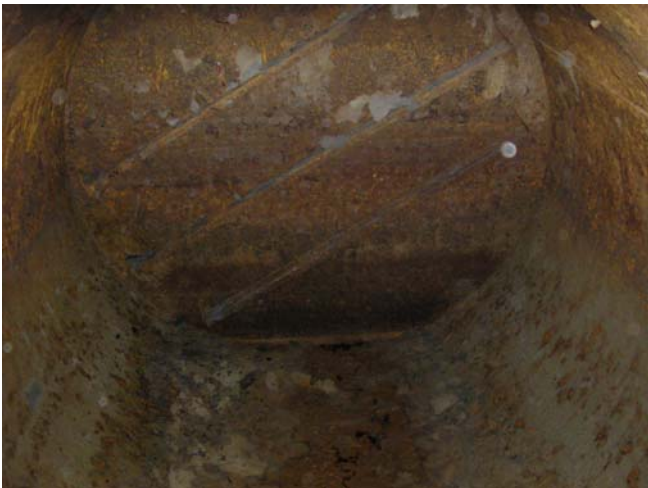
009, 010 and 011: Internal integrity of BBT1-North.

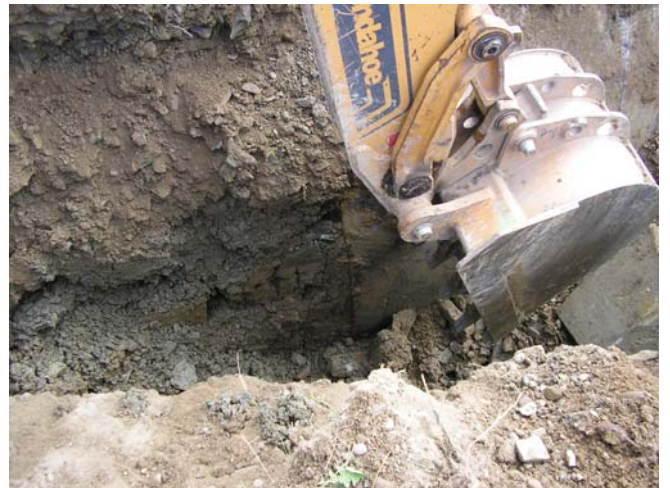
012

012: Western external limits of BBT1-North. Leachate crossover feed not found.

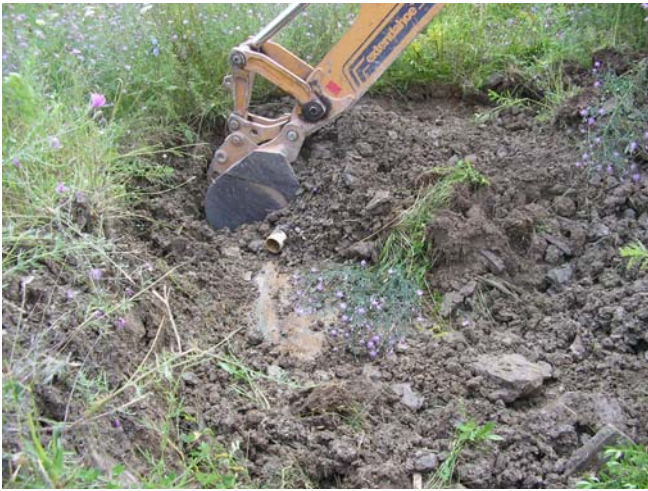
013

013: Excavating east of tank inspection ports for leachate crossover feed.

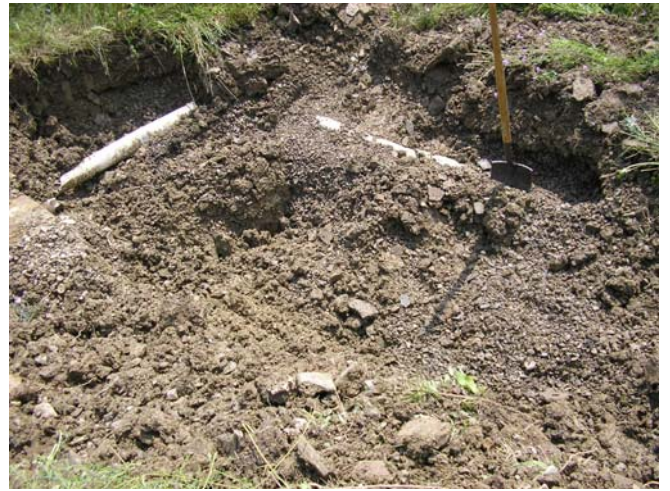
014

014: Crossover pipes found.

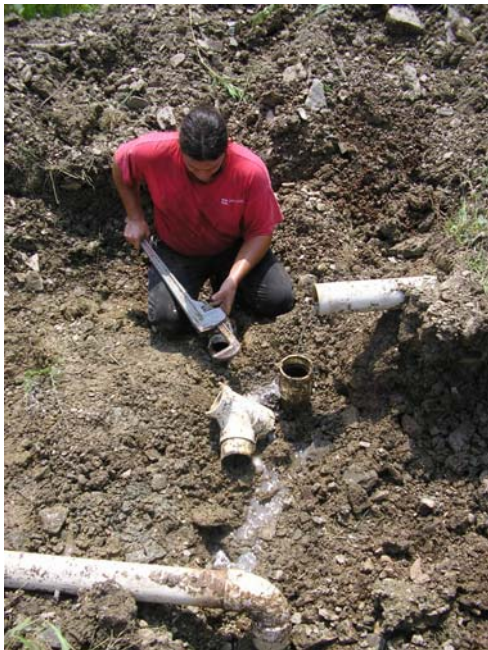
015JPG

015: Removing 4" PVC nipple from BBT1- South steel riser. Pipe at center right is leachate tank feed from site.

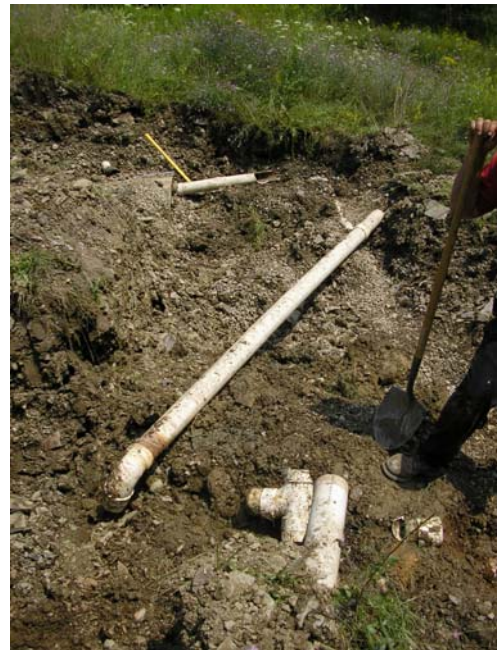
016

016: General pipe length between BBT1 - South and North.

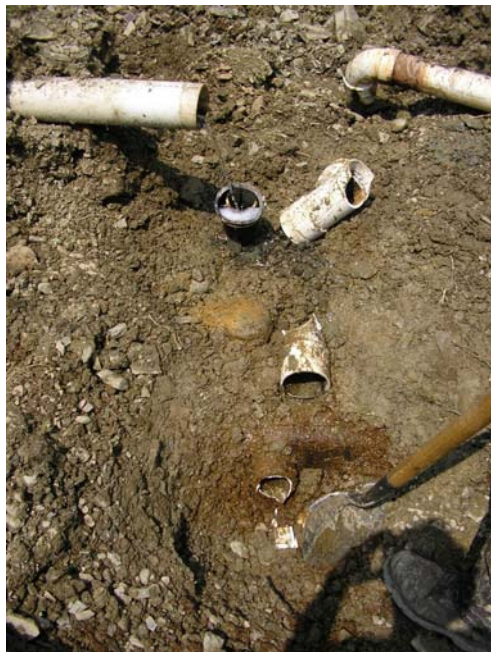
017JPG

017: Pipe at upper left is leachate tank feed from site. Leachate is flowing into BBT1- South tank riser. Pipe at bottom center (shovel point) is leachate outlet, when piped to BBT1-North.

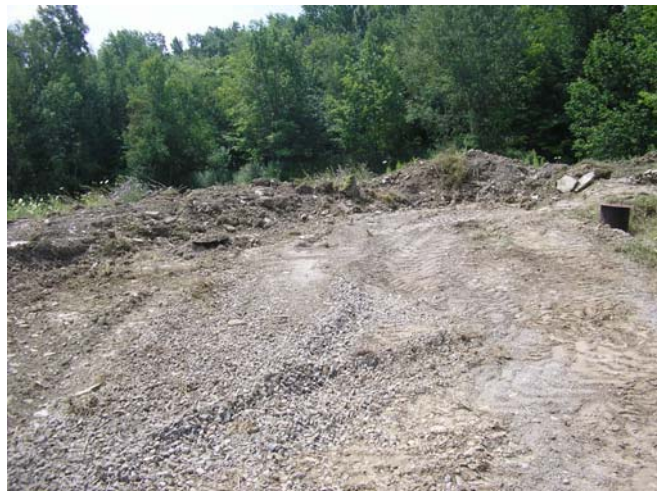
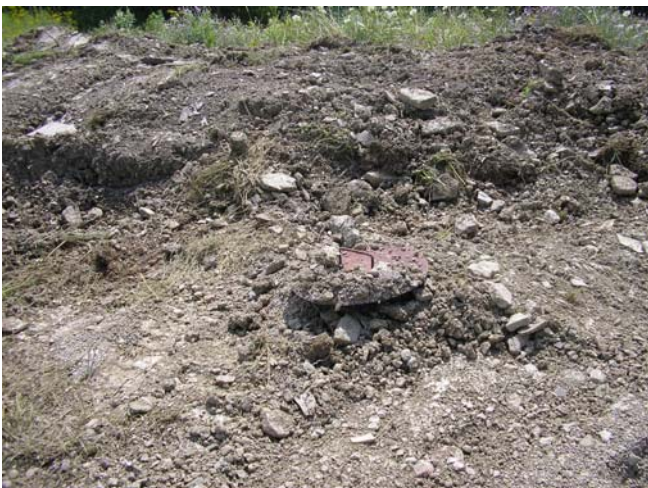
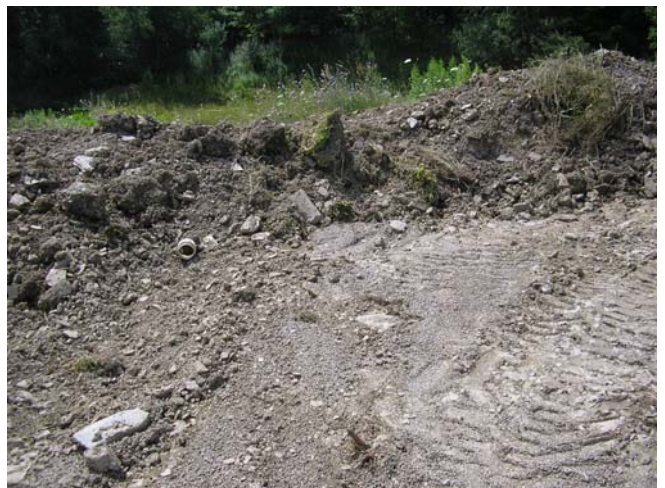
018, 019, and 020: Finished cover at BBT1.

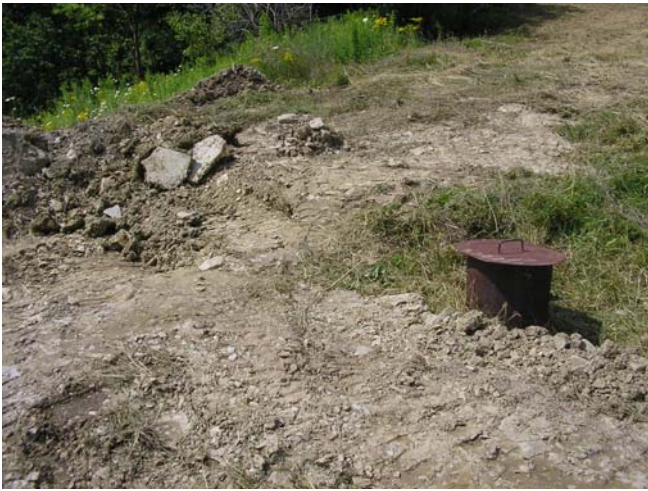
021

021: Finished cover and inspection port to BBT1-South.

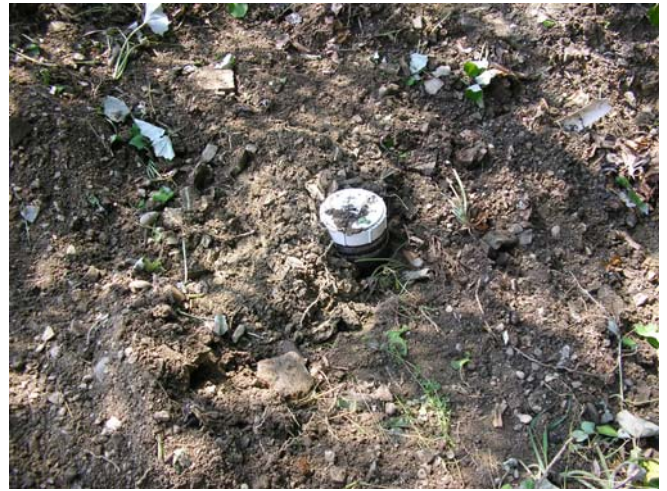
022

022: New riser and cap at BBT2-South.
