| NO. | DATE | APPR. | REVISION | NO. | DATE | APPR. | REVISION | NEW YORK STATE DEPARTMENT OF ENVIRONMENTAL CONSERVATION<br>SUPPLEMENTAL DRAWINGS FOR<br>VAN DER HORST BUILDING DEMOLITION AND DISPOSAL | | | | VAN DER HORST PLANT #2<br>ASBESTOS SAMPLE LOCATIONS<br>AND ANALYTICAL RESULTS | | | | DRAWING NO.<br>SUPP2-1 | |

SUPPLEMENTARY DOCUMENT  
LIMITED SITE DATA  
VAN DER HORST PLANT NOS. 1 AND 2  
SITE NOS. 9-05-008 AND 9-05-022

JANUARY 1994

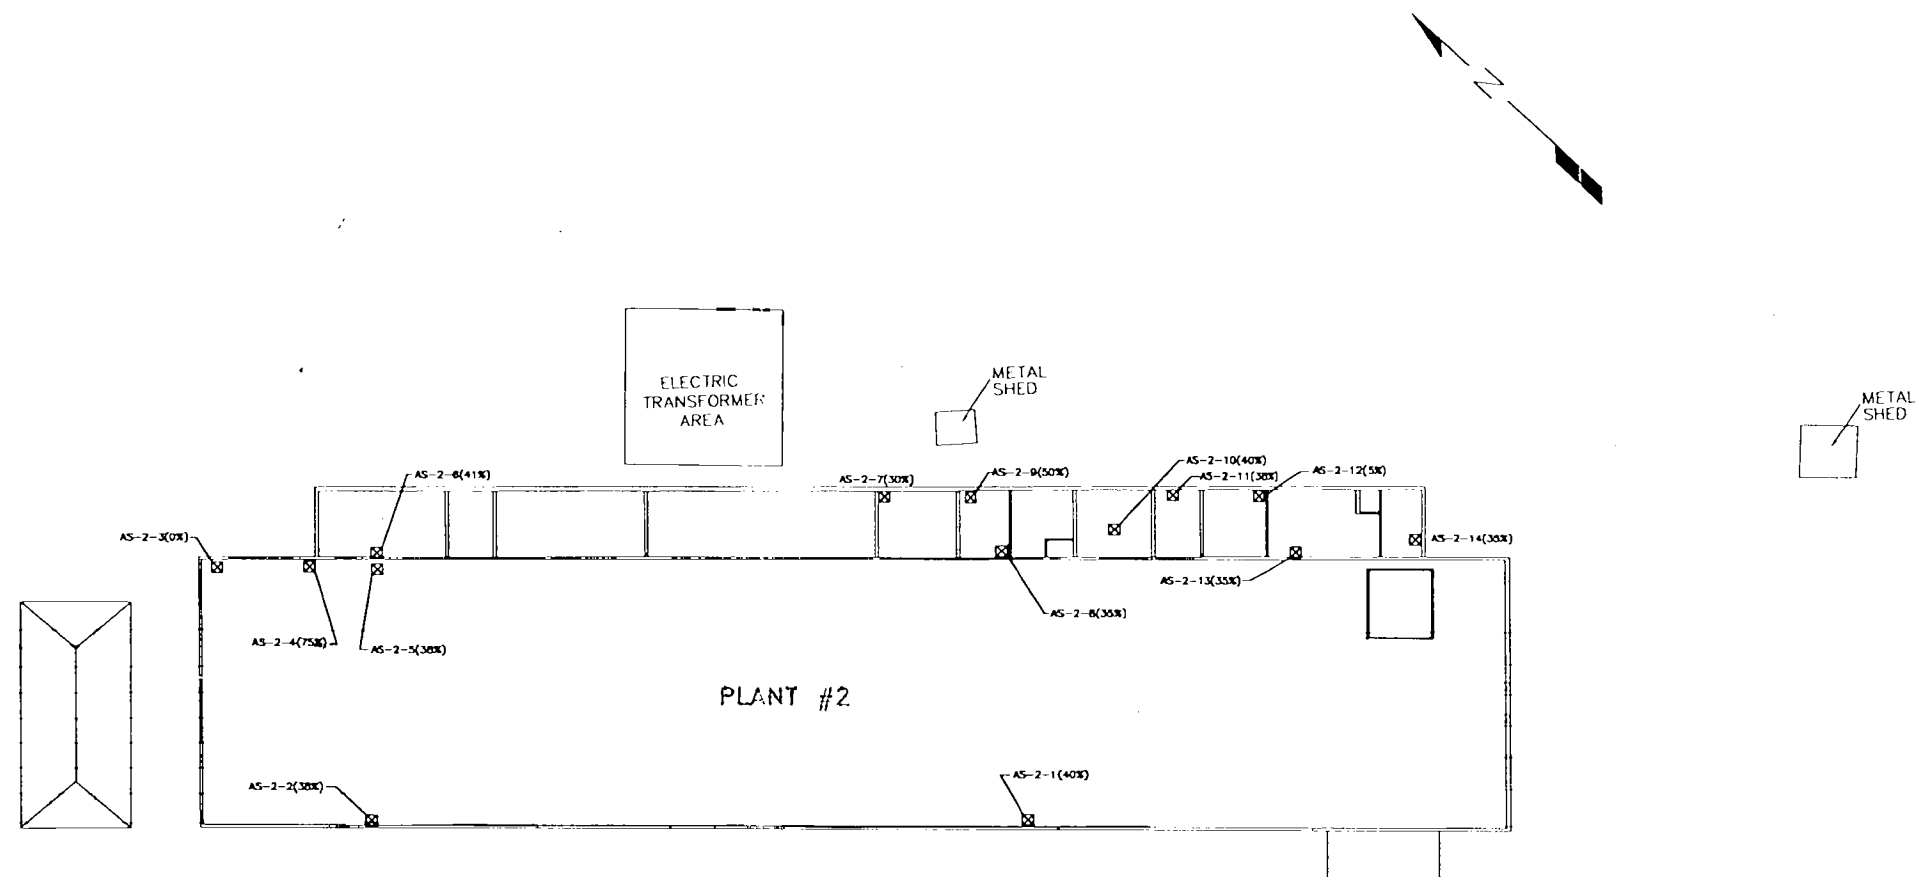
LEGEND  
 ☒ ASBESTOS SAMPLE LOCATION  
 (20%)—PERCENTAGE ASBESTOS IN SAMPLE OF MATERIAL

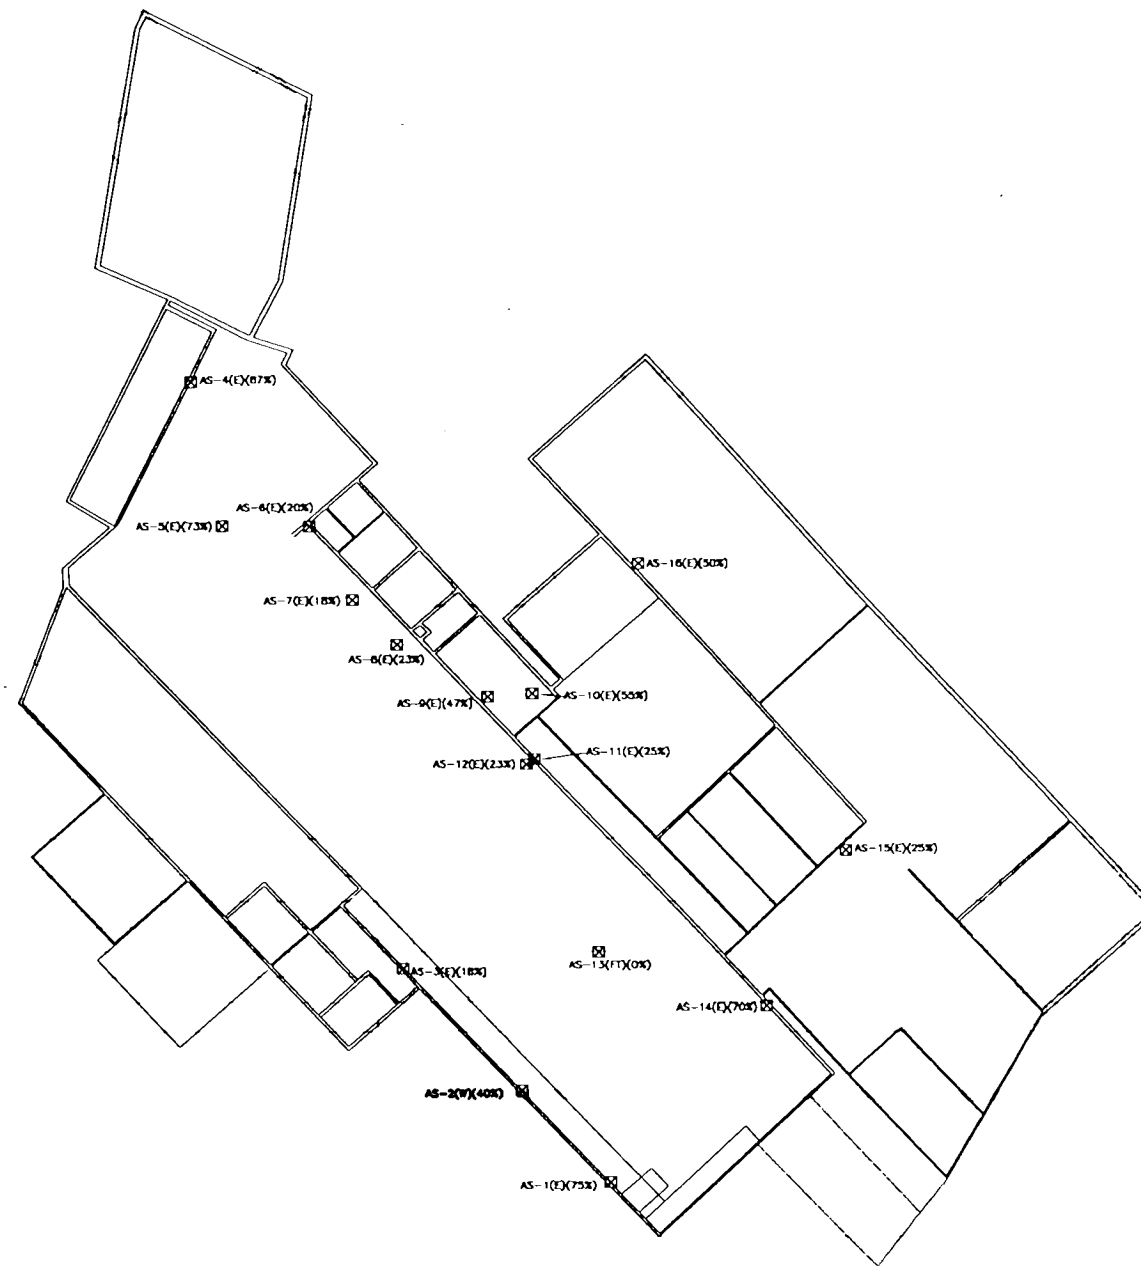
1st FLOOR

LEGEND  
 [Box] ASBESTOS SAMPLE LOCATION  
 (W) - PIPE WRAP  
 (E) - ELBOW  
 (FT) - FLOOR TILE  
 (50%) - PERCENTAGE OF ASBESTOS  
 IN SAMPLED MATERIAL
