NEW YORK STATE DEPARTMENT OF
ENVIRONMENTAL CONSERVATION

REMEDIATION SUMMARY REPORT

SOIL EXCAVATION AND SITE RESTORATION PROJECT
VAN DER HORST PLANT NO. 1 SITE
CITY OF OLEAN, CATTARAUGUS COUNTY
CONTRACT NO. D003494
SITE NO. 9-05-008

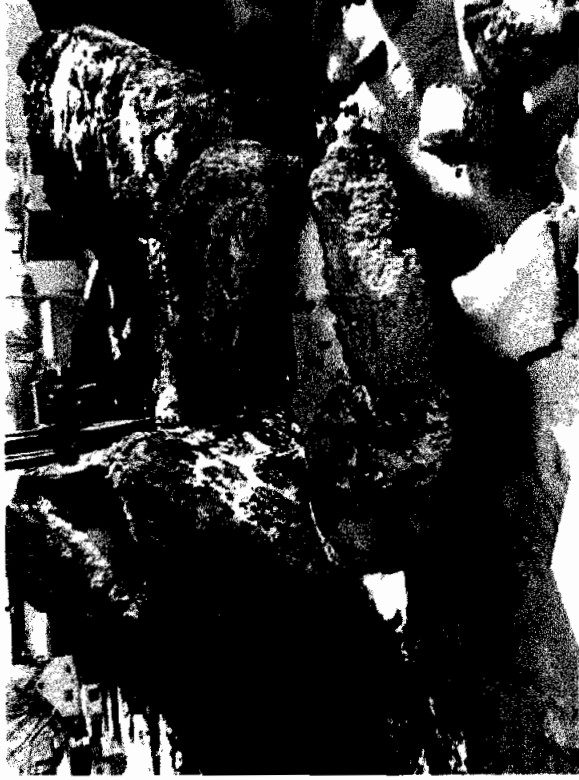
PHOTO No. 2

The contract required that only a small triangular area (570 sq. ft.) be excavated to a depth of 7 feet. As excavations of this area continued, half of the north wall was shown to be stained yellow as was the entire bottom of the vat. After removing the bottom slab, an additional foot of soils stained yellow was removed to a total depth of 8 feet. At the conclusion, the entire plating vat plus adjacent soils were removed.

Contaminated "hazardous" concrete removed from Vat Area M

Note yellow staining into concrete.

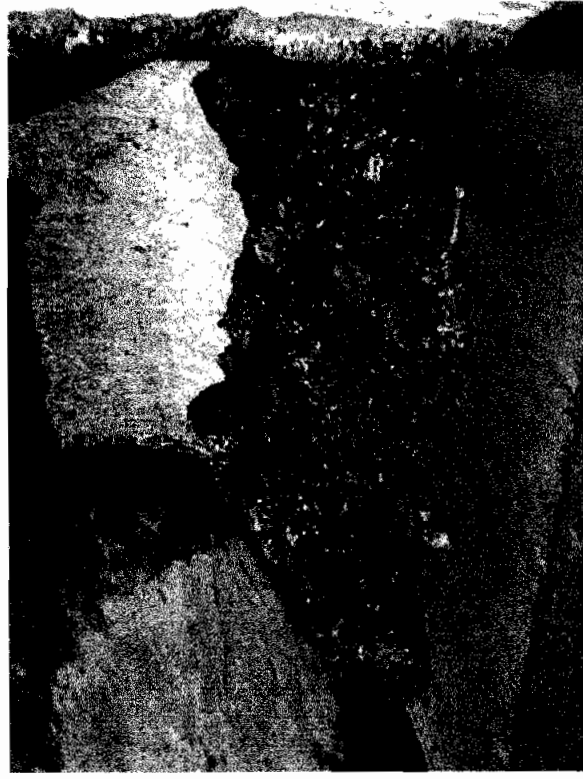
PHOTO No. 3

Typical conglomerate of contaminated soil from monolith material.

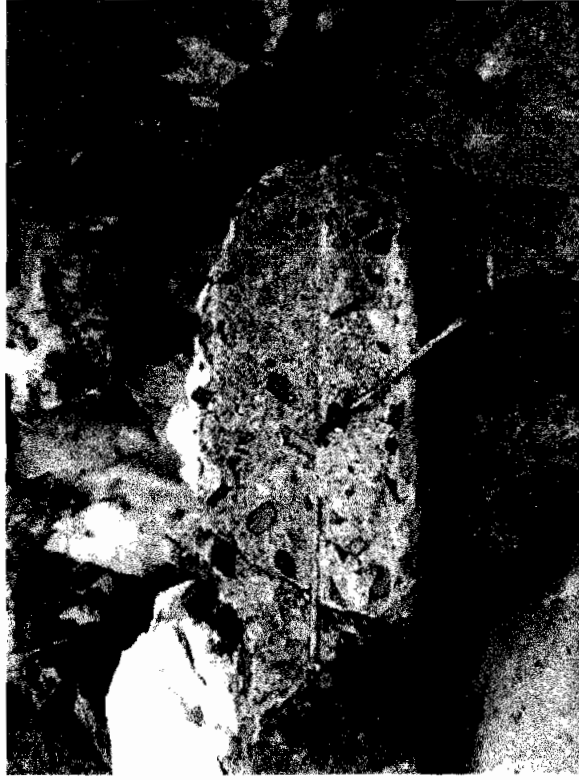
PHOTO 4

Contaminated concrete from Plating vat area.

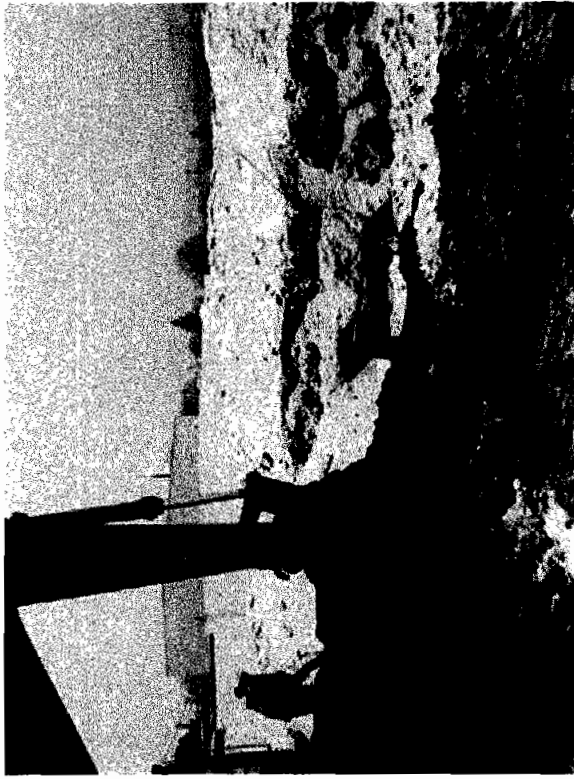
necessary to excavate additional hazardous wastes beyond the extent of the original Plating Vat Area. This plan required the removal of soil from zero to two foot in depth around the Vat Area as required by the original specifications and then the removal of 6 feet of soils (2 feet to 8 feet bgs) determined to be non-hazardous. This soil was stockpiled, to be returned to the excavation after removal of hazardous soil. This 6 foot removal was a continuous ring around the Vat Excavation of approximately 20 to 25 feet wide. This platform, 8 feet below ground level, would allow the excavation of hazardous soils found from 10-18 feet below the original ground surface (photo no. 5).

Excavation in Plating vat Area at 18 foot bgs depth.
PHOTO 5

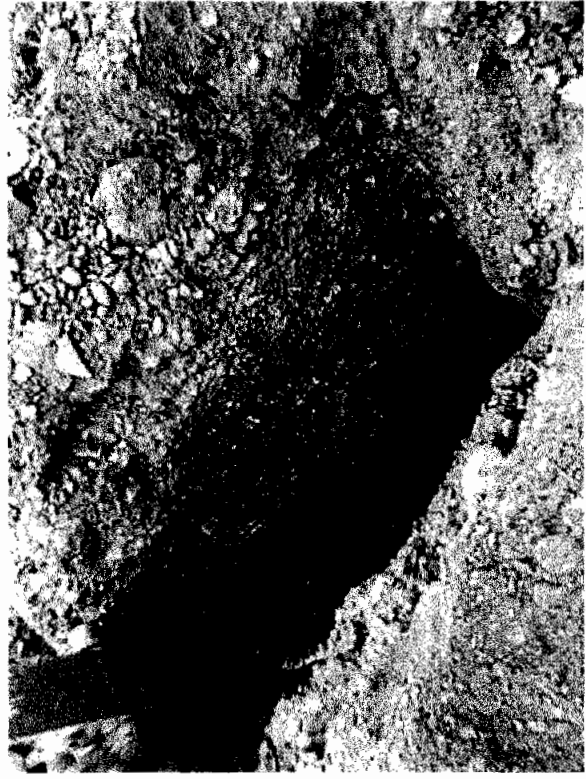
PHOTO 7

Monolith test pit.

Note: Although the excavation is below the groundwater table, there is very little infiltration through the mass.

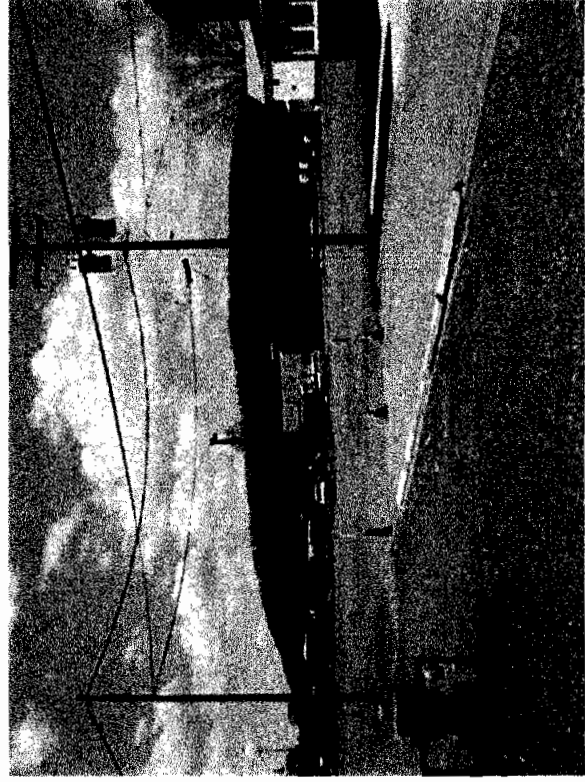
Final Subgrade on site,
Monitoring wells Nos. 17s & 17d being installed.
PHOTO 8

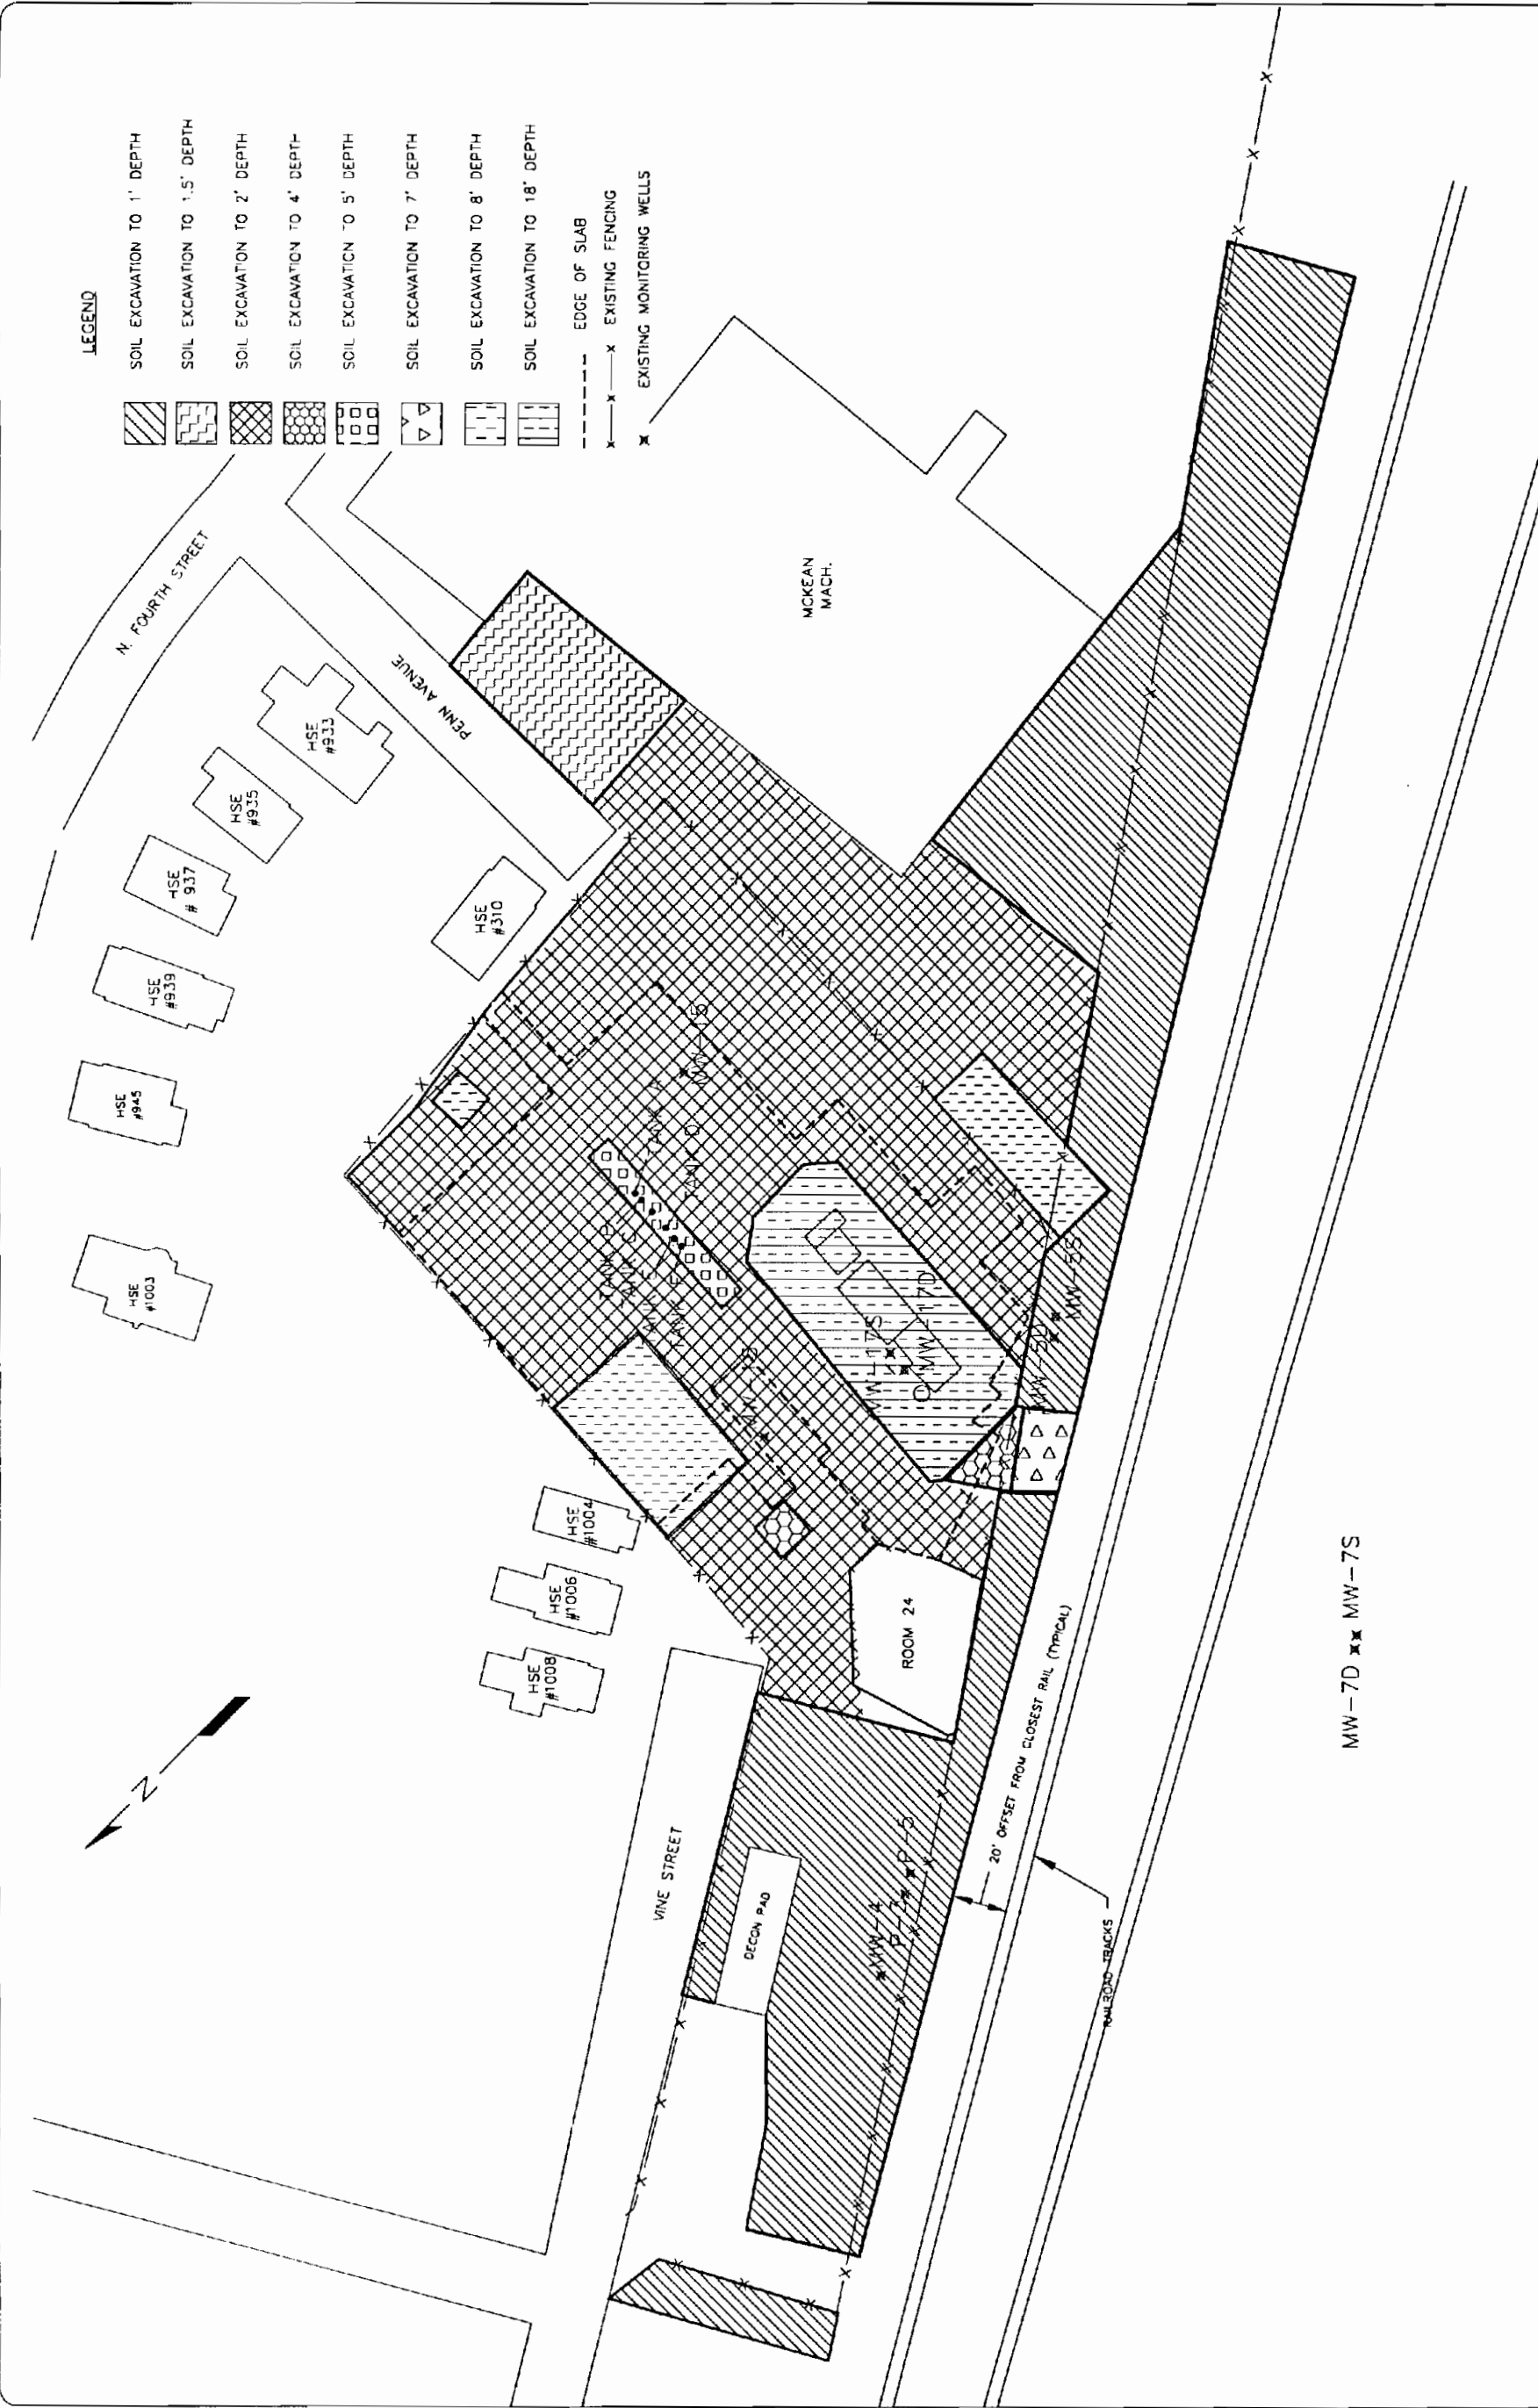
Figure 3

The excavation of the additional hazardous materials began in the north east corner of the excavation and proceeded to the south and around the original excavation. This additional excavation averaged approximately 15 feet horizontally beyond the original excavation and to a depth of 18 feet below original ground surface (Figure 3).

The soil and concrete removed from area "M" increased from 156 cubic yards with approximately 45 cubic yards hazardous to 260 cubic yards with approximately 120 cubic yards hazardous (Figure 3).
