CITY OF OLEAN INACTIVE LANDFILL

LANDFILL COVER REMEDIATION

CONSTRUCTION DOCUMENTATION REPORT

URS COMPANY, INC.

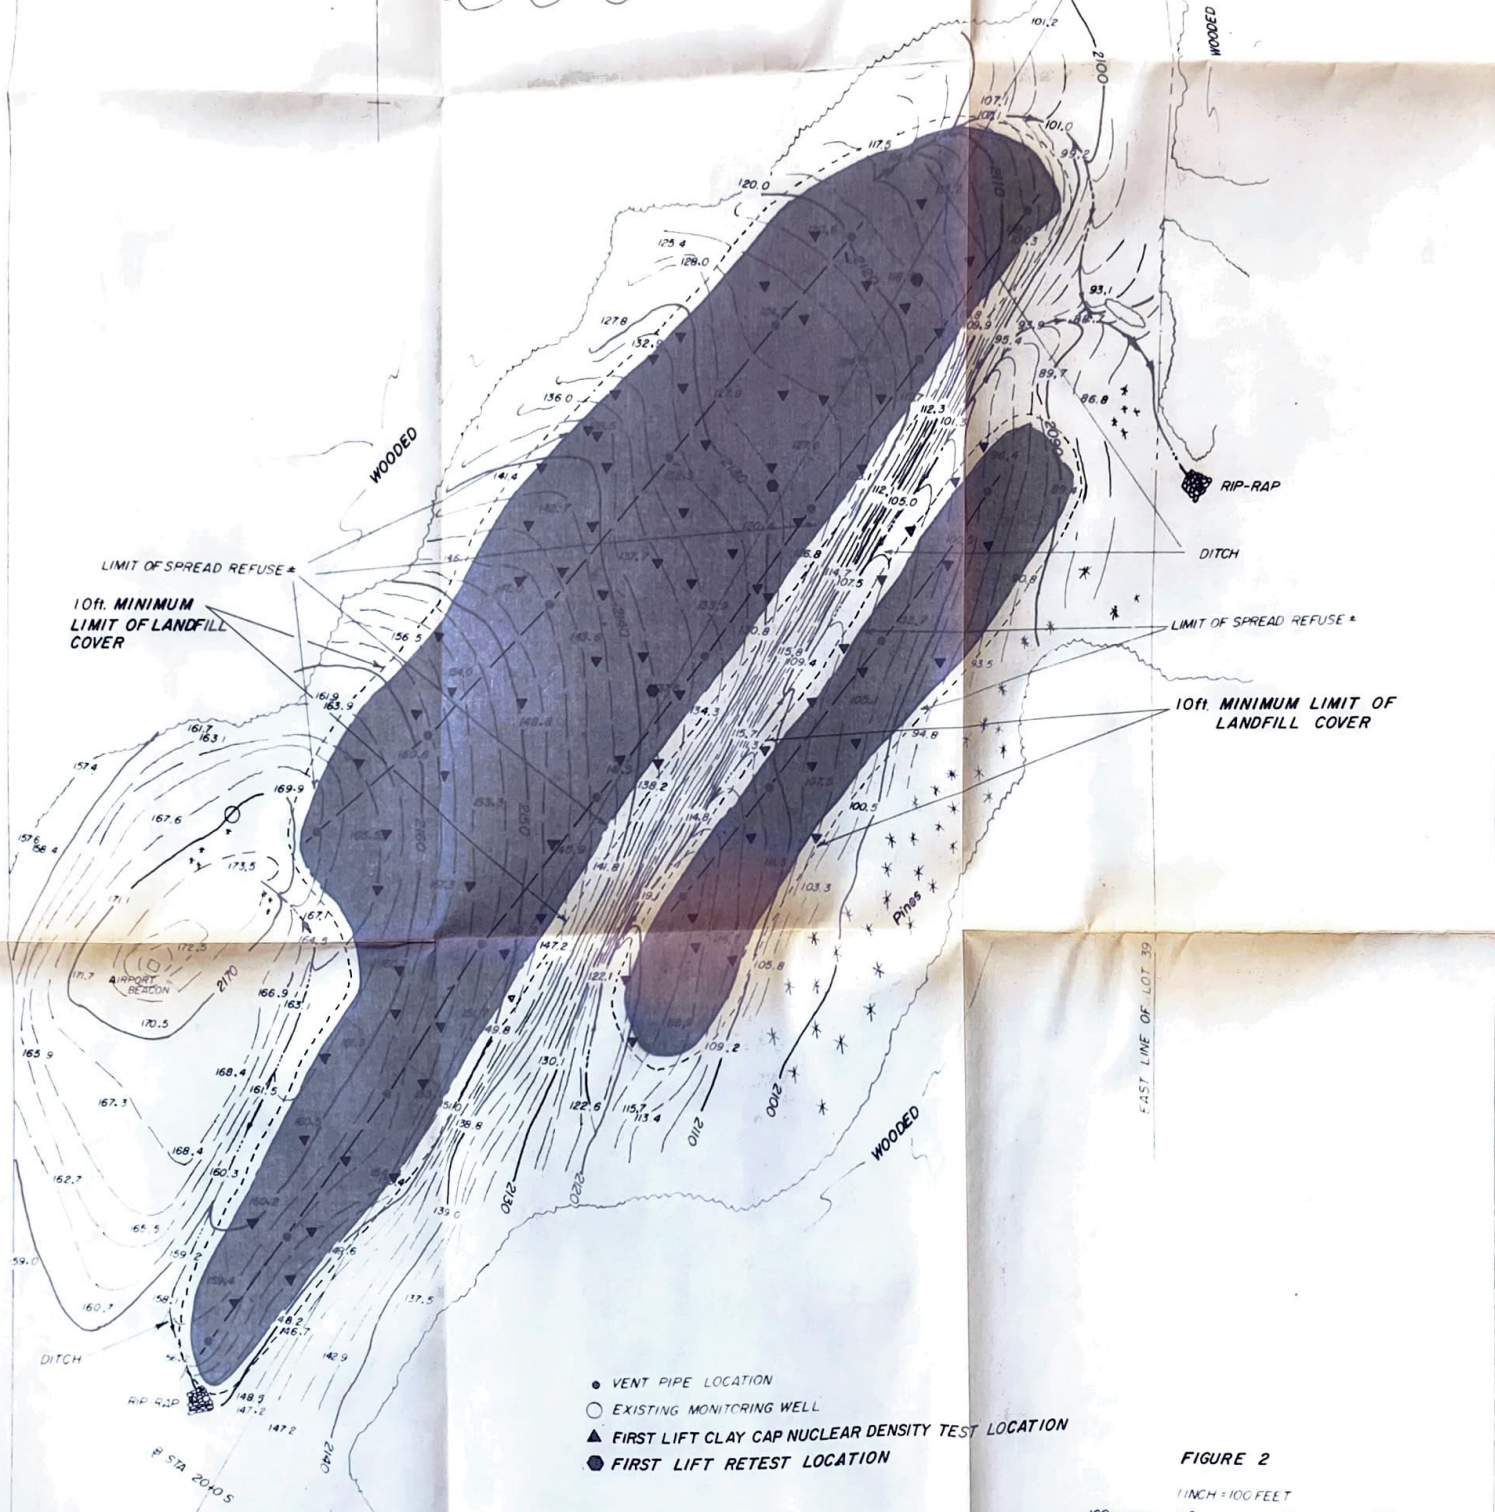
**FIGURE 2**

The location of field tests is shown on Figures 2 and 3 and a summary of test results is presented in Table 4. Frequency distribution plots of the test results, used in approving the compacted fill are shown in Figures 4 and 5. The plots show that all the accepted tests met or exceeded the quality control requirements. A statistical analysis of accepted test results indicates a confidence level of greater than 99 percent in the quality of data. The actual test reports are included in Appendix 3.
