SITE RECON REPORT

Site Name:	Ischua Landfill (City	Inspector(s)	R. Piurek	Well(s)	Yes	ACCESS ID/	9073/
	of Olean)		(Parsons),			SWID#	05S20
			Steven				
			McDonnell				
			(NYSDEC)				
Address	5420 Airport Road,	NYSDEC DMM	Steven	Seeps	Yes, see	Inactive	N/A
	Olean, NY	Manager	McDonnell		fig.	Register #	
					below		
County	Cattaraugus	Site Contact	Robert Ring	Exposed	No	DER Class	N/A
		Name		Waste			
Decimal (Lat)	42.248377,	Site Contact	716-376-5650	Waste	Industrial	Approximate	8 acres
Degrees (Long)	-78.365391	Number		Type	Waste,	Fill Area	
					Ash,		
					Unknown

Title: Ischua Landfill (City of Olean)

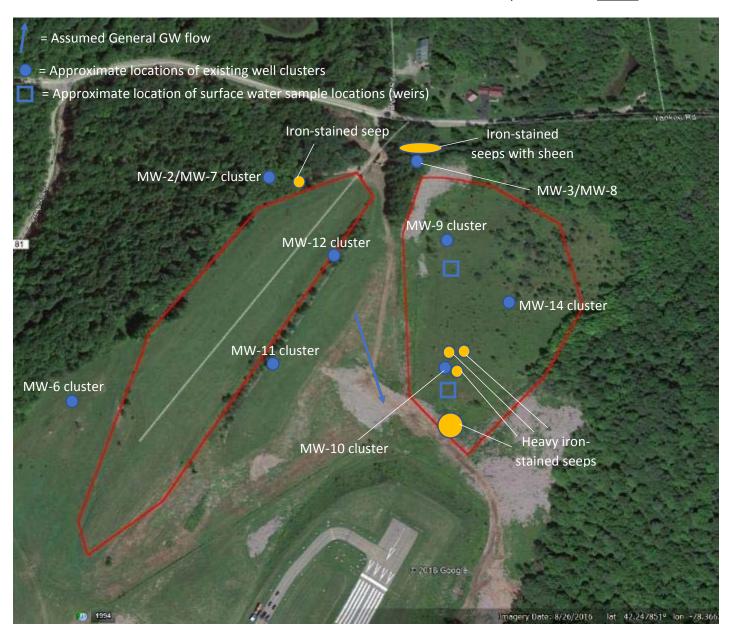
Ischua Landfill Site Plan

Possible leachate seeps (noted by heavy iron floc staining and a visible sheen) were observed at various locations around the perimeter of the landfills. The approximate locations of these leachate seeps are noted on the Site Plan below.

Sampling the potential leachate seeps around the perimeter of the landfill, and the existing monitoring wells at the site would be a prudent first step to assess the presence of PFASs, VOCs, and other contaminants. If necessary, access within the site for additional well placement would not be difficult as the terrain is lightly vegetated. A track-mounted rig would likely be able to access any additional well installations, if required.

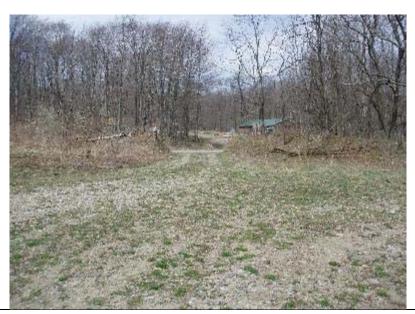
Description: Site access entrance to Ischua Landfill off Yankee Road. Photo facing north.

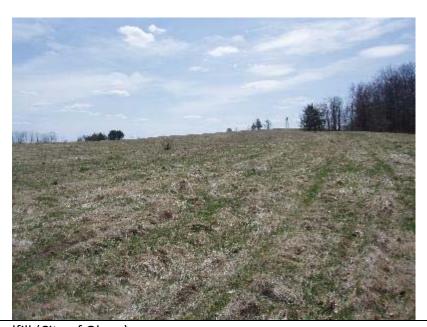
Description: Northern slope of western section of Ischua Landfill. Photo facing south.

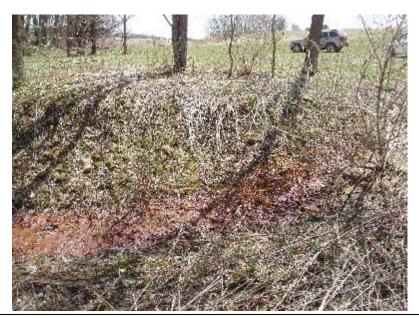
Description: Heavy iron-stained seep with sheen along northern boundary of Ischua Landfill, just

south of Yankee Road. Photo facing south.

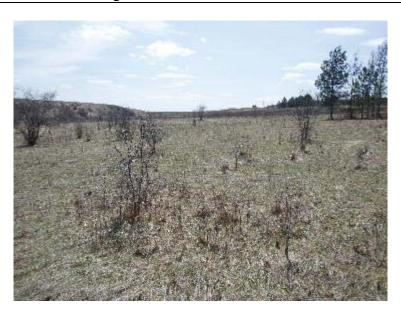
Description: Eastern section of section of Ischua Landfill facing downgradient. Photo facing

south.

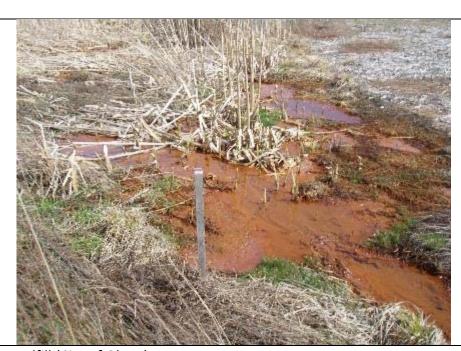
Description: Heavy iron-stained seep with sheen along southern boundary of western section of

Ischua Landfill. Photo facing east.

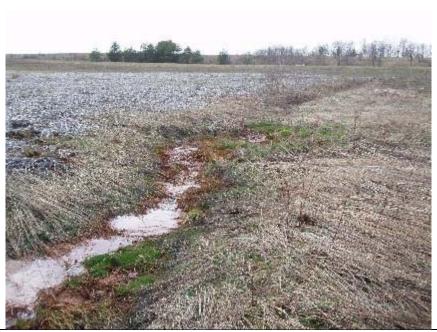
Description: Heavy iron-stained seep with sheen along southern boundary of western section of

Ischua Landfill. Photo facing west.

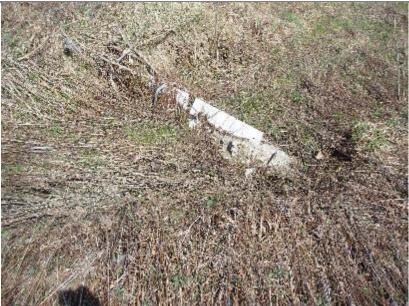
Description: Surface water sampling weir located in the eastern section of the Ischua Landfill.

Photo facing east.

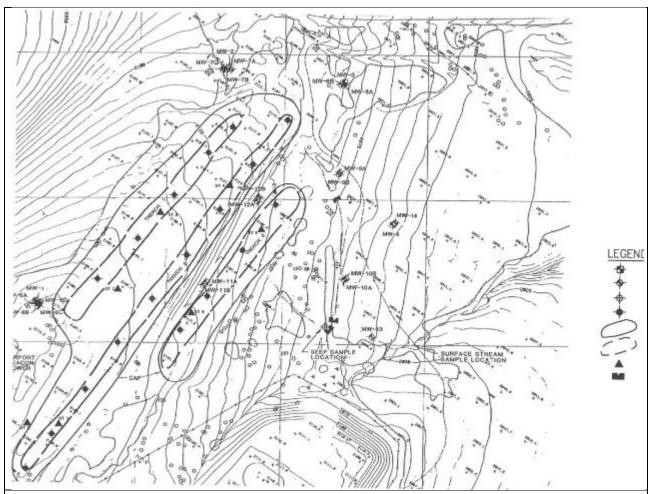
Description: Site Map of the site, complete with sample locations, well locations and well IDs,

provided by LaBella Associates (onsite performing semi-annual sampling event).
