**CONESTOGA-ROVERS  
& ASSOCIATES**

October 22, 2008

Re: Update Report  
Ellison Bronze Site, Falconer, New York

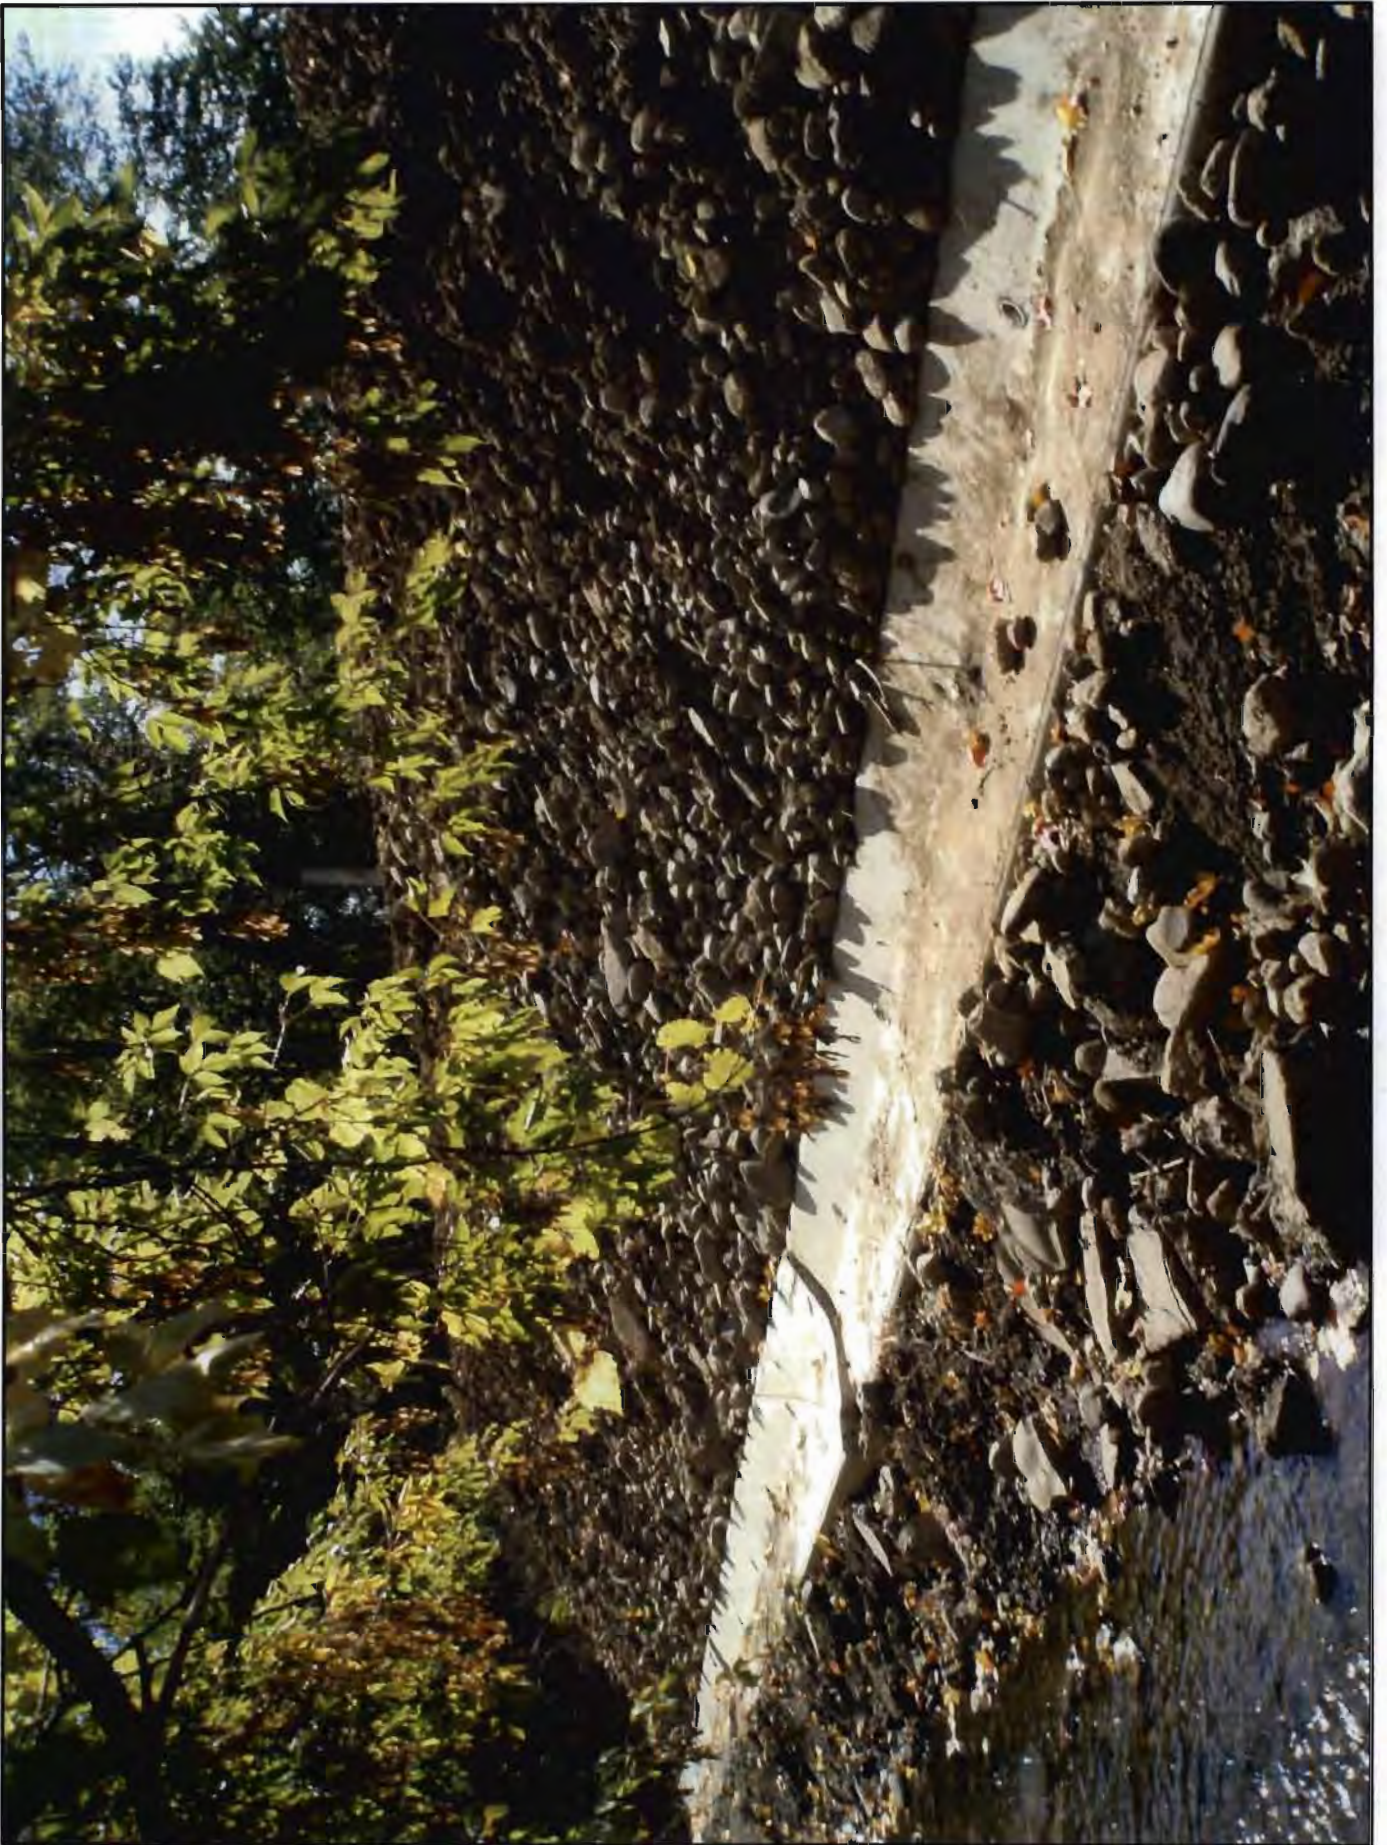
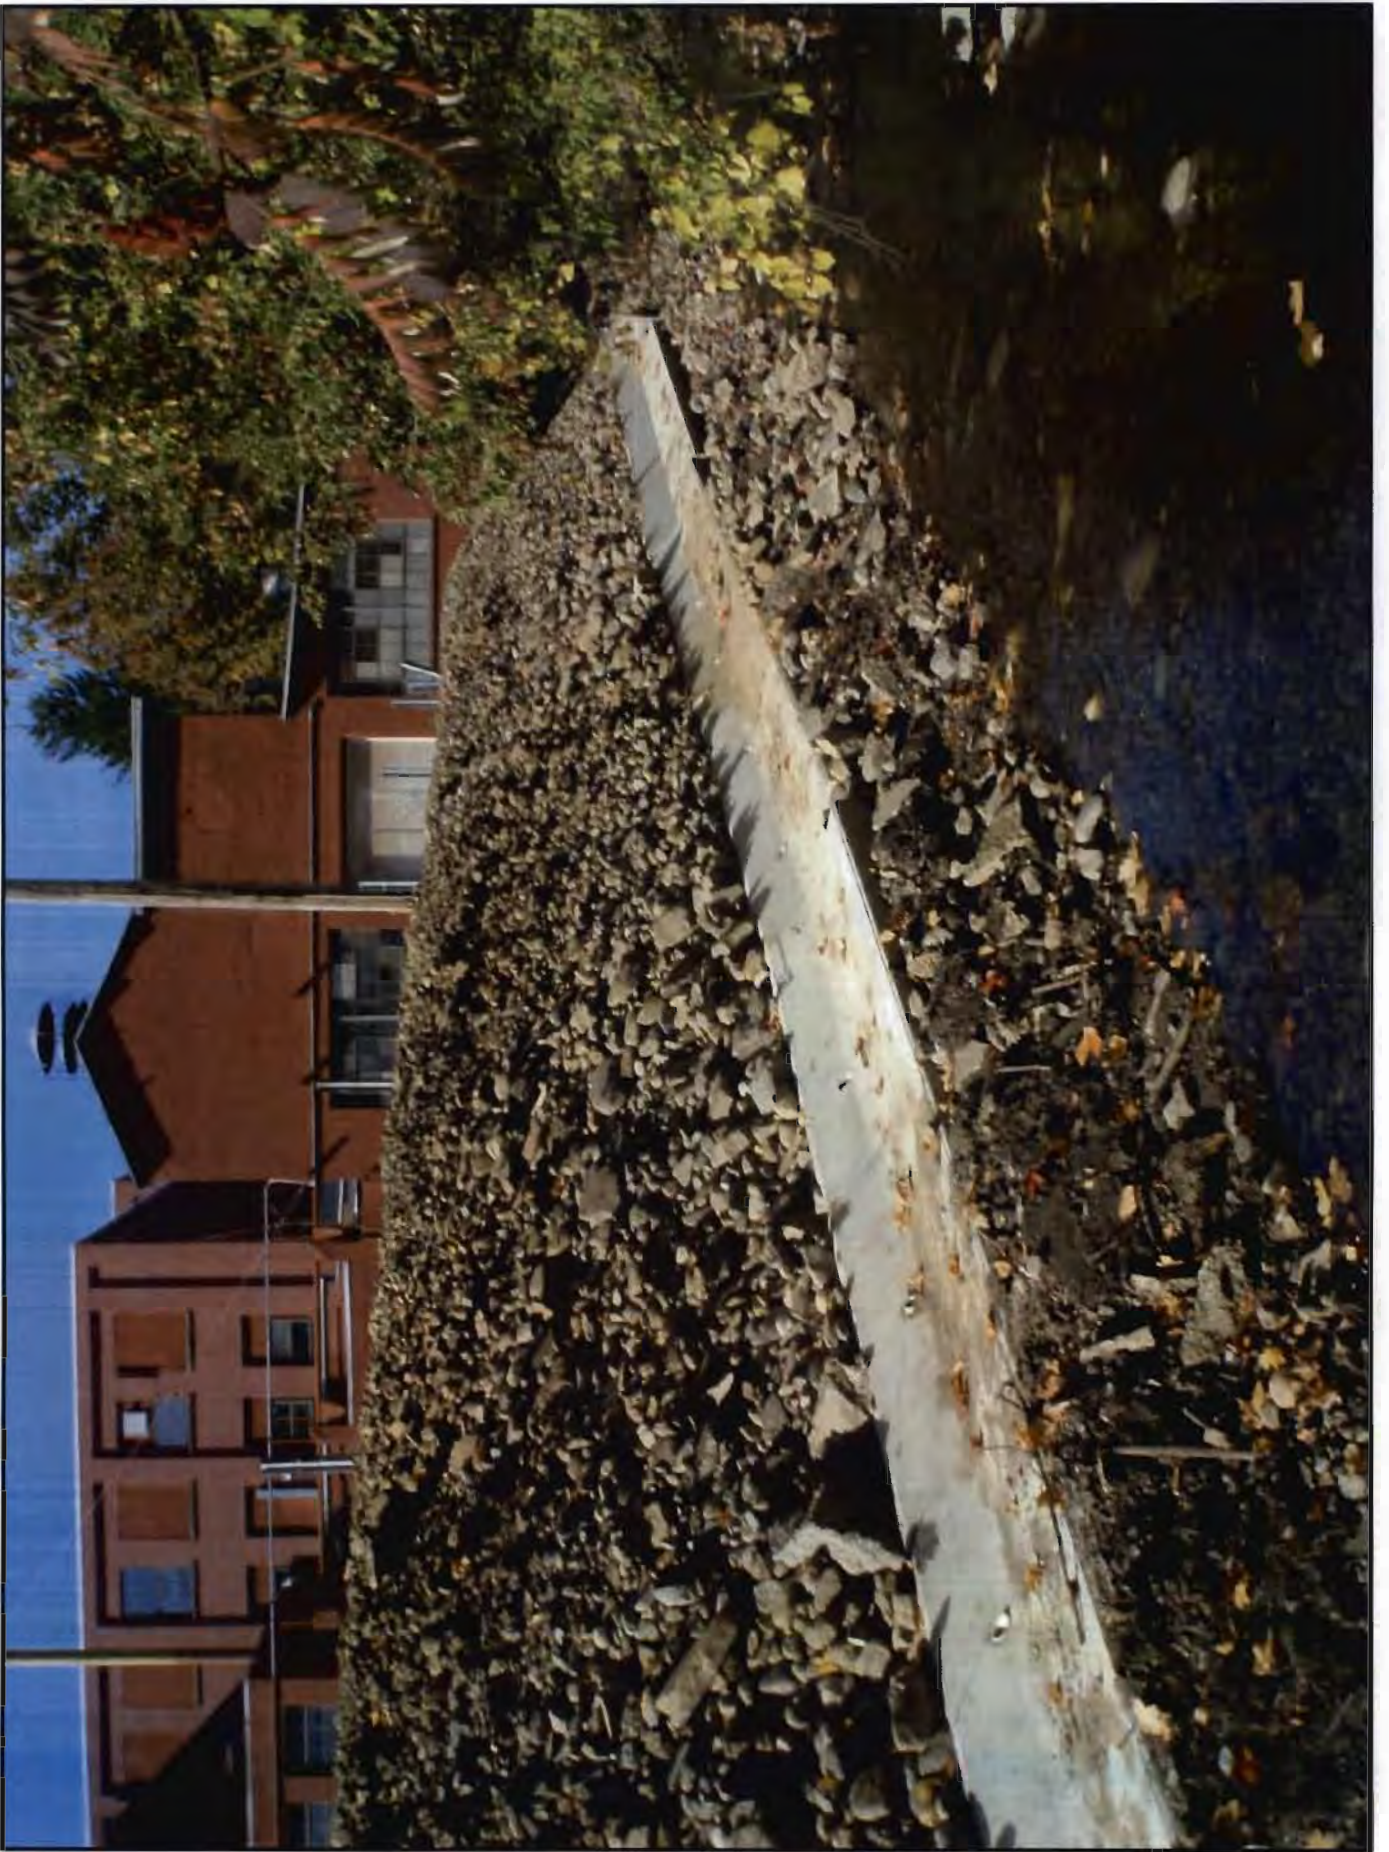
As a result of the summer repairs, the October inspection found all items to be back in good condition. Copies of the April and October inspections are attached. In addition, photographs of the improvements to the streambank stabilization are also attached.

During this year's April inspection, the grassed areas were found to be in good condition. The stream bank and monitoring wells were in satisfactory condition. The paved area was deemed to be in need of repair. As noted in previous correspondence, plans had been submitted and permit applications made to improve the stream bank stabilization. The permits were obtained this year and the stream bank erosion control barriers were upgraded and extended during the summer. In addition, the paved areas were patched in the areas identified as being in need of repair. The paved areas were also sealed and striped. The areas around the monitoring wells were also repaired in conjunction with the paving and grading improvements.
