January 6, 2014

RE: Al Tech Specialty Steel Site
Lucas Avenue East Plant, City of Dunkirk, NY
EEEPD Reference No. 002700.DC06
NYSDEC Site #907022
Structural Assessment Report
Watts Project 13183

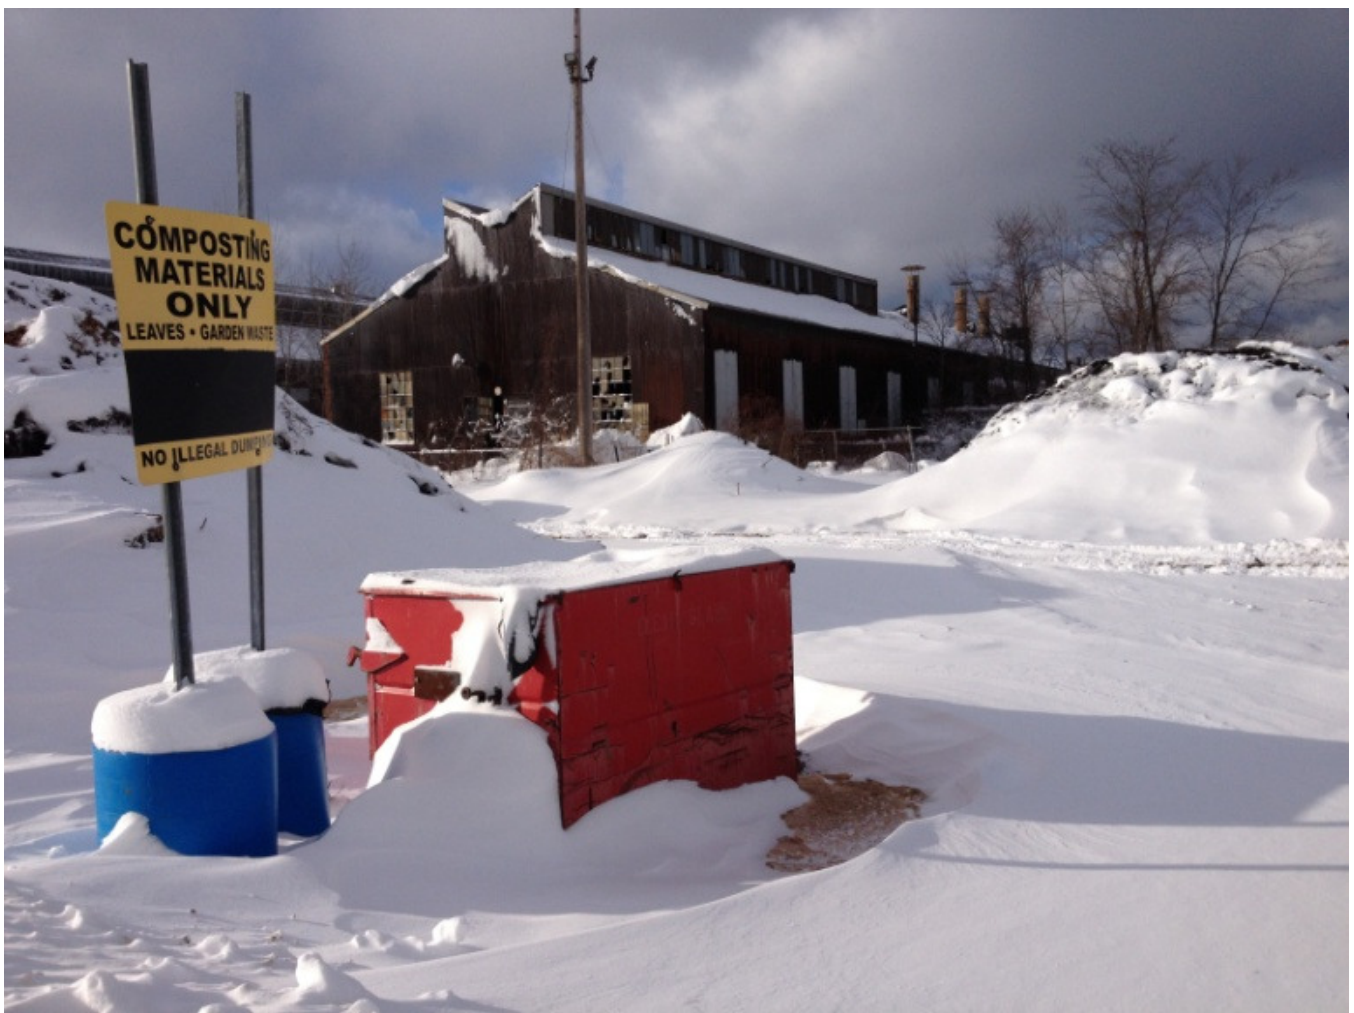
Photo 1: Easterly warehouse elevation with monitor

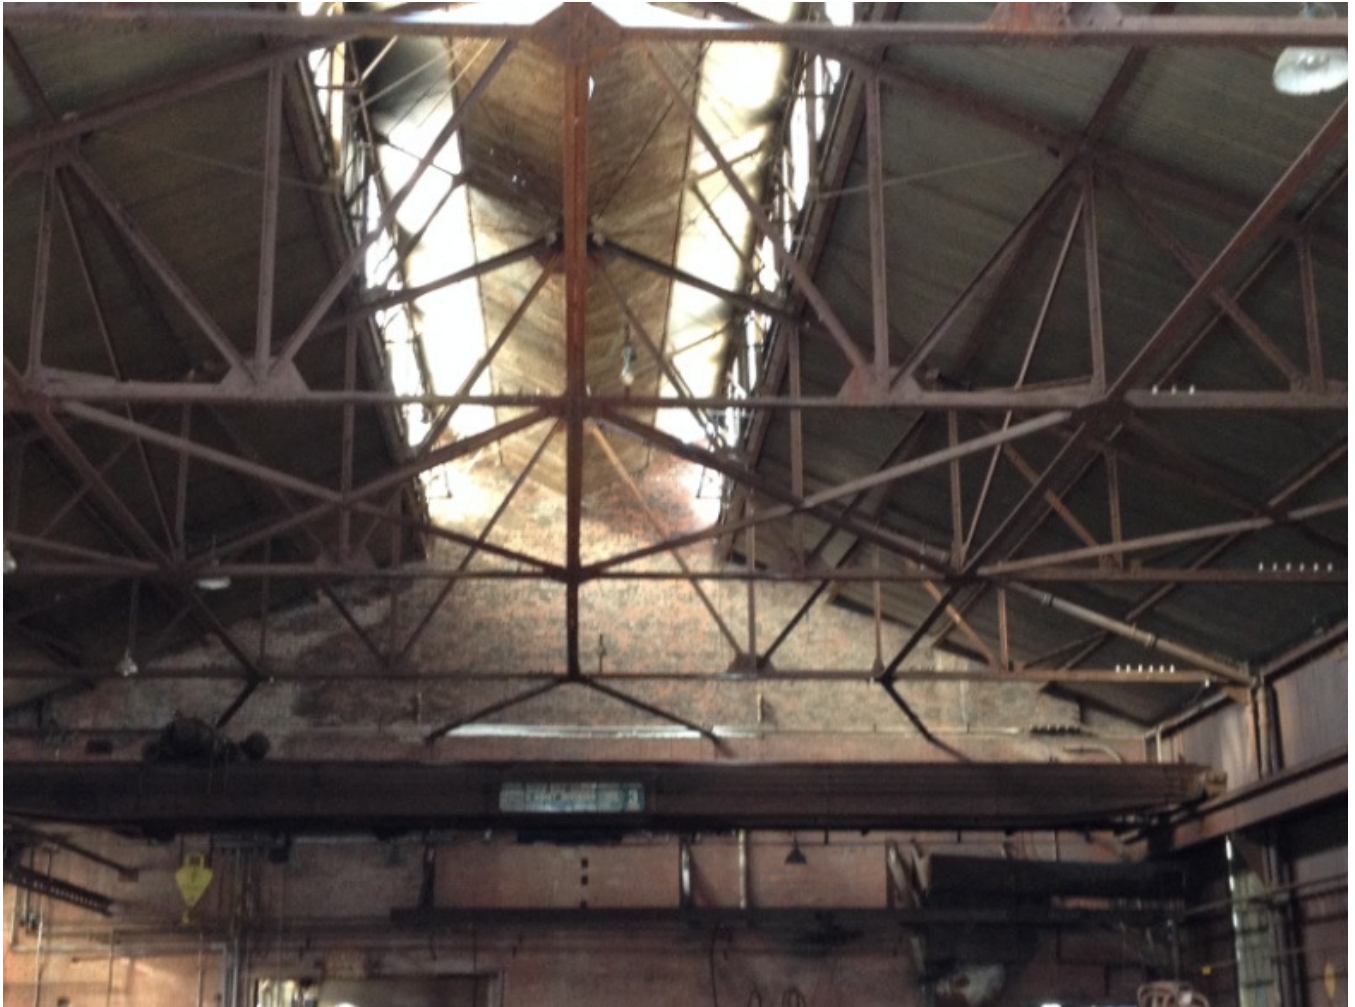
Photo 2: E. end roof trusses & bridge crane

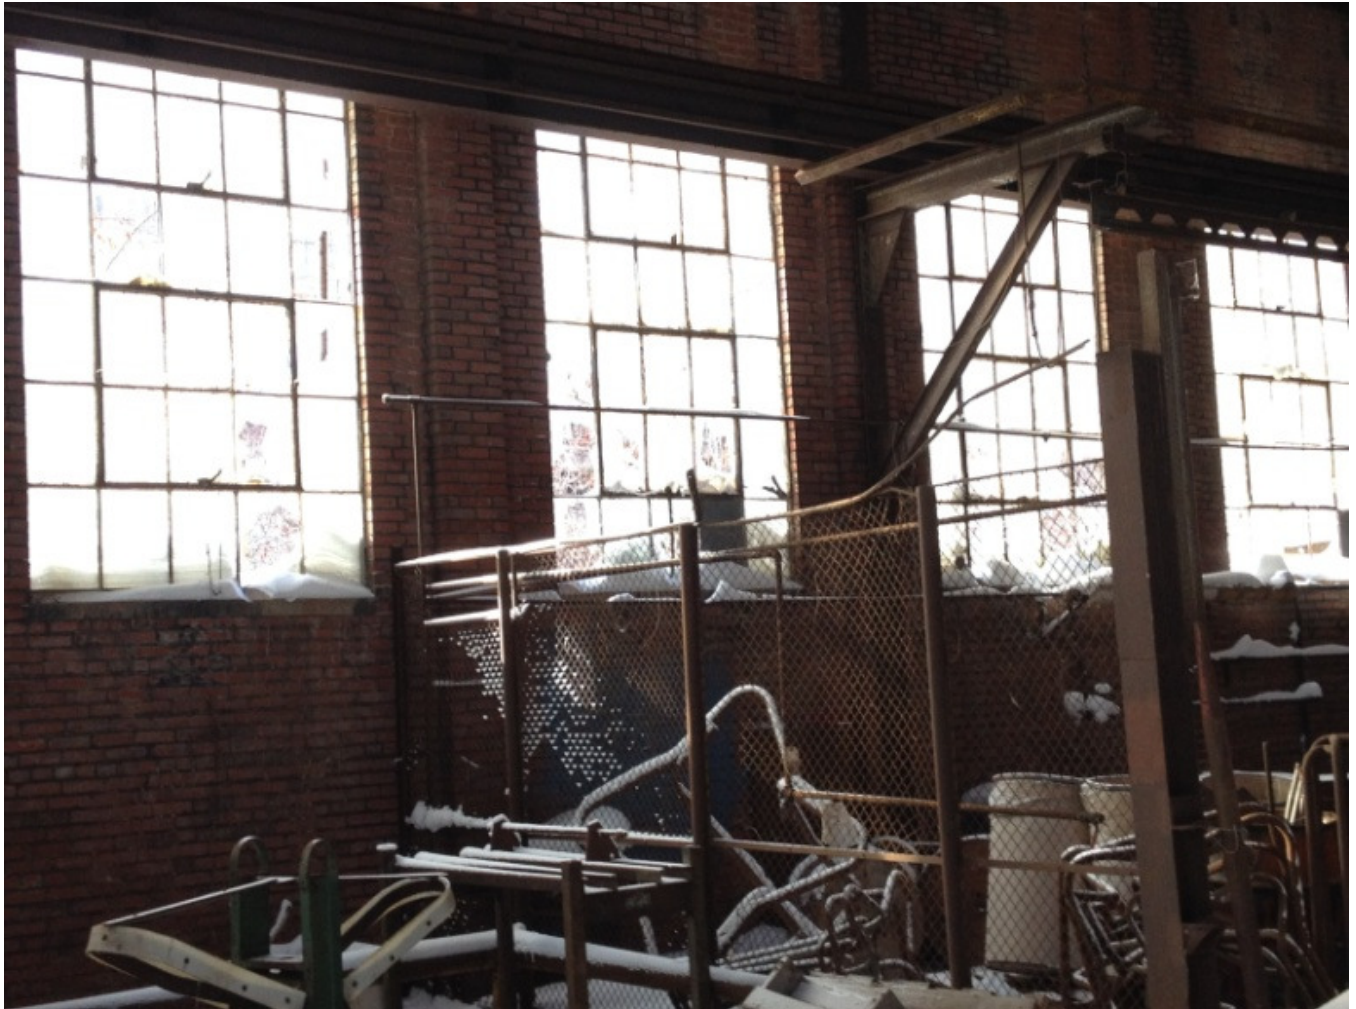
Photo 3: E. warehouse windows & brick masonry walls

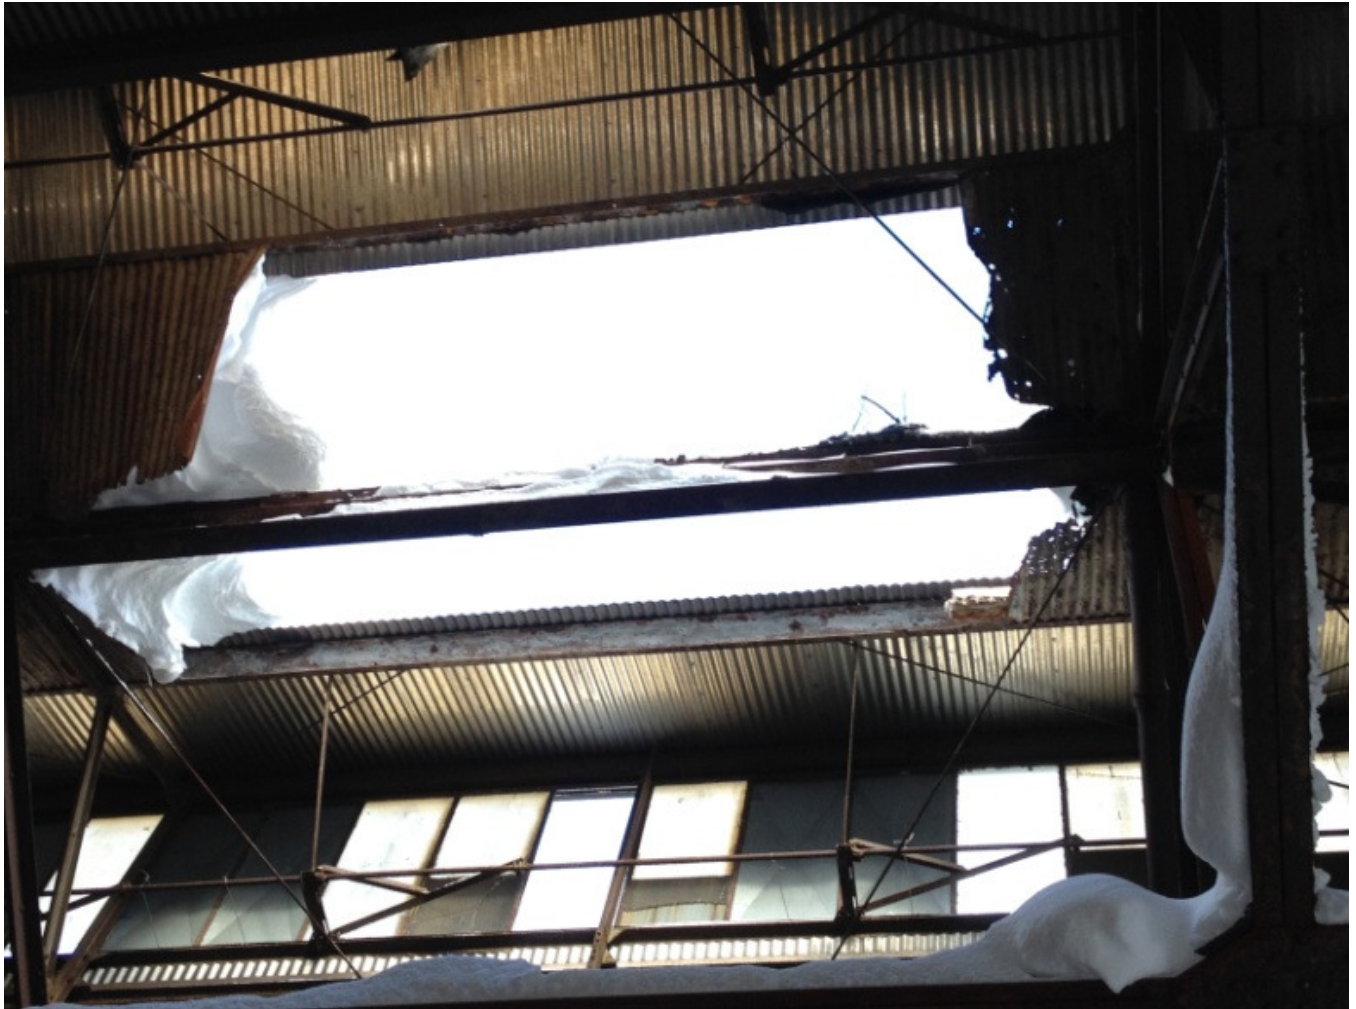
Beginning at the southeasterly corner, the building is a high bay gabled metal roof with an “M” shaped monitor and skylights. The steel columns support riveted steel roof trusses and a southerly face of brick masonry supports large windows whereas the northerly wall is corrugated metal. Upper walls and roof decks are corrugated metal and there is a large hole in the clerestory where the roof has failed. A three ton bridge crane rests on steel crane girders that are supported by steel columns. There is extensive rust on steel framing and the failing rusted roof deck poses a hazard to room occupants.

Photo 4: E. warehouse failed monitor deck & snow drift

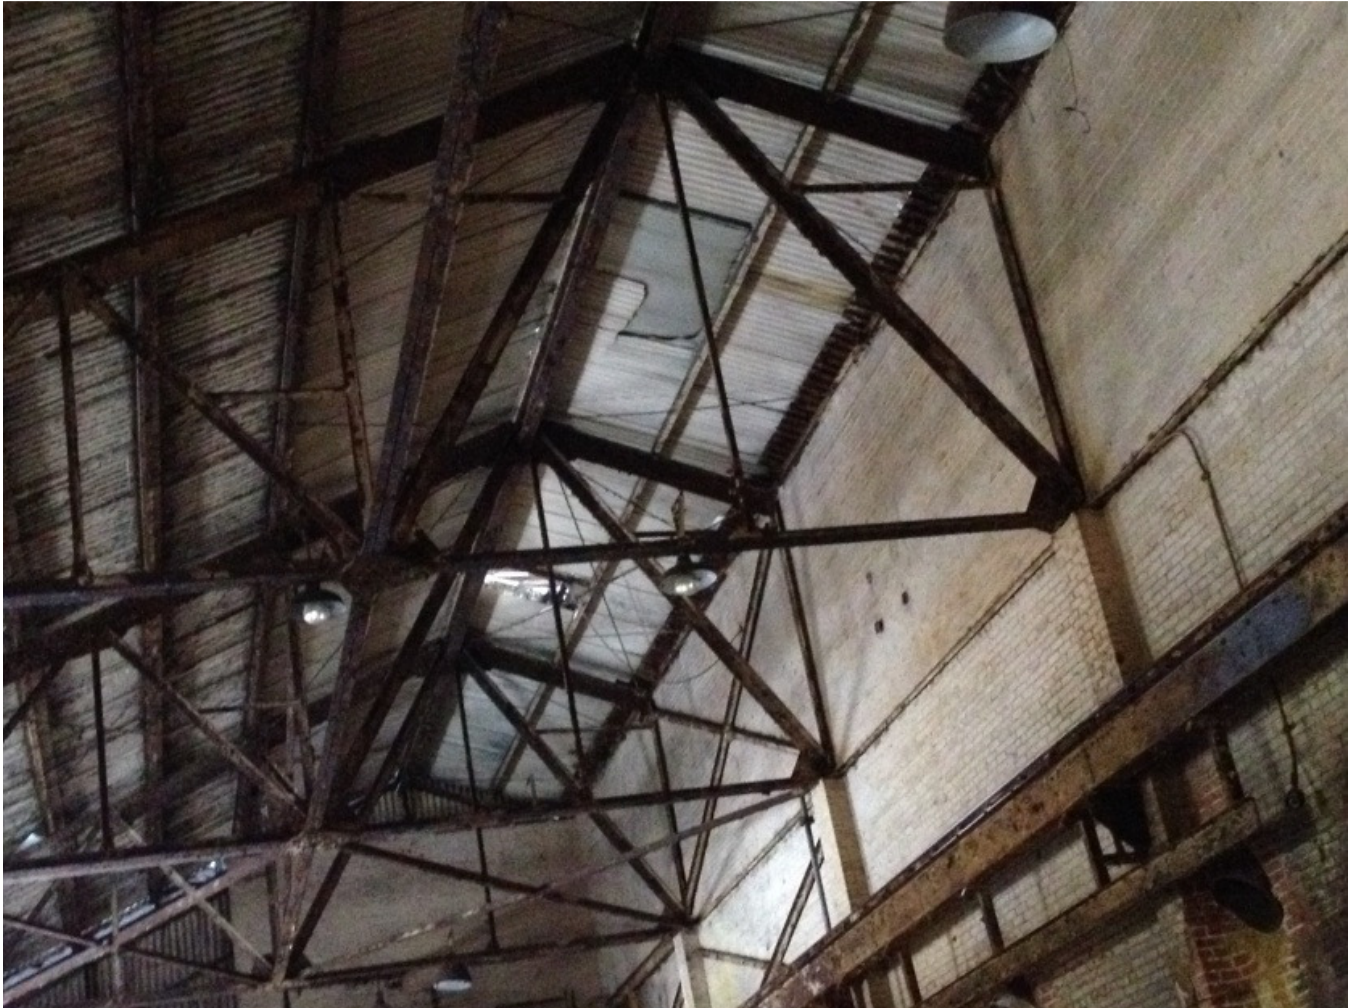
The easterly pickling building has brick masonry walls with pilasters supporting steel roof trusses and metal deck. There is a bridge crane that travels on steel girders fastened to brick pilasters and steel columns. There is extensive rust on steel framing and the potential for the rusted roof deck to fail poses a hazard to room occupants.

Photo 5: East Pickling area brick masonry and steel roof trusses

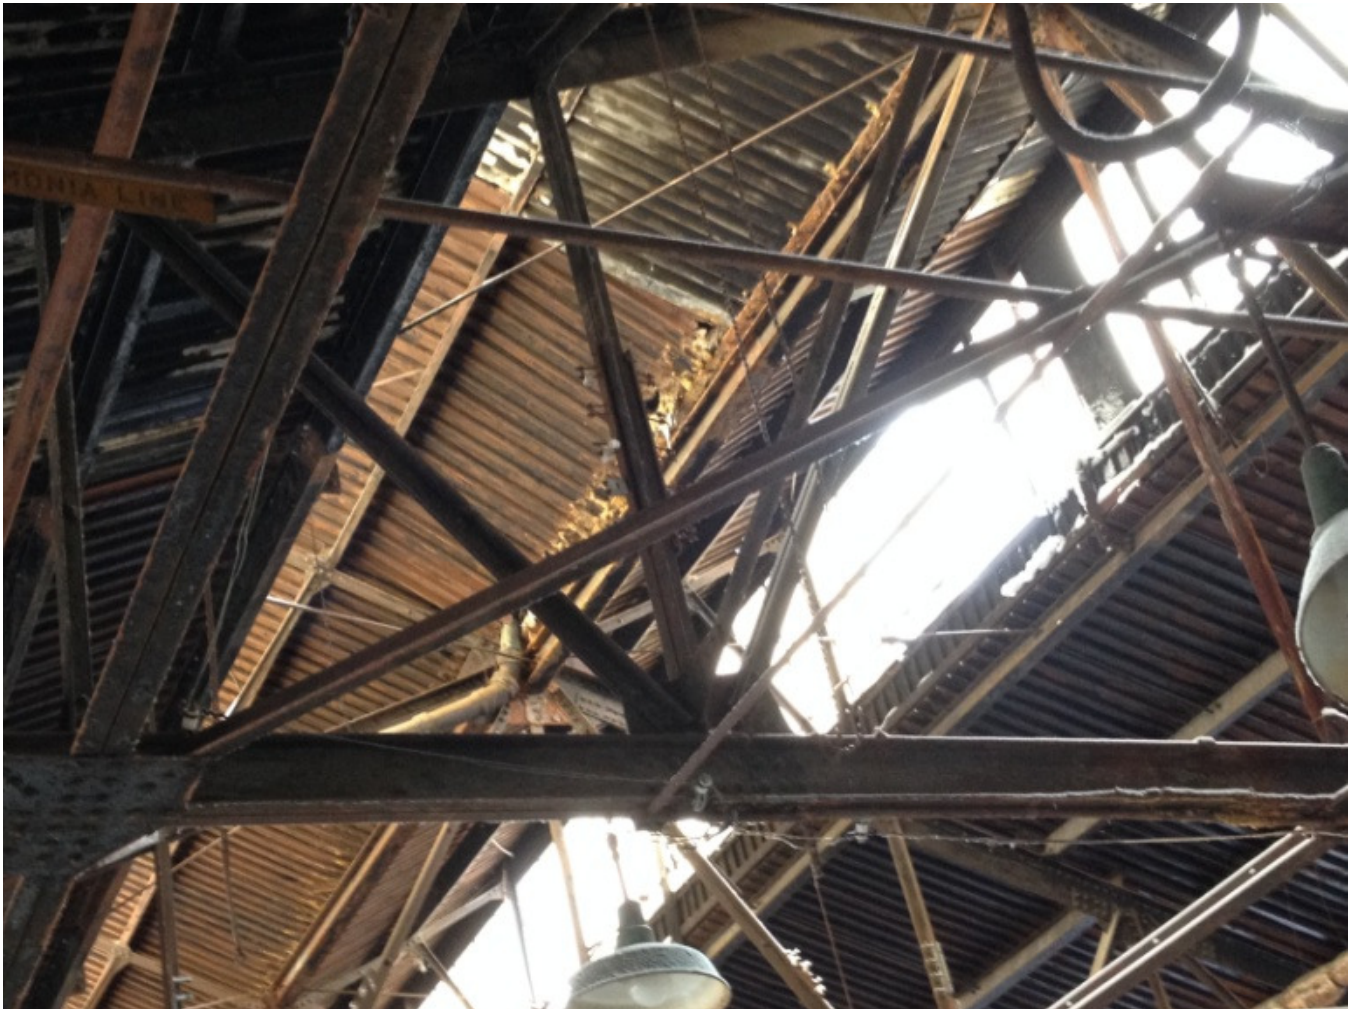
The easterly production area is comprised of a high bay steel framed structure with monitor in the southerly portion and low bay steel framed sawtooth roof on the northerly portion. The high bay monitor steel deck is failing with rust through holes and is a risk for failure from high snow drift loads. The low roof sawtooth construction is collapsing due to rusted through metal deck roof panels under stress from high snow drift loads. Southerly brick masonry walls are bowed, structurally cracked, and nearing collapse.

Photo 6: Southerly high bay deck with rust through holes

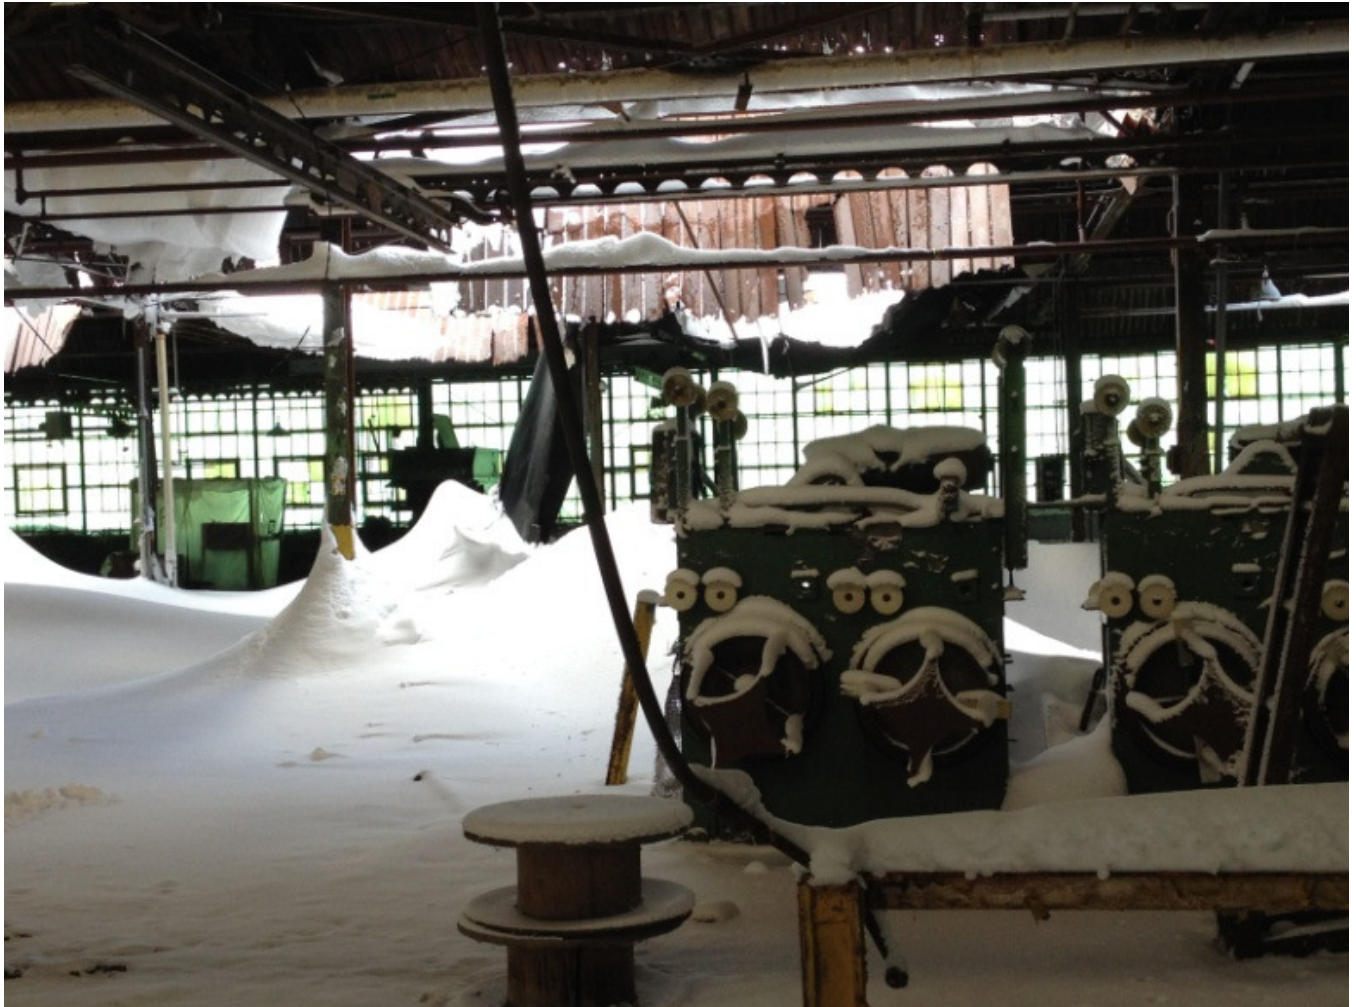
Photo 7: Northerly part with collapsed metal roof deck

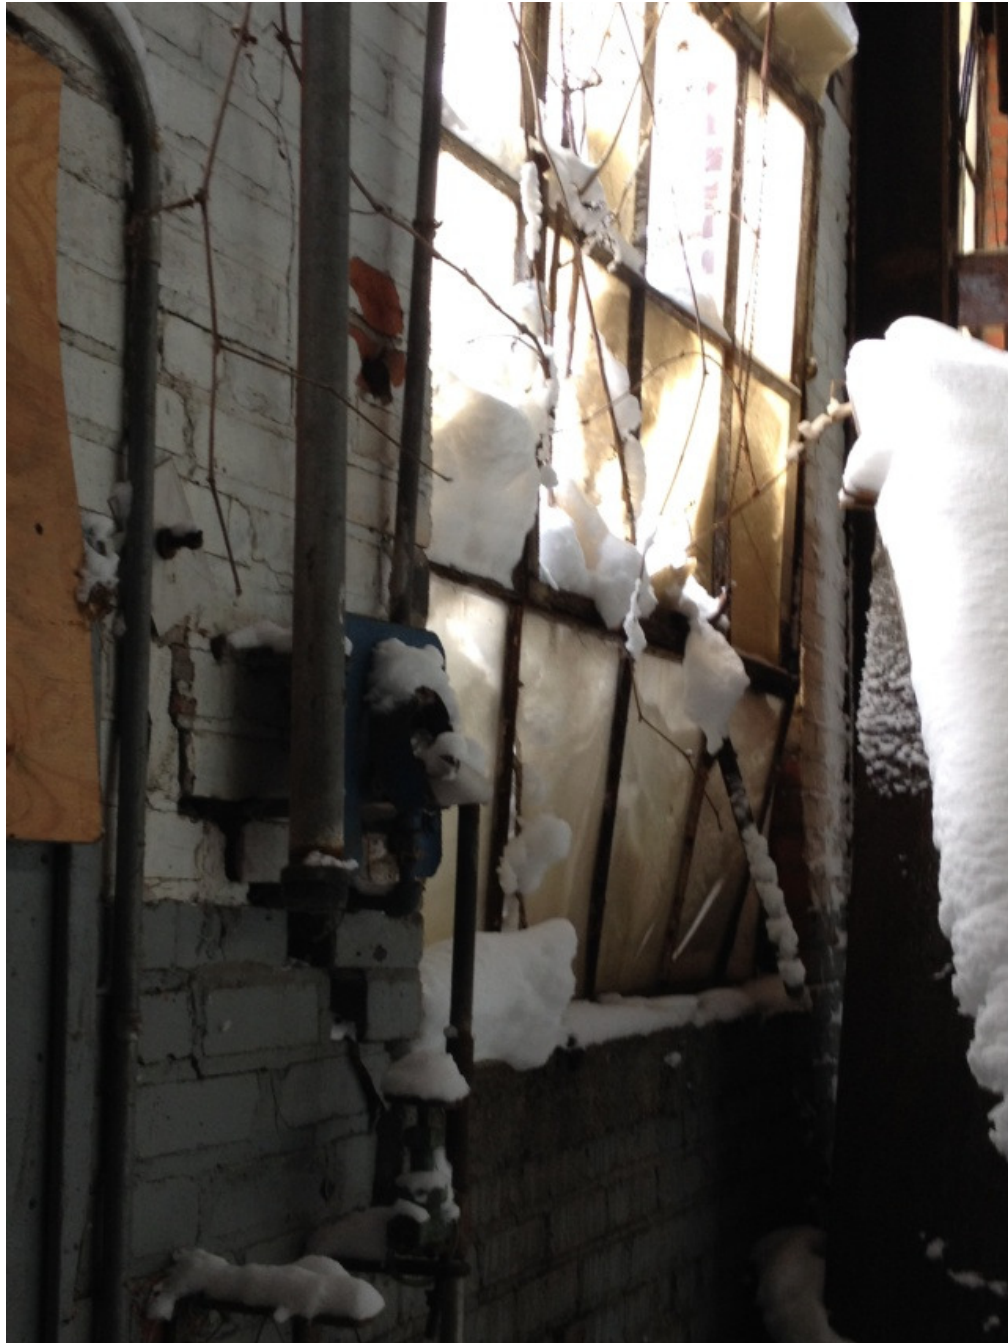
Photo 8: Southerly brick wall bowed & cracked

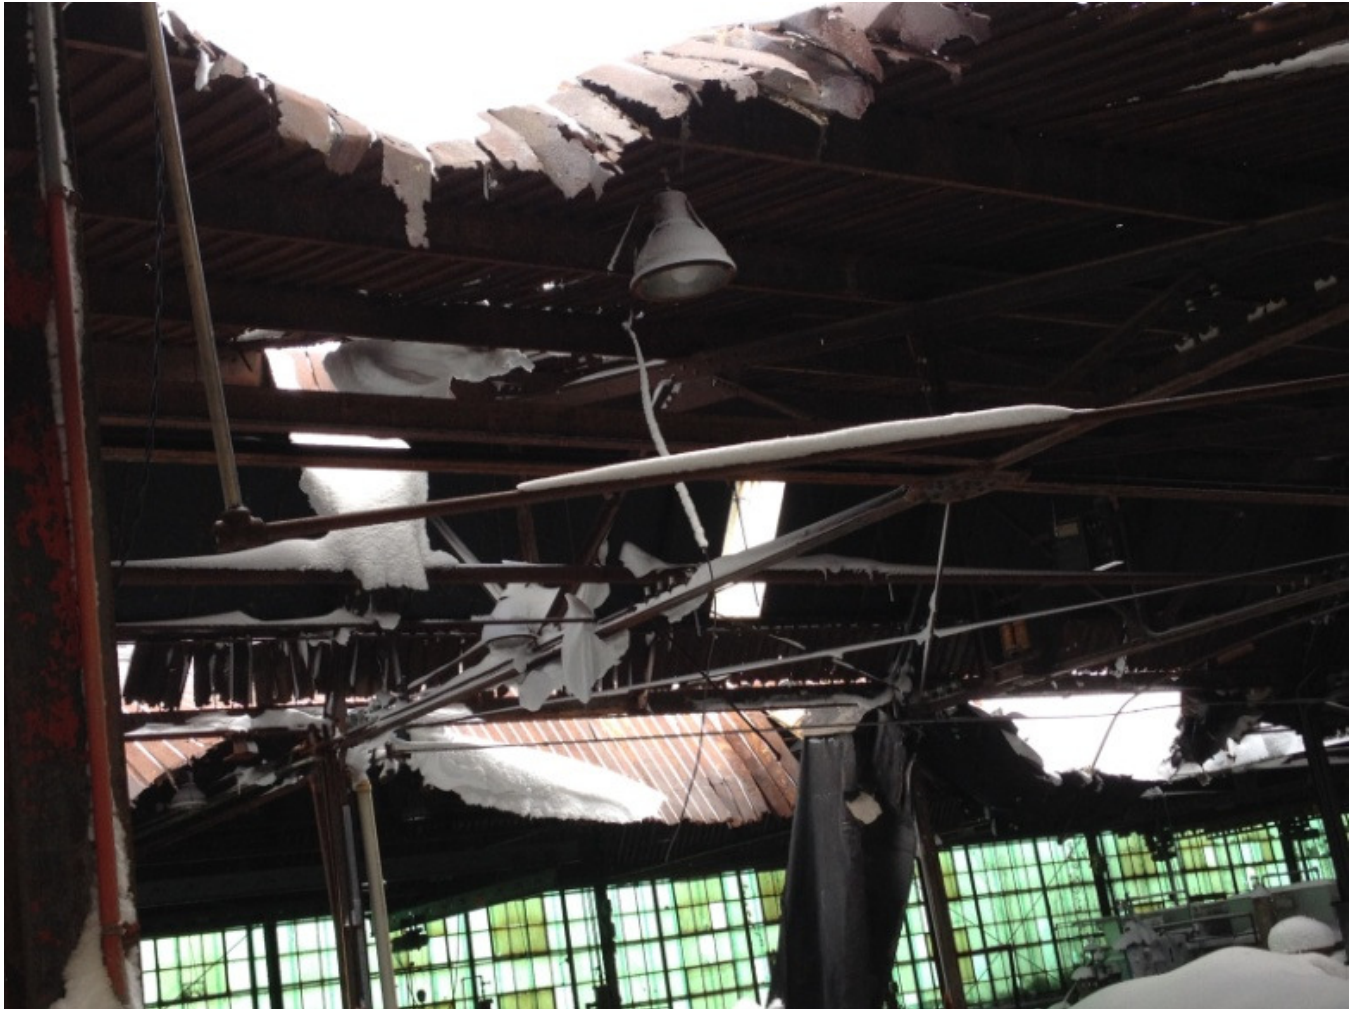
Photo 9: Failed sawtooth metal roof deck multiple bays

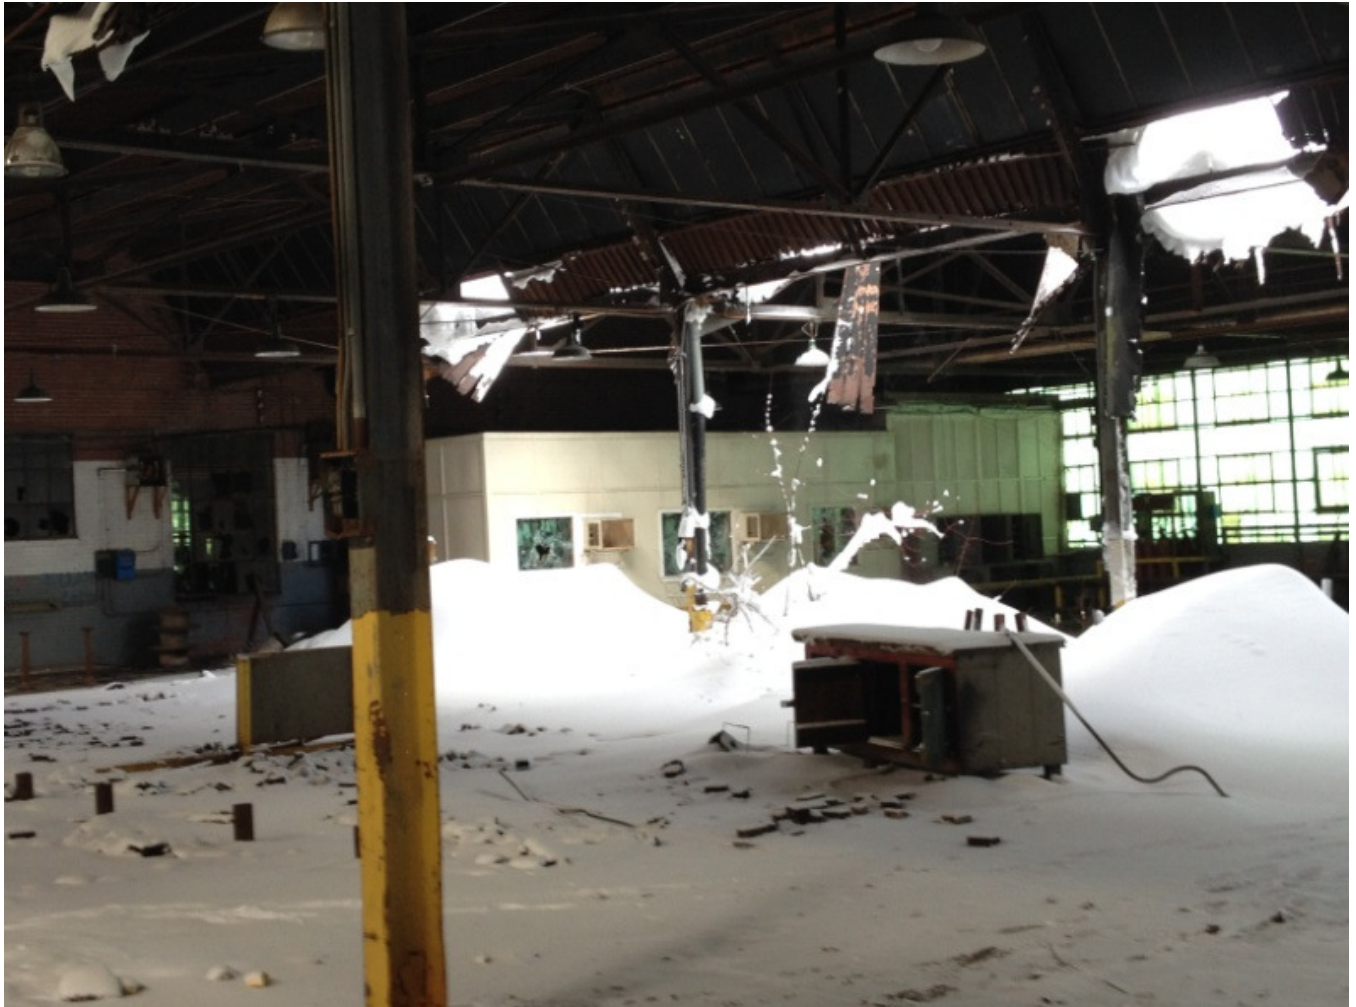
Photo 10: Failed sawtooth metal roof deck near east office

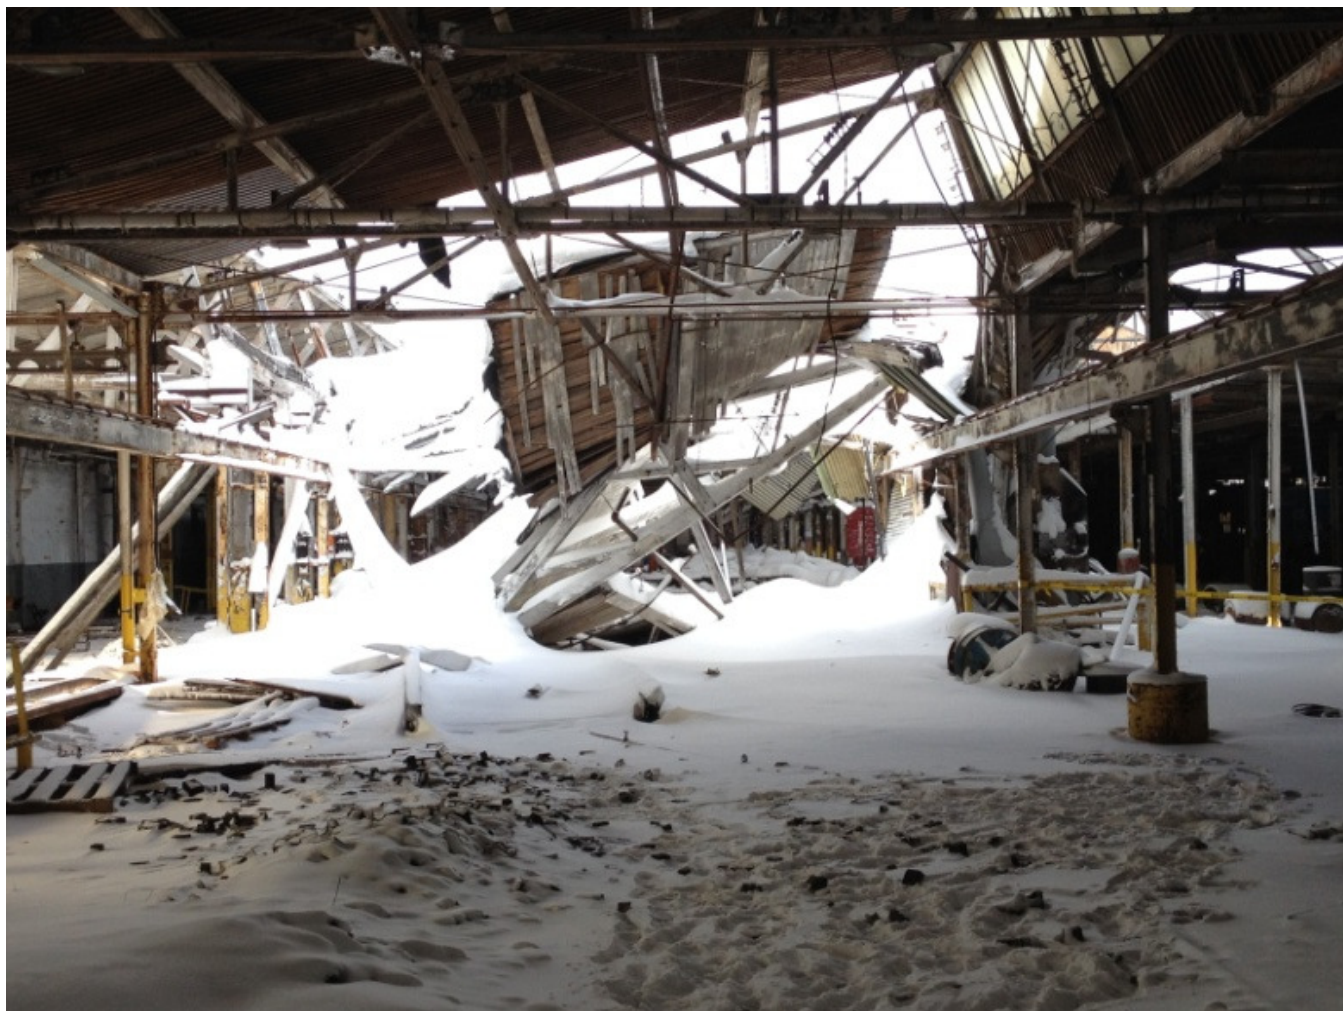
The westerly production area is mostly comprised of a low bay sawtooth configuration wood framed roof structure. The wood framed trusses supporting wood deck have collapsed in many places. Some remedial strengthening work was performed on the wood trusses by adding plywood to the webs. There is a minor area at the easterly end that is framed with steel trusses and metal deck that has failed from high snow drift loads and rust through holes in the metal deck. Steel columns throughout support the metal and wood roof trusses.

Photo 11: Collapsed transition from metal wood framing

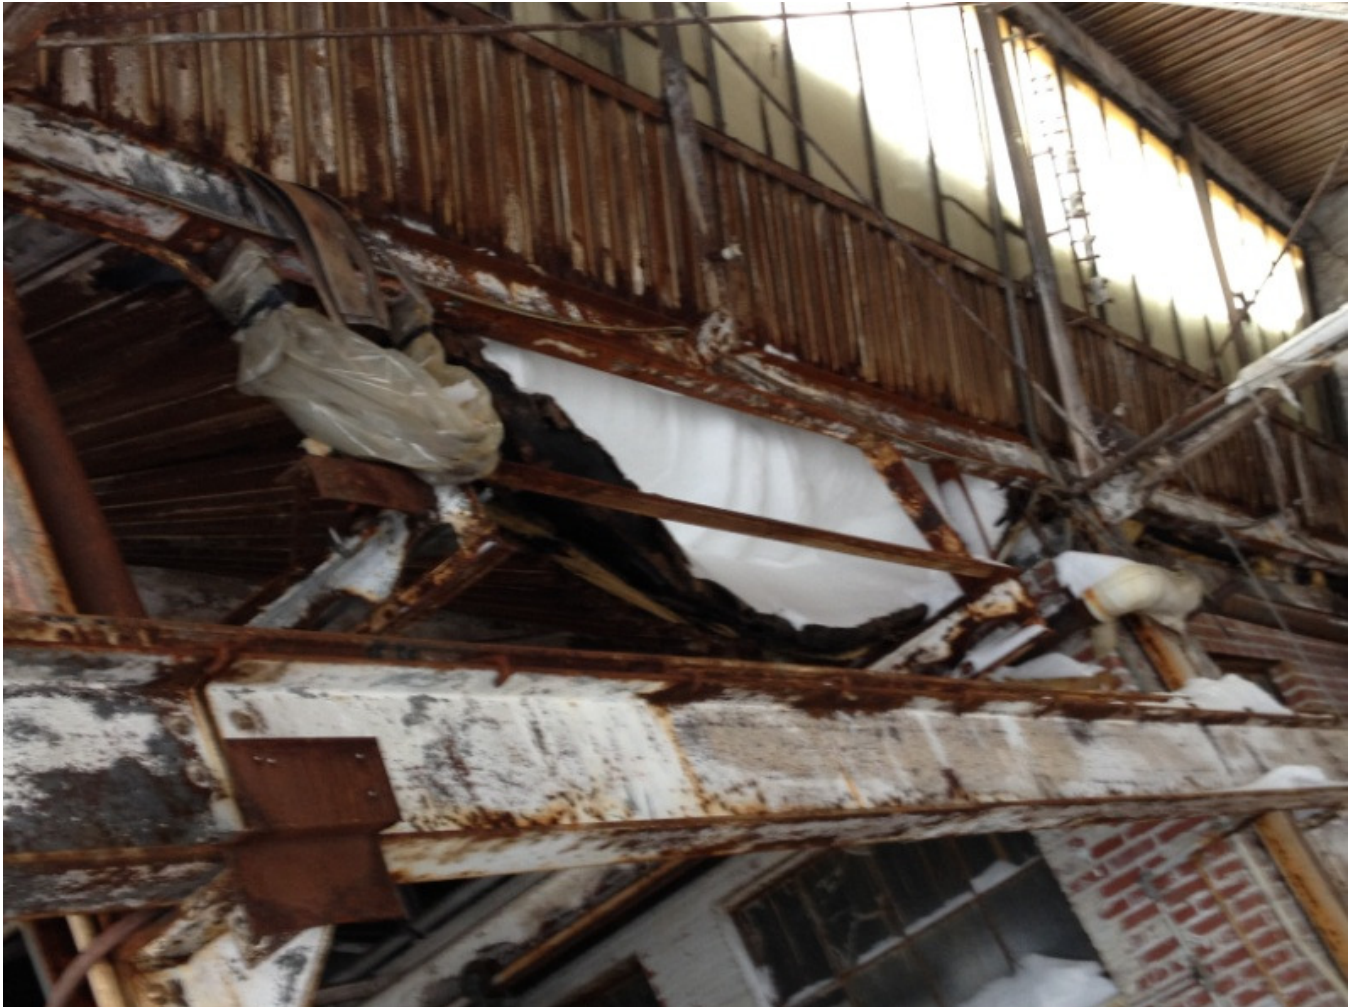
Photo 12: Failed metal roof deck due to snow load

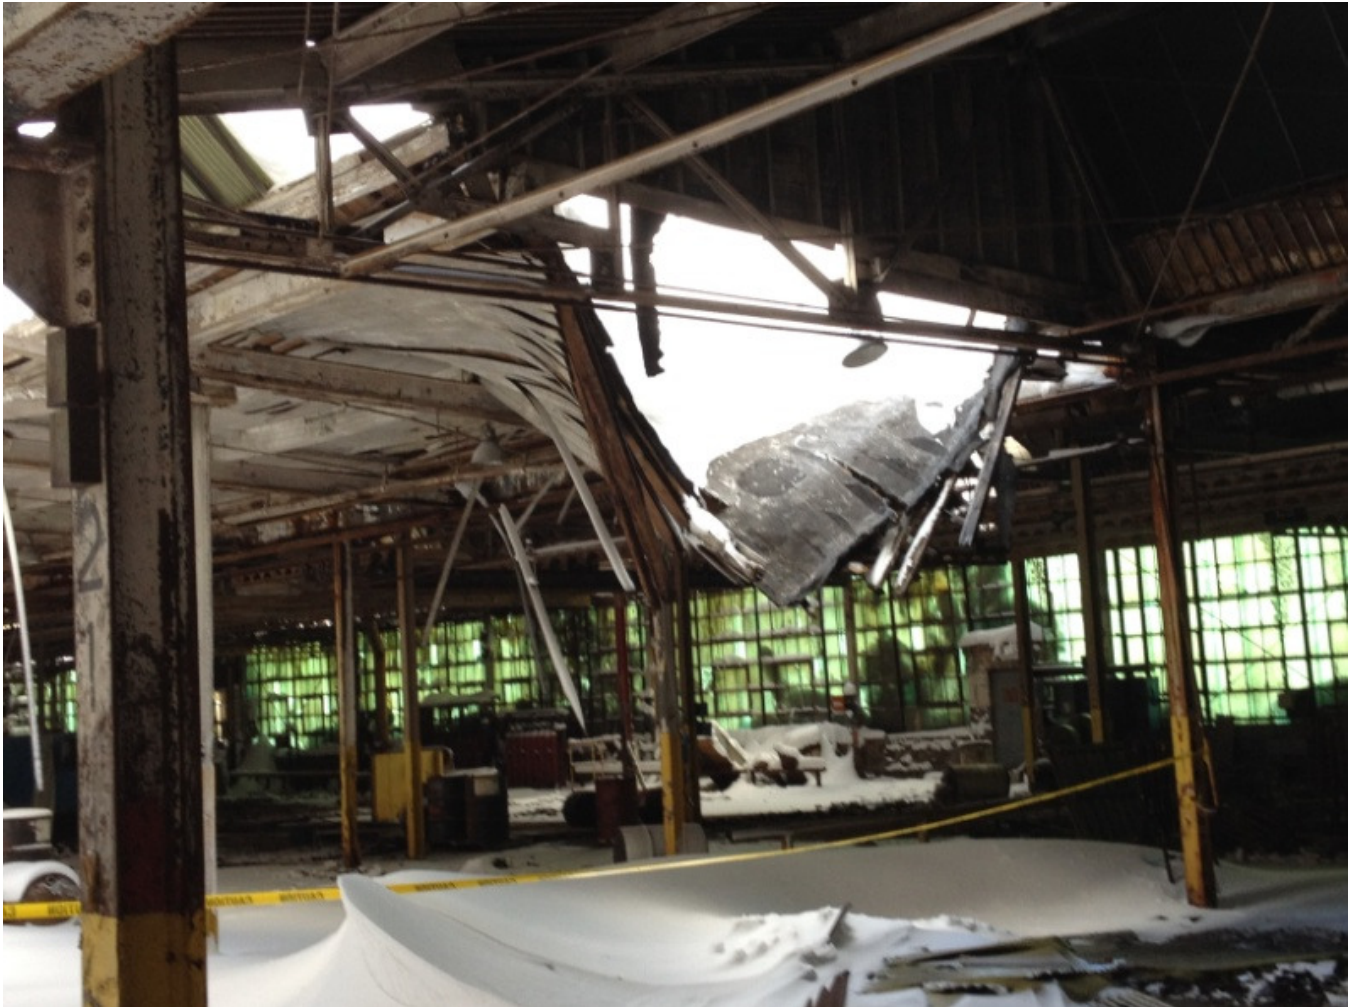
Photo 13: Failed flat roof area at metal to wood transition

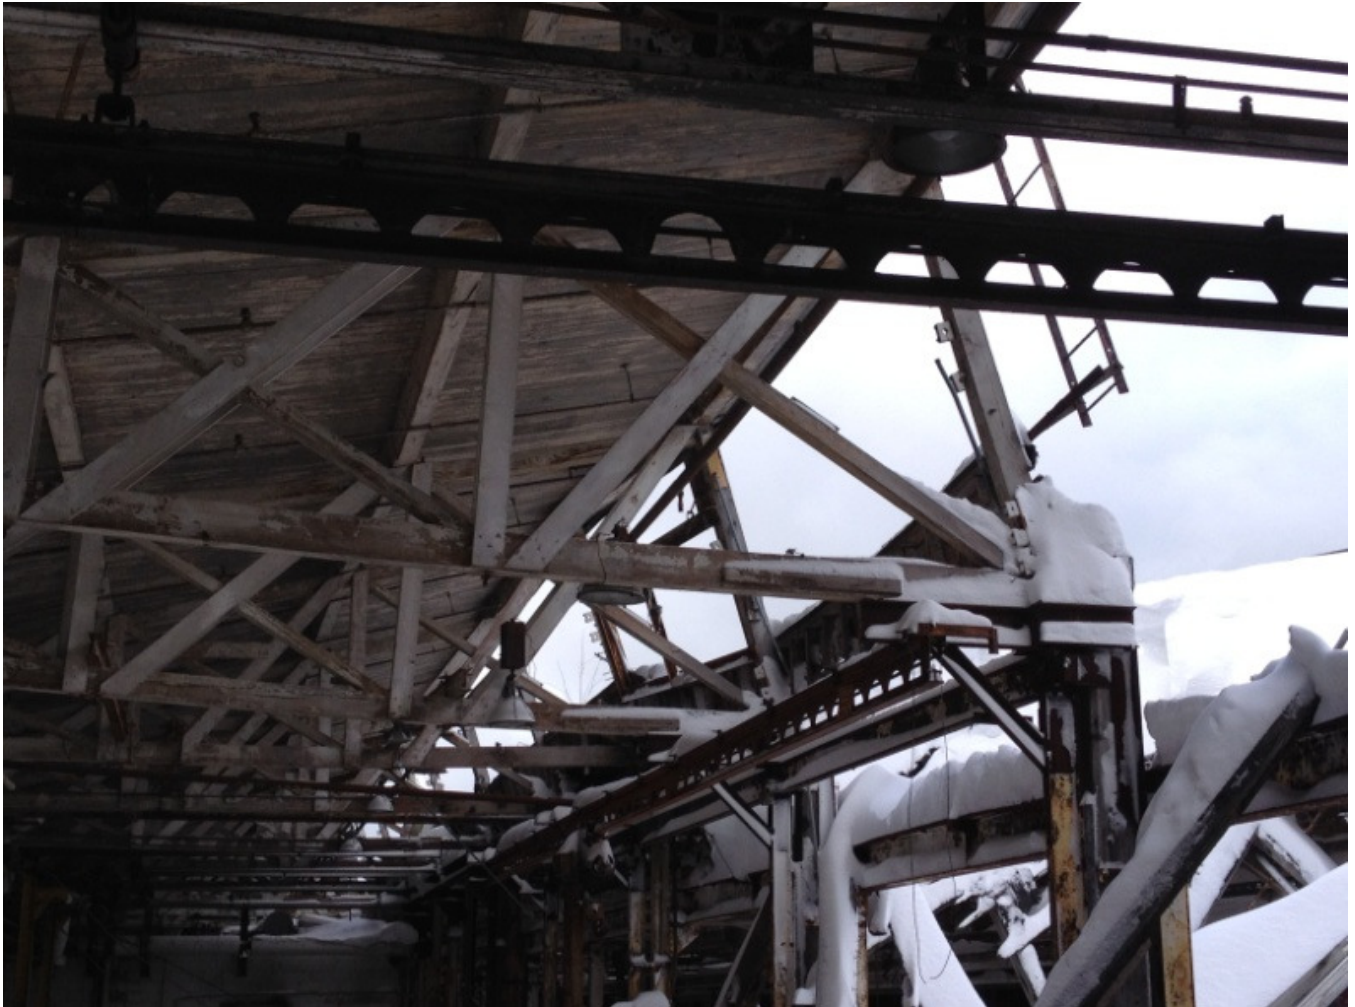
Photo 14: Collapsed wood framed sawtooth roof

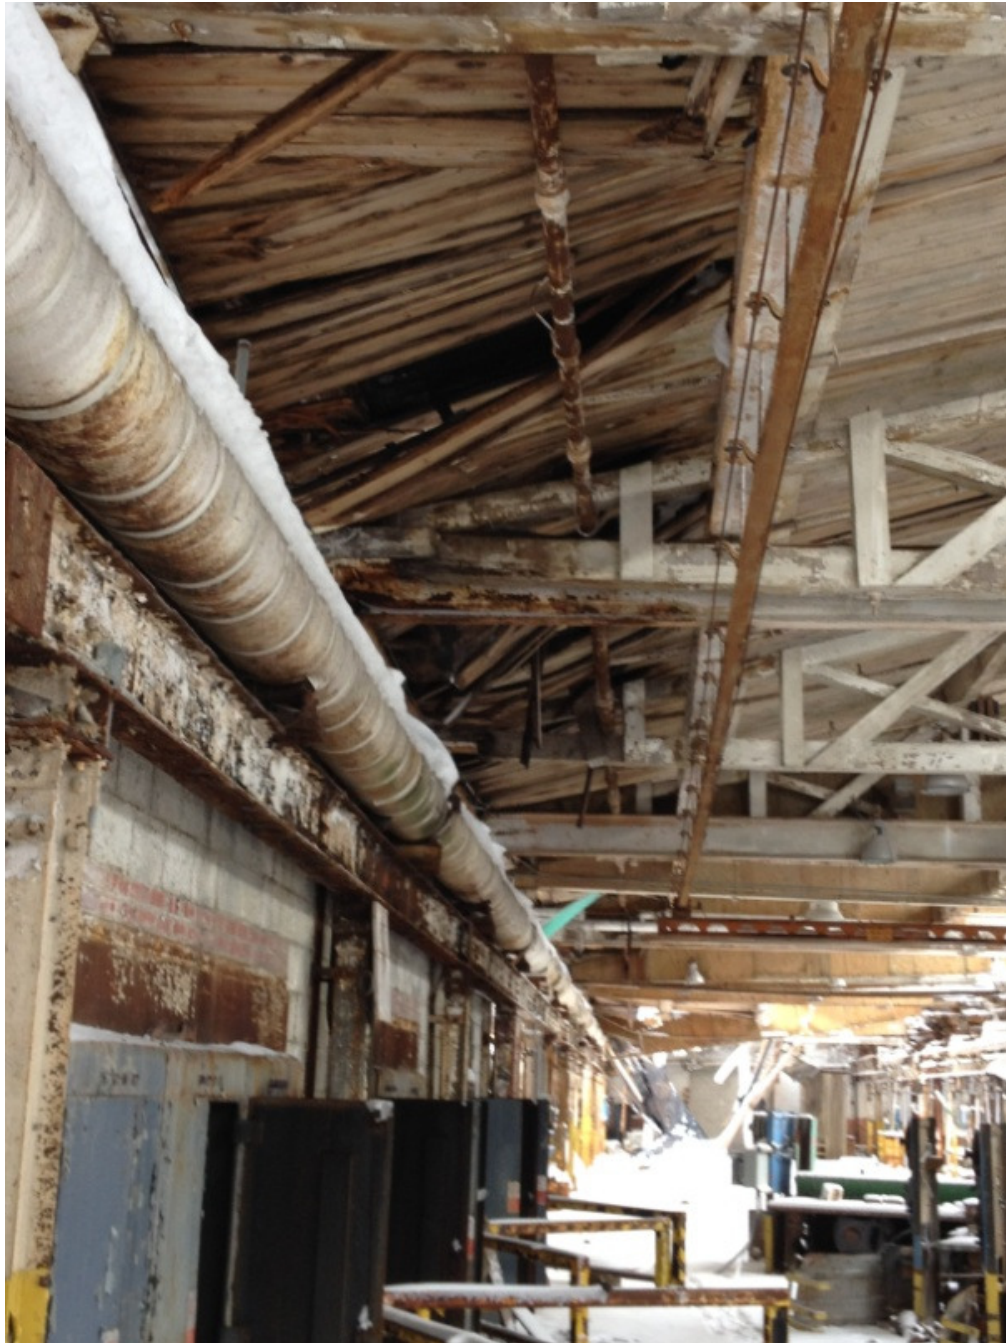
Photo 15: Failed wood deck from rot

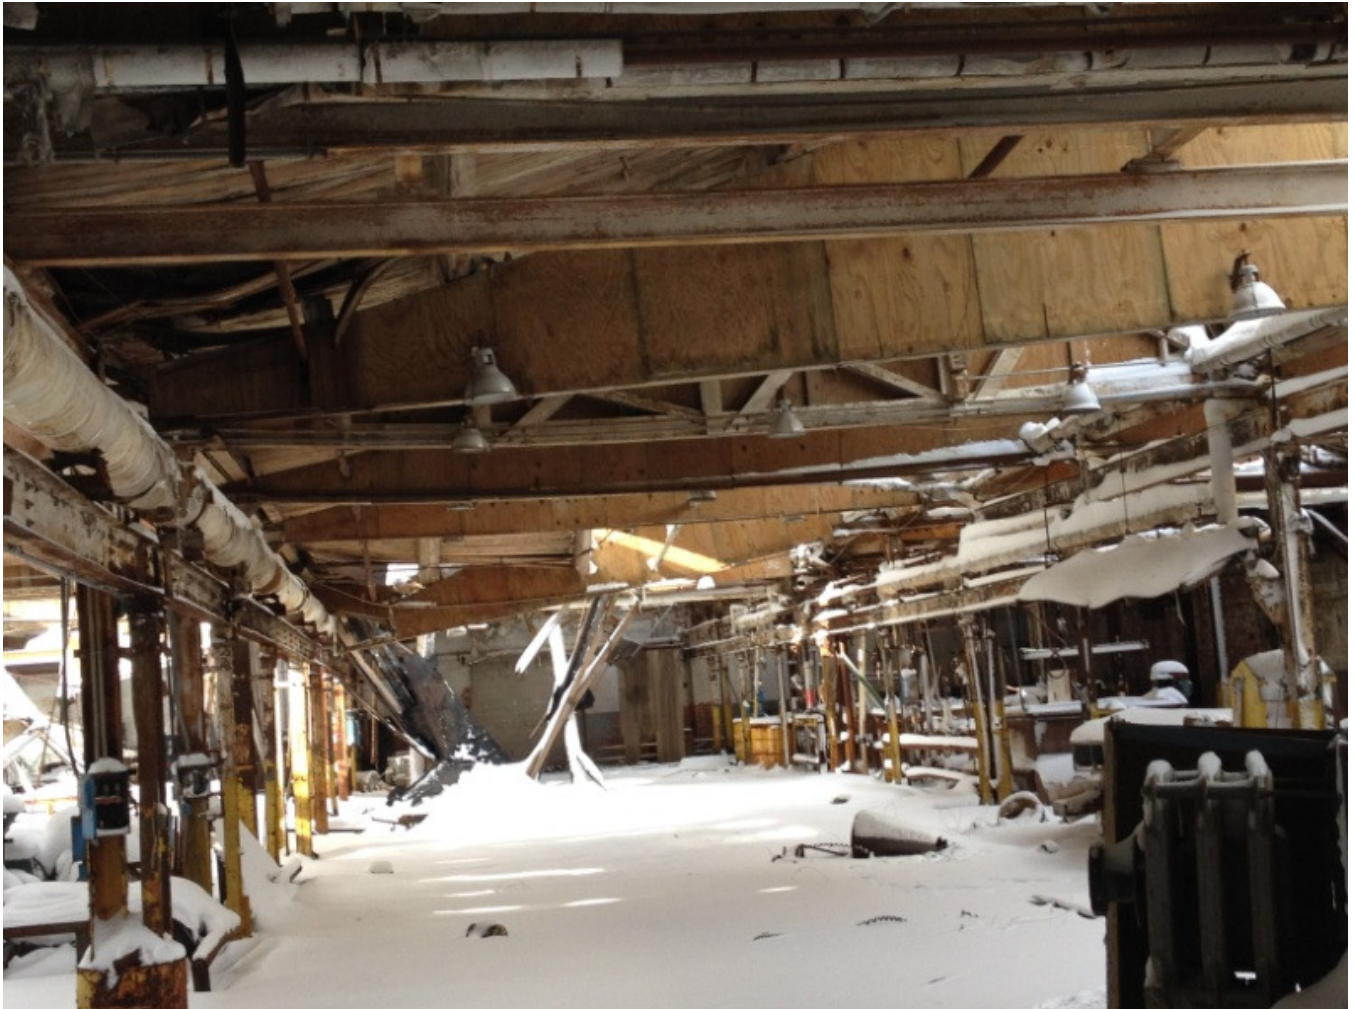
Photo 16: Bowed and collapsed plywood faced trusses
