January 6, 2014

RE: Al Tech Specialty Steel Site
Lucas Avenue East Plant, City of Dunkirk, NY
EEEPD Reference No. 002700.DC06
NYSDEC Site #907022
Structural Assessment Report
Watts Project 13183

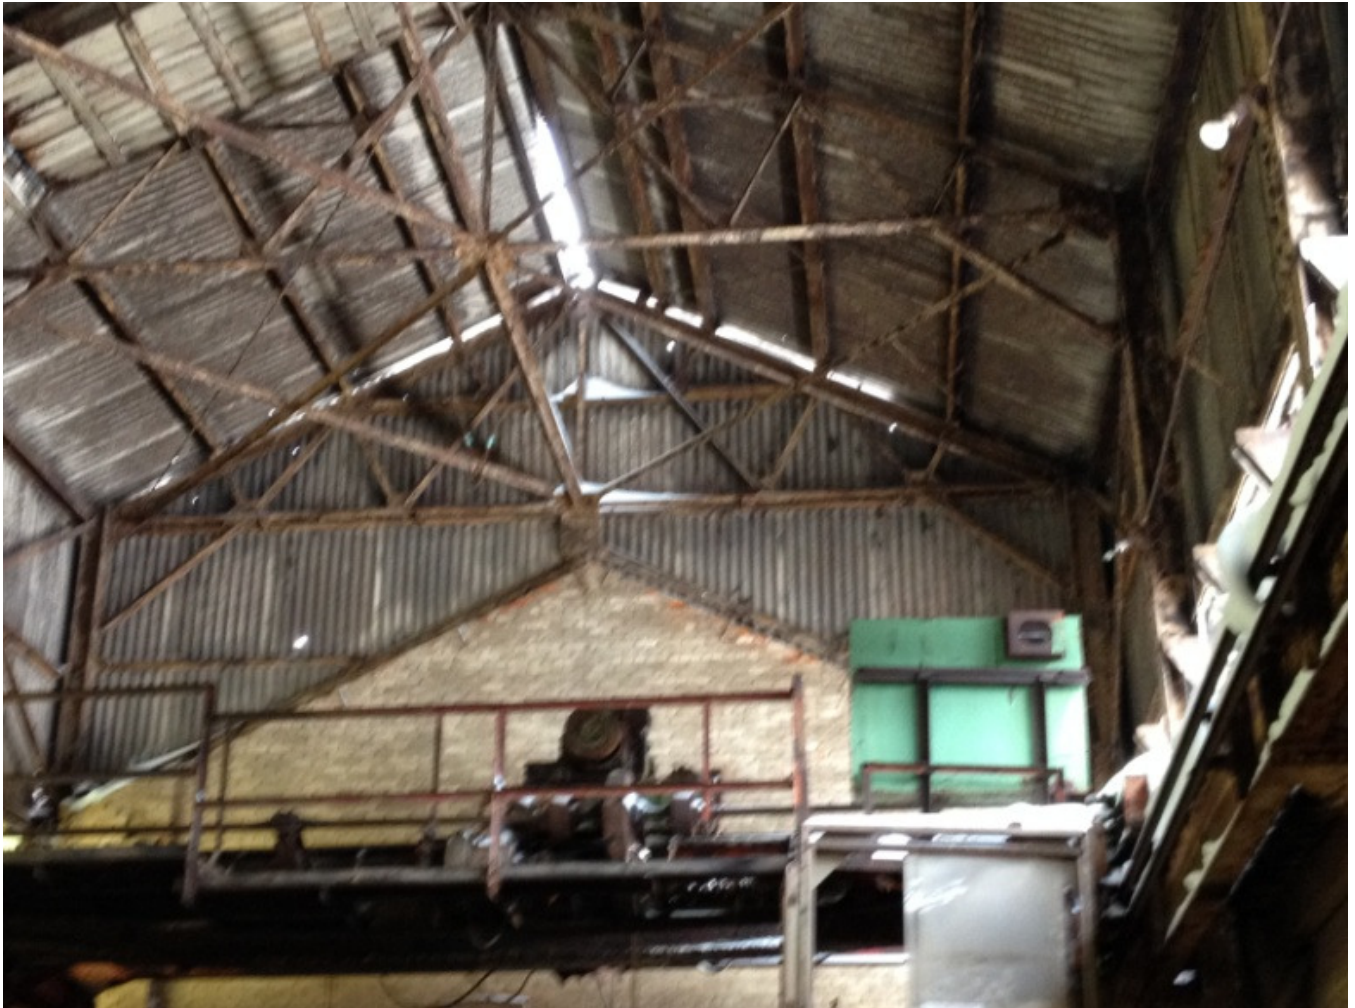
The west pickling room is comprised of steel roof trusses with metal deck supported by steel columns with brick masonry infill walls. The metal roof deck has rust through holes and the steel framing is rust covered. A section of roof has collapsed at the westerly end of the building. The brick masonry wall between the pickling room and the production area has large structural cracks and is failing. The built up riveted steel columns supporting the roof have rust through holes in the webs and the curvature from plumb indicates they may be reaching their buckling load.

Photo 17: Steel trusses and metal deck form high roof

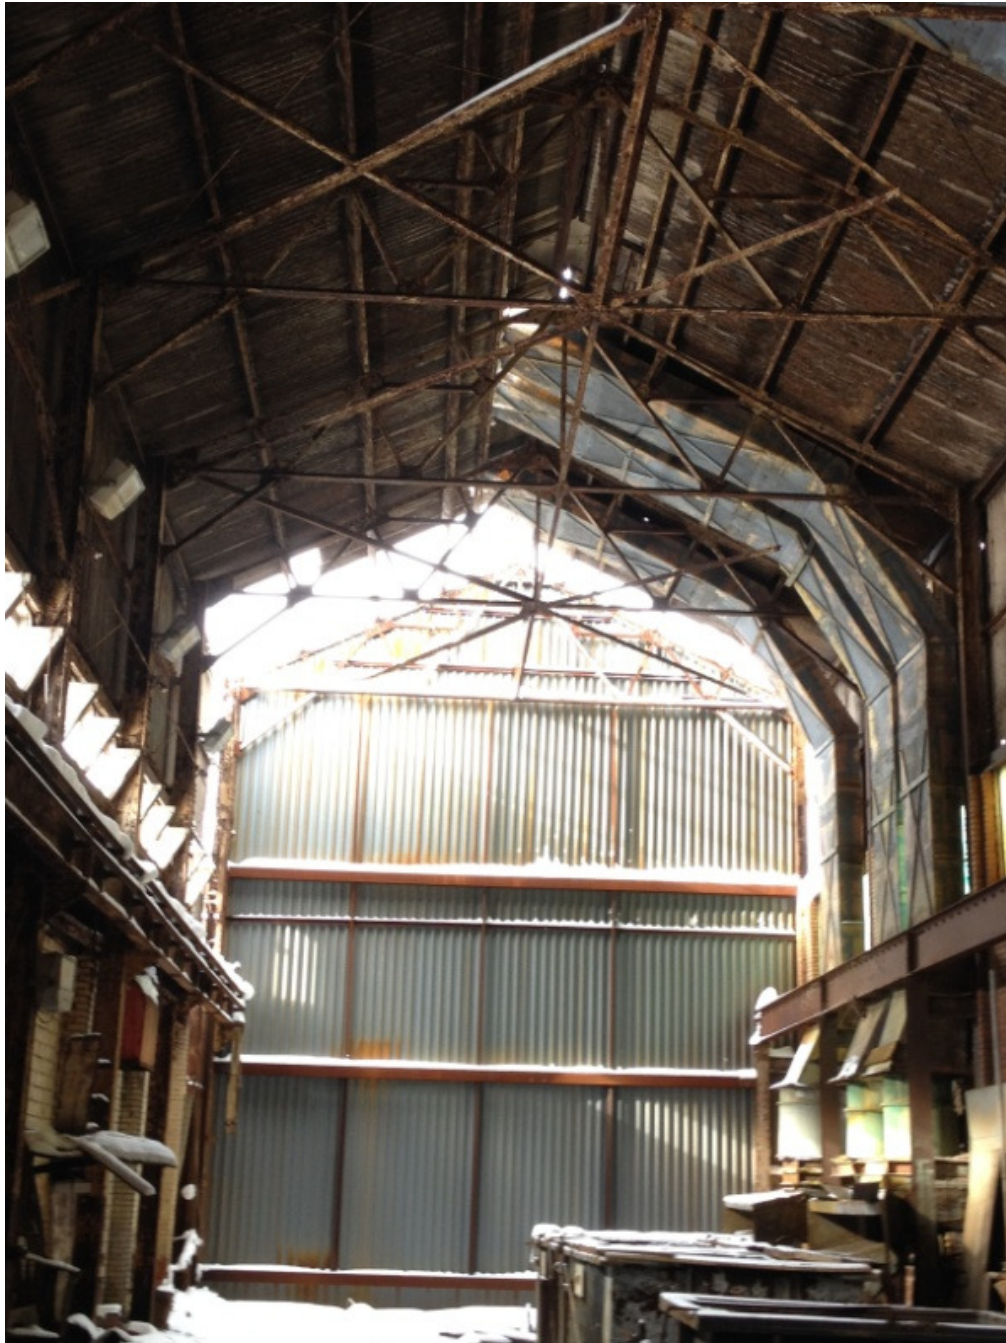
Photo 18: Collapsed roof at west end of building

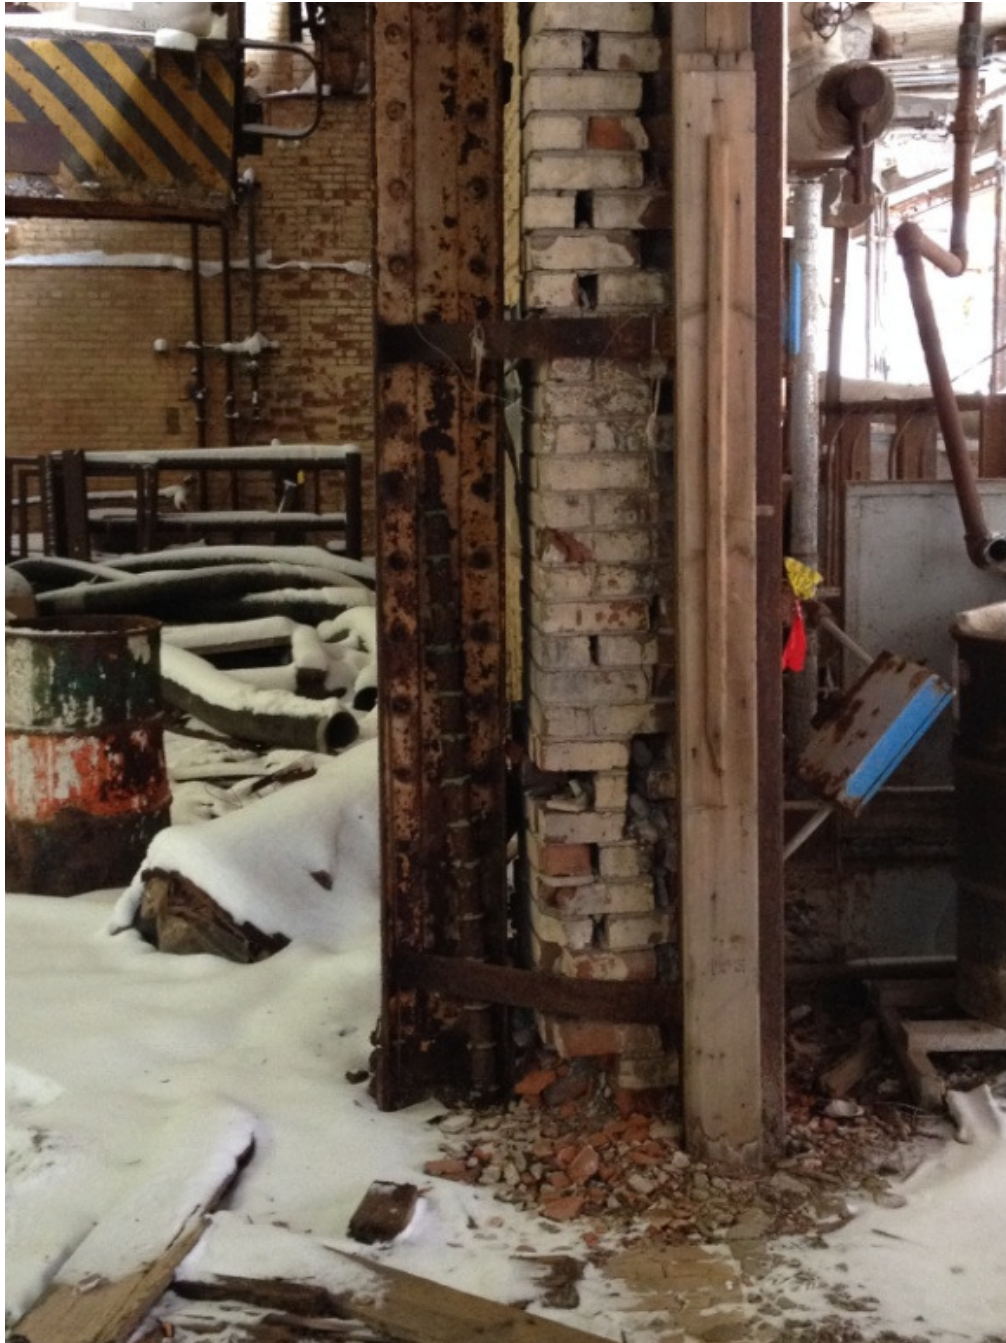
Photo 19: Failing brick masonry wall with large structural cracks

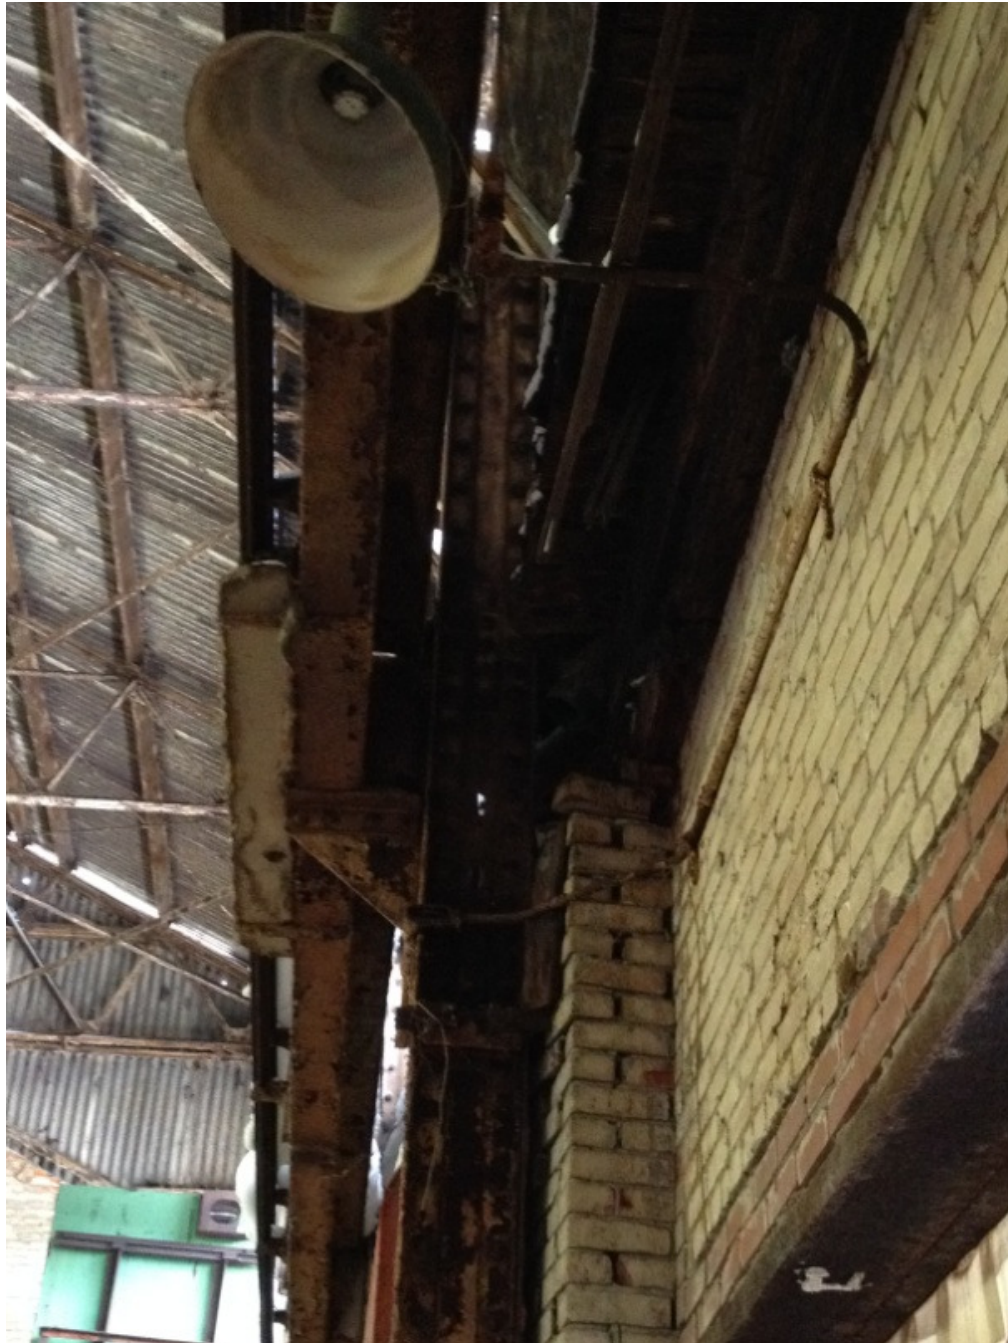
Photo 20: Curved column & rust through holes in web

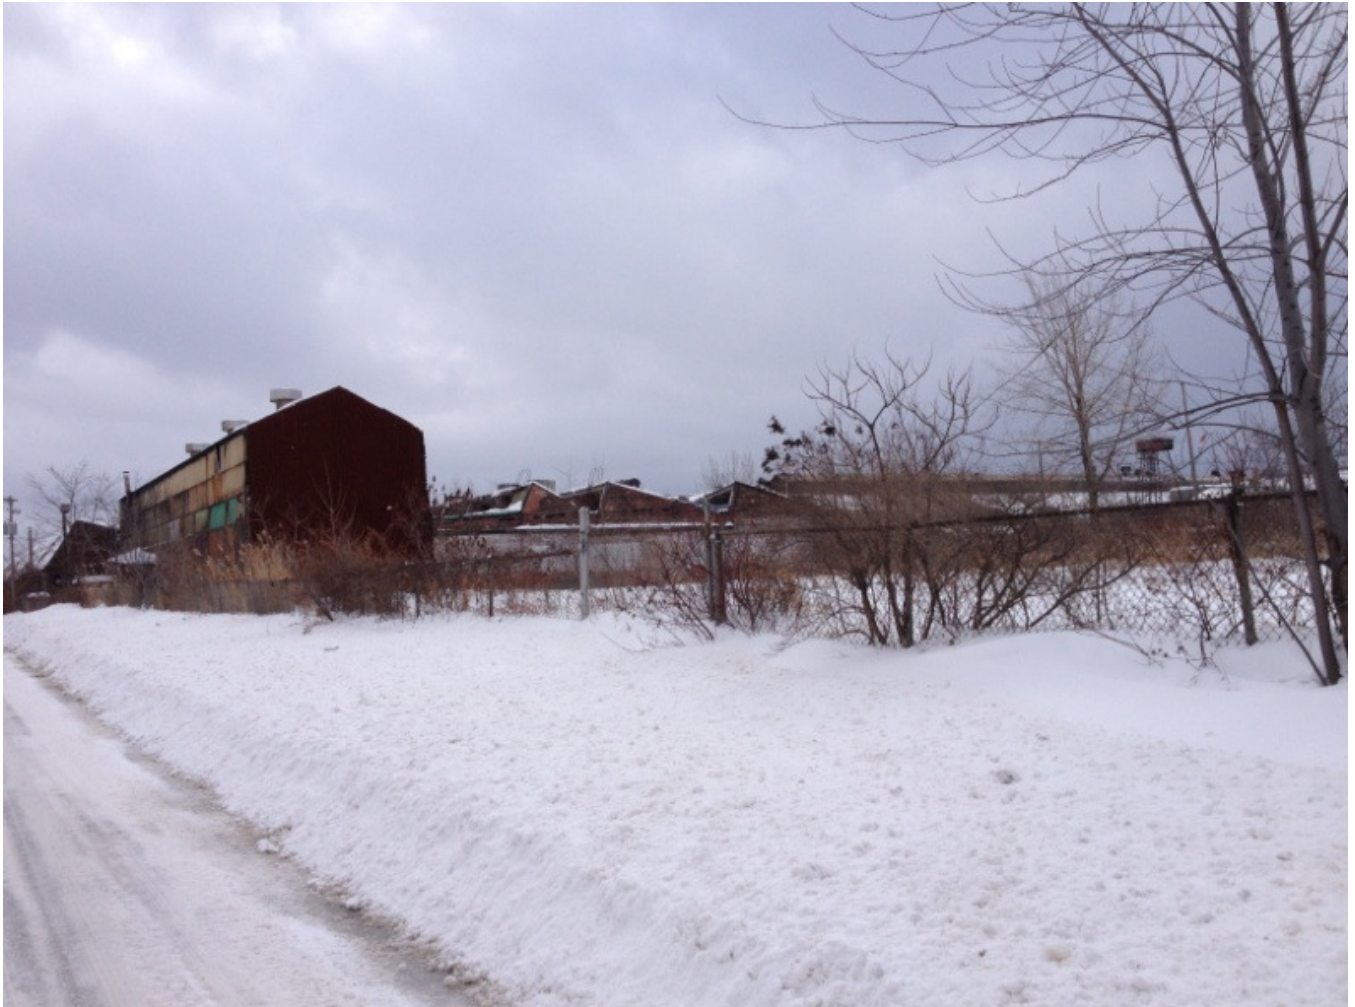
Photo 21: Westerly elevation of pickling and production areas
