November 10, 2017

RE: **VAPOR INTRUSION EVALUATION  
FORMER CHEMICAL LEAMAN TANK LINES FACILITY, SITE NO. 9-15-014  
TONAWANDA (C), ERIE COUNTY, NY**

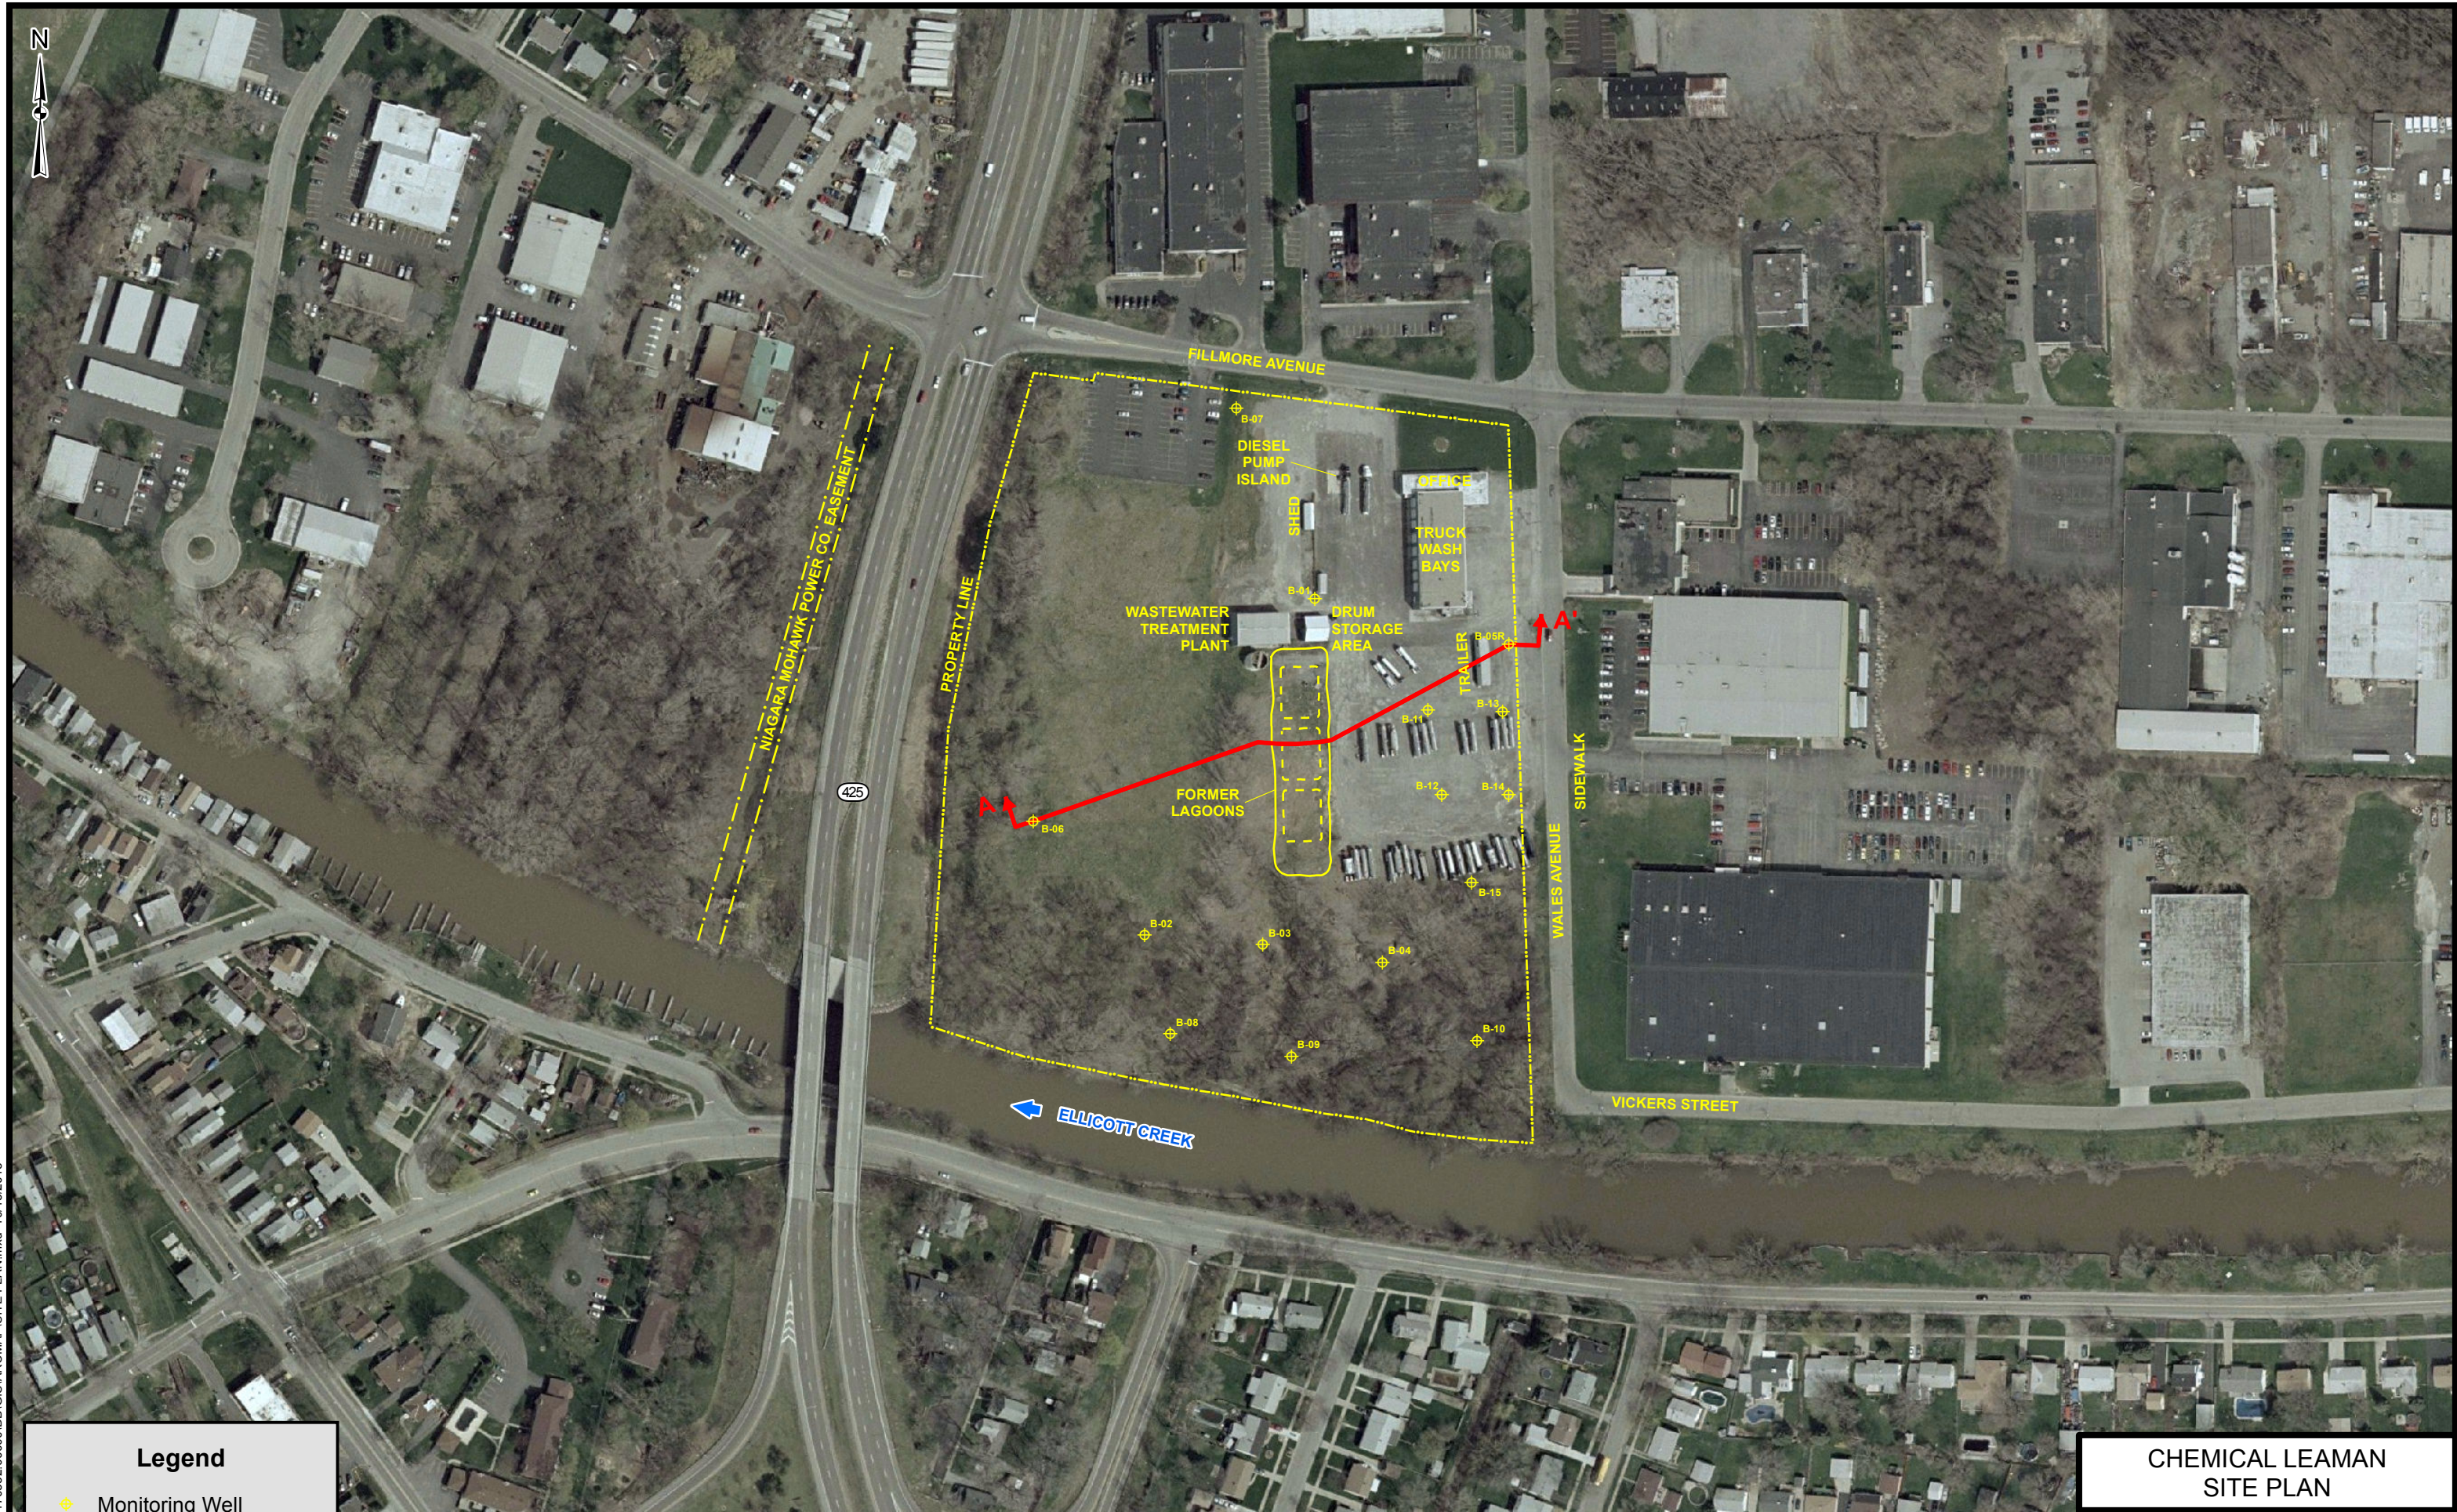
FIGURE 1

There are currently four buildings located on site; 1) the former waste water treatment building, 2) the former drum storage area, 3) the truck wash/service bays, and 4) the office building (Figure 1). All buildings are concrete slab-on-grade construction. The former waste water treatment and drum storage area buildings are no longer used and are unoccupied. The truck wash/service bays building and office building are the only occupied buildings.

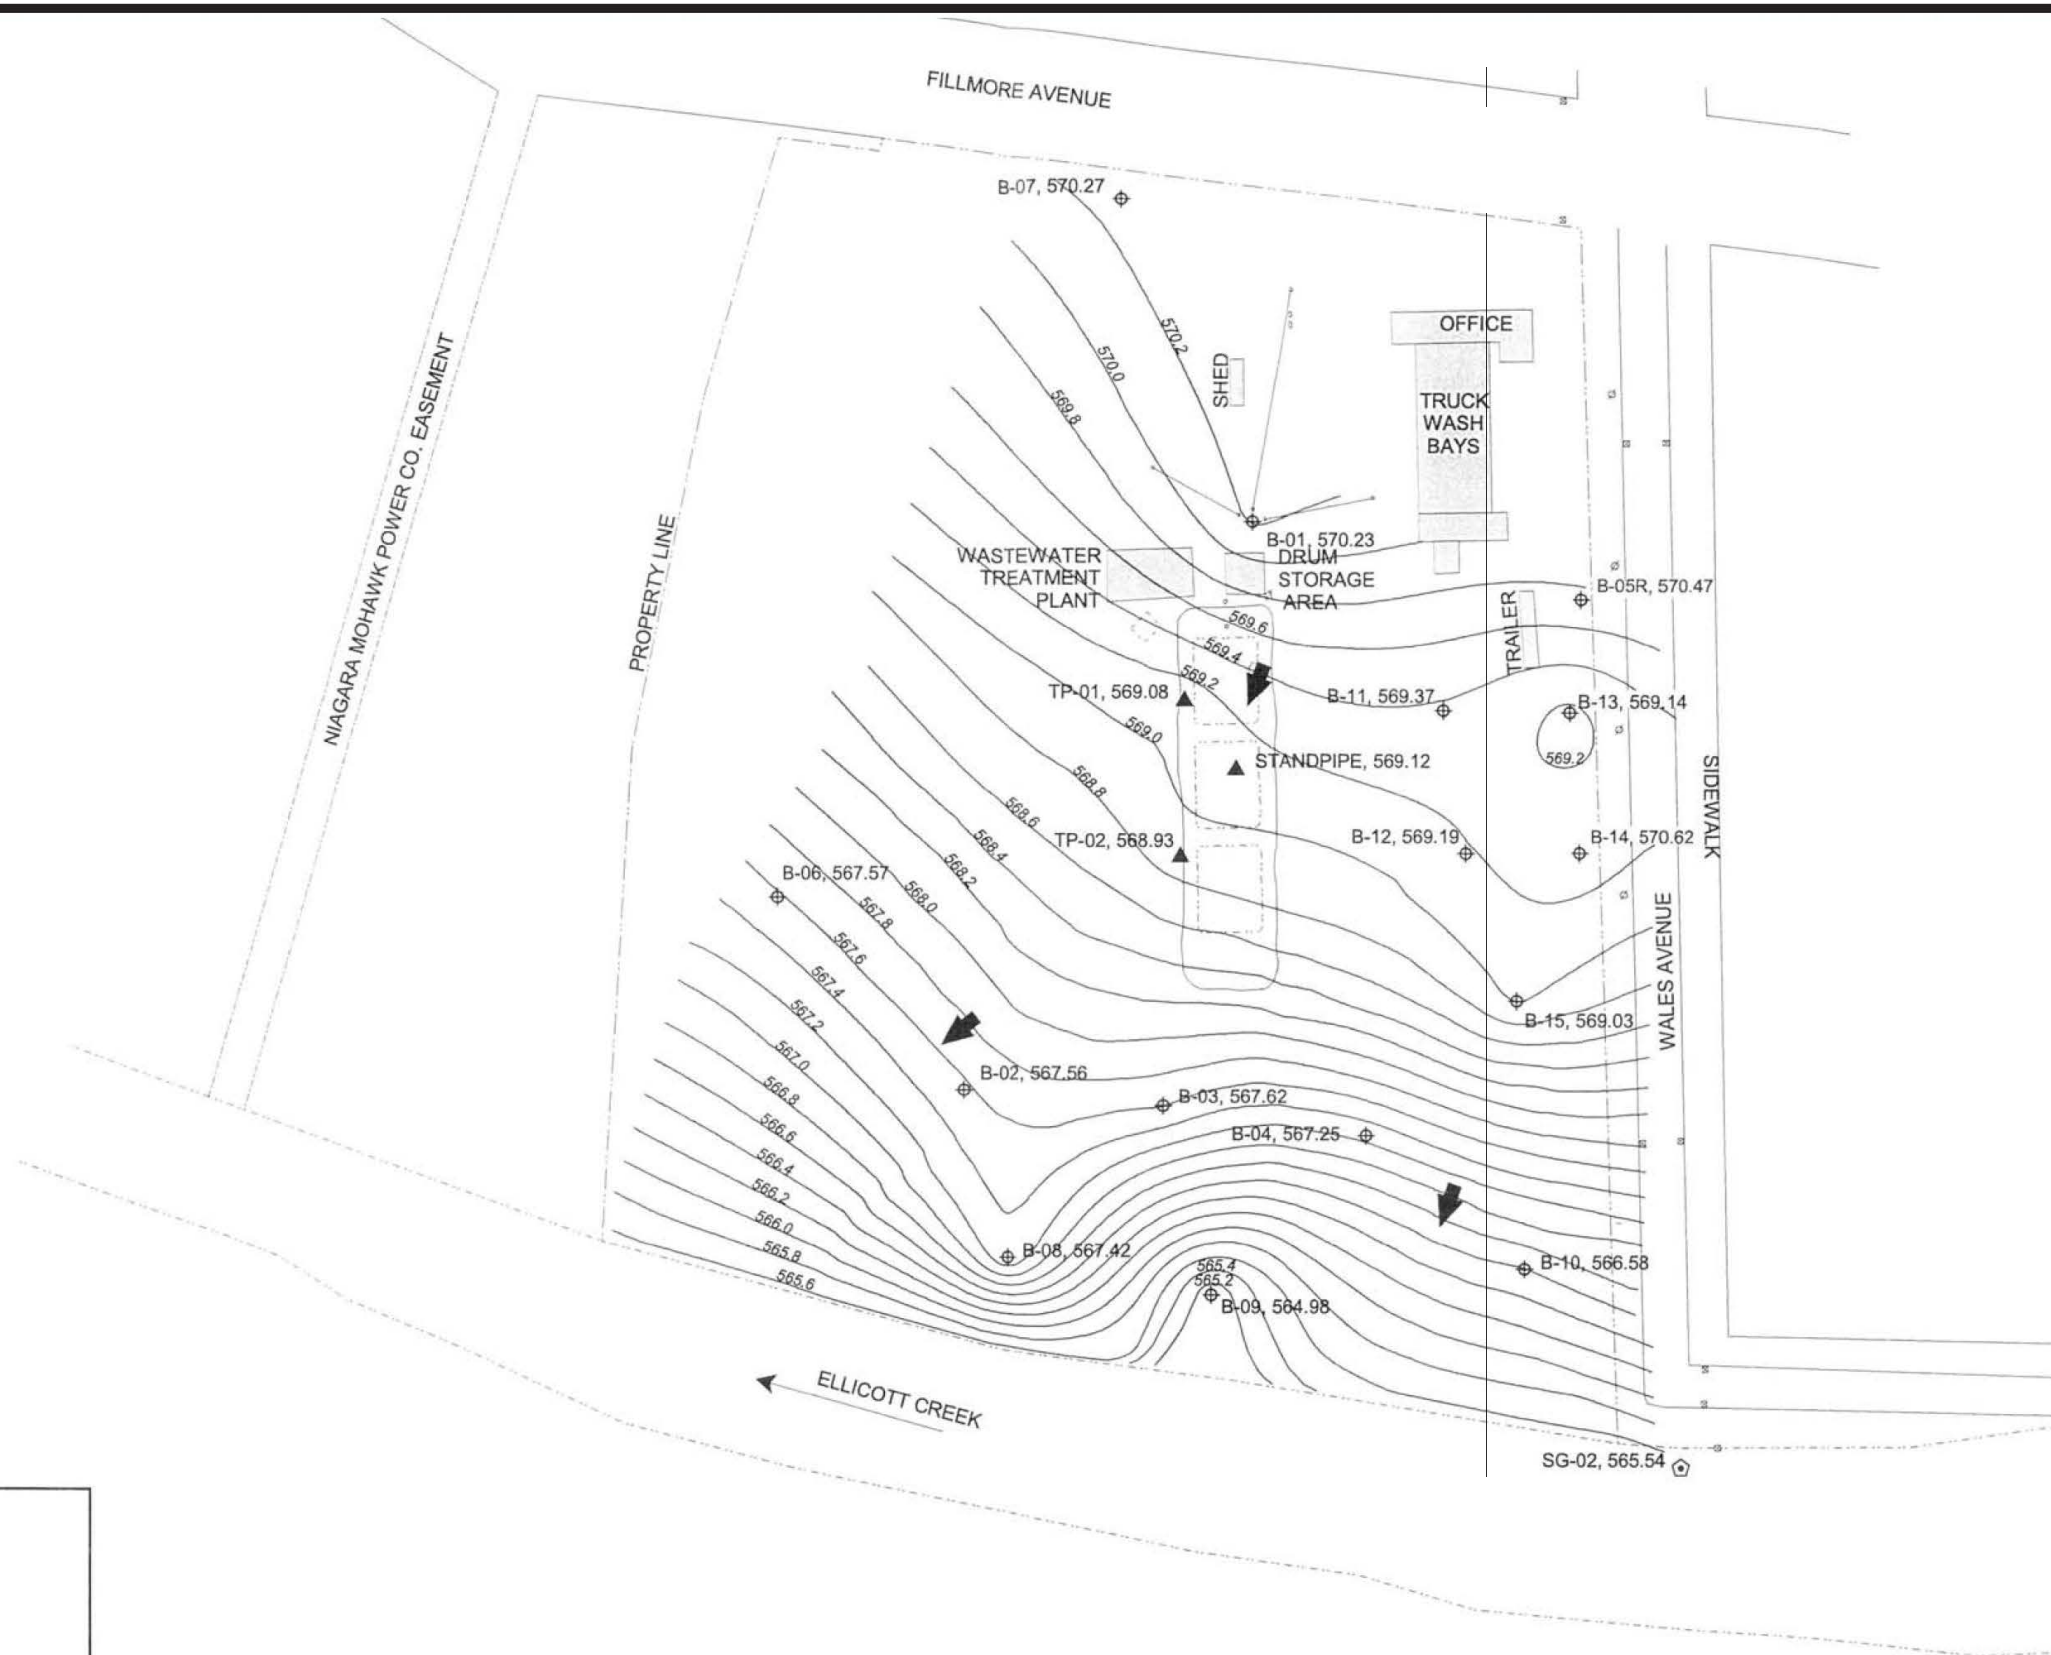
FIGURE 2

Historically, groundwater has been encountered at the Site between 3-8 feet below grade. Flow is predominantly to the south toward Ellicott Creek, with some mounding observed at times in the former lagoon vicinity (Figures 2 and 3).

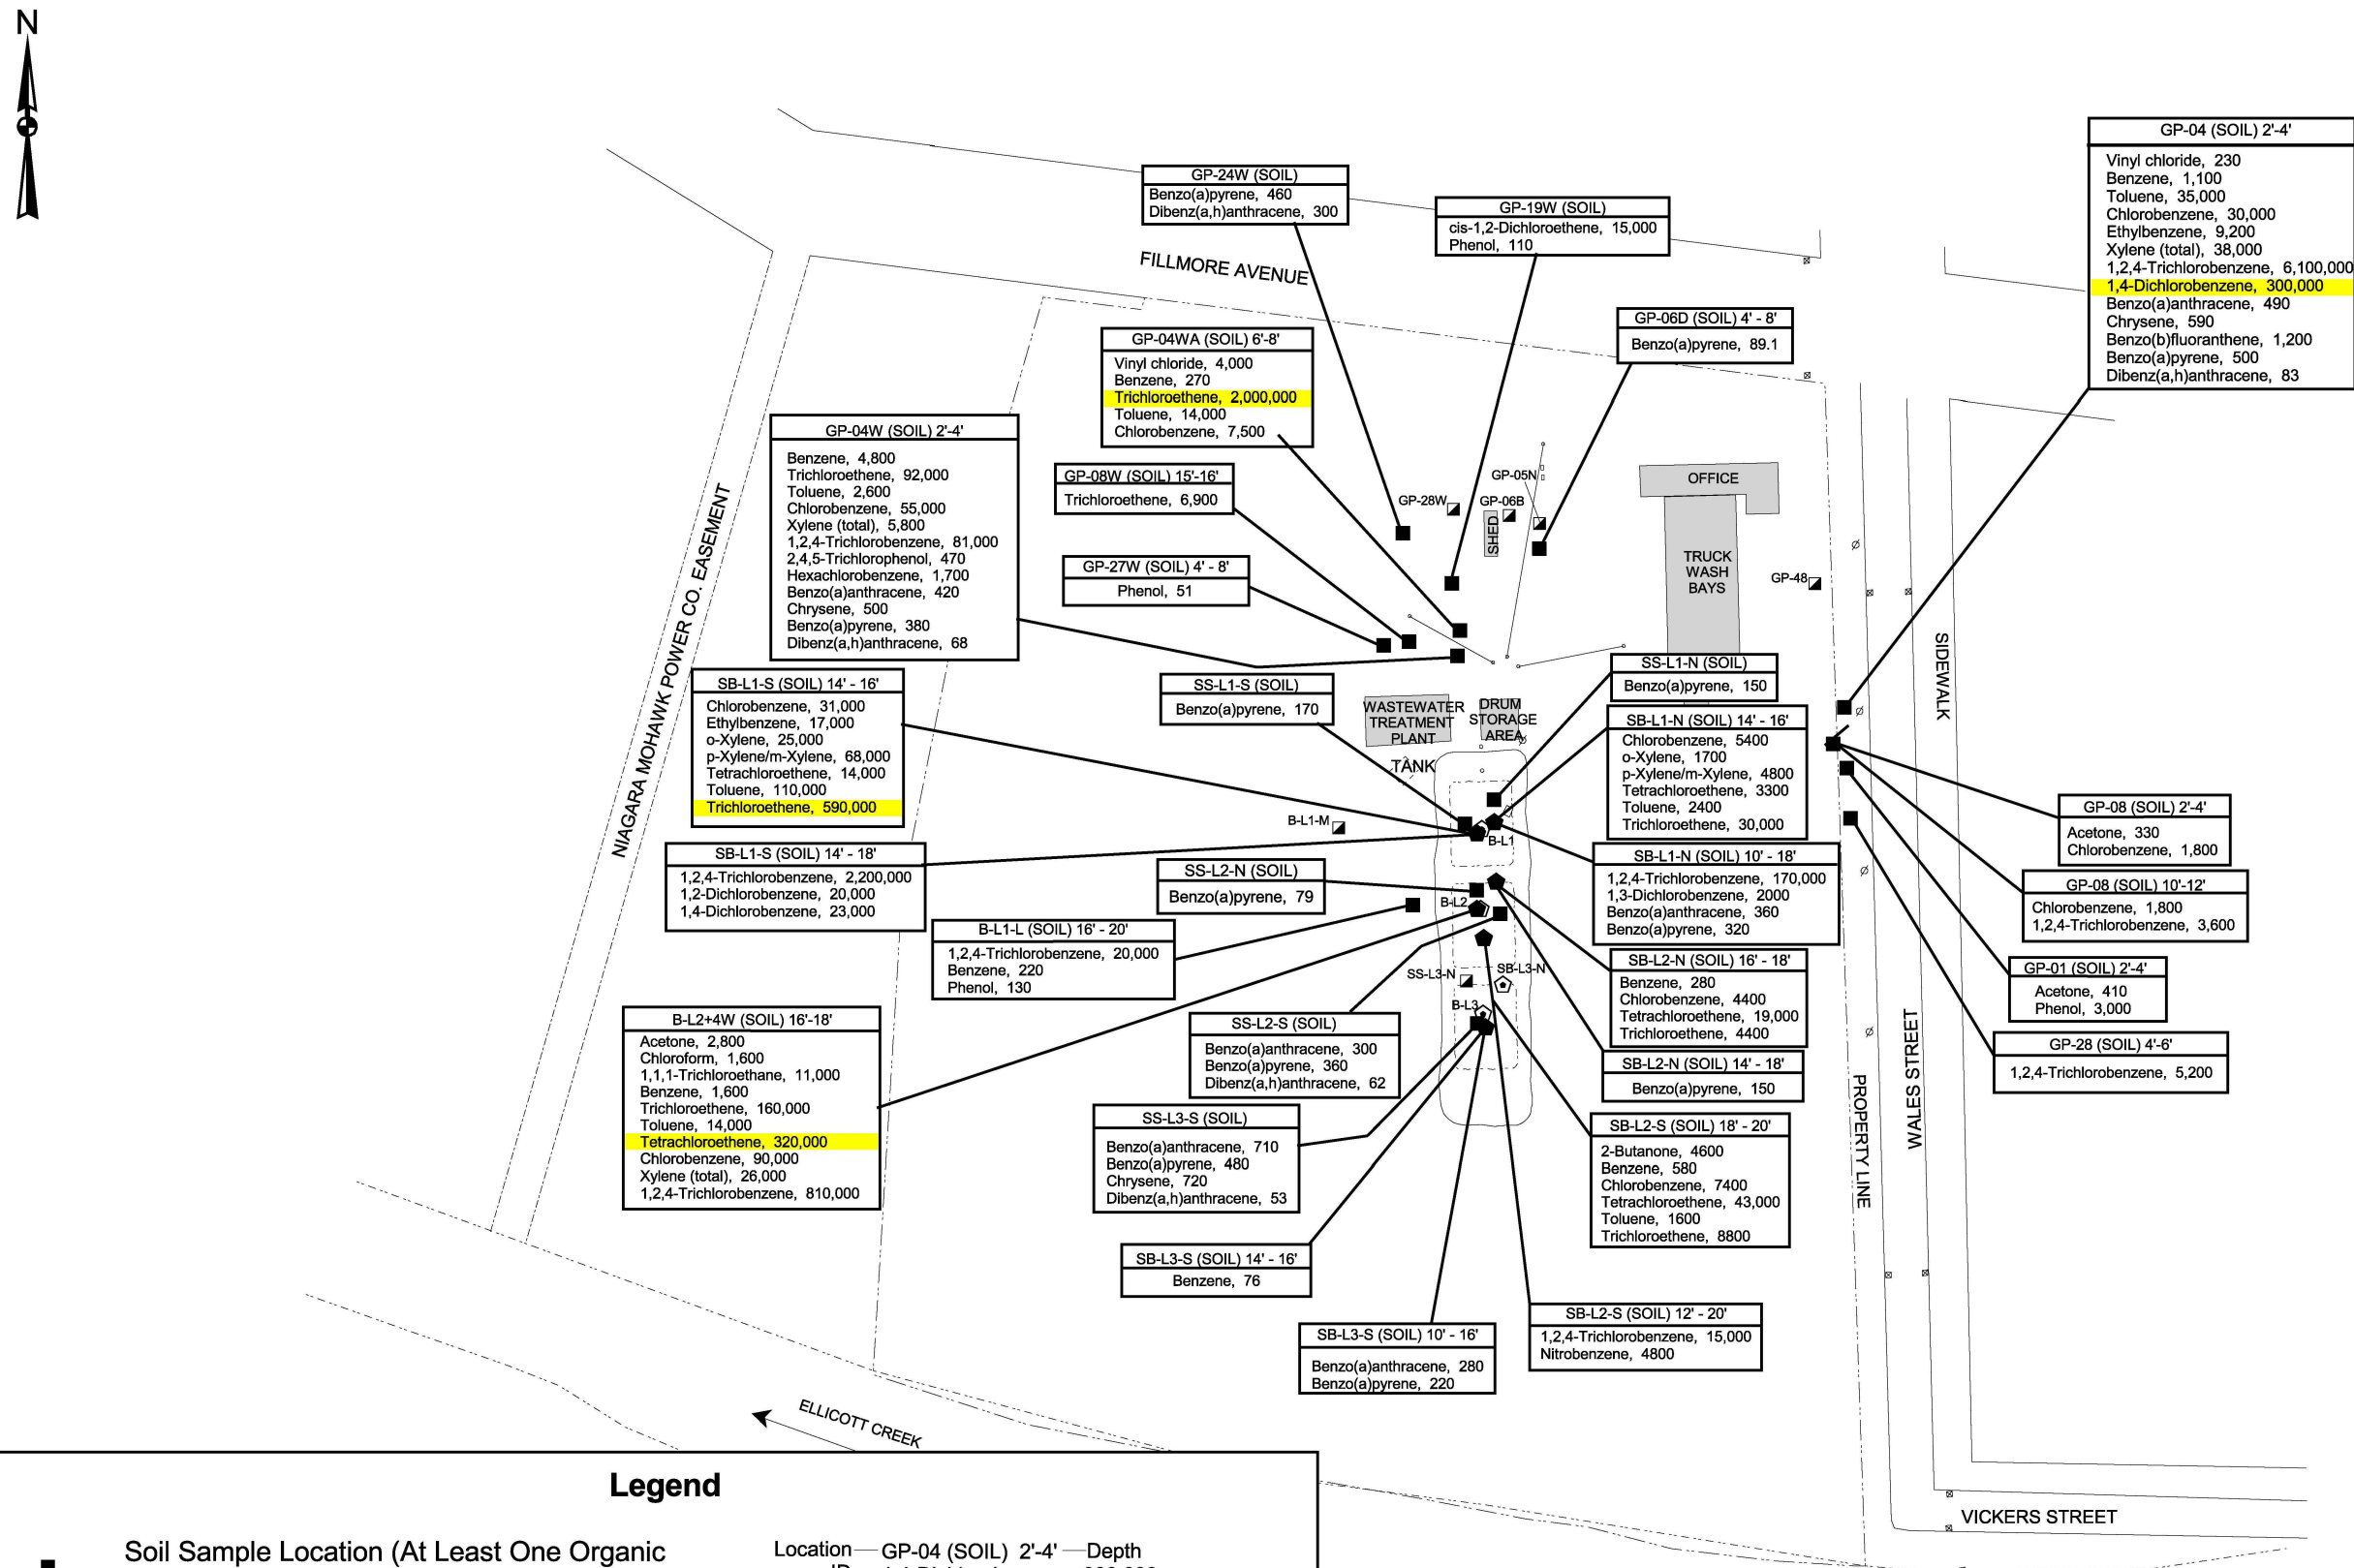
FIGURE 5

During previous investigations, three areas of the Site, identified as Operable Units 1, 2, and 3 (Figure 4) exhibited evidence of soil contamination (Figures 5, 6, and 7). Volatile organic compounds (VOCs) were the primary constituents of concern. When the laboratory analytical results of the soil

- two sample locations within Operable Unit 1 (14-24 feet below ground surface),
- three sample locations within Operable Unit 2 (3-8 feet below ground surface),
- two sample locations within Operable Unit 3 (2-4 feet below ground surface).

Because of the depth of the contamination in Operable Unit 1 it was decided to treat it in March 2015 with nutrient injections to promote enhanced bioremediation. The contamination in Operable Units 2 and 3 was excavated in May 2015 and disposed of off-Site. Confirmation soil samples indicated no exceedances of Part 375 commercial SCOs in Operable Units 2 or 3 following excavation. Additional groundwater sampling has been proposed for Operable Unit 1 to check on the effectiveness of the remedy.

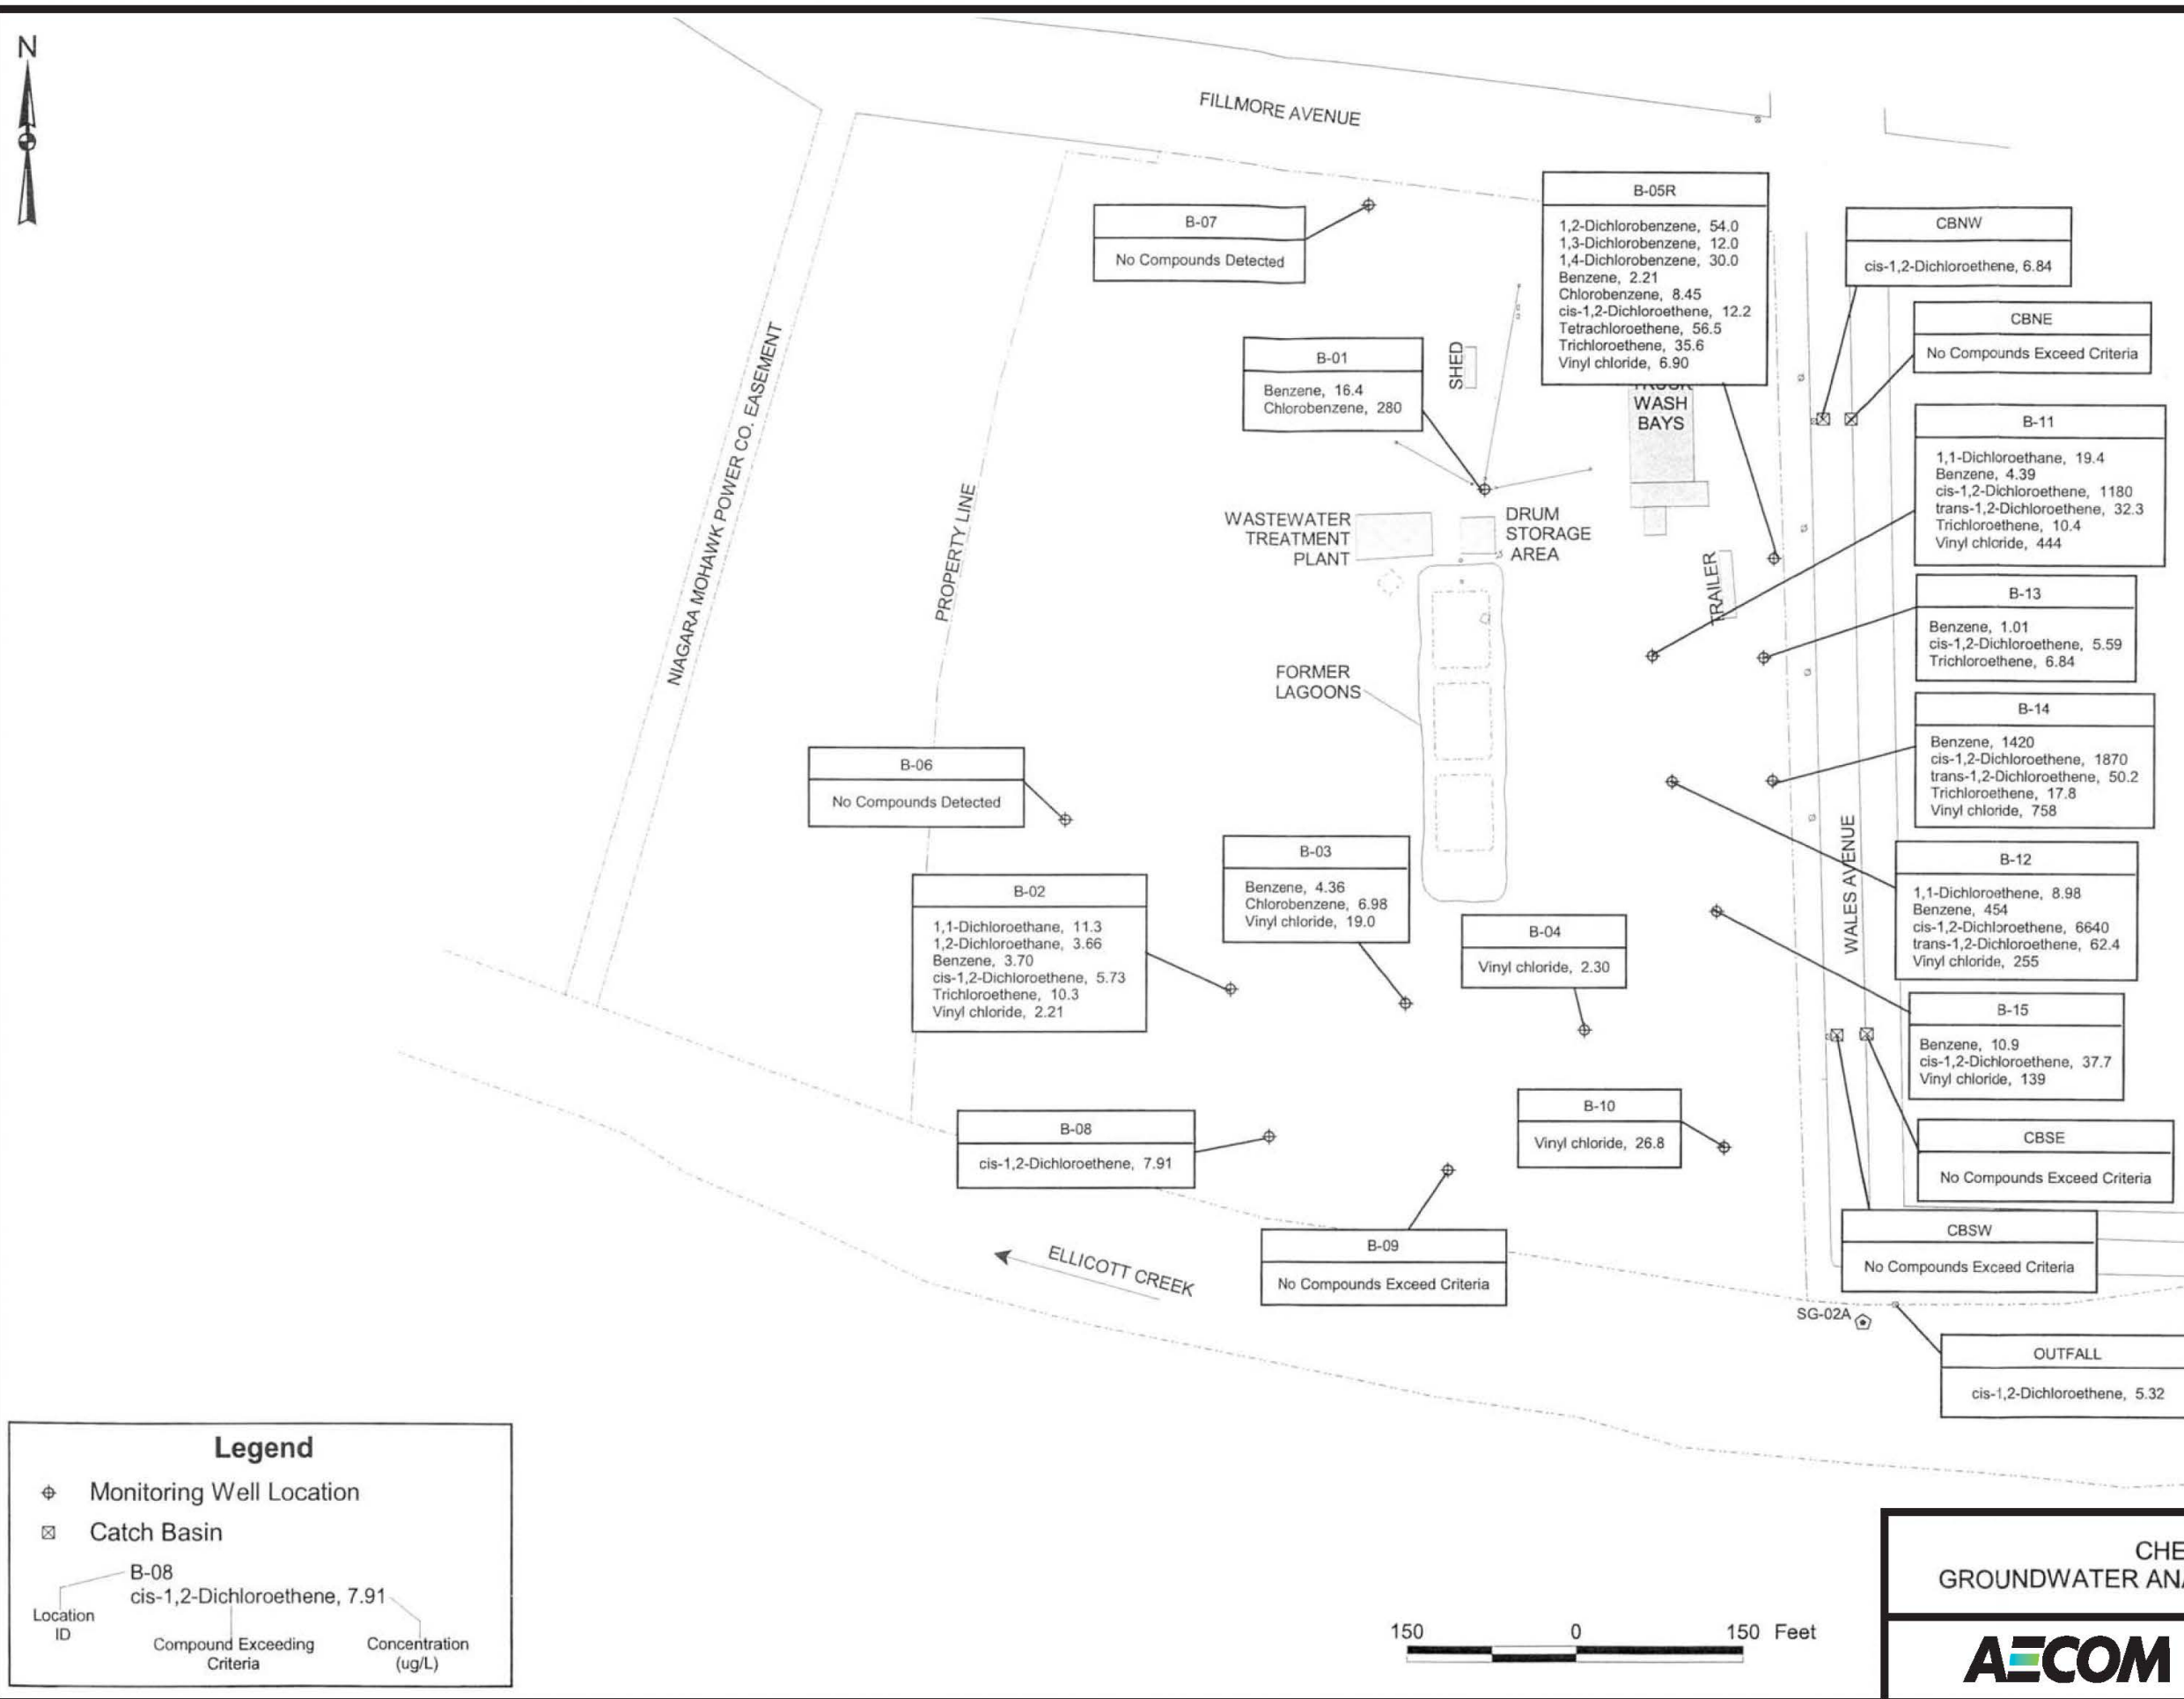
CHEMICAL LEAMAN  
GROUNDWATER ANALYTICAL RESULTS (JUNE 2004)

As indicated in previous investigations, groundwater in the vicinities of the Operable Units was impacted by VOCs at concentrations that exceeded Class GA groundwater standards (Figure 8). However, the last time site-wide groundwater was sampled at the Site was June 2004 and potential source areas have since been excavated or treated by remedial injection. As discussed below, the groundwater contamination was basically downgradient of the Site buildings.

For groundwater, monitoring well B-01 provides the best comparison. In June 2004, benzene was detected at a concentration of 16.4 micrograms per liter (µg/L). The well lies approximately 125 feet from the Truck Wash Bays and more than 150 feet from the Office, basically downgradient (particularly for the Office), and well outside the 30 feet recommended by ASTM E2600-15. In addition, hydrocarbons typically will decay in the vadose zone and, therefore, do not pose a significant risk of VI.
